## Photographic Schedule of Condition

Goulbourne  
Borras Park Road  
Wrexham  
Clywd, LL12 7TF

Star Pubs & Bars

Tel: 01604 664366  
Fax: 01604 664367  
Date: 4 May 2016  
Ref: 0101487-BC-0000

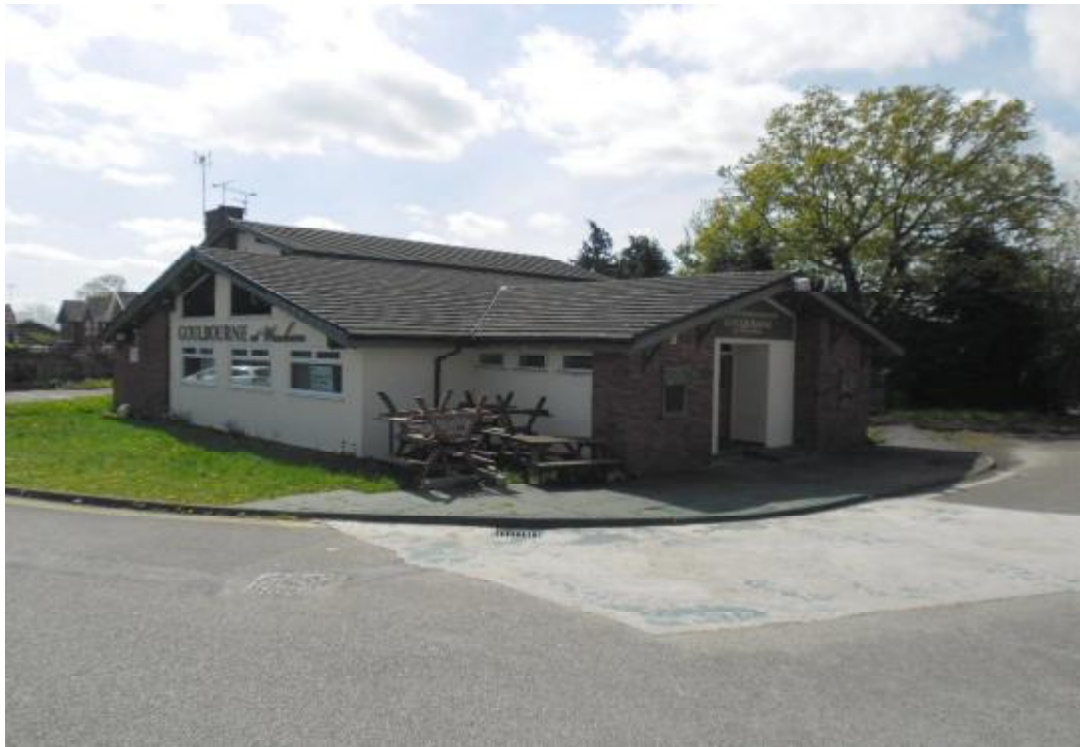
Photograph 1: General view of pub.

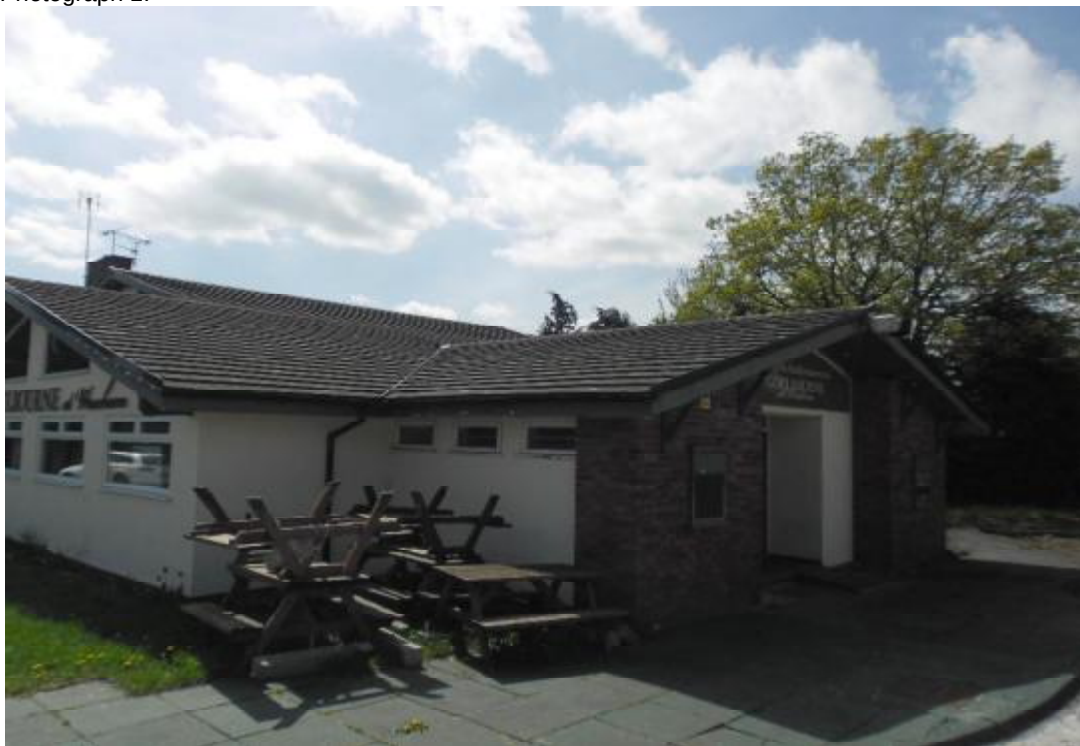
Photograph 2: General view of roof to front elevation.

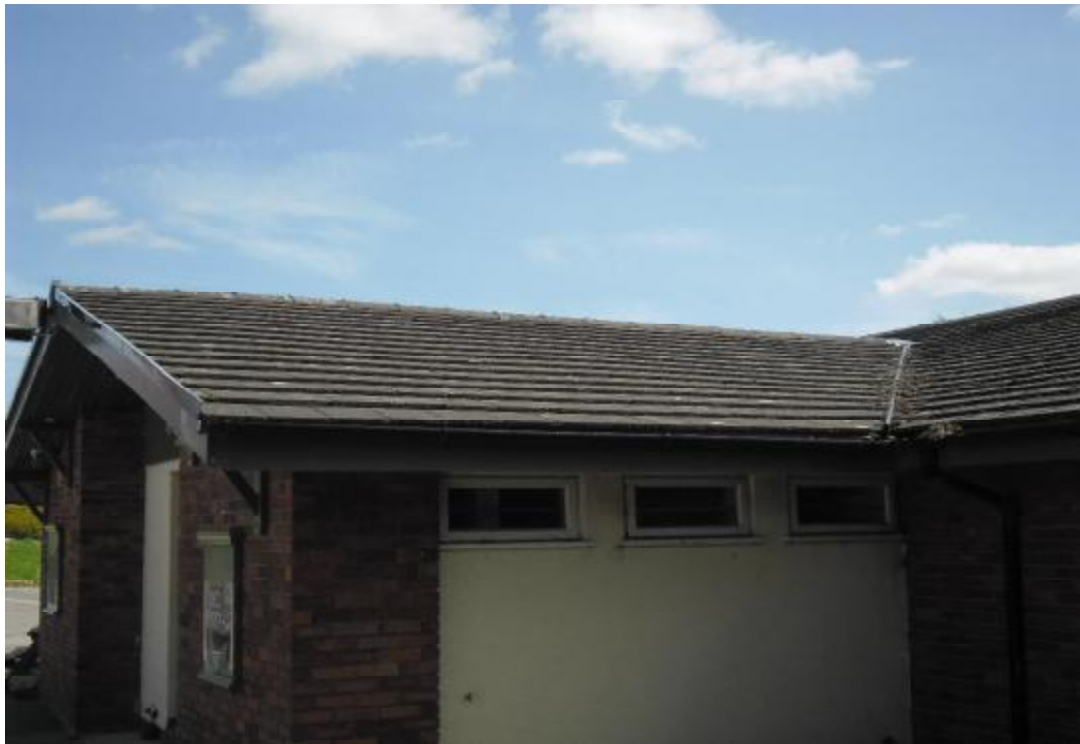
Photograph 3: Alternative view of roof to front elevation.

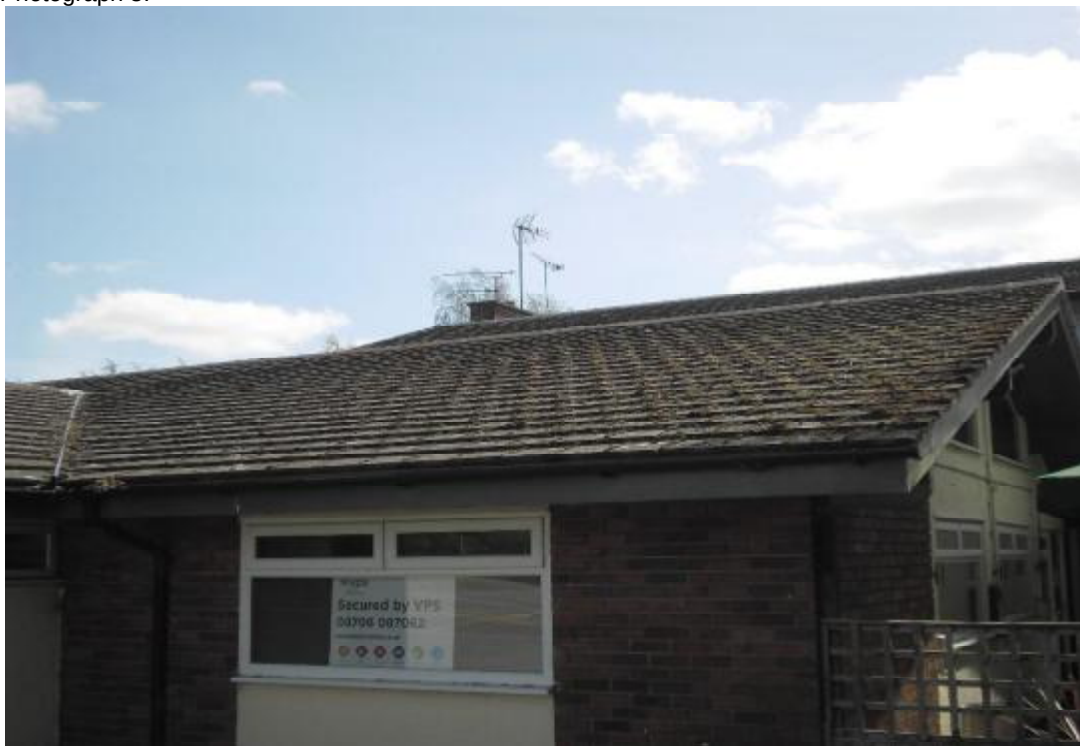
Photograph 4: General view of roof to front elevation.

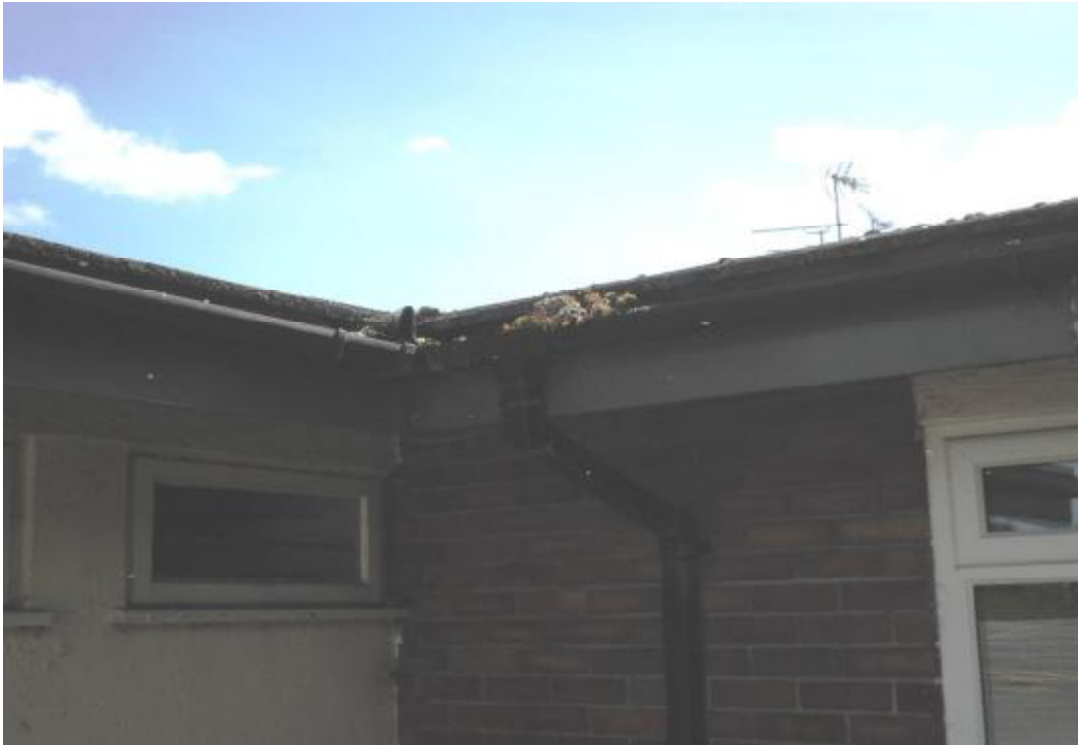
Photograph 5: View of vegetation growth within rainwater gutter to front elevation.

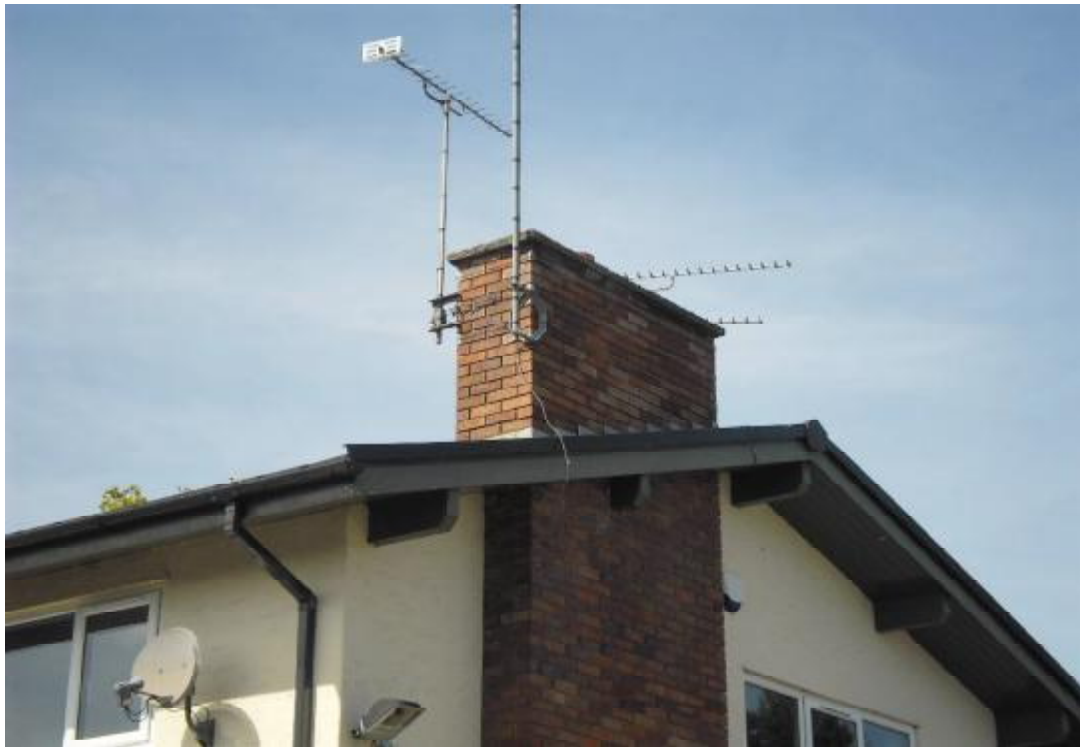
Photograph 7: View of chimney to left-hand side elevation.

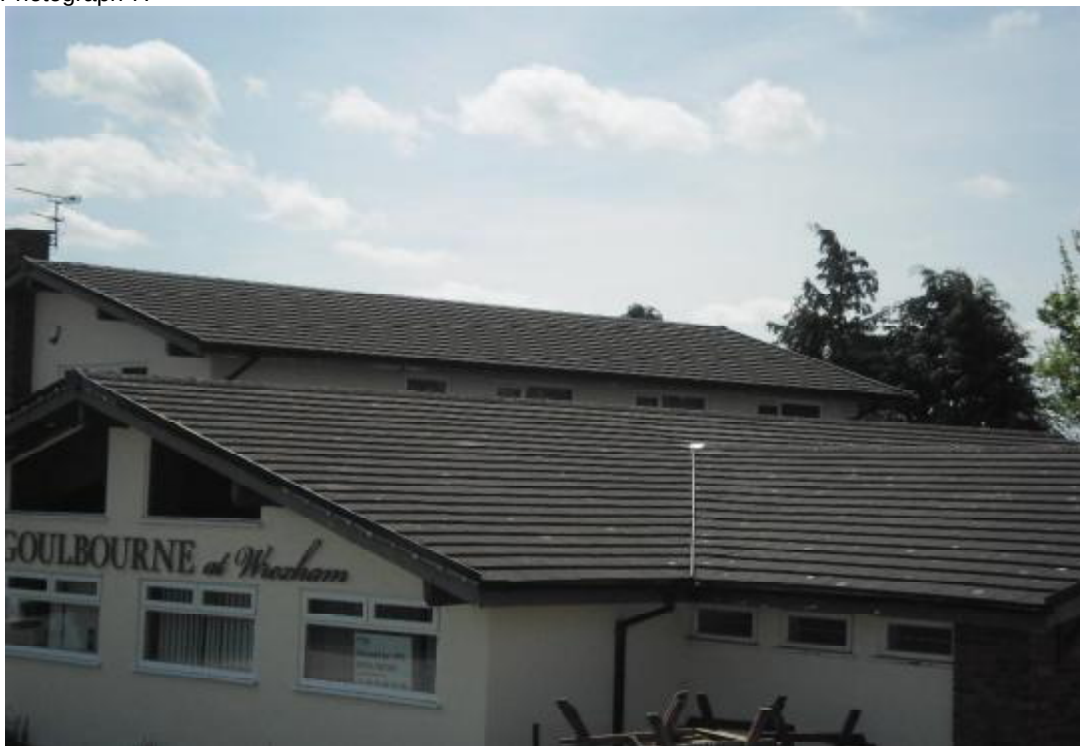
Photograph 8: General view of roof to left-hand side elevation.

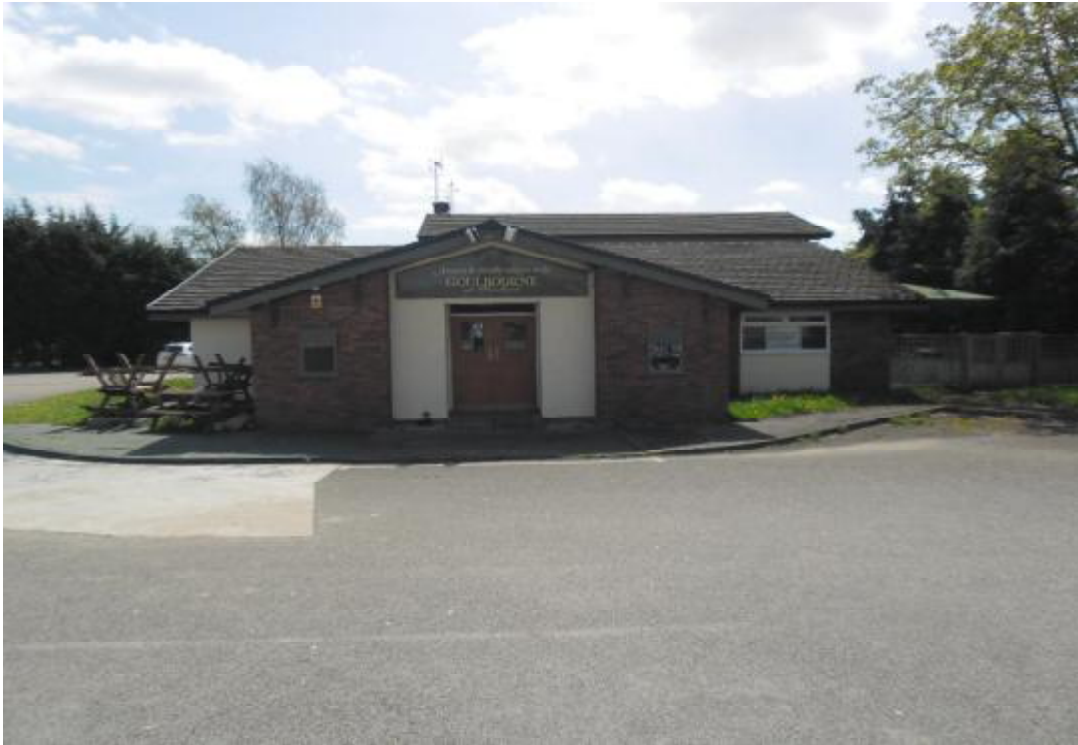
Photograph 9: General view of front elevation.

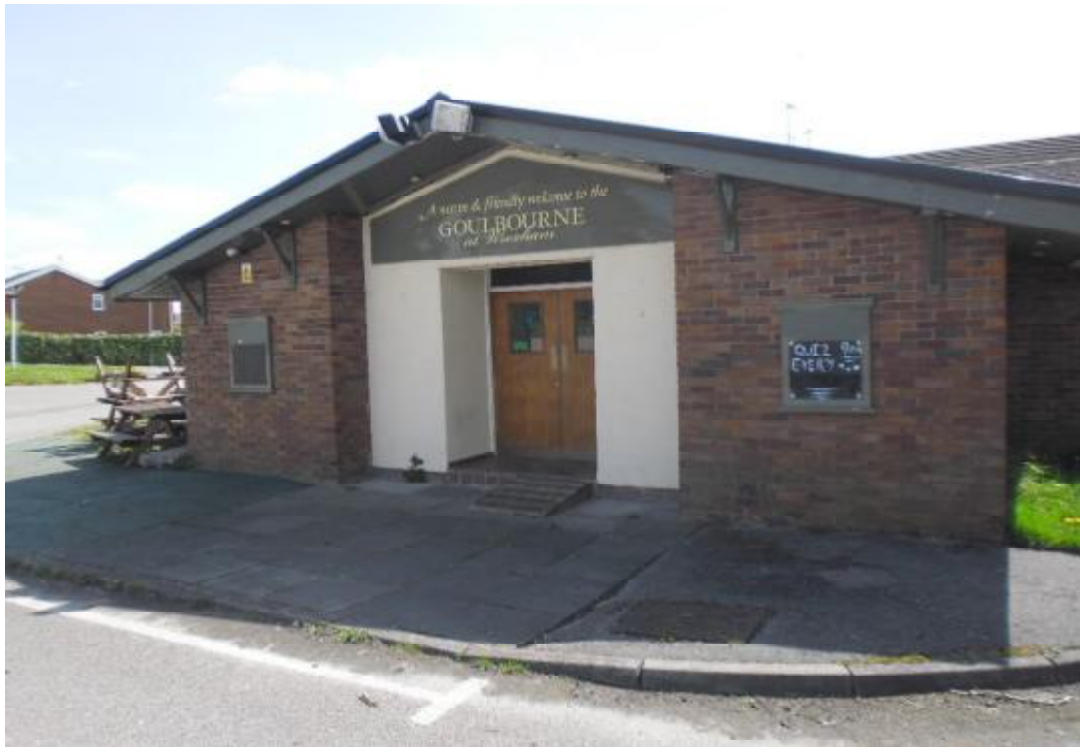
Photograph 11: Central view of front elevation.

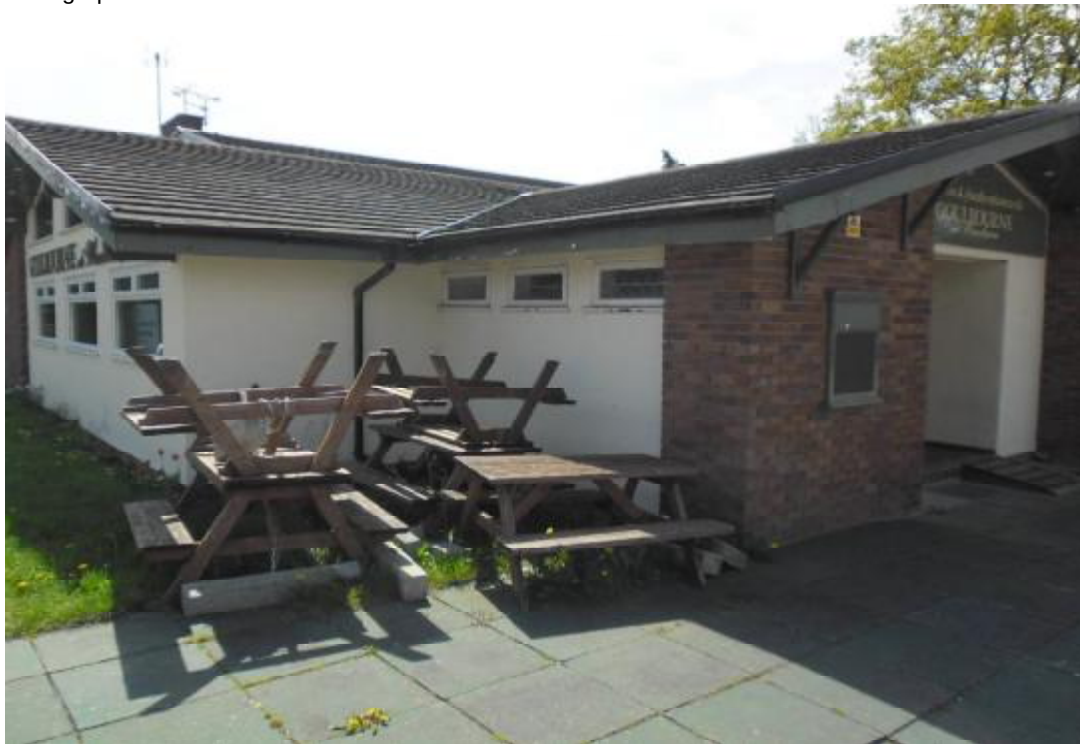
Photograph 12: Left-hand view of front elevation.

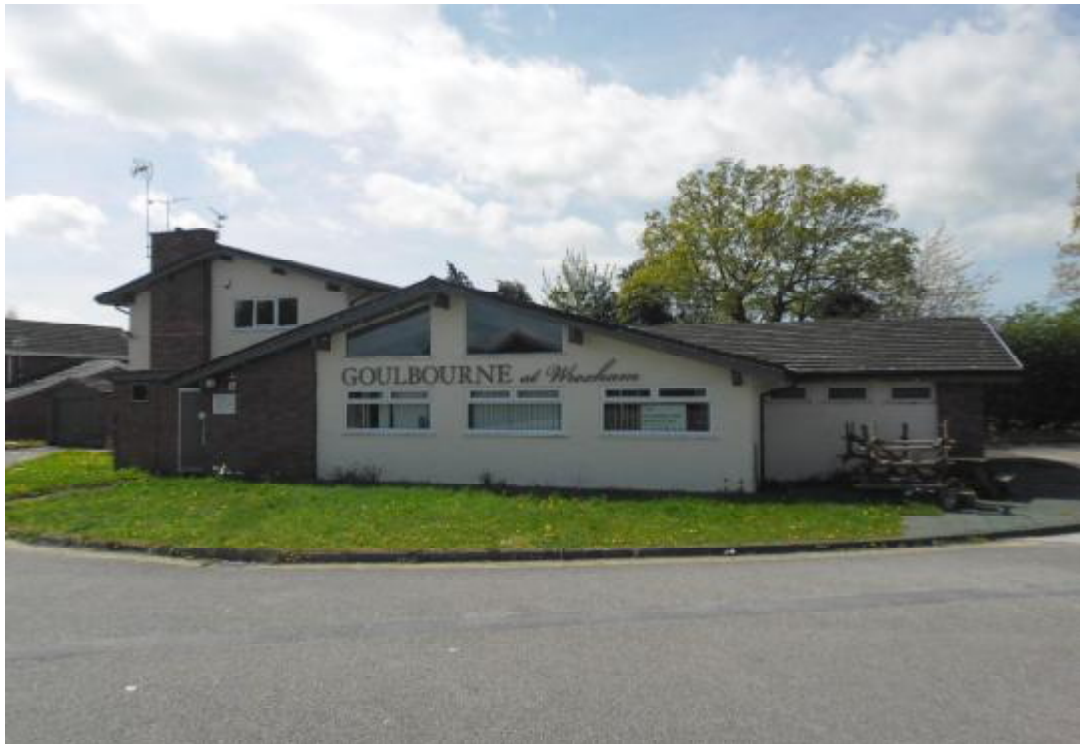
Photograph 13: General view of left-hand elevation.

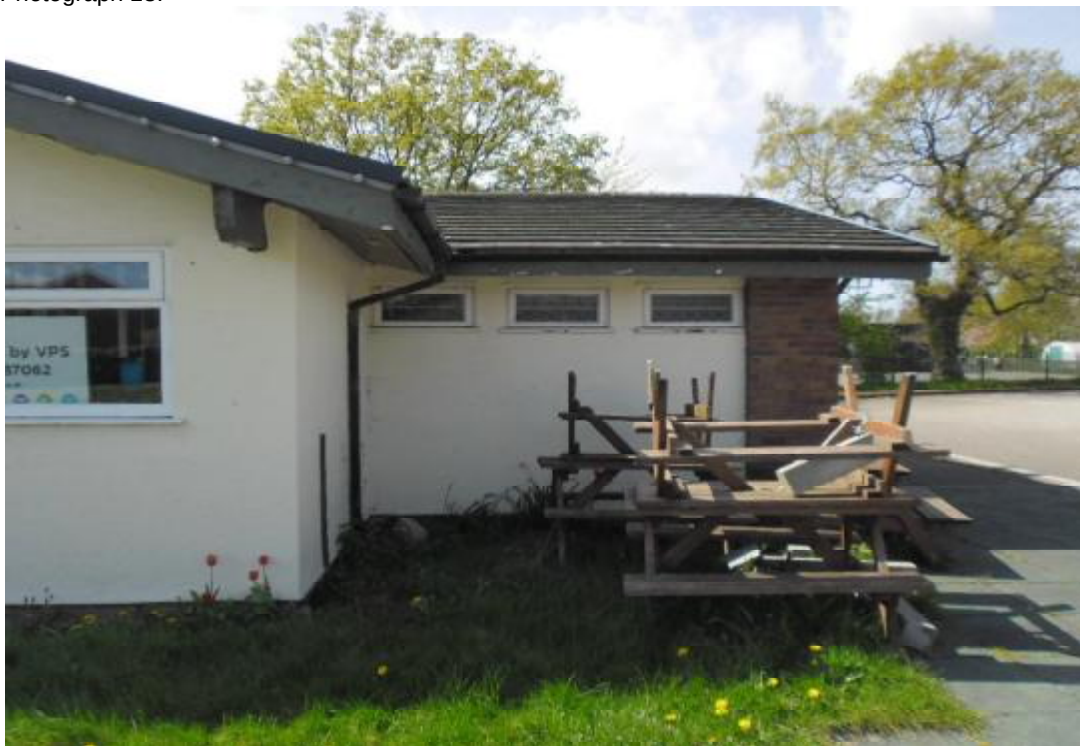
Photograph 14: Right-hand view of left elevation.

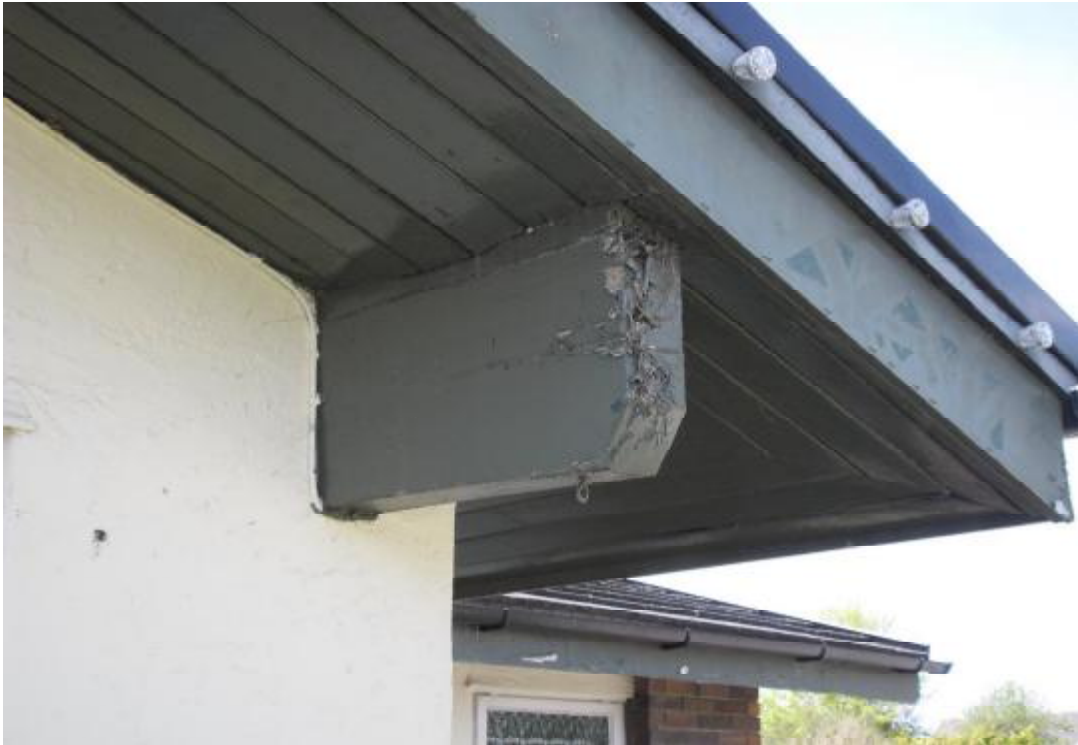
Photograph 15: Poor decorations to soffits.

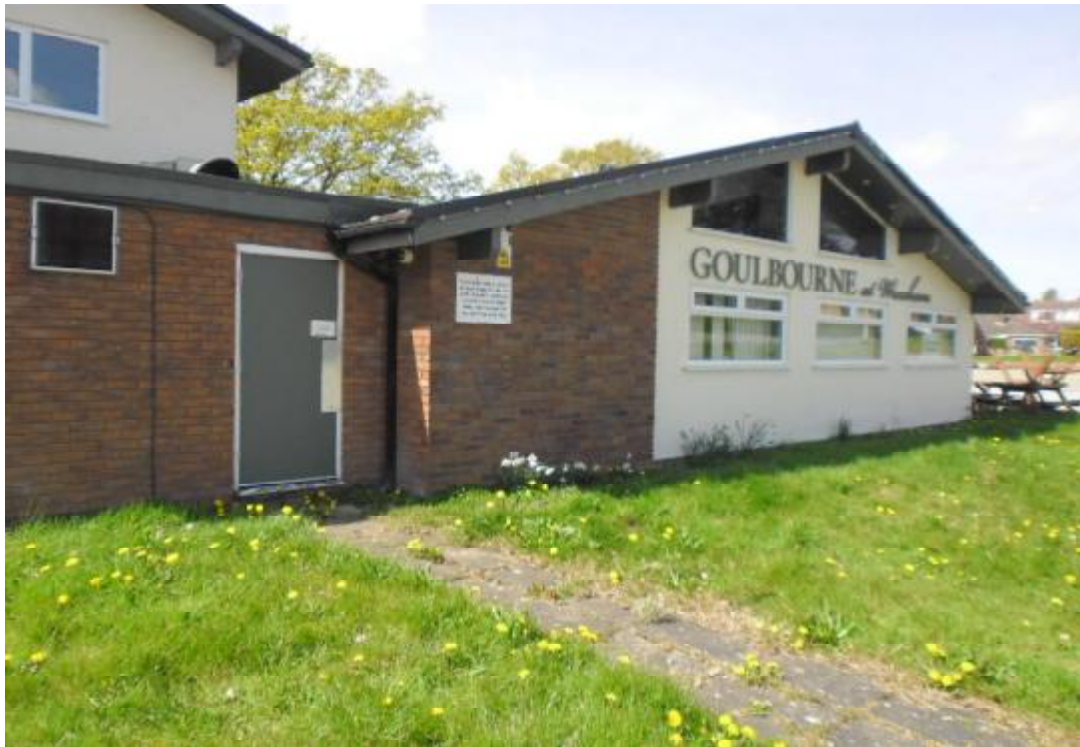
Photograph 17: General view of left-hand side elevation.

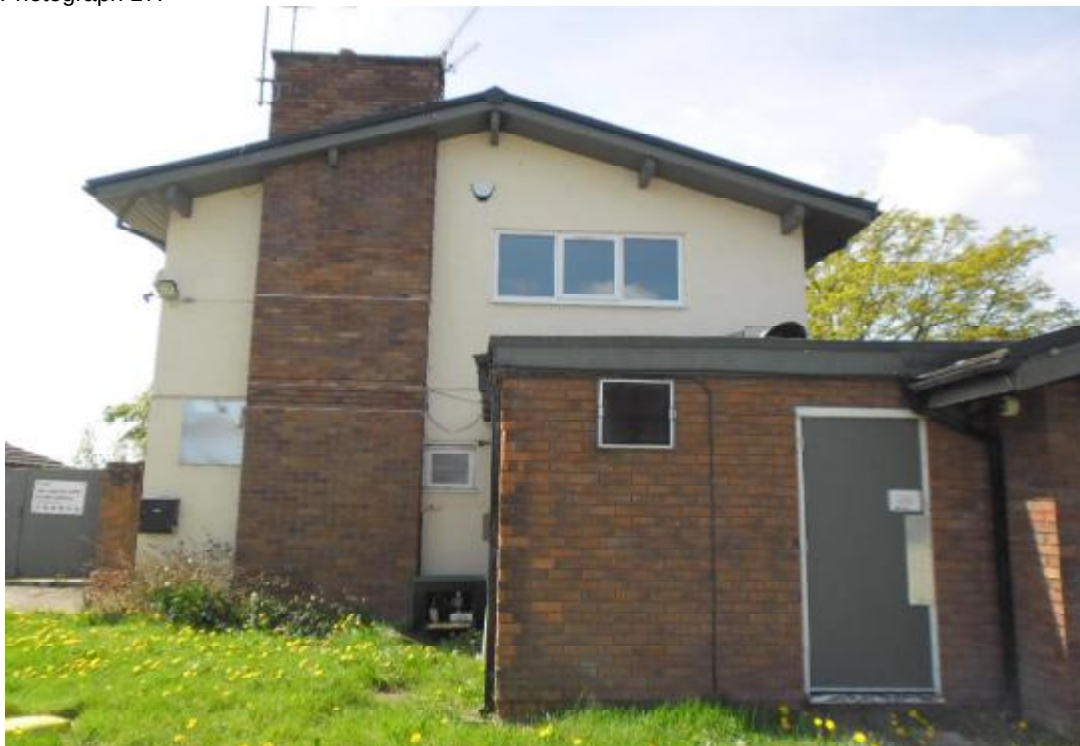
Photograph 18: Left-hand view of left-hand elevation.

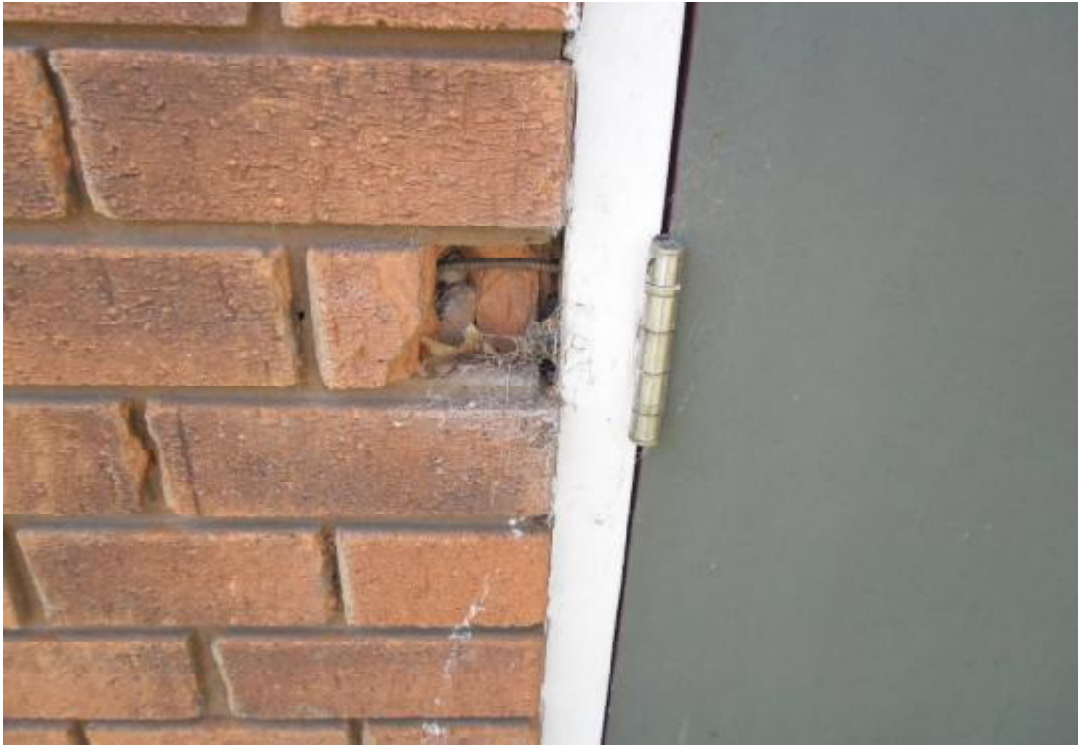
Photograph 19: View of damaged brickwork to left-hand side of entrance door.

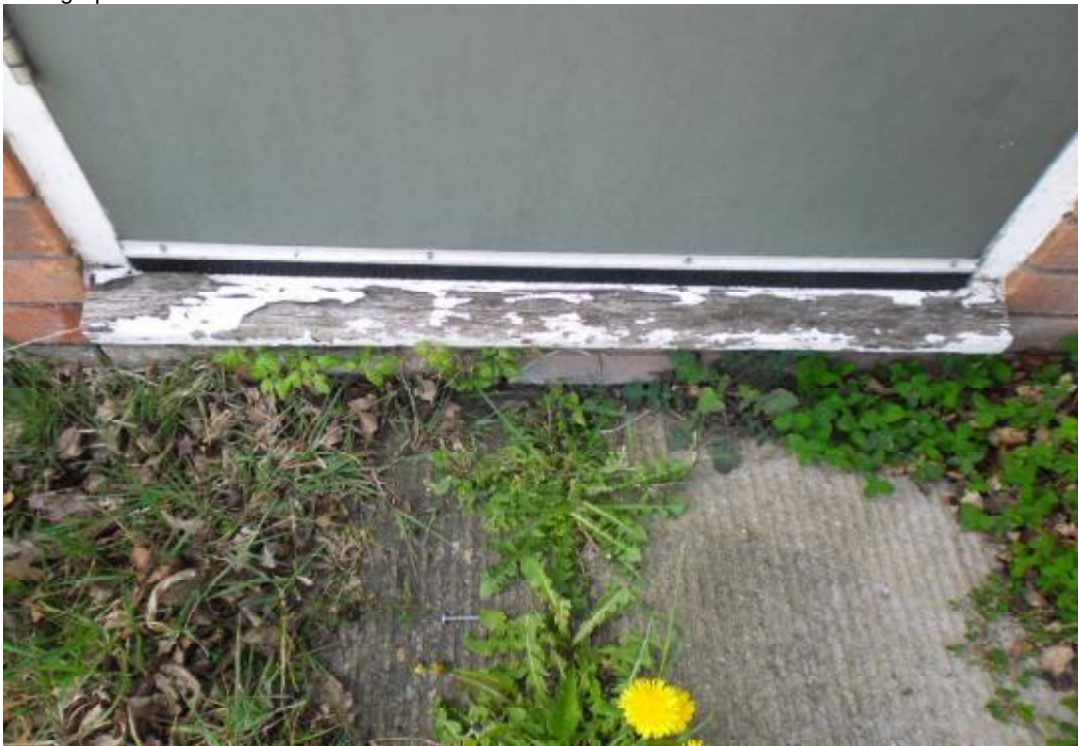
Photograph 20: Damage to timber threshold.

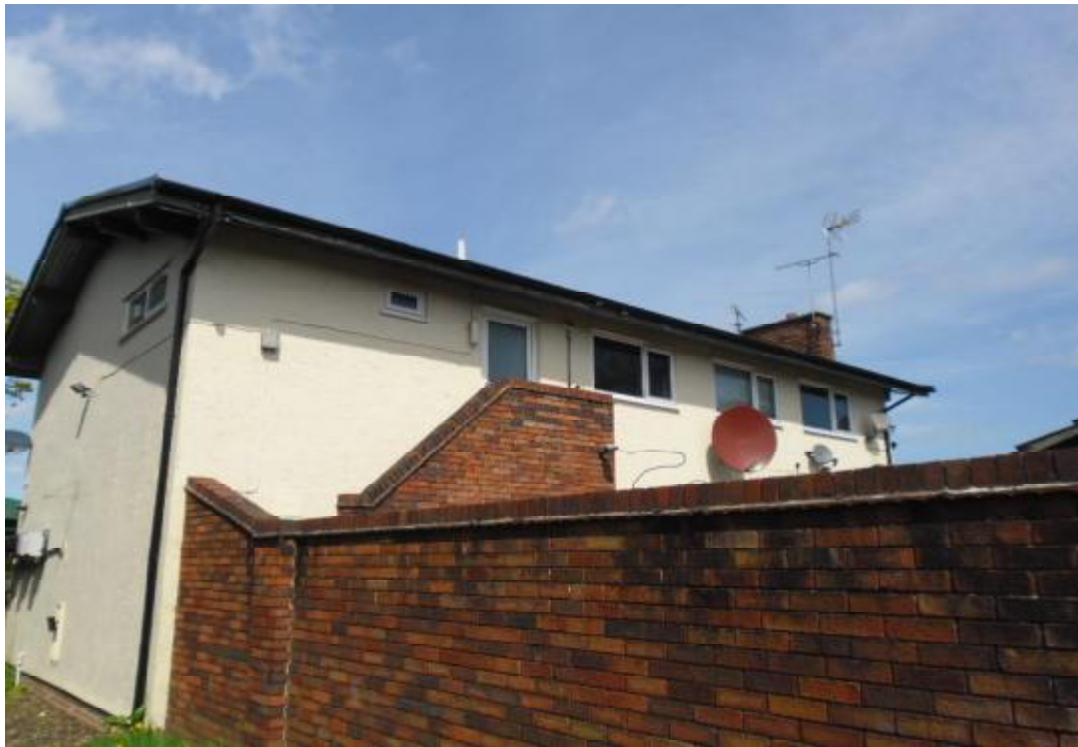
Photograph 25: View of rear elevation.

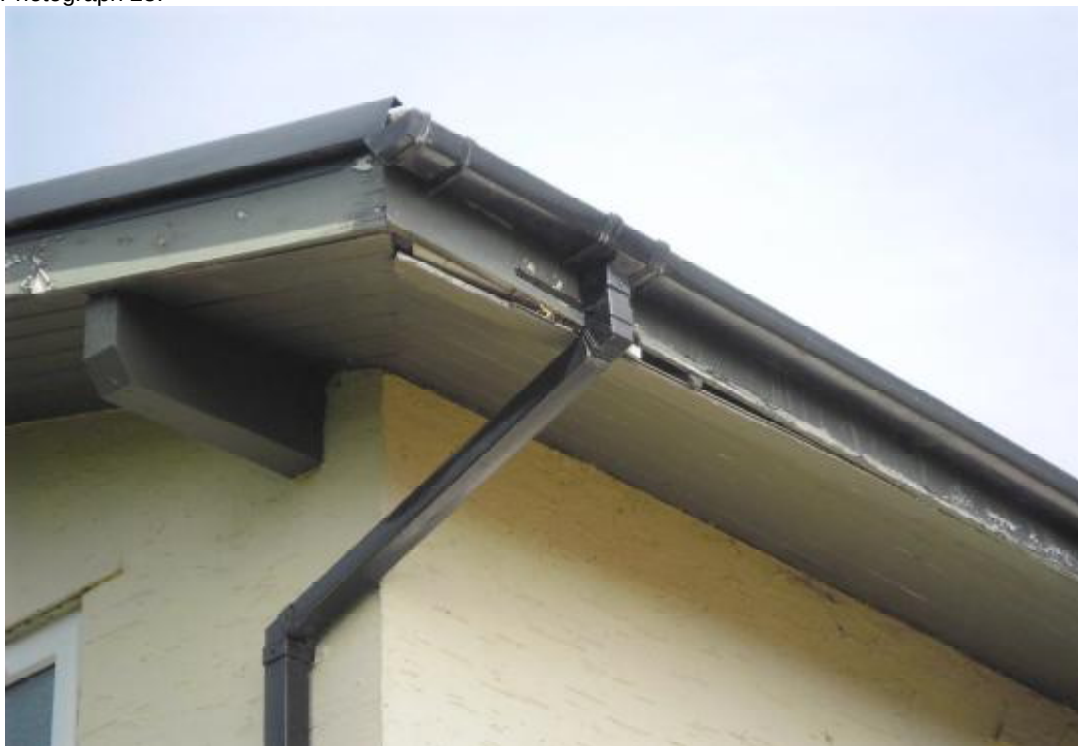
Photograph 26: Damaged timber to soffits to left-hand side of rear elevation.

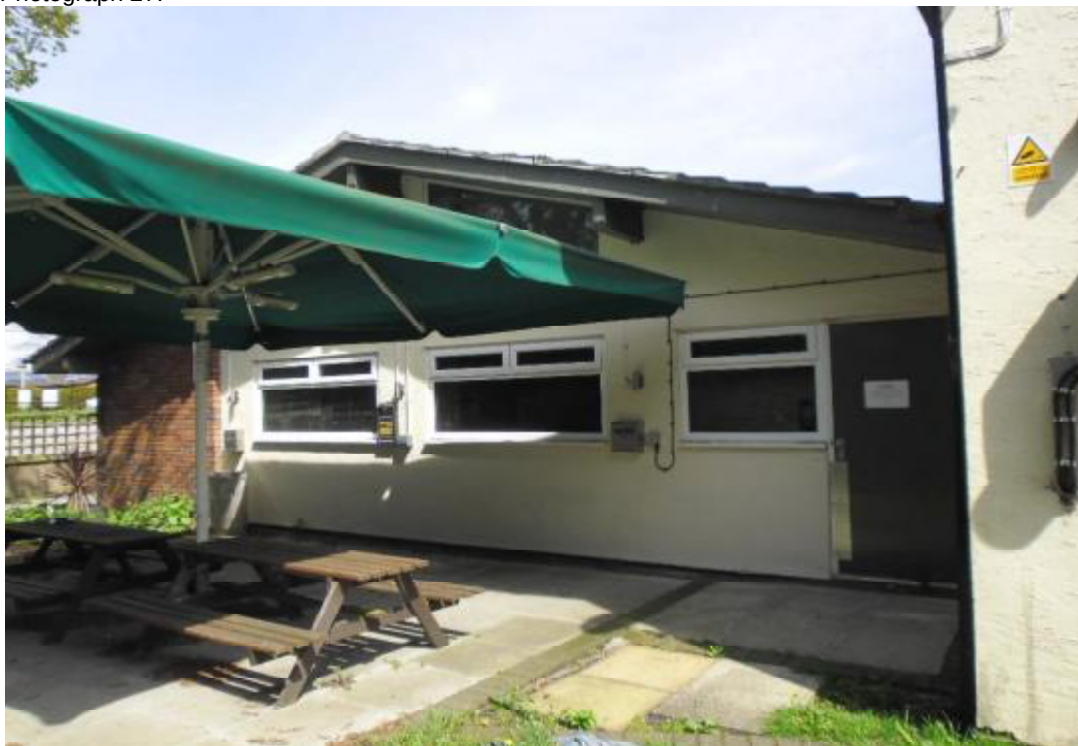
Photograph 28: General view of right-hand elevation.

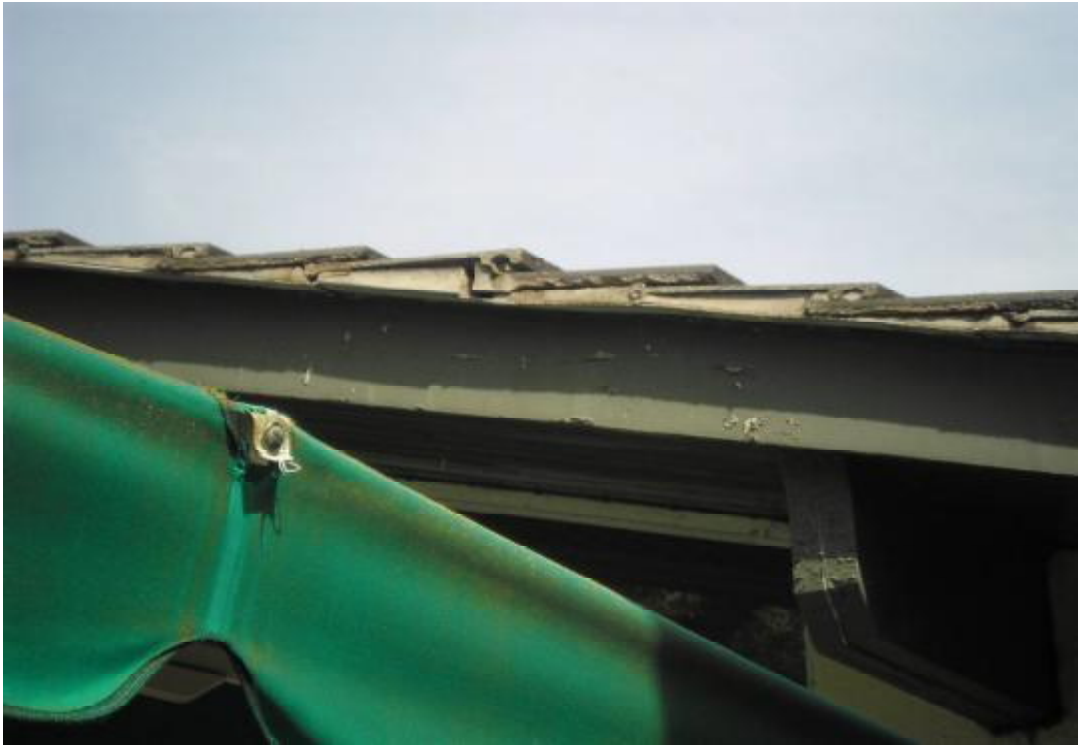
Photograph 29: Decorations to fascia flaking and mortar joints between roof verge cracked.

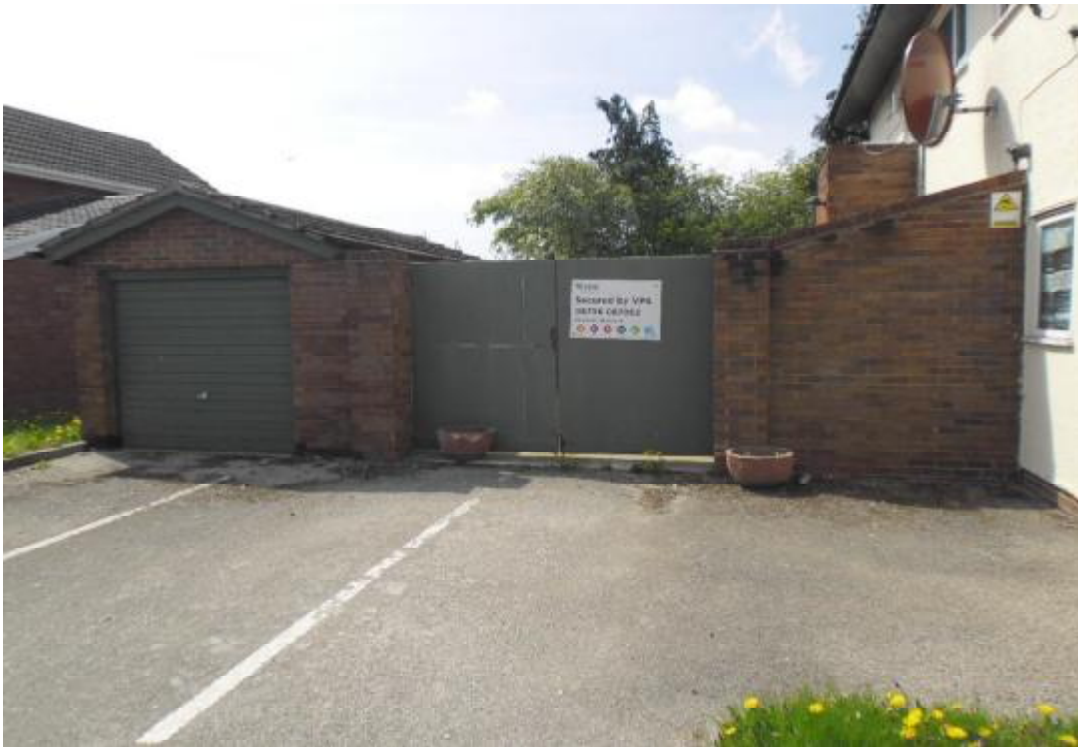
Photograph 31: General view of yard wall and garage.

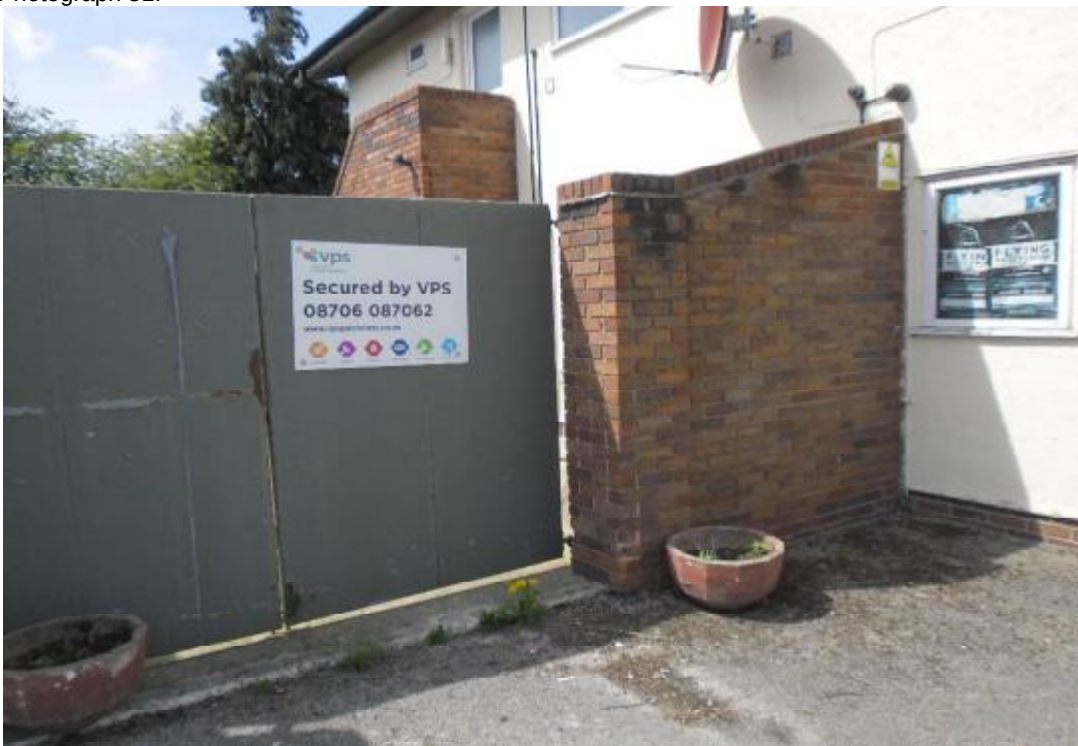
Photograph 32: Boundary wall and access gate to rear yard.

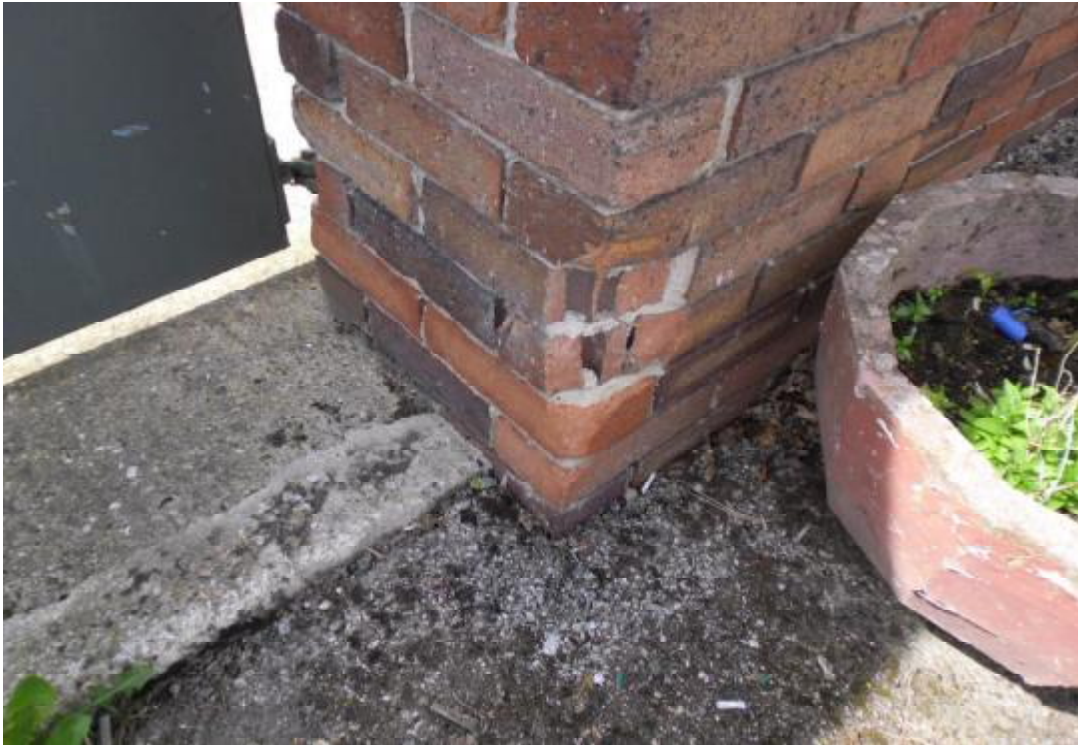
Photograph 33: Brickwork damage to right-hand side of vehicle access gate.

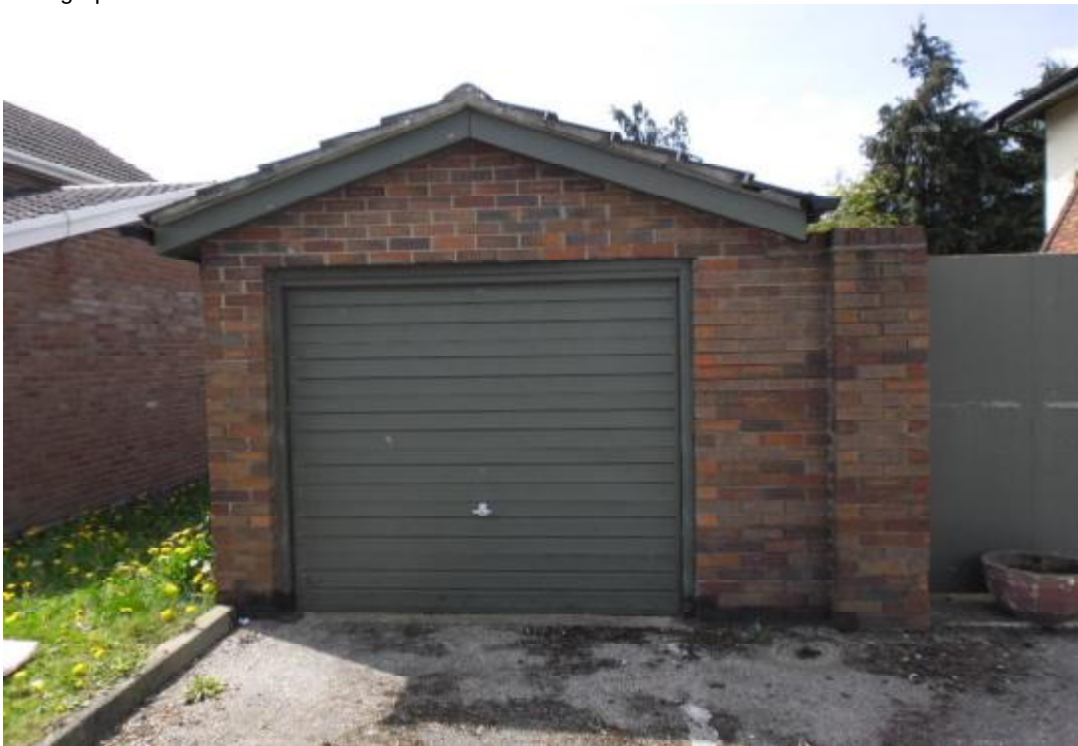
Photograph 34: General view of garage.

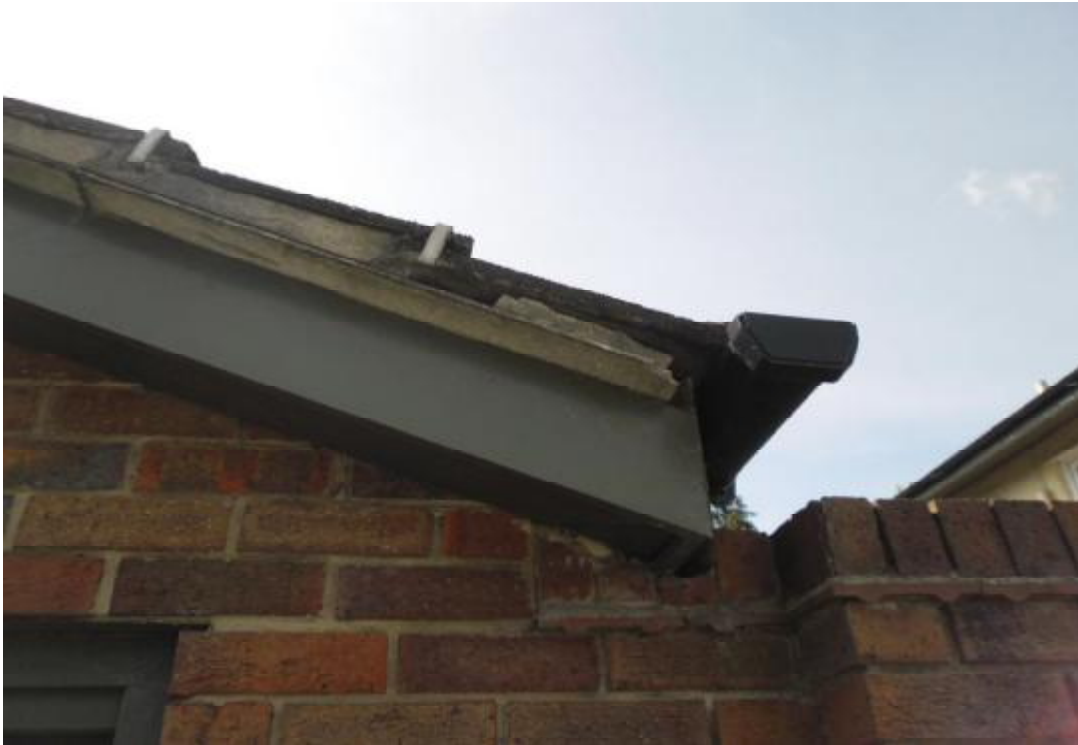
Photograph 35: Mortar joint damage to roof verge.

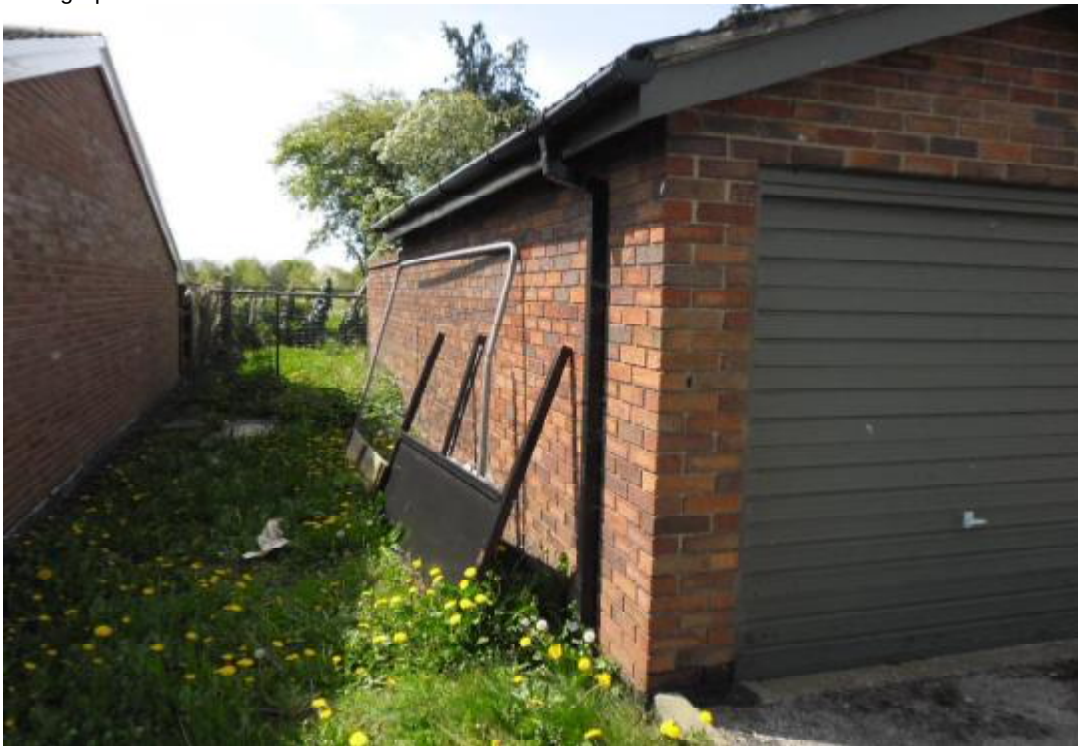
Photograph 36: Side view of garage.

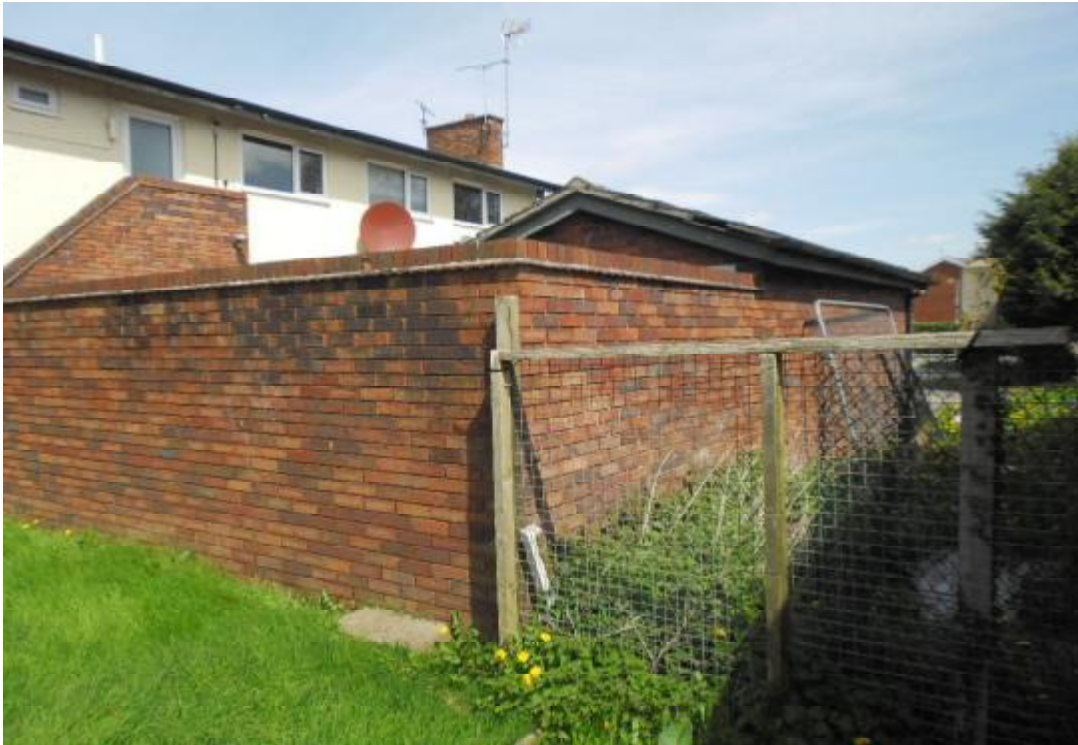
Photograph 37: Rear view of garage and boundary wall forming rear yard.
