## Photographic Schedule of Condition

Goulbourne  
Borras Park Road  
Wrexham  
Clywd, LL12 7TF

Star Pubs & Bars

Tel: 01604 664366  
Fax: 01604 664367  
Date: 4 May 2016  
Ref: 0101487-BC-0000

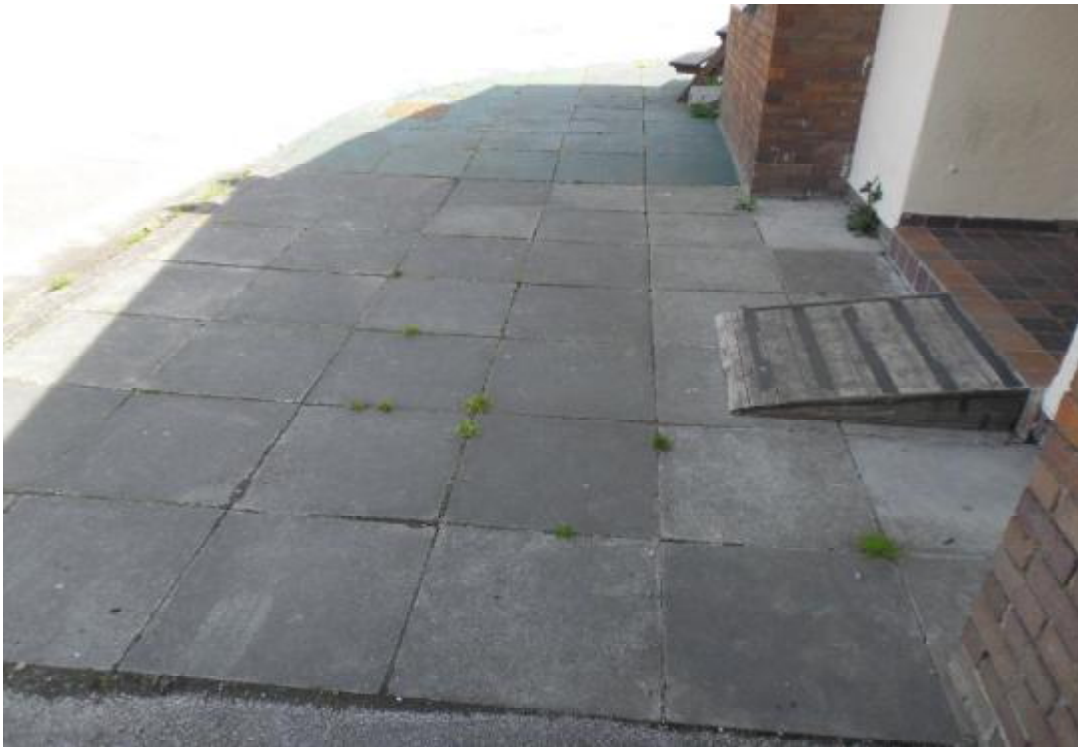
Photograph 55:

Photograph 57: View of cracked paving slabs to front elevation.

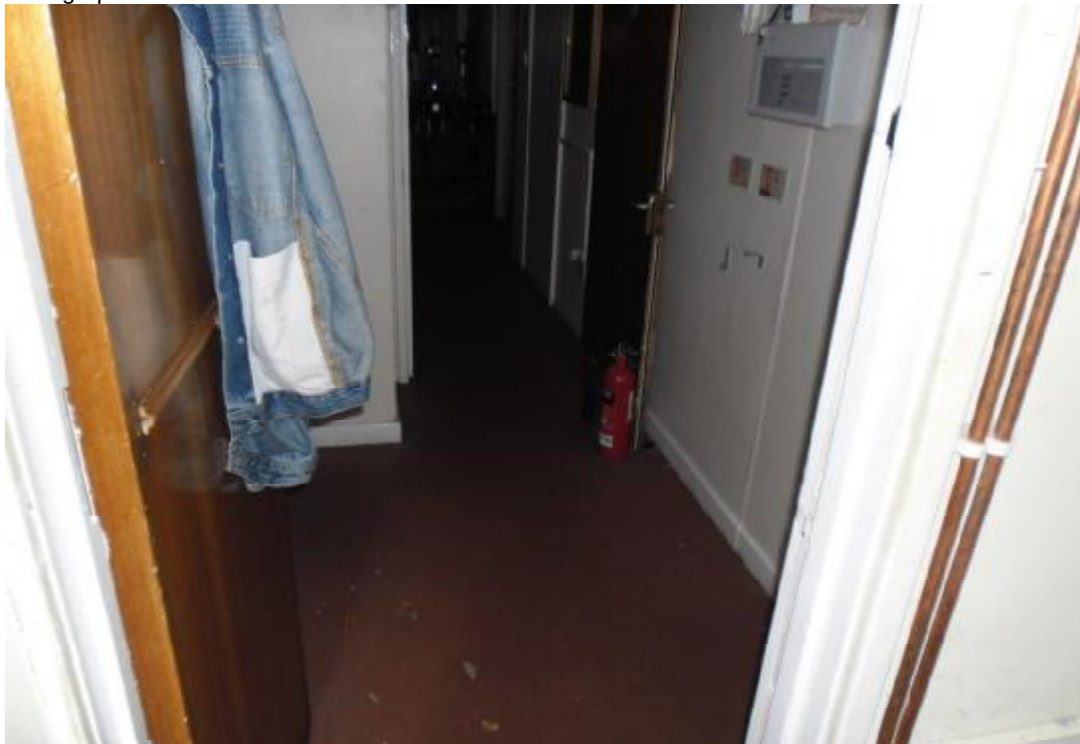
Photograph 88:

Photograph 87: General view of corridor and corridor floor covering.

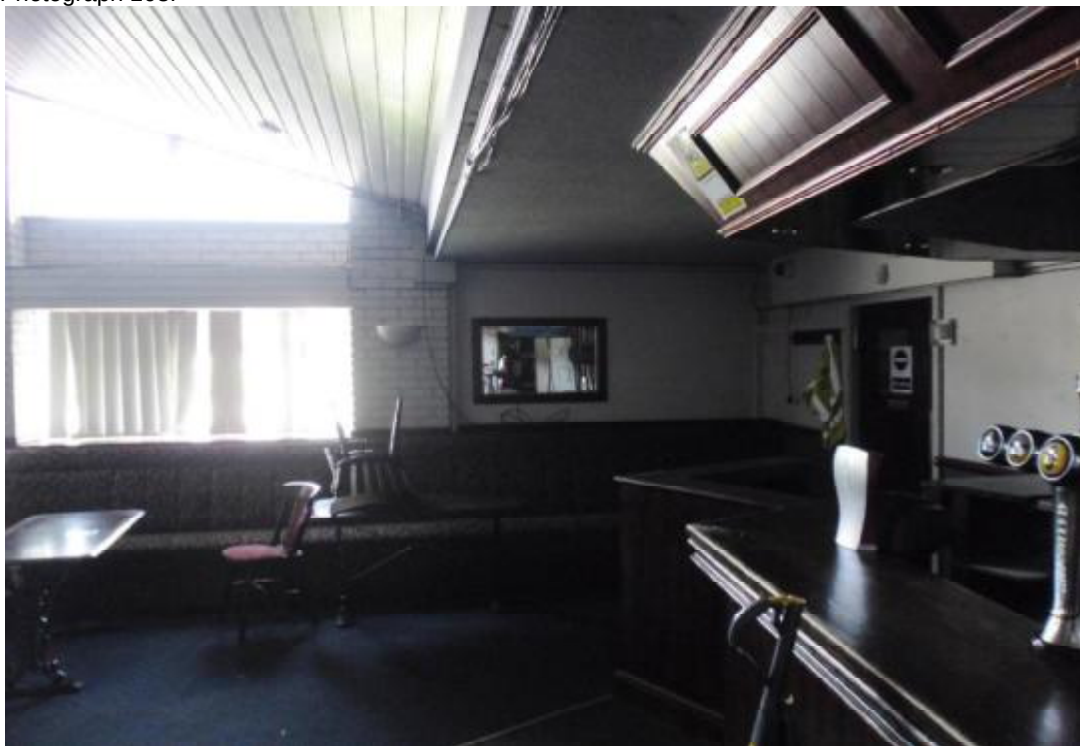
Photograph 104:

Photograph 100: General view of trading area.
