# Conversion of vacant outbuilding off Buck Road, Commonwood

## Structural Appraisal Report

April 2023

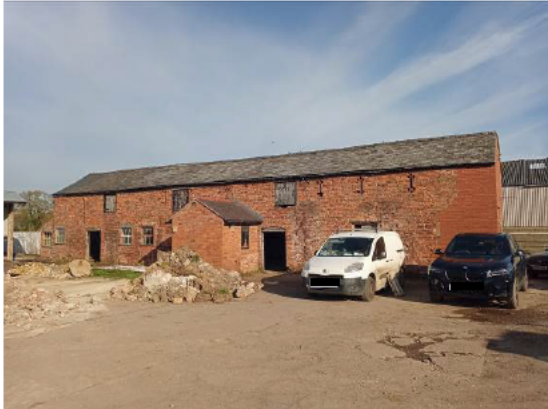
Photo 1 – Front Elevation.

The elevation comprises brickwork to full height with timber, concrete and brick arch lintels to openings (see Photo 1). The right-hand end of the elevation would appear to be a relatively recent extension. The roof over the main part and the outrigger is finished with slate.

No significant cracking was apparent at the time of inspection. Erosion was apparent to the faces of brick units throughout which is particularly prevalent at low level and to areas of previous vegetation growth (see Photo 2). Degradation to timber lintels was apparent. Severe rot and section losses were apparent to one of the lintels.

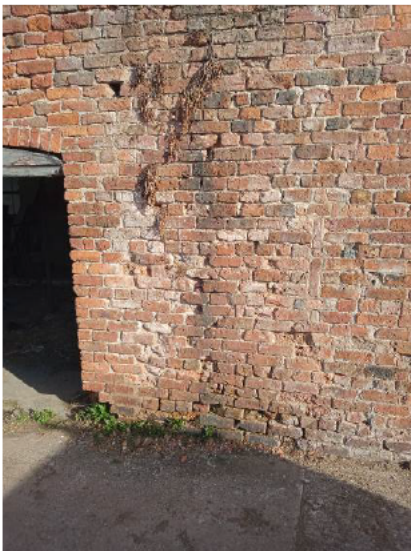
The pointing to the masonry on the main part of the building is lime based and appeared to be generally intact through soft when probed. Isolated areas of losses up to 30mm were apparent particularly at low level.

Photo 2 – Eroded brickwork and pointing.

- Replace existing lintels with new precast concrete units as required.
- Carry out repairs to severely eroded brickwork by replacing individual units. Repoint elevations by raking out existing pointing to a minimum depth of 30mm. New pointing shall comprise a 1:1:6 lime:cement:sand mortar packed tight into joints and finished flush with the face of the wall.

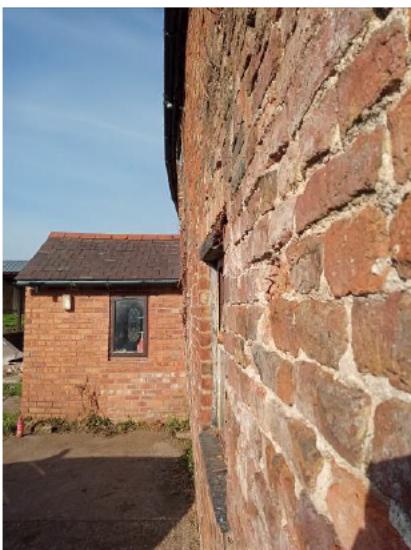
The elevation appeared to be reasonably straight and plumb except for the central section where outwards leans of up to 6% were noted (see Photo 3). The lean would appear to have resulted from roof spread. The defect is considered historic due to there being no appreciable movement since construction of the outrigger.

The elevations appeared to be generally straight and plumb except for the central section of the front elevation which shows a severe outwards bulge. The outwards lean appears to have resulted from roof spread. The fact that no movement is apparent between the elevation and the front outrigger would suggest that any repairs carried out at the time have been successful. No distortions were apparent that would be attributable to foundation movements or settlement. Although the foundations were not exposed, it is apparent that they are satisfactory and would not require modification in the proposed scheme. All of the elevations will require localised repair and repointing as part of the conversion scheme. Lintels to openings generally comprise timber sections which have degraded over time. It would be prudent to replace all of the lintels as part of the conversion scheme to ensure long term durability.

Photo 3 – Outwards bulge to front elevation.

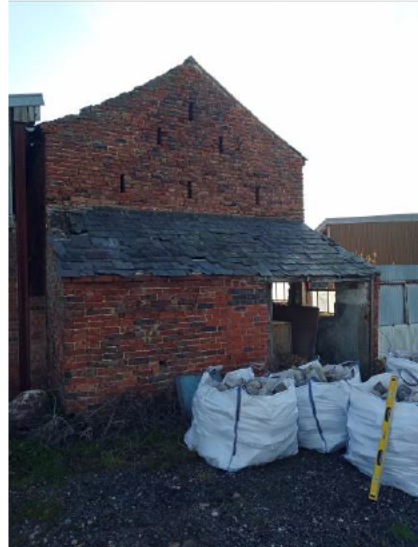
Photo 4 – Left Hand Side Elevation.

The elevation comprises brickwork to full height with timber lintels to openings on the single storey outrigger. The roof over the outrigger is finished with slate (see Photo 4).

The overall condition of the elevation is considered to be fair with the condition of the outrigger roof considered to be poor.

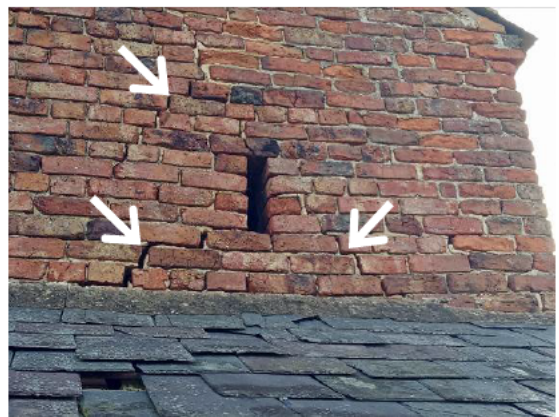
Cracking was apparent to the right-hand side of the main gable above the outrigger roof. A pair of diagonal cracks extend from both ends of the opening in the wall below. The cracking was noted as up to 15mm wide (see Photo 5). The single crack up to 5mm wide then extends vertically up to roof level. The cracking has resulted from a failure of the lintel carrying the wall over the opening into the outrigger. Erosion to the faces of brick units is apparent throughout. Cracking and loose brickwork was noted to the right-hand side of the outrigger (see Photo 6). This would appear to have resulted from roof spread pushing the timber lintel out.

Photo 5 – Cracking above outrigger roof.

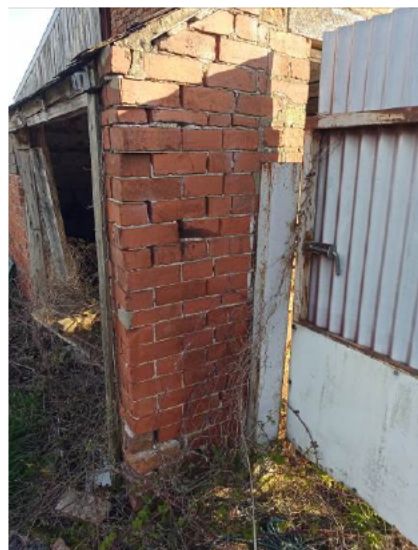
Severe cracking was apparent to the main gable wall above the opening through to the barn. This has resulted from the removal of brickwork at the lintel supports (see Photo 12). Loose brickwork is apparent to the side of the external opening resulting from movement in the timber lintel.

Photo 6 – Cracking and loose brickwork adjacent to opening.

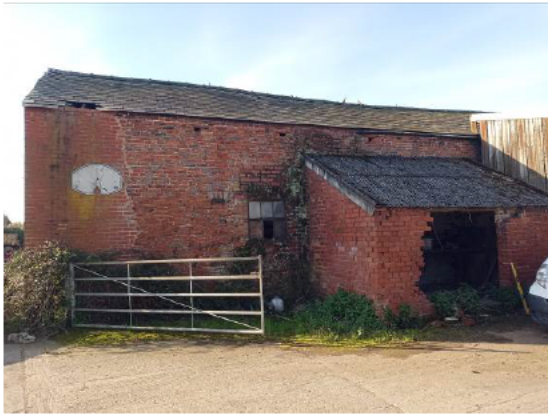
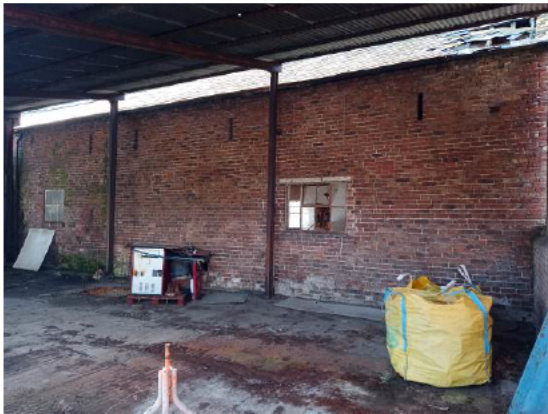
Photos 7 and 8 – Rear Elevation.

The elevation comprises brickwork to full height with timber lintels to openings (see Photos 7 and 8). The left-hand end of the elevation would appear to be a relatively recent extension. The roof over is finished with slate. The outrigger roof is finished in asbestos cement sheets. A steel framed canopy abuts the right-hand side of the elevation – this is due to be demolished and is outside the scope of this report.

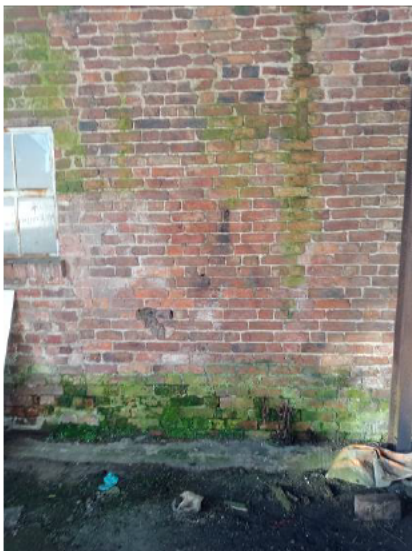
No significant cracking was apparent at the time of inspection. Staining is apparent to significant areas of the elevation due to water cascading from the roof (see Photo 9). Erosion was apparent to the faces of brick units throughout which is particularly prevalent at low level and to areas of staining. Degradation to timber lintels was apparent, though no section losses were noted. Cracking and dislodged brickwork was apparent to the face of the outrigger (see Photo 10). This would appear to have resulted from a vehicle impact and will require localised reconstruction.

Photo 9 – Staining to elevation.

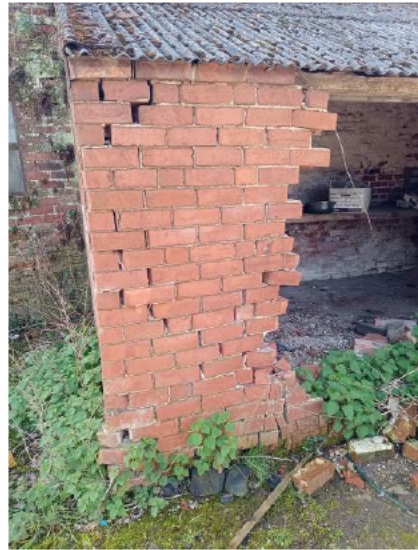
Severe cracking and dislodged brickwork were apparent adjacent to the external opening. This would appear to have resulted from a vehicle impact. The lintel to opening appeared to be in good condition with no significant defects apparent.

Photo 10 – Cracked and dislodged  
brickwork adjacent to opening.

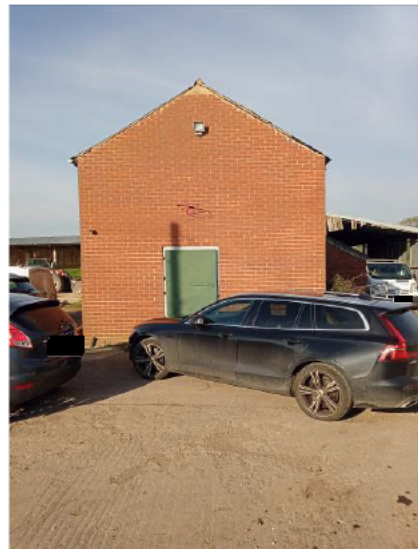
Photo 11 – Right Hand Side Elevation.

The elevation comprises brickwork to full height with a steel lintel over the door opening. The roof over is finished with slate (see Photo 11). It is apparent that this end of the outbuilding has been extended in the recent past.

The overall condition of the elevation is considered to be good.

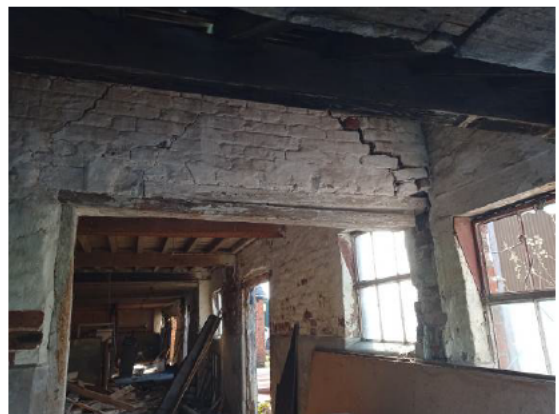
Photo 12 – Cracking to brickwork due  
to support removal from lintel.

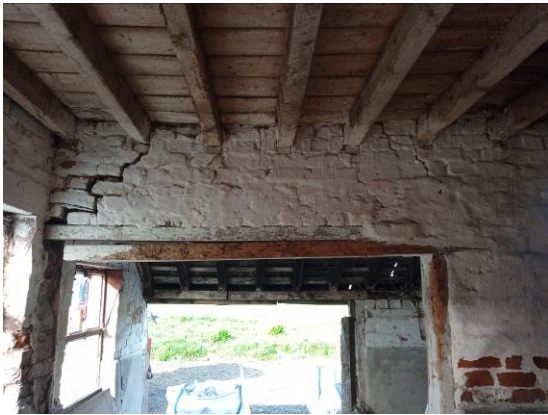
No significant cracking was generally apparent walls at the time of inspection. However, severe cracking was apparent above the opening to the left-hand store (see Photo 13). This has been caused by the removal a brickwork supporting the timber lintel over. Open joints and eroded brickwork were apparent to several areas on the front and rear elevations. The lintels to openings all appeared to be in reasonably good condition. However minor section losses were noted to the lintel over the left-hand store opening.

Photo 13 – Cracking to brickwork due to support removal from lintel.

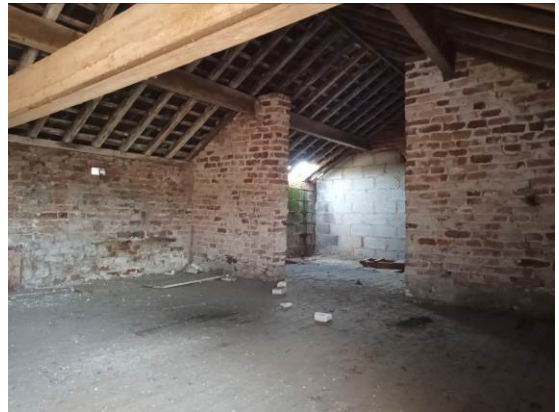
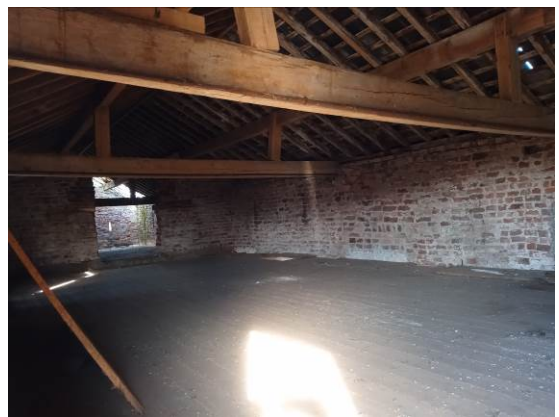
Photos 16 and 17 – General views of first floor store.

The First Floor Store occupies the whole of the upper storey. The roof over comprises traditional timber purlin and rafter construction supported off a series of fabricated timber trusses and brickwork internal and external walls (see Photos 16 and 17). The floor comprises timber decking off joists.

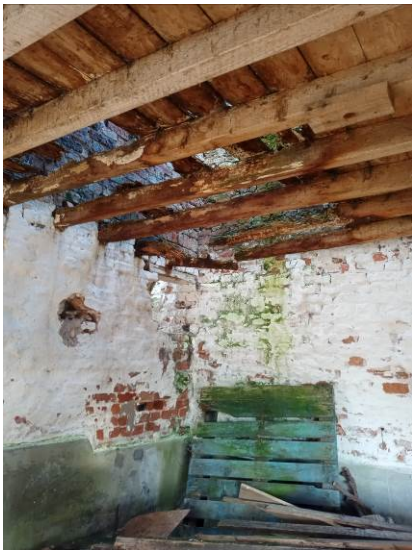
The floor over the room appeared to be in generally fair condition. However, evidence of severe rot and section losses visible to several joists adjacent to the rear elevation (see Photo 14) where two of the joists have rotted through. Staining is also apparent to decking in isolated areas throughout indicative a failed slated finishes in the roof over. Surface corrosion is apparent to the pair of beams spanning the room and also to the beam and post supporting the floor adjacent to the right-hand store. No section losses are apparent.

Photo 14 – Severe rot to floor joists.

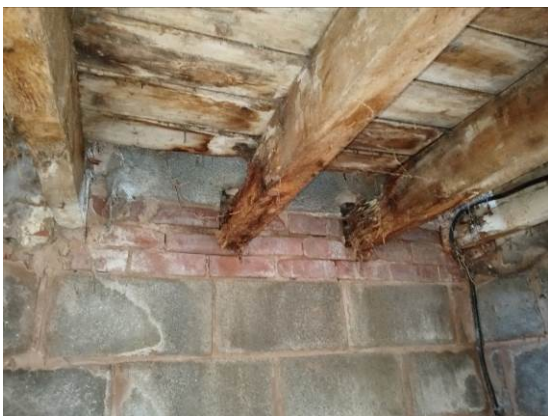
The floor over the room appeared to be in generally fair condition. However, evidence of severe rot and section losses visible to several joists on the rear elevation (see Photo 15). Staining is also apparent to decking locally indicating weather penetration through the roof over. Surface corrosion is apparent to the pair of beams spanning the room, though no section losses are apparent.

Photo 15 – Severe rot to floor joists.

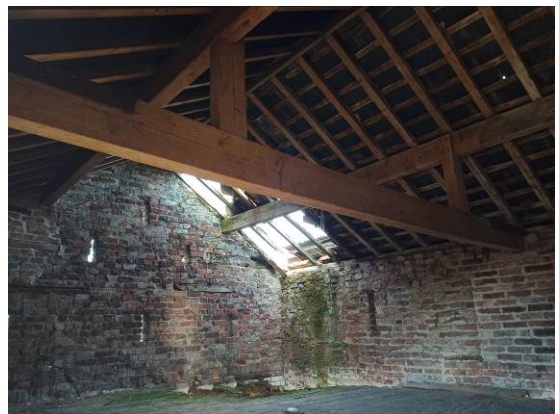
The roof over the room appeared to be in generally fair condition with evidence of several large holes through slated finishes. Severe degradation to timbers was noted below the holes with several of the rafters rotted through (see Photo 18). Staining to timber and isolated daylight was apparent suggesting that the slated finishes are life expired. It is apparent that the intermediate trusses are not original and may have been installed following a failure that caused the lean in the front elevation.

Photo 18 – Severe rot to roof timbers and staining wall walls..
