## Mold Road, Gwersyllt, Wrexham - Proposed Residential Development S278

### **Stage 2 Road Safety Audit**

| <b>Document Reference &amp; Revision:</b> | MAL/MRGW278RSA2 Rev0 |

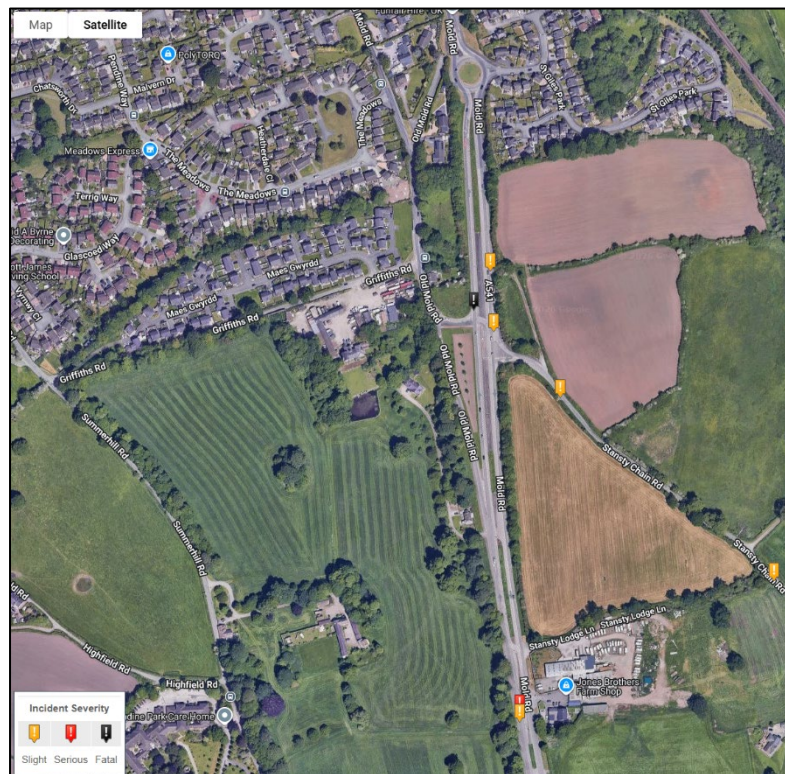
**Figure 1: Collision data**

The data shows that there have been seven collisions on the surrounding roads resulting in one fatal, one serious and five slight in severity. Of these seven collisions three are located within the area affected by the proposed works. The fatal involved a cyclist at the junction with Old Mold Road.

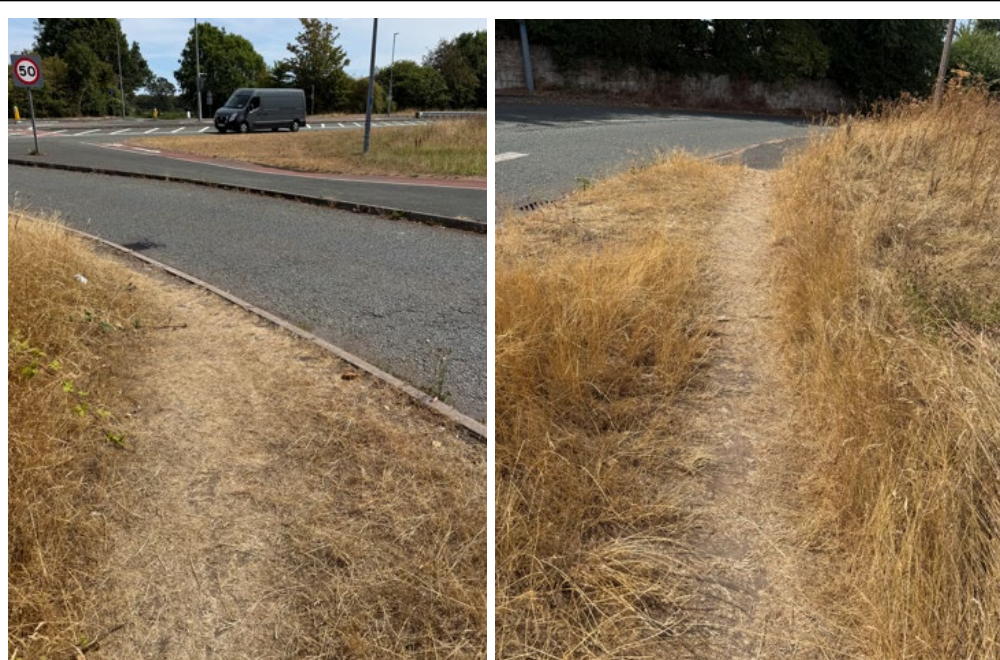
| PROBLEM | | 2-10 |
|---|---|---|
| <p>The Audit Team noted that the existing uncontrolled crossings of Old Mold Road do not correspond to the desire line observed by the Audit Team.</p> <p>Well-worn path in the verge indicates that pedestrians are not following the proposed route over Old Mold Road (slip road). Instead, they are crossing Old Mold Road and walking along the verge.</p> | | |
| <div></div> <p>The photos clearly show that this is a well walked route which would indicate that this is the preferred pedestrian desire line. The new development may well increase footfall and as such formalisation of this route should be considered by the designers. The current route is likely to be underutilised as it is convoluted and lengthy.</p> | | |

| PROBLEM | | 2-10 |
|---|---|---|
| <p>Formalisation of the established desire line that is shown in the photos should be considered as part of the design or introduce pedestrian route signing.</p> | | |
