# Road Safety Audit Stage 2

Mold Road, Gwersyllt

260443

**SEPTEMBER 2026**

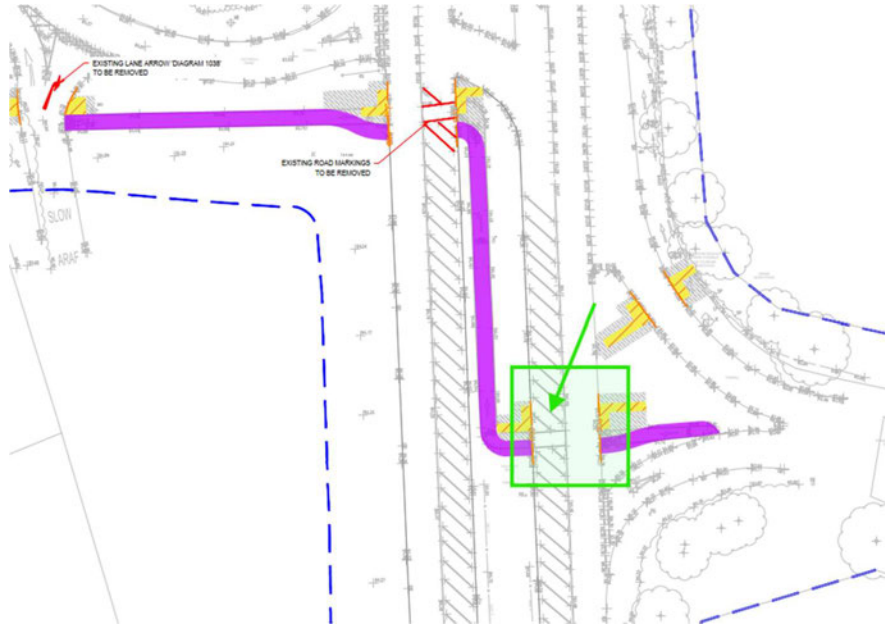
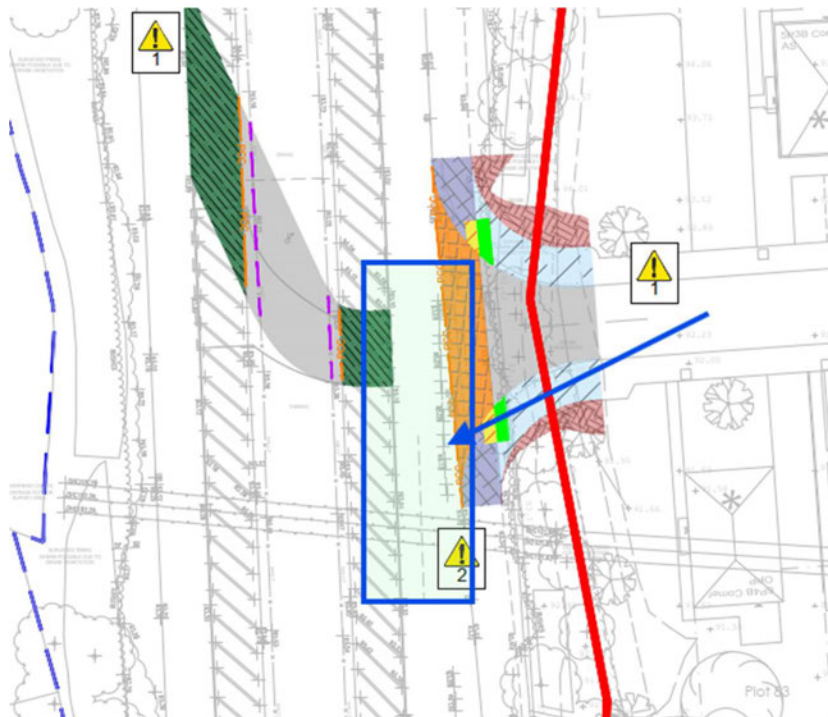
## ITEM 2-4

Drivers could become confused if old road markings are not fully removed before the new markings are implemented

The scheme will introduce a large number of changes to the carriageway and the associated carriageway markings. If the new carriageway markings are laid on top of the old carriageway without fully removing the old ones, drivers could become confused as to where they should be positioned with the carriageway or where they should stop or give way. This could result in drivers making inappropriate manoeuvres and/or failing to stop or give way resulting in collisions with other vehicles or pedestrians/cyclists.

Ensure the existing carriageway markings are fully removed or that the carriageway is resurfaced.

**SCP – R2-4 –** Site clearance drawings includes details of the existing carriageway markings that are to be removed as part of the interventions. It is acknowledged further removal of road markings at the proposed signalised crossing (southbound – Mold Road – see below in green) and length of redundant intermittent road marking associated with the taper south of the proposed access and associated diverge arrow (see below in blue) will be required and these will be included upon agreement of actions with the LHA.

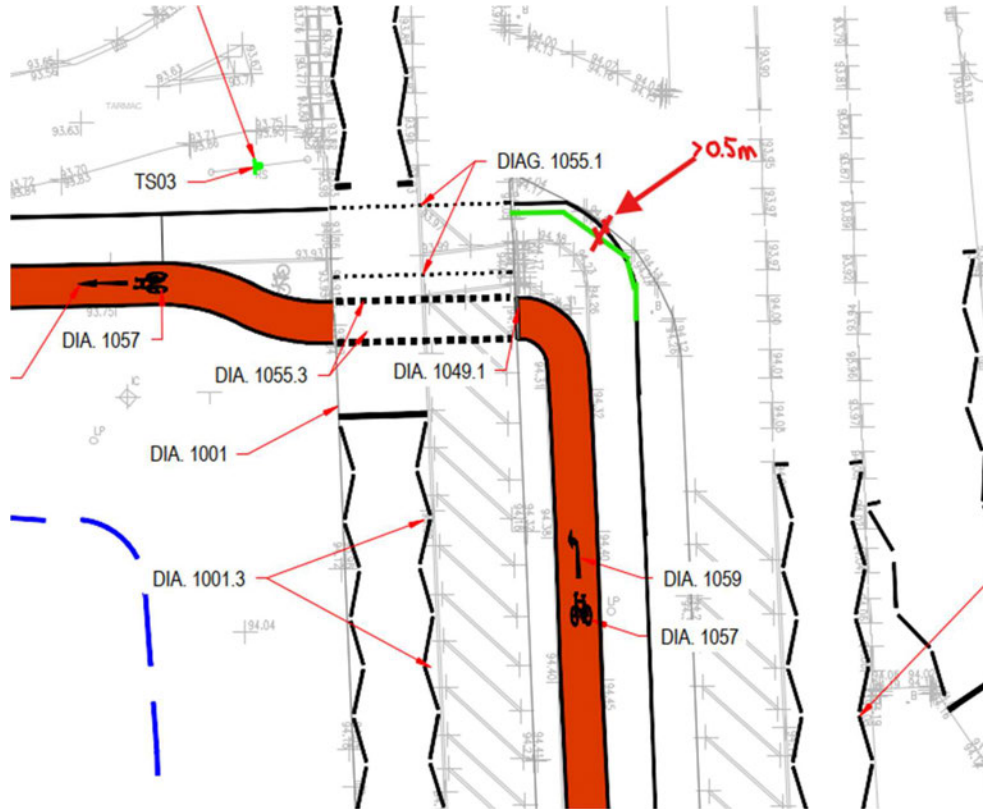
## ITEM 2-5

A lack of clear separation between the new footway and carriageway will increase the risk of vehicles striking pedestrians on the new footway increasing the risk of injury

It is proposed to provide a footway between Old Mold Road and Stansty Chain Road following the route of the existing cycle facilities. Where the footway crosses the central reservation, it is noted that the footway and tactile paving will be very close to the right turn (central reservation crossing) for vehicles exiting Old Mold Road. A lack of clear separation between the new footway and carriageway will increase the risk of vehicles striking pedestrians on the new footway increasing the risk of injury.

It is recommended that as a minimum at least 500mm is provided between the edge of the footway and the carriageway to create an area of separation.

**SCP – R2-5 –** The location of the proposed pedestrian crossing and associated crossing facilities will be shifted south (both sides of the crossing) to provide a minimum 500mm buffer from the central reservation kerbline

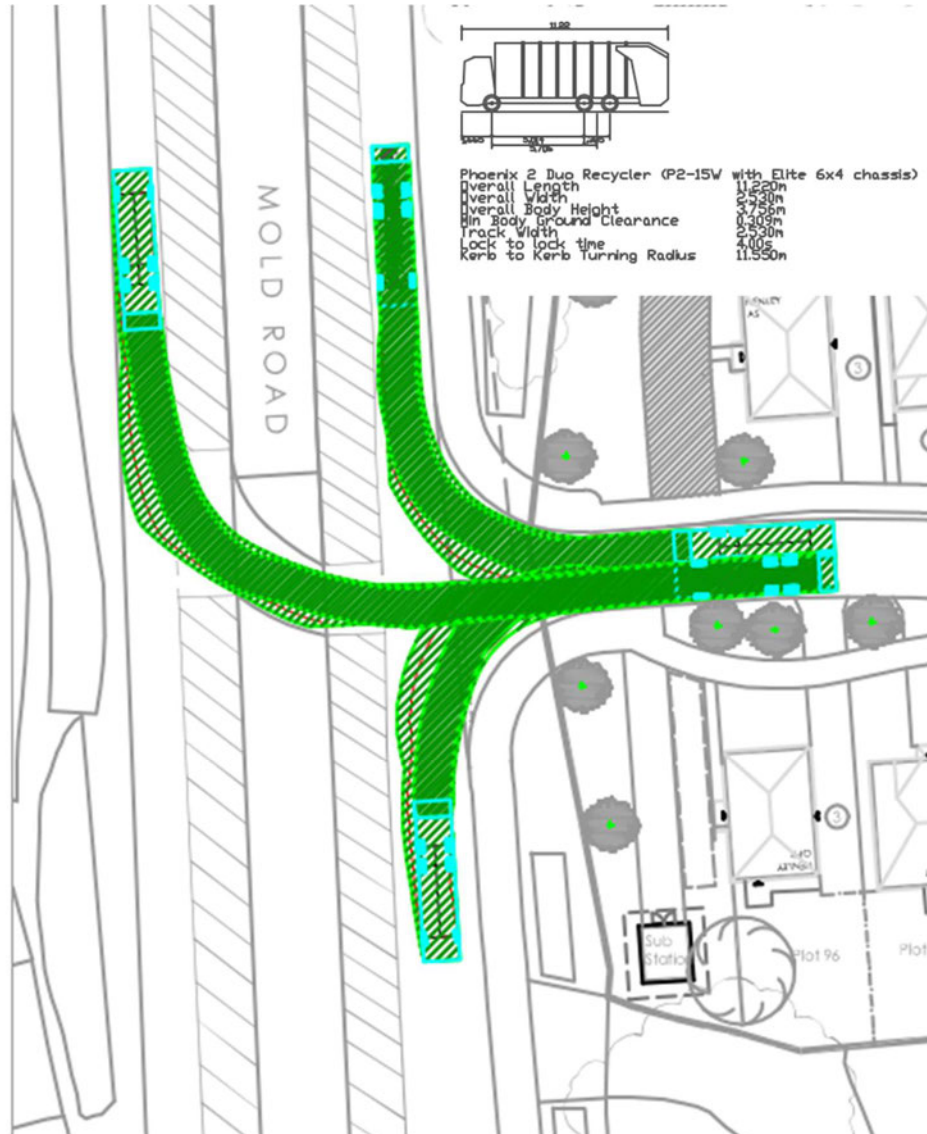
## ITEM 2-6

Inappropriate carriageway widths and turning radii can result in increased vehicle collisions as well as pedestrian/vehicle collisions

Vehicle tracking details were not submitted as part of the RSA information. It is important that all vehicles which are expected to use the access, can safely negotiate the junction. If vehicles cannot safely turn into or out of the access without overrunning the kerbed areas around the junction mouth, there is a risk conflicts between vehicles using the access, and on-going maintenance issues.

**SCP – R2-6 –** Vehicle tracking was completed as part of the planning process and liaison with the highways officer (drawing SCP\_220743\_ATR01 – extract below) which shows how vehicle negotiate the junction with no kerb overrun.

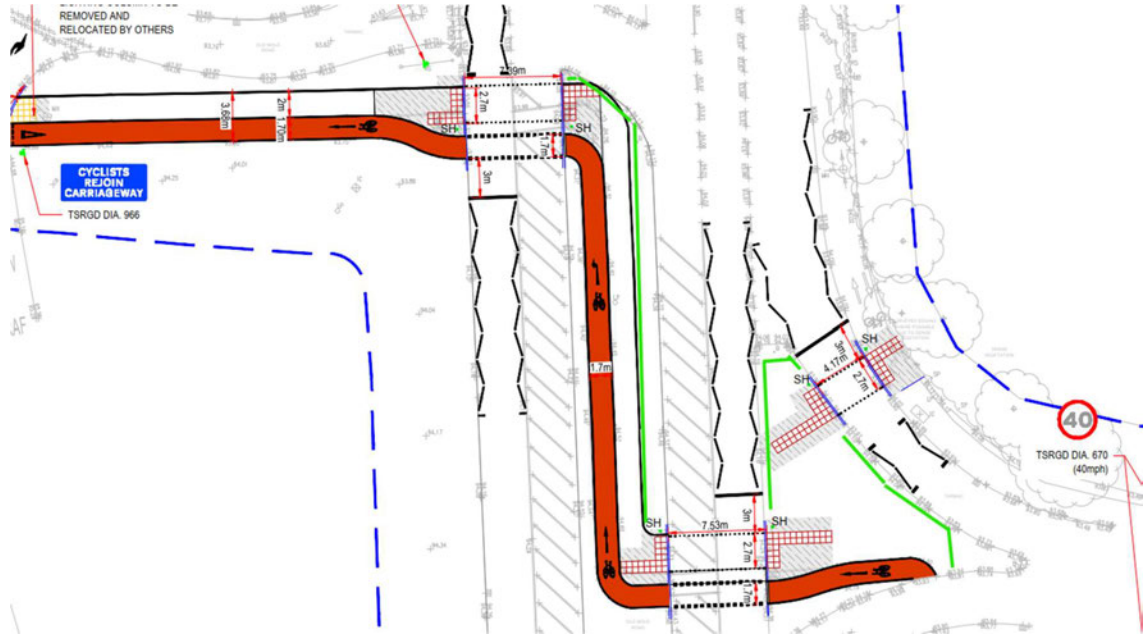
## ITEM 2-7

A lack of edging kerbs and pedestrian guard railing will increase the risk of injury to visually impaired pedestrians

This problem is carried forward to the RSA 2 as it has not been addressed. New footway is to be created across Mold Road. It is unclear how visually impaired pedestrians will be accommodated over the various islands as there is limited guidance, particularly for visually impaired users, to ensure that the various crossing points can be safely located and that the 90-degree bends currently proposed can be negotiated by cyclists. A lack of edging kerbs and pedestrian guard railing will increase the risk of injury to visually impaired pedestrians.

Consider how the visually impaired will be accommodated along the new footpath and how they will be guided between the controlled crossings by considering the introduction of pedestrian guardrail at various key locations around the junction. Also ensure that the layout is compliant with LTN 1/20

**SCP – R2-7 –** SCP proposes the introduction of pedestrian guardrail as shown below in green to be agreed with the LHA.

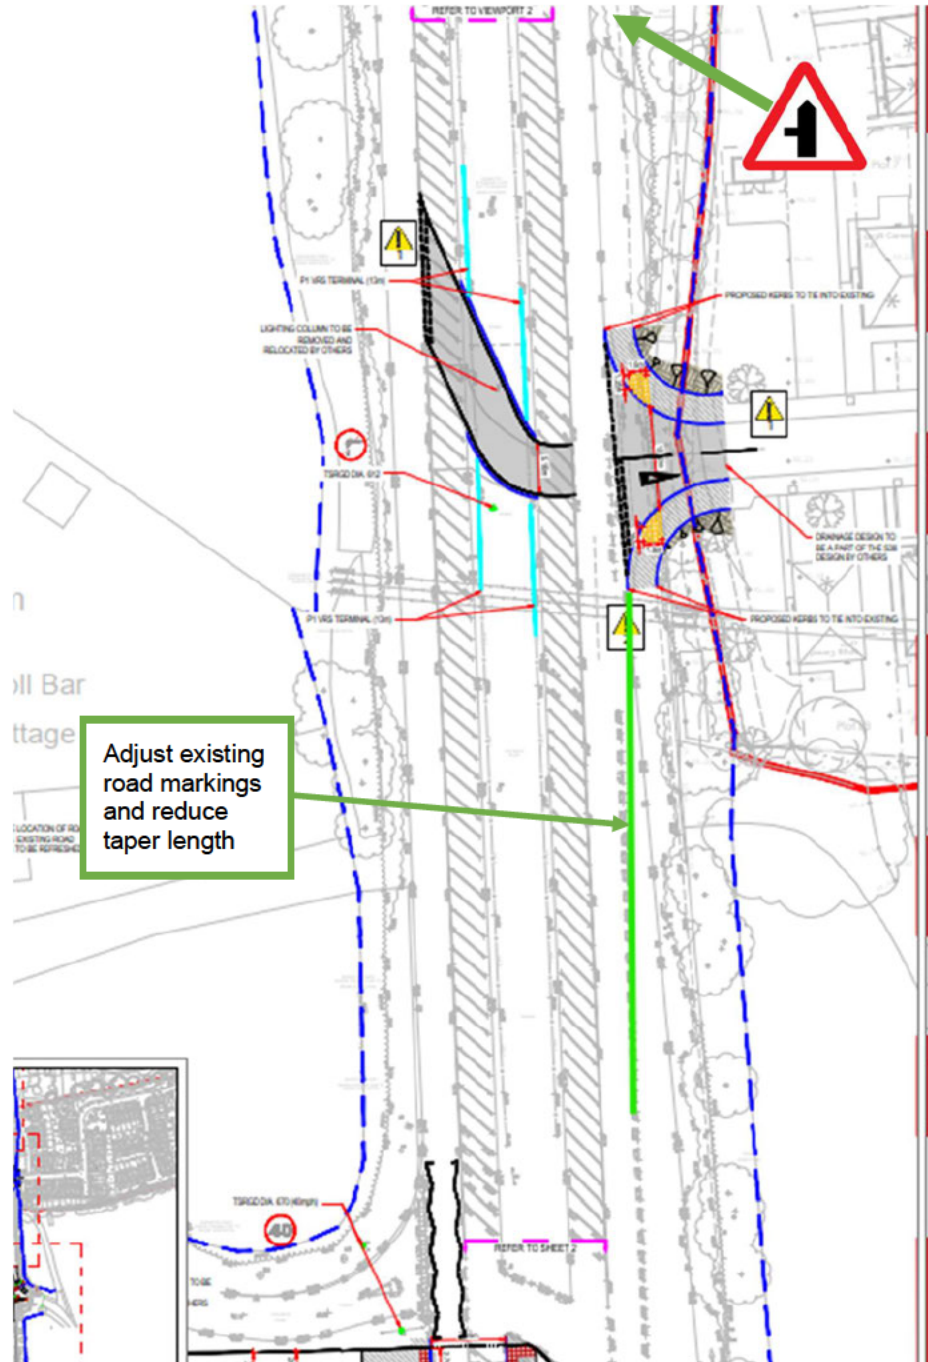
## ITEM 2-8

Closely located junctions can increase the risk of drivers failing to give way

The Audit Team did consider that there was a risk of drivers travelling to Stansty Chain Road indicating to pull left from Mold Road prior to the site access junction. This could be confusing to drivers pulling out of the proposed access in error into the path of an approaching southbound vehicle. It is considered that this is exacerbated by the close proximity of the site junction and the diverge.

It is recommended that the taper diverge is reduced in length so that the diverge point which is very close to the site access junction is moved south and that a level of separation is created. This should be achievable as the design speed of Mold Road will be reduced by the relocation of the speed limit. It is also recommended that signing is introduced to help delineate between the new junction and Stansty Chain Road junction.

**SCP – R2-8 –** The existing taper will be proposed to be reduced by adjusting the existing road markings for a reduction in the taper so it starts immediately south of the site access. Furthermore, the introduction of a warning sign to TSRGD diagramme 506.1 advising the presence of a side road ahead will help to mitigate the above problem.

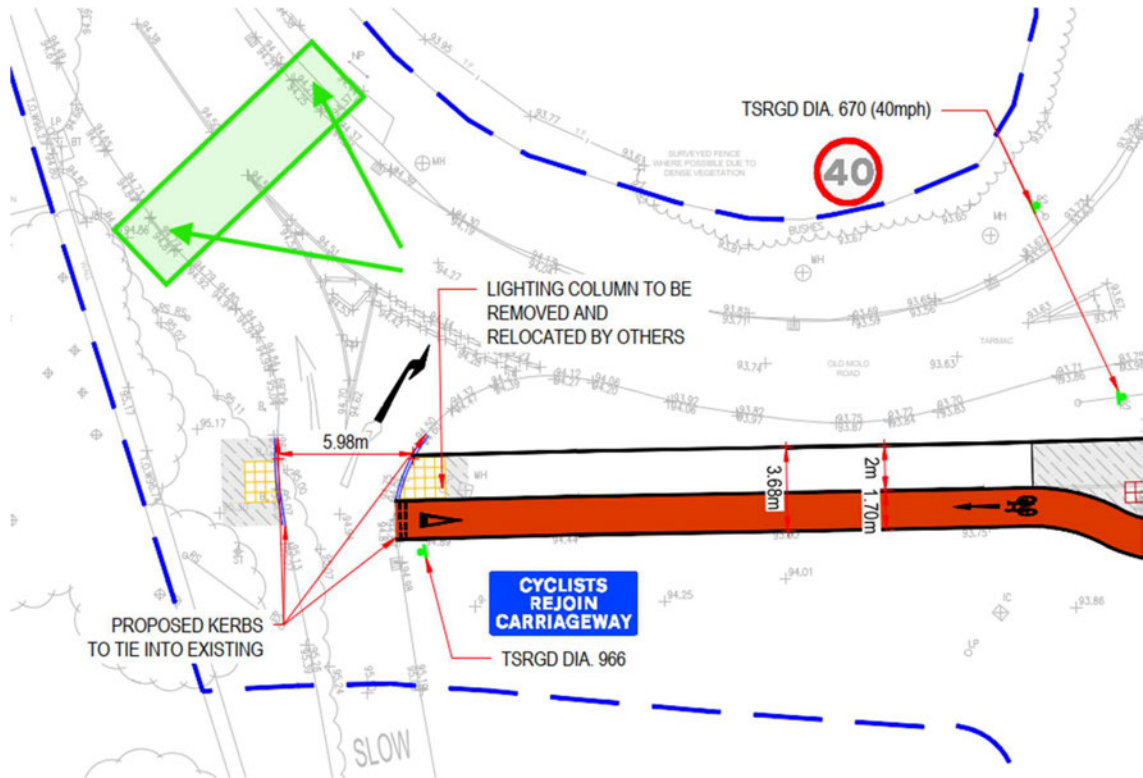
## ITEM 2-9

A lack of suitable uncontrolled crossings will increase the risk of collisions.

It is noted that the existing crossing of Old Mold Road located on the slip from Mold Road will be upgraded and provided with tactile paving. The footway terminates roughly 15m north of the upgraded route over Old Mold Road (slip from Mold Road). This results in pedestrians then crossing Old Mold Road to gain access to the footway along the eastern side of the road to continue their journey. This uncontrolled crossing does not have tactile paving. Which will lead to confusion for visually impaired pedestrians.

Tactile paving needs to be provided at the existing dropped crossing over Old Mold Road

**SCP – R2-9 –** SCP agrees with the auditor and, though the inclusion of tactile paving was not part of the original approved layout, their inclusion as shown below in green is deemed beneficial.

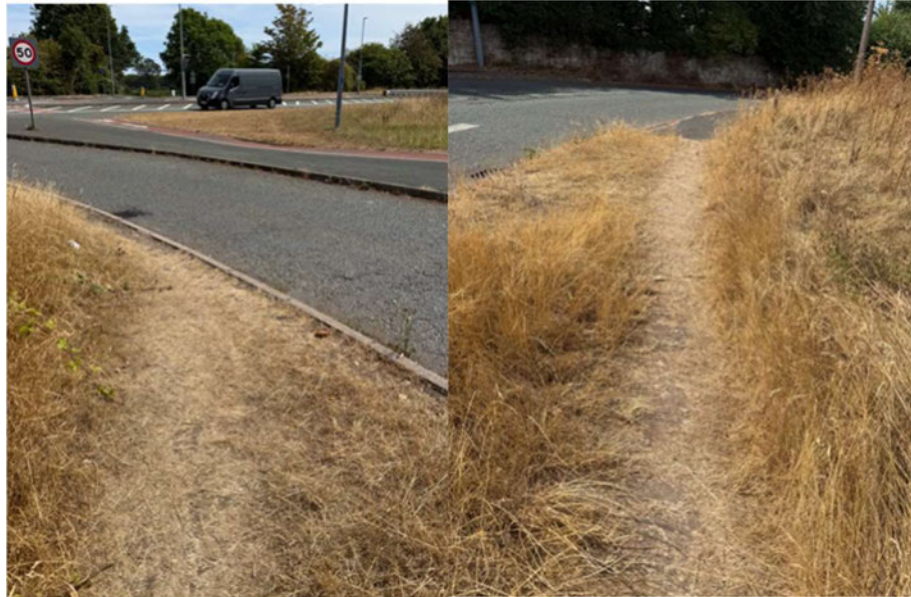
## ITEM 2-10

The Audit Team noted that the existing uncontrolled crossings of Old Mold Road do not correspond to the desire line observed by the Audit Team. Well-worn path in the verge indicates that pedestrians are not following the proposed route over Old Mold

Road (slip road). Instead, they are crossing Old Mold Road and walking along the verge.

The photos clearly show that this is a well walked route which would indicate that this is the preferred pedestrian desire line. The new development may well increase footfall and as such formalisation of this route should be considered by the designers. The current route is likely to be underutilised as it is convoluted and lengthy.

Formalisation of the established desire line that is shown in the photos should be considered as part of the design or introduce pedestrian route signing.

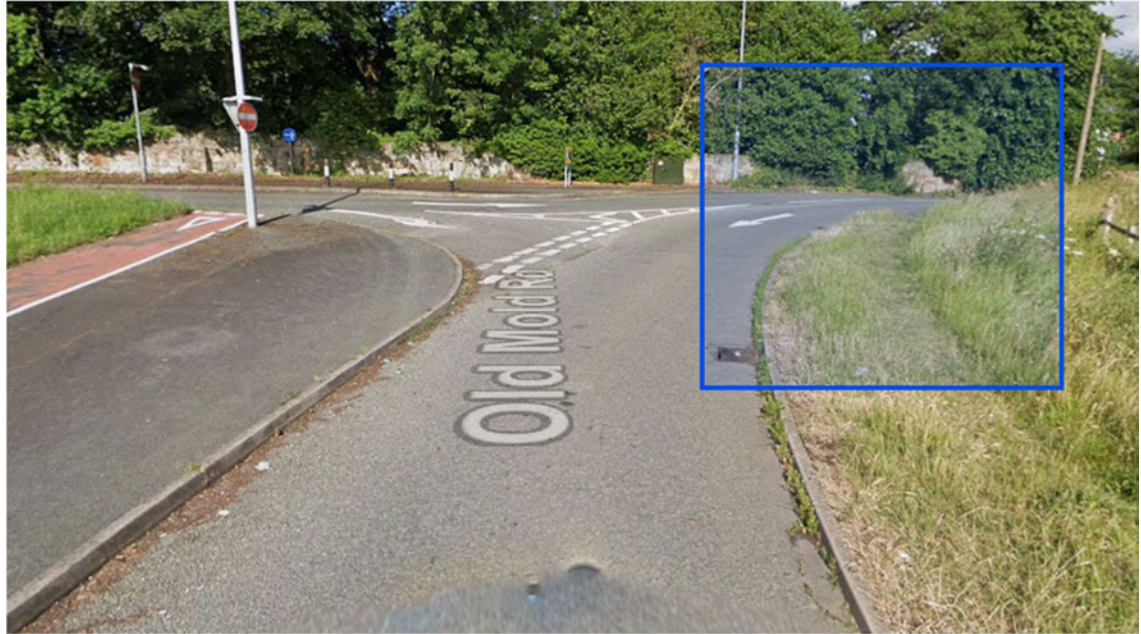
**SCP – R2-10 –** It is understood the desire line shown on the pictures is the result of the lack of crossing facilities on Old Mold Road (northbound) which are proposed as part of these interventions. Furthermore, as raised in Item 2-9 the inclusion of an additional set of tactile paving will contribute towards formalising this arrangement. The introduction of a pedestrian crossing at the end of the desire line is not deemed safe as it would be located on a bend where visibility from the crossing to the right may be limited (see below in blue).
