P2020/0050

Stori Brymbo Project

Mining Report

HF Machine Shop

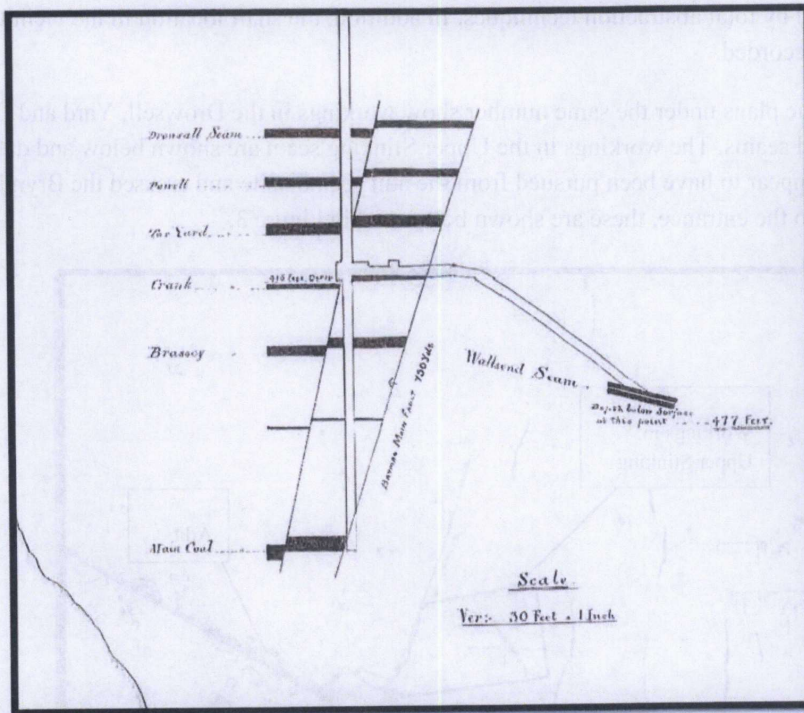
### Bye Pit showing Brymbo fault

Mine plan 5973, dated 1910, showing recorded workings in the Wallsend seam presents a shaft section of the Bye Pit at the Brymbo colliery, see below. This shows the shaft going through the Drowsell, Powell, Two Yard and Crank seams before entering the Brymbo Fault at the level of the Crank seam at 418 feet depth (127m). A roadway is shown going to the Wallsend seam on the east side of the fault at a depth of 477 feet (145m), See below.

The downthrown on the fault is shown as 150 yards in a westerly direction.

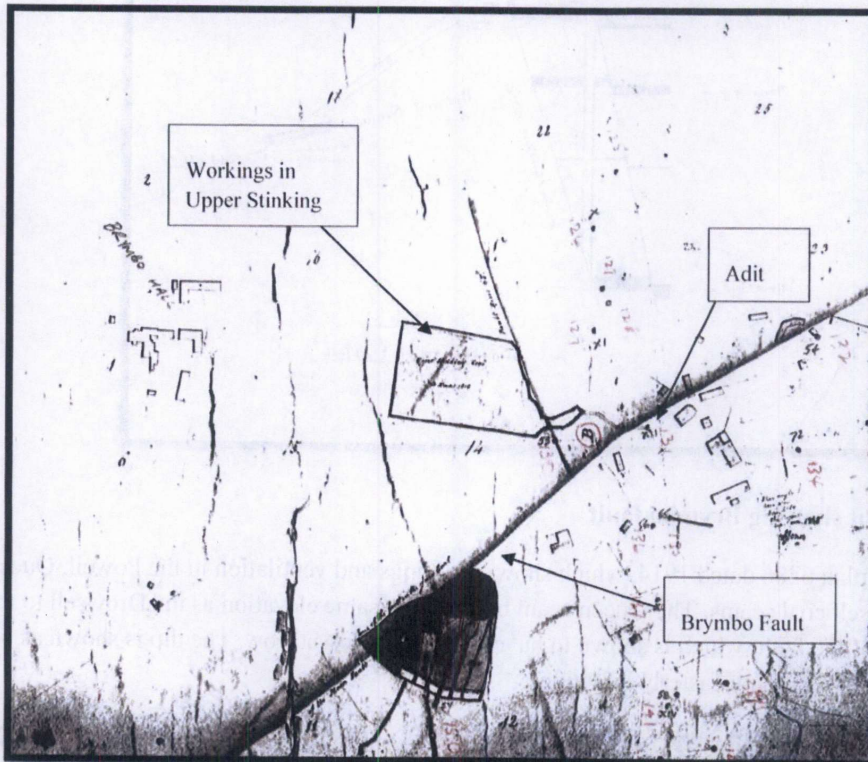
#### Workings in Upper Stinking Seam from Adit on site

Separate mine plans under the same number show workings in the Drowsell, Yard and Upper Stinking coal seams. The workings in the Upper Stinking seam are shown below and dated 1818, they appear to have been pursued from the adit seen on site and crossed the Brymbo Fault close to the entrance, these are shown below and in Figure 3.

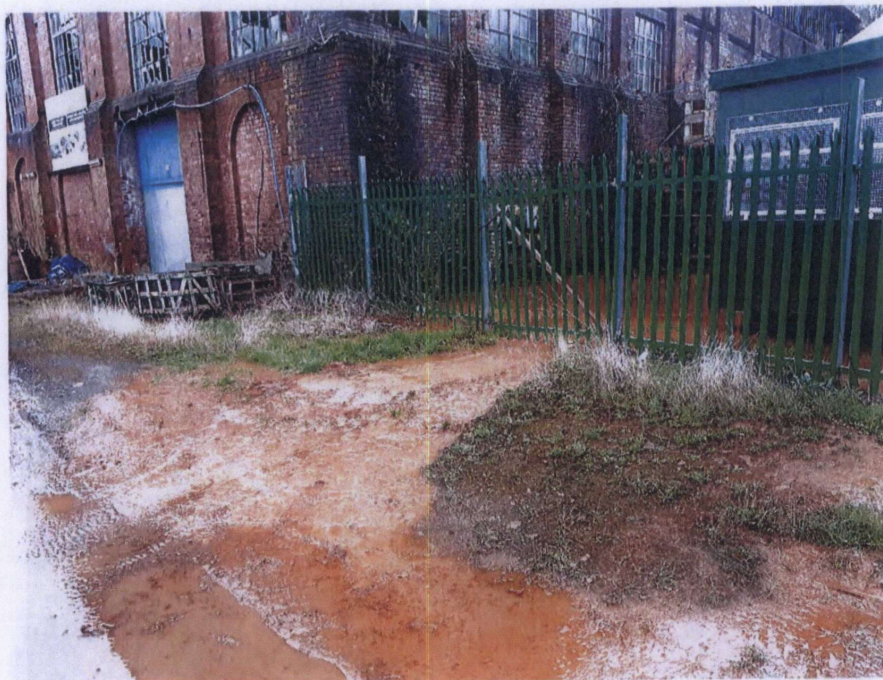
This revealed the presence of an open adit in the south west corner of the works, which is outside of the Heritage site, from which red mine drainage water was issuing. Mr. Brown indicated that this adit had been driven circa 1843 to work a coal seam, which was rapidly exhausted. The walkover also inspected the old Brymbo colliery shafts to the west of the main development, which are both fenced off. According to Mr. Brown these have been partially backfilled by the Coal Authority to depths of around 50 to 60m, with the water standing at around 30m depth. One of the pits was reported to be covered with a metal grill.

Photograph 1 Mine water discharge from adit

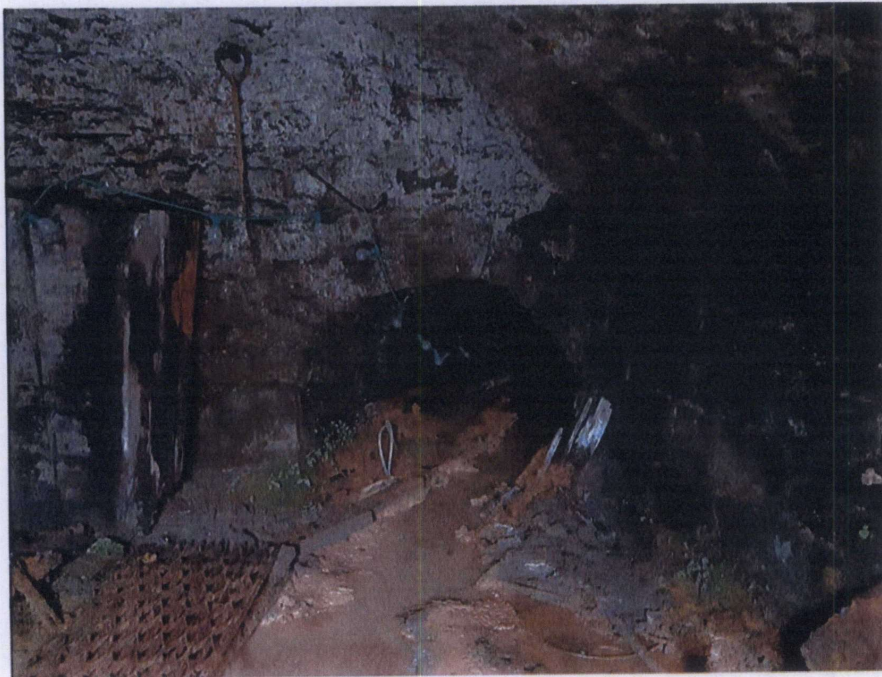
Photograph 10 Adit entrance

329353-131. This entry was investigated in 2002 by JMC Mining Services and was found to be within a building. A metal grill was placed across the entrance to the building to prevent access. The adit was found to be open.

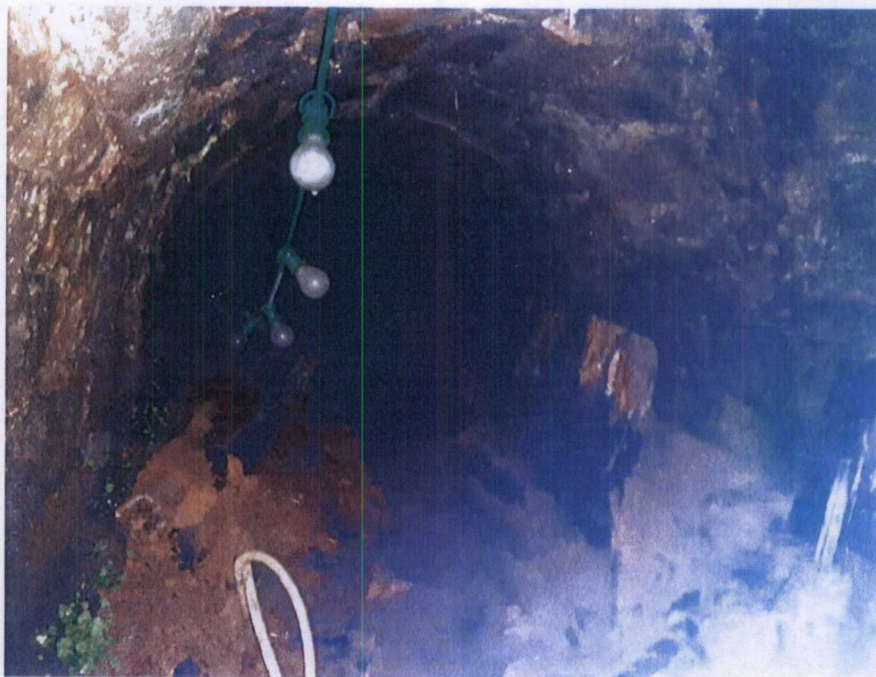
It is likely that the only voids which could influence the site would be the main roadways accessing the Upper Stinking seam. However, the adit is open to tours by the Heritage Trust and the condition of the adit beneath the site can be inspected regularly.

Photograph 11 View up adit

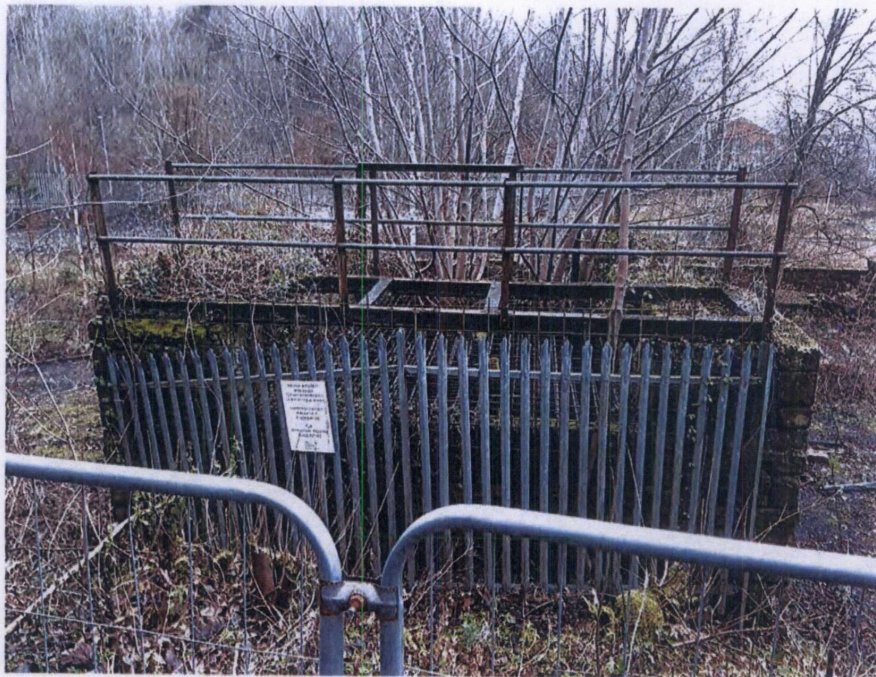
Photograph 16 Shaft 128

329353-128. This shaft was found to be open to a depth of 61m from the top of the heapstead in 2002. The shaft was secured by constructing a palisade fencing on top of the brick heapstead.

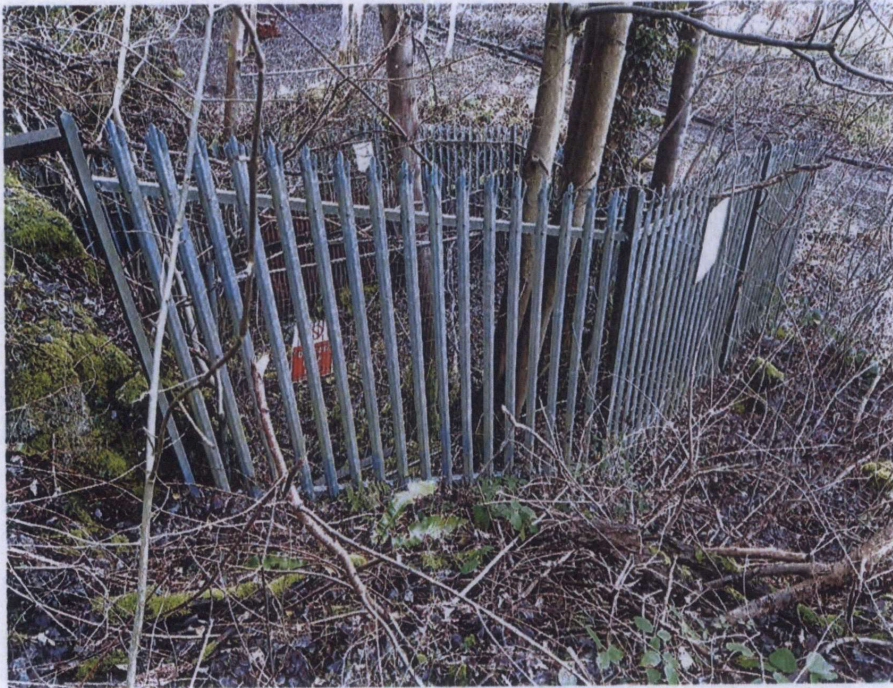
Photograph 17 Shaft 127

329353-127. In 1968 the shaft top was covered with RSJs and sheeting. The entry was found to be open to a depth of 31.5m in 2002. The area around this shaft was secured with palisade fencing.

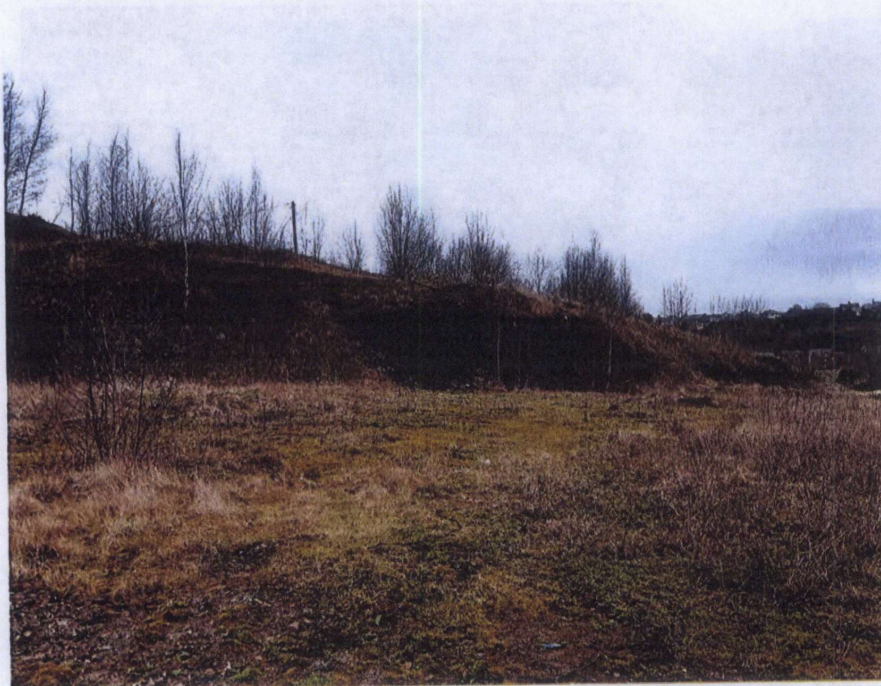
In addition, previous open casting immediately south of the site exposed a coal seam, thought to be the Two-Yard seam, which was dipping gently in an easterly direction. However, immediately west of this outcrop, further coal was exposed dipping steeply to the west, probably indicating it was in the vicinity of the main Brymbo Fault, see Figure 3.

Photograph 18 Outcrop of Two-yard (Hollin) seam dipping eastwards

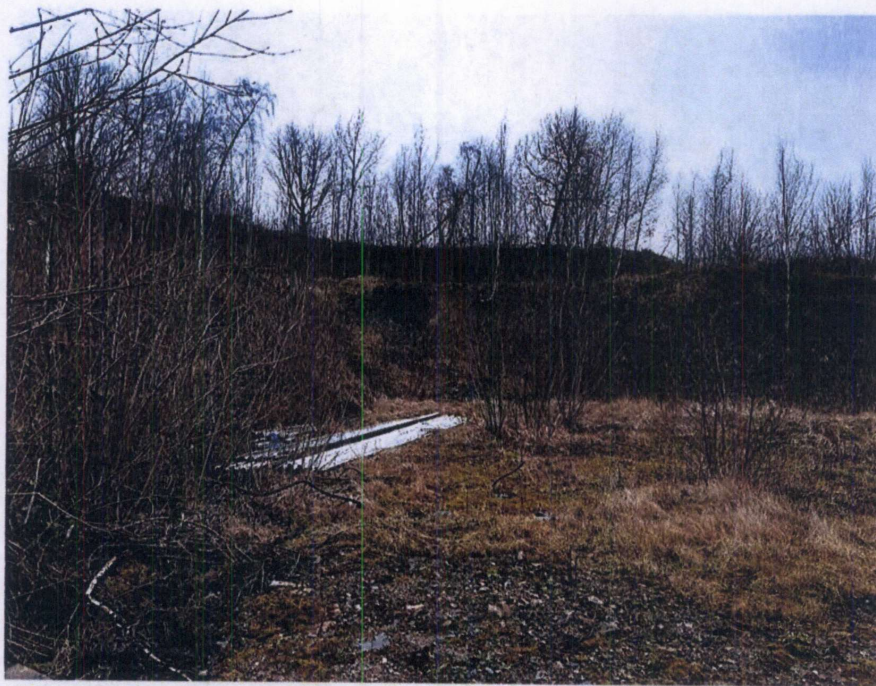
Photograph 19 Two-yard (Hollin) seam tilted in close proximity to fault

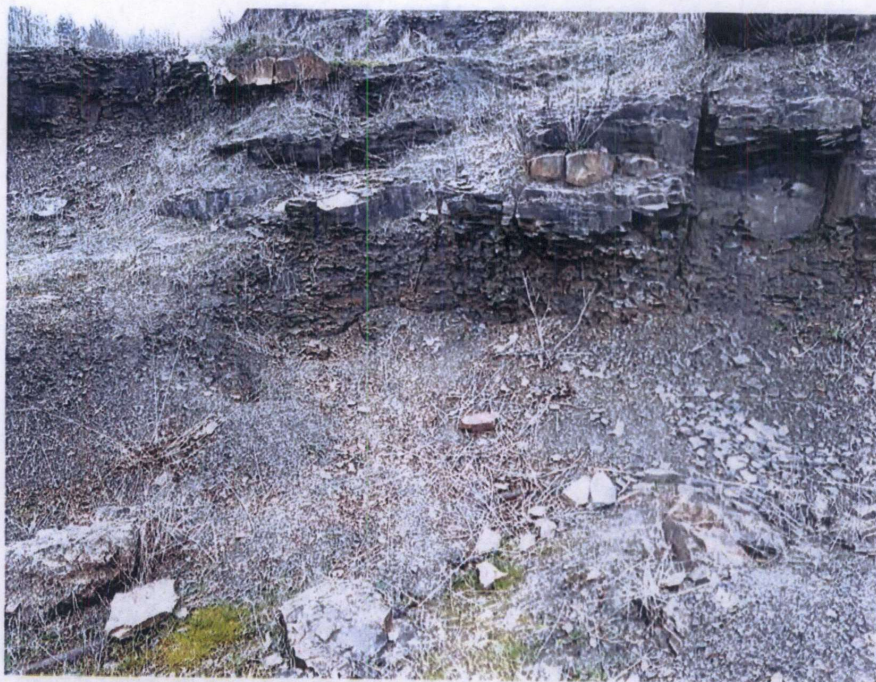
Immediately south east of these exposures is the Fossil Forest, and Mr. Brown indicated that possible Bell Pits had been encountered in excavations for the Fossil Forest.

Photograph 20 Area of bell pitting close to Fossil Forest

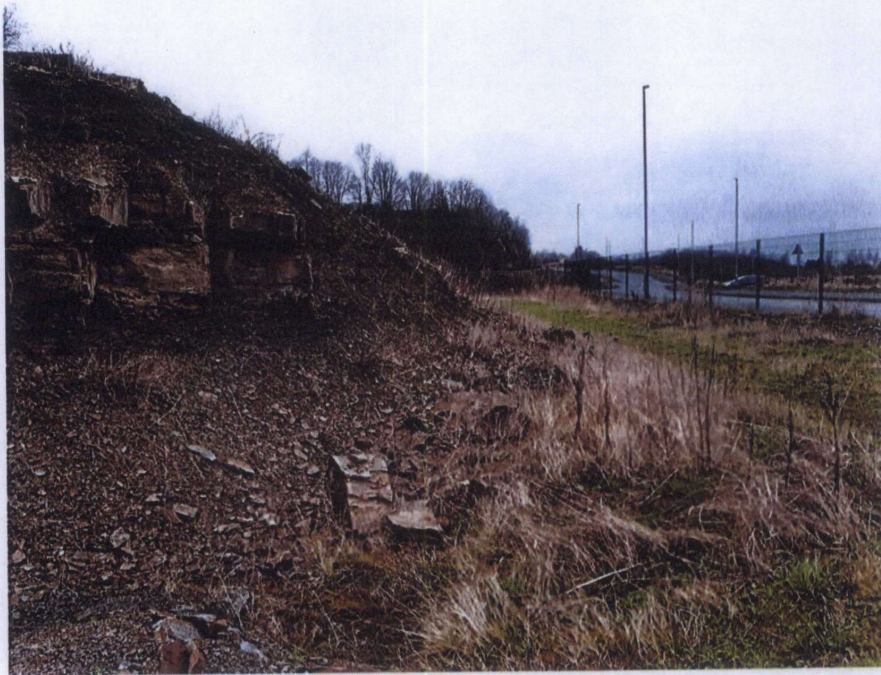
Photograph 21 Showing elevation of Bell Pits to Crank seam
