Stori Brymbo Project

Mining Report

Heritage Area

Brymbo Heritage Trust

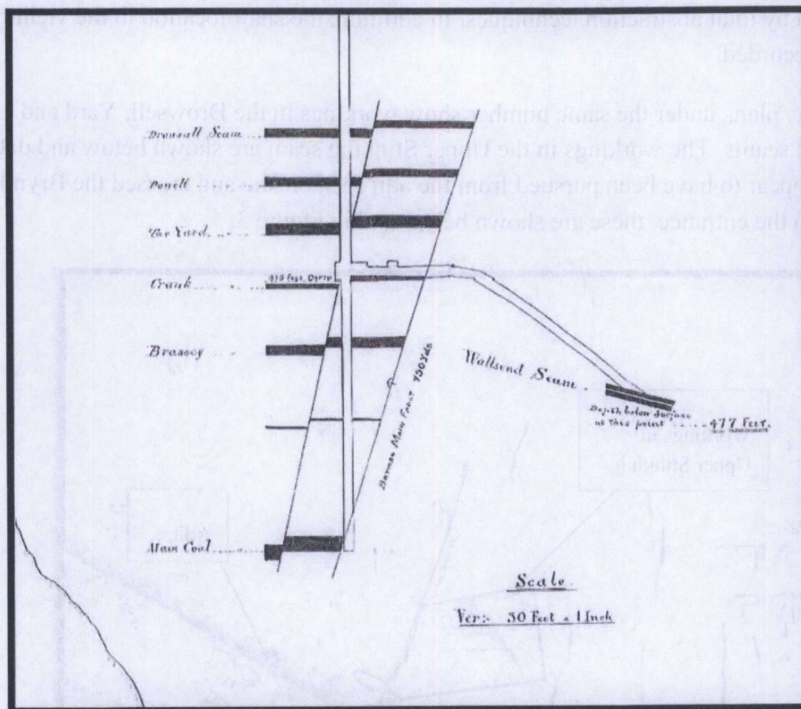
### Bye Pit showing Brymbo fault

Mine plan 5973, dated 1910, showing recorded workings in the Wallsend seam presents a shaft section of the Bye Pit at the Brymbo colliery, see below. This shows the shaft going through the Drowsell, Powell, Two Yard and Crank seams before entering the Brymbo Fault at the level of the Crank seam at 418 feet depth (127m). A roadway is shown going to the Wallsend seam on the east side of the fault at a depth of 477 feet (145m), See below.

The downthrown on the fault is shown as 150 yards in a westerly direction.

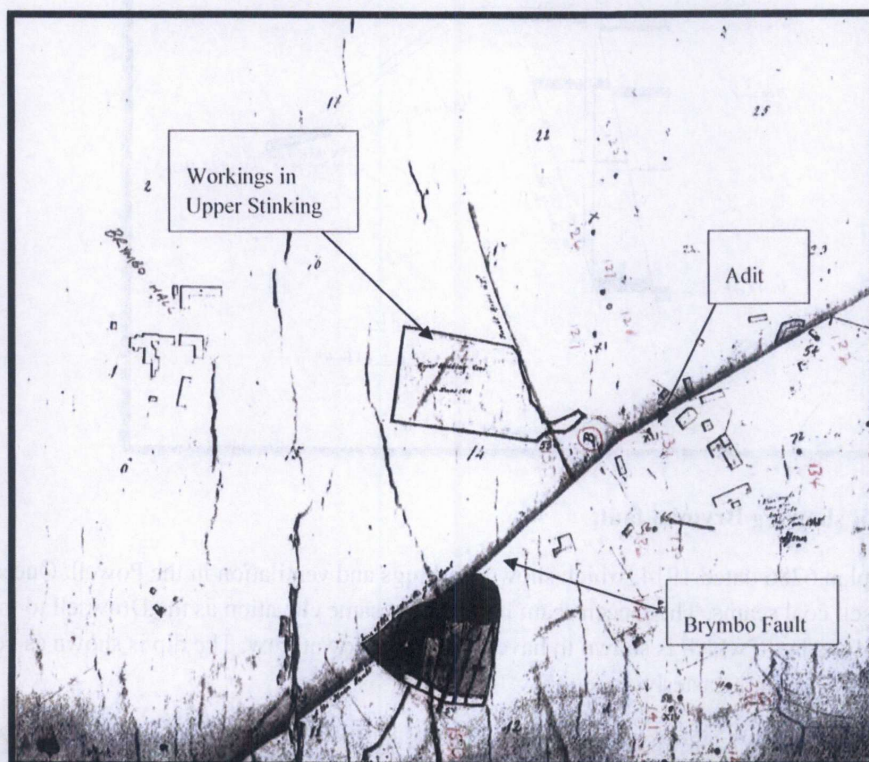
#### Workings in Upper Stinking Seam from Adit on site

Separate mine plans under the same number show workings in the Drowsell, Yard and Upper Stinking coal seams. The workings in the Upper Stinking seam are shown below and dated 1818, they appear to have been pursued from the adit seen on site and crossed the Brymbo Fault close to the entrance, these are shown below and in Figure 3.

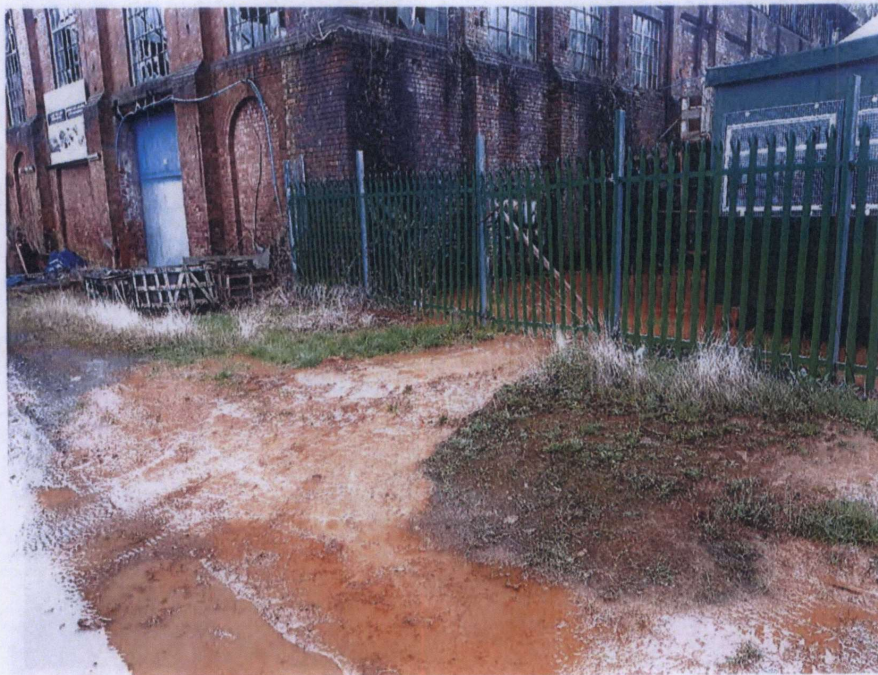
This revealed the presence of an open adit in the south west corner of the works, which is within the site boundary, from which red mine drainage water was issuing. Mr. Brown indicated that this adit had been driven circa 1843 to work a coal seam, which was rapidly exhausted. The walkover also inspected the old Brymbo colliery shafts to the west of the main development, which are both fenced off. According to Mr. Brown these have been partially backfilled by the Coal Authority to depths of around 50 to 60m, with the water standing at around 30m depth. One of the pits was reported to be covered with a metal grill.

Photograph 1 Mine water discharge from adit

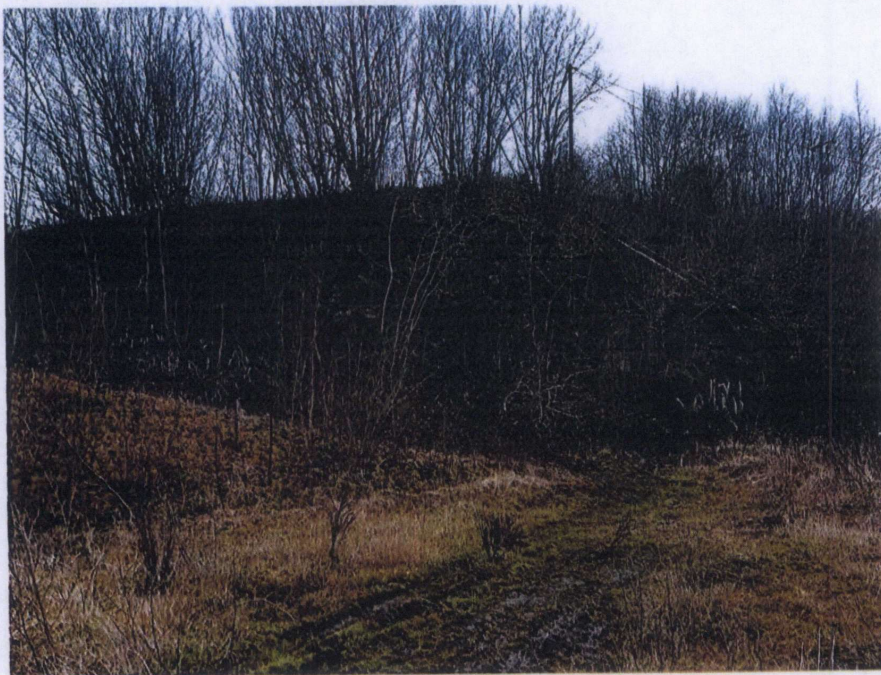
Photograph 2 outcrop of sandstone close to site entrance

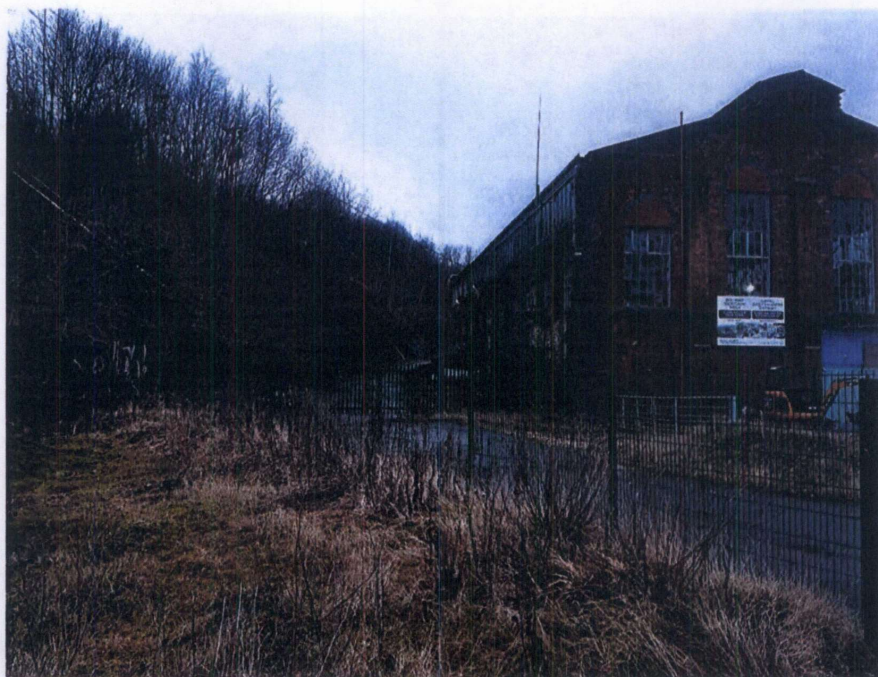
Photograph 3 Southern side of site showing ground level rising rapidly to the south

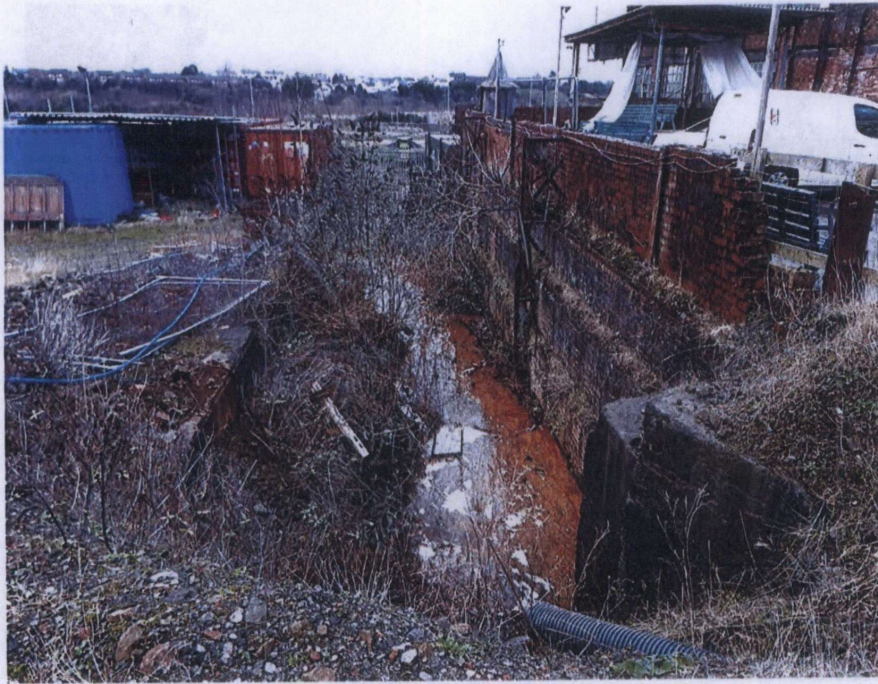
Photograph 5 drainage channel through site

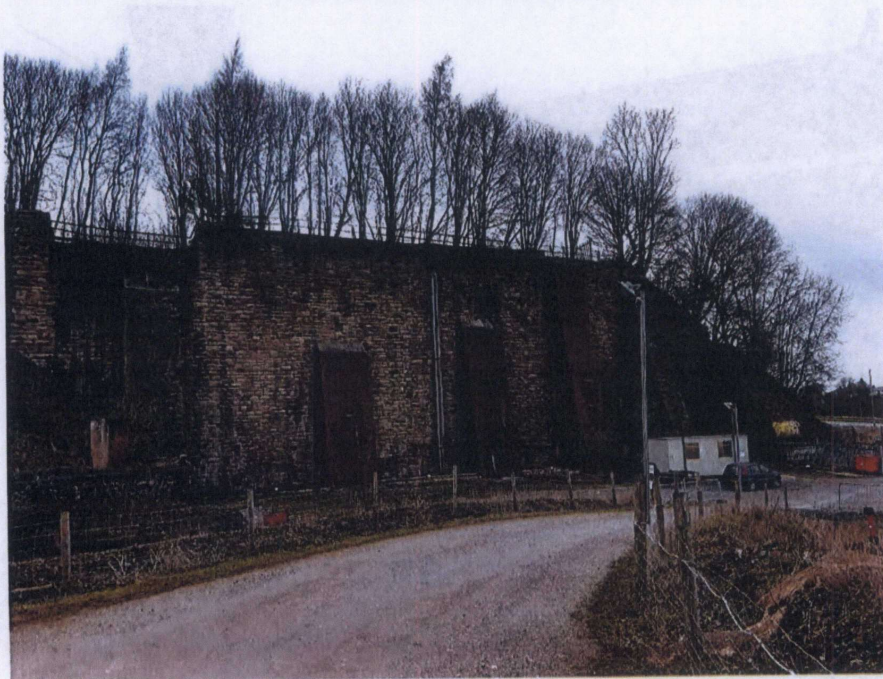
Photograph 6 Retaining structure on northern site boundary

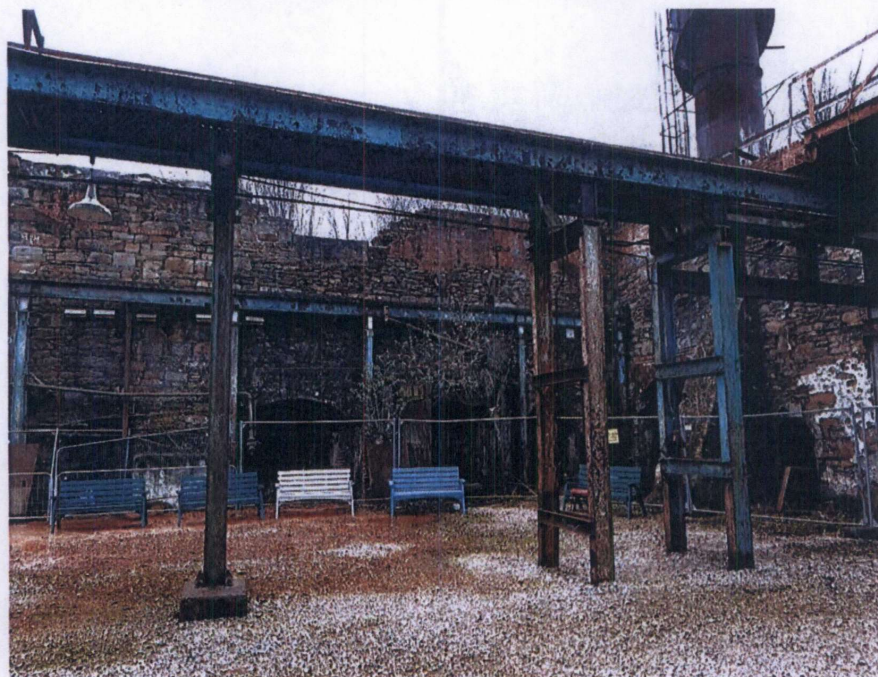
Photograph 8 Adit inside right had entrance

However, adit 131 is open beneath the development area, and is inspected by the Heritage Trust. Therefore, this does not present a risk to the proposed site use. The main risk posed by this adit is its drainage capability. Should it collapse, it would effectively dam the flow of water from the workings, which may cause problems around the site area in terms of water issuing from sealed adits etc. It would therefore be prudent to undertake regular structural inspections of this adit.

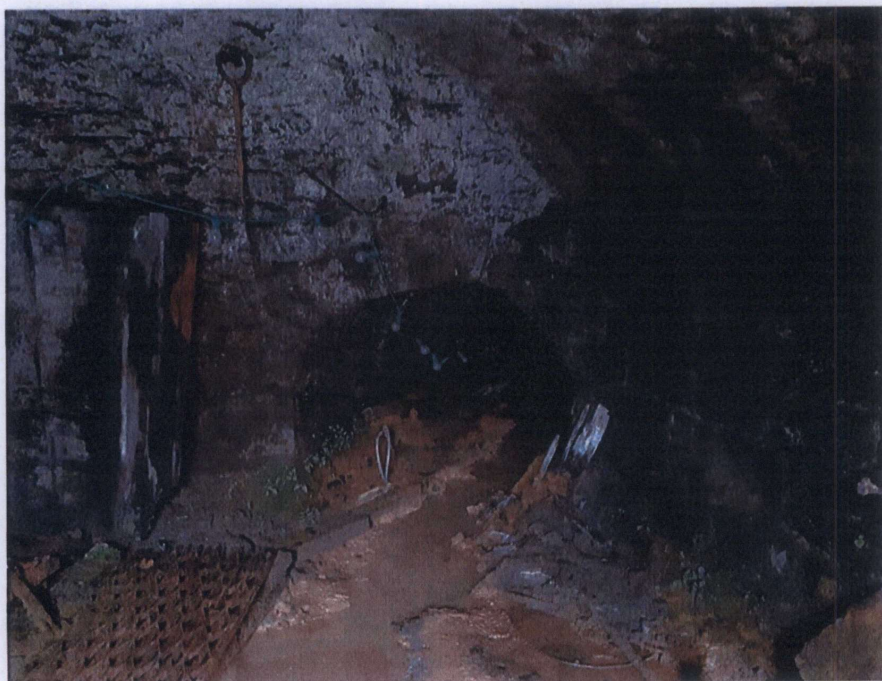
Photograph 9 Adit entrance

329353-131. This entry was investigated in 2002 by JMC Mining Services and was found to be within a building. A metal grill was placed across the entrance to the building to prevent access. The adit was found to be open.

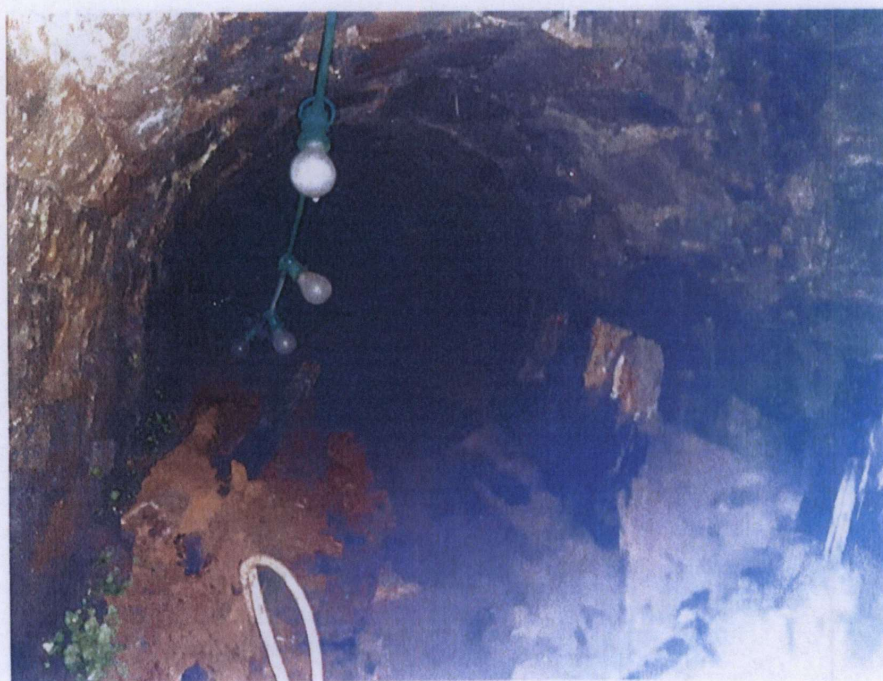
It is likely that the only voids which could influence the site would be the main roadways accessing the Upper Stinking seam. However, the adit is open to tours by the Heritage Trust and the condition of the adit beneath the site can be inspected regularly.

Photograph 10 View up adit

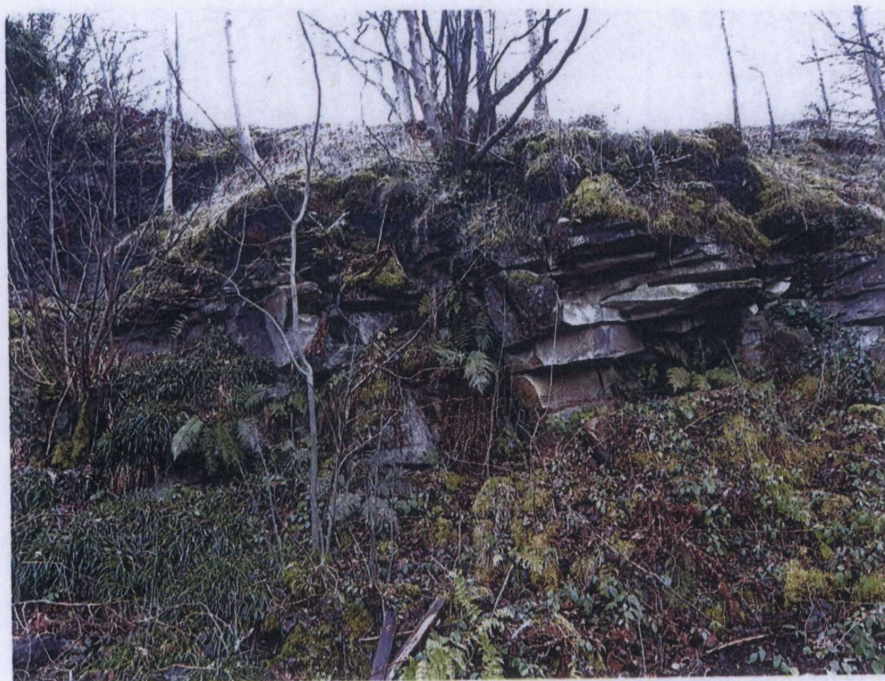
The potential for voids to become unstable has to be considered. To the west of the fault this is considered to be very low as the seam is overlain by a considerable thickness of strong sandstone, which was observed at surface.

Photograph 14 Sandstone outcrop on higher section of the site

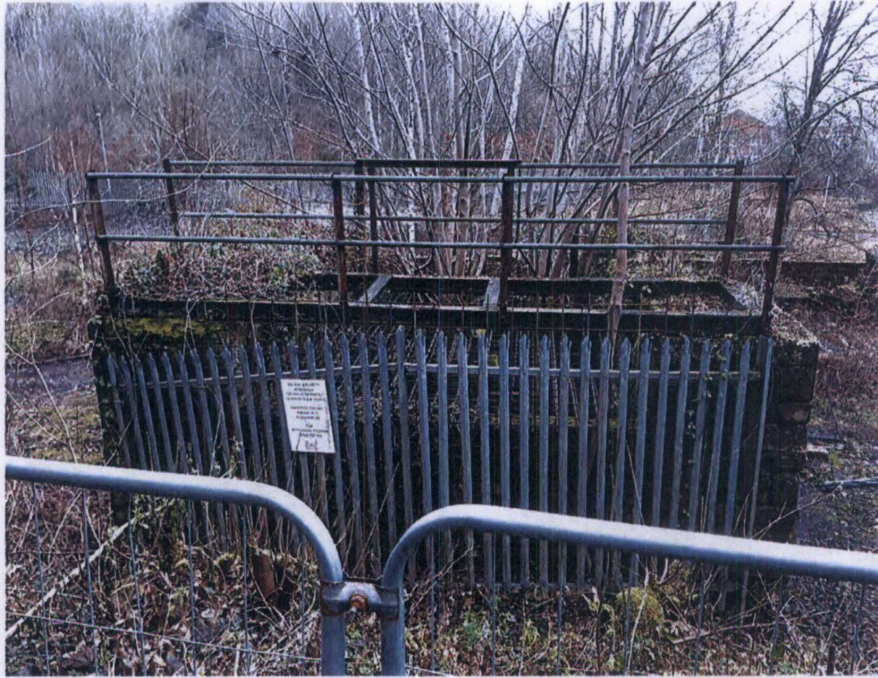
However, the location of mine entrances needs more careful consideration. Shafts if they have not been treated run the risk of sudden collapse, this is due to the fact that they were rarely backfilled full depth, especially if there was insufficient nearby fill. Instead a staging would be constructed at one of the levels, which may deteriorate with time and collapse leading to a surface failure. However, there are no known shafts to the west of the fault that could influence the development area, shafts 127 and 128 being sunk straight into sandstone rock head.

Photograph 15 Shaft 128

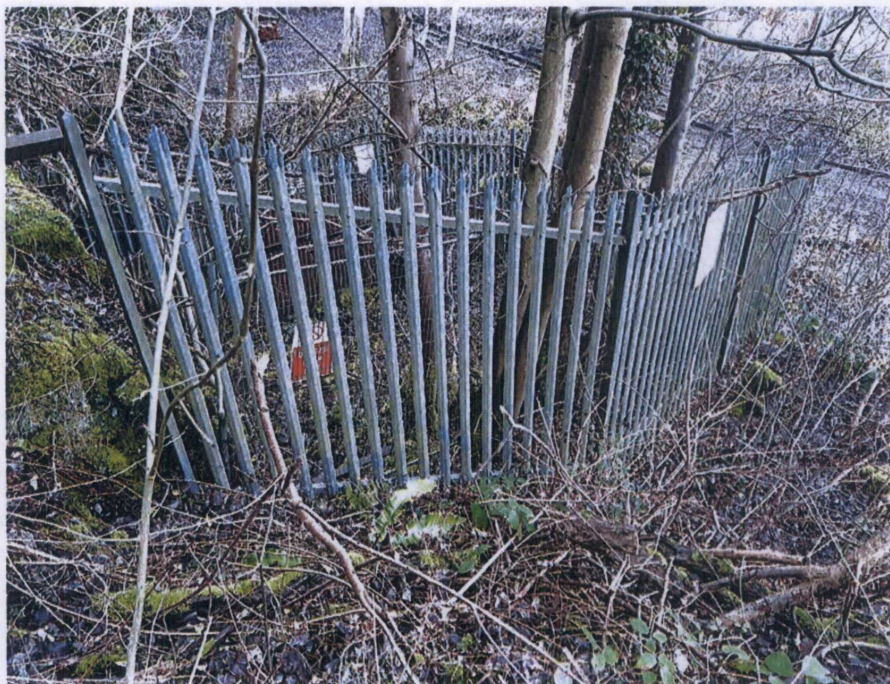
Photograph 16 Shaft 129

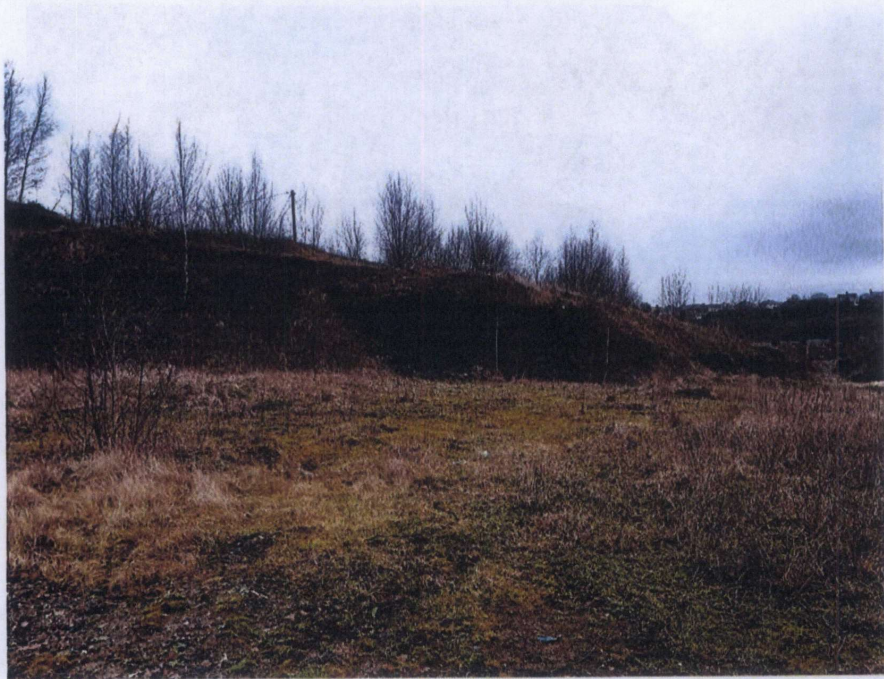
In addition, previous open casting immediately south of the site exposed a coal seam, thought to be the Two-Yard seam, which was dipping gently in an easterly direction. However, immediately west of this outcrop, further coal was exposed dipping steeply to the west, probably indicating it was in the vicinity of the main Brymbo Fault, see Figure 3.

Photograph 17 Outcrop of Two-yard (Hollin) seam dipping eastwards

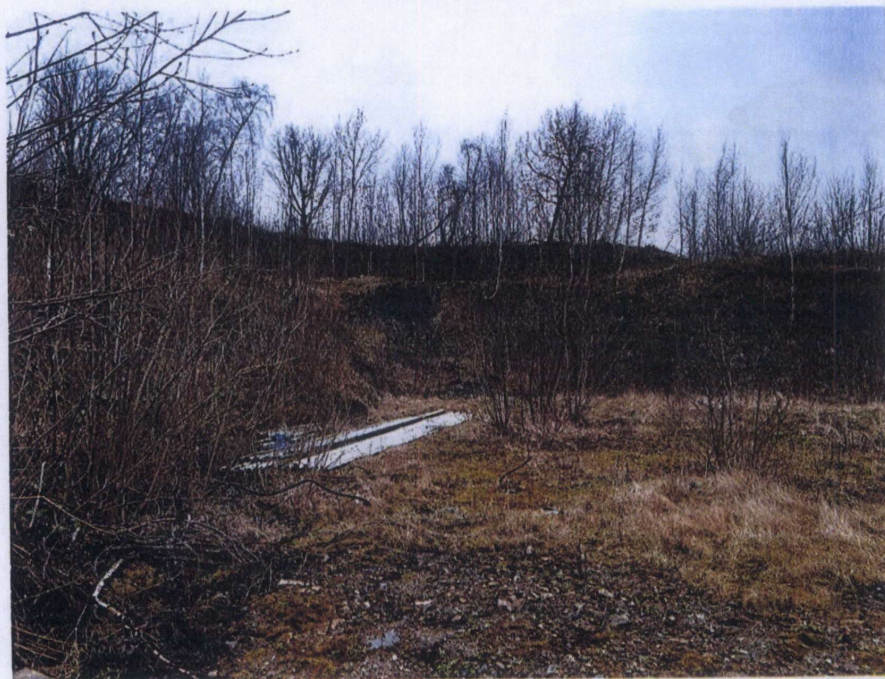
Photograph 18 Two-yard seam tilted in close proximity to fault

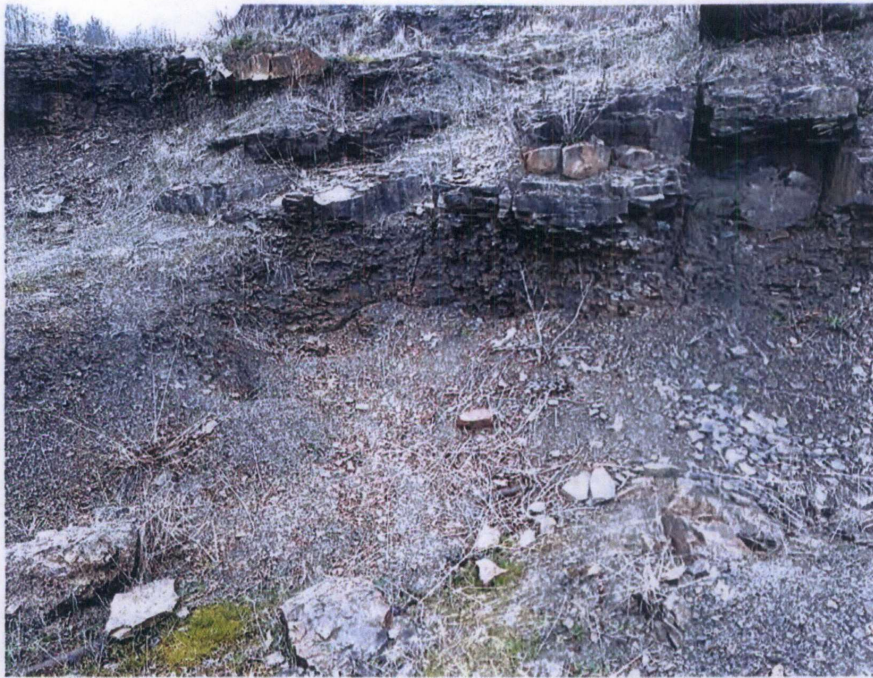
Immediately south east of these exposures is the Fossil Forest. and Mr. Brown indicated that possible Bell Pits had been encountered in excavations for the Fossil Forest.

Photograph 19 Area of bell pitting close to Fossil Forest

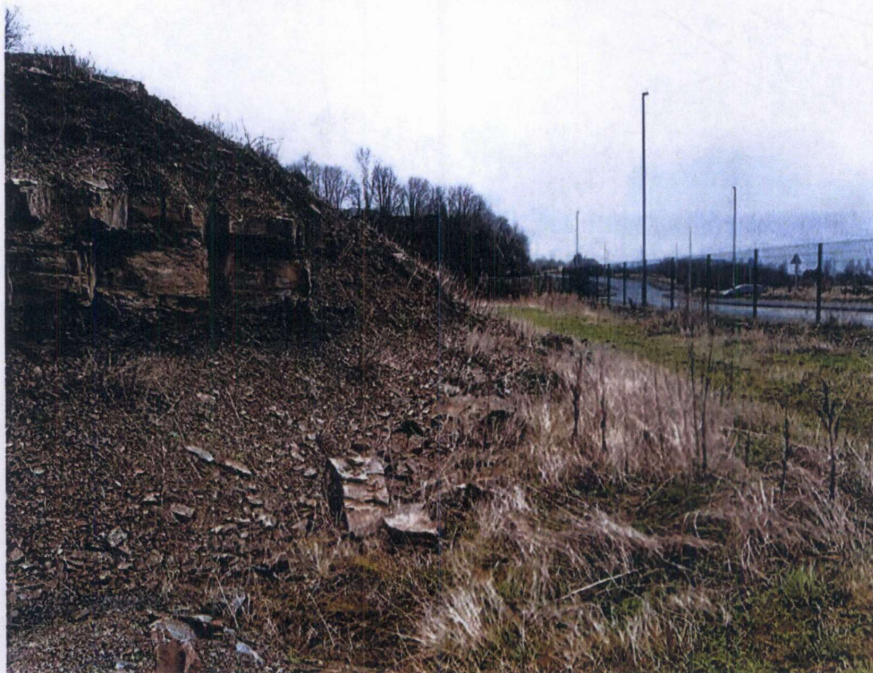
Photograph 20 Showing elevation of Bell Pits to Crank seam
