# TREVOR BASIN WHS ARRIVAL

## Phase I Geo-Environmental Desk Study

Document Ref: 10054502-ARC-XX-XXX-RP-GE-01001

JANUARY 2024

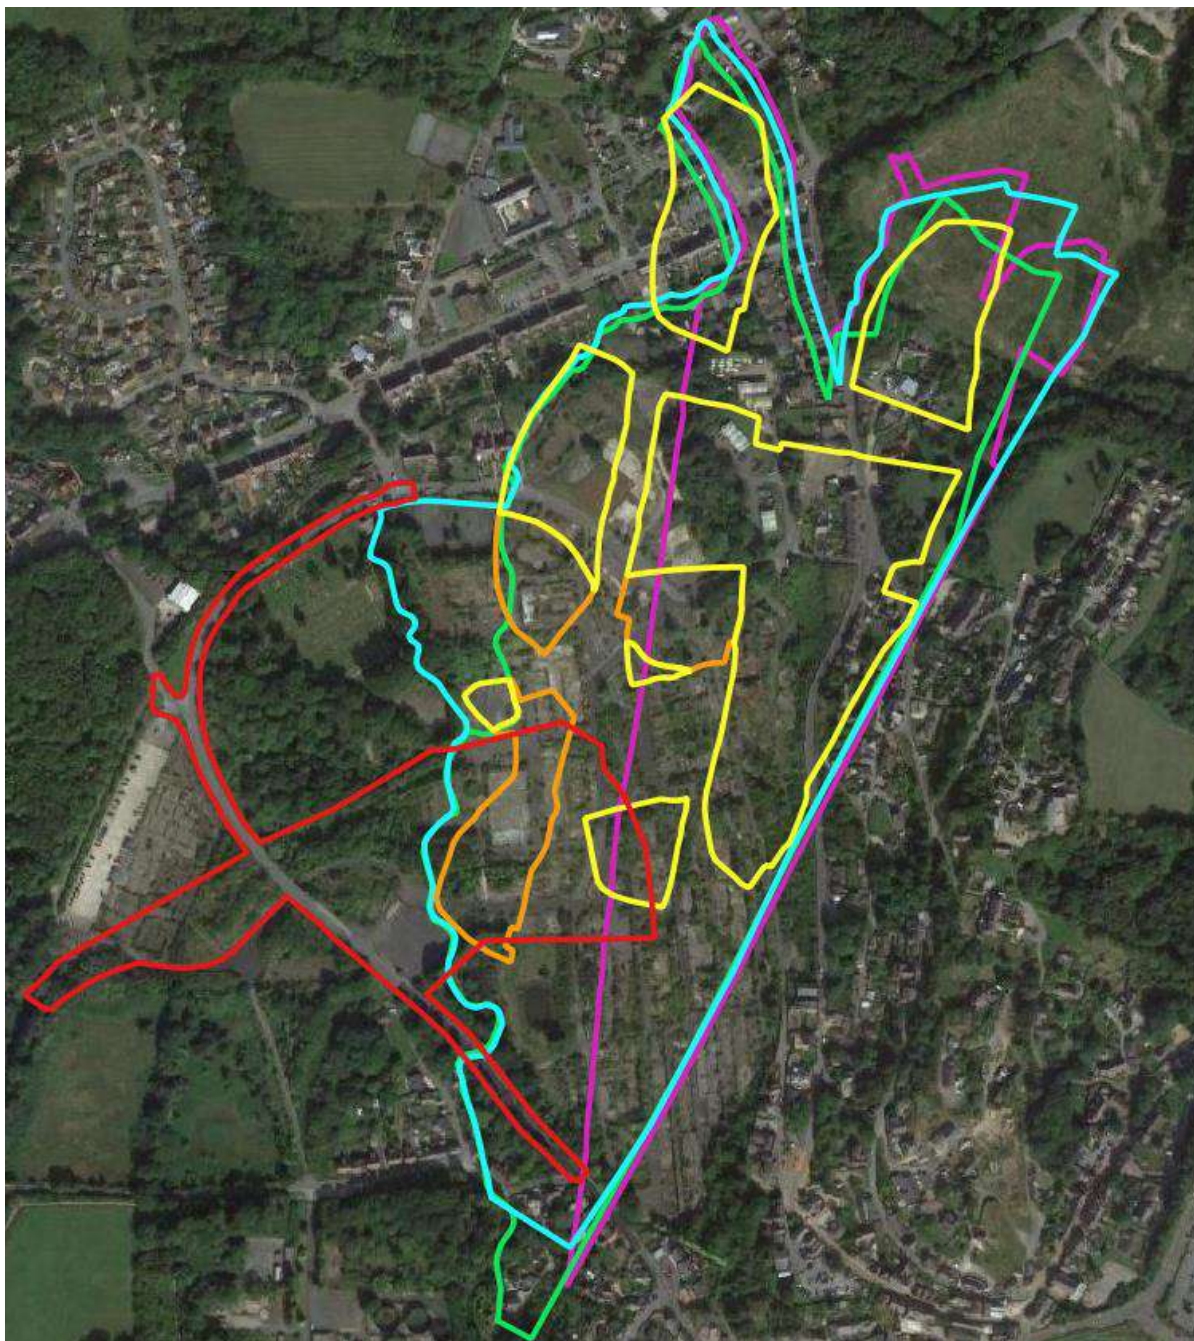
Figure 4-2: Recorded workings obtained from Coal Authority mine abandonment plans © Google Maps 2022

Mine abandonment plans (dated 1949) were obtained from the Coal Authority for workings within four seams beneath the site, these are included in Appendix G. Figure 4-2 below shows the outlines of the recorded workings in relation to the site boundary. These plans are not comprehensive and other unrecorded workings may be present beneath the site.

There is potential for shallow voiding beneath the site due to historical mine workings within several shallow coal seams. Several untreated mine entries are also recorded on the site. There is also the potential for poor ground conditions due to historic backfilling of canals and brooks previously running through the site. Intrusive ground investigation will be required to determine the near surface and deeper ground conditions.

Prior to any redevelopment of the site, intrusive investigations will be required to establish the nature of the ground conditions, identify any instability issues associated with potential shallow voiding / mine entries resulting from historical mining beneath the site, and the backfill of the former canal and brook, and to obtain development-specific geotechnical design parameters.

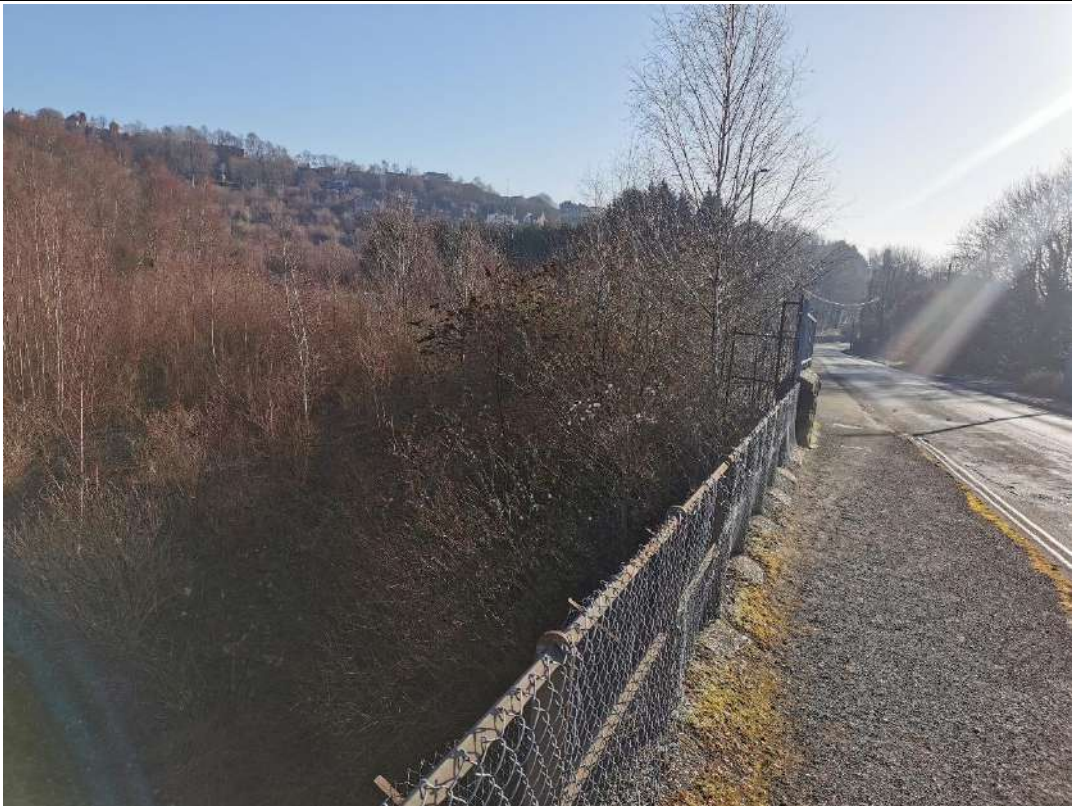
| Plate 1. – View from overpass showing general vegetation, overpass surfacing, and underpass access | | | | |

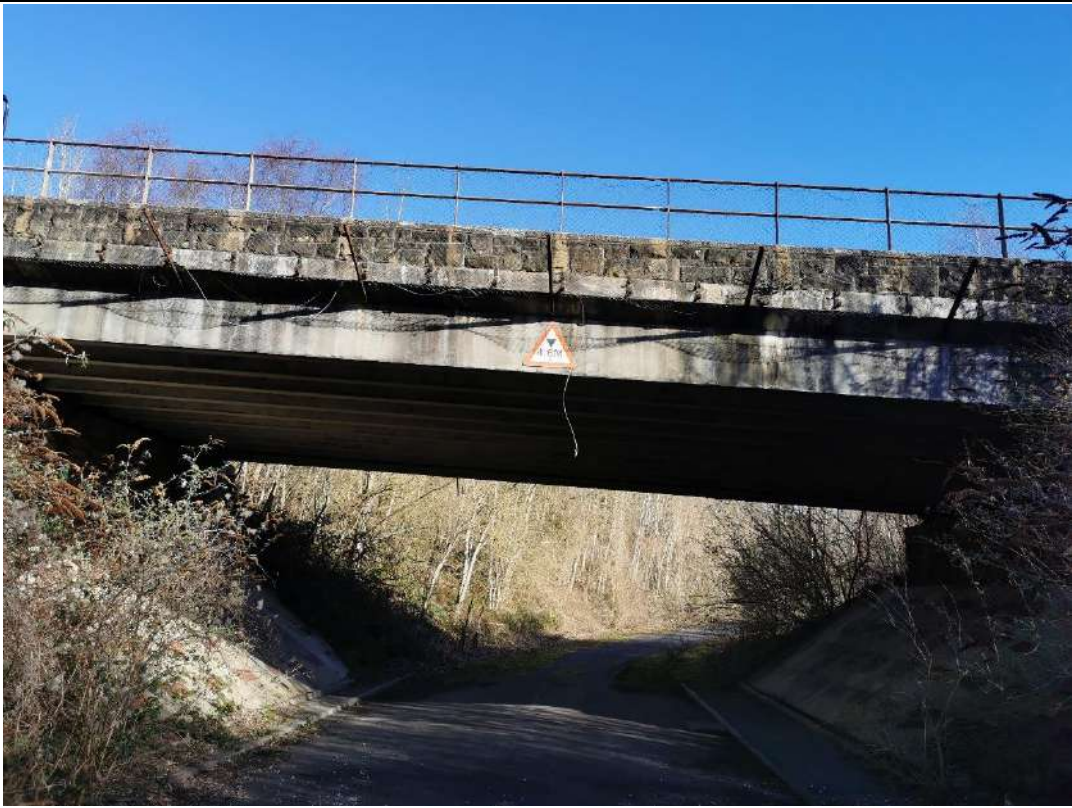
| Plate 2. – View from underpass showing general surfacing, topography changes, and height restrictions | | | | |

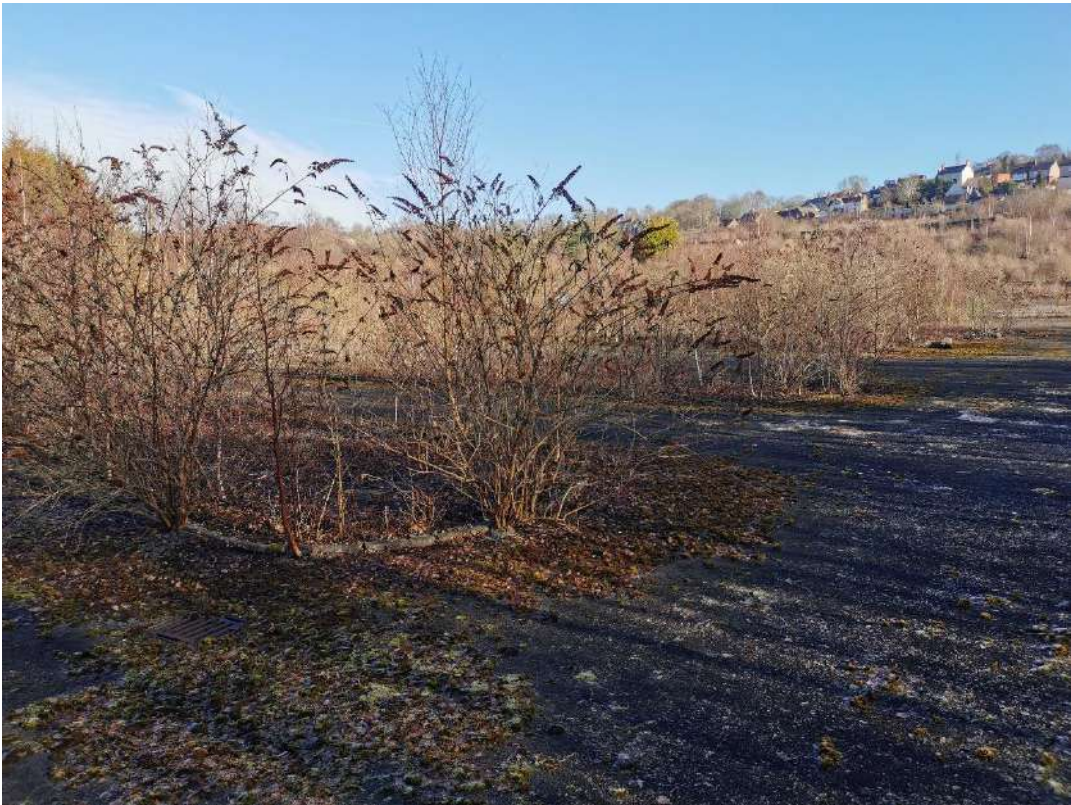
Plate 3. – Hardstanding surfacing and overgrown vegetation

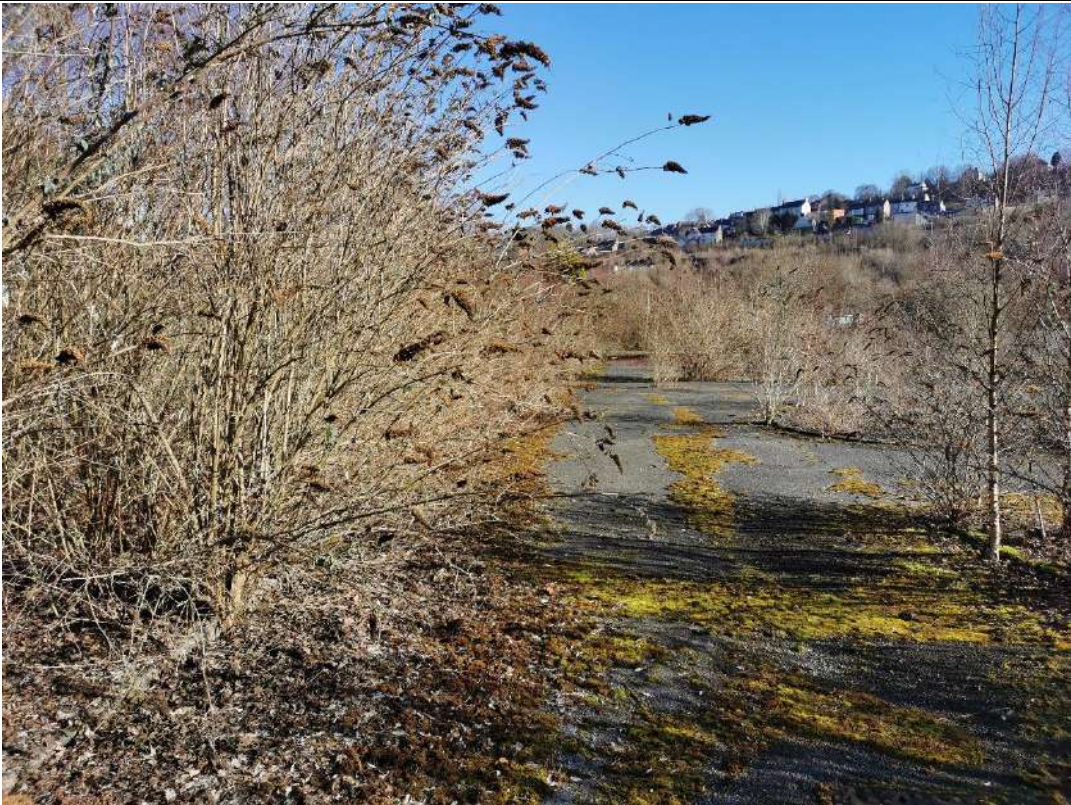
Plate 4. – Hardstanding surfacing and overgrown vegetation

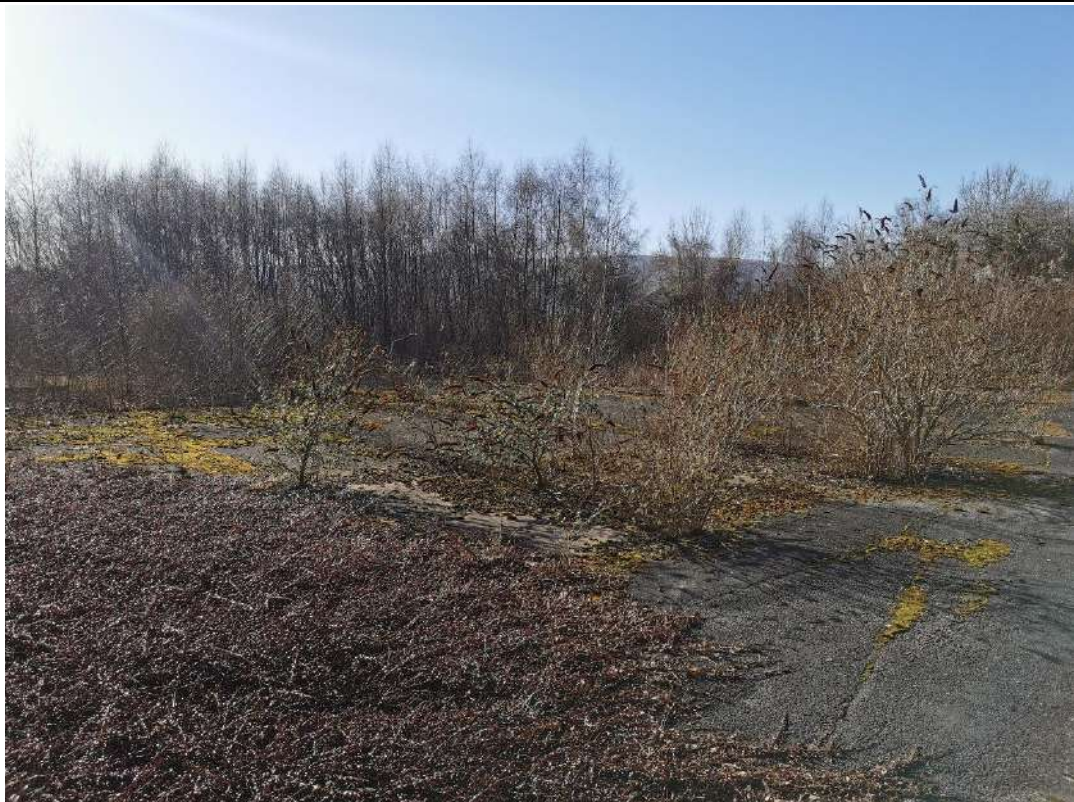
| Plate 5. – Hardstanding surfacing and overgrown vegetation | | | | |

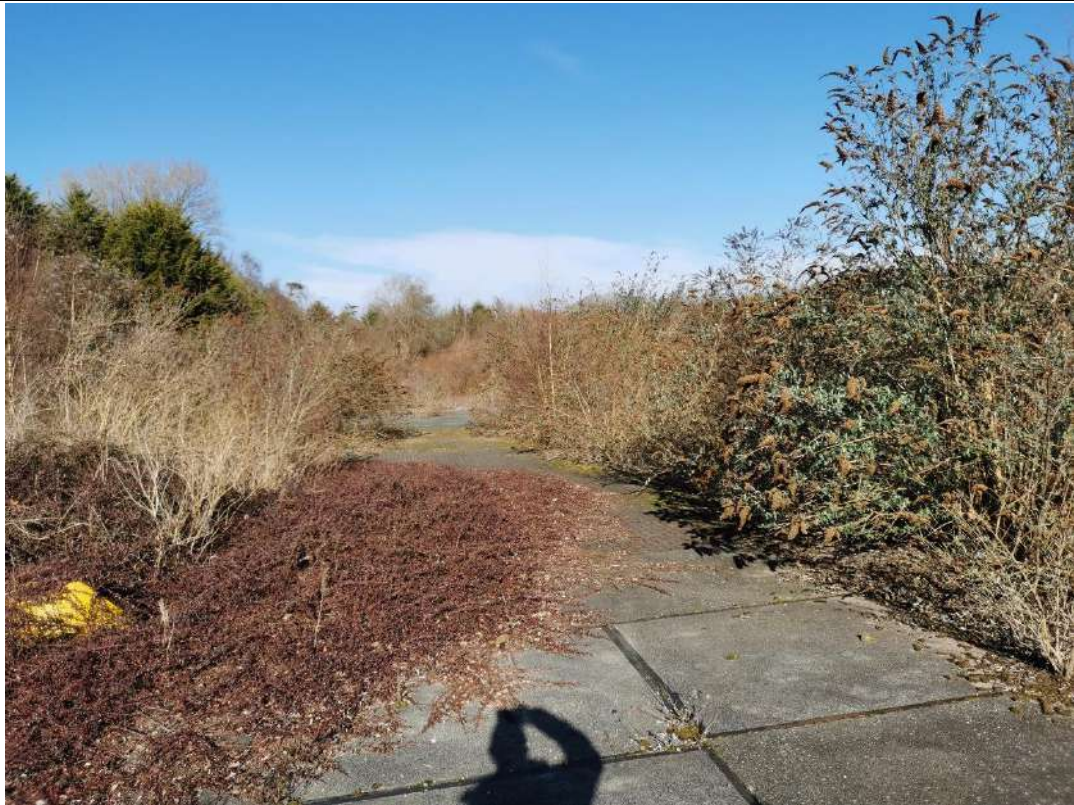
| Plate 6. – Hardstanding surfacing and overgrown vegetation | | | | |

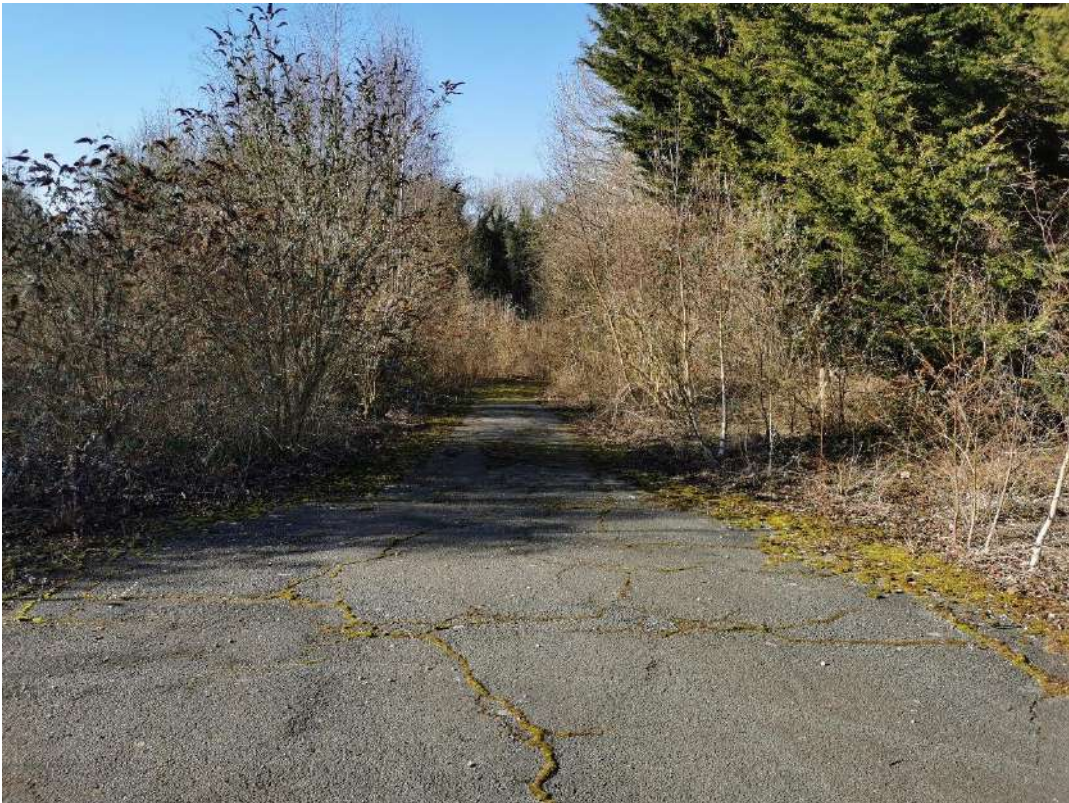
| Plate 7. – Hardstanding surfacing and overgrown vegetation | | | | |

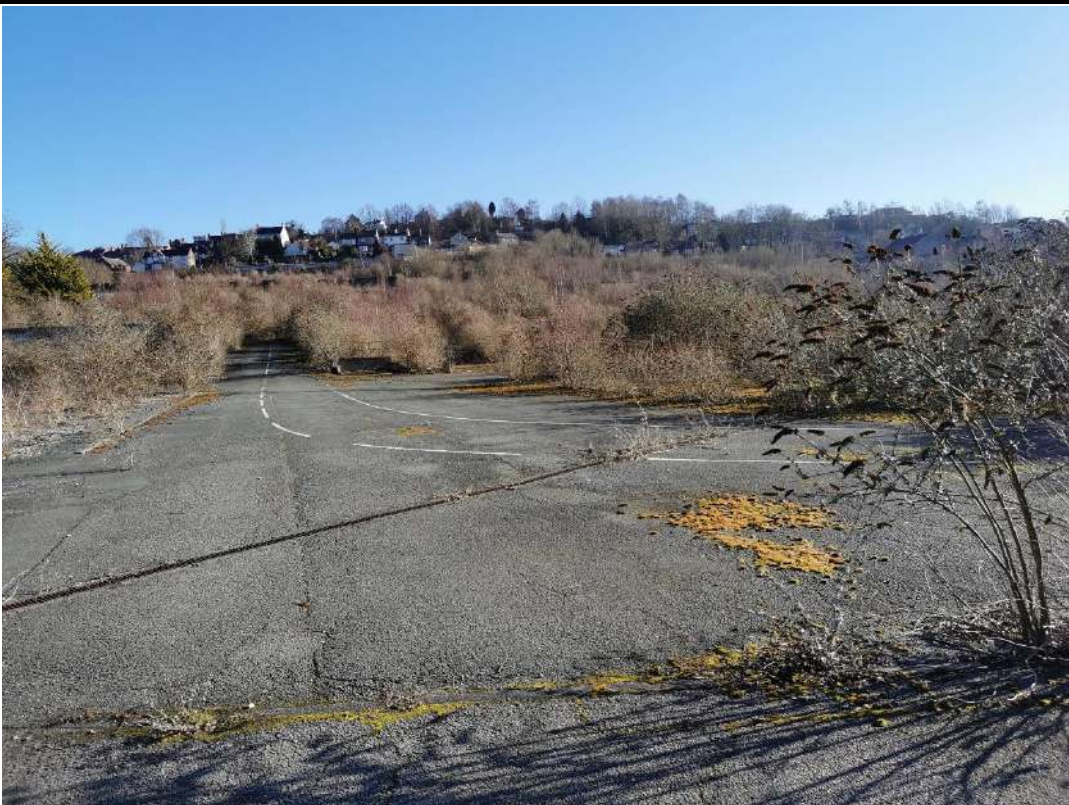
| Plate 8. – Hardstanding surfacing and overgrown vegetation | | | | |

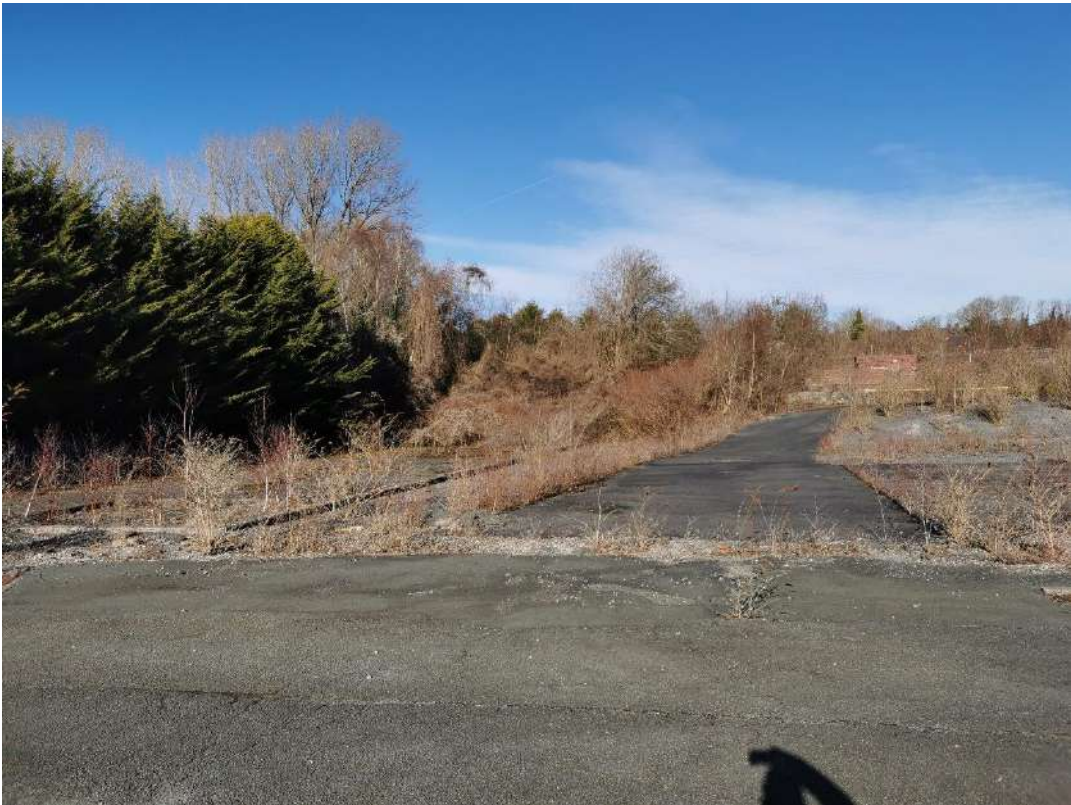
Plate 9. – Hardstanding surfacing and overgrown vegetation

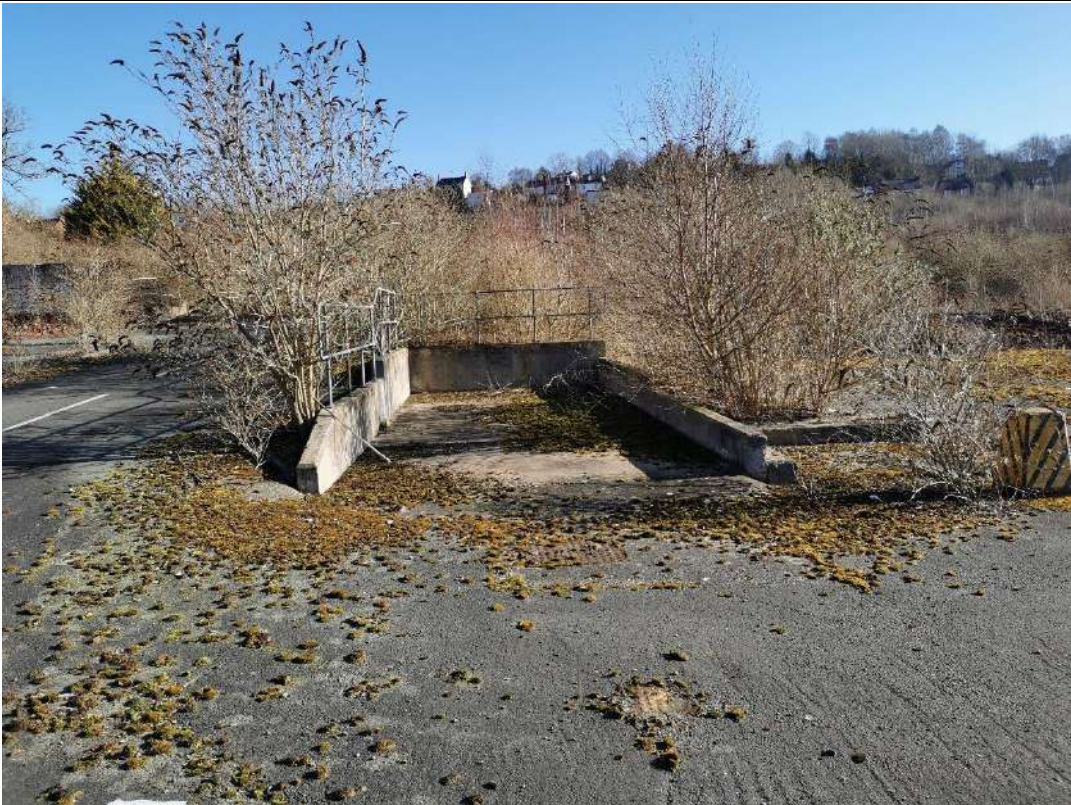
Plate 10. – Hardstanding surfacing and overgrown vegetation. Evidence of historic industrial features

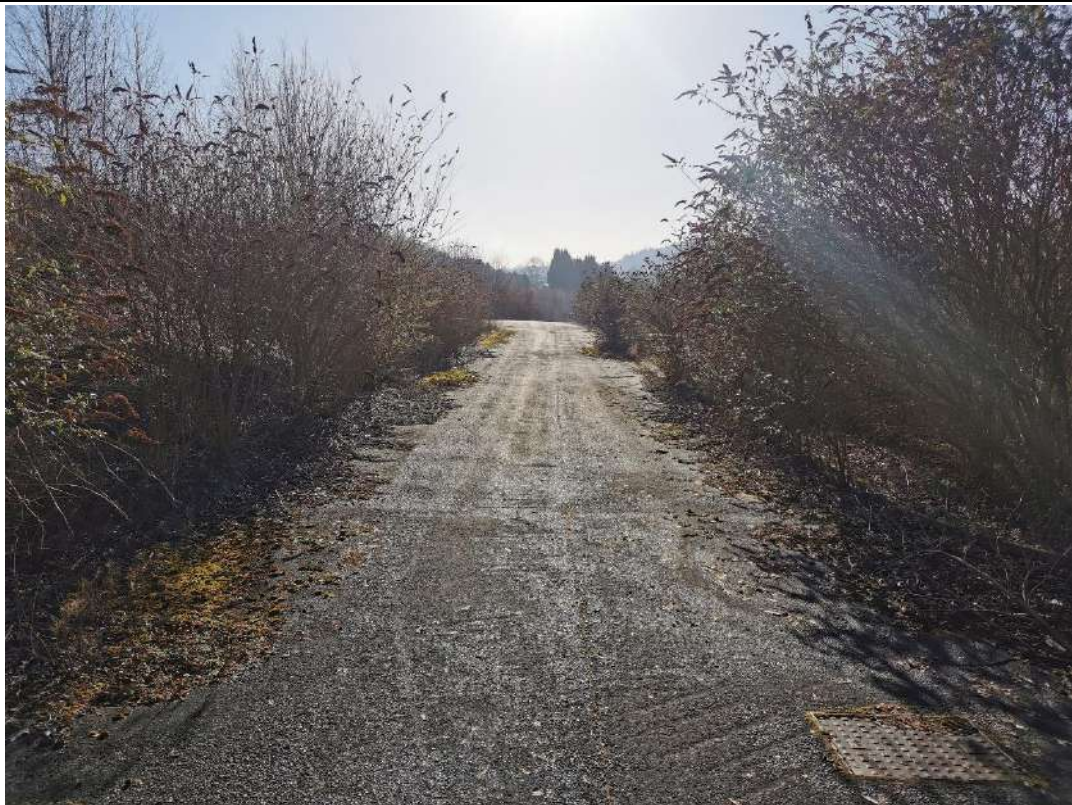
| Plate 11. – Hardstanding surfacing and overgrown vegetation | | | | |

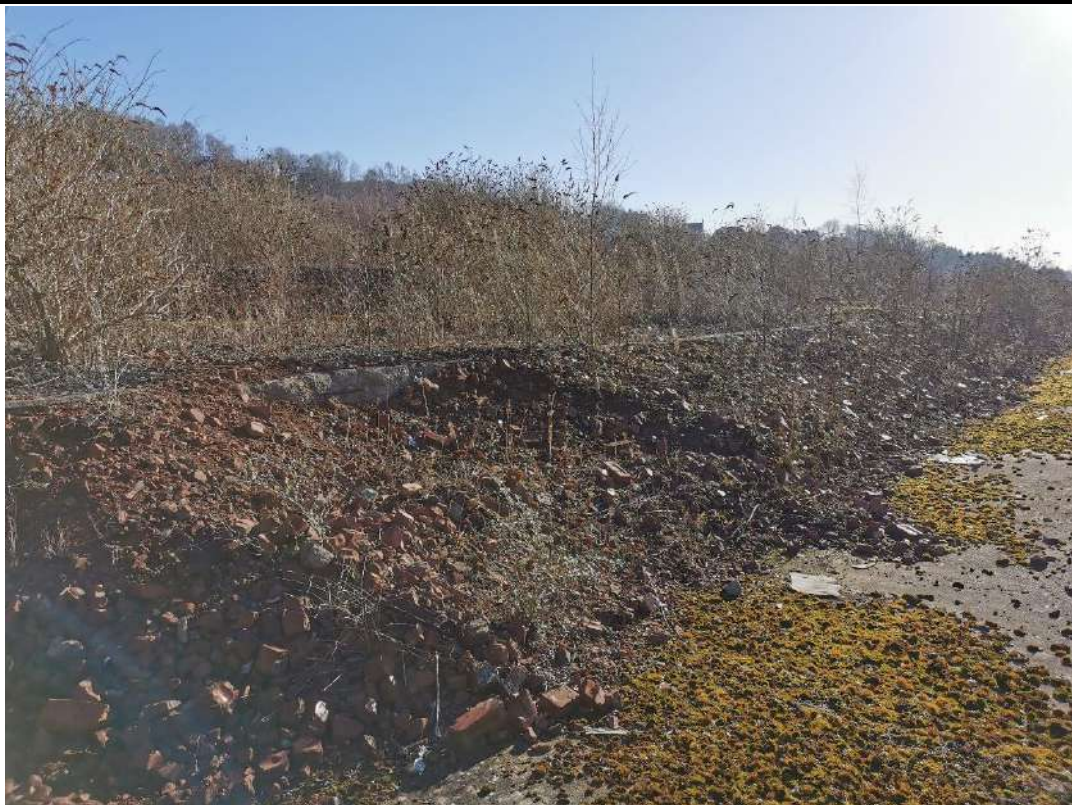
| Plate 12. – Level change in areas of former industrial features | | | | |

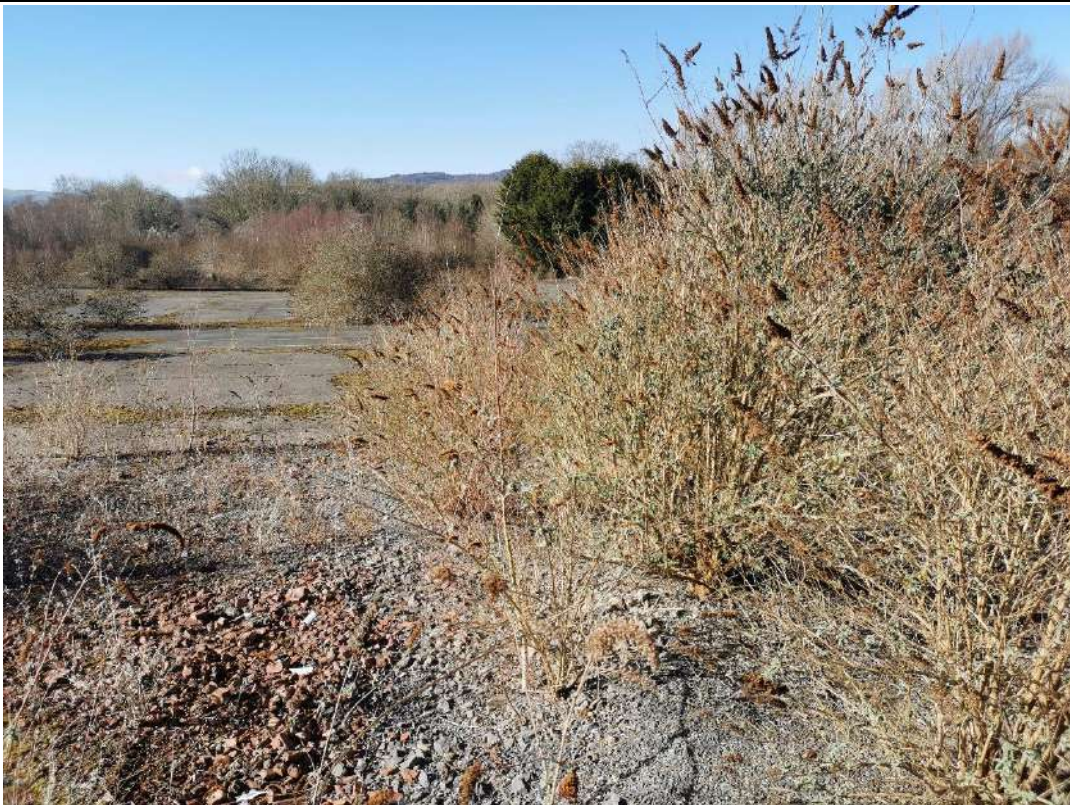
| Plate 13. –<br>Hardstanding surfacing<br>and overgrown<br>vegetation | | | | |

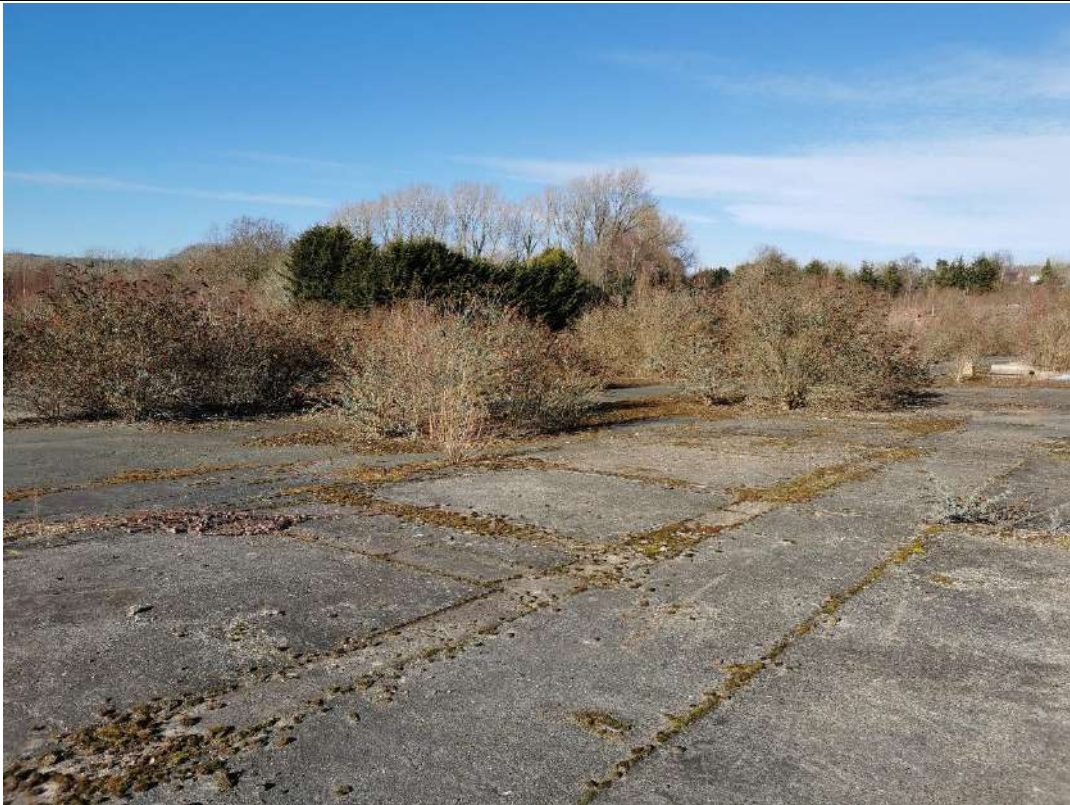
| Plate 14. –<br>Hardstanding surfacing<br>and overgrown<br>vegetation | | | | |

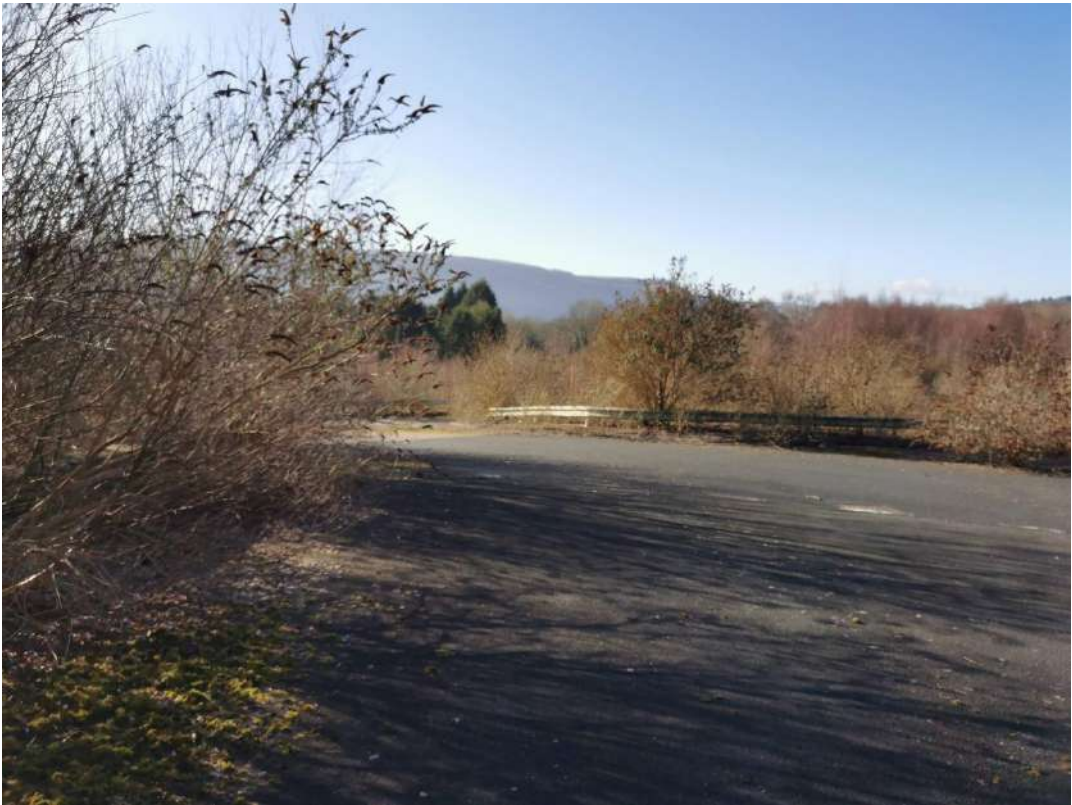
Plate 15. – Hardstanding surfacing and overgrown vegetation

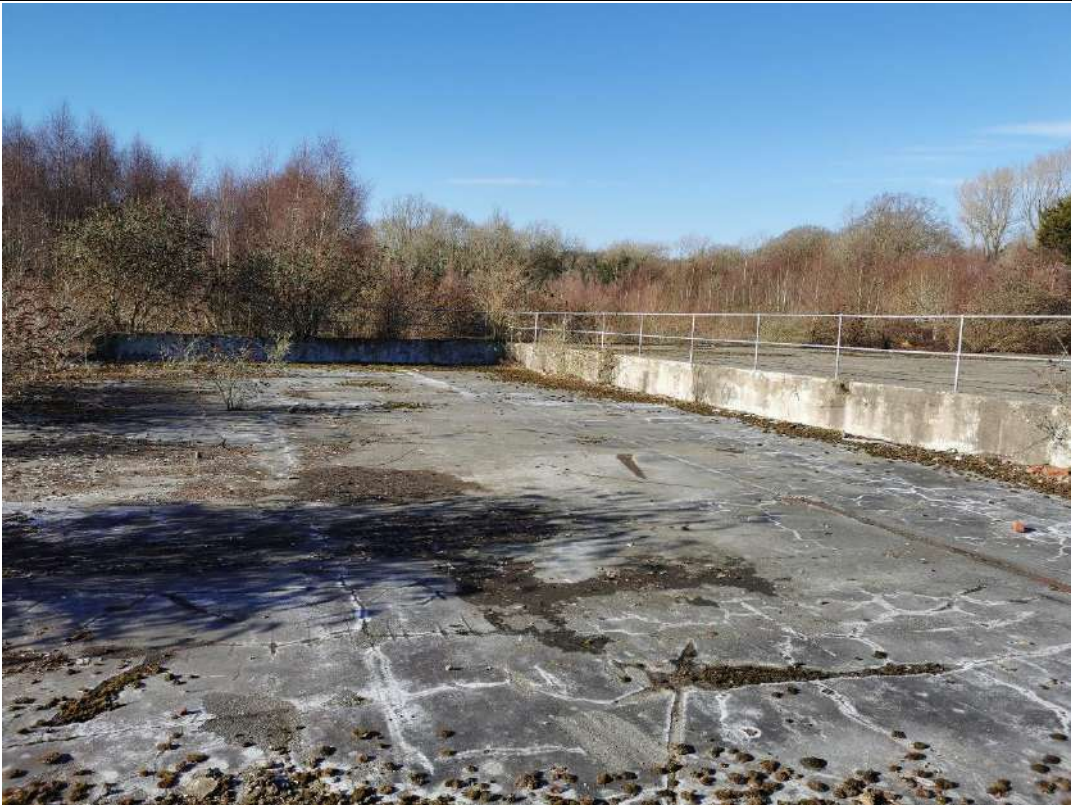
Plate 16. – Level change in area of former industrial feature.

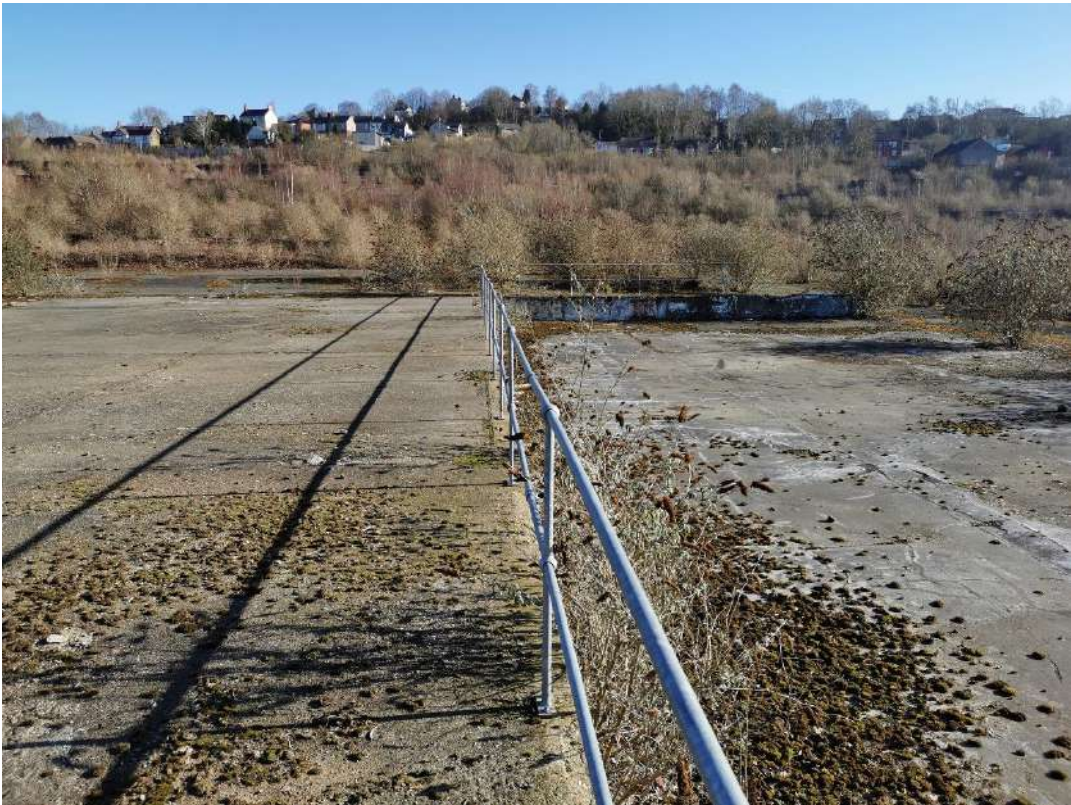
Plate 17. – Level change in area of former industrial feature.

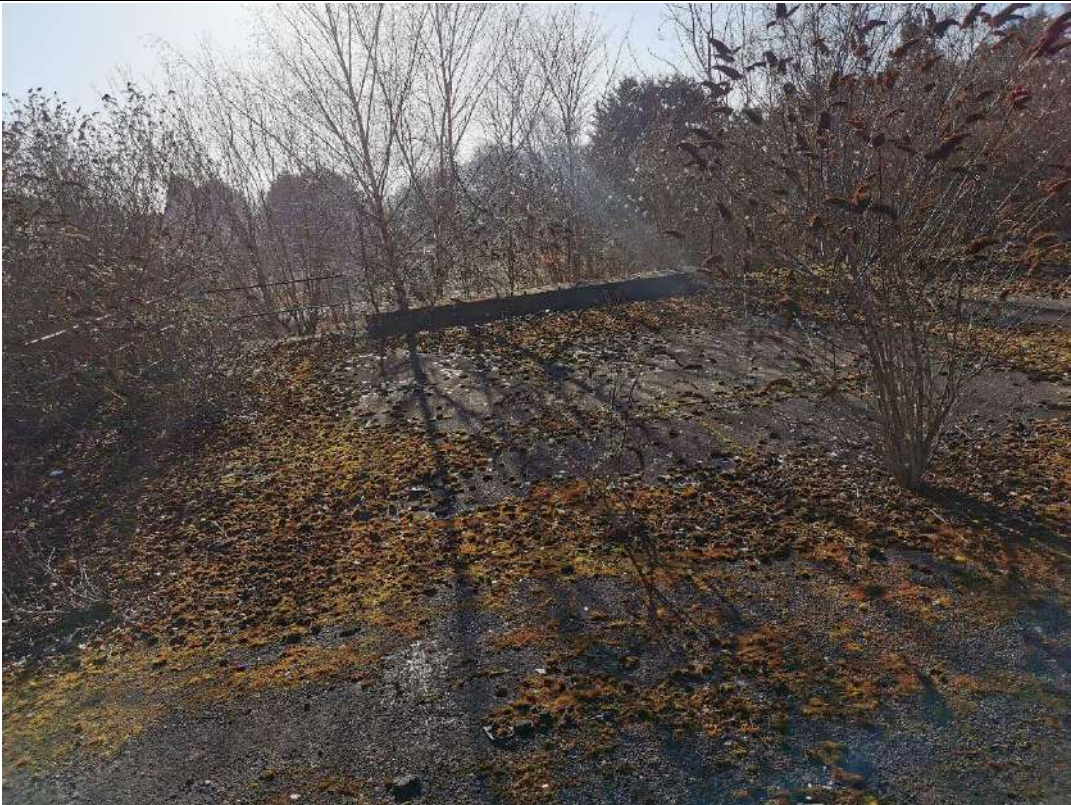
Plate 18. – Hardstanding surfacing and overgrown vegetation. Evidence of historic industrial features

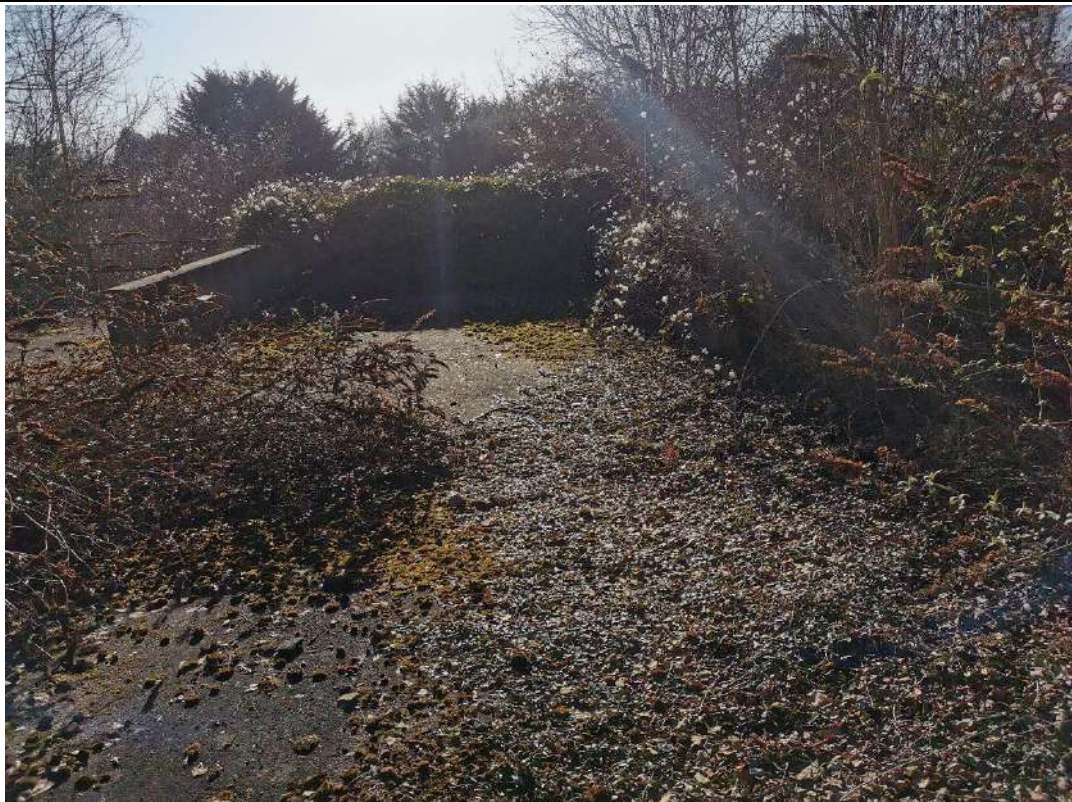
| Plate 19. – Hardstanding surfacing and overgrown vegetation. Evidence of historic industrial features | | | | |

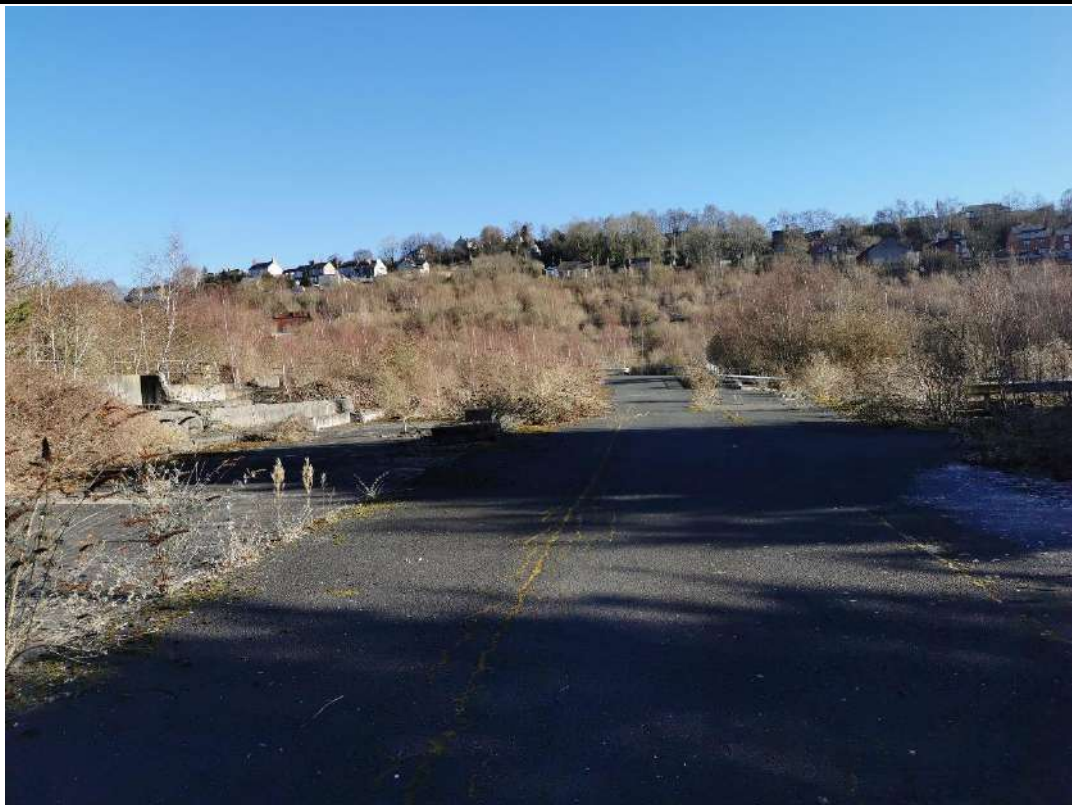
| Plate 20. – Hardstanding surfacing and overgrown vegetation | | | | |

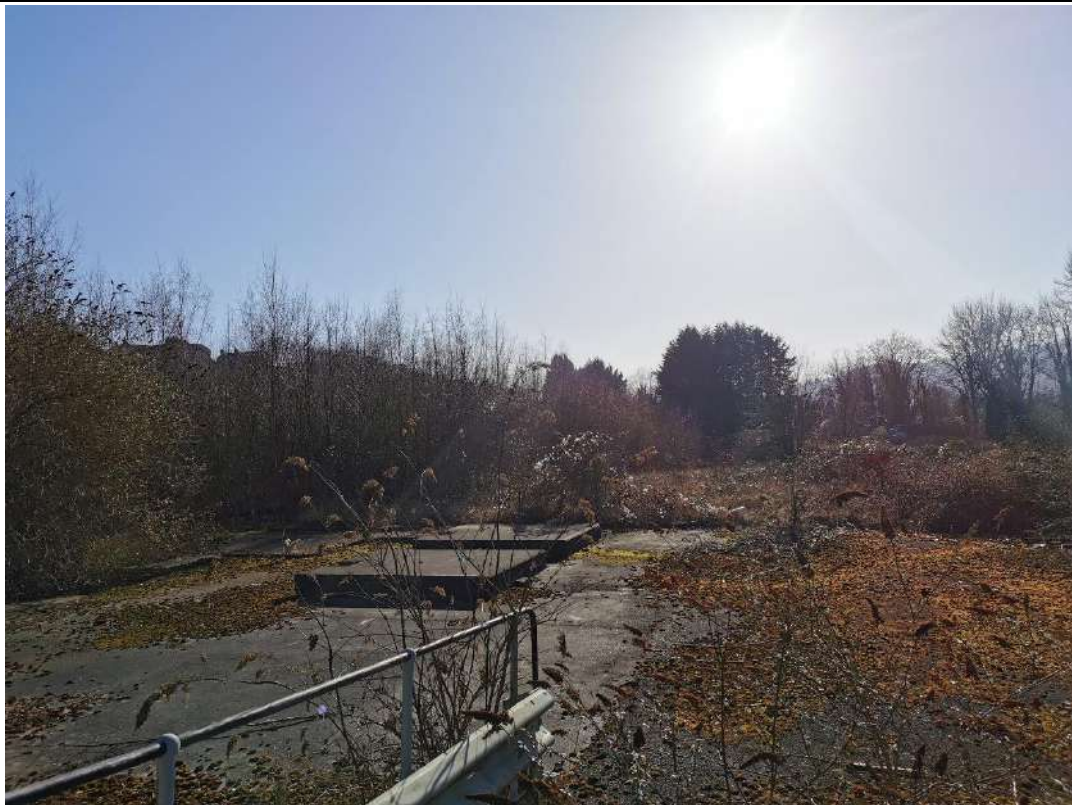
| Plate 21. –<br>Hardstanding surfacing and overgrown vegetation. Evidence of historic industrial features | | | | |

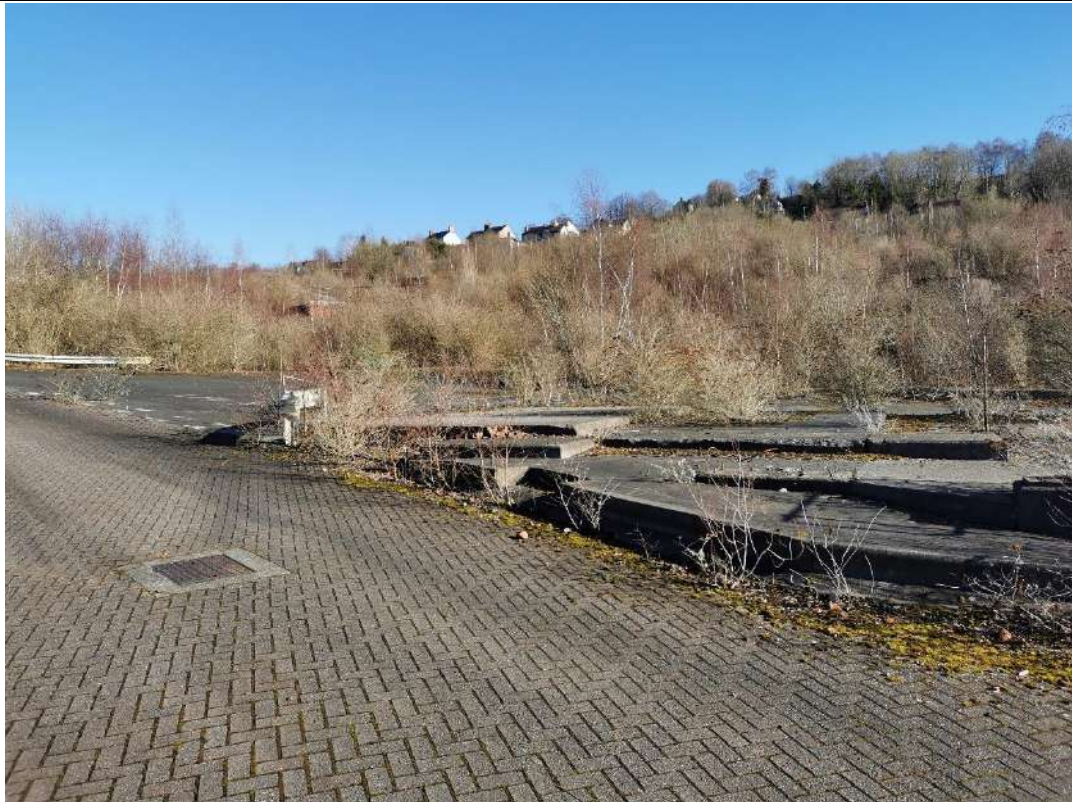
| Plate 22. –<br>Hardstanding surfacing and overgrown vegetation. Evidence of historic industrial features | | | | |

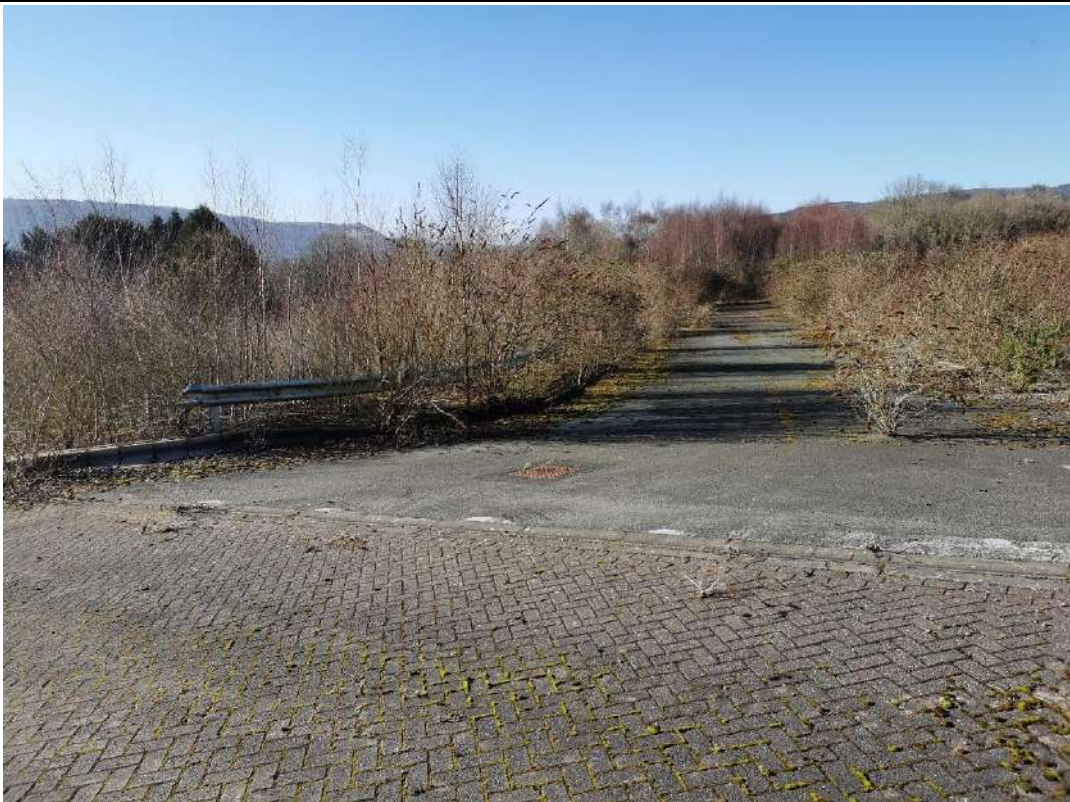
| Plate 23. –<br>Hardstanding surfacing<br>and overgrown<br>vegetation | | | | |

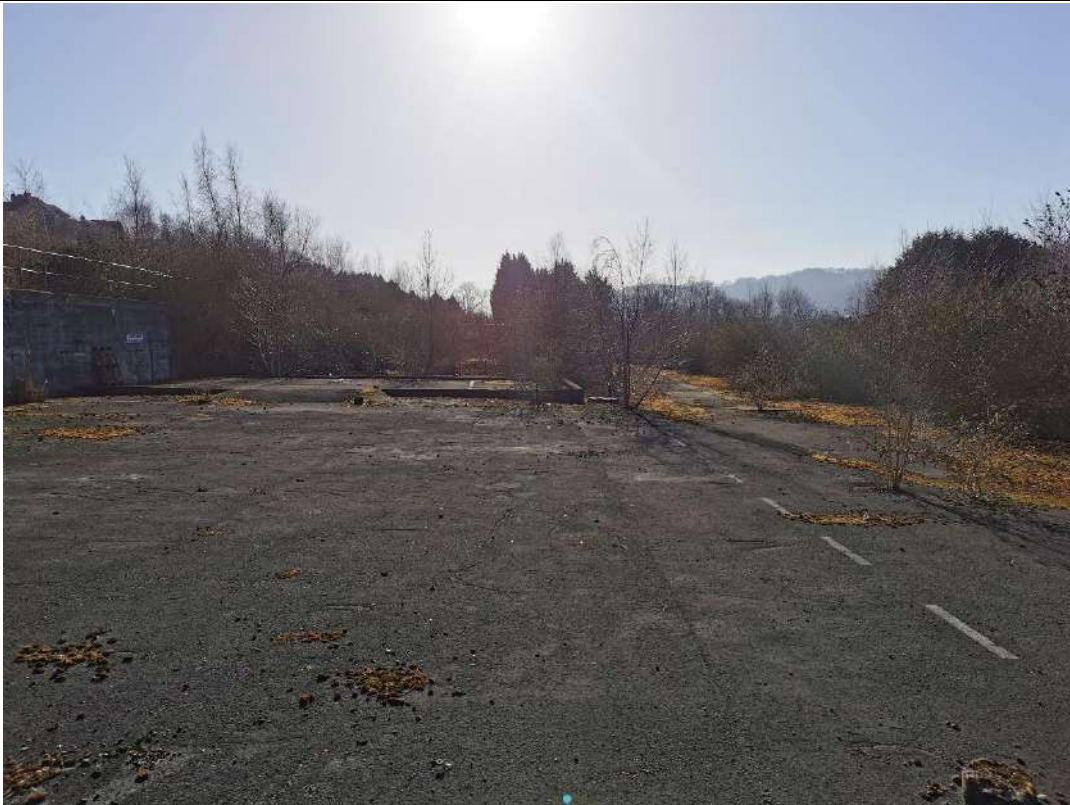
| Plate 24. –<br>Hardstanding surfacing<br>and overgrown<br>vegetation | | | | |
