# TREVOR BASIN WHS ARRIVAL

## Phase I Geo-Environmental Desk Study

Document Ref: 10054502-ARC-XX-XXX-RP-GE-01001

JANUARY 2024

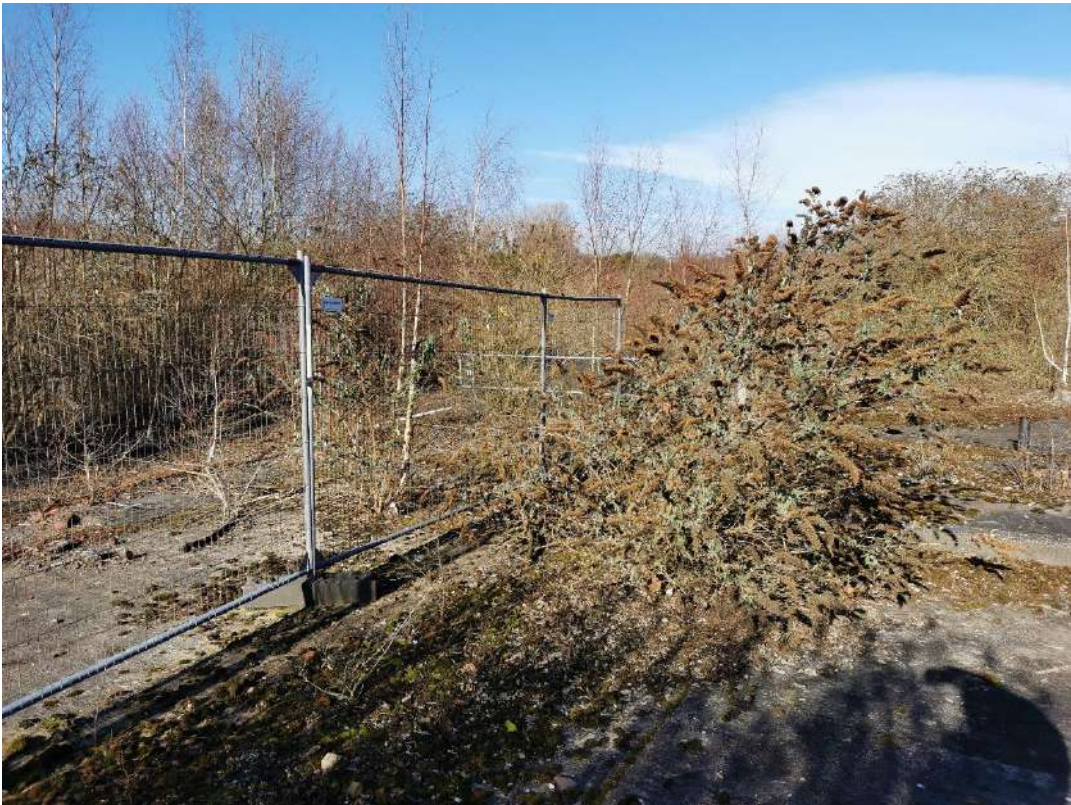
Plate 25. –  
Hardstanding surfacing and overgrown vegetation. Localised fencing.

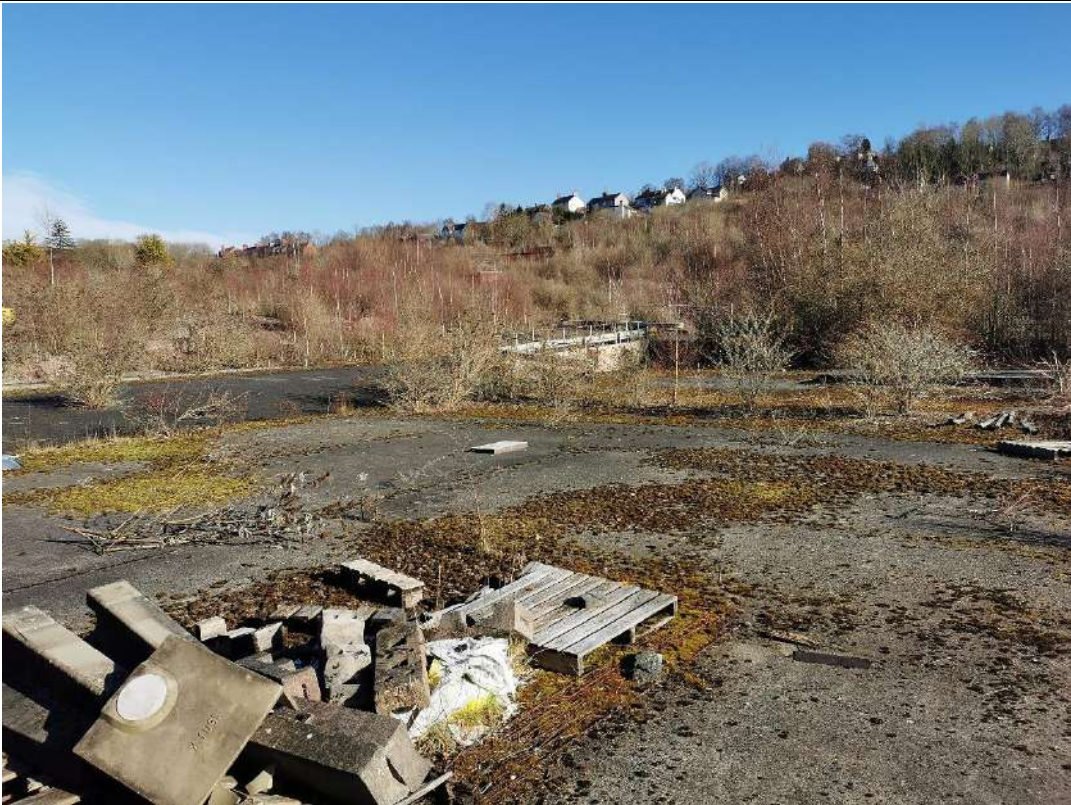
Plate 26. –  
Hardstanding surfacing and overgrown vegetation. Localised fly tipping.

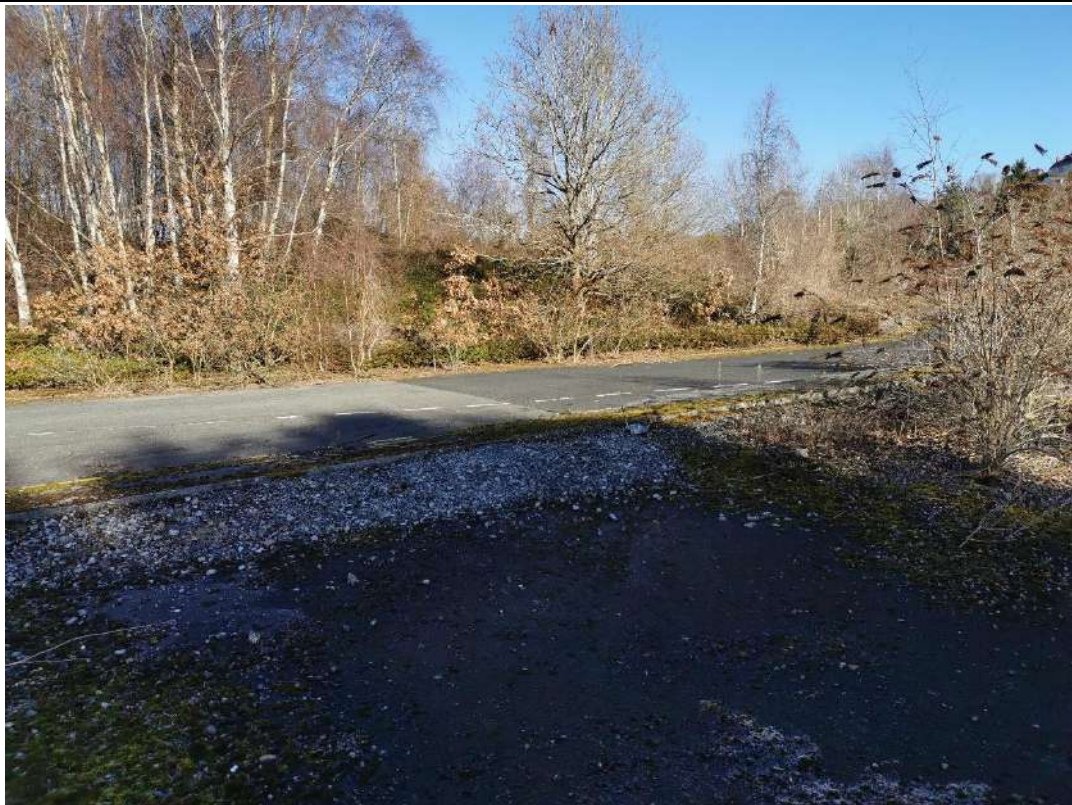
| Plate 27. –<br>Hardstanding surfacing<br>and overgrown<br>vegetation | | | | |

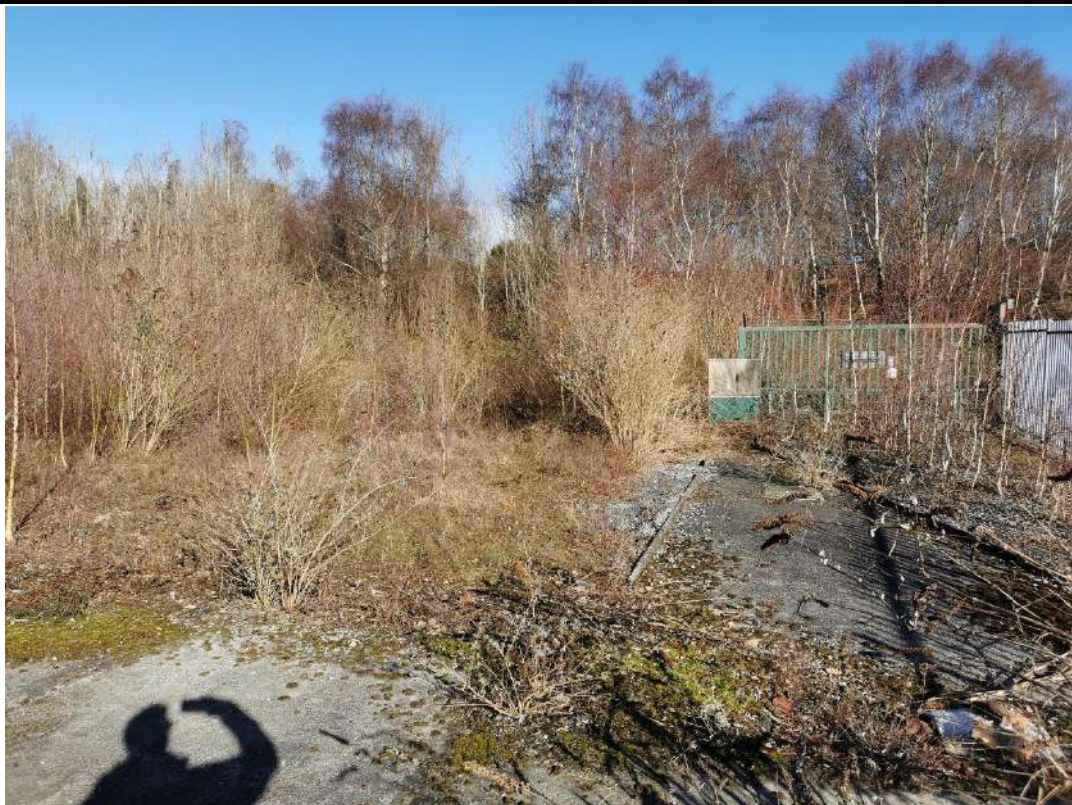
| Plate 28. –<br>Hardstanding surfacing<br>and overgrown<br>vegetation. Evidence of<br>former boundary<br>fencing. | | | | |

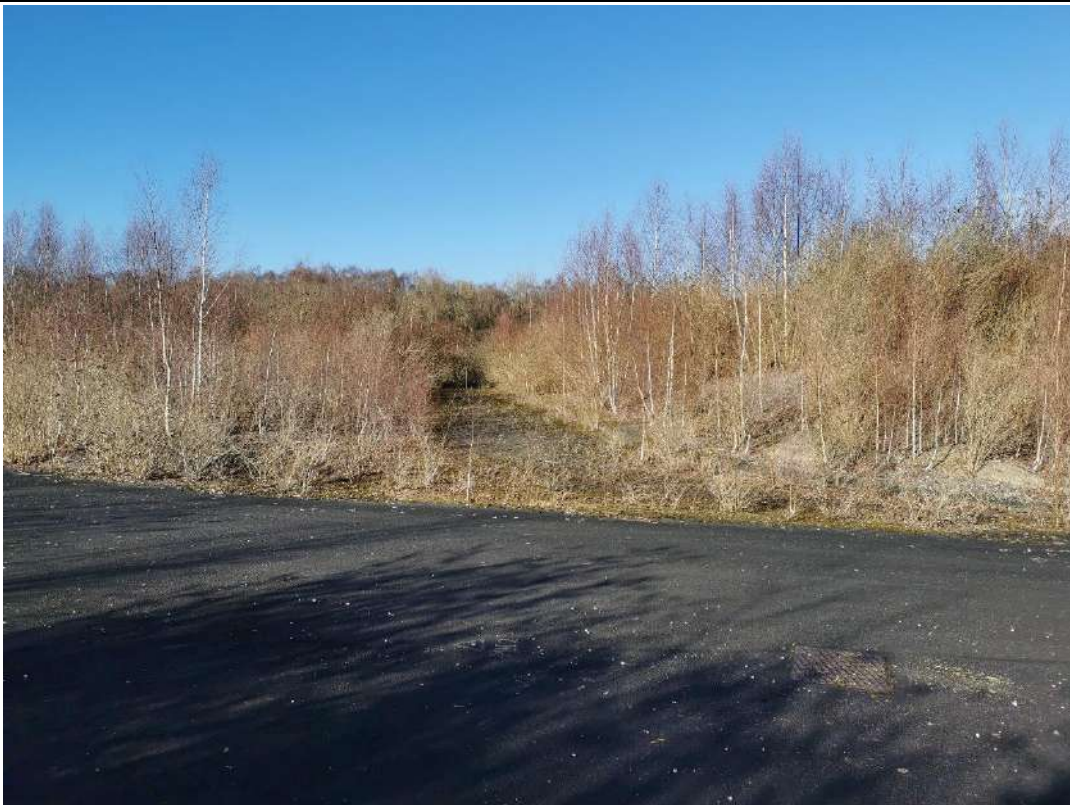
| Plate 29. –<br>Hardstanding surfacing<br>and overgrown<br>vegetation | | | | | |
