# Appendix 11.7: Bat Roost Technical Appendix

# LAND NORTH OF BRYN LANE WREXHAM BAT ROOST SURVEY REPORT

| Document Title | Bat Roost Survey Report |
| Document Ref | 9134.005 |

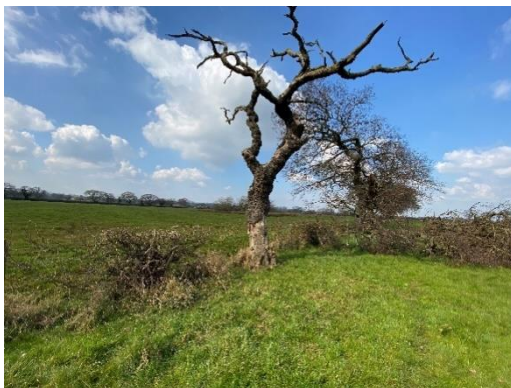
| Tree ID | Description and PRF Characteristics | | Roost Suitability based on ground-based assessment | Recommendations if tree is to be impacted |
|---|---|---|---|---|
| T25 | <p>Standing dead pedunculate oak tree situated within hedgerow (H3).</p> <p>SJ 38871 51325.</p> <p>PRFs:<br/>A: Numerous due to lifted bark and desiccation fissures throughout. Knot hole with cavity visible from east aspect at approximately 6 m.</p> | | Moderate | <p>Two separate survey visits. Including one dusk emergence survey and a separate dawn re-entry survey, undertaken between May to September with at least one survey undertaken between May to August.</p> <p>Health and safety: May not be suitable to climb due to amount of deadwood.</p> |

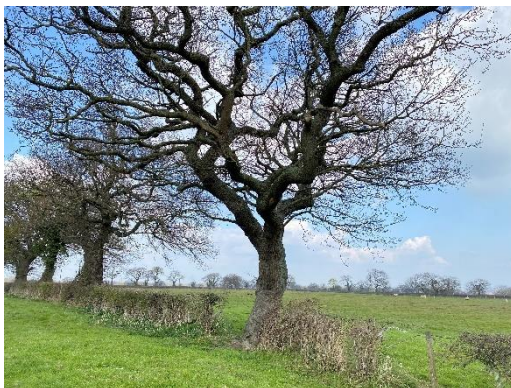
| Tree ID | Description and PRF Characteristics | Roost Suitability based on ground-based assessment | Recommendations if tree is to be impacted |
|---|---|---|---|
| T28 | <p>Large middle age pedunculate oak tree situated within the hedgerow (H3).</p> <p>SJ 38860 51378.</p> <p>PRFs:</p> <p>A: Tear out visible from south-west aspect at approximately 5 m.</p> <p>B: Cavity on south leading branch visible from the north-west aspect at approximately 3 m. Access into cavity also present on east aspect.</p> | <p>Moderate</p> | <p>Aerial climb and endoscopic inspection also possible to further assess PRFs and tree categorisation.</p> <p>Two separate survey visits. Including one dusk emergence survey and a separate dawn re-entry survey, undertaken between May to September with at least one survey undertaken between May to August.</p> |

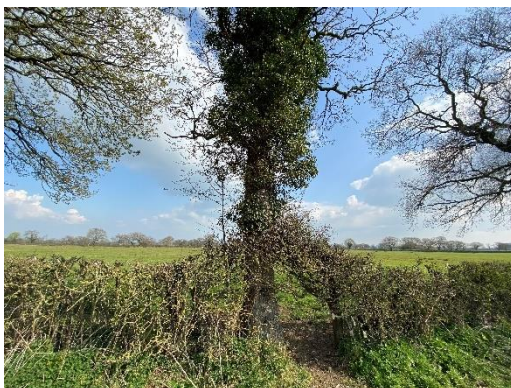
| Tree ID | Description and PRF Characteristics | Roost Suitability based on ground-based assessment | Recommendations if tree is to be impacted |
|---|---|---|---|
| T29 | <p>Middle age pedunculate oak tree with partial ivy coverage situated within the hedgerow.</p> <p>SJ 38856 51406</p> <p>PRFs: Partial ivy cladding may obscure additional features but does not act as a PRF itself.</p> <p>A: Two knot holes in proximity visible from west aspect at approximately 3 m.</p> | <p>Moderate</p> | <p>Aerial climb and endoscopic inspection also possible to further assess PRFs and tree categorisation.</p> <p>Two separate survey visits. Including one dusk emergence survey and a separate dawn re-entry survey, undertaken between May to September with at least one survey undertaken between May to August.</p> |

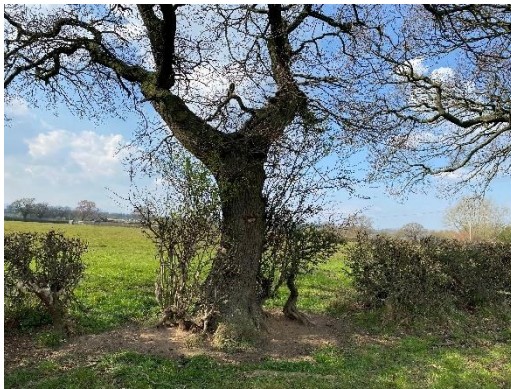
| Tree ID | Description and PRF Characteristics | Roost Suitability based on ground-based assessment | Recommendations if tree is to be impacted |
|---|---|---|---|
| T33 | <p>A middle age pedunculate oak tree situated within the hedgerow.</p> <p>SJ 38845 51452.</p> <p>PRFs:</p> <p>A: Cavity visible from eastern aspect traversing the entirety of north leading branch.</p> <p>B: Upward facing feature visible from eastern aspect on south-west leading branch.</p> <p>C: Tear out visible from western aspect on south-west leading branch at approximately 6 m.</p> | | <p>Moderate</p> <p>Aerial climb and endoscopic inspection also possible to further assess PRFs and tree categorisation.</p> <p>Two separate survey visits. Including one dusk emergence survey and a separate dawn re-entry survey, undertaken between May to September with at least one survey undertaken between May to August.</p> |

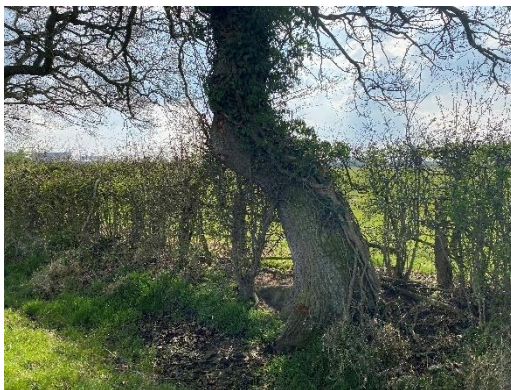
| Tree ID | Description and PRF Characteristics | Roost Suitability based on ground-based assessment | Recommendations if tree is to be impacted |
|---|---|---|---|
| T39 | <p>A middle age pedunculate oak tree situated within the field boundary hedgerow (H5). SJ 38654 51402.</p> <p>PRFs:</p> <p>A: Thick ivy cladding on northern aspect of stem and into the canopy provides potential roosting habitat. May also be obscuring tree cavities.</p> | <p>Moderate</p> | <p>Two separate survey visits. Including one dusk emergence survey and a separate dawn re-entry survey, undertaken between May to September with at least one survey undertaken between May to August.</p> <p>Aerial climb should not be undertaken where there is potential to injure bats roosting under ivy.</p> |

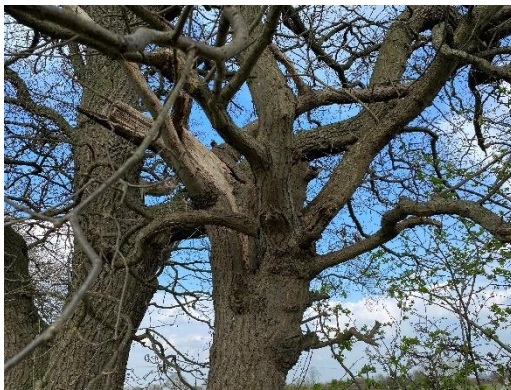
| Tree ID | Description and PRF Characteristics | Roost Suitability based on ground-based assessment | Recommendations if tree is to be impacted |
|---|---|---|---|
| T40 | <p>Multi-stemmed mature pedunculate oak tree situated within the hedgerow (H5). SJ 38661 51389.</p> <p>PRFs:</p> <p>A: Tear out on north leading branch visible from western aspect.</p> <p>B: Knot hole on south-west leading branch visible from eastern aspect.</p> <p>C: Large cavity visible from northern aspect on north leading branch. Moderately exposed.</p> | <p>Moderate</p> | <p>Aerial climb and endoscopic inspection also possible to further assess PRFs and tree categorisation.</p> <p>Two separate survey visits. Including one dusk emergence survey and a separate dawn re-entry survey, undertaken between May to September with at least one survey undertaken between May to August.</p> |

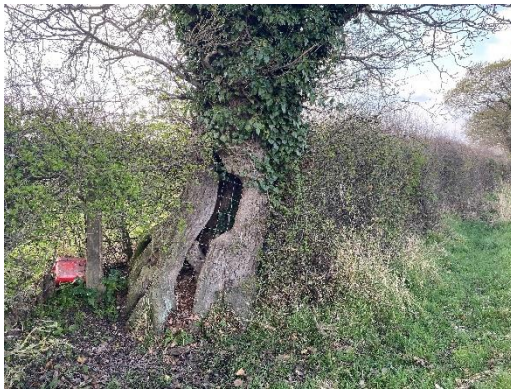
| Tree ID | Description and PRF Characteristics | Roost Suitability based on ground-based assessment | Recommendations if tree is to be impacted |
|---|---|---|---|
| T44 | <p>A mature pedunculate oak tree situated within the field boundary hedgerow (H5).<br/>SJ 38710 51311.</p> <p>PRFs:<br/>A: Main stem is hollowed out with large entrance on eastern aspect. Light is visible internally suggesting no hibernation/maternity potential due to unsuitable conditions. Partial ivy cladding of main stem. PRFs throughout.</p> | <p>Moderate</p> | <p>Two separate survey visits. Including one dusk emergence survey and a separate dawn re-entry survey, undertaken between May to September with at least one survey undertaken between May to August.</p> <p>Health and safety: Not suitable to climb.</p> |

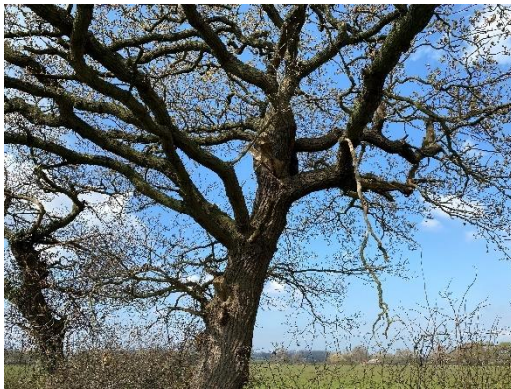
| Tree ID | Description and PRF Characteristics | | Roost Suitability based on ground-based assessment | Recommendations if tree is to be impacted |
|---|---|---|---|---|
| T53 | <p>A middle age pedunculate oak tree situated within the field boundary hedgerow.</p> <p>SJ 38735 51145.</p> <p>PRFs:</p> <p>A: Knot hole visible from southern aspect at approximately 3 m appears well occluded from ground.</p> <p>B: Knot hole visible from southern aspect at approximately 5 m appears well occluded from ground.</p> | | Low | No further surveys required. Precautionary soft felling/pruning measures must be adhered to under supervision of a licenced bat ecologist. |

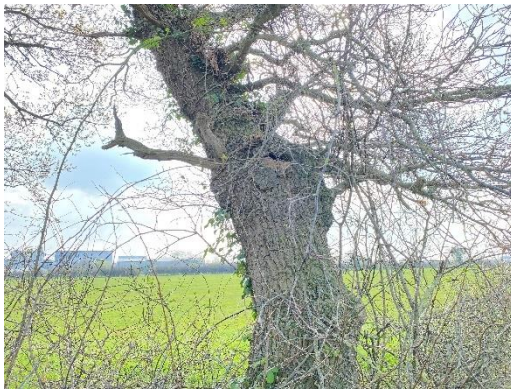
| Tree ID | Description and PRF Characteristics | | Roost Suitability based on ground-based assessment | Recommendations if tree is to be impacted |
|---|---|---|---|---|
| T54 | <p>A smaller middle age pedunculate oak tree situated within the field boundary hedgerow (H6). SJ 38728 51145.</p> <p>PRFs</p> <p>A: Cavity visible from north aspect at approximately 3 m.</p> | | Moderate | <p>Aerial climb and endoscopic inspection also possible to further assess PRFs and tree categorisation.</p> <p>Two separate survey visits. Including one dusk emergence survey and a separate dawn re-entry survey, undertaken between May to September with at least one survey undertaken between May to August.</p> |

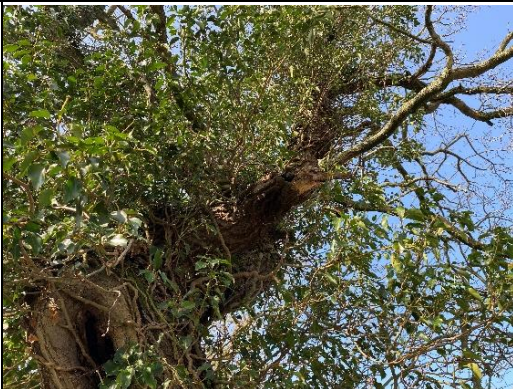
| Tree ID | Description and PRF Characteristics | | Roost Suitability based on ground-based assessment | Recommendations if tree is to be impacted |
|---|---|---|---|---|
| T74 | <p>A middle age pedunculate oak tree situated within field boundary hedgerow (H13), partially covered in ivy. Ivy does not provide suitable PRF itself, but may be obscuring other PRFs.</p> <p>SJ 38454 50994.</p> <p>PRF features:</p> <p>A: Knot hole south-east facing at approximately 2.5 m high. Does not appear deep.</p> <p>B: Transverse snap south-east facing at approximately 3 m.</p> | | Moderate | <p>Aerial climb and endoscopic inspection also possible to further assess PRFs and tree categorisation.</p> <p>Two separate survey visits. Including one dusk emergence survey and a separate dawn re-entry survey, undertaken between May to September with at least one survey undertaken between May to August.</p> |

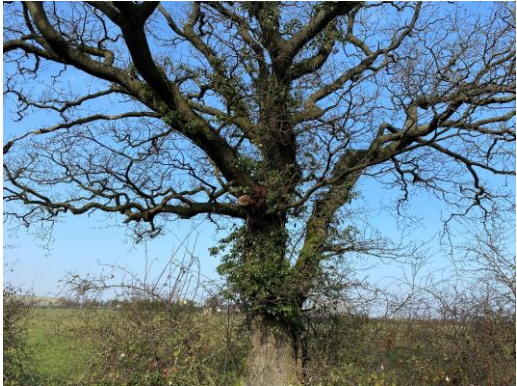
| Tree ID | Description and PRF Characteristics | | Roost Suitability based on ground-based assessment | Recommendations if tree is to be impacted |
|---|---|---|---|---|
| T81 | <p>A mature pedunculate oak located within hedge H13. SJ 38292 50925</p> <p>PRFs:</p> <p>A: Pruning cut visible from the southern aspect with desiccation approximately 3.5m high.</p> <p>B: A wound on the northern aspect approximately 6m high.</p> | | Moderate | <p>Aerial climb and endoscopic inspection also possible to further assess PRFs and tree categorisation.</p> <p>Two separate survey visits. Including one dusk emergence survey and a separate dawn re-entry survey, undertaken between May to September with at least one survey undertaken between May to August.</p> |

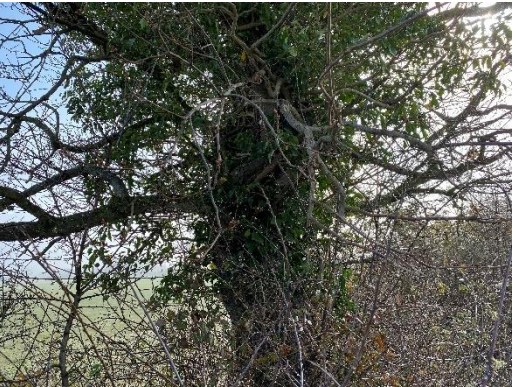
| Tree ID | Description and PRF Characteristics | | Roost Suitability based on ground-based assessment | Recommendations if tree is to be impacted |
|---|---|---|---|---|
| T84 | <p>A middle age pedunculate oak tree with ivy cover. Ivy does not provide suitable PRF itself. Situated within the hedgerow.</p> <p>SJ 38516 51103.</p> <p>PRFs:</p> <p>A: Branch partially covered in ivy has west-facing cavity.</p> <p>B: East-facing cavity at approximately 2 m.</p> <p>C: Desiccated branch with east-facing cavity attached to north leading branch.</p> | | Moderate. | <p>Aerial climb and endoscopic inspection also possible to further assess PRFs and tree categorisation.</p> <p>Two separate survey visits. Including one dusk emergence survey and a separate dawn re-entry survey, undertaken between May to September with at least one survey undertaken between May to August.</p> |

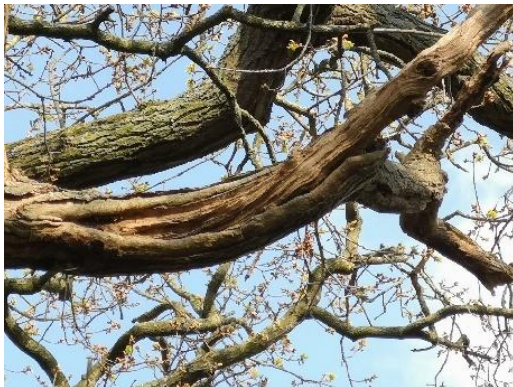
| Tree ID | Description and PRF Characteristics | Roost Suitability based on ground-based assessment | Recommendations if tree is to be impacted |
|---|---|---|---|
| T97 | <p>A mature pedunculate oak tree, sparsely clad with ivy, situated within the northern boundary hedgerow (H19). Ivy does not provide suitable PRF itself, but may be obscuring other PRFs.</p> <p>SJ 38334 51272.</p> <p>PRFs:</p> <p>A: Transverse snap/hazard beam, south-east aspect at approximately 5 m.</p> <p>B: Desiccated limb with ram's horns, and other features. South facing at approximately 6 m.</p> <p>C: Desiccated limb with potential cavities. North facing at 5 m.</p> | <p>Moderate</p> | <p>Aerial climb and endoscopic inspection also possible to further assess PRFs and tree categorisation.</p> <p>Two separate survey visits. Including one dusk emergence survey and a separate dawn re-entry survey, undertaken between May to September with at least one survey undertaken between May to August.</p> |

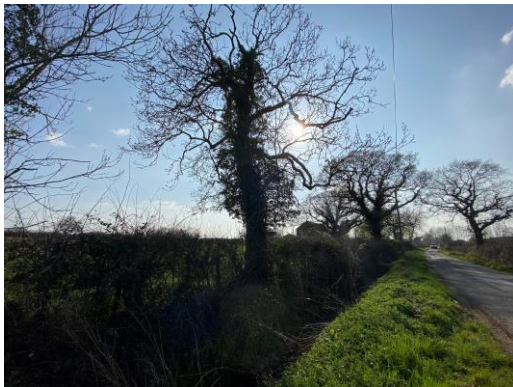
| Tree ID | Description and PRF Characteristics | Roost Suitability based on ground-based assessment | Recommendations if tree is to be impacted |
|---|---|---|---|
| T98 | <p>A middle age, ivy-clad pedunculate oak within northern boundary hedgerow (H19). SJ 38358 51280.</p> <p>PRFs:</p> <p>A: Large cavity at top of stem in canopy.</p> <p>B: Two knot holes adjacent to each other at branch fork near top of canopy at approximately 10 m. Adjacent branch to this, snapped branch resting on fork creating potential feature.</p> <p>C: Large cavity/wound running up main stem from approximately 1 m to 4 m, on eastern aspect.</p> <p>D: West facing branch at approximately 4 m has snapped, leaving a potential cavity in the exposed pith – unclear from ground level.</p> | | <p>High</p> <p>Three separate survey visits. Including at least one dusk emergence survey and a separate dawn re-entry survey (the third visit being either a dusk emergence or dawn re-entry survey) undertaken between May to September with at least two surveys undertaken between May to August.</p> <p>Health and safety: Tree unsuitable to climb to due hollow stem.</p> |

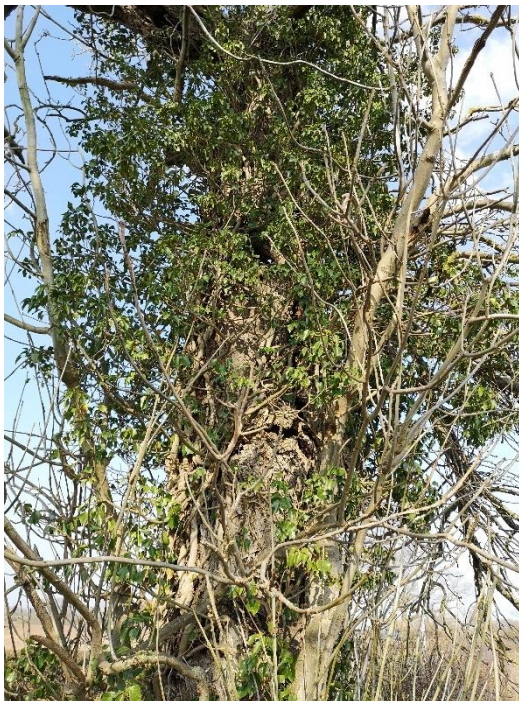
| Tree ID | Description and PRF Characteristics | Roost Suitability based on ground-based assessment | Recommendations if tree is to be impacted |
|---|---|---|---|
| T99 | <p>A middle age common ash tree situated in the northern boundary hedgerow (H19).<br/>SJ 38364 51284.</p> <p>PRFs:<br/>A: Severe split running up entire main stem on north and south aspect, multiple PRFs throughout. .</p> | High | <p>Three separate survey visits. Including at least one dusk emergence survey and a separate dawn re-entry survey (the third visit being either a dusk emergence or dawn re-entry survey) undertaken between May to September with at least two surveys undertaken between May to August.</p> <p>Health and safety: Unsuitable to climb due to amount of deadwood present.</p> |

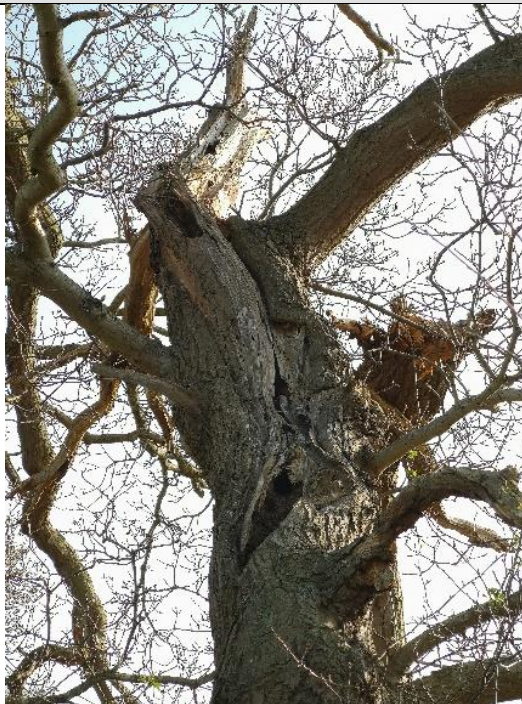
| Tree ID | Description and PRF Characteristics | Roost Suitability based on ground-based assessment | Recommendations if tree is to be impacted |
|---|---|---|---|
| T105 | <p>A mature pedunculate oak tree situated within the hedgerow (H22). SJ 38439 51221.</p> <p>PRFs:</p> <p>A: Main stem cavity below fork on southern aspect at approximately 2 m.</p> <p>B: Knot hole adjacent to where four branches fork. Northwest aspect of western limb at approximately 7 m.</p> <p>C: Two knot holes in proximity southern aspect of west leading limb, one approximately 0.5 m above the other.</p> <p>D: Multiple large cavities present due to recent large failure/tear out in western mid canopy. At approximately 4 -5 m.</p> | <p>High</p> | <p>Aerial climb and endoscopic inspection also possible to further assess PRFs and tree categorisation.</p> <p>Three separate survey visits. Including at least one dusk emergence survey and a separate dawn re-entry survey (the third visit being either a dusk emergence or dawn re-entry survey) undertaken between May to September with at least two surveys undertaken between May to August.</p> |

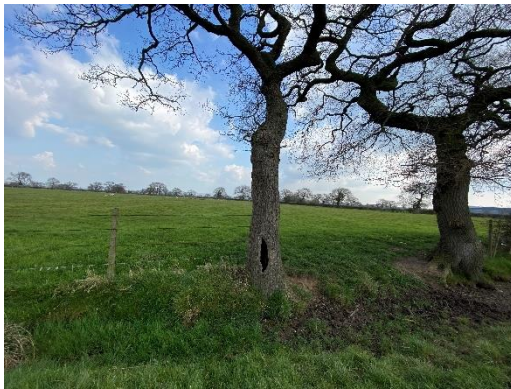
| Tree ID | Description and PRF Characteristics | | Roost Suitability based on ground-based assessment | Recommendations if tree is to be impacted |
|---|---|---|---|---|
| G1.4 | <p>Middle age pedunculate oak tree situated within hedgerow within a group of similar four trees. Fourth tree within the group, starting from the south. SJ 38874 51306.</p> <p>Large cavity visible from western aspect at approximately 1 m. Endoscopy revealed the cavity extends high into the stem.</p> | | High | Three separate survey visits. Including at least one dusk emergence survey and a separate dawn re-entry survey (the third visit being either a dusk emergence or dawn re-entry survey) undertaken between May to September with at least two surveys undertaken between May to August. |

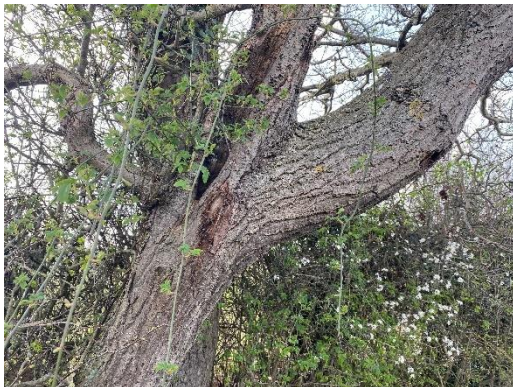
| Tree ID | Description and PRF Characteristics | Roost Suitability based on ground-based assessment | Recommendations if tree is to be impacted |
|---|---|---|---|
| G5.2 | <p>A middle age pedunculate oak tree in a group of four trees. Second tree counting from the north. SJ 38731 51277.</p> <p>PRFs:</p> <p>A: Tear out visible from eastern aspect offering some limited opportunities. Downward facing feature.</p> | Low | No further surveys required. Precautionary soft felling/pruning measures must be adhered to under supervision of a licenced bat ecologist. |

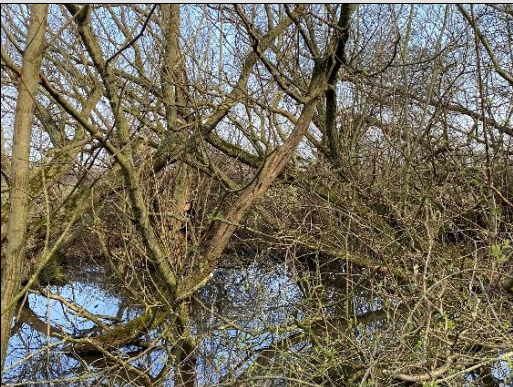
| Tree ID | Description and PRF Characteristics | Roost Suitability based on ground-based assessment | Recommendations if tree is to be impacted |
|---|---|---|---|
| G10.5 | <p>A willow tree growing out of the pond/waterlogged area. Approximately situated at SJ 38325 51095.</p> <p>PRFs:</p> <p>A: Longitudinal crack visible on western aspect. Unable to inspect closely due to water.</p> | | <p>Moderate.</p> <p>Two separate survey visits. Including one dusk emergence survey and a separate dawn re-entry survey, undertaken between May to September with at least one survey undertaken between May to August.</p> <p>Health and safety: Aerial climb unsuitable due to water.</p> |

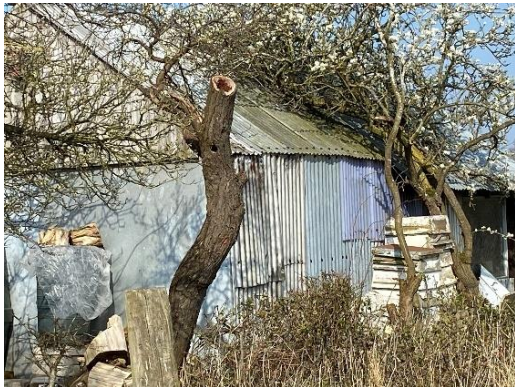
| Tree ID | Description and PRF Characteristics | Roost Suitability based on ground-based assessment | Recommendations if tree is to be impacted |
|---|---|---|---|
| G11.1 | <p>Apple tree within group of trees within residential garden, adjacent to building B10. SJ 38310 51217.</p> <p>PRFs:</p> <p>A: Pruning cut or failed main stem and woodpecker hole below on southern aspect.</p> | | <p>High</p> <p>Ladder climb and endoscopic inspection also possible to further assess PRFs and tree categorisation.</p> <p>Three separate survey visits. Including at least one dusk emergence survey and a separate dawn re-entry survey (the third visit being either a dusk emergence or dawn re-entry survey) undertaken between May to September with at least two surveys undertaken between May to August.</p> |

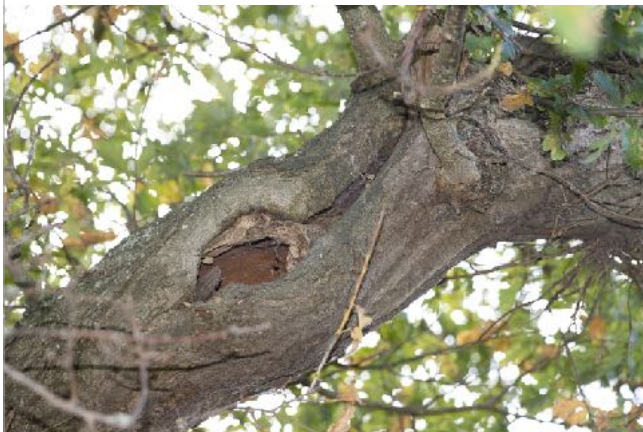
| Tree / feature number | Species | Height | DBH / Aspect | JPEG | Description | Comments | Can it be fully checked ? | Suitability | Further survey? |
|---|---|---|---|---|---|---|---|---|---|
| T46 | Oak | 7 | 50 | | Oak tree in field hedgerow boundary. Heavy foliage of black thorns and hawthorn to base. Main stem cavity. | | Yes | Low | No |

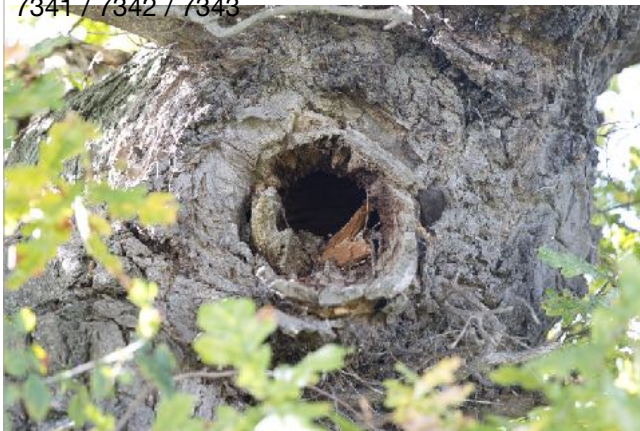
| Tree / feature number | Species | Height | DBH / Aspect | JPEG | Description | Comments | Can it be fully checked ? | Suitability | Further survey? |
|---|---|---|---|---|---|---|---|---|---|
| T46.1 | PRF1 | 2 | SW | 7341 / 7342 / 7343 | Multiple features on main stem cavity. Rot holes at 2, 3 and 4m. All cavities lead into main stem. More than 1m of travel. Open to elements and predators. Suitable for night roost. More suitable to nesting birds. | Open to elements and predators. | Yes | Low | No |

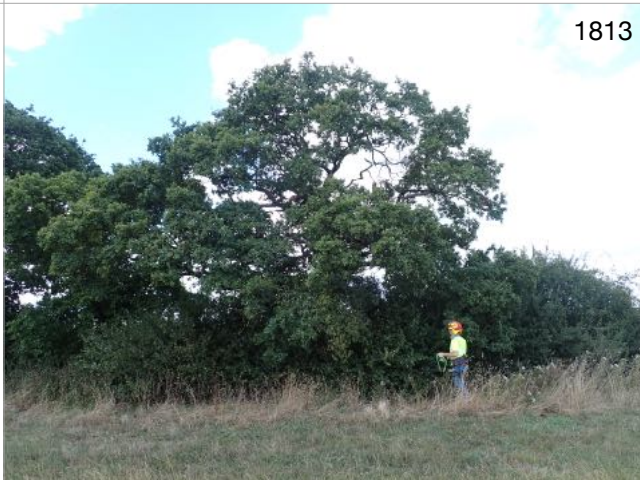
| Tree / feature number | Species | Height | DBH / Aspect | JPEG | Description | Comments | Can it be fully checked ? | Suitability | Further survey? |
|---|---|---|---|---|---|---|---|---|---|
| T47 | Oak | 8 | 40 | 1813 | Mature oak tree in field hedgerow boundary with knot holes, dead, and failed limbs in the crown. | | Yes | High | Yes |

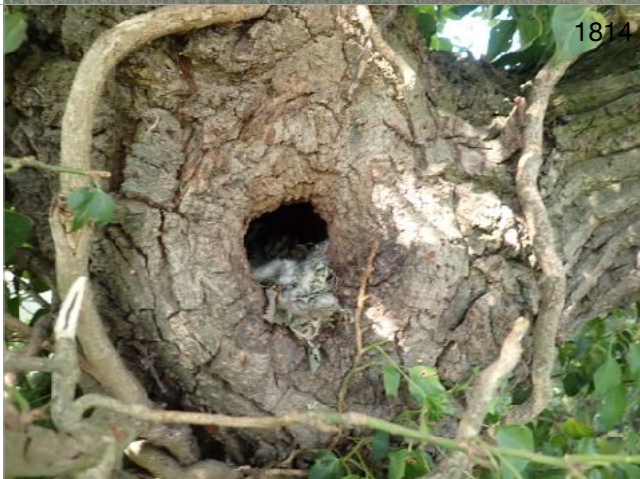
| Tree / feature number | Species | Height | DBH / Aspect | JPEG | Description | Comments | Can it be fully checked ? | Suitability | Further survey? |
|---|---|---|---|---|---|---|---|---|---|
| T47.1 | PRF1 | 3 | S | 1814 | Knot hole at 4m on the south side of the main stem, 10cm diameter entrance into main stem cavity with >50cm of upward travel. Packed with nesting materials at the base. | | Yes | High | Yes |

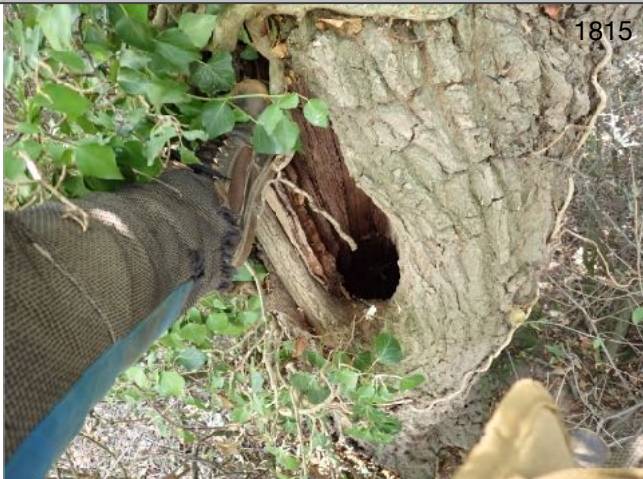
| Tree / feature number | Species | Height | DBH / Aspect | JPEG | Description | Comments | Can it be fully checked ? | Suitability | Further survey? |
|---|---|---|---|---|---|---|---|---|---|
| T47.2 | PRF2 | 5 | S | 1815 | Main stem cavity at 1m on the south side of main stem. | | Yes | High | Yes |

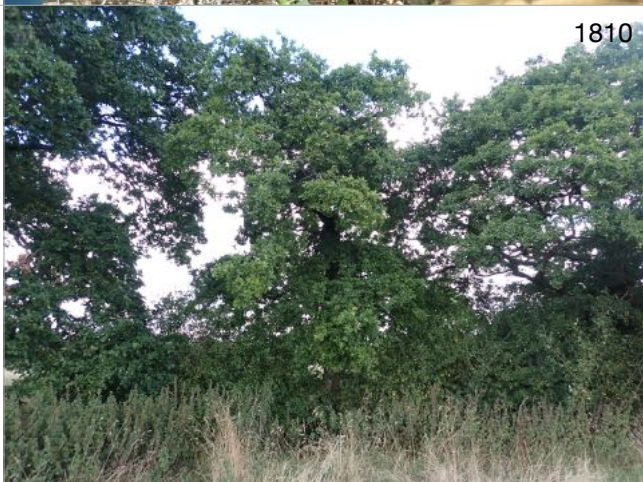
| Tree / feature number | Species | Height | DBH / Aspect | JPEG | Description | Comments | Can it be fully checked ? | Suitability | Further survey? |
|---|---|---|---|---|---|---|---|---|---|
| T48 | Oak | 6 | 30 | 1810 | Mature oak tree in field boundary hedgerow with dead and failed limbs in the crown, light ivy cover, missing bark, and exposed heartwood on the main stem. | Check crevices by torch before felling | Yes | Low | Yes |

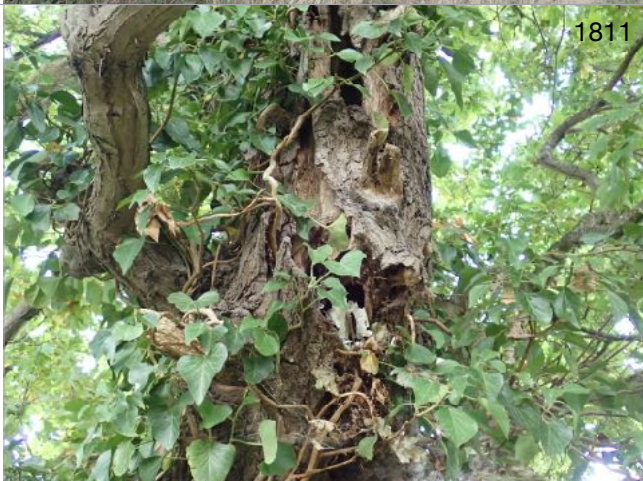
| Tree / feature number | Species | Height | DBH / Aspect | JPEG | Description | Comments | Can it be fully checked ? | Suitability | Further survey? |
|---|---|---|---|---|---|---|---|---|---|
| T48.1 | PRF1 | 3 | S | 1811 | Rot holes at 3m on the south side of dead limb 10cm diameter entrance with 30cm upward travel to secondary entrance hole. Open from above, packed with nesting materials at base. | Check crevices by torch before felling | Yes | Low | Yes |

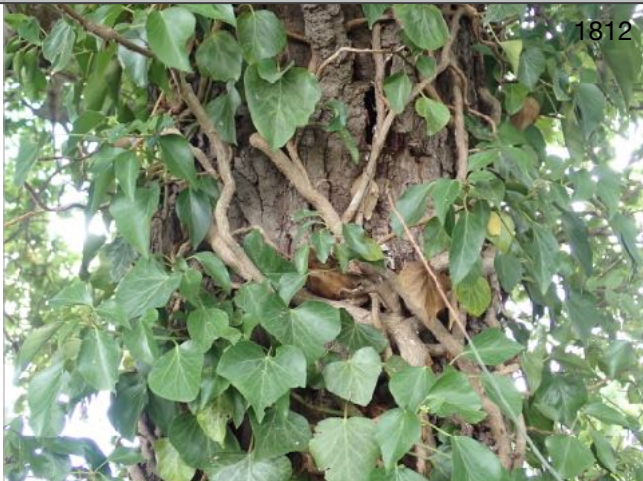
| Tree / feature number | Species | Height | DBH / Aspect | JPEG | Description | Comments | Can it be fully checked ? | Suitability | Further survey? |
|---|---|---|---|---|---|---|---|---|---|
| T48.2 | PRF2 | 1 | All | 1812 | Ivy cover and missing bark on main stem with numerous minor pockets suitable for single bats. | Check crevices by torch before felling | Yes | Low | Yes |

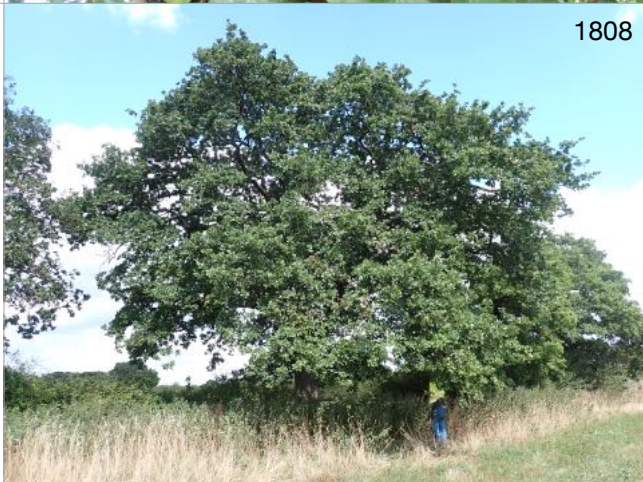
| Tree / feature number | Species | Height | DBH / Aspect | JPEG | Description | Comments | Can it be fully checked ? | Suitability | Further survey? |
|---|---|---|---|---|---|---|---|---|---|
| T49 | Oak | 10 | 70 | 1808 | Mature oak tree in field boundary hedgerow with dead and failed limbs in the crown. | | Yes | Negligible | No |

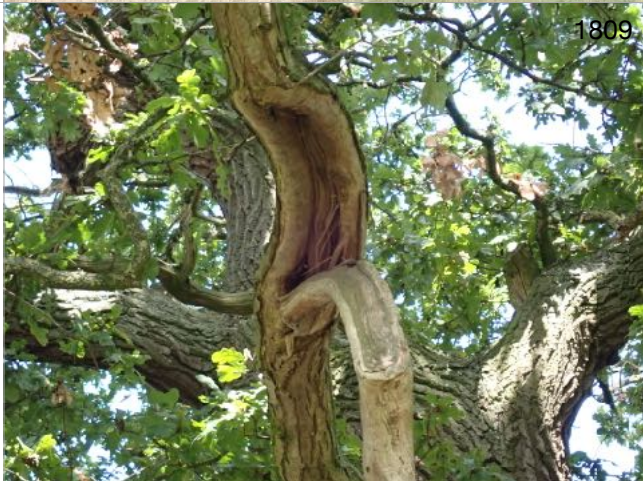
| Tree / feature number | Species | Height | DBH / Aspect | JPEG | Description | Comments | Can it be fully checked ? | Suitability | Further survey? |
|---|---|---|---|---|---|---|---|---|---|
| T49.1 | PRF1 | 3 | SW | 1809 | Tear out on underside of horizontal limb at 3m, 50cm of exposed heartwood with no suitable cavities. | | Yes | Negligible | No |

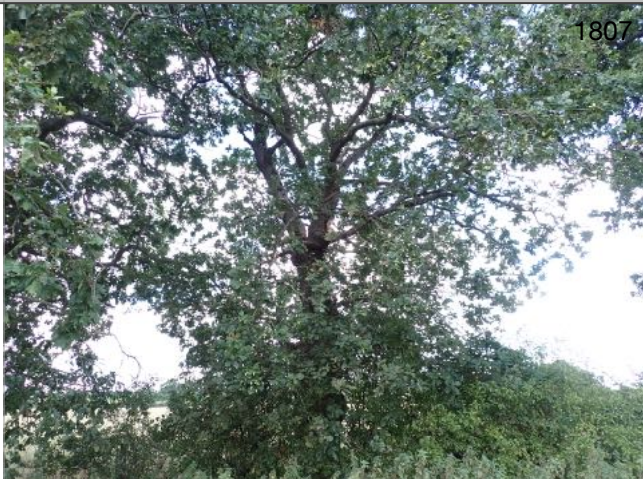
| Tree / feature number | Species | Height | DBH / Aspect | JPEG | Description | Comments | Can it be fully checked ? | Suitability | Further survey? |
|---|---|---|---|---|---|---|---|---|---|
| T50 | Oak | 8 | 70 | 1807 | Oak tree in field boundary hedgerow with loose and missing bark, dead and failed limbs, knot holes in main stem. Not safe to climb. | Not safe to climb. | No | Moderate | Yes |

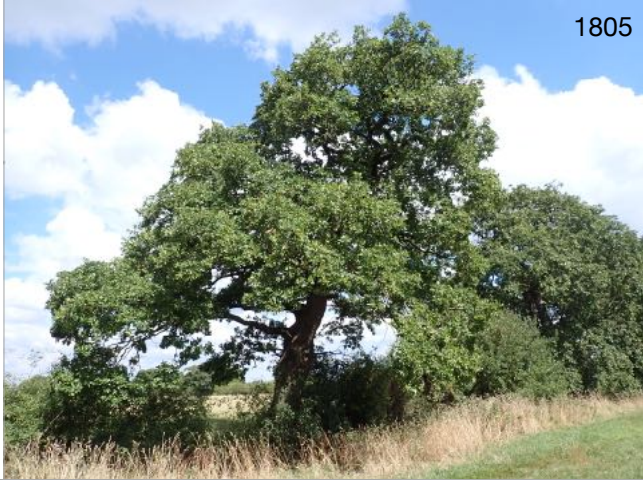
| Tree / feature number | Species | Height | DBH / Aspect | JPEG | Description | Comments | Can it be fully checked ? | Suitability | Further survey? |
|---|---|---|---|---|---|---|---|---|---|
| T52 | Oak | 8 | 70 | 1805 | Mature oak tree in field hedgerow boundary with knot holes, dead, and failed limbs in the crown. All features checked, none suitable for use by roosting bats. | | Yes | Negligible | No |

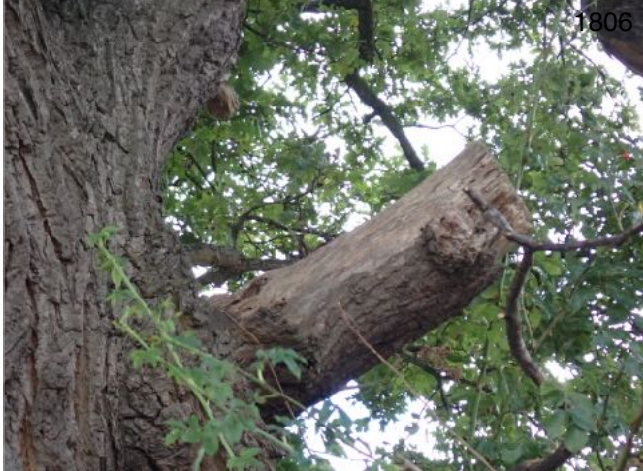
| Tree / feature number | Species | Height | DBH / Aspect | JPEG | Description | Comments | Can it be fully checked ? | Suitability | Further survey? |
|---|---|---|---|---|---|---|---|---|---|
| T52.1 | PRF1 | | | 1806 | Failed major limb at 2m on east side of main stem with minor cavity at base, packed with nesting materials. Open to the elements, not suitable for use by roosting bats. | | Yes | Negligible | No |

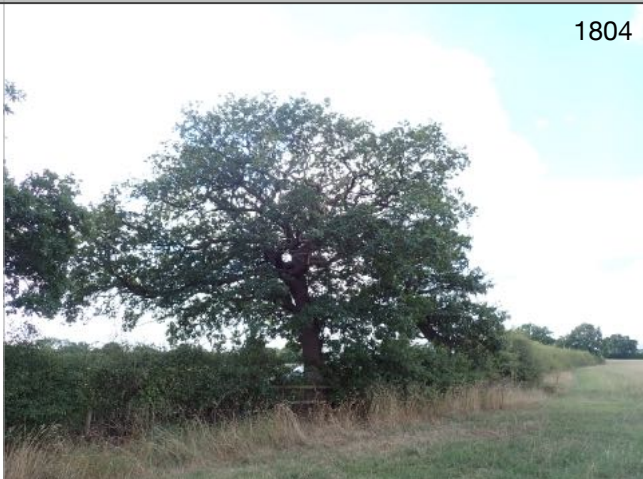
| Tree / feature number | Species | Height | DBH / Aspect | JPEG | Description | Comments | Can it be fully checked ? | Suitability | Further survey? |
|---|---|---|---|---|---|---|---|---|---|
| T54 | Oak | 5 | 30 | 1804 | Mature oak tree in field hedgerow boundary with dead branches in the crown and knot hole on north side of main stem n | | Yes | Low | No |

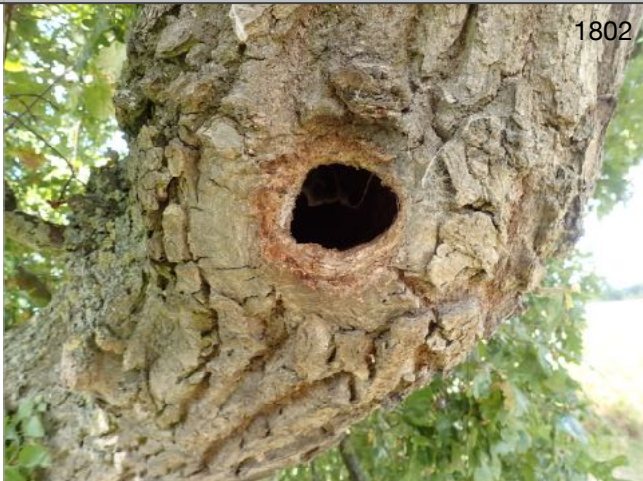
| Tree / feature number | Species | Height | DBH / Aspect | JPEG | Description | Comments | Can it be fully checked ? | Suitability | Further survey? |
|---|---|---|---|---|---|---|---|---|---|
| T56.1 | PRF1 | 4 | S | 1802 | Woodpecker hole on south side of near horizontal limb. No upward travel. 70cm of downward travel in 10cm diameter dry and smooth cavity, packed with squirrel nesting materials at base. | | Yes | High | Yes |

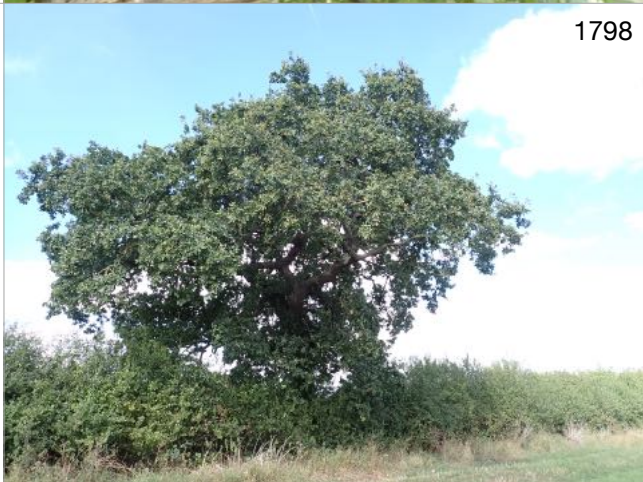
| Tree / feature number | Species | Height | DBH / Aspect | JPEG | Description | Comments | Can it be fully checked ? | Suitability | Further survey? |
|---|---|---|---|---|---|---|---|---|---|
| T59 | Oak | 8 | 60 | 1798 | Mature oak tree in field hedgerow boundary with minor ivy cover on main stem and into lower crown, dead and rotting limbs, and knot holes in the crown. | No features suitable for use by roosting bats. | Yes | Negligible | No |

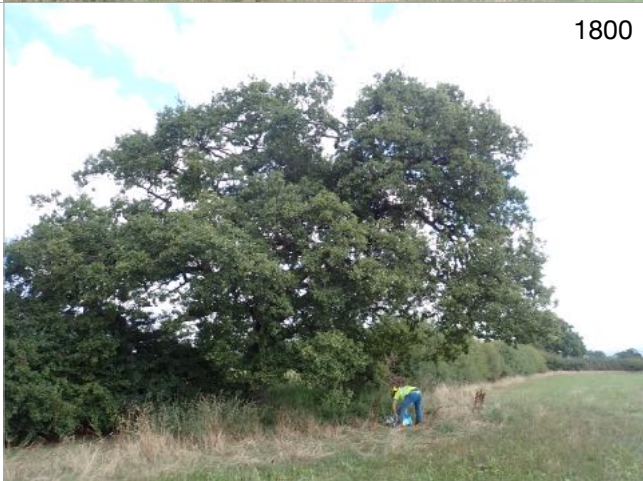
| Tree / feature number | Species | Height | DBH / Aspect | JPEG | Description | Comments | Can it be fully checked ? | Suitability | Further survey? |
|---|---|---|---|---|---|---|---|---|---|
| T62 | Oak | 10 | 60 | 1800 | Mature oak tree in field hedgerow boundary with dead and failed limbs, knot holes, and tear outs in the crown. | | Yes | Negligible | No |

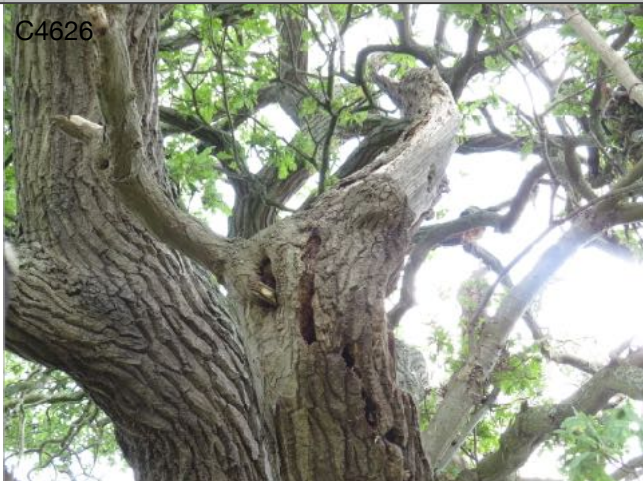
| Tree / feature number | Species | Height | DBH / Aspect | JPEG | Description | Comments | Can it be fully checked ? | Suitability | Further survey? |
|---|---|---|---|---|---|---|---|---|---|
| T62.1 | PRF1 | 4 | SE | C4626 | Failed limb with exposed heartwood, splits, and rot hole on the underside. Opening on top of the limb has more than 50cm of downward travel which is packed with squirrel nesting materials. Open to the elements, wet, unlikely to support roosting bats. | | Yes | Low | No |

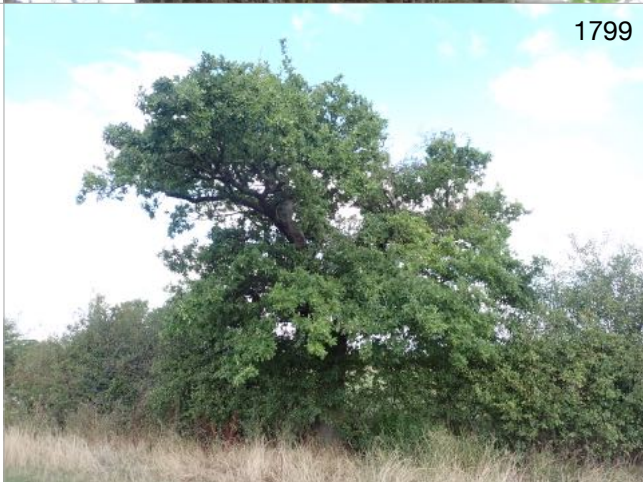
| Tree / feature number | Species | Height | DBH / Aspect | JPEG | Description | Comments | Can it be fully checked ? | Suitability | Further survey? |
|---|---|---|---|---|---|---|---|---|---|
| T64 | Oak | 5 | 40 | 1799 | Mature oak tree in field hedgerow boundary with dead and rotting limbs, tear outs, and knot holes in the crown. | | Yes | Negligible | No |

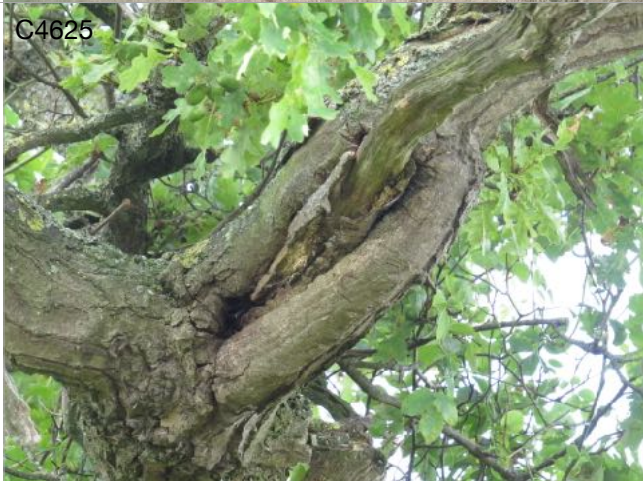
| Tree / feature number | Species | Height | DBH / Aspect | JPEG | Description | Comments | Can it be fully checked ? | Suitability | Further survey? |
|---|---|---|---|---|---|---|---|---|---|
| T64.1 | PRF1 | 4 | NE | C4625 | Tear out with dead wood on underside of near horizontal limb, minor cavity at base of deadwood <5cm, wet, open to the elements. | | Yes | Negligible | No |

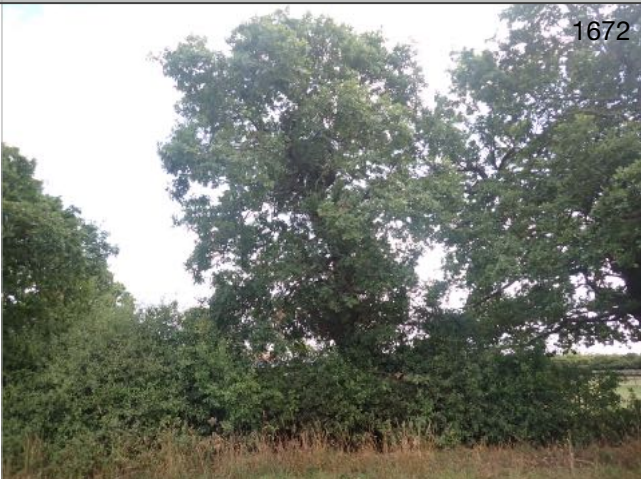
| Tree / feature number | Species | Height | DBH / Aspect | JPEG | Description | Comments | Can it be fully checked ? | Suitability | Further survey? |
|---|---|---|---|---|---|---|---|---|---|
| T74 | Oak | 10 | 70 | 1672 | Mature oak tree in field boundary hedgerow with ivy from base into crown, and dead and rotting limbs and knot holes. Ivy does not form a suitable roosting feature, and does not obscure other features. Dead and rotting branches and knot holes do not provide any suitable roosting features. | | | Negligible | No |

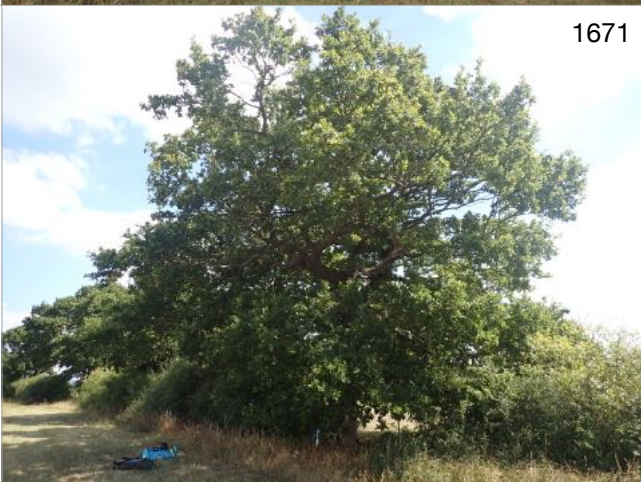
| Tree / feature number | Species | Height | DBH / Aspect | JPEG | Description | Comments | Can it be fully checked ? | Suitability | Further survey? |
|---|---|---|---|---|---|---|---|---|---|
| T75 | Oak | 10 | 60 | 1671 | Mature oak tree in field hedgerow boundary with dead and rotting limbs and branches in the crown. Majority of features are not suitable for roosting bats. PRF1 below could not be fully checked as squirrel present, but could be suitable for roosting bats. | | No | Moderate | Yes |

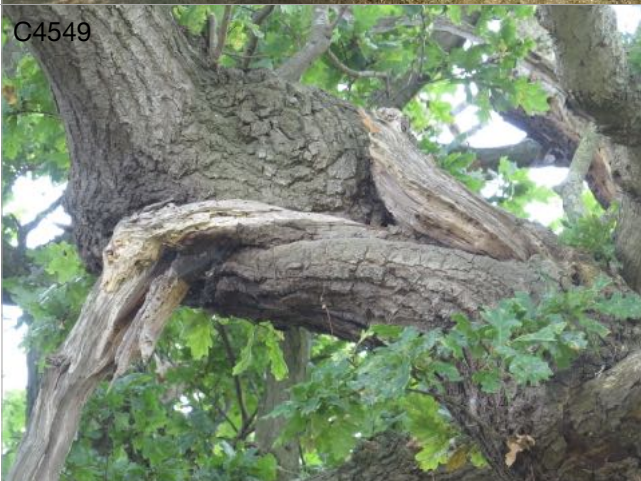
| Tree / feature number | Species | Height | DBH / Aspect | JPEG | Description | Comments | Can it be fully checked ? | Suitability | Further survey? |
|---|---|---|---|---|---|---|---|---|---|
| T75.1 | PRF1 | 6 | N | C4549 | Tear out and rot hole with part of rotting limbs still present, at 6m on north side of crown. Callus rolls have partially closed the feature. Rot hole has approximately 30cm of upward travel. Currently in use by squirrel, could not be fully checked | Currently in use by squirrel. | No | Moderate | Yes |

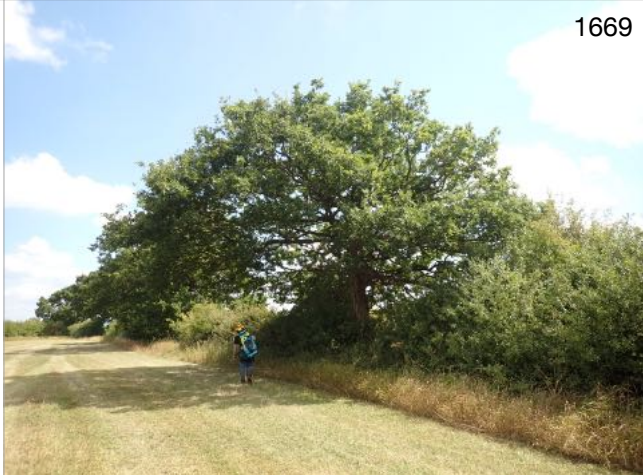
| Tree / feature number | Species | Height | DBH / Aspect | JPEG | Description | Comments | Can it be fully checked ? | Suitability | Further survey? |
|---|---|---|---|---|---|---|---|---|---|
| T76 | Oak | 8 | 60 | 1669 | Mature oak tree in field boundary hedgerow with dead and failed limbs in the crown and splits, and missing bark on main stem. | | Yes | Negligible | No |

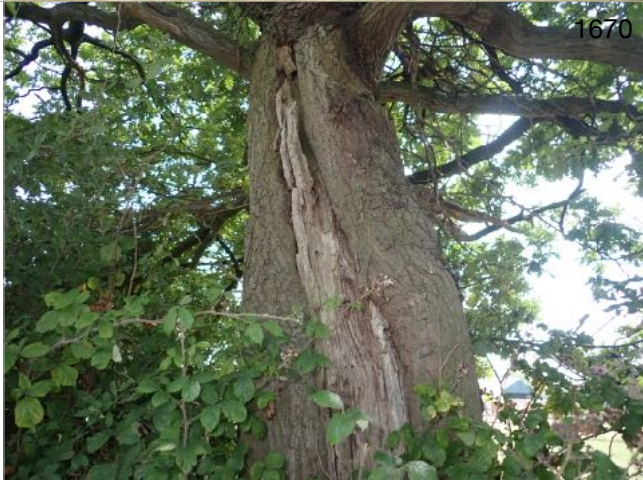
| Tree / feature number | Species | Height | DBH / Aspect | JPEG | Description | Comments | Can it be fully checked ? | Suitability | Further survey? |
|---|---|---|---|---|---|---|---|---|---|
| T76.1 | PRF1 | <3 | N | 1670 | Split on north side of main stem from base to 3m with exposed heartwood and minor splits in desiccated wood. Callus rolls are tight against heartwood with no suitable cavities present. | | Yes | Negligible | No |

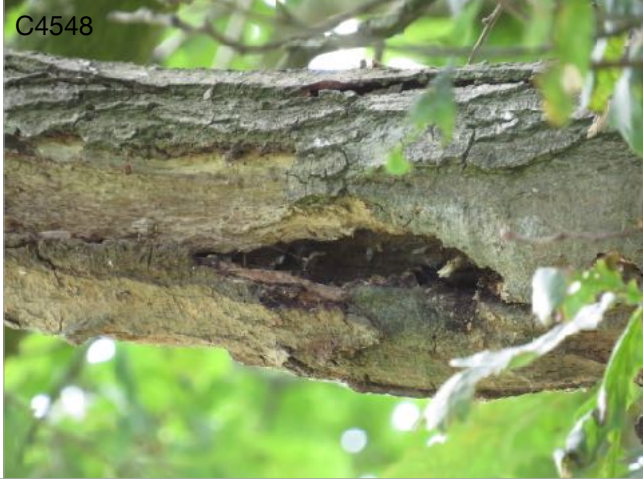
| Tree / feature number | Species | Height | DBH / Aspect | JPEG | Description | Comments | Can it be fully checked ? | Suitability | Further survey? |
|---|---|---|---|---|---|---|---|---|---|
| T76.2 | PRF3 | 3 | S | C4548 | Rot hole on side of horizontal limb at 3m on south side of the crown. 10 x 2cm rot hole with minor cavities (<5cm) at either end. | | Yes | Negligible | No |

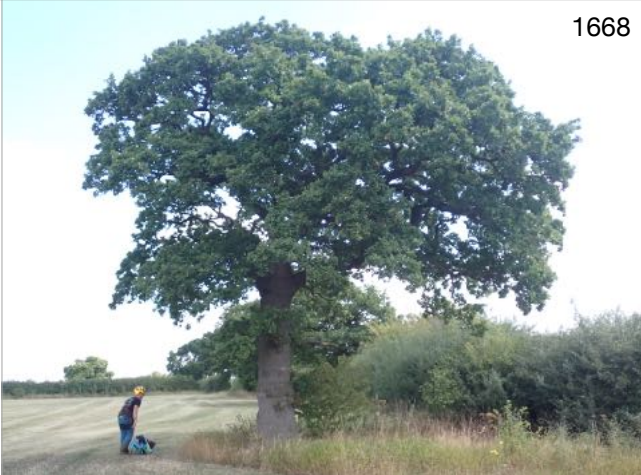
| Tree / feature number | Species | Height | DBH / Aspect | JPEG | Description | Comments | Can it be fully checked ? | Suitability | Further survey? |
|---|---|---|---|---|---|---|---|---|---|
| T77 | Oak | 10 | 90 | 1668 | Mature oak tree in field boundary hedgerow with knot holes and dead branches in the crown. | | Yes | Negligible | No |

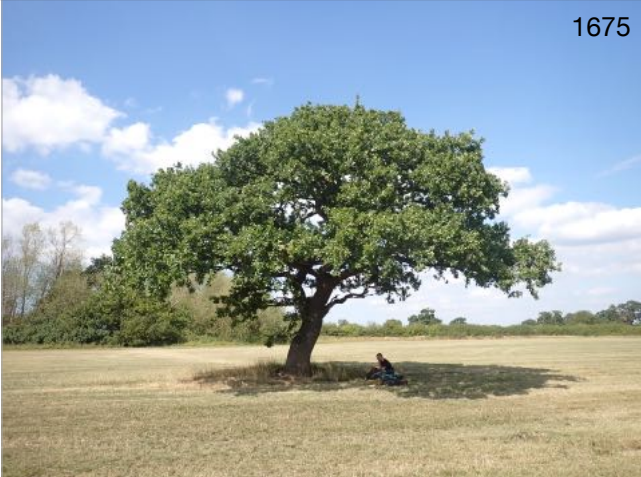
| Tree / feature number | Species | Height | DBH / Aspect | JPEG | Description | Comments | Can it be fully checked ? | Suitability | Further survey? |
|---|---|---|---|---|---|---|---|---|---|
| T79 | Oak | 8 | 80 | 1675 | Mature oak tree in field with dead and rotting limbs in the crown. | Check feature prior to felling. | Yes | Low | No |

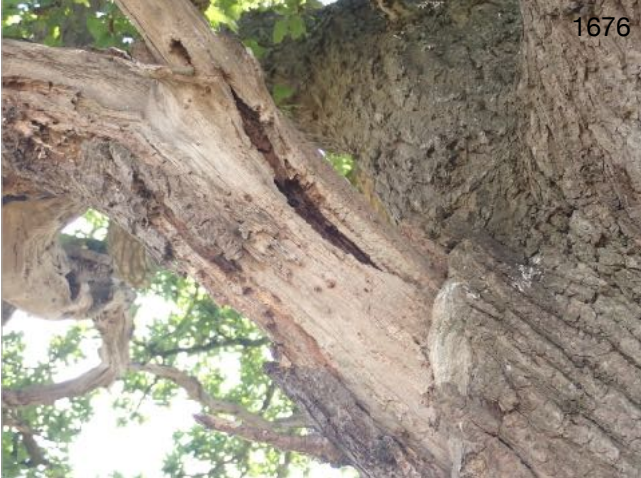
| Tree / feature number | Species | Height | DBH / Aspect | JPEG | Description | Comments | Can it be fully checked ? | Suitability | Further survey? |
|---|---|---|---|---|---|---|---|---|---|
| T79.1 | PRF1 | 2 | NE | 1676 | Dead and rotting limb with missing bark, and rot hole at base close to main stem. 5cm diameter entrance hole with <10cm downward travel into dry cavity, with squirrel fur inside. | Check prior to felling | Yes | Low | No |

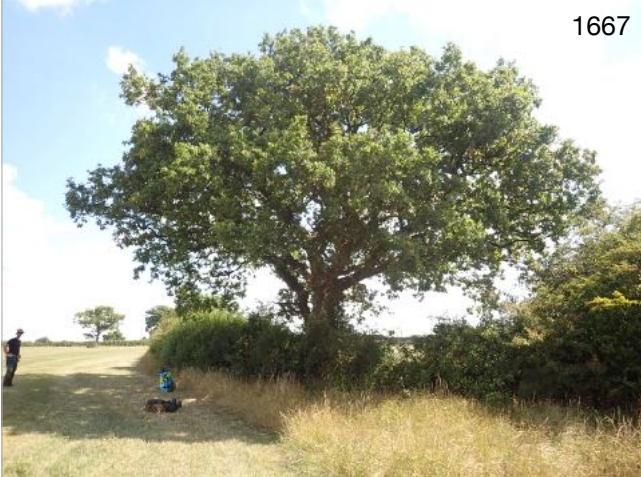
| Tree / feature number | Species | Height | DBH / Aspect | JPEG | Description | Comments | Can it be fully checked ? | Suitability | Further survey? |
|---|---|---|---|---|---|---|---|---|---|
| T81 | Oak | 10 | 80 | 1667 | Mature oak tree in field hedgerow boundary with dead branches, pruning cuts, and light ivy in the crown. | | Yes | Negligible | No |

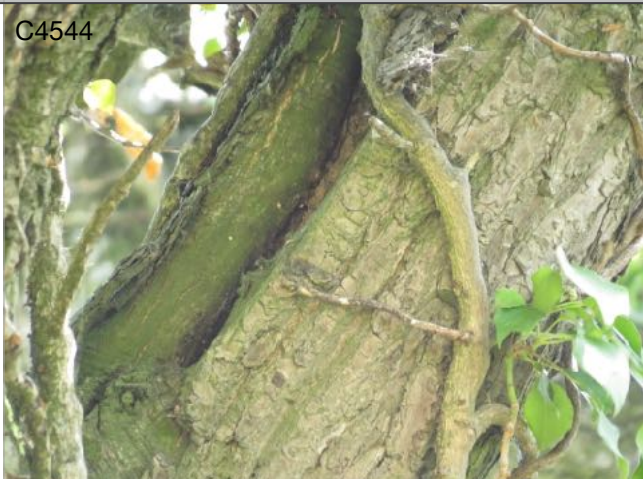
| Tree / feature number | Species | Height | DBH / Aspect | JPEG | Description | Comments | Can it be fully checked ? | Suitability | Further survey? |
|---|---|---|---|---|---|---|---|---|---|
| T81.1 | PRF1 | 5 | N | C4544 | Split bark with minor exposed heartwood on inside of diagonal limb. No suitable cavity. | | Yes | Negligible | No |

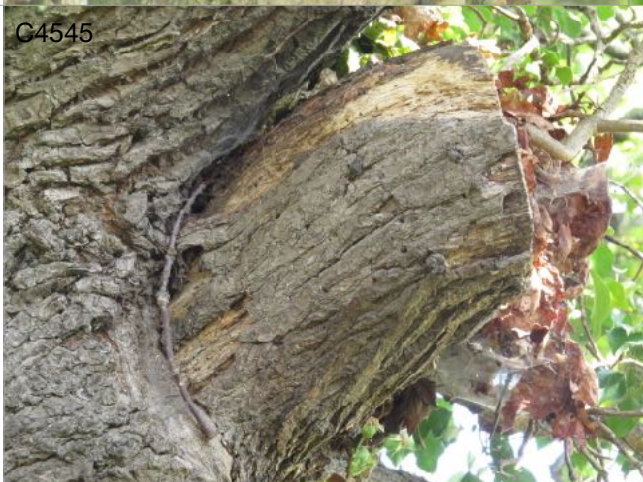
| Tree / feature number | Species | Height | DBH / Aspect | JPEG | Description | Comments | Can it be fully checked ? | Suitability | Further survey? |
|---|---|---|---|---|---|---|---|---|---|
| T81.2 | PRF2 | 4 | S | C4545 | Pruned limb on southern side of main stem at 4m, missing bark and exposed heartwood, but no suitable cavities. | | Yes | Negligible | No |
