# Appendix 11.7: Bat Roost Technical Appendix

# LAND NORTH OF BRYN LANE WREXHAM BAT ROOST SURVEY REPORT

| Document Title | Bat Roost Survey Report |
| Document Ref | 9134.005 |

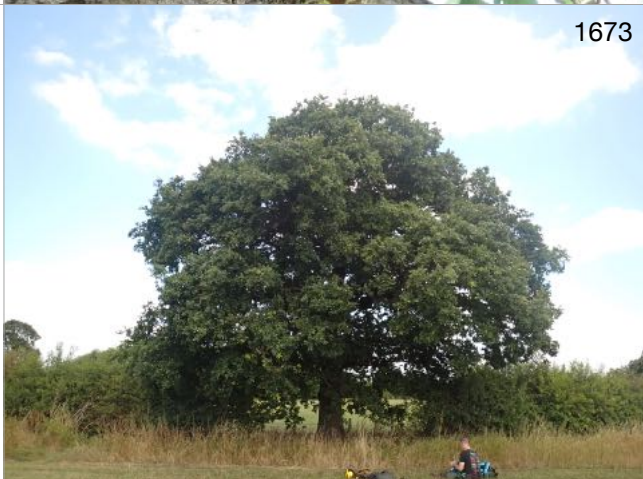
| Tree / feature number | Species | Height | DBH / Aspect | JPEG | Description | Comments | Can it be fully checked ? | Suitability | Further survey? |
|---|---|---|---|---|---|---|---|---|---|
| T85 | Oak | 10 | 60 | 1673 | Oak tree in field boundary hedgerow with dead and rotting branches in the crown, areas of exposed heartwood on top of limbs and knot holes in limbs. | | Yes | Negligible | No |

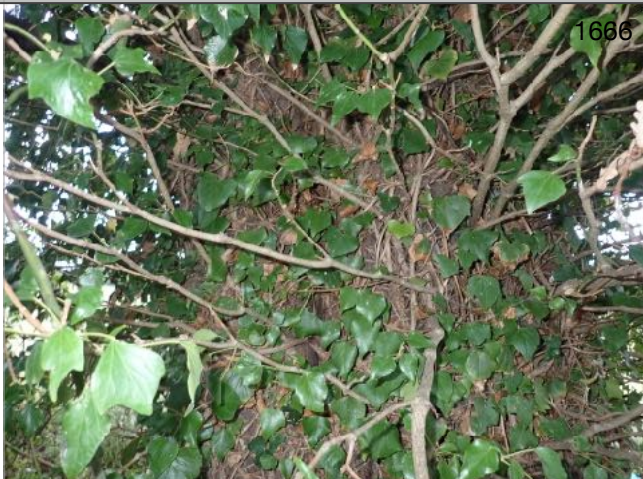
| Tree / feature number | Species | Height | DBH / Aspect | JPEG | Description | Comments | Can it be fully checked ? | Suitability | Further survey? |
|---|---|---|---|---|---|---|---|---|---|
| T86.2 | PRF2 | 2 | N | 1666 | Bees nest can not be fully checked, at least 10cm of downward travel. Horizontal travel can not be checked as to tight for endoscope | Will need to be fully endoscope when bees have left | No | Precautionary moderate | Yes |

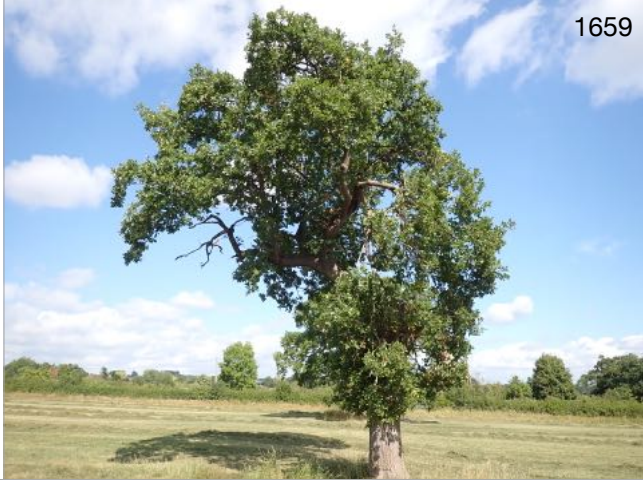
| Tree / feature number | Species | Height | DBH / Aspect | JPEG | Description | Comments | Can it be fully checked ? | Suitability | Further survey? |
|---|---|---|---|---|---|---|---|---|---|
| T89 | Oak | 8 | 60 | 1659 | Mature oak tree in line of four trees in field. With missing and failed limbs, exposed heartwood and dead branches in the crown. | | Yes | Negligible | No |

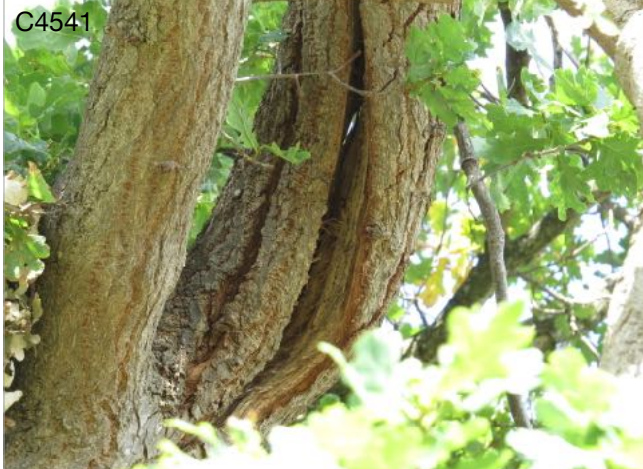
| Tree / feature number | Species | Height | DBH / Aspect | JPEG | Description | Comments | Can it be fully checked ? | Suitability | Further survey? |
|---|---|---|---|---|---|---|---|---|---|
| T89.1 | PRF1 | 5 | W | C4541 | Failed limb in centre of crown with branch still hanging and open splits. Open through the splits with no enclosed spaces. Cracks will change size as the limb moves in the wind. | | Yes | Negligible | No |

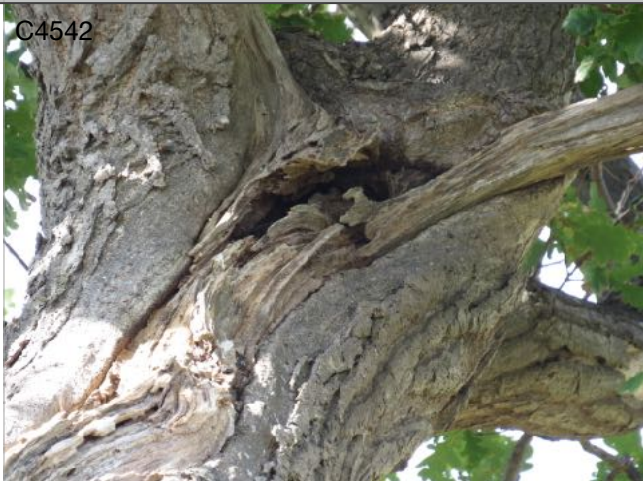
| Tree / feature number | Species | Height | DBH / Aspect | JPEG | Description | Comments | Can it be fully checked ? | Suitability | Further survey? |
|---|---|---|---|---|---|---|---|---|---|
| T89.2 | PRF2 | 4 | W | C4542 | Missing bark and exposed heartwood on top of diagonal limb to west side of crown. Minor splits, callus rolls are tight against heartwood, minor cavity at top of feature, less than 5cm deep with no suitable shelter. | | Yes | Negligible | No |

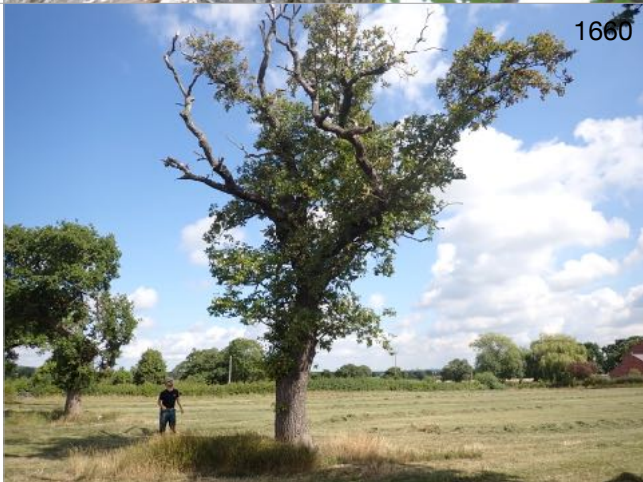
| Tree / feature number | Species | Height | DBH / Aspect | JPEG | Description | Comments | Can it be fully checked ? | Suitability | Further survey? |
|---|---|---|---|---|---|---|---|---|---|
| T90 | Oak | 8 | 60 | 1660 | Mature oak tree in line of four trees in field, with dead limbs and branches in the crown, knot holes and pruning wounds on branches and the main stem. | | Yes | Negligible | No |

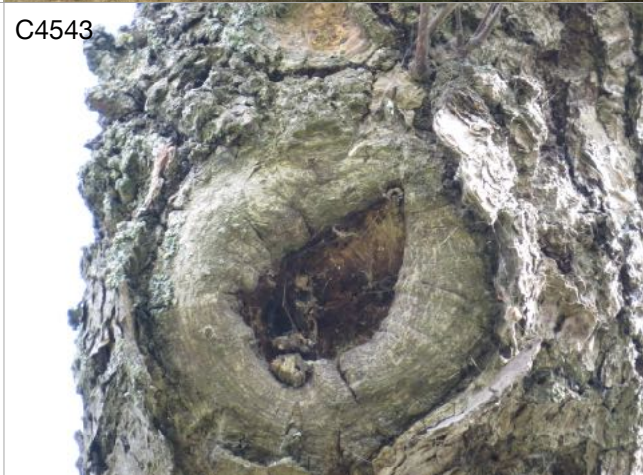
| Tree / feature number | Species | Height | DBH / Aspect | JPEG | Description | Comments | Can it be fully checked ? | Suitability | Further survey? |
|---|---|---|---|---|---|---|---|---|---|
| T90.1 | PRF1 | All | All | C4543 | Knot holes and pruning wounds on limbs on all aspects of the tree from 2m into the crown. All checked, none with cavities suitable for use by roosting bats. | | Yes | Negligible | No |

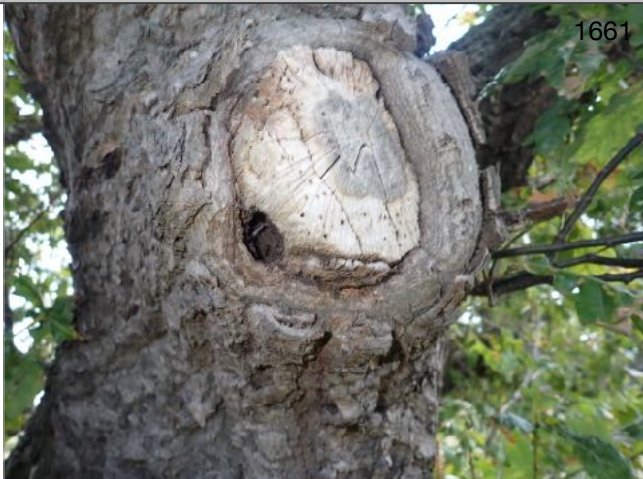
| Tree / feature number | Species | Height | DBH / Aspect | JPEG | Description | Comments | Can it be fully checked ? | Suitability | Further survey? |
|---|---|---|---|---|---|---|---|---|---|
| T90.2 | PRF2 | 4 | NW | 1661 | Pruning wound with exposed heartwood and small 3cm diameter rot hole with <5cm travel in open wet cavity. | | Yes | Negligible | No |

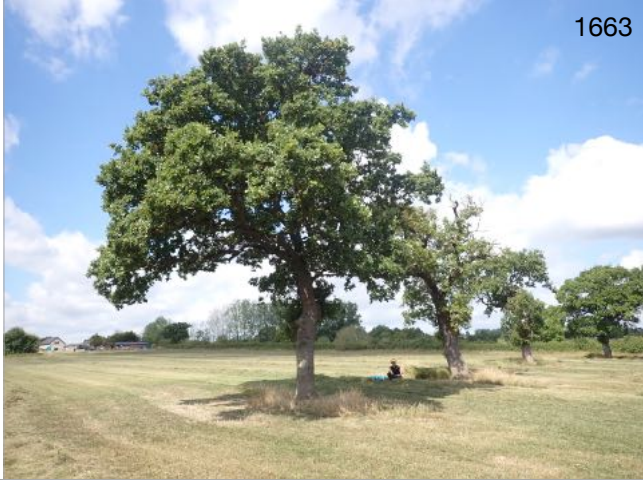
| Tree / feature number | Species | Height | DBH / Aspect | JPEG | Description | Comments | Can it be fully checked ? | Suitability | Further survey? |
|---|---|---|---|---|---|---|---|---|---|
| T91 | Oak | 8 | 50 | 1663 | Mature oak tree, southern tree in line of four trees in field, with dead limbs and branches in the crown, knot holes and pruning wounds on branches and the main stem. None with features suitable for use by roosting bats. | Dead branches have missing bark and minor splits in exposed heartwood, but none are suitable for roosting. | Yes | Negligible | No |

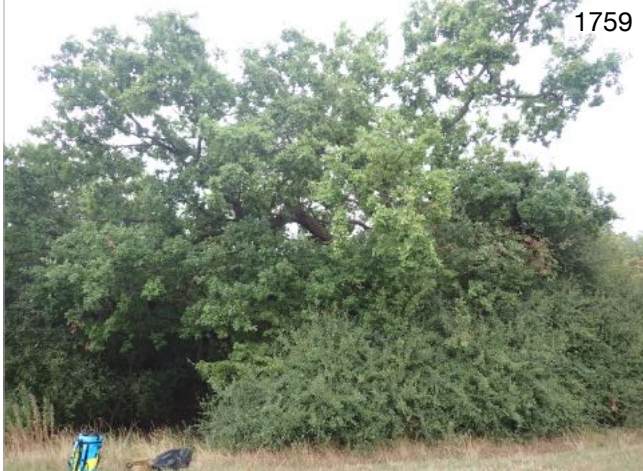
| Tree / feature number | Species | Height | DBH / Aspect | JPEG | Description | Comments | Can it be fully checked ? | Suitability | Further survey? |
|---|---|---|---|---|---|---|---|---|---|
| T101 | Oak | 10 | 1.2 | 1759 | Mature oak tree adjacent pond with multiple dead, rotting, and hanging limbs in the crown, and a large main stem cavity. Not safe to climb as large dead limbs are hanging above features which need to be inspected. | | No | High | Yes |

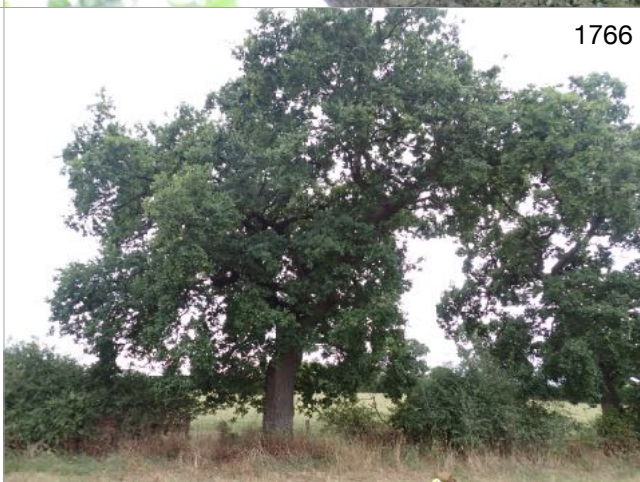
| Tree / feature number | Species | Height | DBH / Aspect | JPEG | Description | Comments | Can it be fully checked ? | Suitability | Further survey? |
|---|---|---|---|---|---|---|---|---|---|
| T107 | Oak | 8 | 70 | 1766 | Oak tree in field boundary hedgerow with dead branches, knot holes, and tear outs in the crown. Not safe to climb as very active wasps nest at 1.5m on south side of main stem. | Not safe to climb. | No | High | Yes |

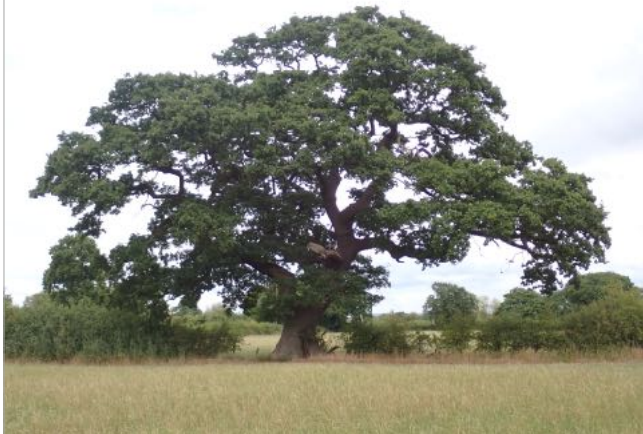
| Tree / feature number | Species | Height | DBH / Aspect | JPEG | Description | Comments | Can it be fully checked ? | Suitability | Further survey? |
|---|---|---|---|---|---|---|---|---|---|
| T109 | Oak | 16 | 2 | 1761 | A large, mature oak tree with a wide, spreading canopy, standing in a field. The tree has a thick trunk and many branches with green leaves. The ground in front is covered with dry grass. | Veteran oak tree in field boundary hedgerow with multiple failed limbs in the crown, knot holes, and deadwood. Dropped limbs and knot holes have areas of exposed heartwood and minor splits and cavities which are too small for use by roosting,neg bats. | | Negligible | No |

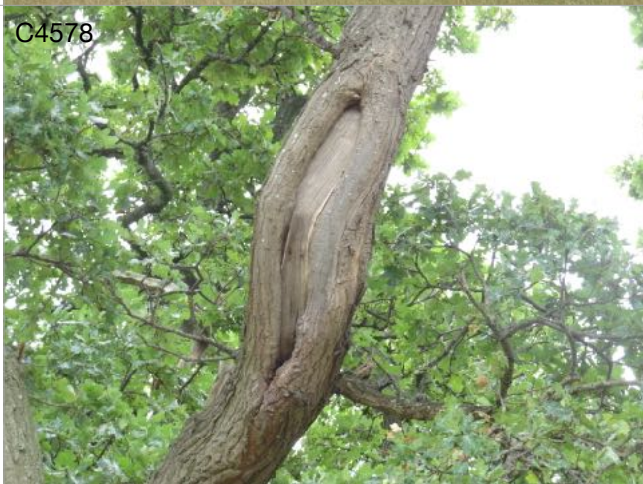
| Tree / feature number | Species | Height | DBH / Aspect | JPEG | Description | Comments | Can it be fully checked ? | Suitability | Further survey? |
|---|---|---|---|---|---|---|---|---|---|
| T109.1 | PRF1 | 7 | NW | C4578 | A close-up view of a tree trunk showing a large, irregular hole or cavity in the bark. The bark is light brown and peeling in places. The hole is deep and has a rough, uneven interior. | Tear out at 7m on west side of near- vertical limb in the northwest corner of the crown. 1m x 20cm of exposed heartwood with callus rolls on the sides. Callus rolls are tight against heartwood with only minor splits on right hand side, which are not large enough to be used by roosting bats. Minor gap at top of feature has no upward travel. | Yes | Negligible | No |

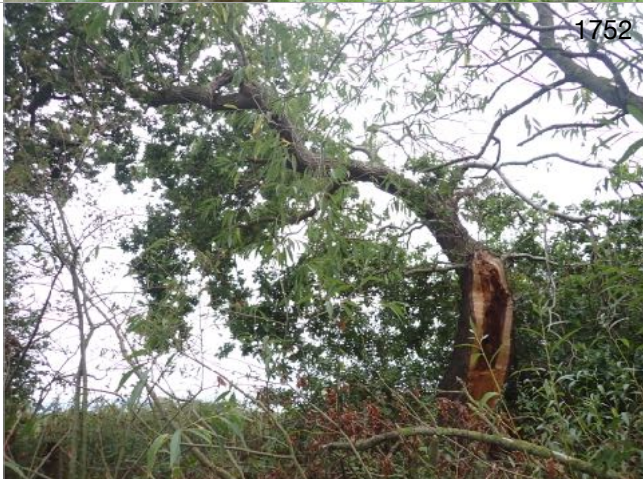
| Tree / feature number | Species | Height | DBH / Aspect | JPEG | Description | Comments | Can it be fully checked ? | Suitability | Further survey? |
|---|---|---|---|---|---|---|---|---|---|
| T116 | Oak | 6 | 80 | 1752 | A tree trunk with a large, vertical cavity or hole, surrounded by dense foliage. The cavity is deep and has a rough, uneven interior. The surrounding foliage is green and dense. | Failed oak tree on pond boundary, majority of the tree has fallen into pond large cavity on main stem | Yes | Low | No |

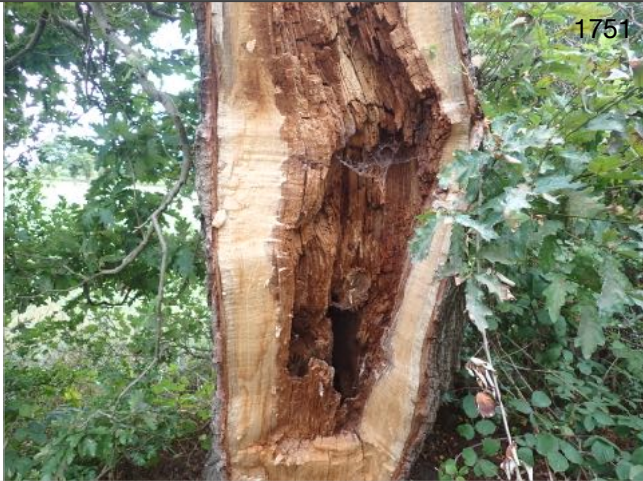
| Tree / feature number | Species | Height | DBH / Aspect | JPEG | Description | Comments | Can it be fully checked ? | Suitability | Further survey? |
|---|---|---|---|---|---|---|---|---|---|
| T116.1 | PRF1 | 1 | S | 1751 | Limb failure on the south side of the tree with 2 meters exposed heartwood minor cavity within the heartwood 10cm of upward travel. | | Yes | Low | No |

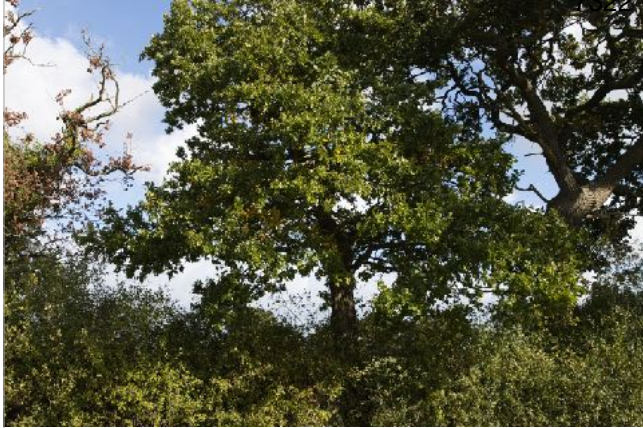
| Tree / feature number | Species | Height | DBH / Aspect | JPEG | Description | Comments | Can it be fully checked ? | Suitability | Further survey? |
|---|---|---|---|---|---|---|---|---|---|
| G4.2 | Oak | 8 | 30 | | 7322 Middle aged oak tree in field hedgerow boundary. Deadwood, rot hole and woodpecker hole in main stem. | Not safe to climb due to wasps nest | No | High | Yes |

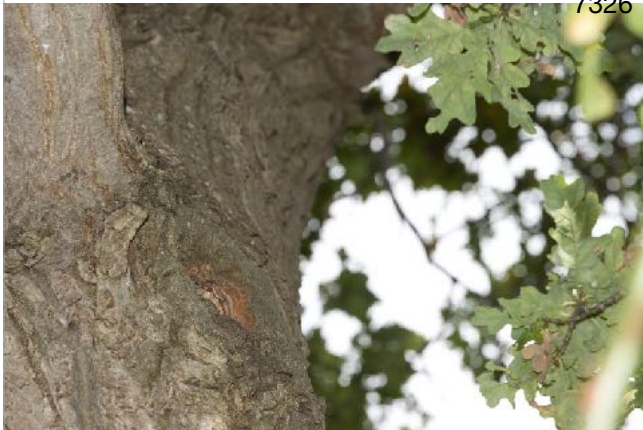
| Tree / feature number | Species | Height | DBH / Aspect | JPEG | Description | Comments | Can it be fully checked ? | Suitability | Further survey? |
|---|---|---|---|---|---|---|---|---|---|
| G4.2.1 | PRF | 3 | S | | 7326 Woodpecker hole at 3m on the southern aspect. Entrance 5cm x 5cm | Cannot be checked due to wasps nest in hole | No | High | Yes |

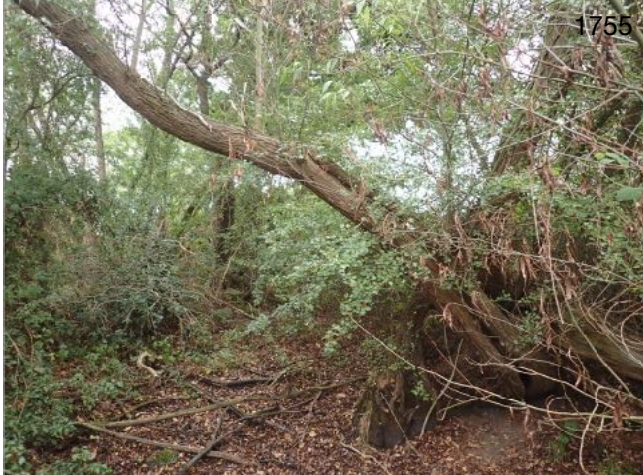
| Tree / feature number | Species | Height | DBH / Aspect | JPEG | Description | Comments | Can it be fully checked ? | Suitability | Further survey? |
|---|---|---|---|---|---|---|---|---|---|
| G10.1 | Willow | 8 | 50 | | 1755 Multi stem leaning willow in pond with tear out on north east side of leaving limb from base to 3 meters | | Yes | Low | No |
