# Arboricultural Technical Note- Legacy ESS Cable Route Options

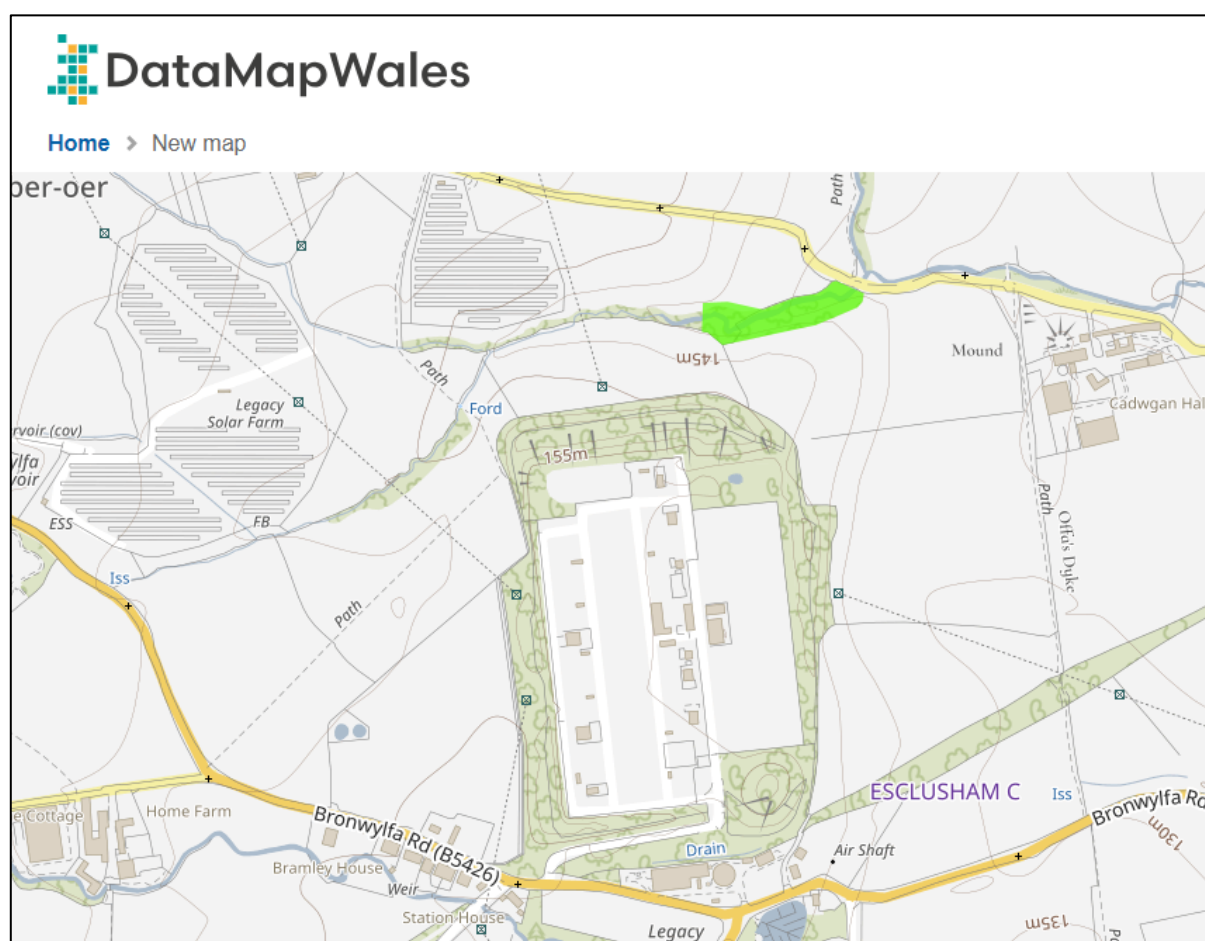
- 2.10 According to the Woodland Trust's 'Ancient Tree Inventory', T12, as labelled on the Tree Constraints Plan (TCP) is classified as a Veteran Hybrid Sessile and English oak (*Quercus x rosacea*), and is located at grid reference SJ2958848780.
- 2.11 The area of ASNW commented on by the Woodland Trust is confirmed by Natural Resources Wales 'Ancient Woodland Inventory 2021', via the interactive mapping software. The extent of this ASNW (approximately 1.25 acres in area) is illustrated in Figure 2 below.

Figure 2. Location and scale of the ASNW present at the site (Natural Resources Wales 2024 ©).

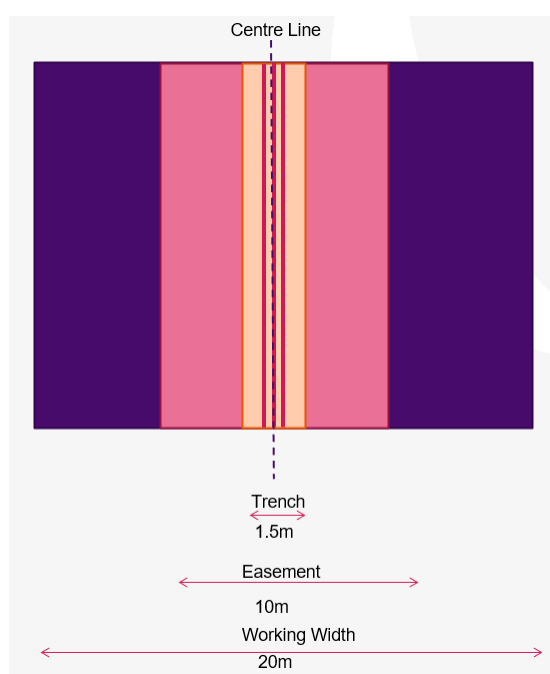
- 3.3 Unlike route 2, route 1 and route 3 would primarily involve trench cable installations, but with sections of horizontal directional drilling beneath Offa's Dyke and trees as part of W25 and W26, respectively. This ensures the complete retention of these high value individual trees and woodland assets. The locations of the associated launch (approx. 50m x 50m area) and receival pits (approx. 25m x 25m area) required for the directional drilling will be positioned outside of all RPAs.

Figure 3: Proposed Cable Route Installation Parameters.

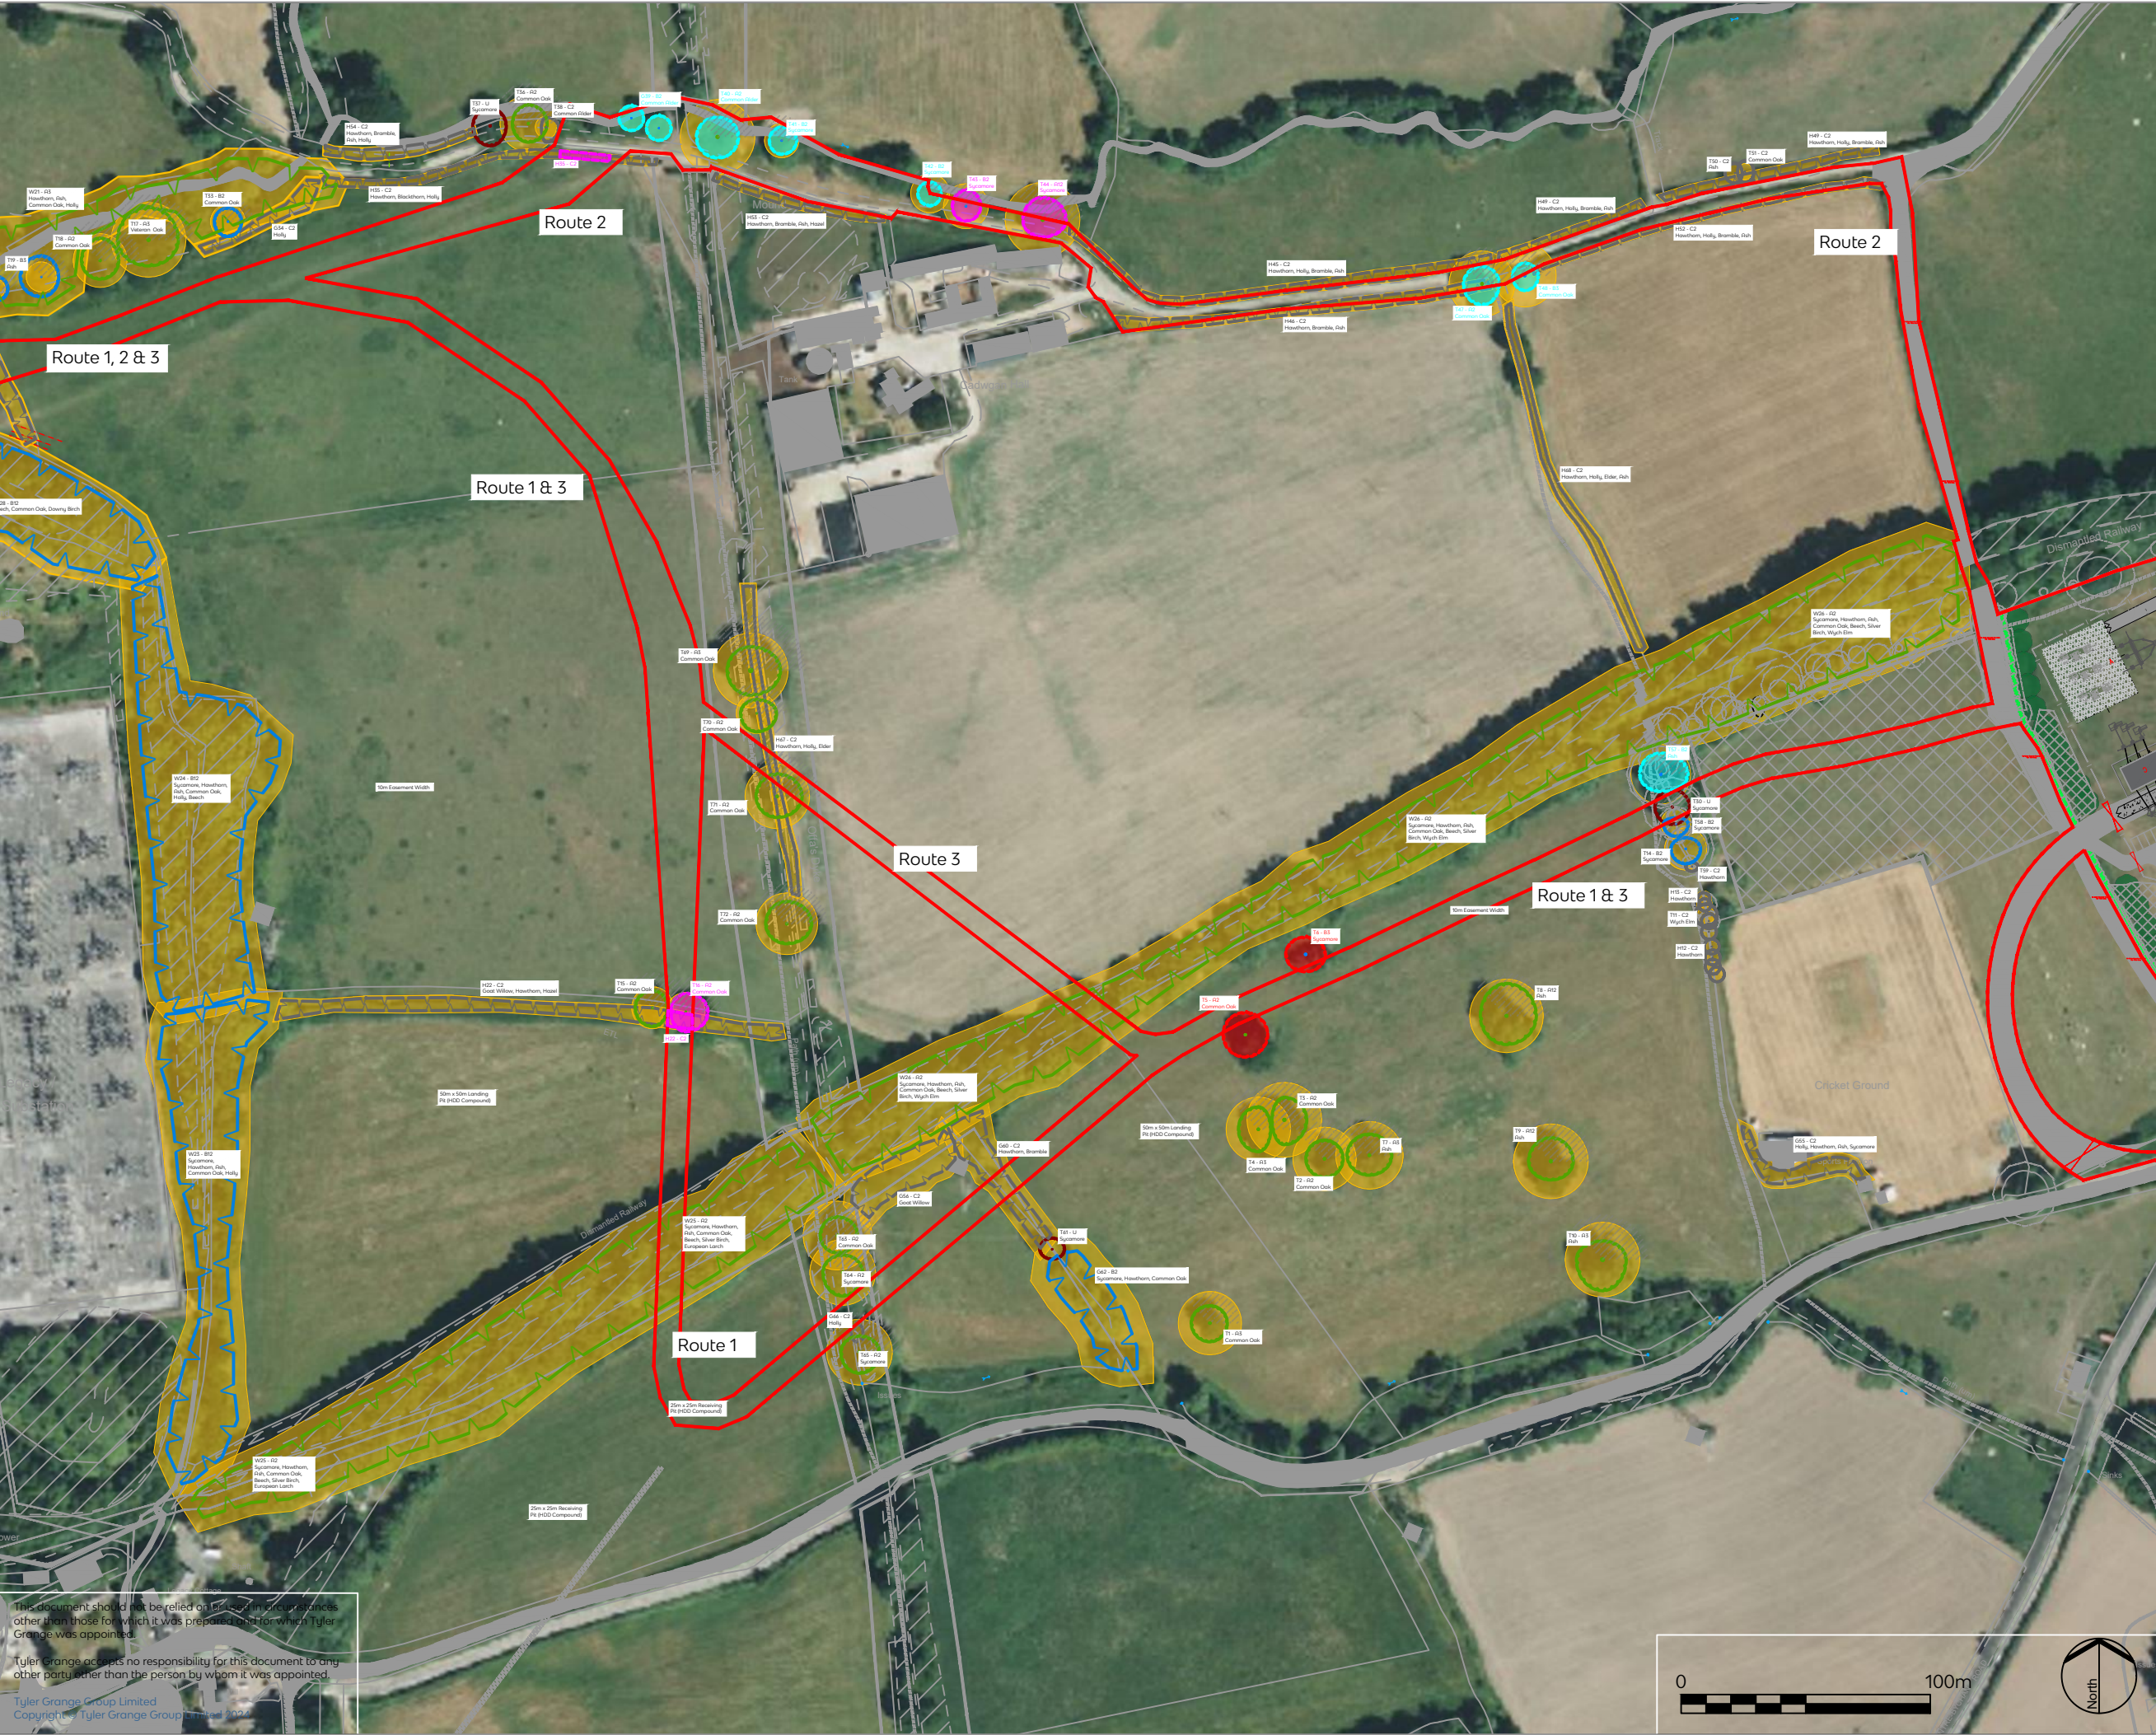
Plan 2: Tree Retention & Removal Plan (16589\_P02)

- 3.2 Sufficient offset from RPAs have been achieved across the majority of the three cable route options, as illustrated on the TRRP. Exceptions to this are associated with the trees positioned alongside the farm access track to the north. The 'route 2' option would be installed via a trench within the existing highway in this location. Providing a 20m working width in this section cannot be achieved due to the limited physical extent of the adopted highway, yet this is in favour of tree retention and may result in reduced tree impacts.

- 3.5 Irrespectively, if either route 1 or route 3 is pursued, it is recommended that T5 and T6 can be compensated for by planting a minimum of 8no. extra-heavy standard native trees (comprising oak, beech, or alder, for example), located within the on-site mitigation land positioned to the west of the cricket pitch. This represents an extension to the ratio specified within paragraph 6.4.42 of PPW, and utilising advanced tree stock is intended to be proportionate to the maturity and high-moderate quality of the tree removals. It is recommended that the new trees could be planted surrounding the existing scattered mature specimens (in the vicinity of T7-T10) to offer successional benefits and increase the tree population in this locality. Furthermore, their long-term establishment and management operations could be prescribed within a collective landscape management plan produced for the wider scheme upon the detailed design stage.
