# TREVOR BASIN AREA SITE ARRIVAL & CAR PARK

## Coal Mining Risk Assessment

Document Ref: 10054502-ARC-XX-XXX-RP-GE-01002

MAY 2024

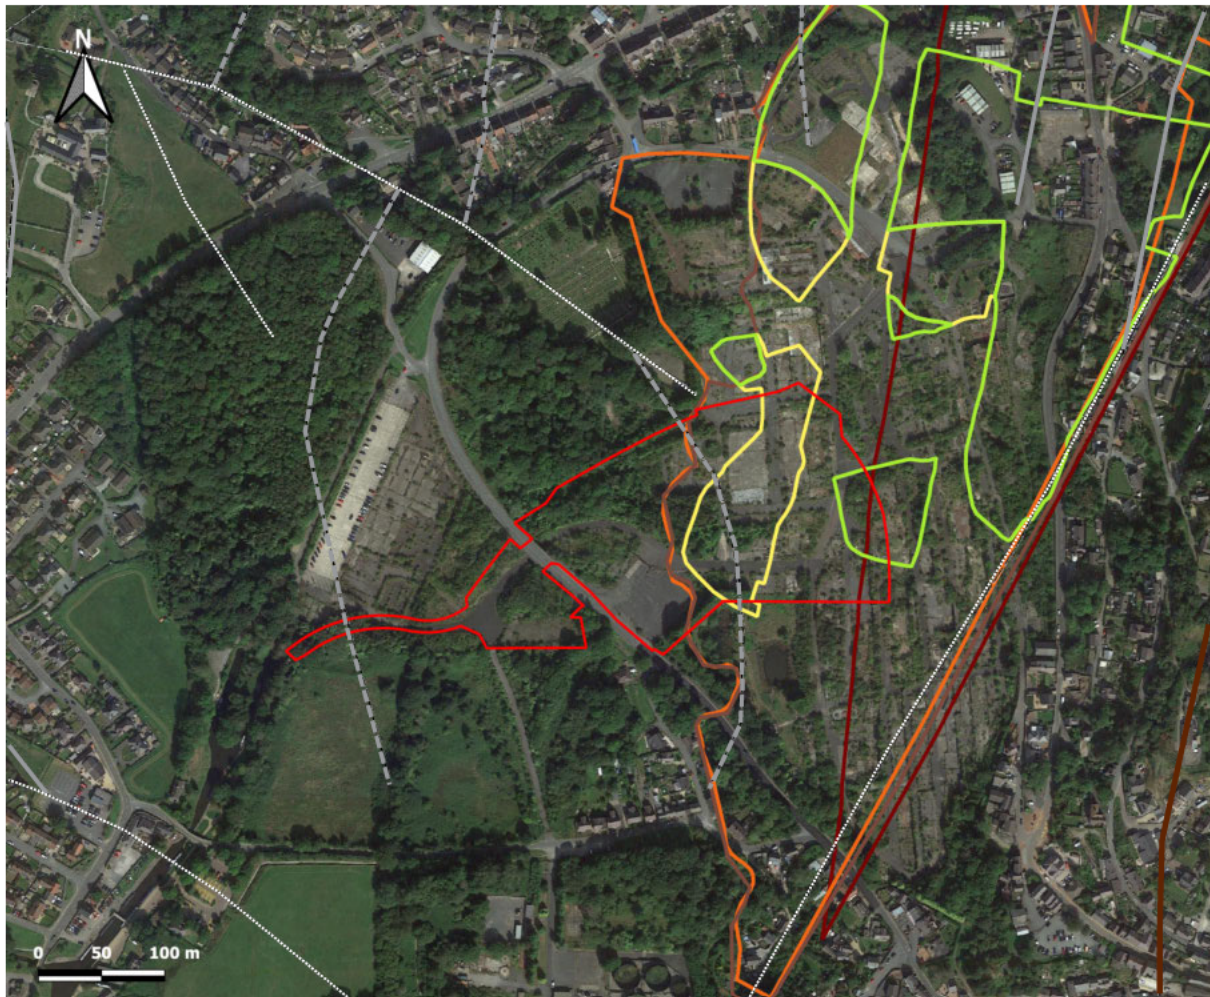
*Figure 4-2: Recorded workings obtained from Coal Authority mine abandonment plans. Seam Outcrop and Faulting obtained from BGS mapping © Google Satellite 2024*

Four mine abandonment plans (dated 1949) were obtained from the Coal Authority for shallow workings beneath the site, these are included in Appendix F. Figure 4-2 below shows the outlines of the recorded workings beneath the site in relation to the site boundary. These are labelled with the seam names provided on the abandonment plans.

The Coal Mining Report also suggests that there are 'probable' unrecorded workings (shallow and moderate depths) beneath the site. The Coal Authority viewer indicates this may include the remaining areas of the site outside of the area of recorded workings shown in Figure 4-2.

Workings have been recorded within several shallow seams beneath the site, including the Stone, Nant, Ruabon Yard and Wall and Bench seams. The CA Coal Mining Report indicates the shallowest workings (Stone seam) may be approximately 6m bgl, with an extraction thickness of 200cm. The Coal Mining Conceptual Site Model in Figure 4-4 illustrates the approximate depth below surface of the various seams.

Given the dates the seams were last worked (1860-1862) and considering the development that has taken place on the site in the intervening time, the risks from these voids may have previously been mitigated, however, there are no available records to confirm this, and therefore at this stage the risk to the proposed development is considered to be high.

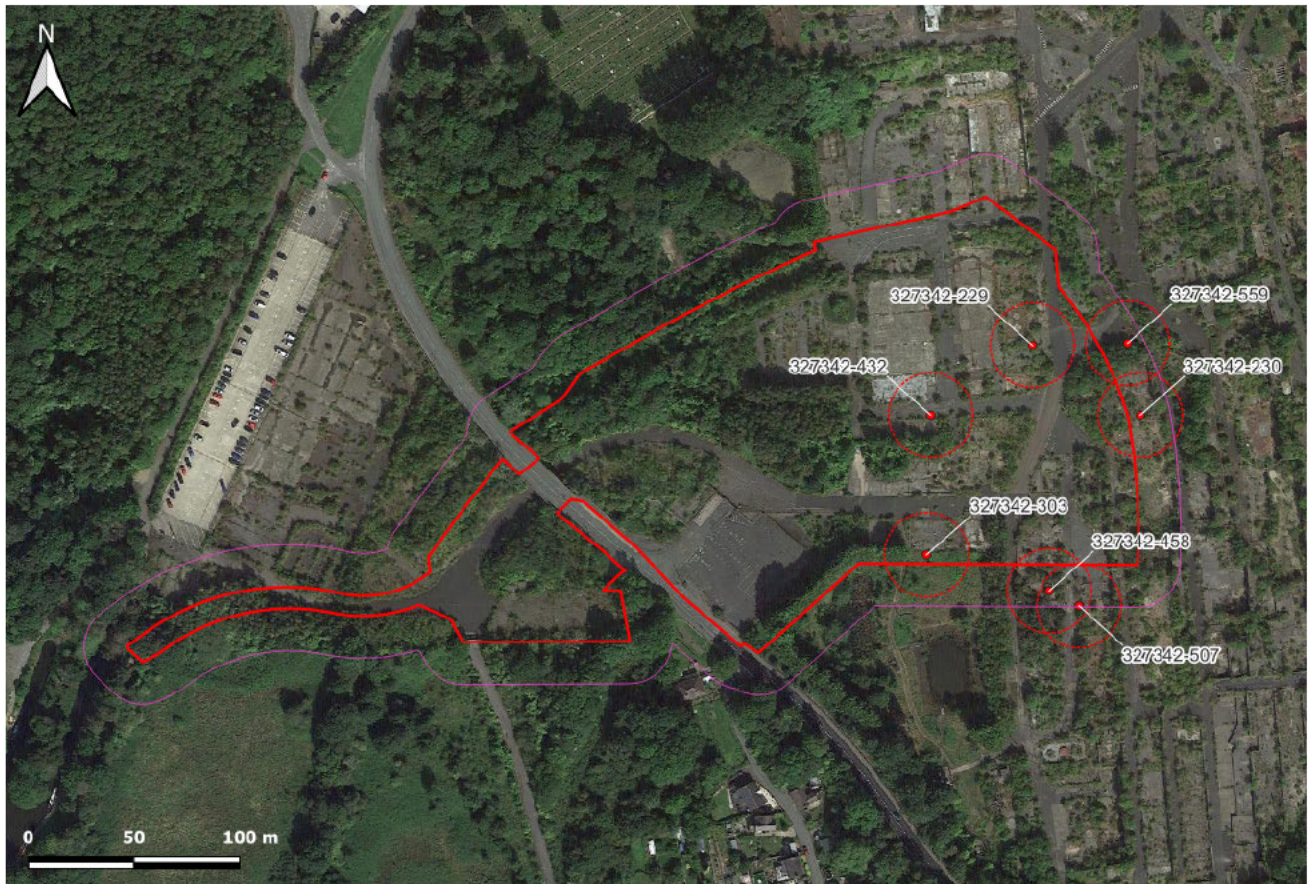
Figure 4-3: Recorded mine entries within 20m of the site boundary © Google Satellite 2024

The Coal Mining Report provides details of numerous mine entries within 100m of the site boundary. Three of these appear to be located within the site boundary, with a further four shown to be within a 20m of the site; these are illustrated in Figure 4-3 and any available details are summarised in Table 4-3.

There are no details relating to remediation or capping of the on-site coal shafts within the Coal Authority information. Although there has been subsequent development in the areas of these mine entries, there is no evidence to show that they have been suitably remediated. There remains a potential risk of collapse of abandoned mine shafts in these areas.

Three mine entries are recorded onsite and a further four are indicated within a 20m buffer of the site boundary: no treatment details available for these. The risk from potential collapse of mine entries is therefore high at this stage.

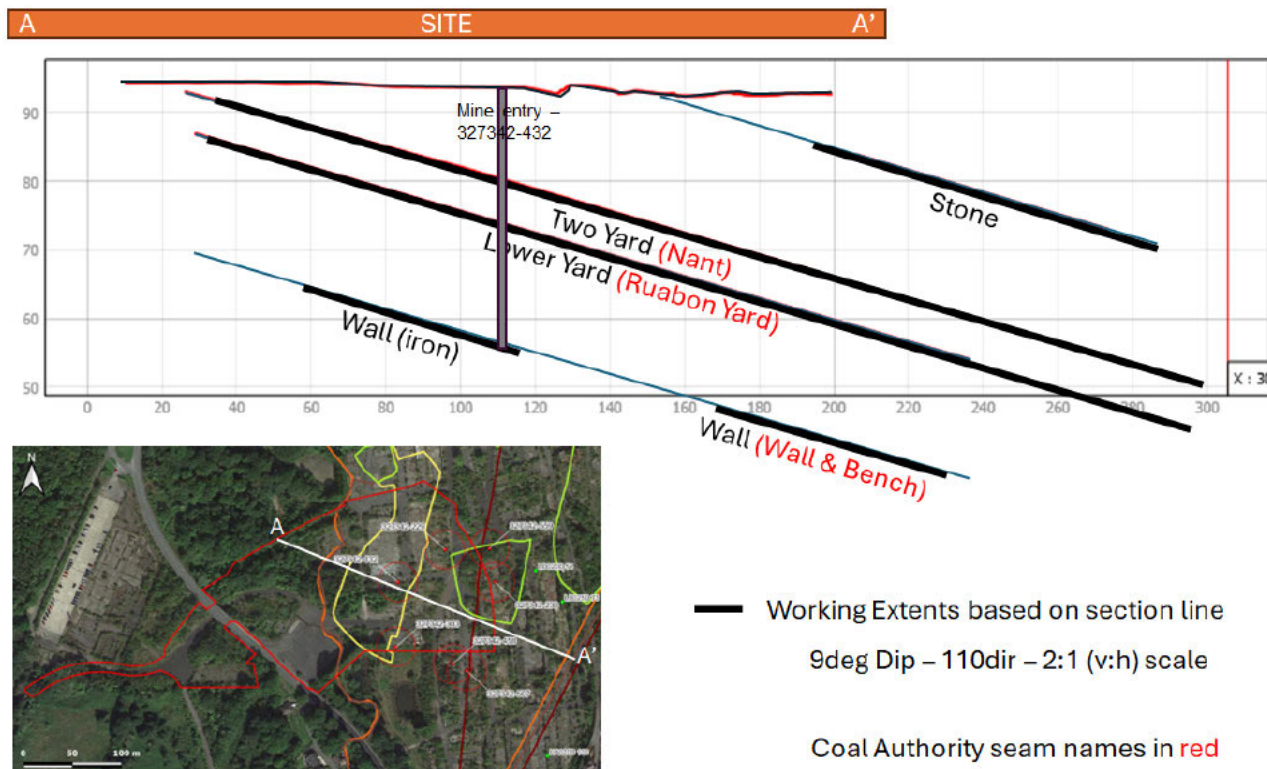
Figure 4-4: Indicative Sketch Coal Mining Conceptual Site Model

The information detailed above has been used to create an indicative sketch coal mining conceptual site model for the site, highlighting the extent of known underground coal workings taken from the mine abandonment plans (Figure 4-4).

The seam names used in Figure 4-4 are taken directly from the mine abandonment plans. One of the plans also featured a vertical stratigraphic section, this has been compared with generalized vertical sections provided on the BGS 1:10,000 and 1:50,000 geological maps, and the log for the Bye Pit at Cae Glo Colliery approximately 390m northeast (provided in Appendix G). The seam nomenclature across the data sources are detailed in Table 4-4 below.
