# **Bat and Nesting Bird Assessment Report**

**Dwelling and Detached Outbuilding,  
Dolwar,  
Park Road,  
Coedpoeth,  
Wrexham,  
LL11 3TD**

**Date: May 2022**

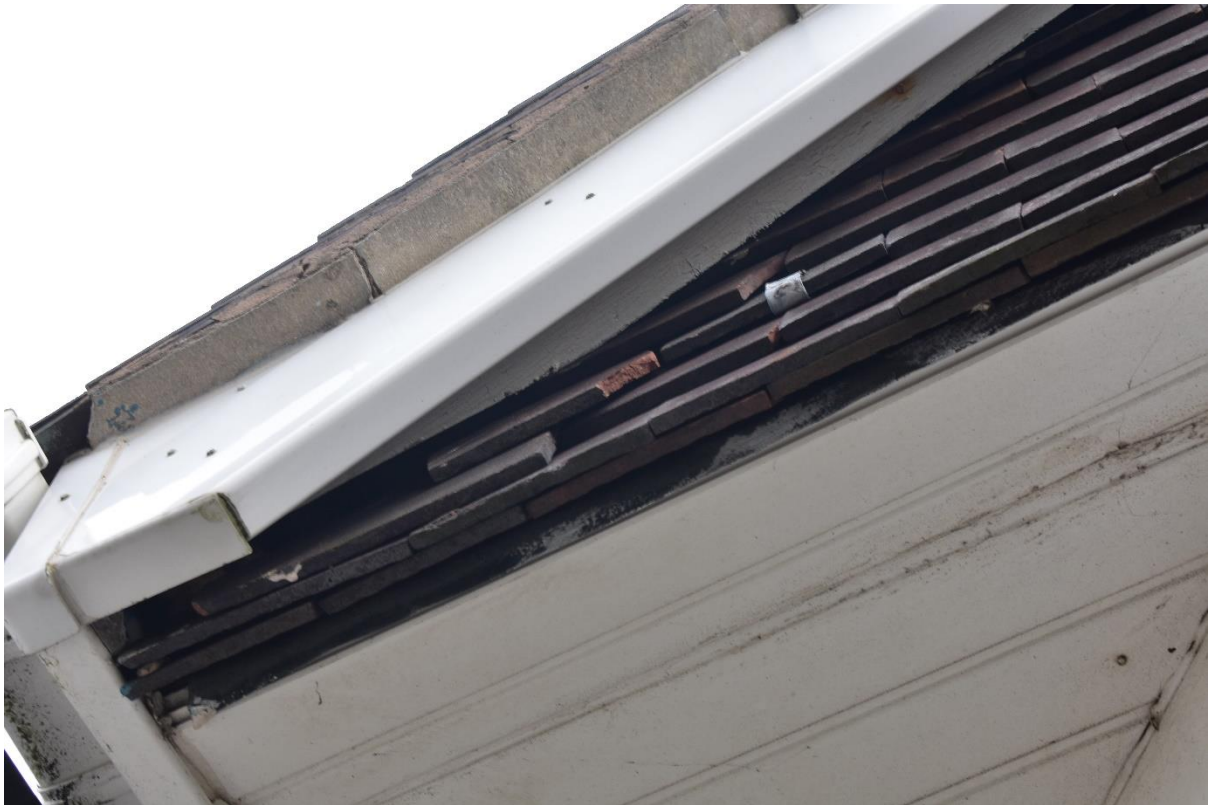
**Summary:** Of importance, it was noted that there are a small number of slipped roof tiles, a small number of lifted curved ridge tiles, and there are some gaps present beneath the hanging ceramic tiles which are fitted above the dormer window. There is also a single gap present between the otherwise-tightly fitted soffits and the walls on the west-facing aspect of the building.

Given the limited number and poor-quality of the potential roosting features identified upon the dwelling's exterior and the absolute lack of access to the building's interior, the building is categorised as having only low potential to support roosting bats.

**Figure 3.6:** The gaps present on the hanging ceramic tiles fitted onto the dormer window.
