# SALEM CHAPEL, PENTRE BROUGHTON

## MITIGATION STRATEGY

Report Ref EE.3669.22.KW

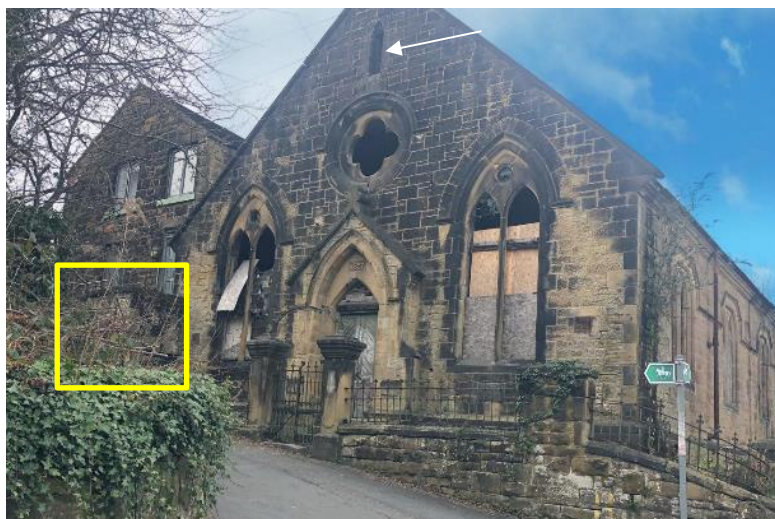
**FIGURE 2.3 – SOUTHERN GABLE OF CHAPEL – SHOWING AREA 'A' (YELLOW), 'SLIT' FOR EMERGENCE (WHITE ARROW) AND OPEN CLOVER FEATURE AND WINDOWS**

- 2.6.2 The original surveys (Enfys Ecology, 2018) observed LHS emerging from the ‘slit’ in the southern gable (which accesses the loft space directly) then re-entering the building on the southern gable through the clover window and other windows, before emerging from windows on both the southern and northern gables. It was concluded that the loft space was the main roosting area and the other areas of the Chapel were used for light sampling and night roosting. The survey in 2022 saw a small number of bats emerge directly from the loft space through the ‘slit’ before re-entering (less than 5 bats were observed doing this). The majority of emergences came from the windows and the clover-window on the southern gable, with some light sampling behaviour and re-entering, before emerging again and flying to the woodland adjacent to the south. While the whole interior of the Chapel could not be accessed prior to the emergence survey, the ceiling and upper areas could be viewed from the broken windows and no LHS were observed; the scattered droppings (as opposed to any large piles) within the main congregation area of the Chapel also suggest that the bats are still using the loft space as their main day roosting area. It is considered that they are primarily

- 3.4 As bats were using both gables to emerge in the 2016 and 2017 survey, the original report had suggested removing the emergence point on the southern gable to reduce the risk to bats that were emerging and then 'dropping' into the road (Enfys Ecology, 2018). During the 2022 emergence survey, LHS were only observed emerging from the southern gable and flying directly into the adjacent woodland, no bats were observed emerging from the other elevations; therefore, it is considered necessary to replicate their access point on the southern gable in the rebuild works, the 'slit', and allow for their continued use of this entry/

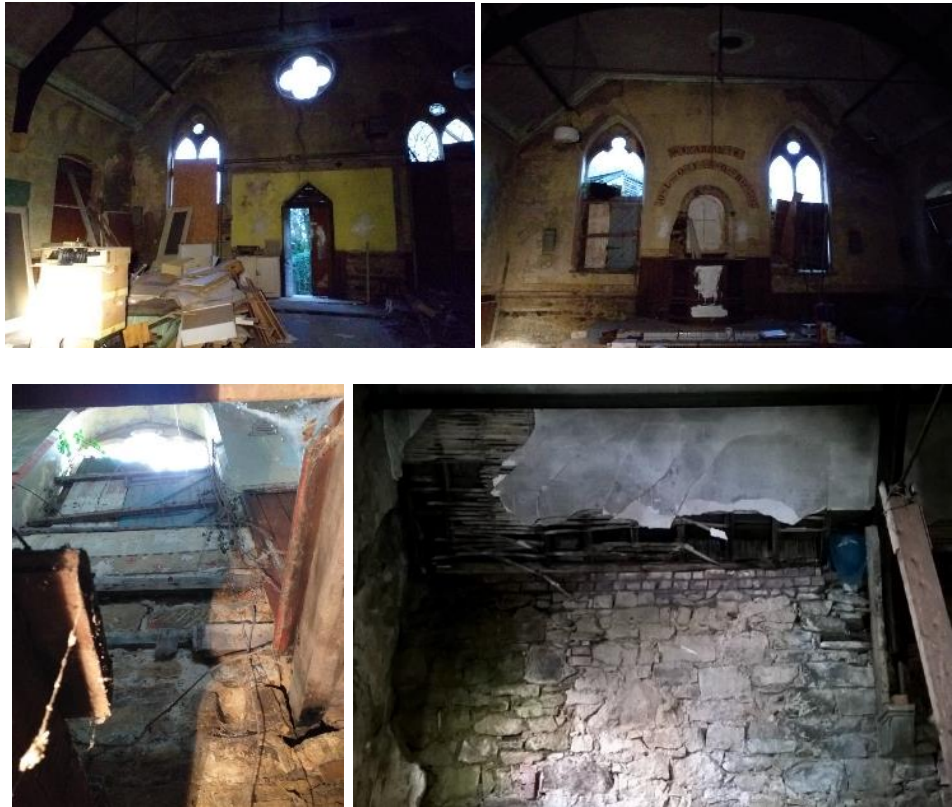
- 2.4.3 The loft space could not be accessed due to health and safety concerns. There were areas where the lathe and plaster ceiling had come away, leaving direct access points into the loft space. This was noted on the previous surveys (Enfys Ecology, 2018) but it could not be confirmed if the extent of the damage had increased since the surveys in 2017. There were several gaps large enough for LHS to access the main chapel directly from the loft space, which would also allow draughts and light into the loft space from the main congregation area.

- 2.4.4 The interior of the main congregation area of the chapel was well illuminated with all the open windows, and was extremely draughty. The coal store underneath the pulpit was open from the stairway entrance, as well as being exposed to the main congregation area above it through large holes in the floor (see Figure 2.4C); therefore, this area was also subject to high air flow and felt cooler than the rest of the building.

**FIGURE 2.4: INTERNAL VIEWS OF A) SOUTHERN GABLE AND B) NORTHERN GABLE SHOWING NON-BOARDED AREAS OF WINDOWS; C) VIEW OF MAIN CONGREGATION AREA WINDOW FROM HOLE IN FLOOR ABOVE THE COAL STORE; D) LARGE HOLES INTO THE LOFT SPACE WHERE THE CEILING HAD COME AWAY.**
