**Bridgeway Centre,  
Wrexham Industrial Estate,  
Wrexham  
Tree Constraints Report**

Report Ref: 197/R/100

February 2022

Abridged Version to  
support Prior Approval for  
Demolition Application  
Jan 2024

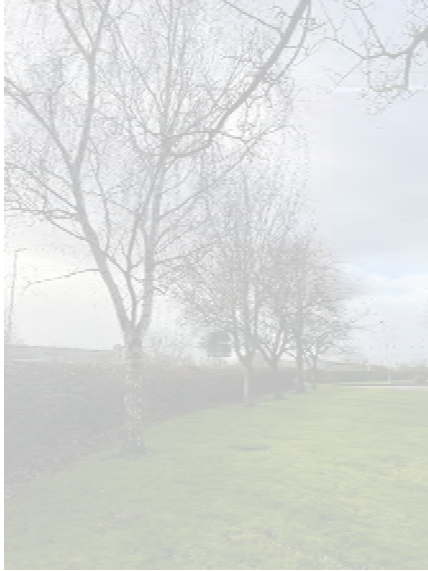
T1-T5 inclusive, H1

| Tree ref | Species | Height | Stem dia. | Crown spread | | | Height of crown clearance | Height and direction of lowest branch | Maturity | Condition | Comments on form condition, health and significant defects | BS5837 Tree Quality Category | Radius of RPA | Management recommendations | Estimated remaining contribution | |
|---|---|---|---|---|---|---|---|---|---|---|---|---|---|---|---|---|
| T1 | Prunus sp. (ornamental cherry) | 5 | 240 | 3.5 | 1.7<br>1.6 | 3 | 2 | E 1.5 | Middle Age | Fair | Bifurcate at 1.5m; asymmetric growth; a tree of low value in the landscape | C1 | 2.88 | | <10 years | |
| T2 | Prunus sp. (ornamental cherry) | 8 | 380 | 5.4 | 3.6<br>3.6 | 6 | 2 | S 2 | Early Mature | Good | Upright spreading crown; raised roots in grass; mower damage; a tree of moderate value in the landscape | B2 | 4.56 | | 20-40 years | |
| T3 | Prunus cerasifera (cherry plum) | 6 | 330 | 4.4 | 5<br>3.2 | 6 | 1.8 | E 1.8 | Early Mature | Good | Upright spreading crown; trifurcate at 2m; epicormic growth typical of species type; raised roots in grass; mower damage; a tree of moderate value in the landscape | B2 | 3.96 | | 20-40 years | |

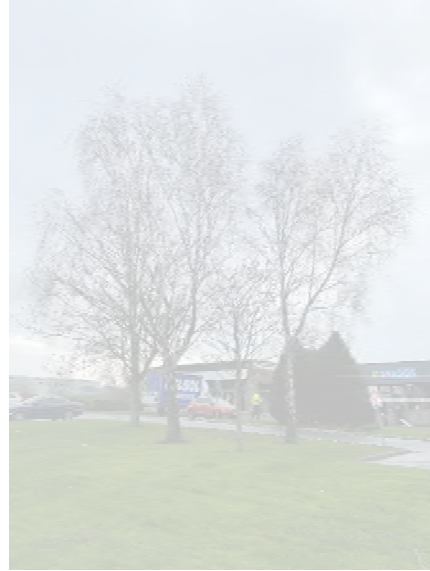
T12-T15 inclusive, G1

| Tree ref | Species | Height | Stem dia. | Crown spread | | | Height of crown clearance | Height and direction of lowest branch | Maturity | Condition | Comments on form condition, health and significant defects | BS5837 Tree Quality Category | Radius of RPA | Management recommendations | Estimated remaining contribution |
|---|---|---|---|---|---|---|---|---|---|---|---|---|---|---|---|
| T13 | Betula pendula (silver birch) | 14 | 410 | 3.7 | 5<br>3.7 | 5.3 | 1.5 | W 3 | Middle Age | Good | Upright growth; damaged leader but recovering; tree of moderate quality in the landscape | B2 | 4.92 | | 20-40 years |

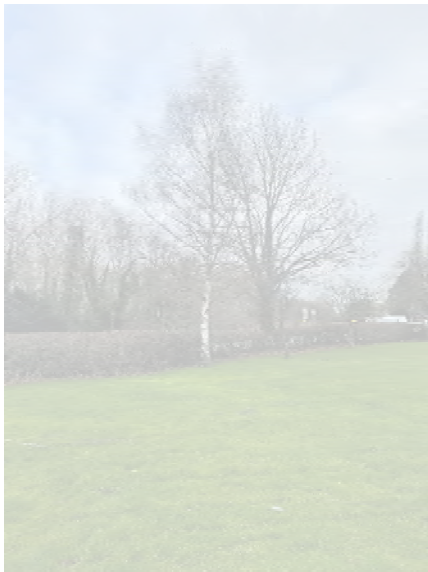
T8-T11 inclusive, H1

| Tree ref | Species | Height | Stem dia. | Crown spread | | | Height of crown clearance | Height and direction of lowest branch | Maturity | Condition | Comments on form condition, health and significant defects | BS5837 Tree Quality Category | Radius of RPA | Management recommendations | Estimated remaining contribution |
|---|---|---|---|---|---|---|---|---|---|---|---|---|---|---|---|
| T10 | Prunus cerasifera (cherry plum) | 4 | 150 | 2.5 | 2.5<br>2.3 | 1.4 | 1.8 | W 1.5 | Semi-mature | Good | Splits to stem; basal decay; tree of low quality in the landscape | C1 | 1.8 | | <10 years |

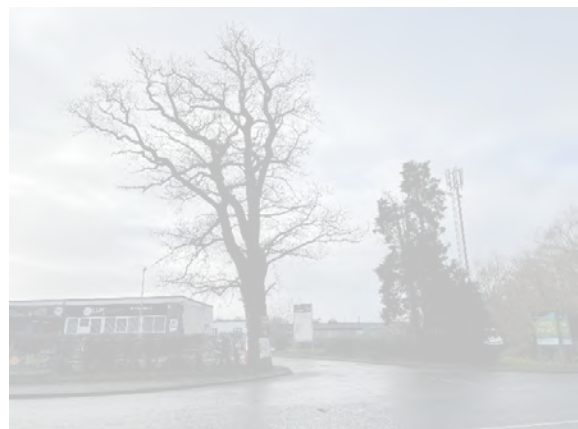
T18, T19

| Tree ref | Species | Height | Stem dia. | Crown spread | | | Height of crown clearance | Height and direction of lowest branch | Maturity | Condition | Comments on form condition, health and significant defects | BS5837 Tree Quality Category | Radius of RPA | Management recommendations | Estimated remaining contribution |
|---|---|---|---|---|---|---|---|---|---|---|---|---|---|---|---|
| T18 | Quercus robur (English oak) | 16 | 870 | 4 | 7.6<br>5.5 | 7.8 | 1.8 | E 3 | Mature | Fair | Upright form and bifurcate at 3.5m; dieback to crown and epicormic growth; broken limbs; located at edge of road; historic wound to base and branch loss; probable root damage and restricted growth due to hard surface; habitat value; tree of moderate value in the landscape | B3 | 10.44 | Monitor condition and reinspect annually | 10-20 years |

Two trees T18 oak and T28 beech, should be reinspected in summer to assess extent of dieback, monitored and reinspected annually for physical changes. T28 should be monitored for bark changes to both stems, pruning to the crown may be recommended after a reinspection to reduce weight above the stem affected by bark loss and to the stem that is exhibiting signs of buckling.

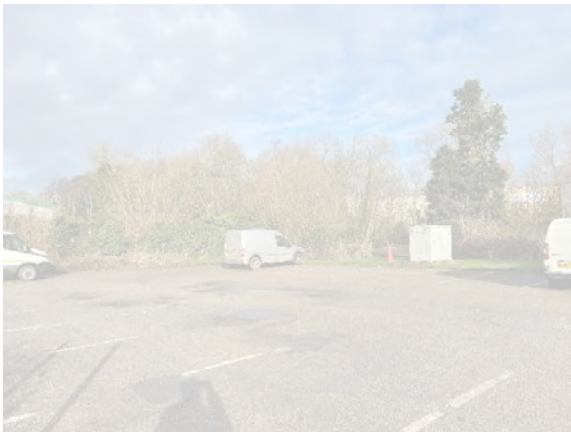
| Tree ref | Species | Height | Stem dia. | Crown spread | | | Height of crown clearance | Height and direction of lowest branch | Maturity | Condition | Comments on form condition, health and significant defects | BS5837 Tree Quality Category | Radius of RPA | Management recommendations | Estimated remaining contribution |
|---|---|---|---|---|---|---|---|---|---|---|---|---|---|---|---|
| W1 | Quercus robur (English oak)<br>Prunus avium (wild cherry)<br>Crataegus monogyna (hawthorn)<br>Salix fragilis (crack willow)<br>Prunus spinosa (blackthorn)<br>Betula pendula (silver birch) | 16 | | | | see plan | | | Middle Age<br>Mature | Good | Woodland belt following drain/watercourse adjacent to fence line; varied age structure but with high percentage of mature specimens; forms buffer and screening between development; only surveyed from south edge where access available; high landscape and habitat value | A2 | see plan | | 20-40 years |

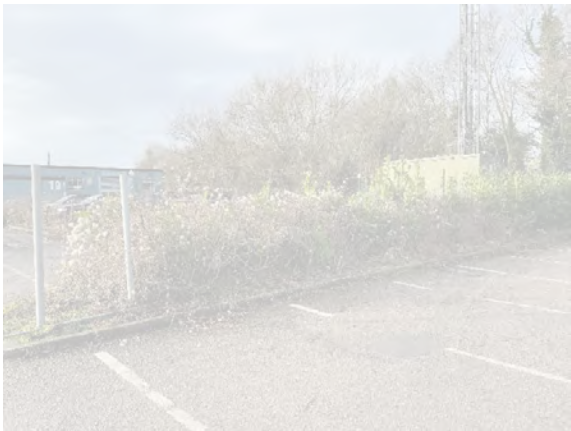
| Tree ref | Species | Height | Stem dia. | Crown spread | | | Height of crown clearance | Height and direction of lowest branch | Maturity | Condition | Comments on form condition, health and significant defects | BS5837 Tree Quality Category | Radius of RPA | Management recommendations | Estimated remaining contribution | |
|---|---|---|---|---|---|---|---|---|---|---|---|---|---|---|---|---|
| H2 | Prunus laurocerasus (Cherry laurel) | 0.75 | | | | | | | young | Fair | Low juvenile hedge plants smothered by bramble and ruderal growth | | | | | |

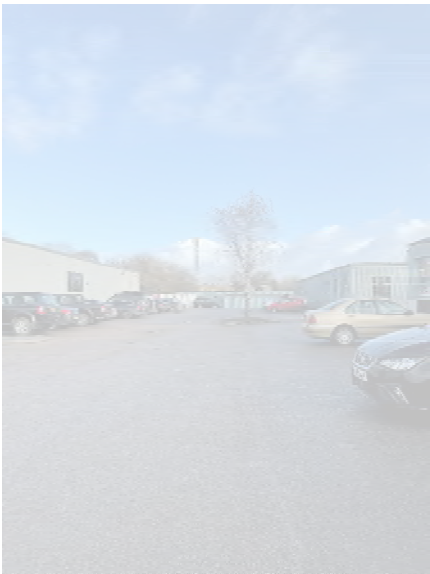
| Tree ref | Species | Height | Stem dia. | Crown spread | | | Height of crown clearance | Height and direction of lowest branch | Maturity | Condition | Comments on form condition, health and significant defects | BS5837 Tree Quality Category | Radius of RPA | Management recommendations | Estimated remaining contribution |
|---|---|---|---|---|---|---|---|---|---|---|---|---|---|---|---|
| G3 | Betula pendula (silver birch) | 8 | 190;<br>190 | see plan | | | 1.2 | W 1.2 | Semi-mature | Fair | Two trees in triangular bed within car park; one of poor quality and broken branches; trees of low quality in the landscape; rooting likely impeded by hard surfacing and constrained within kerb area | C1 | see plan | | 10-20 years |

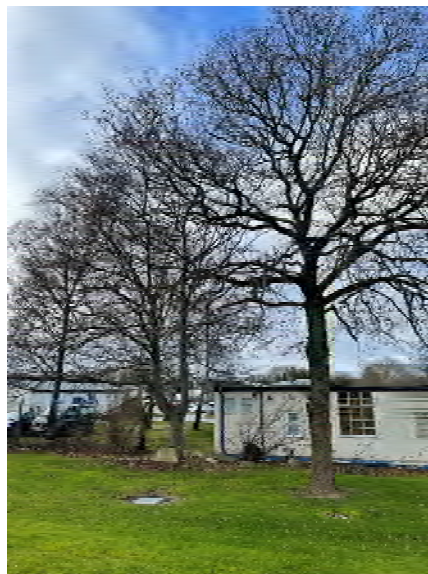
T28, T29

| Tree ref | Species | Height | Stem dia. | Crown spread | | | Height of crown clearance | Height and direction of lowest branch | Maturity | Condition | Comments on form condition, health and significant defects | BS5837 Tree Quality Category | Radius of RPA | Management recommendations | Estimated remaining contribution |
|---|---|---|---|---|---|---|---|---|---|---|---|---|---|---|---|
| T28 | Fagus sylvatica (beech) | 14 | 560 | 7.3 | 8.5 | 5.1 | 1.2 | W 2 | Mature | Fair | Growing on boundary with wall at base; buried root flare, ground level changed; bifurcate at 1.8m; co-dominant stems with U-shaped tension fork and potential buckling to one stem and has major bark loss to circumference on the other; no cracks evident; descending branches; some root girdling; tree of moderate value in the landscape | C2 | 6.72 | Monitor condition and reinspect annually; re-inspect in spring/summer 2022 to assess whether dieback is present above bark damage and inspect annually for changes in bark appearance, buckling to other stem; provisionally categorised as C2 | 10-20 years |

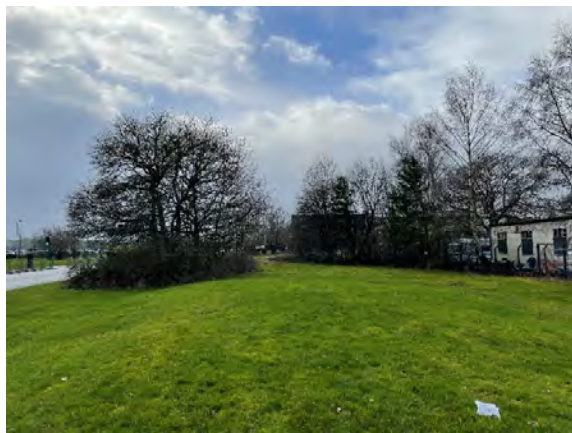
T31, T32, G11, G12

The trees are in fair to good condition overall, however no regular arboricultural or woodland management is evident. Planting in G11 has planting accessories still present which should be removed.

Redundant stakes, guards and ties should be removed to ensure continued tree establishment is not impeded in group G11 to the south-east of the site.

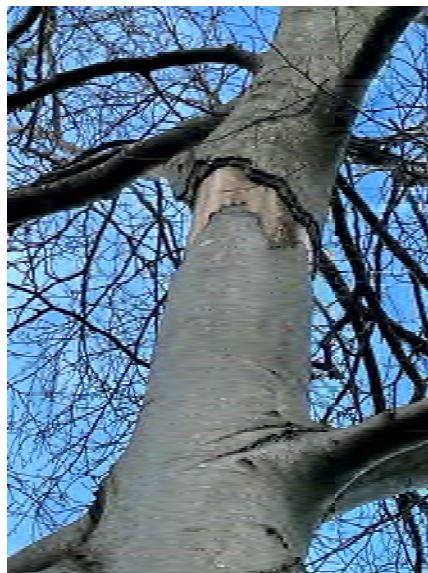
T28 bark loss

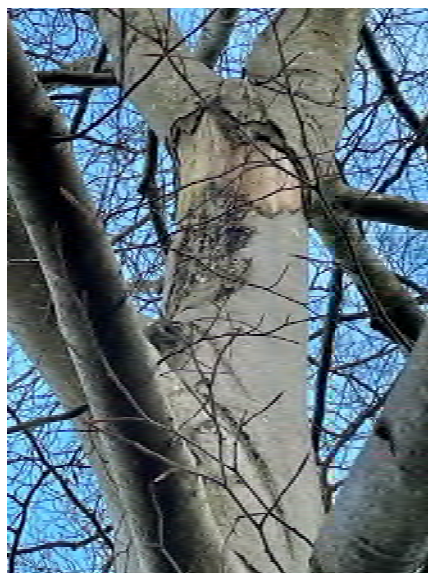
T28 bark loss

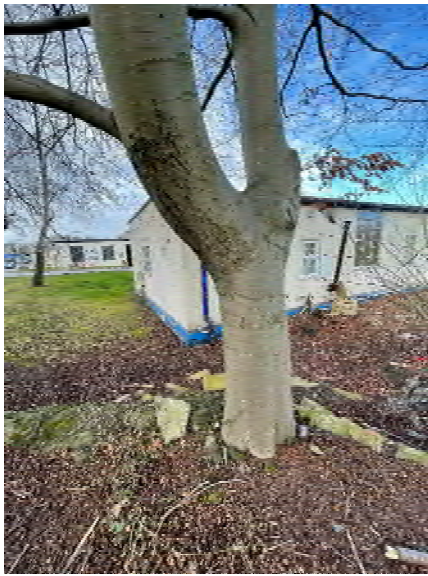
T28 tension fork, buckling
