## **PROTECTED SPECIES SURVEY**

**LEGACY COTTAGE**

**LEGACY, WREXHAM**

**27<sup>th</sup> January 2024**

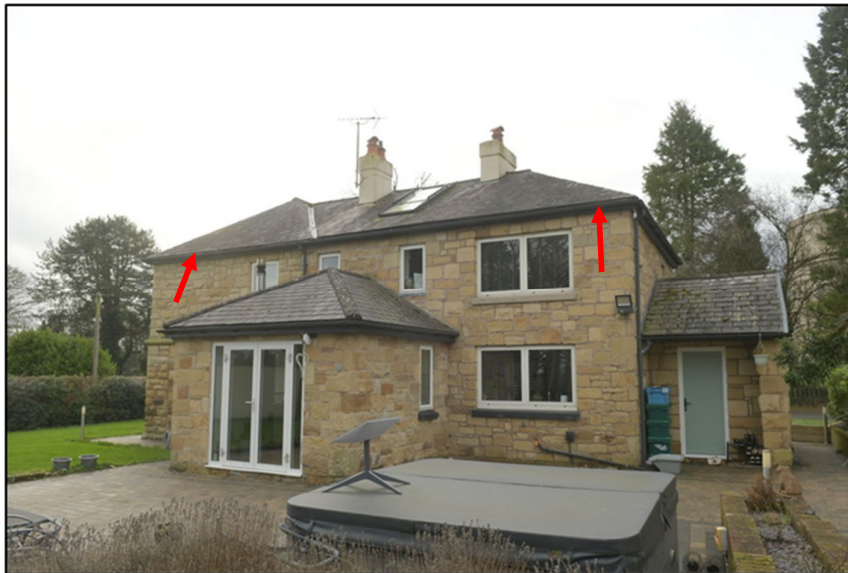
At the time of the survey the only evidence of nesting birds was under two small gaps on the rear, north-east facing elevation (see photo below). Bird droppings were evident on the wall and just inside the gap between soffit and wall, feathers were also visible. In this location and with the space being tight it is most likely that these two sections have been used by swifts.

The section on the right (far side of the window) will not be affected by the proposed extension so nesting provision should still remain available. The left-hand section will be lost due to the proposed extension. Therefore, to mitigate for the loss of the nest site three Vivara Pro swift nest boxes (downward facing) will be secured to the wall at eaves level on the north-west (side) elevation as shown below in red. These nest boxes will be secured to the wall prior to carrying out the main construction works.

**Works to the rear of the house will need to take place between October and February inclusive to avoid any potential disturbance (disturbance to roof areas, soffits, eaves etc) to nesting birds.**

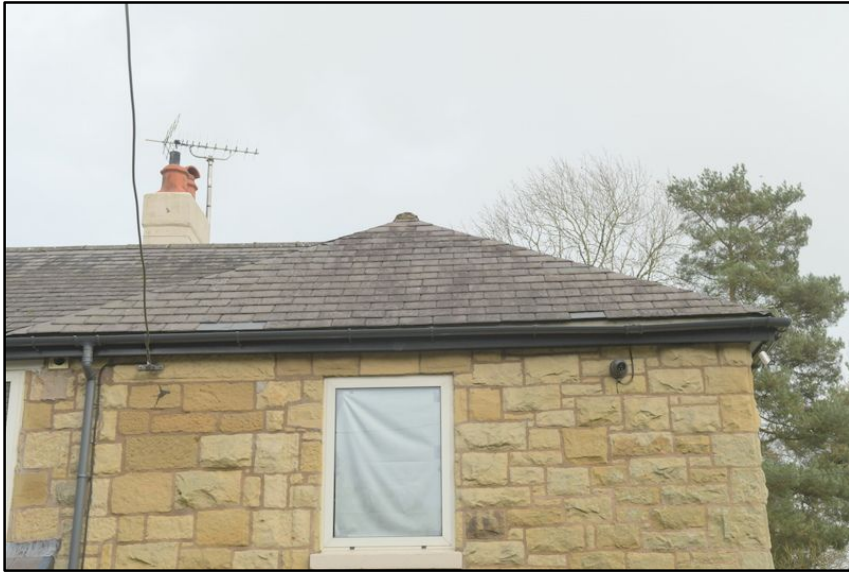
Externally, the roof slates all appear to be intact and secure with no slipped sections, gaps or holes. There is some evidence of past slate replacement in some areas but everything is intact at the present time. The ridge tiles are also secure and intact, the mortar on the lower section of the hipped roof is also intact with no gaps.

**Slates are all intact and secure**

- **All slates should be carefully removed by hand to ensure that no roosting, torpid or hibernating bats are injured during the proposed works.**

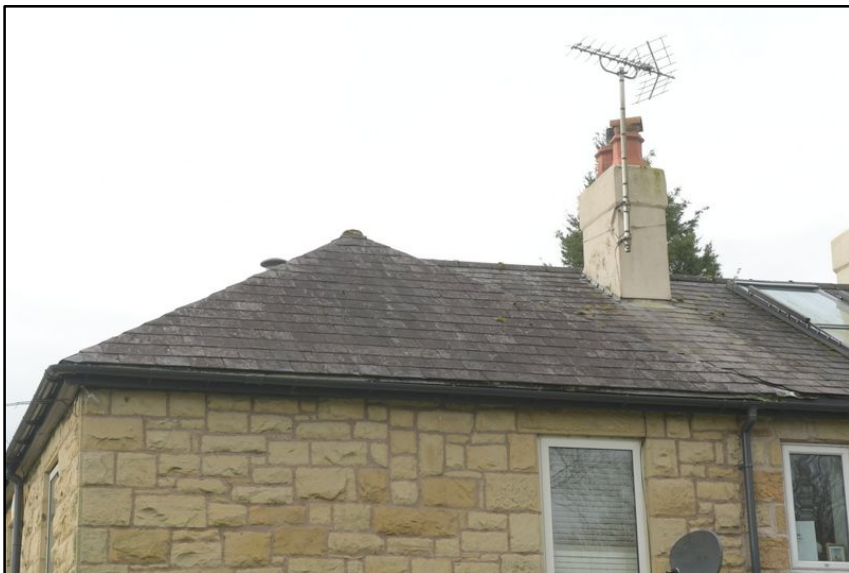
**As above**

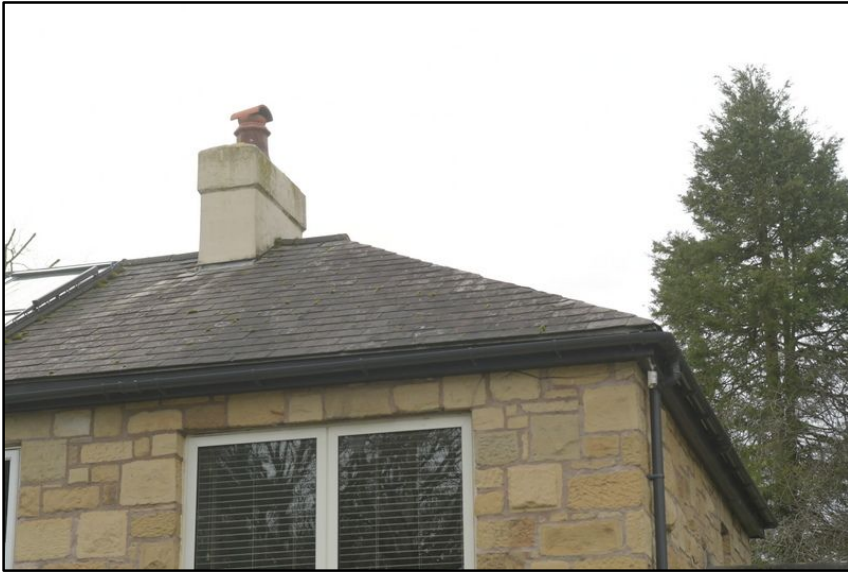
**Ridge tiles are all intact and secure**

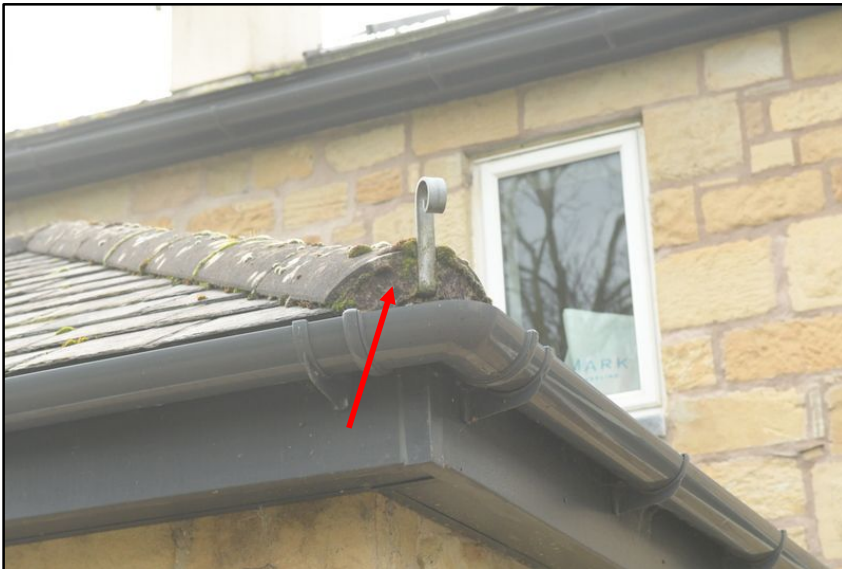
**Ridge mortar is intact**

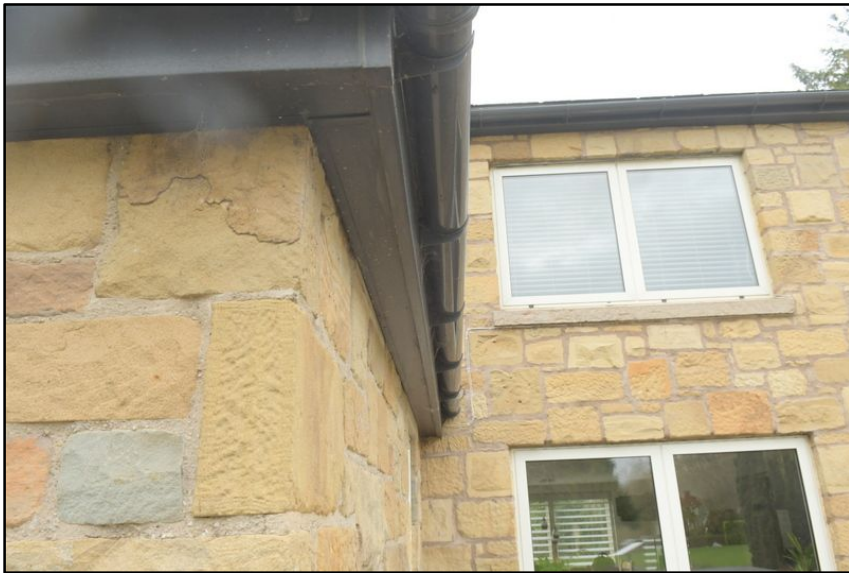
The UPVC soffits on the rear extension (which will need to be removed) are all well sealed with no gaps or cavities. On the main roof the UPVC soffits are also all well sealed and intact. There are two small gaps on the rear elevation (north-east facing) which have each been used by nesting birds, details below.

**Soffits are well sealed on the rear extension**

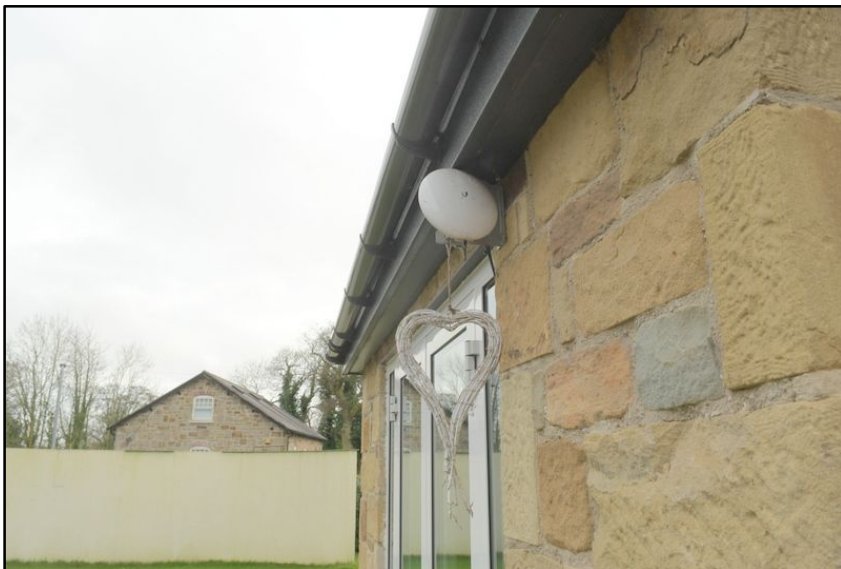
**Intact and sealed soffits**

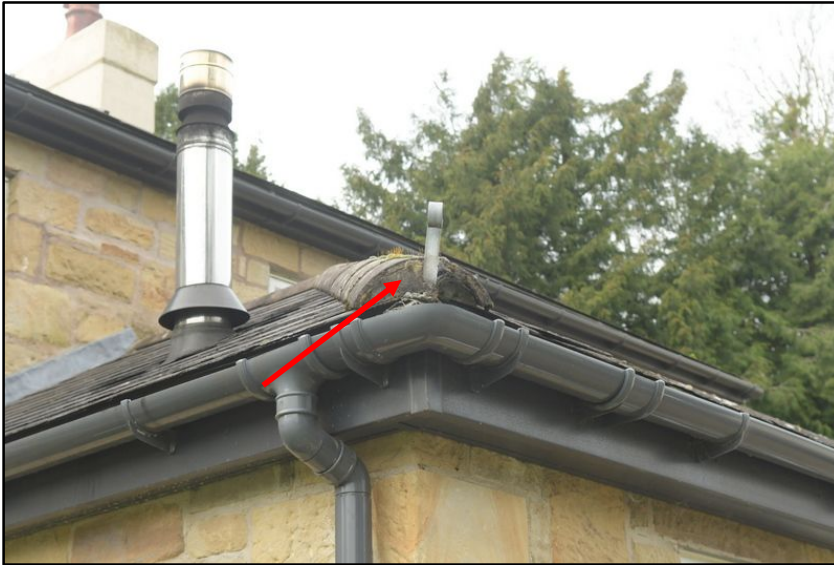
**Intact mortar**

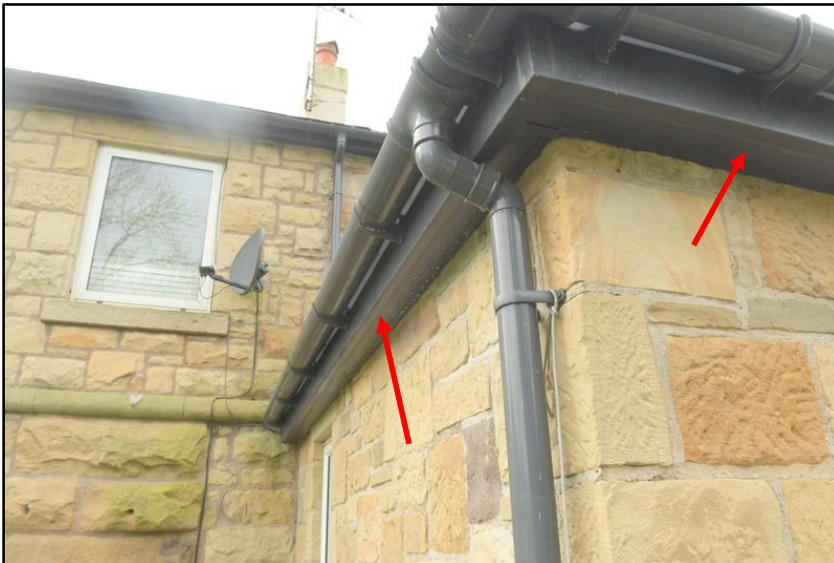
**Intact and sealed soffits**

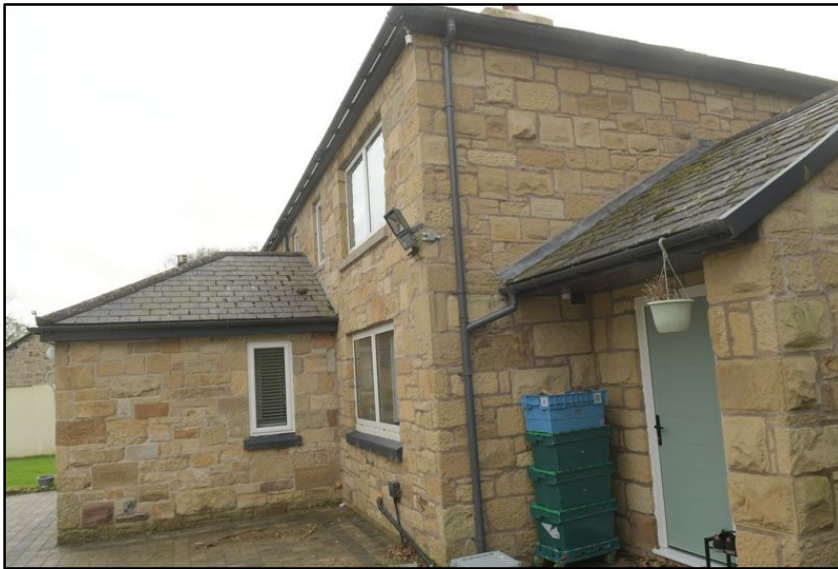
**Intact roof on the rear extension**

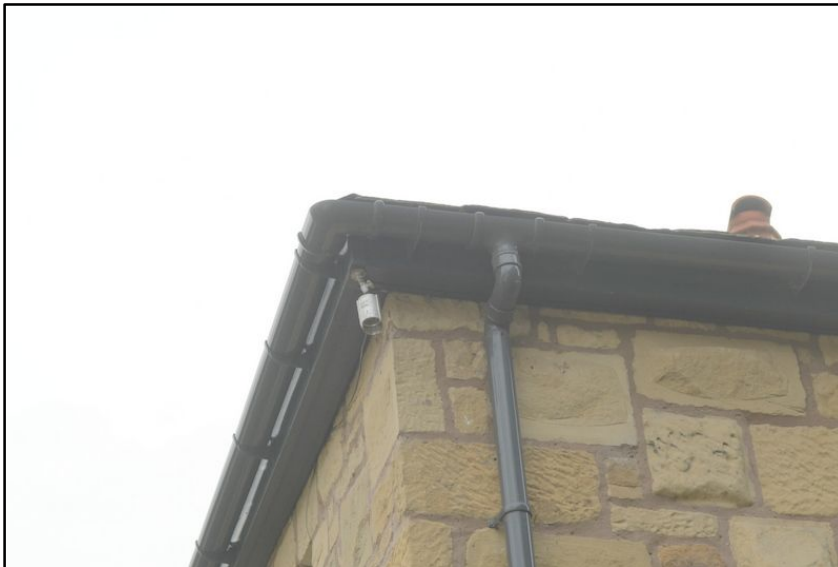
**Soffits at the side and front are sealed**

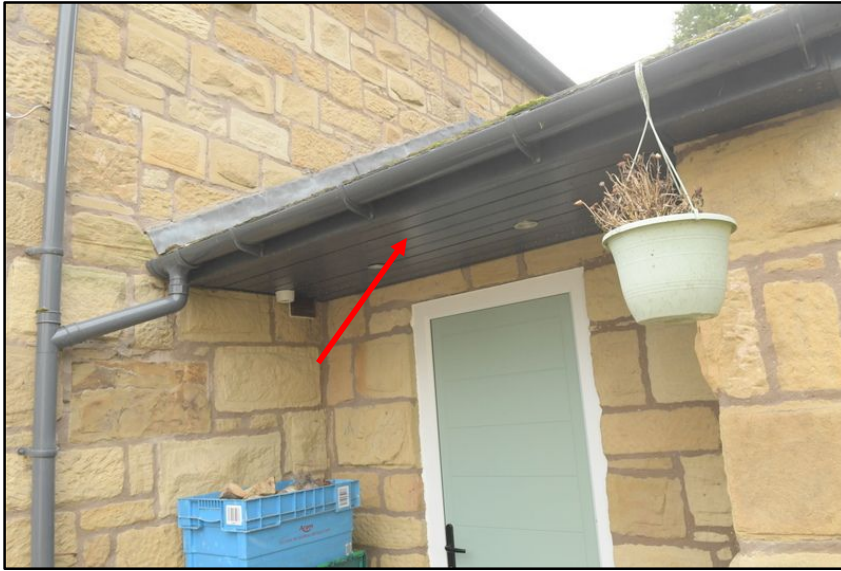
**Porch overhang is well sealed**

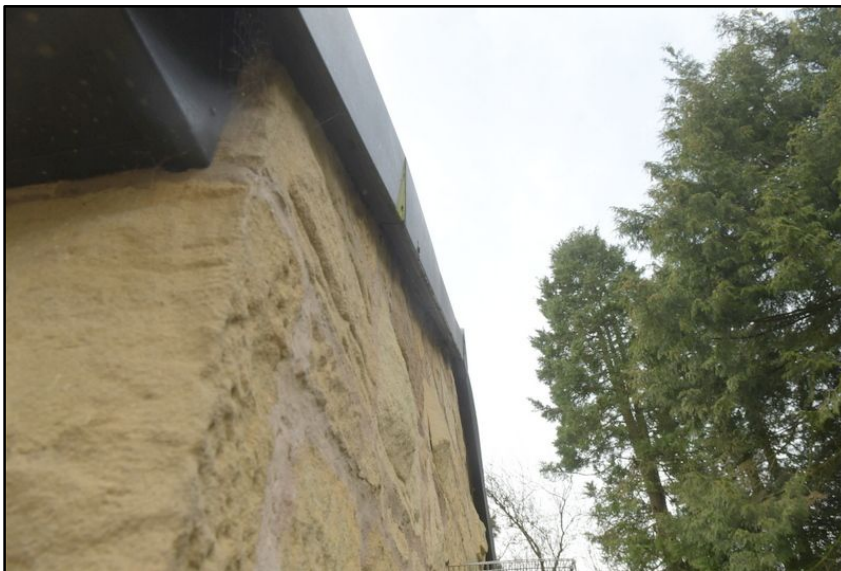
**Gable fascia is sealed with no gaps**
