Stori Brymbo Project  
Mining Report  
HF Machine Shop  
Brymbo Heritage Trust

## **1.0 INTRODUCTION**

Job Number: 2326  
Mining Report  
Issue January 2020

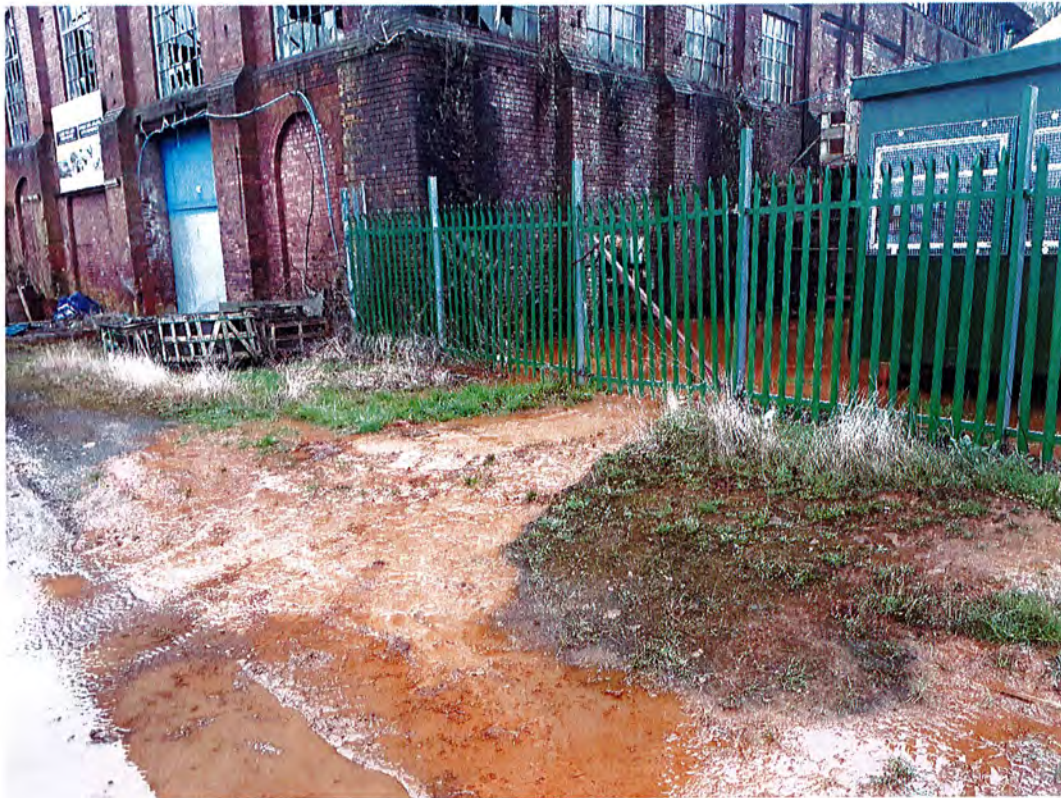
This revealed the presence of an open adit in the south west corner of the works, which is outside of the Heritage site, from which red mine drainage water was issuing. Mr. Brown indicated that this adit had been driven circa 1843 to work a coal seam, which was rapidly exhausted. The walkover also inspected the old Brymbo colliery shafts to the west of the main development, which are both fenced off. According to Mr. Brown these have been partially backfilled by the Coal Authority to depths of around 50 to 60m, with the water standing at around 30m depth. One of the pits was reported to be covered with a metal grill.

Photograph 1 Mine water discharge from adit

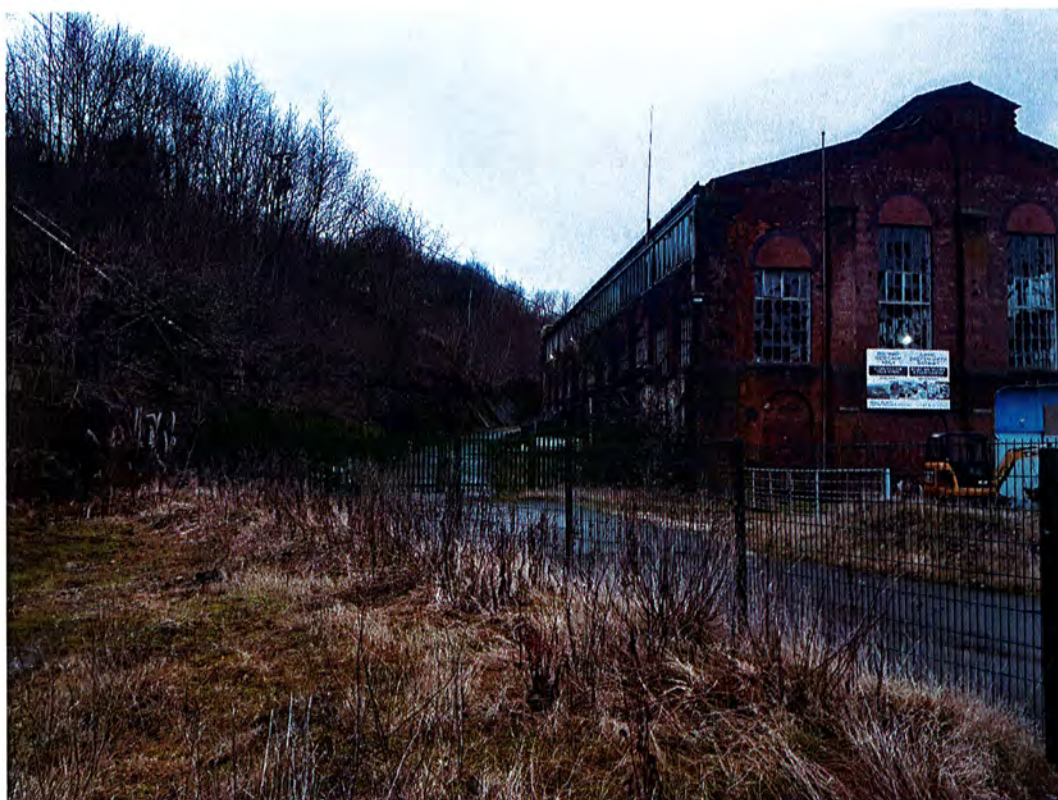
Photograph 3 Southern side of site showing ground level rising rapidly to the south

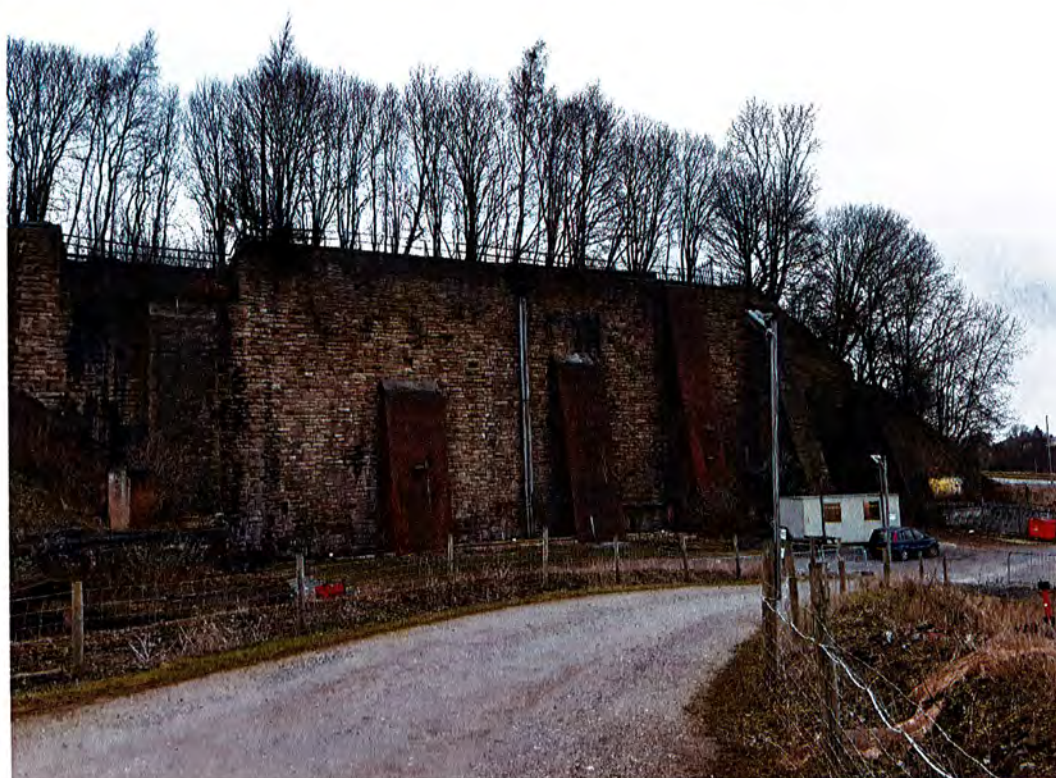
Photograph 6 Retaining structure on northern site boundary

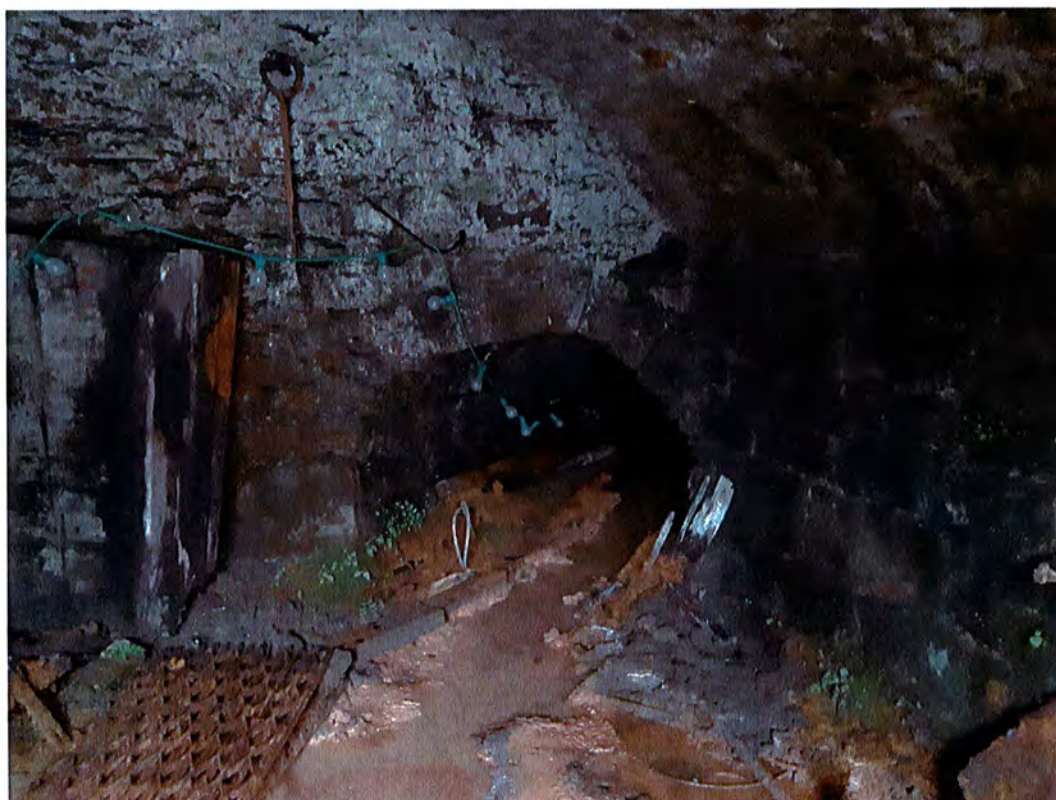
Photograph 10 Adit entrance

329353-131. This entry was investigated in 2002 by JMC Mining Services and was found to be within a building. A metal grill was placed across the entrance to the building to prevent access. The adit was found to be open.

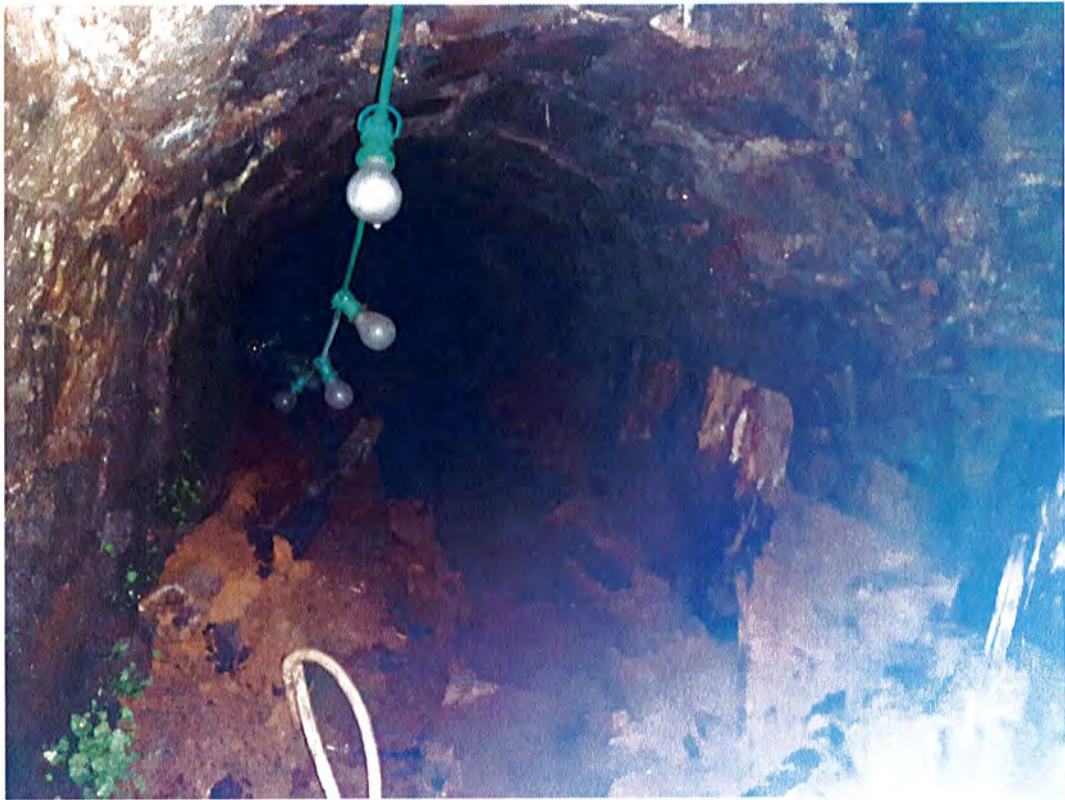
It is likely that the only voids which could influence the site would be the main roadways accessing the Upper Stinking seam. However, the adit is open to tours by the Heritage Trust and the condition of the adit beneath the site can be inspected regularly.

Photograph 11 View up adit

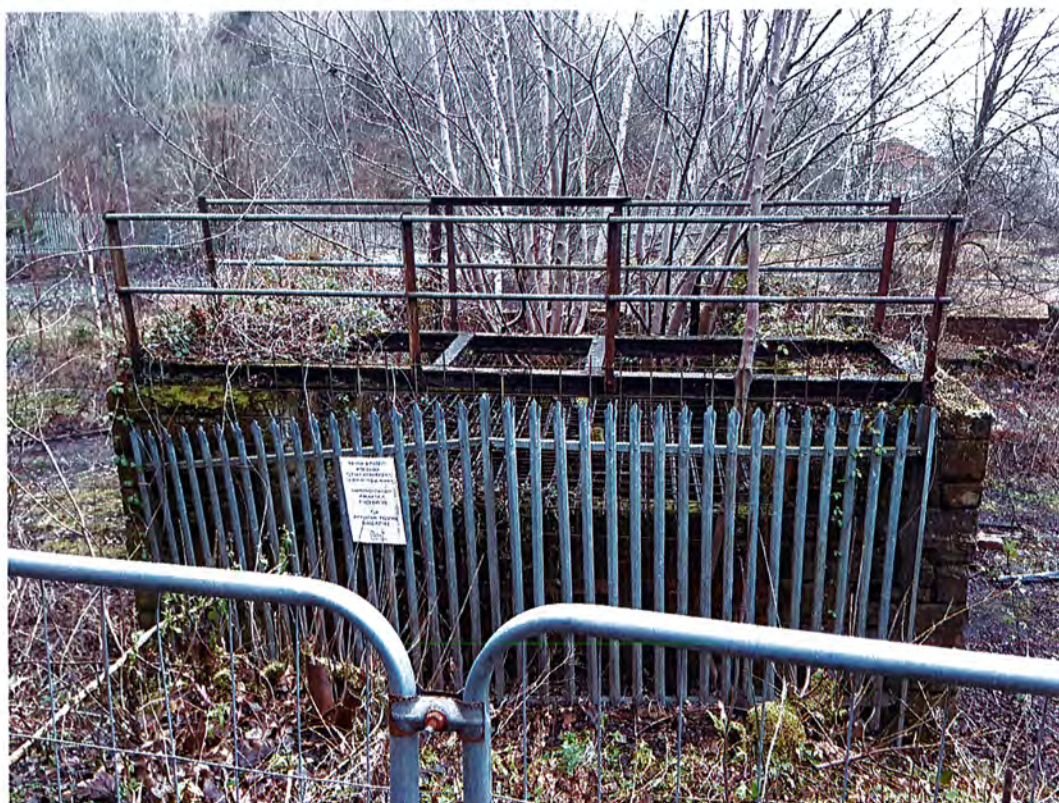
Photograph 16 Shaft 128

329353-128. This shaft was found to be open to a depth of 61m from the top of the heapstead in 2002. The shaft was secured by constructing a palisade fencing on top of the brick heapstead.

However, the location of mine entrances needs more careful consideration. Shafts if they have not been treated run the risk of sudden collapse, this is due to the fact that they were rarely backfilled full depth, especially if there was insufficient nearby fill. Instead a staging would be constructed at one of the levels, which may deteriorate with time and collapse leading to a surface failure. However, there are no known shafts to the west of the fault that could influence the development area, shafts 127 and 128 being sunk straight into sandstone rock head.

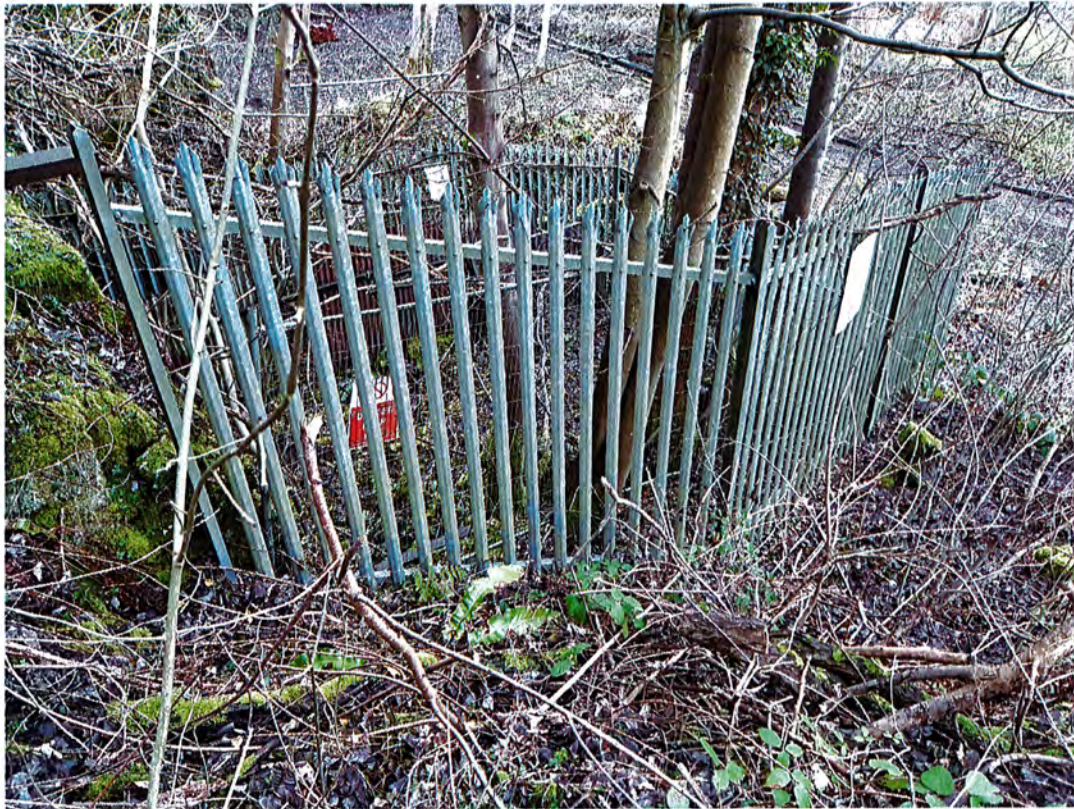
Photograph 17 Shaft 127

329353-127. In 1968 the shaft top was covered with RSJs and sheeting. The entry was found to be open to a depth of 31.5m in 2002. The area around this shaft was secured with palisade fencing.

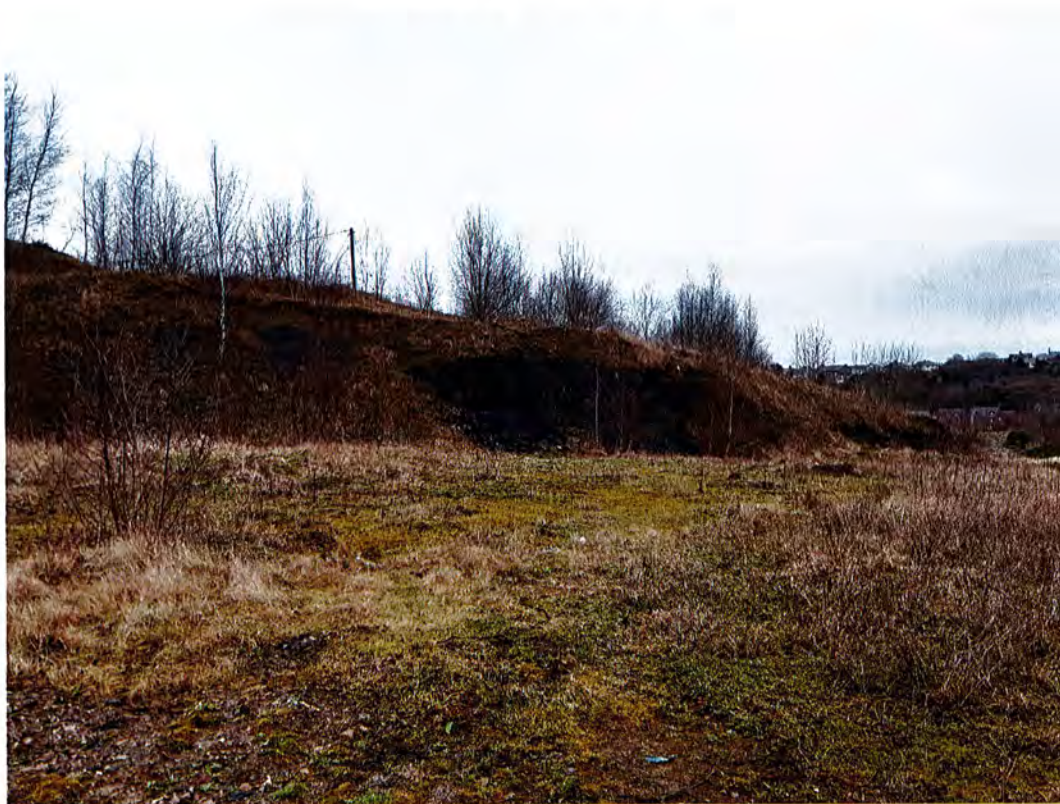
In addition, previous open casting immediately south of the site exposed a coal seam, thought to be the Two-Yard seam, which was dipping gently in an easterly direction. However, immediately west of this outcrop, further coal was exposed dipping steeply to the west, probably indicating it was in the vicinity of the main Brymbo Fault, see Figure 3.

Photograph 18 Outcrop of Two-yard (Hollin) seam dipping eastwards

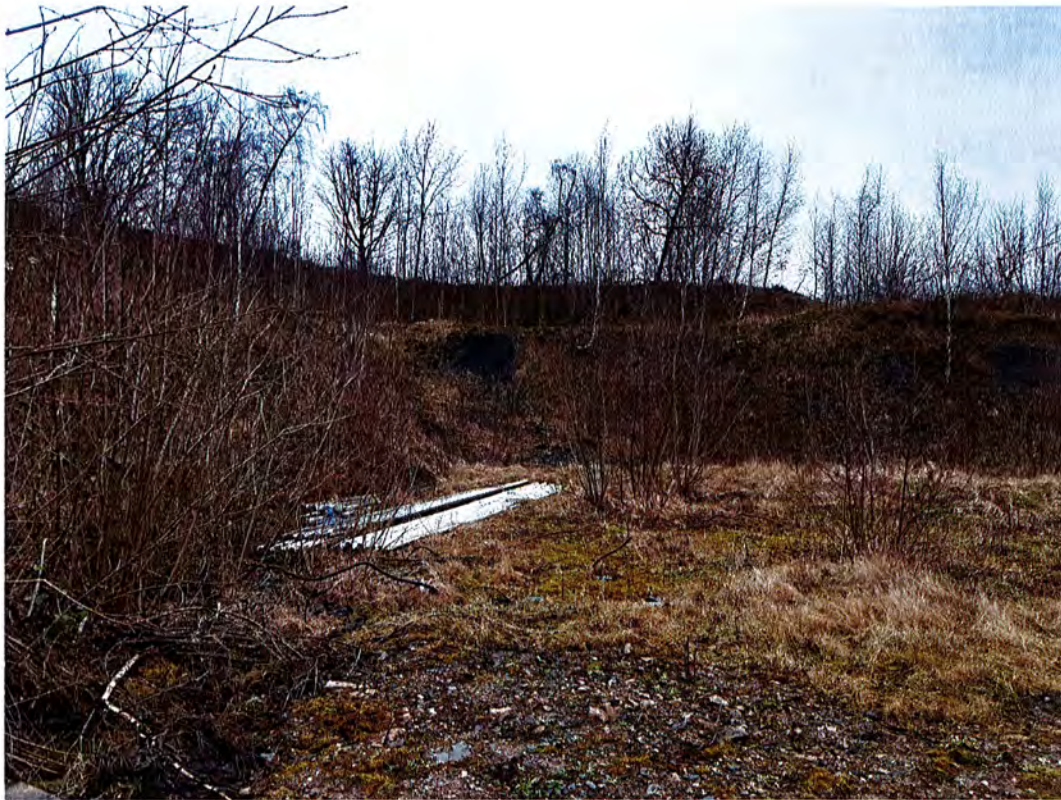
Photograph 19 Two-yard (Hollin) seam tilted in close proximity to fault

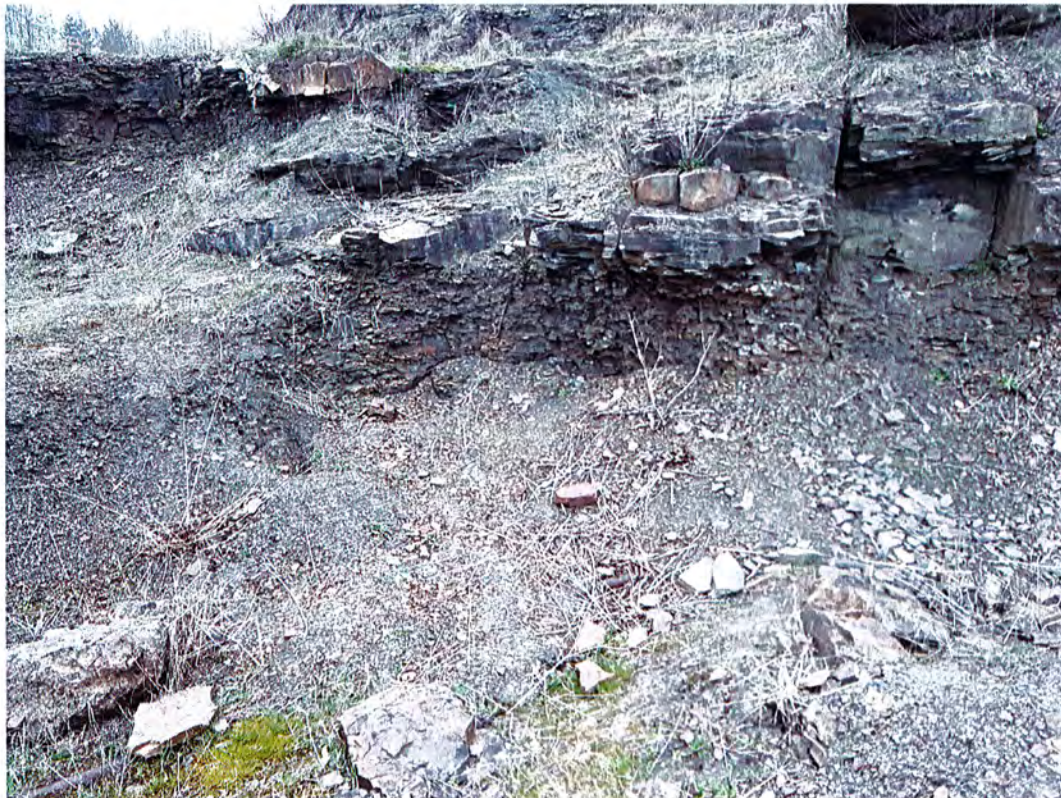
Immediately south east of these exposures is the Fossil Forest. and Mr. Brown indicated that possible Bell Pits had been encountered in excavations for the Fossil Forest.

Photograph 20 Area of bell pitting close to Fossil Forest

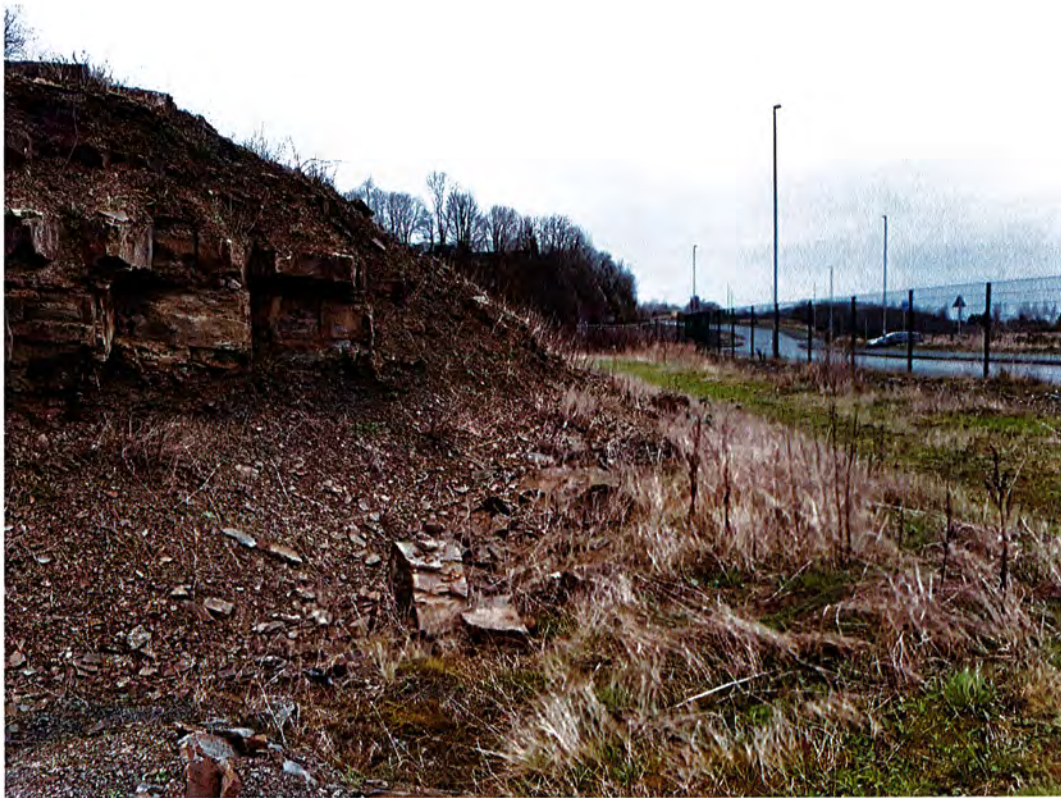
Photograph 21 Showing elevation of Bell Pits to Crank seam
