## Coal Mining Risk Assessment

Land Opposite Royal Oak  
Cottages

Brynydd

**Report No. A5744/23/CMRA**

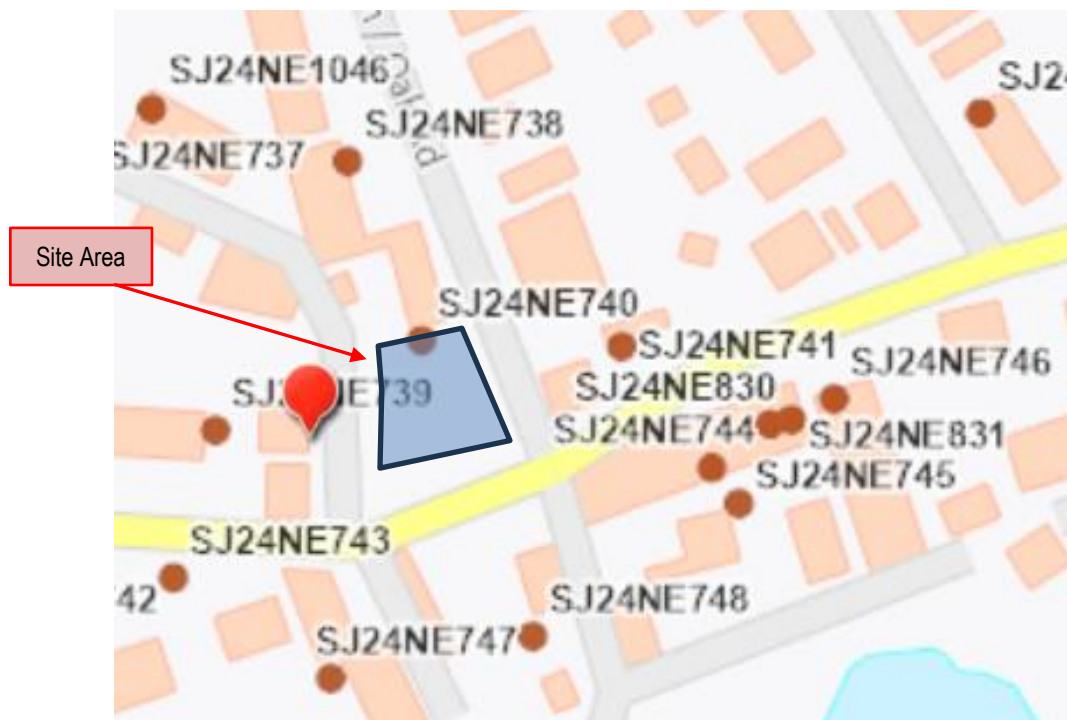
**Figure 3: British Geological Survey Boreholes**

- 3.5 Borehole record SJ24N740 on or close to the northern boundary is an unnamed shaft.
- 3.6 Borehole record SJ24N739 to the west of the site is a unnamed shaft.
- 3.7 Borehole record SJ24N741 to the east of the site is a unnamed shaft.
- 3.8 A previous site investigation is available 10m west of the site (NKC Geotech Ltd 'Mining Investigation Report', dated June 2017). Figure 4 (below) shows the location of all rotary open hole boreholes.

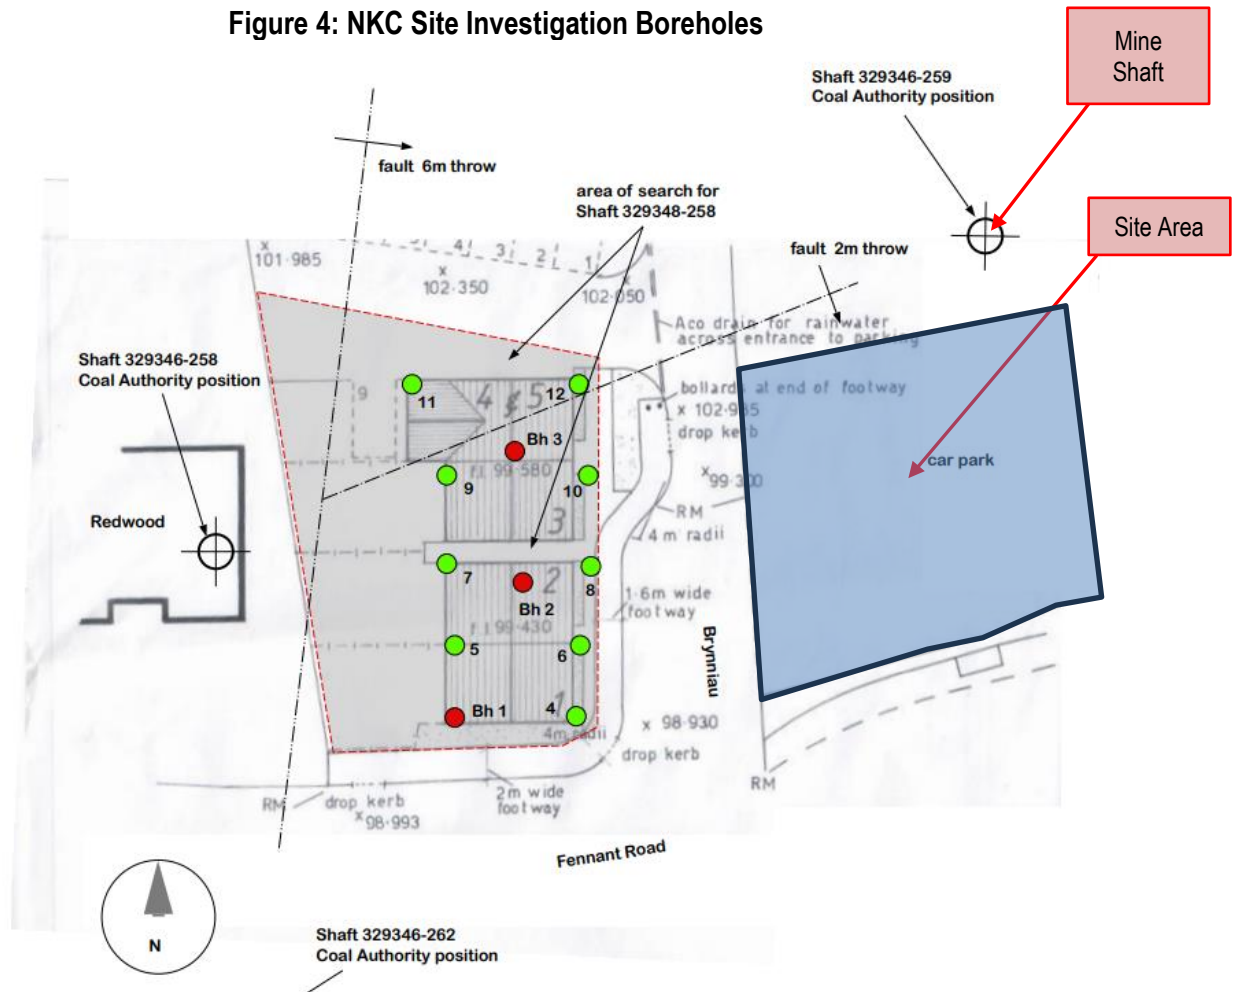
**Figure 4: NKC Site Investigation Boreholes**

- 3.9 The investigation included the drilling of rotary open-hole boreholes to investigate the shallow coal mining regime, as well as excavation and probe drilling for a mine shaft recorded to be on site.

- 3.10 The borehole records show superficial deposits to 1.5m underlain by sandstone, shale, and coal seams. The report suggests that the regional dip of strata is seven degrees to the east.

- 3.11 The Main Coal seam was found at a depth of 18m bgl. The Brassey Coal seam was found at a depth of 25.8m bgl.
- 3.12 The investigation found no evidence of past shallow mining activity within the Main Coal seam.

- 3.13 The underlying Brassey coal seam has been partially worked but lies “too deep to affect surface stability”.
- 3.14 The report concluded that proposed dwellings could use reinforced strip foundations designed to span 2.0m, with no other necessary remedial work.

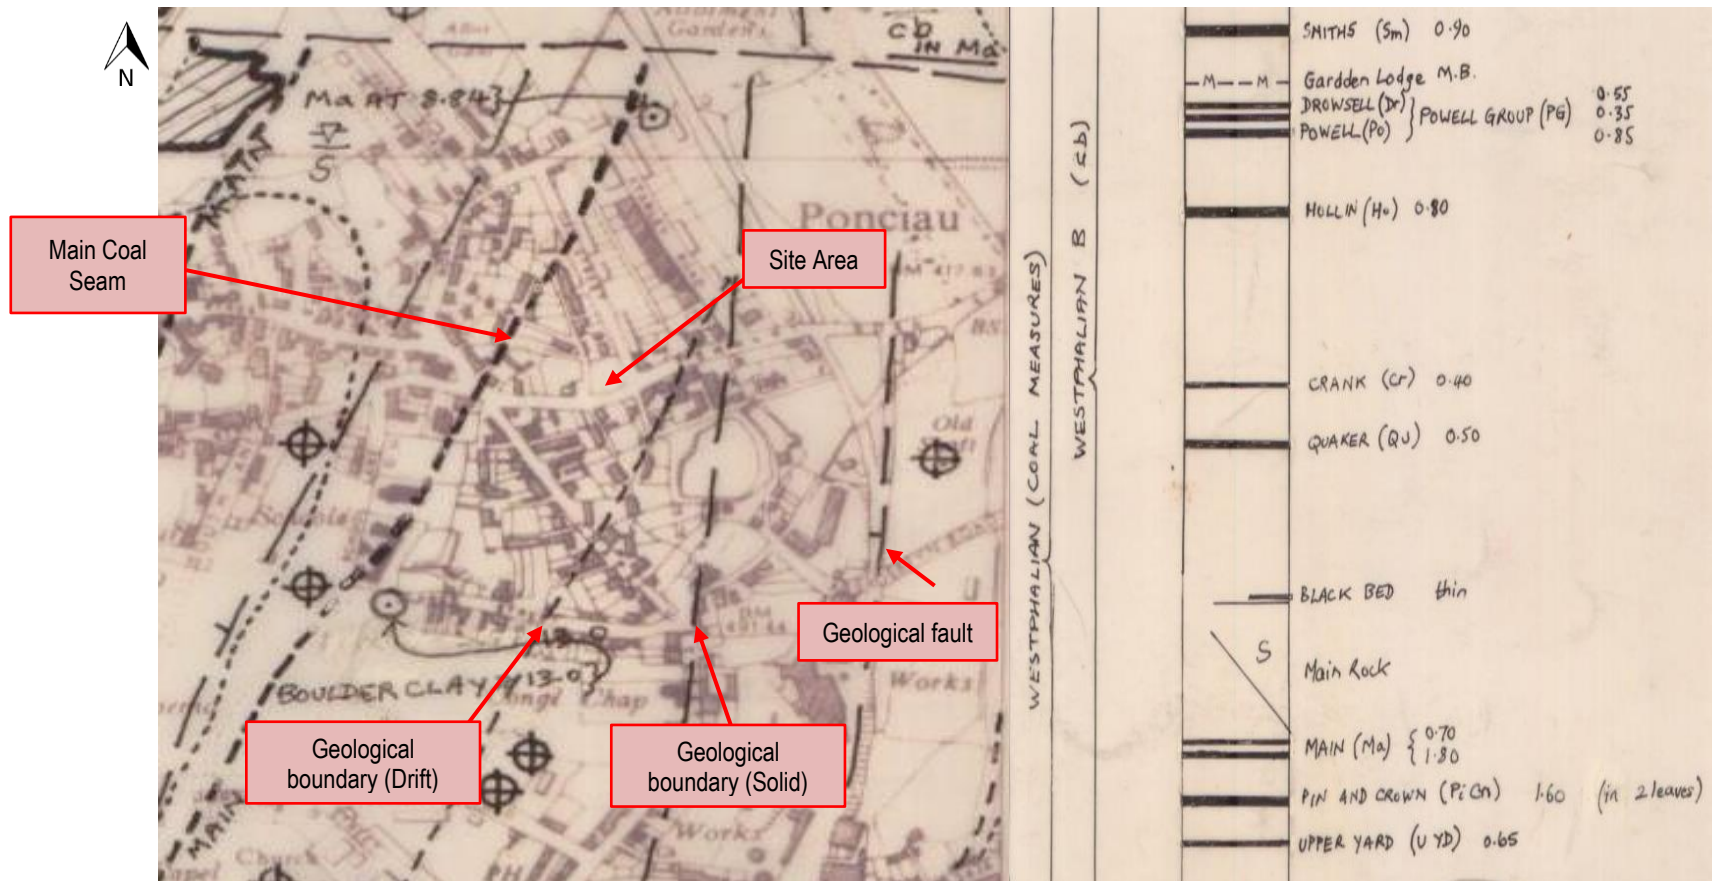
Figure 5: BGS Geology Map Extract

- 3.16 The geological map shows the inferred outcrop of the Main coal seam approximately 140m west of the site, overlain by sandstone (Main Rock).
- 3.17 The Main coal is split into two coals seams, 0.7m and 1.80m thick.
- 3.18 The inferred direction of dip of strata is to the east based on the geological map.

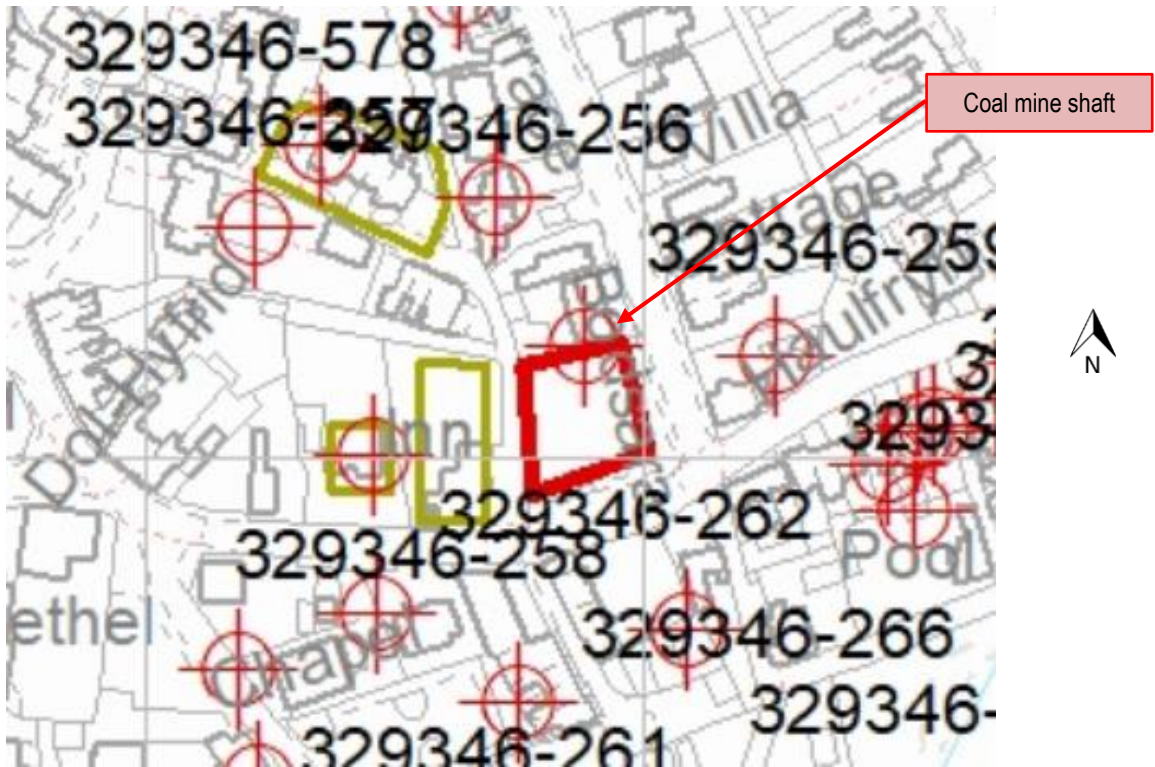
Figure 6: Coal Authority Map Extract

- 3.20 A Coal Authority Mining Report (extract shown as Figure 6) has been acquired for the site. This indicates that past underground mining has occurred beneath the site. This is related to the Main Coal seam that was last mined in 1860 at a depth of 13m bgl.

- 3.21 The seam is recorded to have an extraction thickness of 2.4m with a dip of 7.5 degrees to the east.
- 3.22 The report states that there are probable unrecorded shallow workings beneath the site, however the Coal Authority Interactive Viewer indicates that the site lies within an area of moderate probable coal workings.

- 3.23 Despite the information on geological maps the Coal Authority reports suggests that there are no local outcrops.
- 3.24 There are several mine entries recorded within 100m of the site with shaft 329346-259 located close to the northern boundary of the site. There is no record in relation to treatment of the mineshaft. The Coal Authority Interactive Viewer suggests a positional accuracy (departure) of 10m.

- 4.11 Information suggests there could be a risk of historical shallow workings being present beneath the development area.
- 4.12 As a result, a site investigation is recommended in order to further assess the shallow coal mining regime.
- 4.13 Furthermore, the mine shaft that is currently located near to the northern site boundary has no records of treatment works within the Coal Authority report. A a site investigation would be necessary to prove/disprove the location the shaft position, as it may not be on the site, or its zone of influence may extend onto the site.
- 4.14 The site investigation will require a permit from the Coal Authority, together with the development of a risk and method statement.
- 4.15 This report should allow for planning permission to be granted with relevant conditions in relation to the site investigation and any possible remedial measures.
