# Preliminary Roost Assessment

Holm Lea

Church Street

Holt

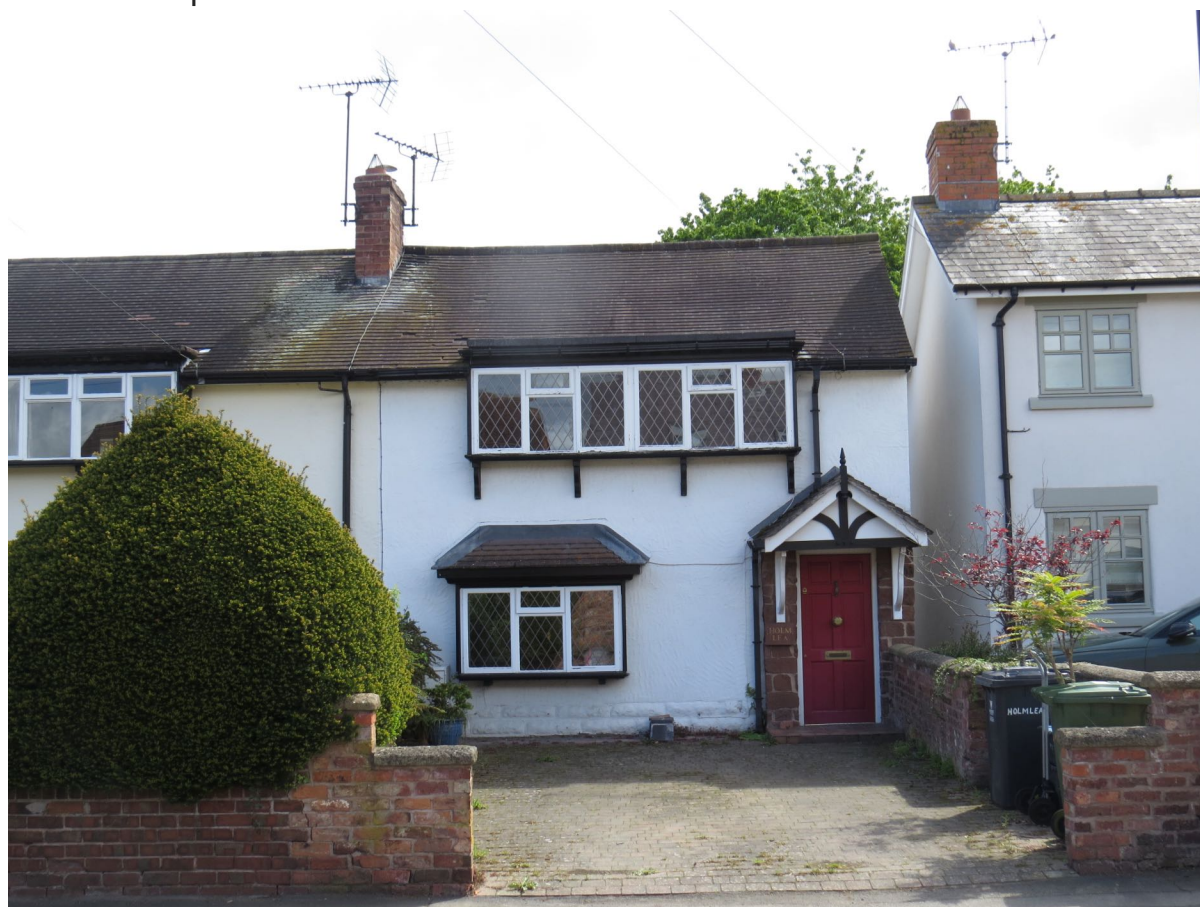
3.1a – The front of the house.

Holm Lea, Church Street, Holt, is a pre-1950's end-terraced house, which was occupied until recently. It has a pitched roof, covered with plain clay roof tiles, and ceramic ridge tiles. A dormer at the front of the house has a flat felt-covered roof. There is a UPVC and glass conservatory to the rear.

The building is well maintained, and in good condition. Ridge tiles are fixed tightly, there are no damaged or missing ridge tiles. There are two slipped roof tiles at the front of the house; however, the back of the tiles are intact, and there are no gaps which could be used by roosting bats.

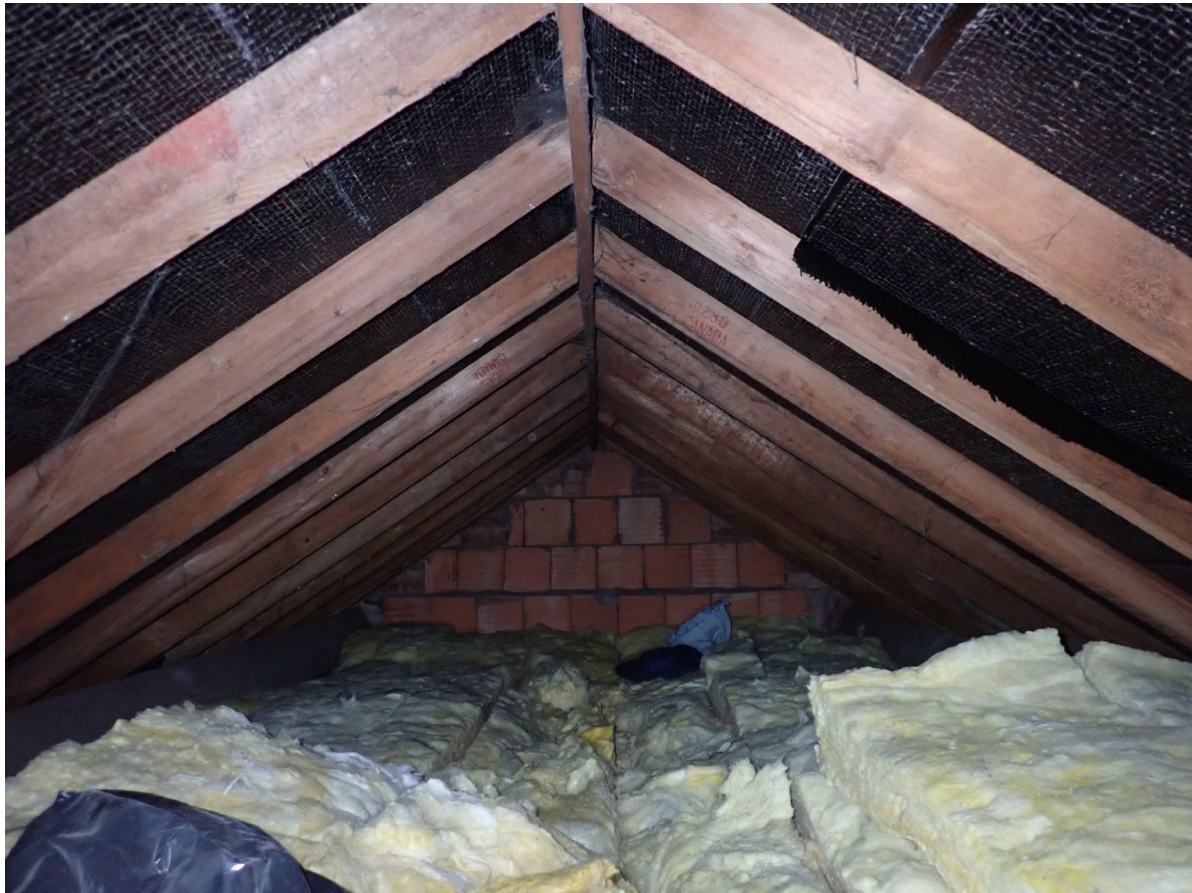
3.2a – The roof void.

The house has a single roof void, which was used for storage, and accessed infrequently for essential maintenance.

The roof has a timber rafter and purlin structure, lined with bitumen felt, and insulated with mineral wool between the ceiling joists. The roof lining is in good condition with no tears, or gaps.

The wall plate and eaves inspected using an endoscope. There are no gaps at the wall-plate; and there are no gaps which give direct access to the roof void from the outside. Boxed soffits open into the roof void and were inspected from above.

The small gaps between roofing materials, timbers, and brickwork at the gable end were inspected using an endoscope. These areas are dusty and cobwebbed, and no gaps, or indications of use by bats were present.

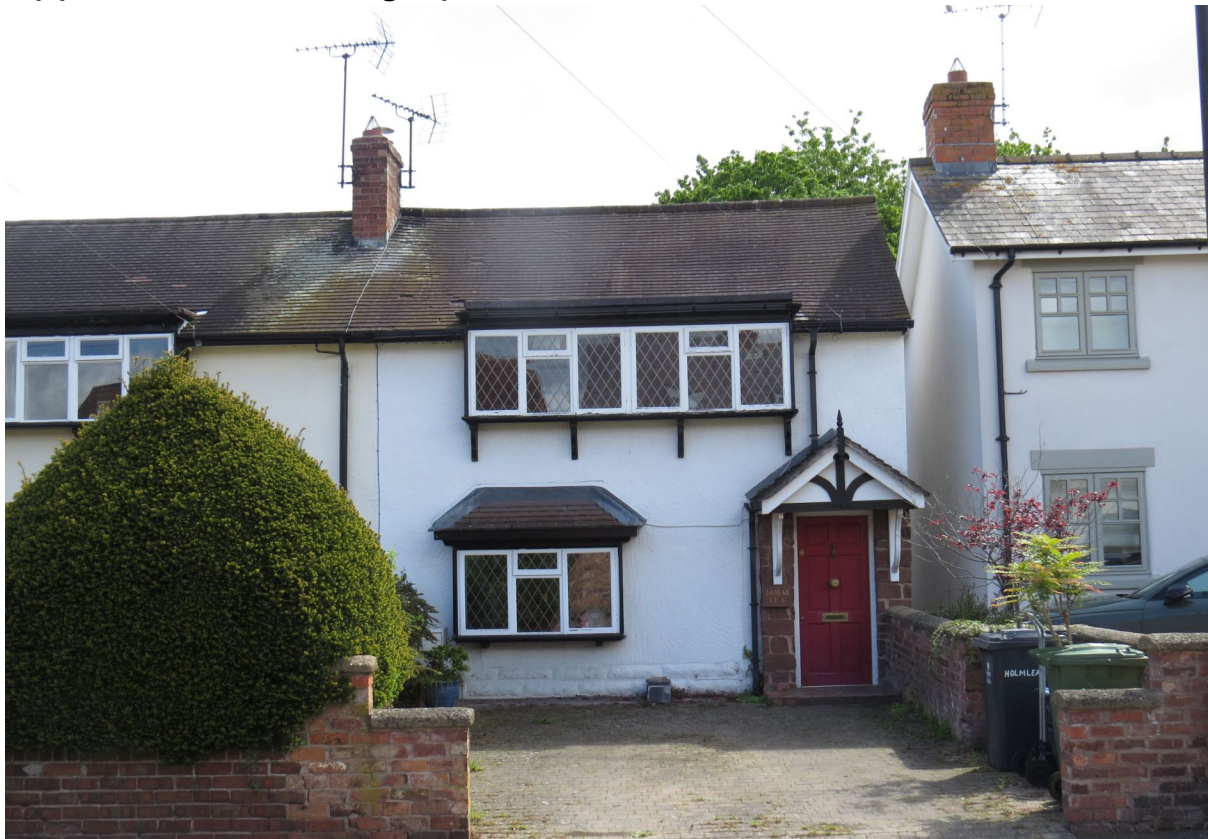
1 – The front of the house.

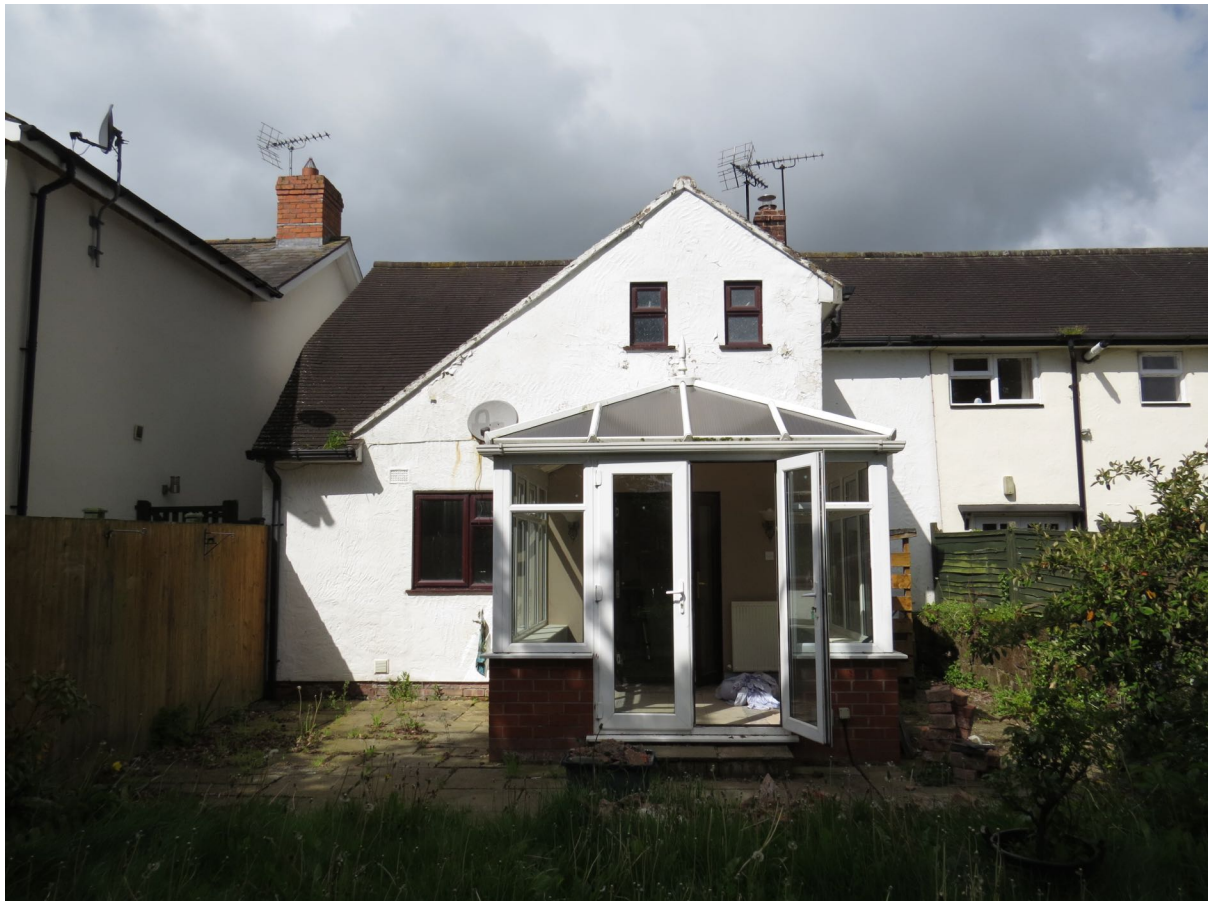
2 – The rear of the house.

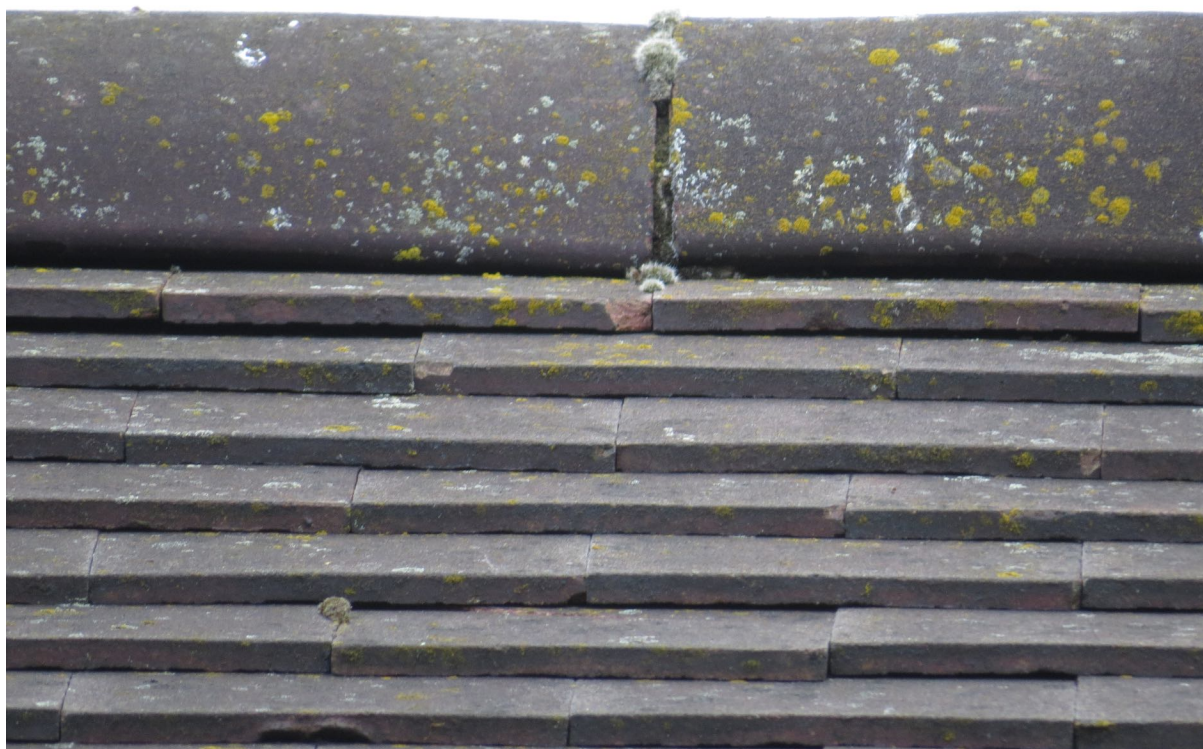
Roof and ridge tiles are in good condition; ridge tiles are sealed with cement. There are no gaps between roofing materials which could be used by roosting bats.

3– Roof and ridge tiles are in good condition with no suitable gaps.

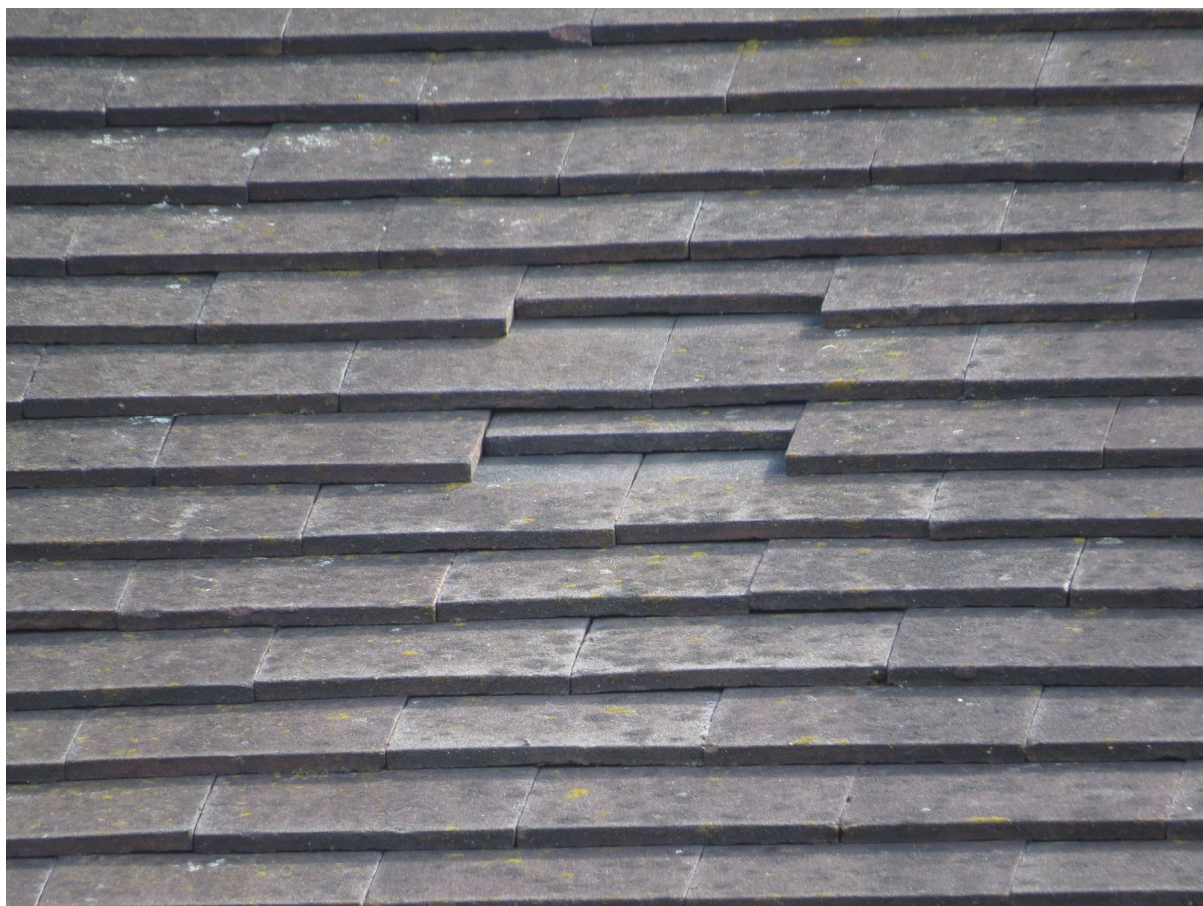
4 – Two slipped tiles at the front of the house do not provide access for roosting bats.

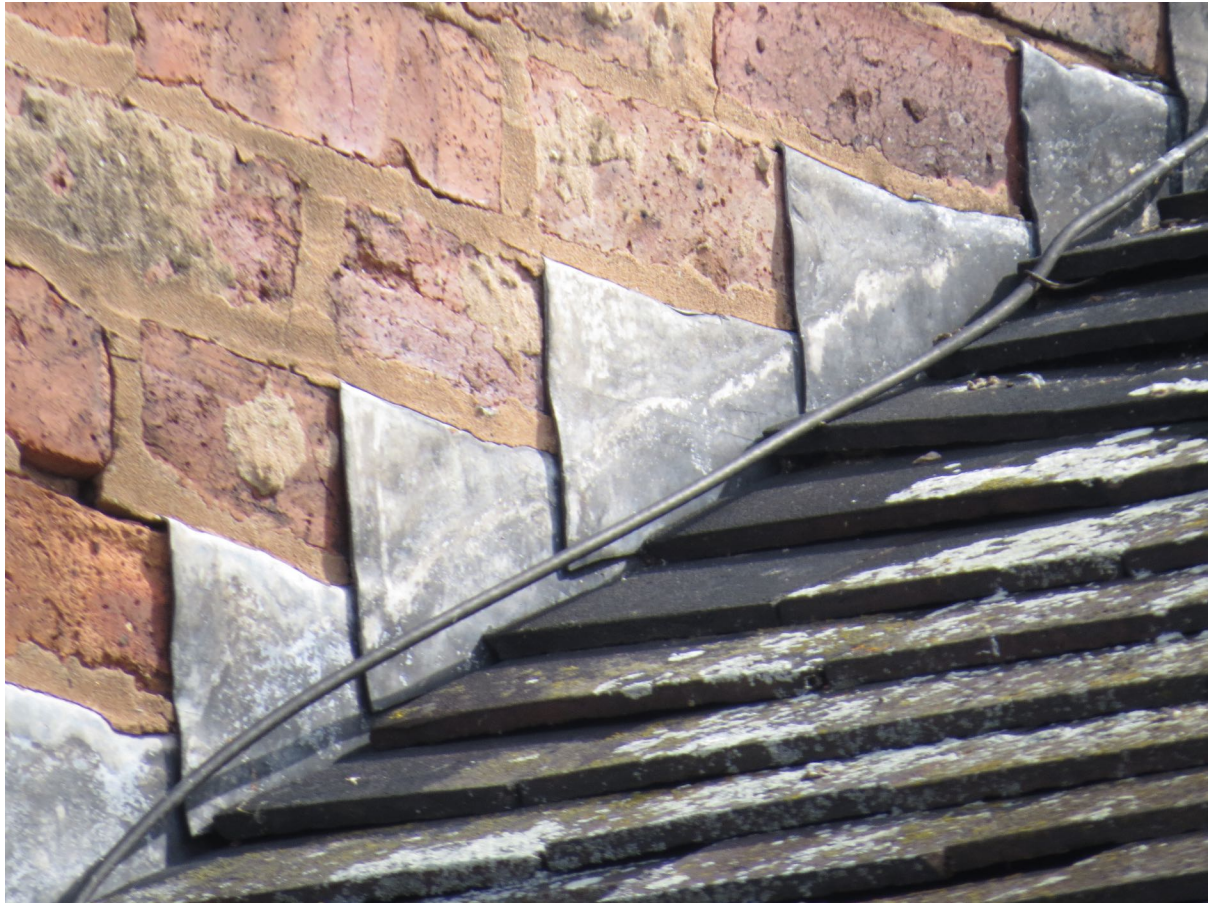
5 – Lead flashing is fitted tightly with no suitable gaps.

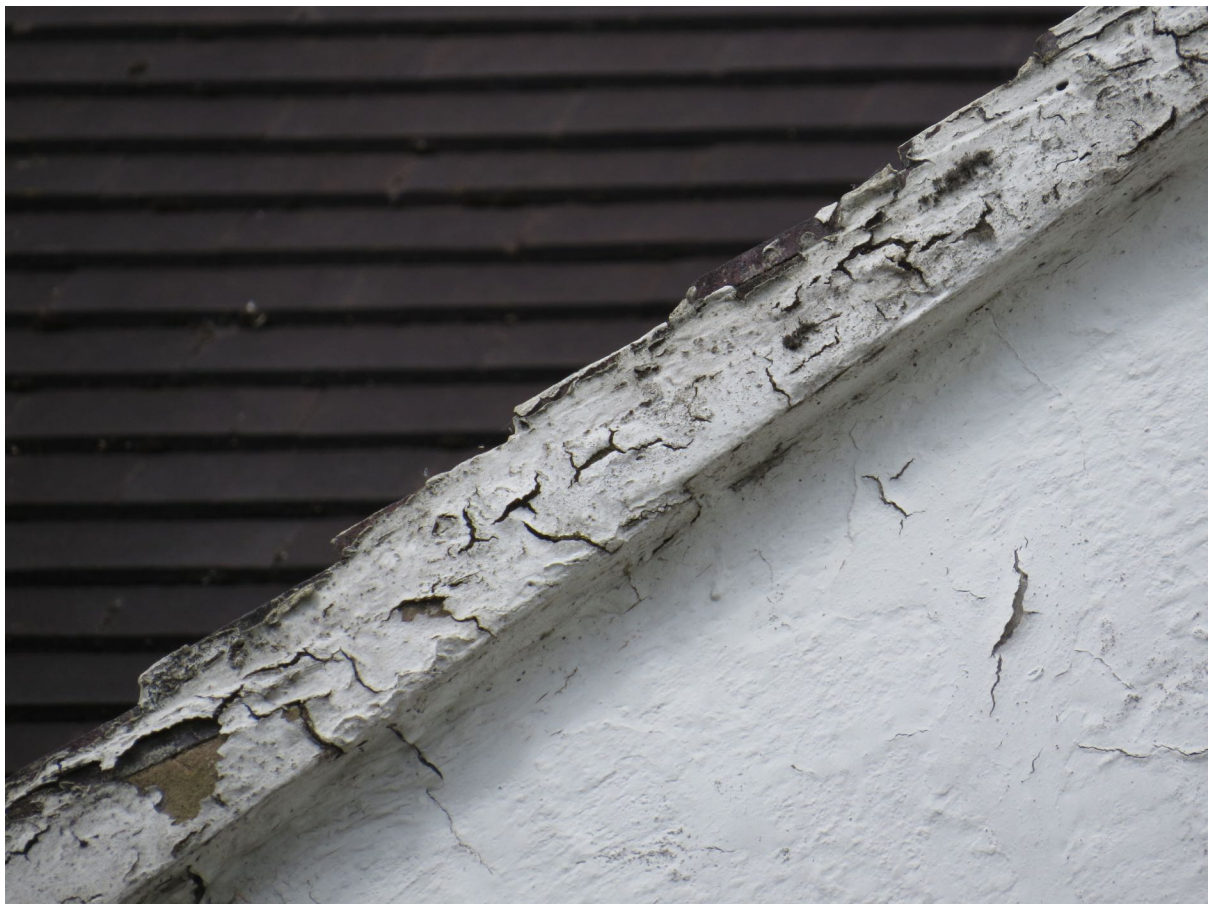
6 – Cement at the gable end verges is intact, with no suitable gaps.

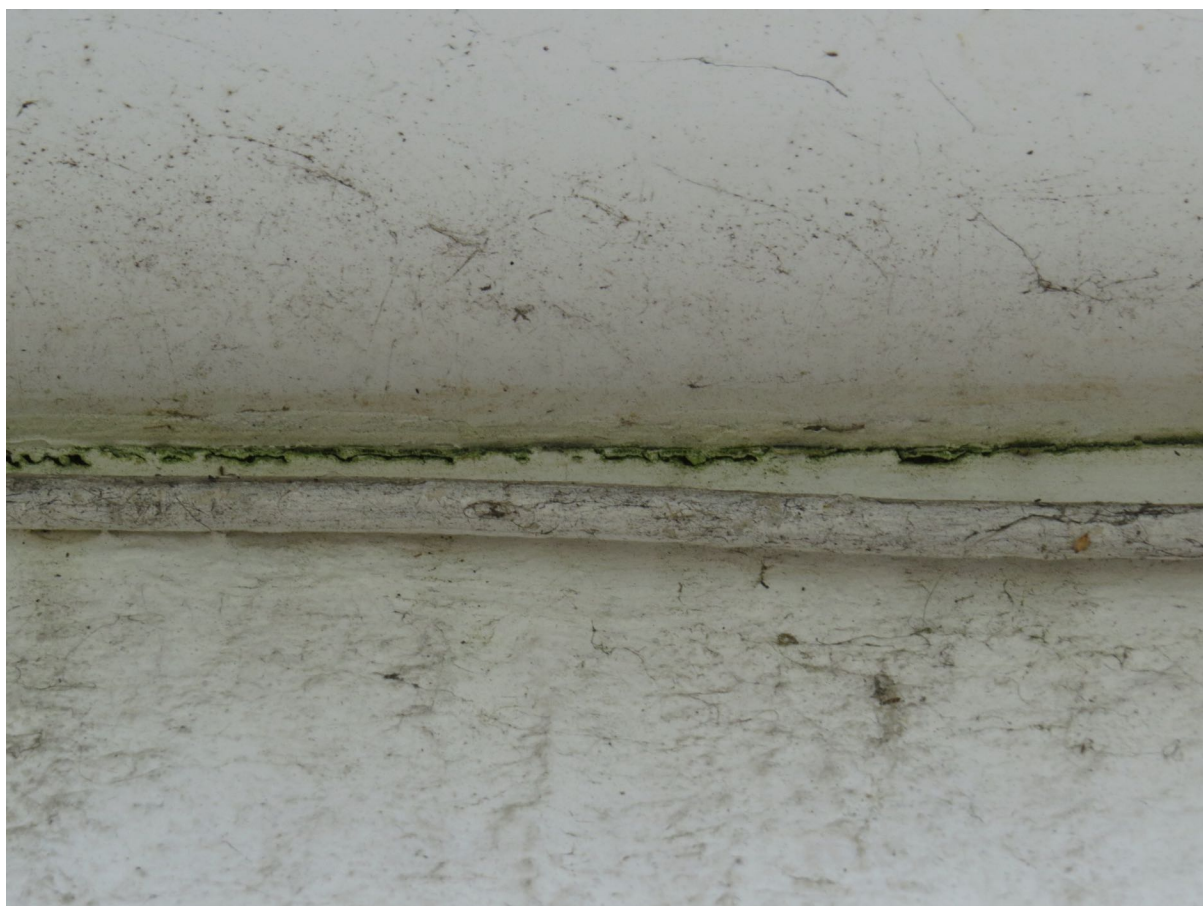
Timber fascia boards and boxed soffits at the eaves are fixed tightly against brickwork, with no suitable gaps; boxed soffits open into the roof void, and were inspected from above.

7 – There are no gaps between boxed soffits and render at the eaves.

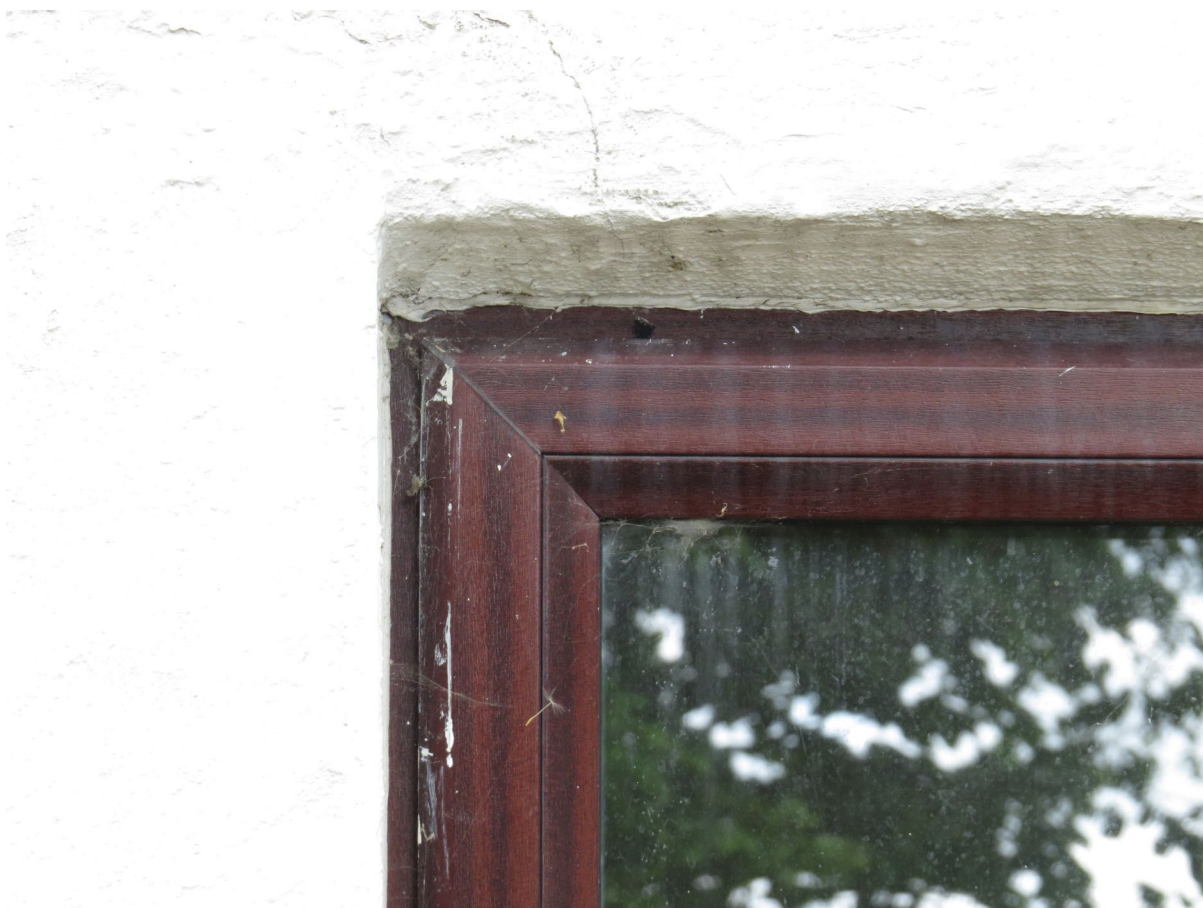
Window and door frames are fixed into the brickwork, gaps are filled with sealant, and offer no suitable roosting opportunities.

8 – Window and door frames are tightly sealed into brickwork with no suitable gaps.

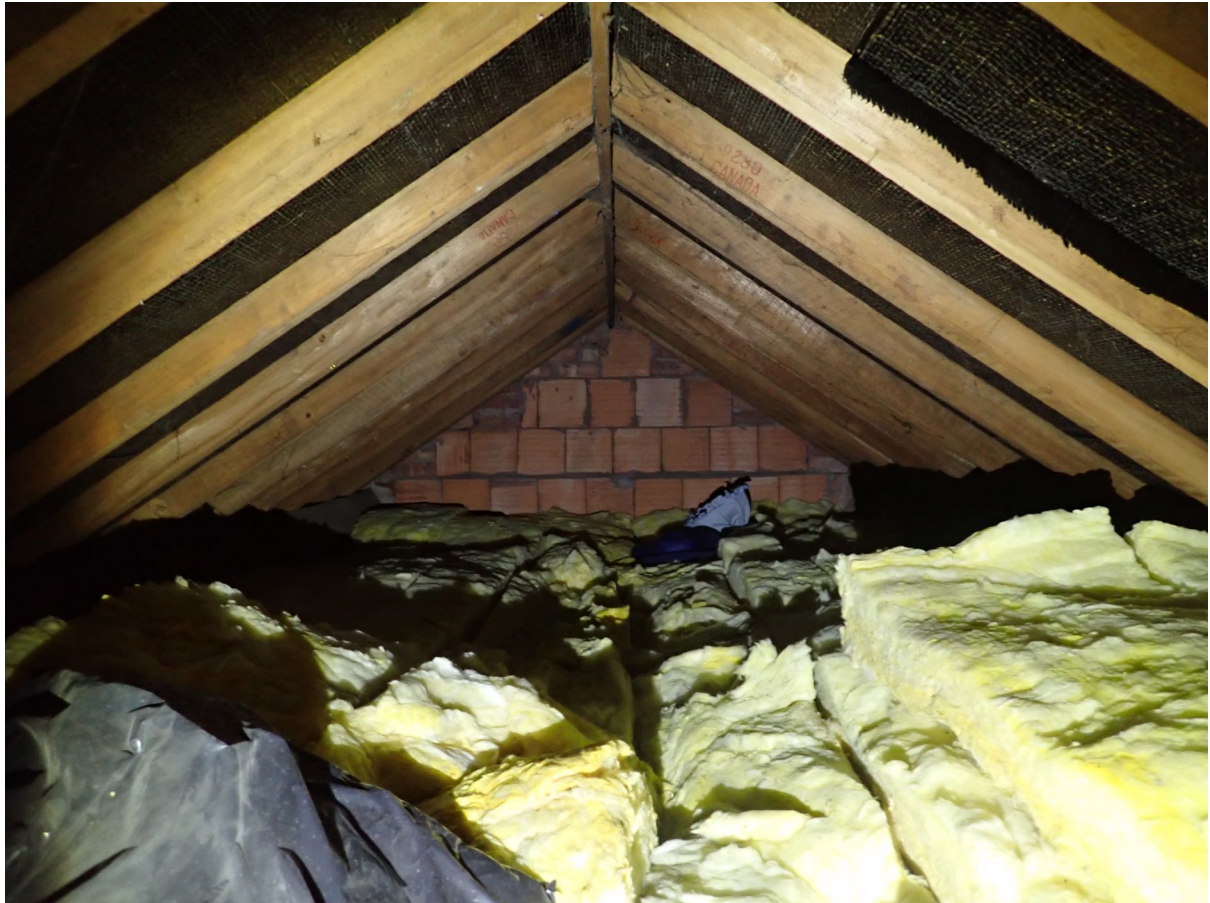
9 – The house has a single roof void which is not used for storage.

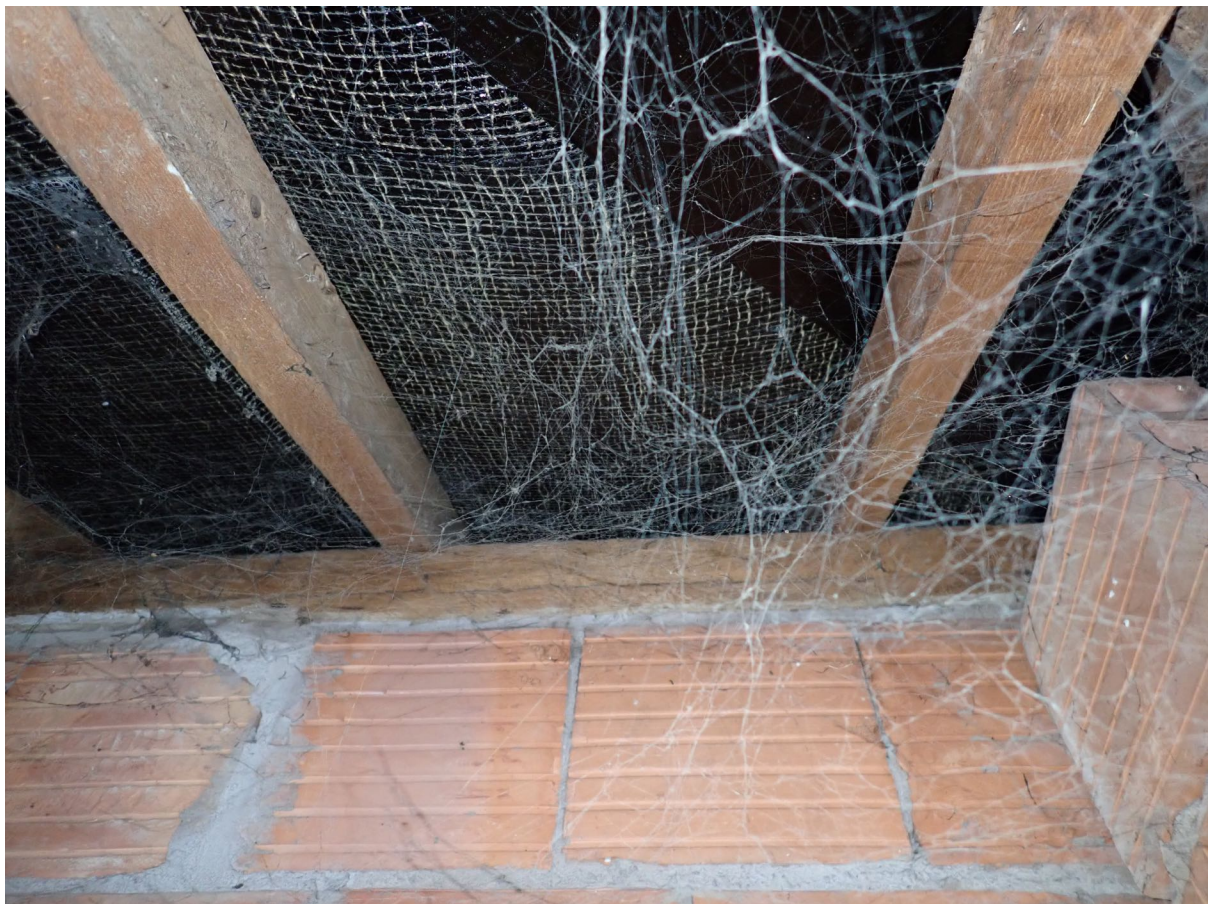
10 – Roof lining is in good condition timbers are covered in cobwebs.
