Stori Brymbo Project  
Mining Report  
Heritage Area  
Brymbo Heritage Trust

GroundSolve Ltd

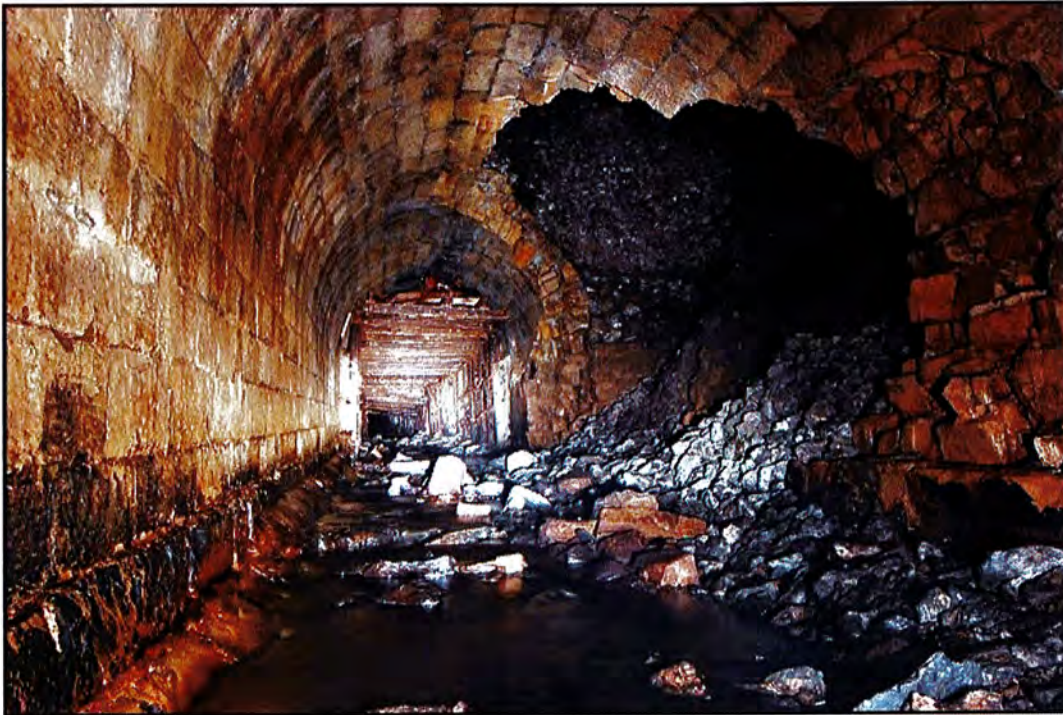
An example of a well-constructed roadway, typical of ironstone workings, but which has collapsed is presented below.

**Well-constructed roadway with collapse**

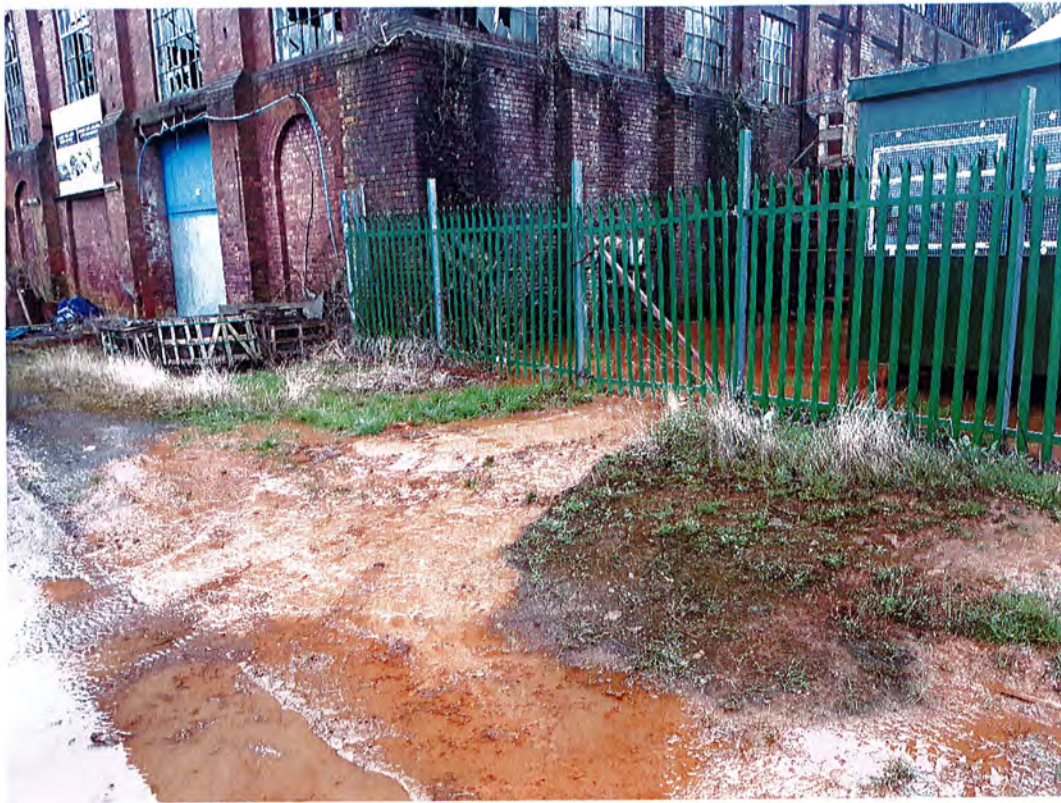
This revealed the presence of an open adit in the south west corner of the works, which is within the site boundary, from which red mine drainage water was issuing. Mr. Brown indicated that this adit had been driven circa 1843 to work a coal seam, which was rapidly exhausted. The walkover also inspected the old Brymbo colliery shafts to the west of the main development, which are both fenced off. According to Mr. Brown these have been partially backfilled by the Coal Authority to depths of around 50 to 60m, with the water standing at around 30m depth. One of the pits was reported to be covered with a metal grill.

Photograph 1 Mine water discharge from adit

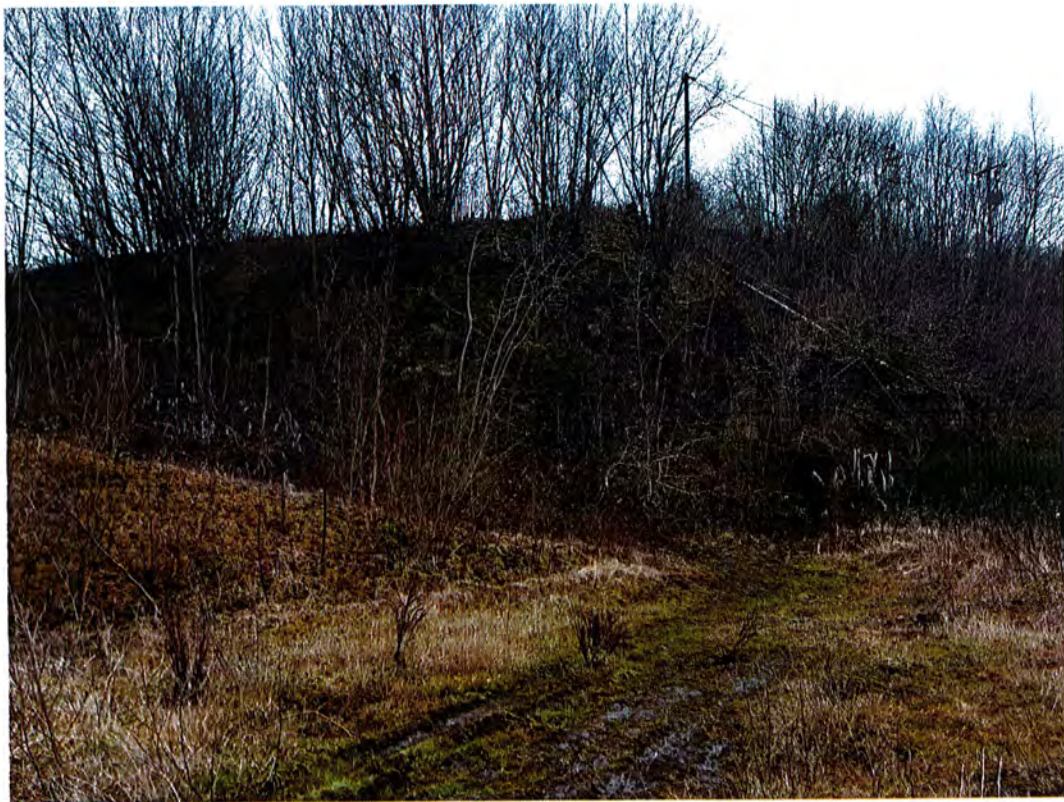
Photograph 2 outcrop of sandstone close to site entrance

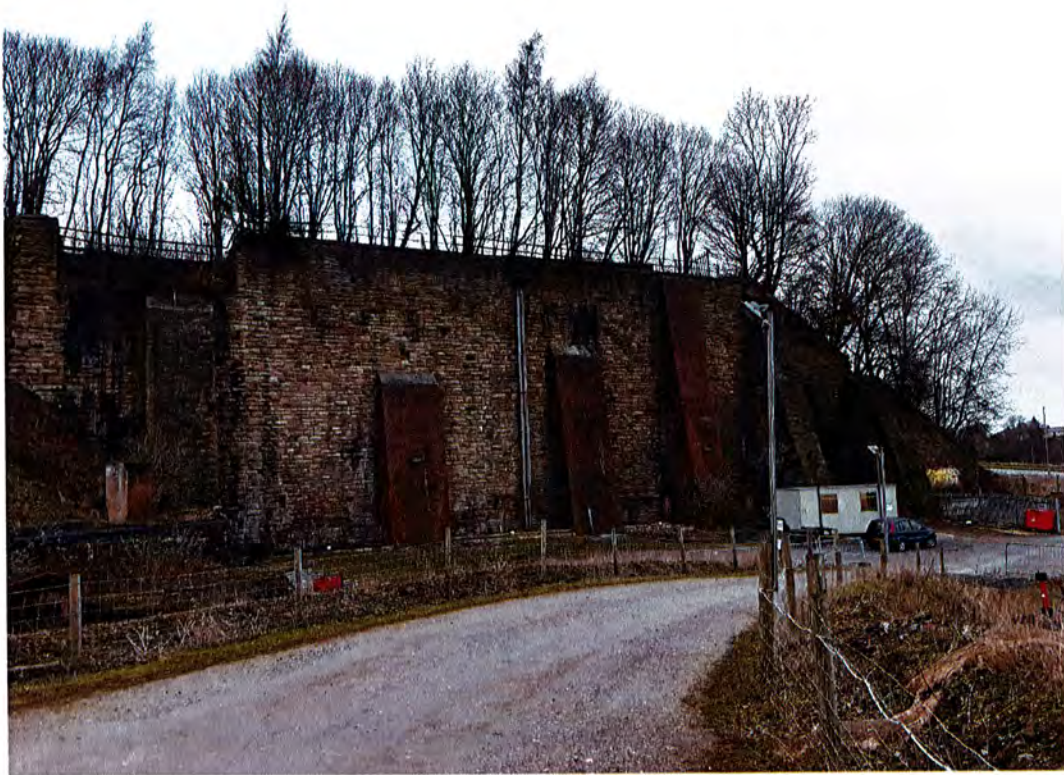
Photograph 6 Retaining structure on northern site boundary

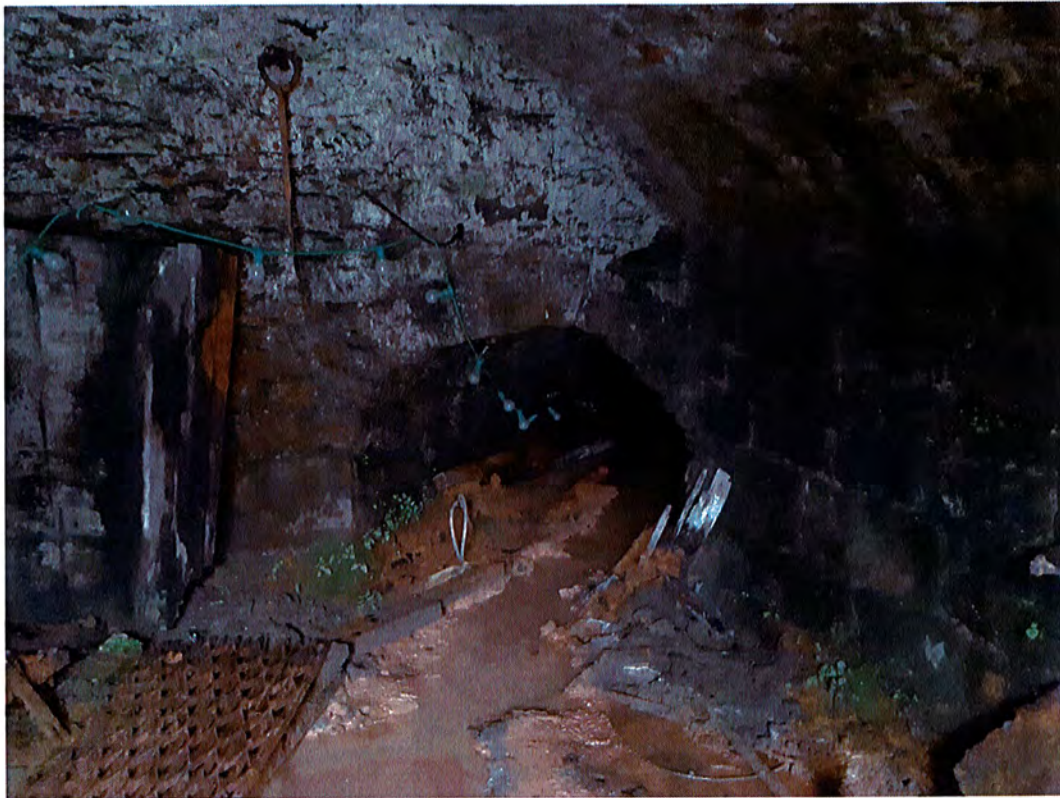
Photograph 9 Adit entrance

However, adit 131 is open beneath the development area, and is inspected by the Heritage Trust. Therefore, this does not present a risk to the proposed site use. The main risk posed by this adit is its drainage capability. Should it collapse, it would effectively dam the flow of water from the workings, which may cause problems around the site area in terms of water issuing from sealed adits etc. It would therefore be prudent to undertake regular structural inspections of this adit.

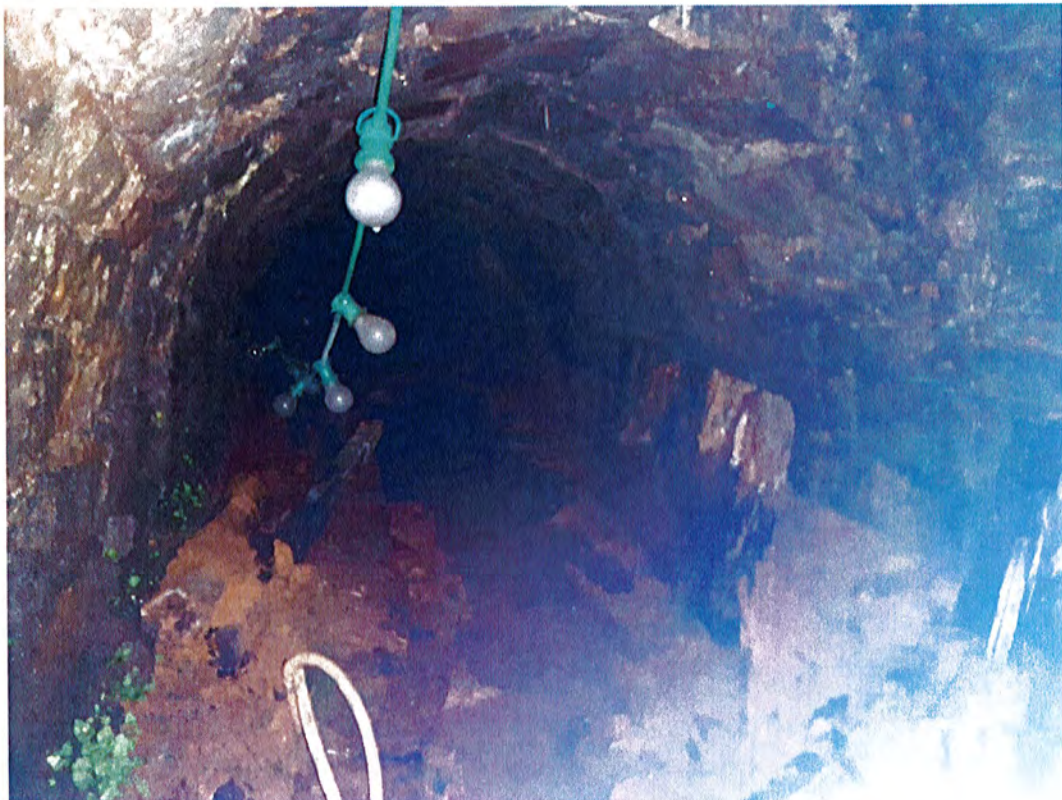
Photograph 10 View up adit

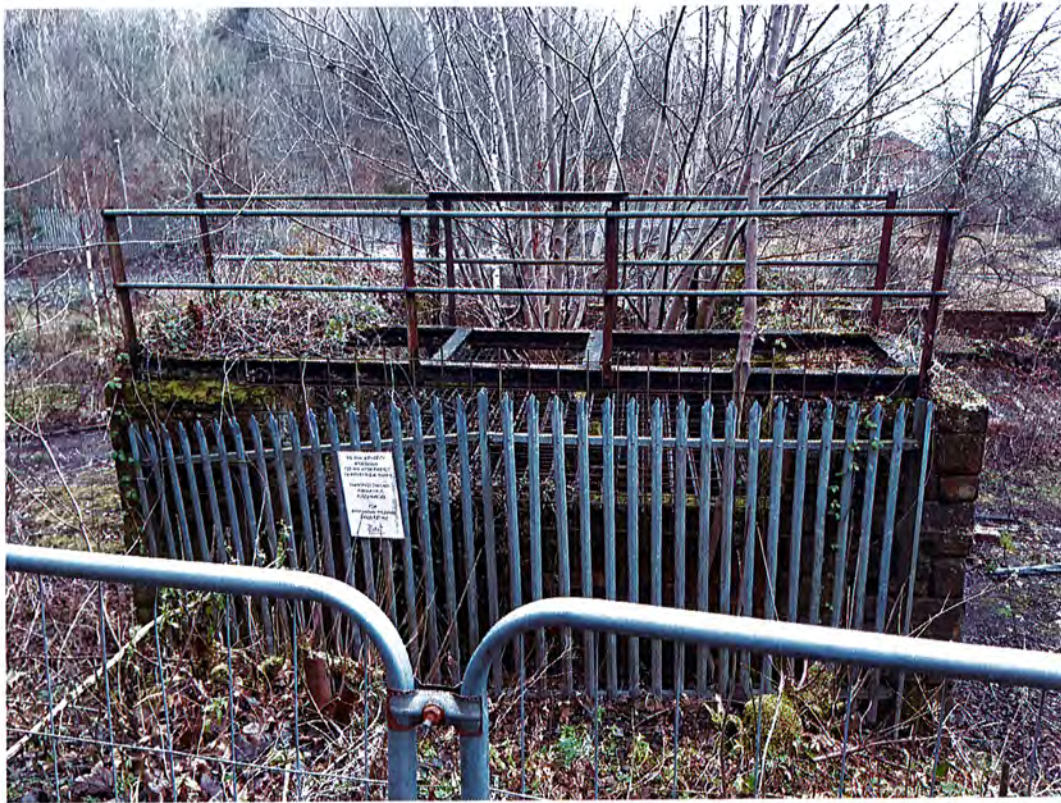
However, the location of mine entrances needs more careful consideration. Shafts if they have not been treated run the risk of sudden collapse, this is due to the fact that they were rarely backfilled full depth, especially if there was insufficient nearby fill. Instead a staging would be constructed at one of the levels, which may deteriorate with time and collapse leading to a surface failure. However, there are no known shafts to the west of the fault that could influence the development area, shafts 127 and 128 being sunk straight into sandstone rock head.

Photograph 15 Shaft 128

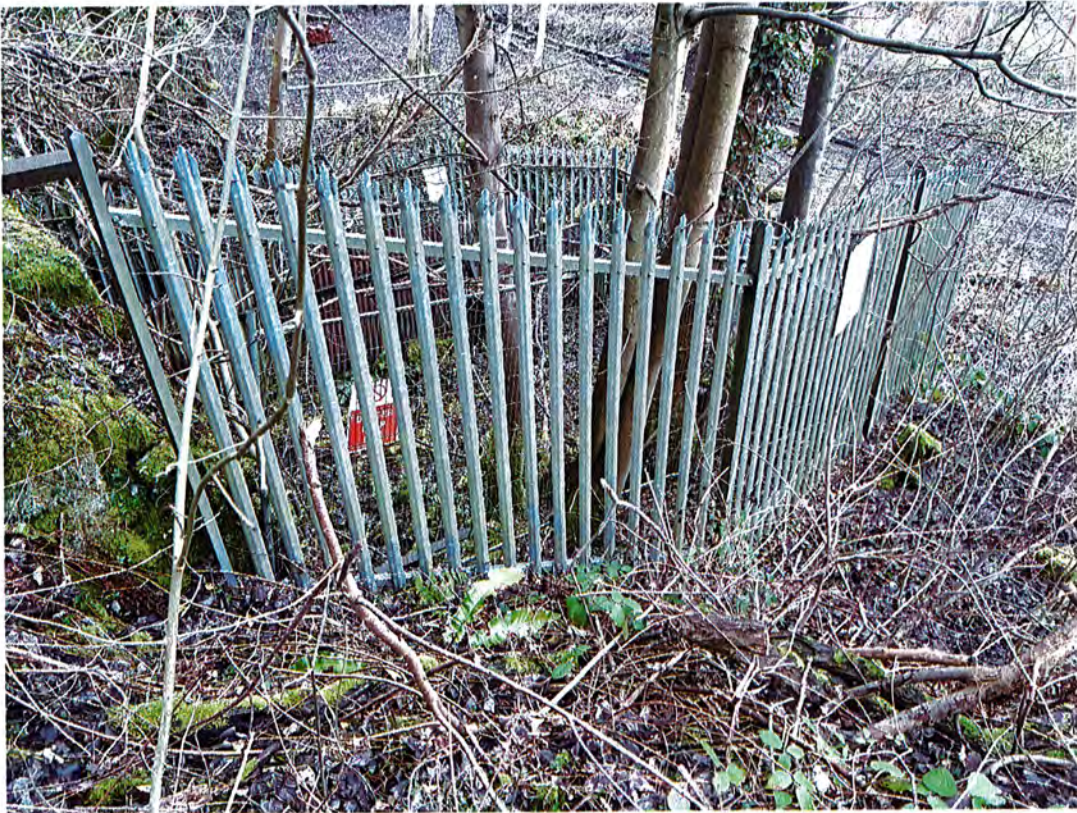
Photograph 16 Shaft 129

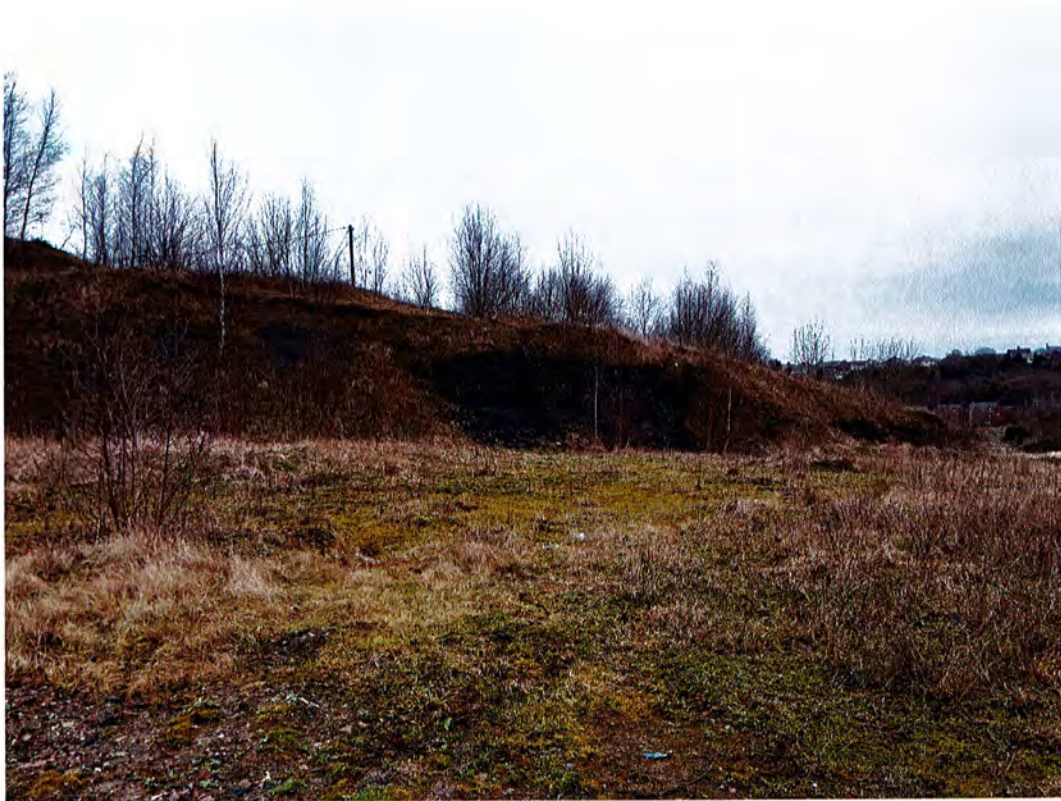
In addition, previous open casting immediately south of the site exposed a coal seam, thought to be the Two-Yard seam, which was dipping gently in an easterly direction. However, immediately west of this outcrop, further coal was exposed dipping steeply to the west, probably indicating it was in the vicinity of the main Brymbo Fault, see Figure 3.

Photograph 17 Outcrop of Two-yard (Hollin) seam dipping eastwards

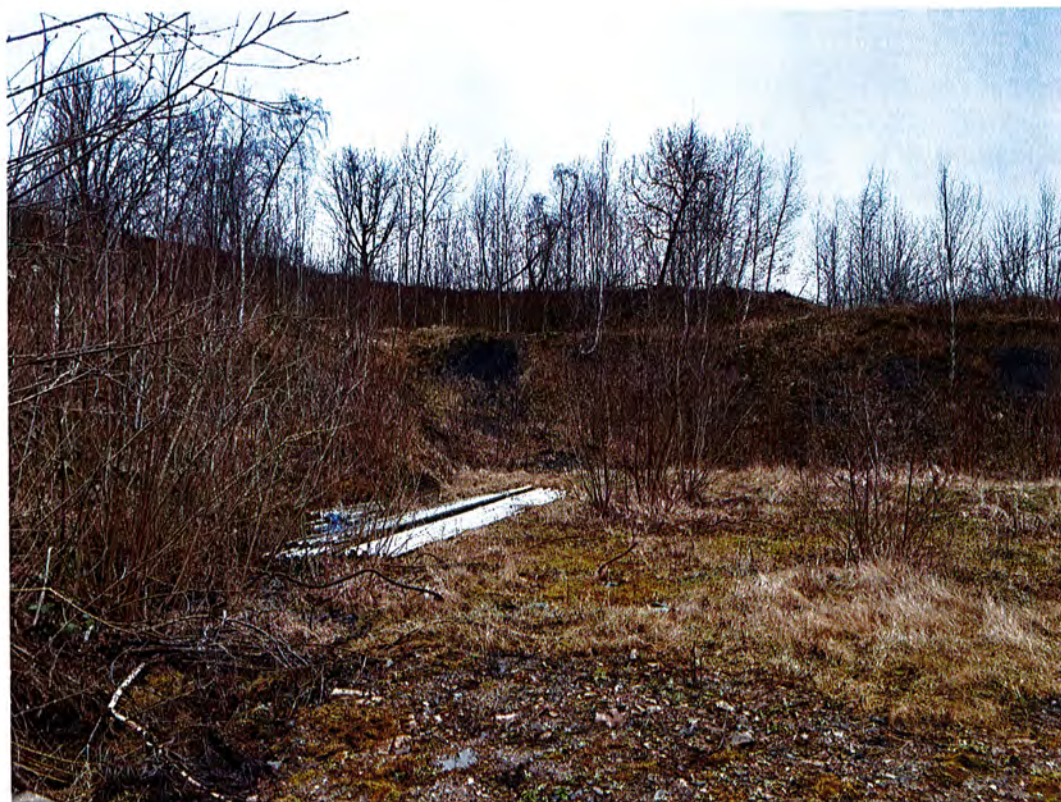
Photograph 18 Two-yard seam tilted in close proximity to fault

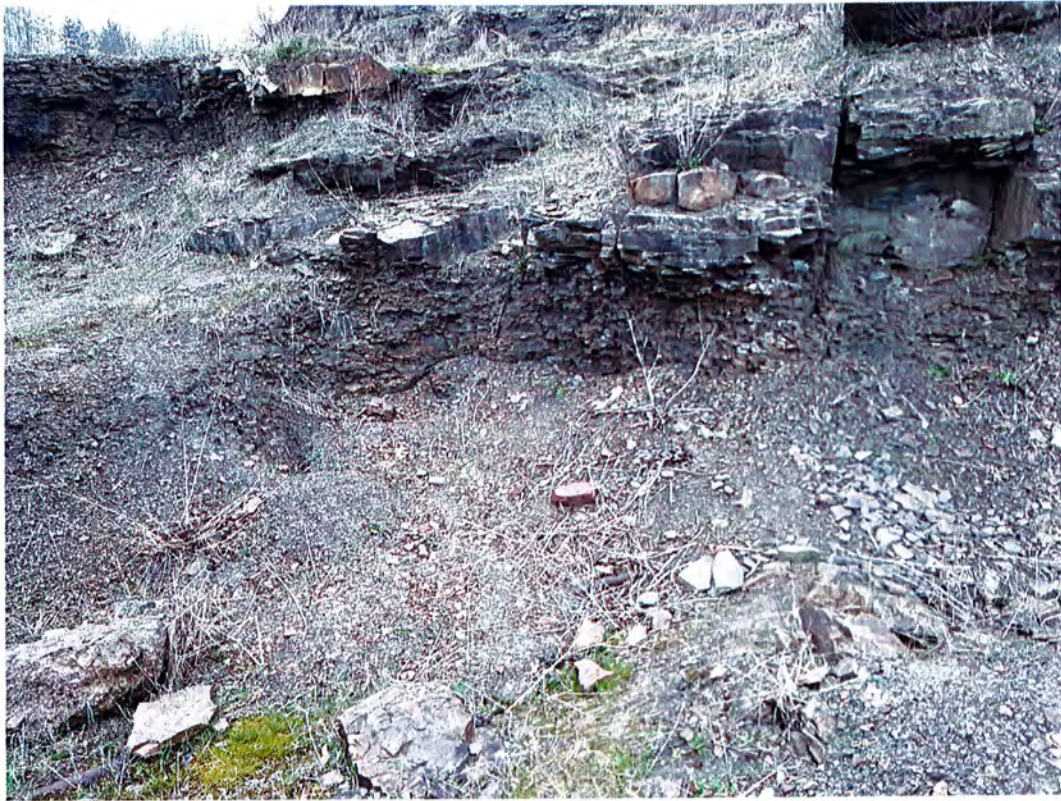
Immediately south east of these exposures is the Fossil Forest. and Mr. Brown indicated that possible Bell Pits had been encountered in excavations for the Fossil Forest.

Photograph 19 Area of bell pitting close to Fossil Forest

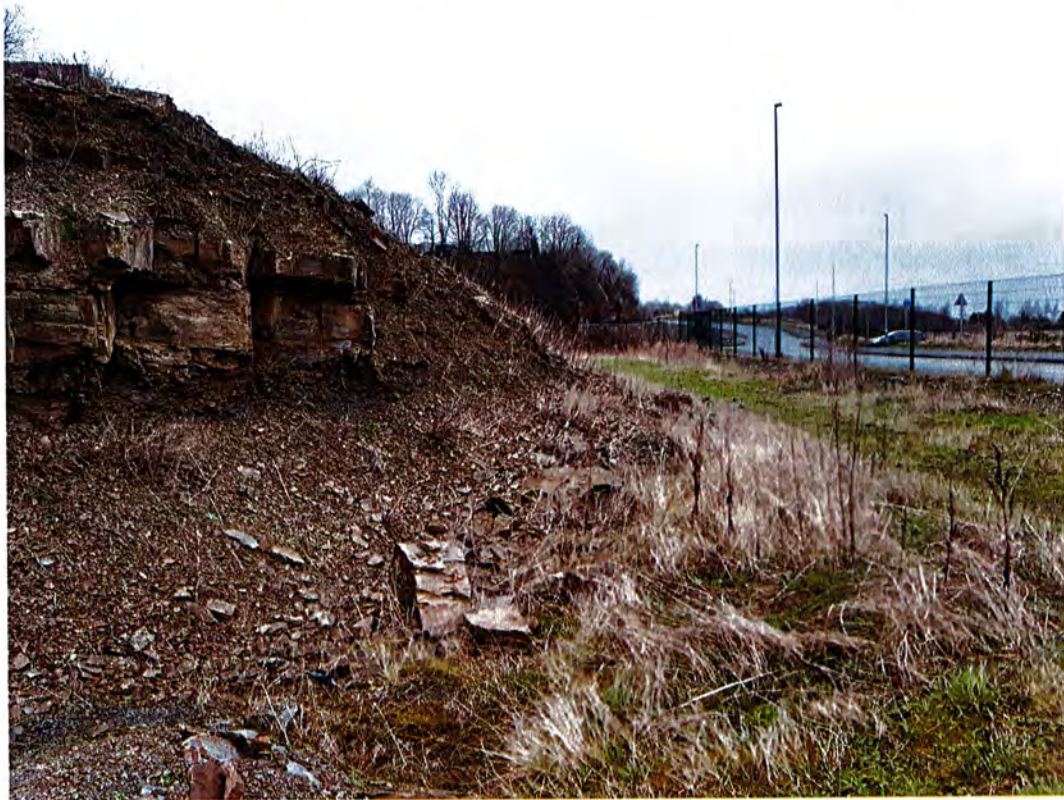
Photograph 20 Showing elevation of Bell Pits to Crank seam
