| <b>Report Title</b> | <b>Proposed Demolition of The Bungalow, Henblas Street, Rhostyllen, Wrexham – Preliminary Roost Assessment/ Nesting Bird Assessment</b> |
| <b>Date issued</b> | <b>11<sup>th</sup> August 2022</b> |
| <b>Report Version</b> | <b>C489/ 1.0/ PRA</b> |
| <b>Client</b> | <b>Wrexham County Borough Council</b> |

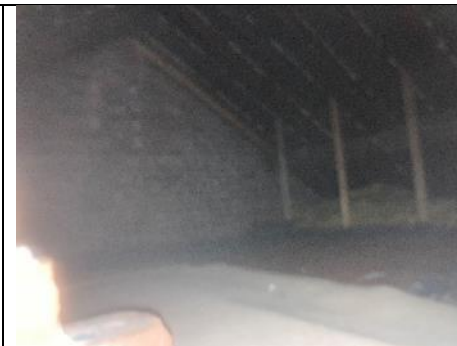
Loft space in eastern half of building.

- 4.2.4 The loft of Building B1 was thoroughly checked and no droppings or evidence of bat use was found. No direct flight access points were present and no light ingress through cracks or similar was seen within the loft. The membrane was in excellent condition with no rips or damage.
- 4.2.5 Building B2, the garage/ snooker room provides no features suitable for roosting bats. The barge boards are all well sealed with only minimal gaps present (0 mm to 10 mm) and cobwebbed. The garage/ snooker room has a flat roof and provides no roosting features within it. There is no access onto the wall plate due to the barge boards. The building is

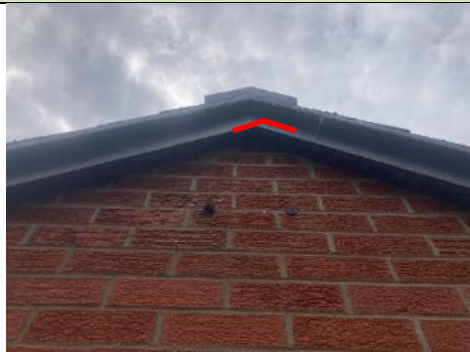
| Building B1 | | |
|---|---|---|
| <b>Bungalow northern elevation</b> | One PRF present. Verge sealed apart from one gap. Close inspection identified as cobwebbed over with two large spiders 'guarding' the feature. No bat droppings were seen associated with this feature.<br><br><i>Ruled out due to presence of spiders.</i> | |

- 6.1.4 A licensed bat-worker or accredited agent should be present to oversee removal of the two sub-optimal potential bat features prior to any other demolition-related works on Building B1. The removal of any feature with bat roost potential, will be undertaken by hand in suitable weather conditions and under direct ecological supervision. Where applicable, materials will be removed carefully away and not rolled or sprung to avoid potential harm to bats. The undersides of these materials will be checked by the licensed ecologist or accredited agent for bats that may be clung to them before removal.

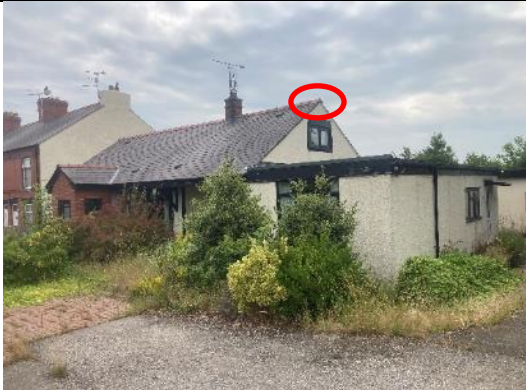
| Building B1 | | |
|---|---|---|
| <b>Bungalow western elevation</b> | A small gap in the mortar at the apex of the verge on the western aspect was also identified, this was not accessible to check. It is approximately 20 mm x 15 mm, which is considered a sub-optimal access point for bats. | |

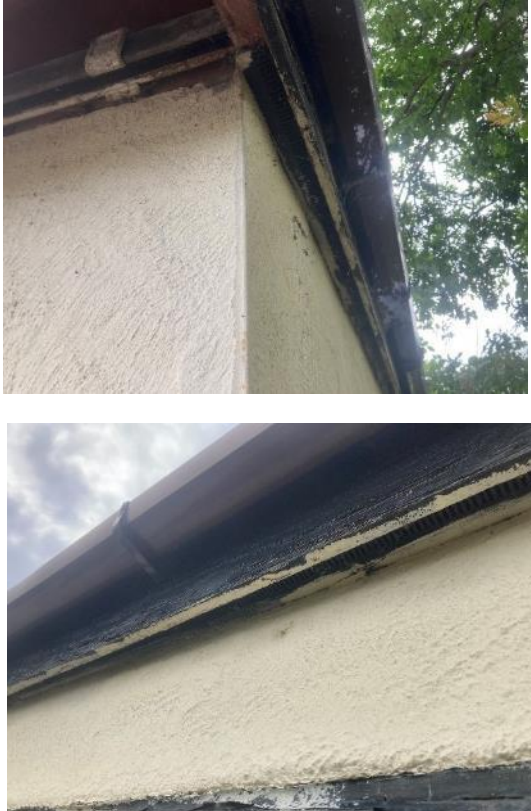
| Building B2 | | |
|---|---|---|
| Garage/ snooker room | <p>No PRF's present within garage/ snooker room.</p> <p>Barge boards very well sealed.</p> | |
