# **Arboricultural Impact Assessment**

## **BS5837 Trees in Relation to design, demolition and construction – Recommendations**

**Ref:** NWTC.22.11

I, Peter Gardner have been commissioned by Edgeplan Ltd to conduct a BS5837 Trees in Relation to design, demolition and construction – Recommendations, arboricultural survey and report for a proposed development at 38 Pen y Bryn, Wrexham.

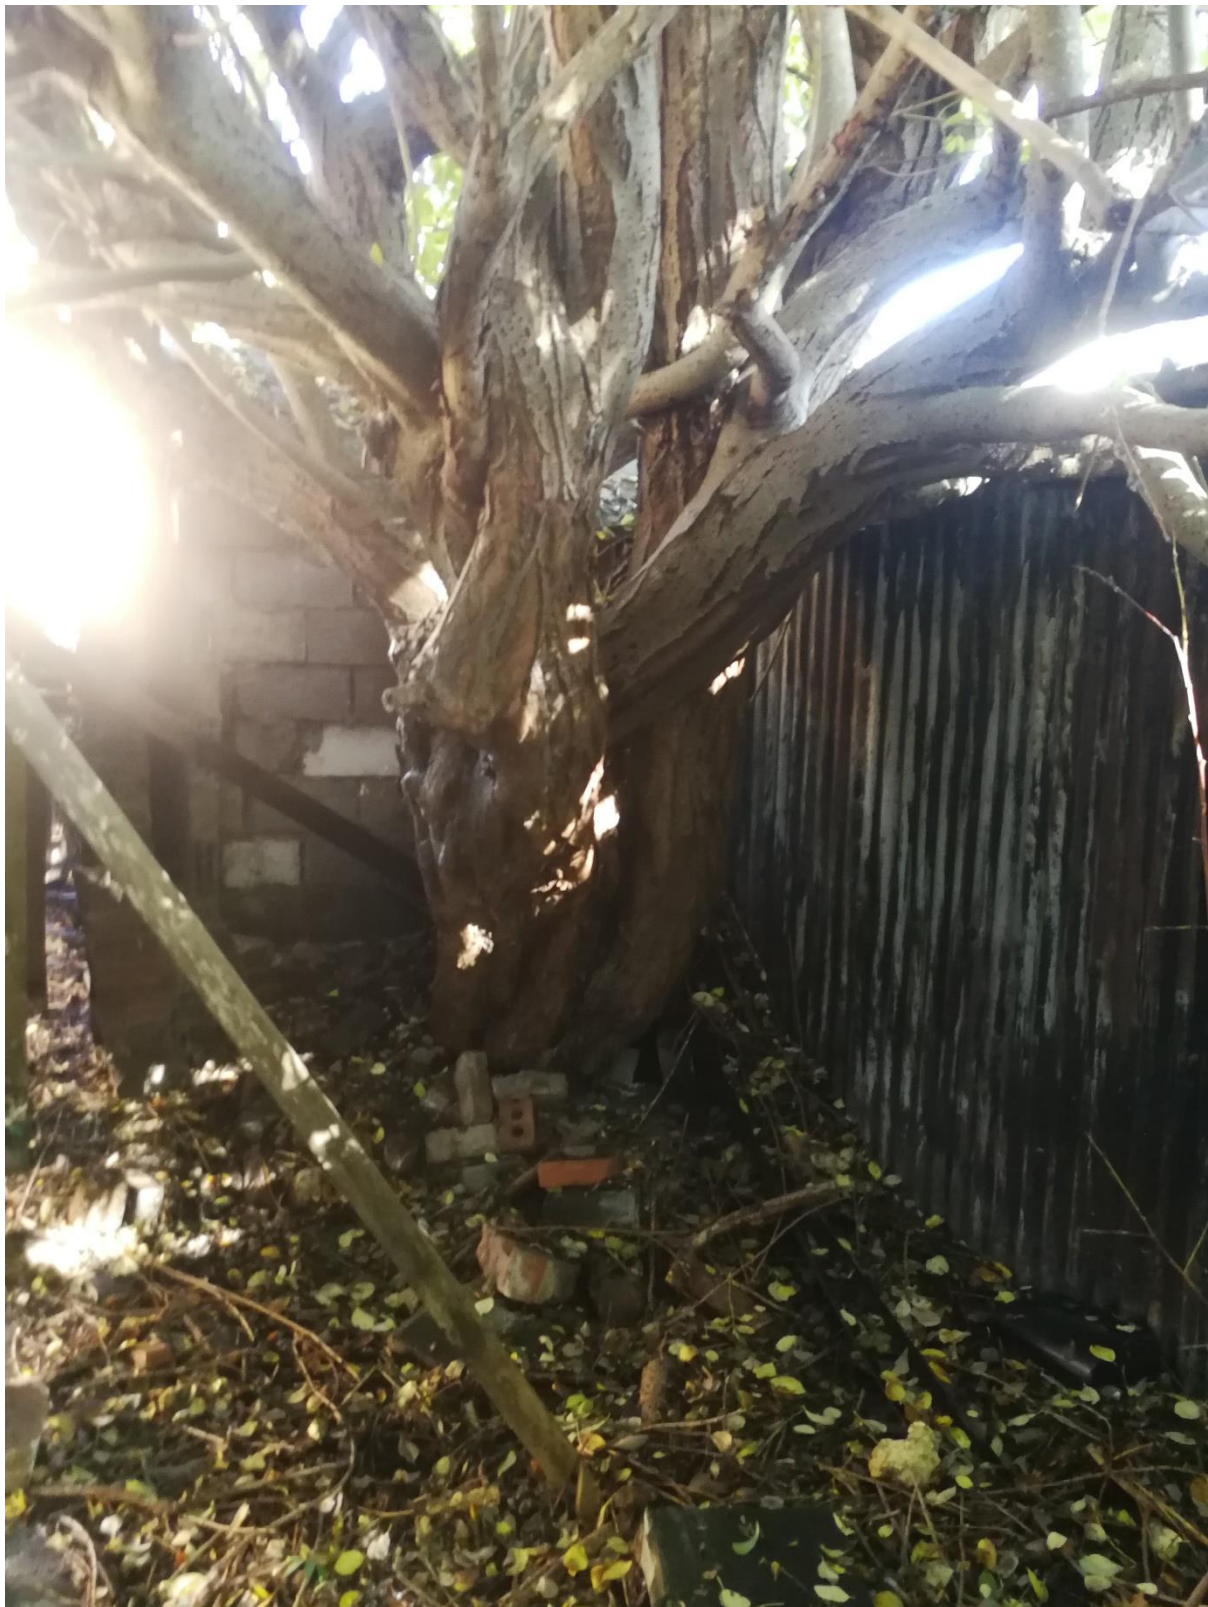
A mature tree of significant girth for the species, the tree has been poorly pruned and has a poor rooting environment due to its close proximity to the existing building (figure 1), this has resulted in a significant lean of the stem to the south at ~45 degrees. However due to its considerable size for the species it has been categorised B1 therefore an effort must be made to retain the tree, furthermore the proposed works will likely improve the growing conditions for T1 in the long term and increase its SULE. The previous pruning on T1 has resulted in a congested scaffold of crossing contorted branches all naturally bracing one another with no dominant leader. It is not necessary to rectify this unusual branch arrangement as this would cause unnecessary stress and remove the beneficial structural role these crossing branches play. Instead, the crown size and canopy height should be managed to ensure the crown remains a suitable size for its location and does not pose an above ground constraint to the demolition of the existing buildings and construction of the proposed plant area. Goat willow are a resilient species it is therefore considered the tree will tolerate and recover from the proposed development.

*Figure 1 T1 Goat willow, contorted branch structure, growing in close proximity to buildings waste present around tree base*

- Crown reduce by 2m or to most appropriate growth point to manage crown size
- Target prune previous pruning stubs to aid occlusion of wounds
- Crown raise to 2m to facilitate access around the tree for demolition and construction

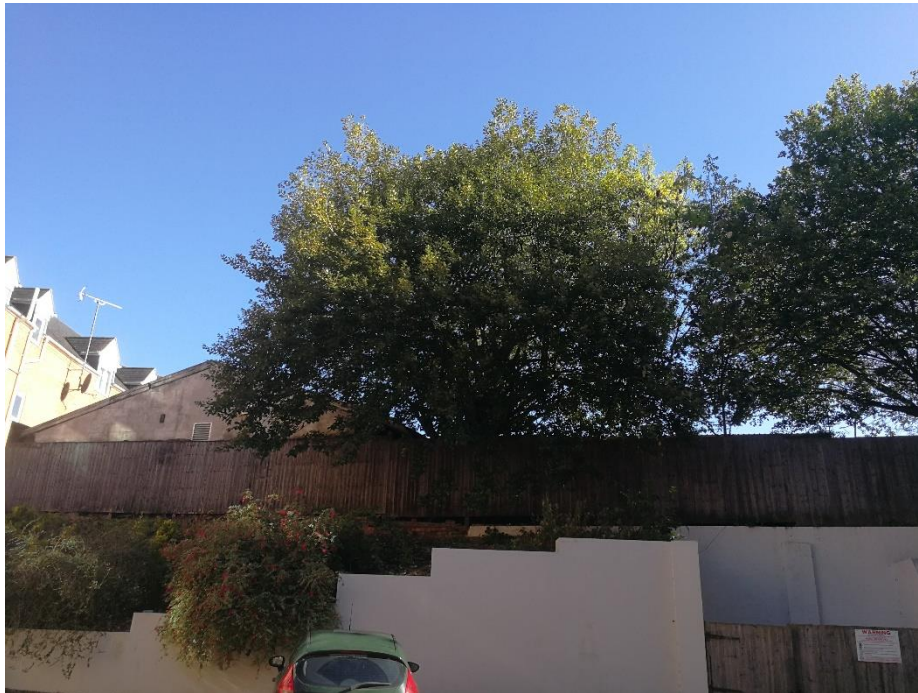
*Figure 2 T1 Goat willow crown, elevated position from car park, picture taken from west looking east*

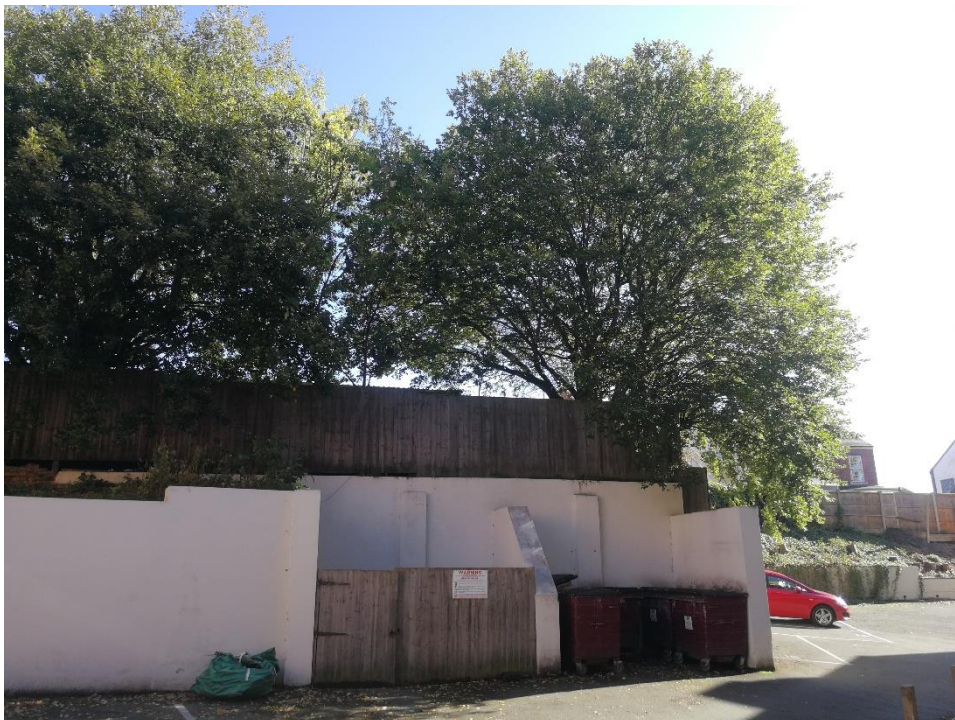
A mature tree of significant diameter for the species categorised B1 (figure 3). T4s girth is not as large as T1s however it exhibits better form with a straight stem and large well-formed open crown. T4 has a similar contorted scaffold structure to T1 also likely the result of poor previous pruning. T4 is located in close proximity to the southwest corner of the current storage building which will become the proposed plant storage area. Root development to the northeast will have been restricted by the presence of the existing building, it is unlikely roots are completely absent from the current storage area however fine surface roots vulnerable to compaction are more likely to have developed into more favourable surrounding soil in the bank. Therefore, the estimated RPA of T4 presents a below ground constraint to the construction of the proposed plant area. Due to the historical barriers to root development in the proposed plant area and the good physiological condition of the tree it is concluded that the construction of the plant storage area will not have a long-term negative impact on T4. As with T1 the crown size and canopy height should be managed to ensure the crown remains a suitable size for its location and does not pose an above ground constraint to the demolition of the existing buildings and construction of the proposed plant area.

*Figure 3 showing tree crowns of T1 T2 T3 and T4, picture take from west looking east*

- Crown reduce by 2m or to most appropriate growth point to manage crown size
- Target prune previous pruning stubs to aid occlusion of wounds
- Crown raise to 2m to facilitate access around the tree for demolition and construction

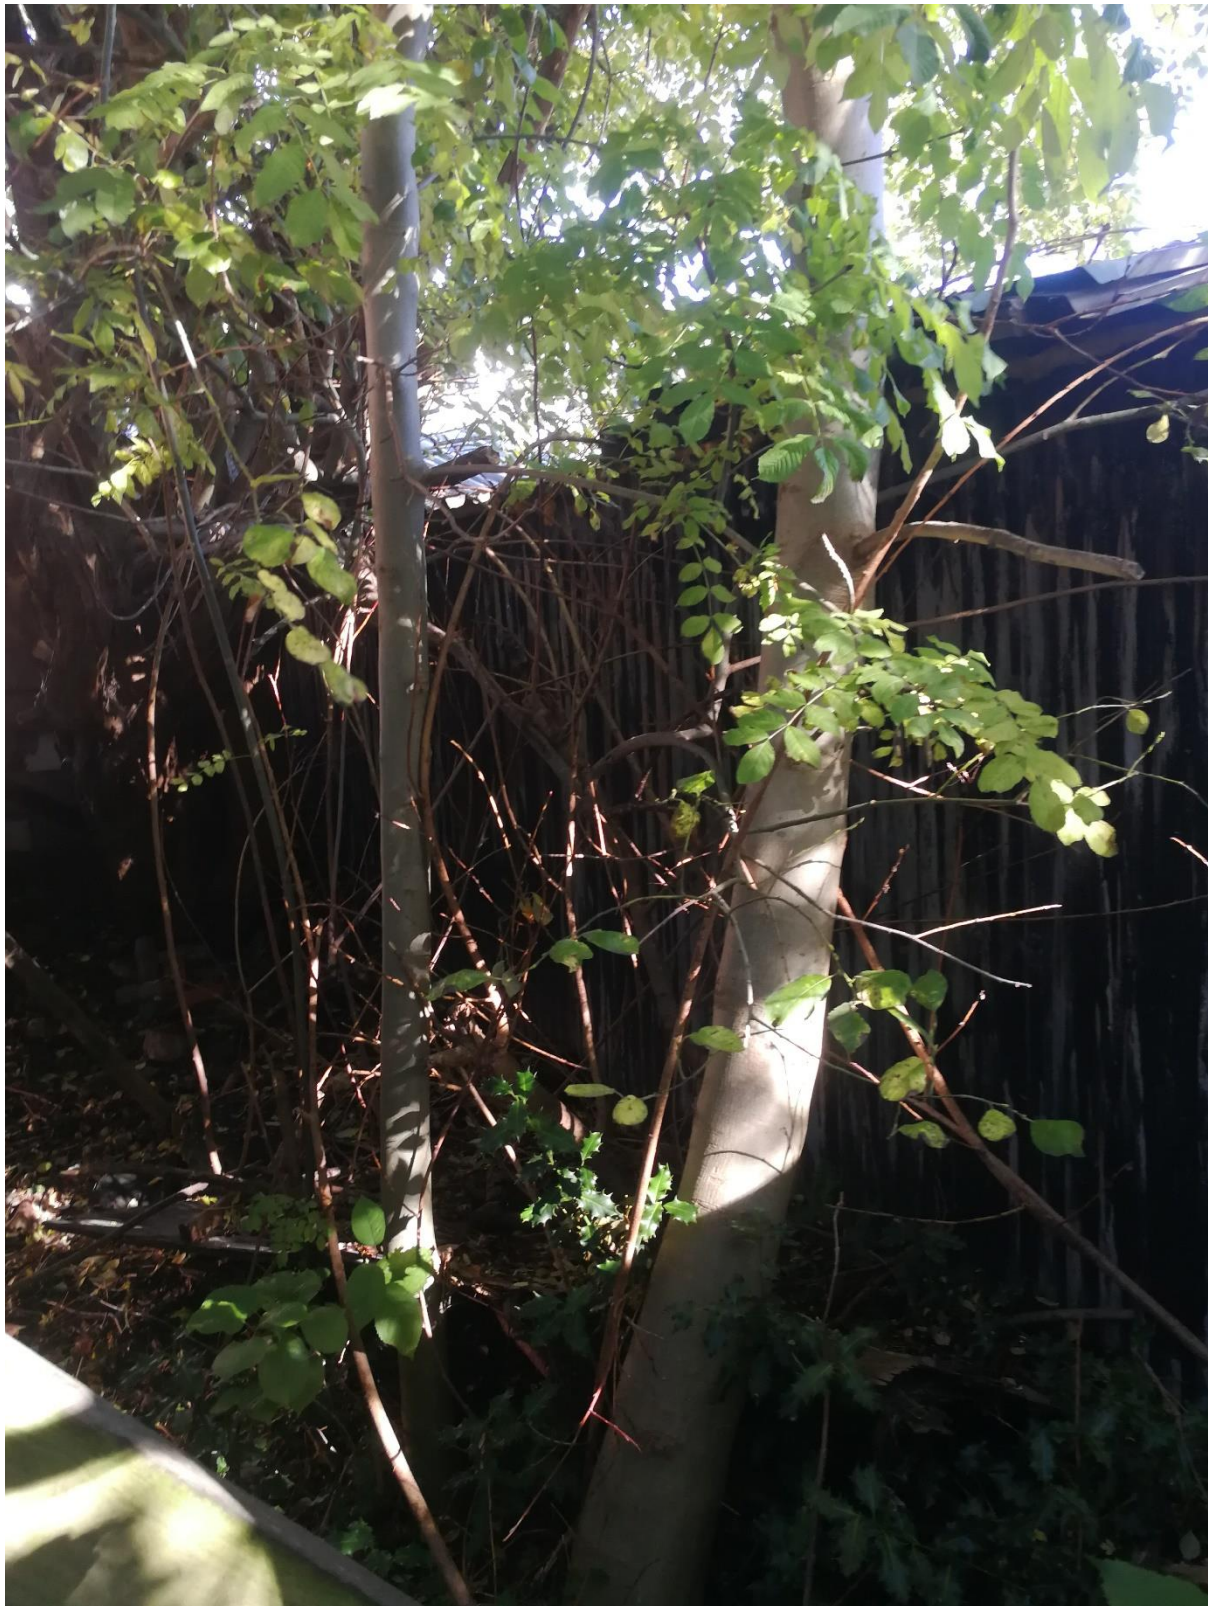
A self-seeded small diameter tree of low quality C1 (figure 4), exhibiting early signs of ash die back (*Hymenoscyphus fraxineus*), the tree is heavily suppressed by the adjacent goat willow crowns and is therefore unlikely to significantly contribute to the site. Removal of this tree will facilitate the demolition and constructions of the proposed buildings.

*Figure 2 Stem of T2 self seeded ash, building waste around tree base*

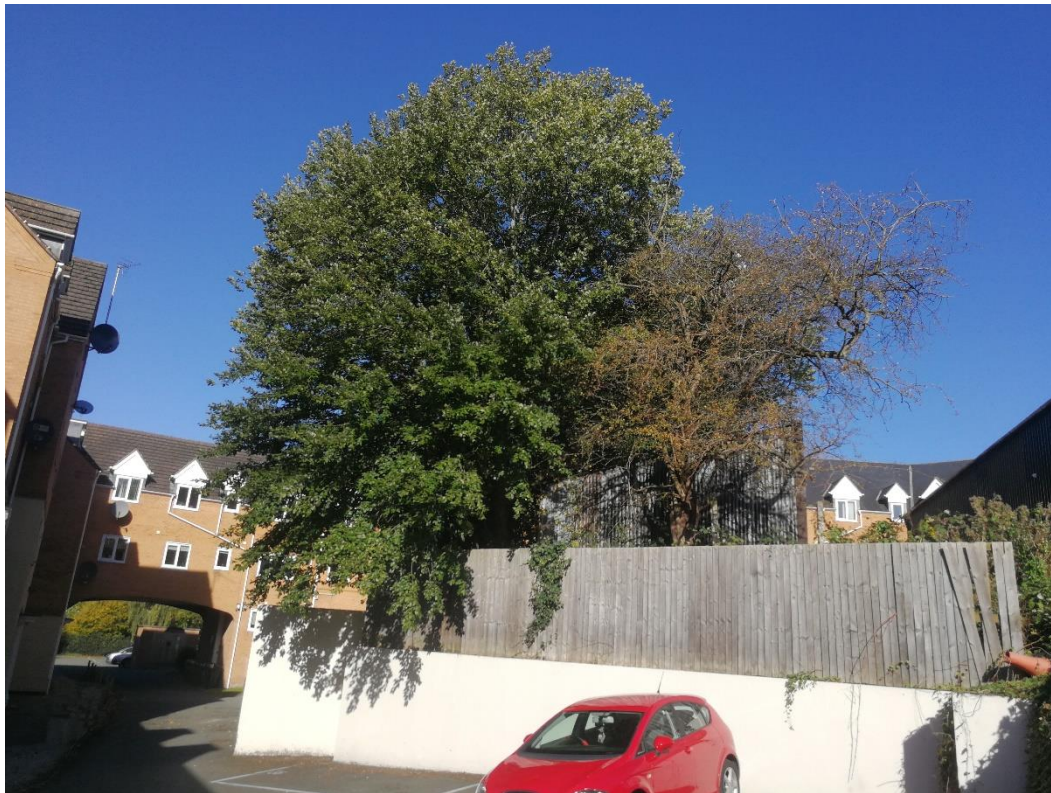
A low-quality tree categorised C1, (figures 5 & 6) retention of this tree is optional however it is unlikely its condition will improve with management, and it will likely cause future conflict with the proposed plant store. Its removal will facilitate demolition of the existing buildings and the construction of the proposed buildings as well as facilitating the future crown development of T4.

*Figure 4 T4 Goat willow left and T5 hawthorn right. picture taken south looking north*

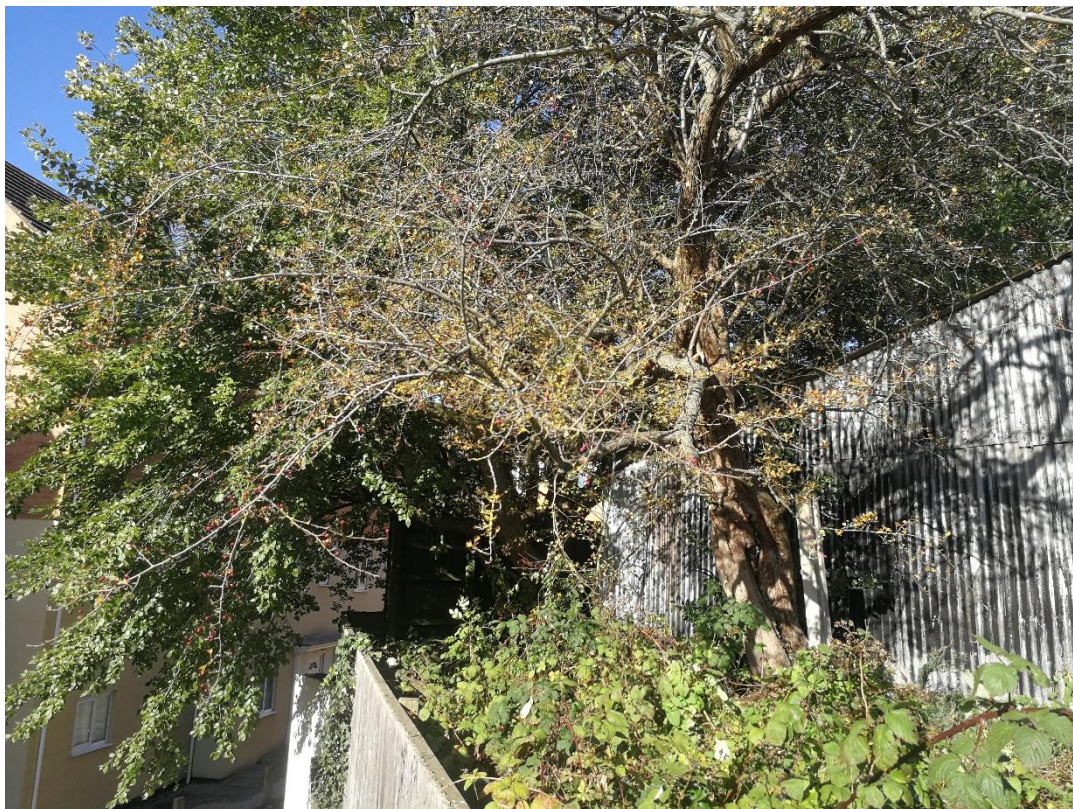
*Figure 3 T5 hawthorn growing in close proximity to existing building to north*
