# Chapel House, Bronington Bat Report

Project Number TT3507

Title Chapel House, Bronington

Document Number R01-Bat Report-Rev00

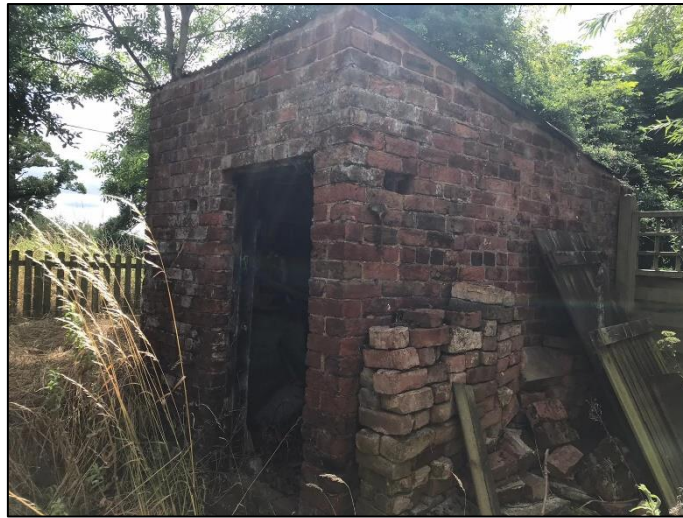
*Plate 5. Outhouse*

The outhouse is built from single thickness red brick with an open doorway and tin sheet roofing, this building is in poor condition with the door missing and roof damaged. The bricks are also crumbling due to the weather eroding the brickwork (*Plate 5*).

The small outhouse within the rear garden is in poor condition with crumbling brickwork, damaged roof sheets and a missing door. There is no enclosed loft space within this building and the walls are single thickness brick. No evidence of bat use was recording during the initial roost assessment and no suitable roosting features were found within this building. The building does offer some suitable areas for perch feeding, however no feeding remains were found inside the outbuilding (*Plate 5*).

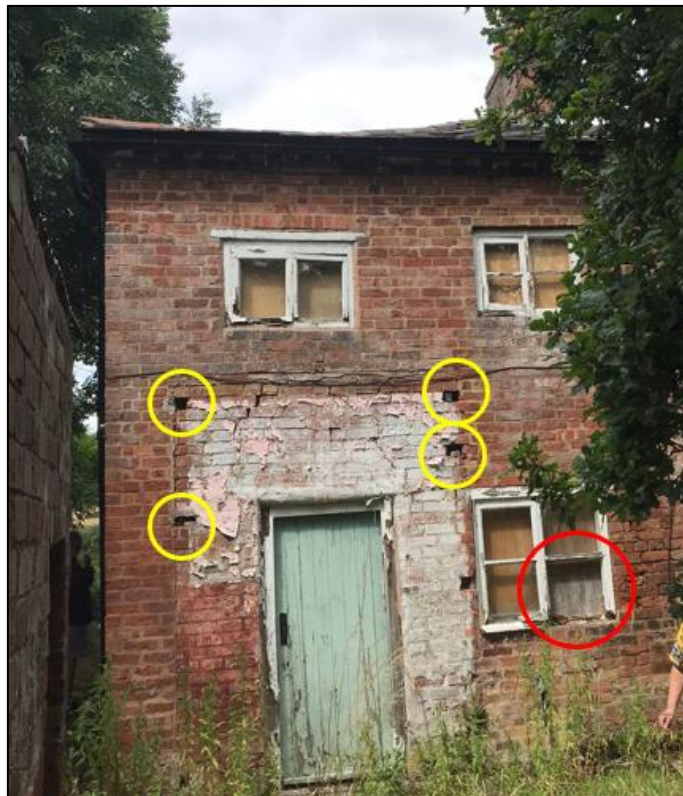
Suitable roosting features around the Chapel building include gaps around the wall tops where the roof tiles have lifted from the brick, holes in the brickwork at the rear of the property where an old extension has been demolished, a gap above the front door frame on the northern aspect of the building and a broken window on the first-floor of the Chapel overlooking the staircase which was large enough to allow access into the property for bats. There are also several lifted and missing roof tiles, gaps where the lead flashing around the chimney has lifted and gaps within the brick work of the chimney where the chimney has moved over time. (*Plates 9 to 11*).

*Plate 9. Holes in the brickwork on the rear of the property and damaged window frames/broken panes of glass*

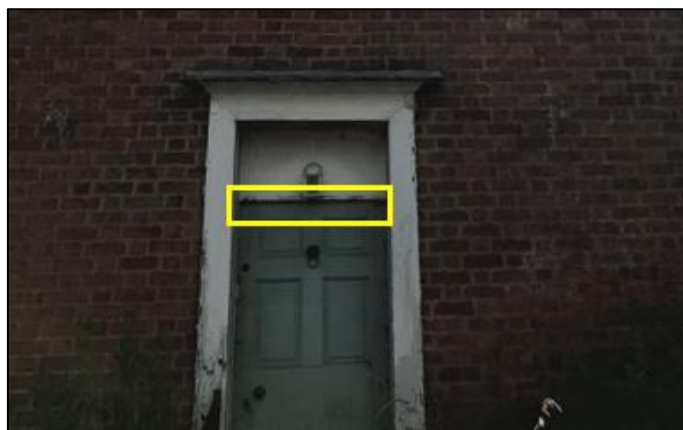
*Plate 10. Gap above the front door*

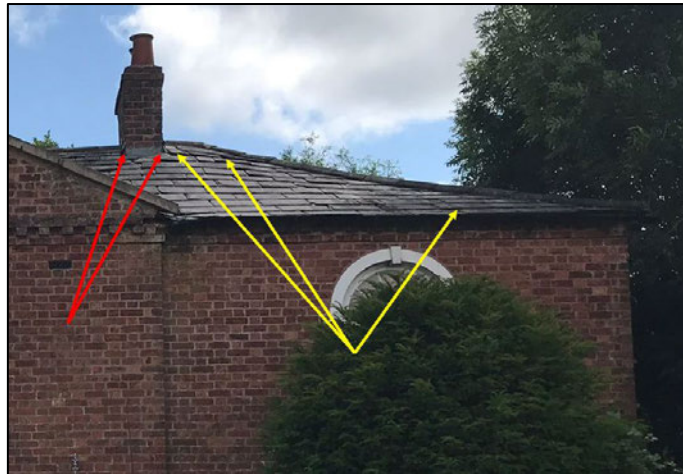
*Plate 11. Examples of lifted roof tiles (yellow arrows) and gaps under the chimney flashing (red arrows)*

- Roof stripping and the removal of the slate tiles and ridgeline tiles will be completed under the watching brief of a licenced ecologist, with the roof tiles being removed carefully by hand. Supervision by the ecologist of repair works to the roof, chimney and ridgeline will also be required due to these features offering suitable roosting areas for bat species.

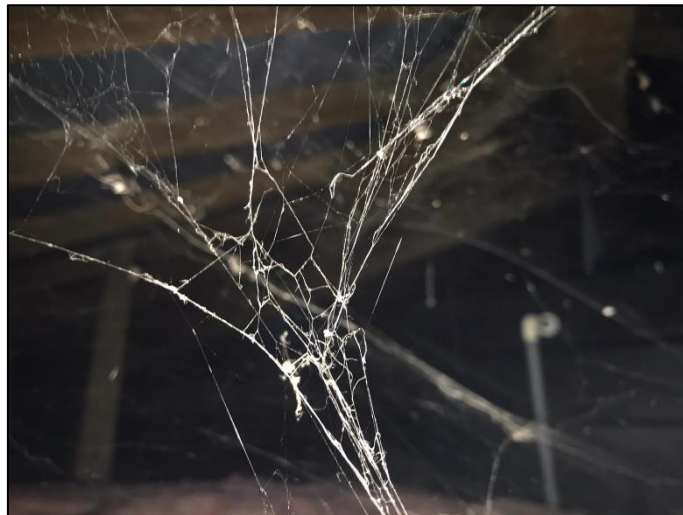
There were no bat droppings recorded within the loft space of the Chapel with cobwebs observed along the wall top inside the loft (*Plate 12*), however due to the limited access available into the loft space and the gaps noted around the chimney, gaps where tiles have slipped and gaps along the wall tops Chapel House offers roosting areas for bat species with access easily possible for bats into the loft space and wall tops.

*Plate 12. Cobwebs over beams within the loft space*

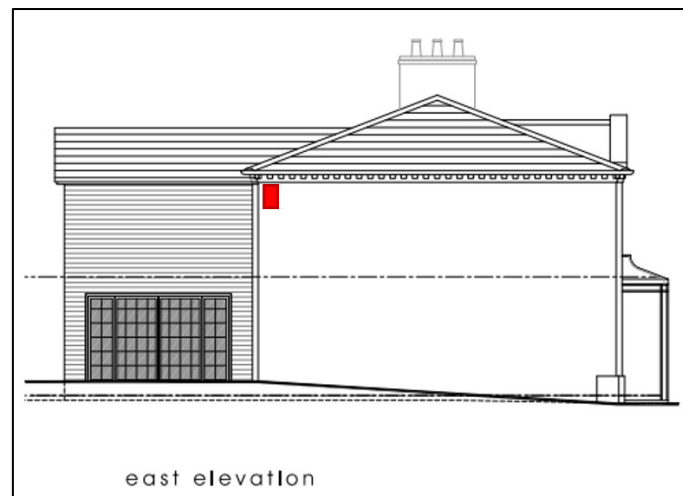
Figure 9. Proposed Beaumaris Woodstone bat box location on Chapel (red rectangle)

- If roosting features are to be lost then these must be replaced with similar features during the construction phase of the extension.
- Additional simple roosting features will also be created by incorporating at least two bat tiles and one Beaumaris Woodstone Bat Box (or equivalent) into the new extension section of the property (*Figures 9 & 10*).

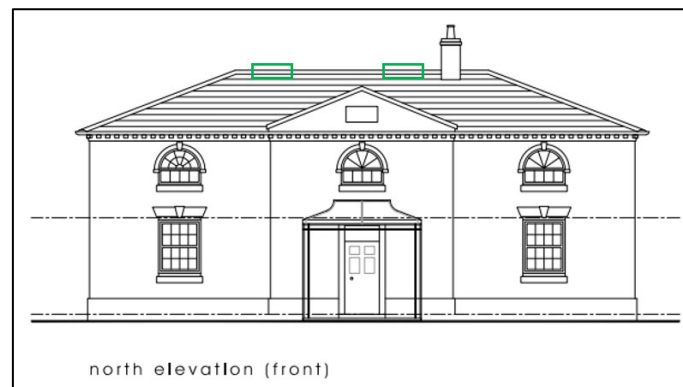
Figure 10. Proposed lifted ridge tile locations on Chapel (green rectangles)
