**PAT'S COACHES  
DERWEN HOUSE  
SOUTHSEA ROAD  
SOUTHSEA  
WREXHAM  
LL11 6PP**

**TREE ASSESSMENT REPORT**

| <b>Date of Survey</b> | <b>16 August 2023</b> |
| <b>Reference</b> | <b>082023/TAR/KD</b> |

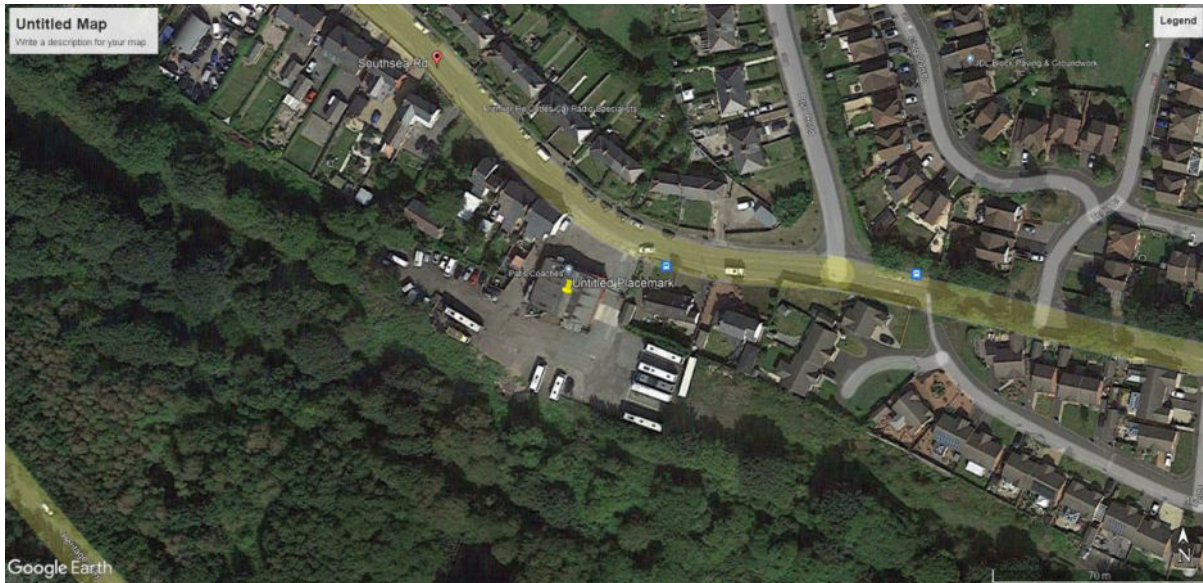
As I did not view the site prior to the recent works, it is not possible to determine exactly how many trees were removed, but in looking at the Google Earth imagery before and after the works (see *Appendix 1*) it appears that a small number of trees in the Southeast of the site were removed. One rootball dumped in the area of rough vegetation to the South of the car park area near the East boundary of the site was identified as a mature Cherry. The client stated that the tree contractor employed to carry out the tree works identified the trees that were removed as Ash, which were showing signs of decline due to Chalara Ash Dieback Disease.

Google Earth image pre-development works.

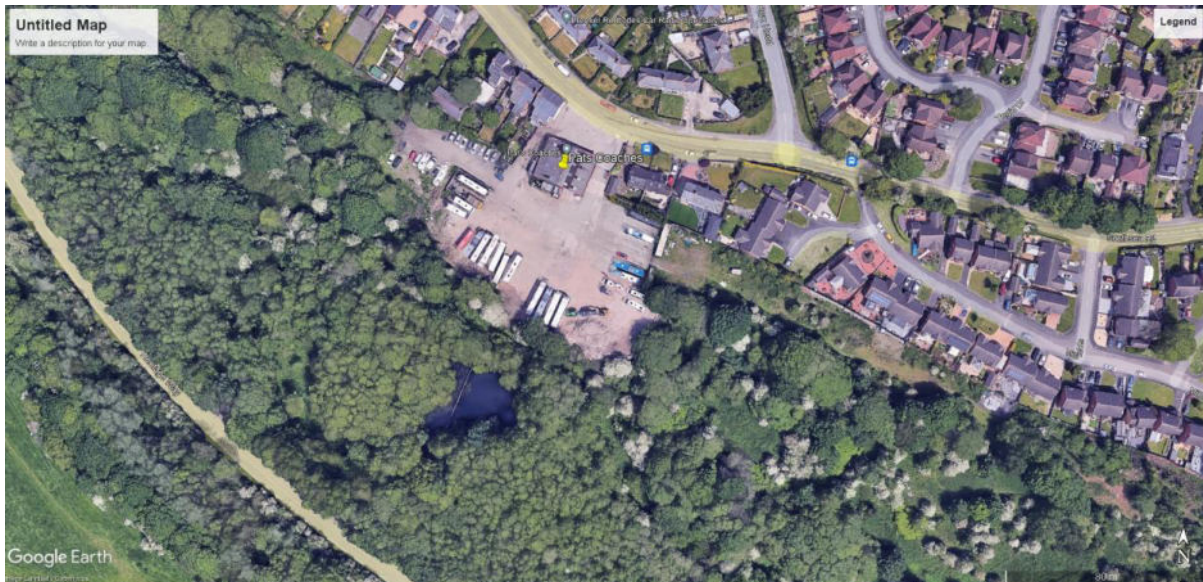
Google Earth image post-development works.

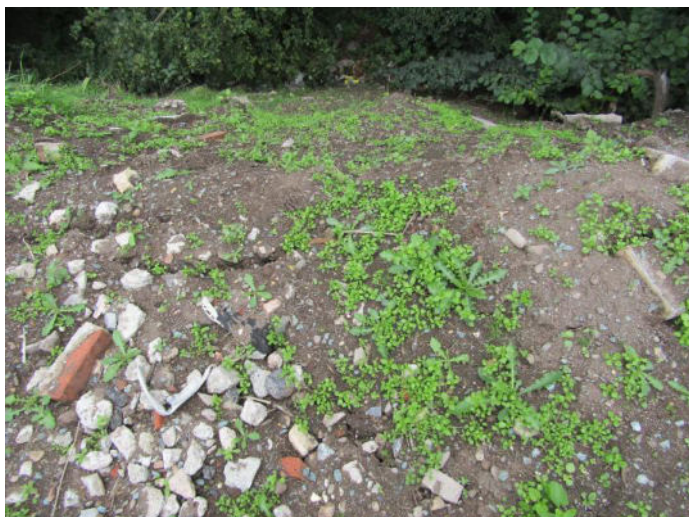
The existing hardstanding parking area for coaches, to the rear of the coach depot has been extended to the South, by infilling an area of rough vegetation on the former railway line, with hardcore and soil. The surface of the infill has been levelled and compacted. The infill has increased the existing grade by circa 4-5m depth and the material has spilled to create an uncompacted bank down into the edge of the woodland.

Photo 1: Soil and rubble on edge of infill.

The existing rough vegetation in the area to the South of the car park, near the East boundary of the site will be trimmed down and a layer of 30cm clean topsoil (to BS3882) will be applied to the surface. Similarly a 30cm layer of clean topsoil will be applied to the surface of the bank of the hardcore infill, to provide a suitable growing medium for the new plants.

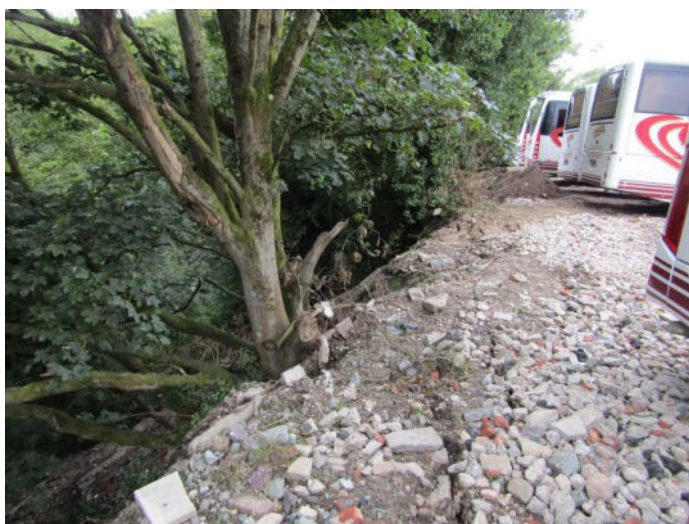
Some of the mature Sycamore and Common Alder trees (circa 4-5 trees) located on the woodland edge have material piled up against the trunks. Some branches and stems have been broken, with resulting torn and split stubs.

The impact damage to the trunks has caused bark wounds and the broken branches and stems have resulted in torn and split stubs. These wounds provide entry points for pathogens (fungi, bacteria, insects etc.) which can result in decay developing in the wood tissues.

The affected trees are likely to decline in condition over a period of years due to compaction and possible decay.

Photo 2: Sycamore with rubble piled around trunk.

It is recommended that the trees on the woodland edge that have been impacted by the rubble and soil piled against the trunks, be coppiced (above level of soil around stems) and allowed to regenerate by the development of new shoots. These trees will then need to be managed in the future as coppice stools, by re-cutting on a 7-year cycle. Coppicing these trees will enable additional light to reach the new trees to be planted.

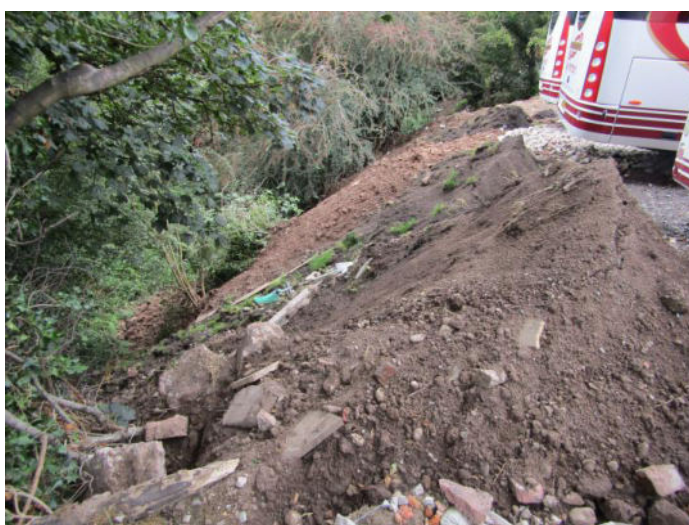
Photo 3: Soil and rubble on edge of infill.

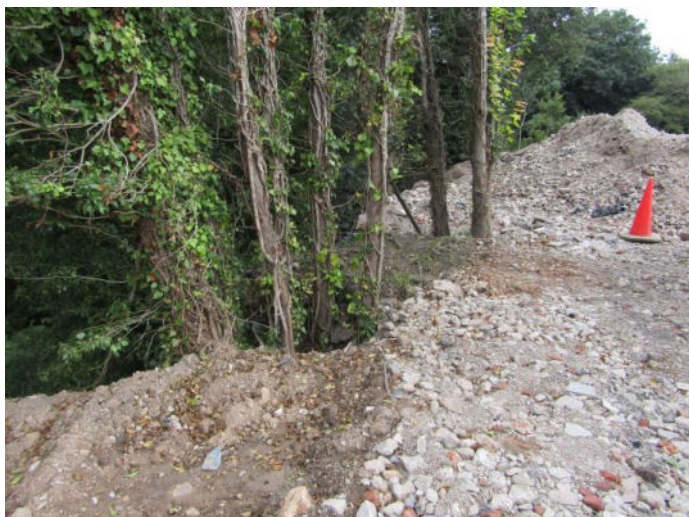
Increasing the grade of the soil within the Root Protection Area of a tree can have a significant negative effect on the tree condition due to compaction. Compaction destroys the large macropores in the soil, reducing the air pockets which impedes the ability of the roots to respire (absorb oxygen and release carbon dioxide). This affects the gaseous exchange at the soil surface, which can result in the roots suffocating and dying. Compaction of the soil limits the ability of the roots to extend and grow, resulting in stunted growth. Compaction also restricts the drainage in the soil, leading to waterlogging. The mature Sycamore and Common Alder trees on the woodland edge with material piled around the trunks are likely to decline in vigour and health. This may take several years for the symptoms to become evident in the crowns.

Photo 4: Sycamore and Alder trees with rubble piled around trunks.

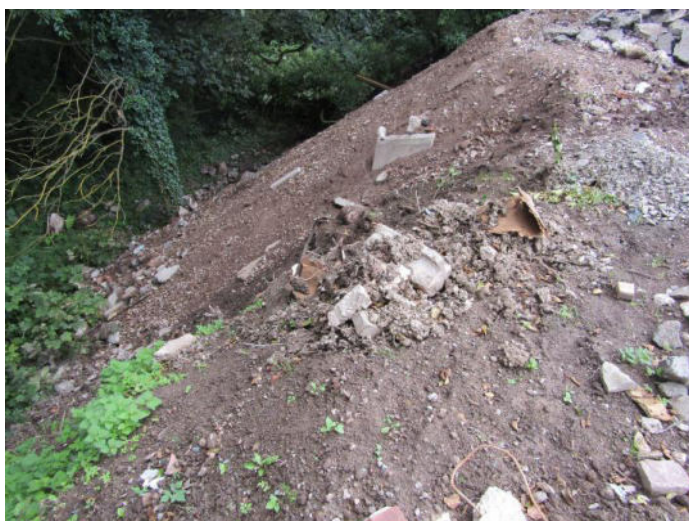
Photo 5: Sycamore with rubble and soil piled against trunk.

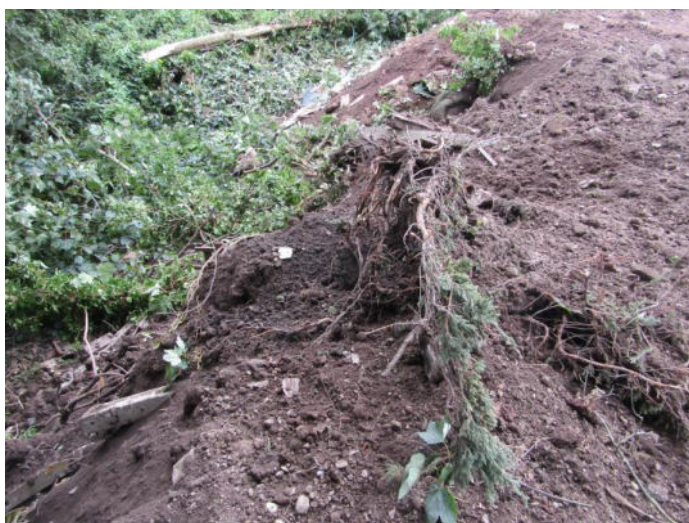
Photo 6: Soil and rubble on edge of infill.

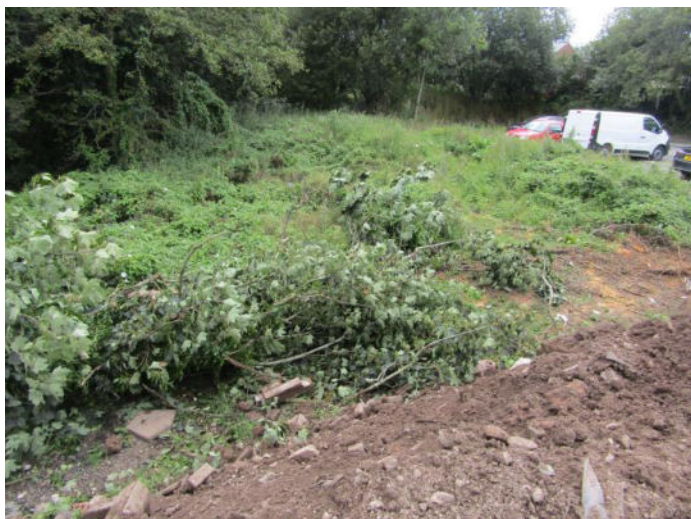
Photo 7: Area of rough vegetation to South of car park area.
