SITE AT 332260, 356840, BRISTOL

## APPENDIX 3

### Site Walkover Photographs

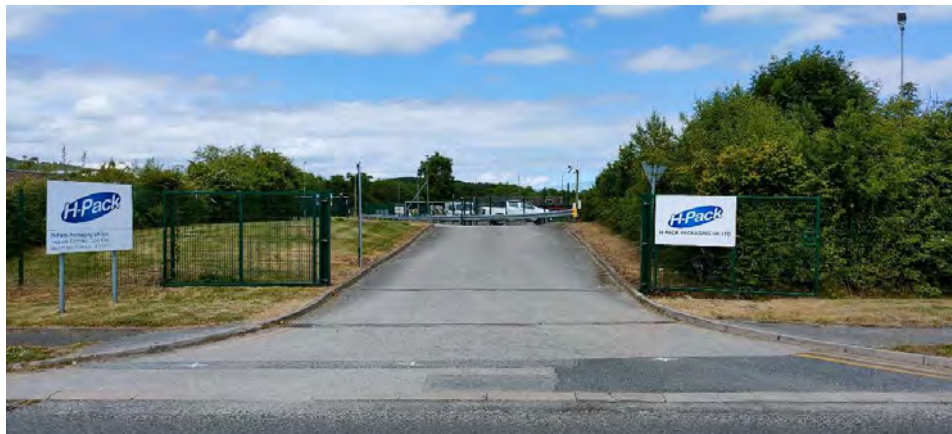
1. H-Pack main entrance from Davy Way.

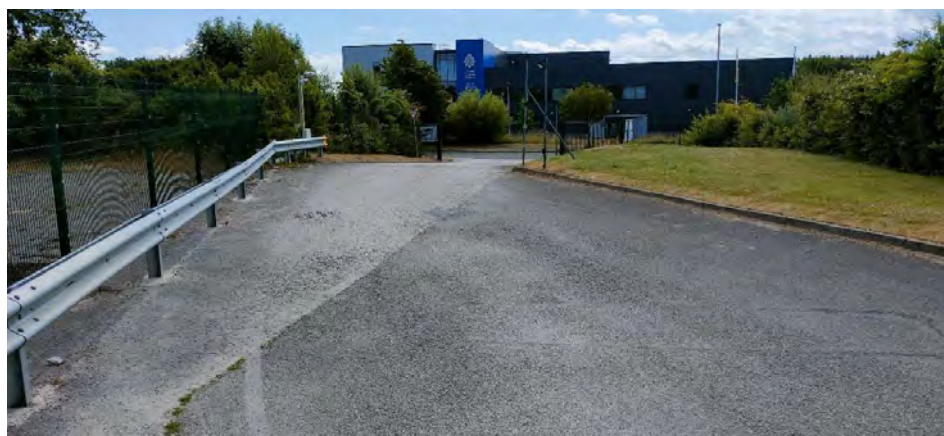
2. Access road from Davy Way.

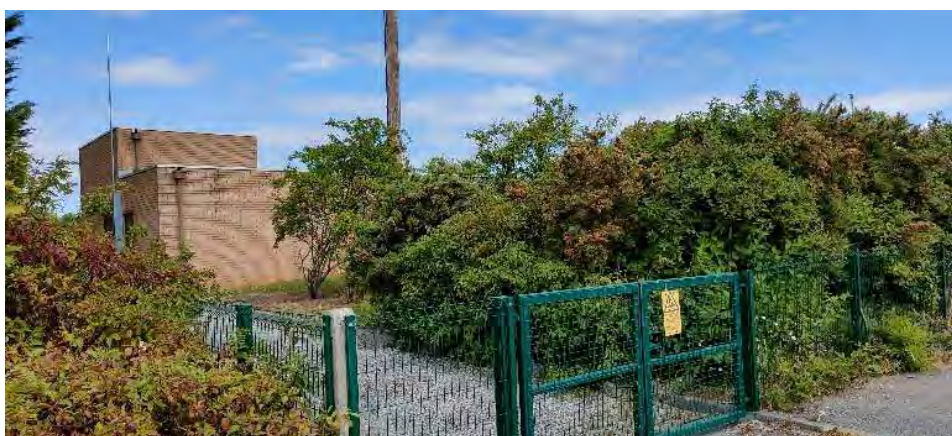
3. Electrical Substation in the southern tip of the Site.

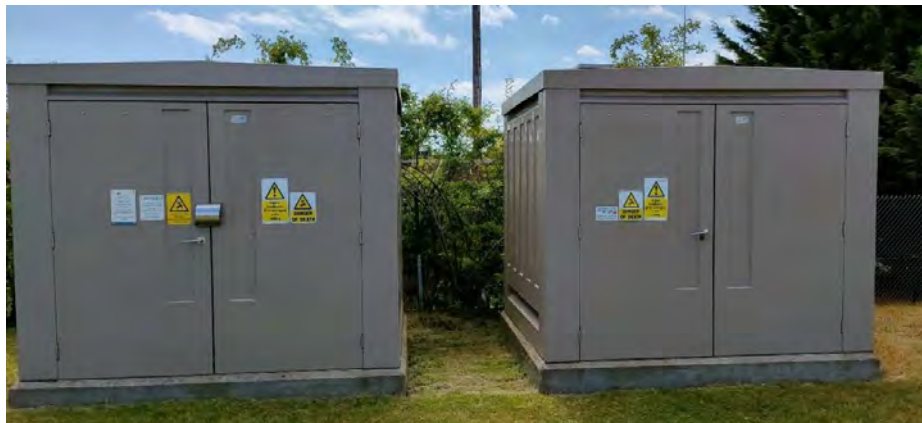
4. Further electrical substation units in the southern tip of the Site.

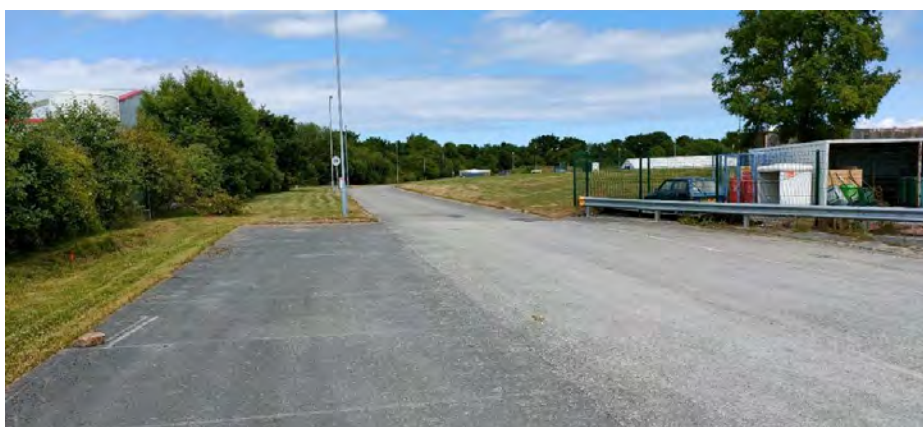
5. Access road between the electrical substation and the main Development Site.

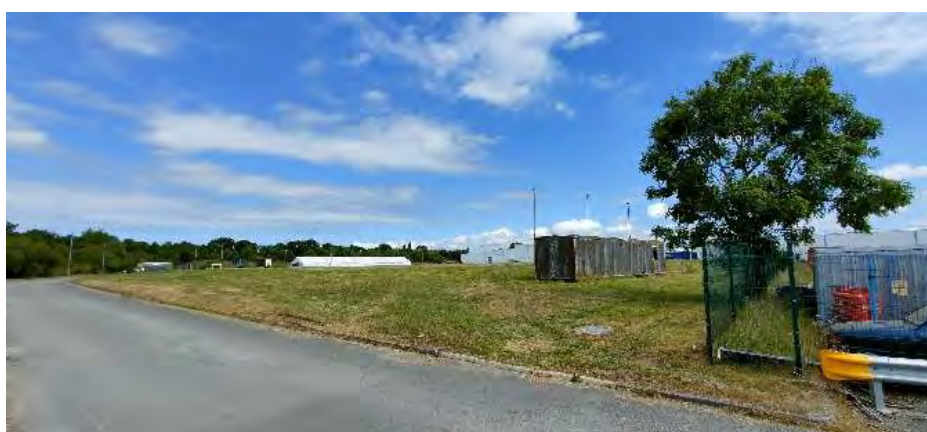
6. Access road from the south to the main Development Site.

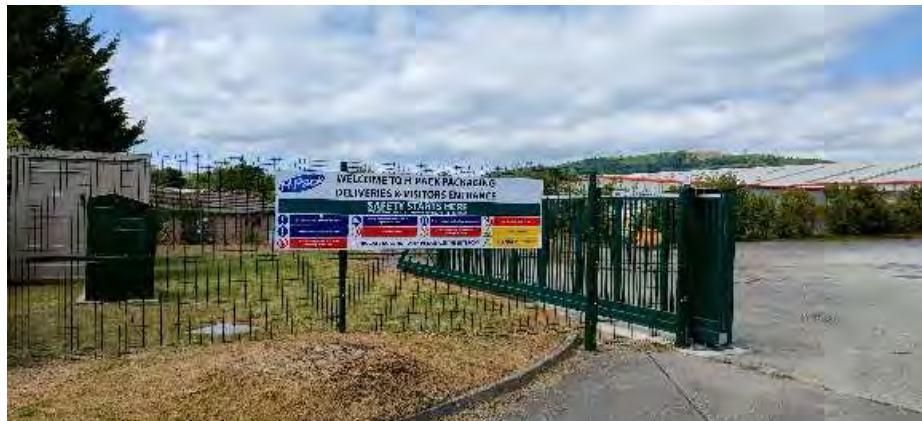
7. Second entrance gate, electrical substation units to the left.

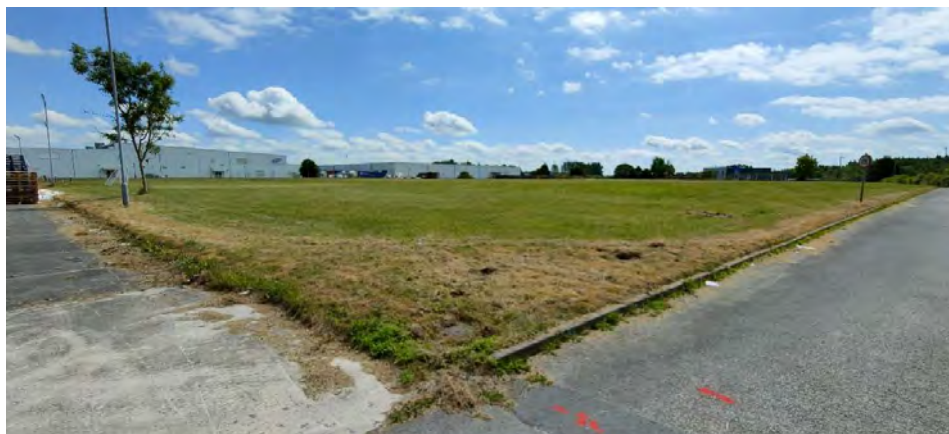
8. Development Site, view from the north-west towards the south-east.

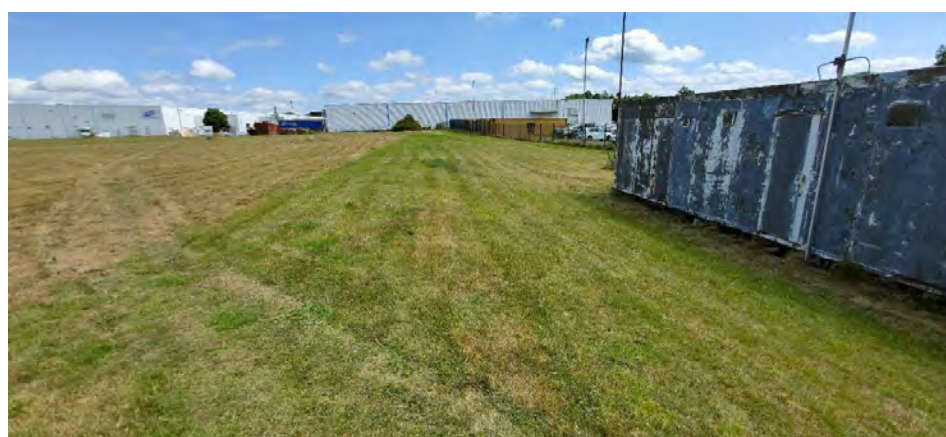
9. The southern area of Development Site.

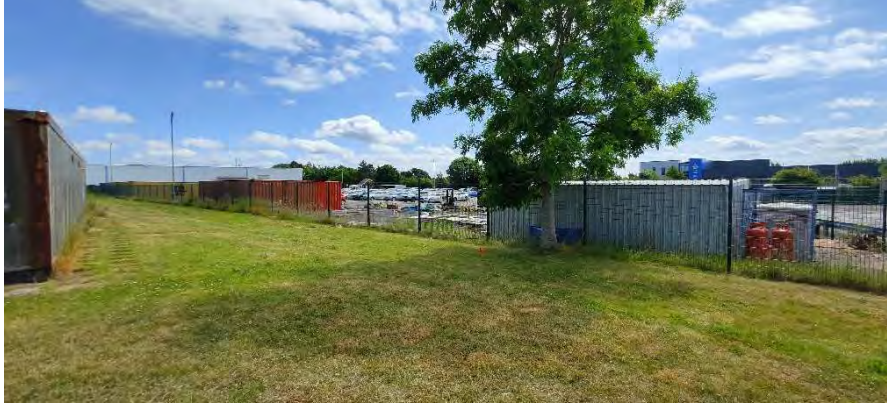
10. South-eastern Development Site boundary, SHARP carp park behind the fence.

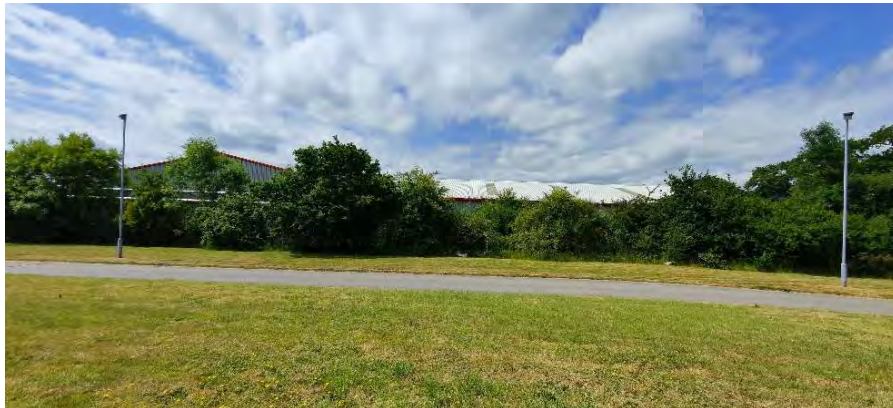
11. Access road to the south-west and the west of the Site.

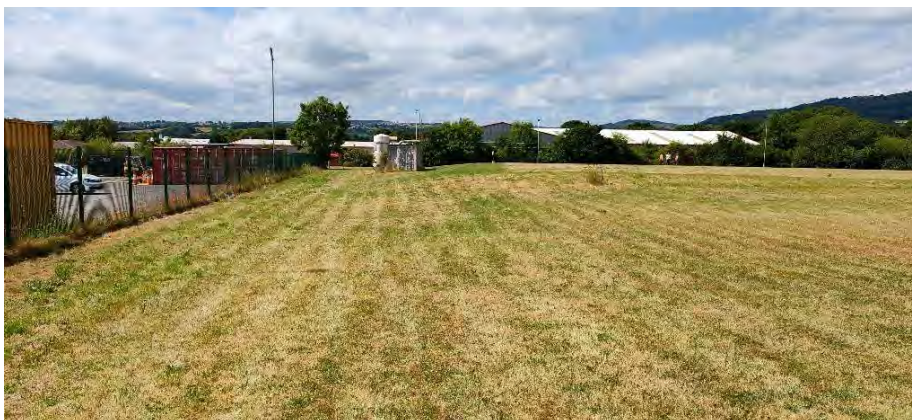
12. Development Site, view from the south-eastern corner towards the south-west.  
South-eastern boundary to the left.

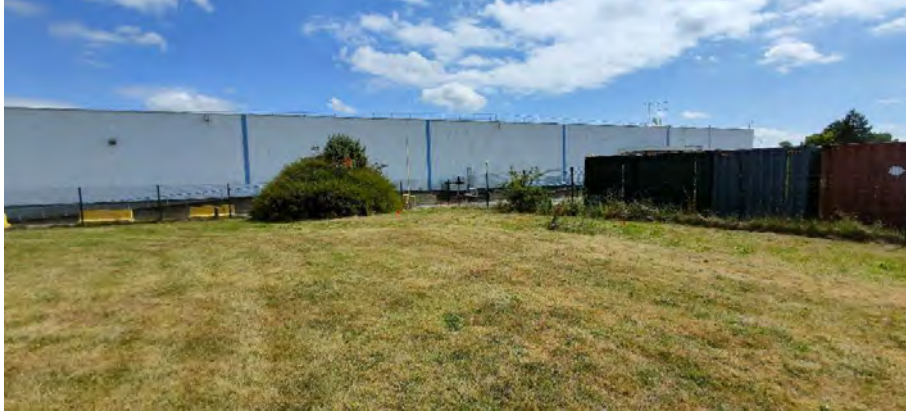
13. View towards the south-eastern corner of the Development Site, SHARP warehouse behind.

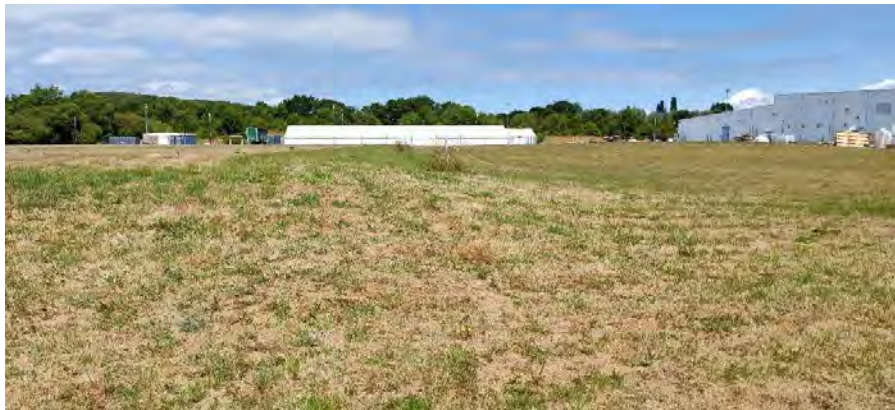
14. View from the south-east towards the north-west of Development Site.

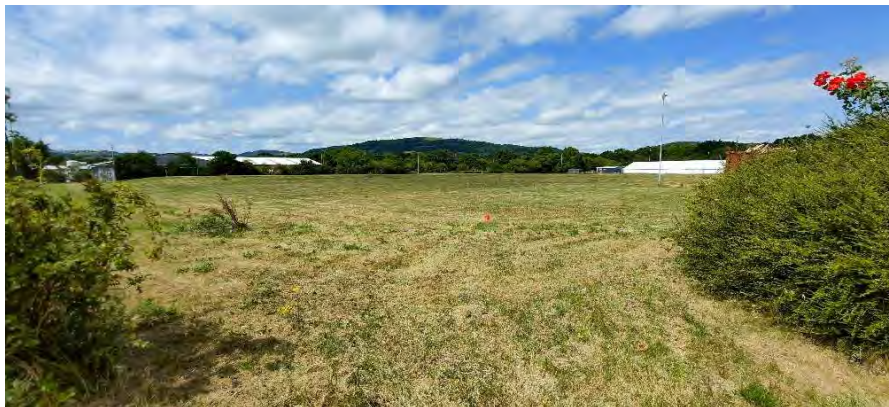
15. View from the south-eastern corner towards the north-west of Development Site.

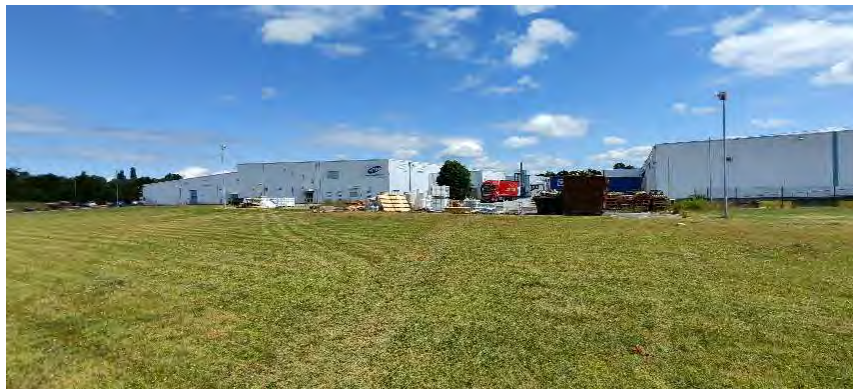
16. H-Pack warehouse to the left and SHARP warehouse to the right along the eastern Development Site boundary.

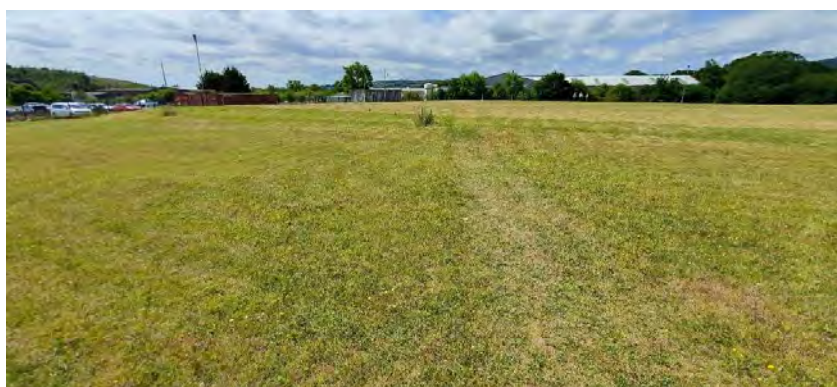
17. The centre of Development Site, currently a football pitch and a “desire” footpath crossing the field. The central part of the football pitch is slightly elevated.

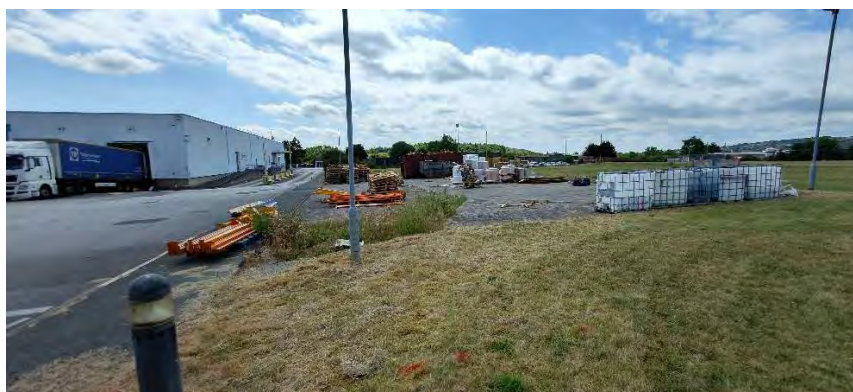
18. Eastern boundary of Development Site, view towards the south and SHARP warehouse to the left.

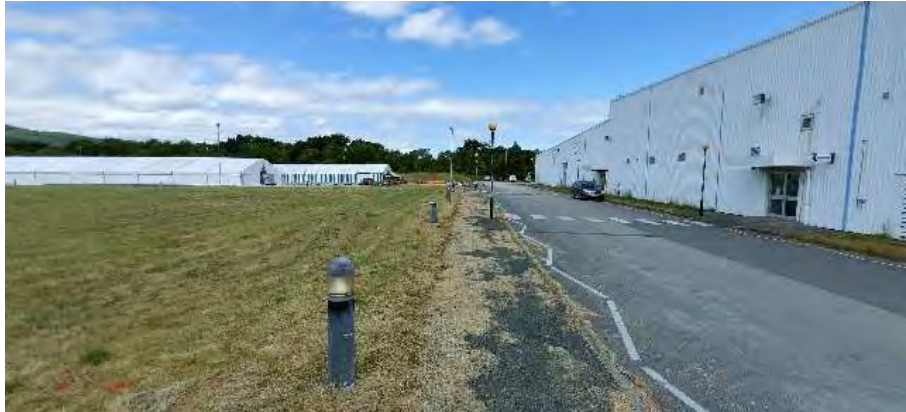
19. Eastern boundary of Development Site, view towards the north and H-pack warehouse to the right.

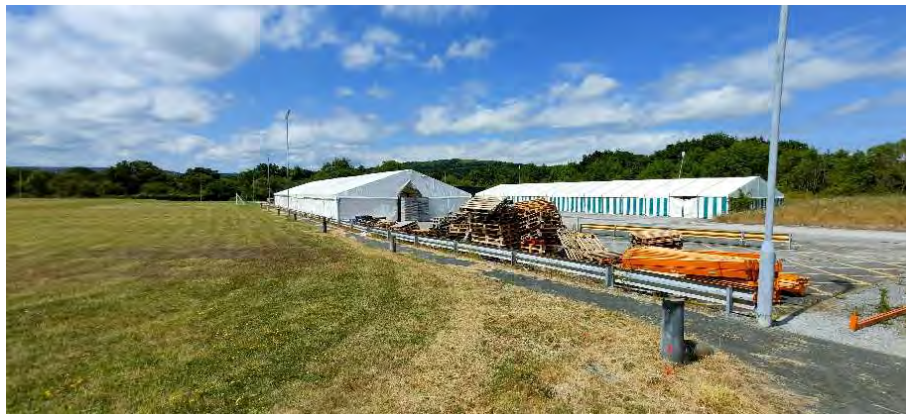
20. Eastern part of Development Site, football pitch to the left, access road and temporary storage units to the right.

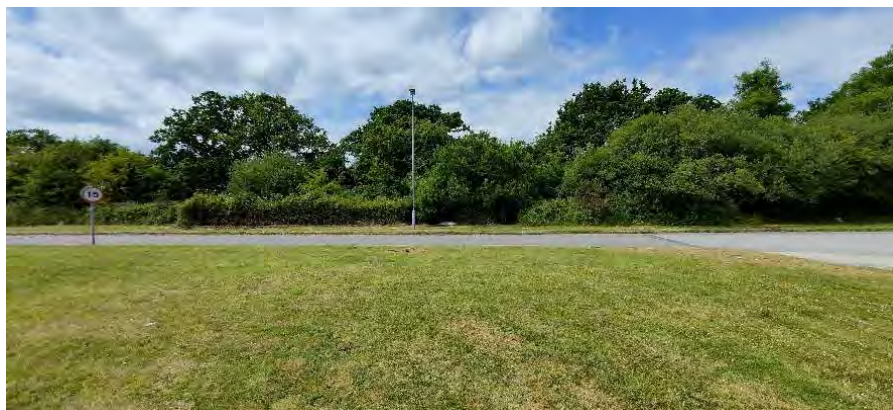
21. Access road east of the Site, view from the football pitch to the east.

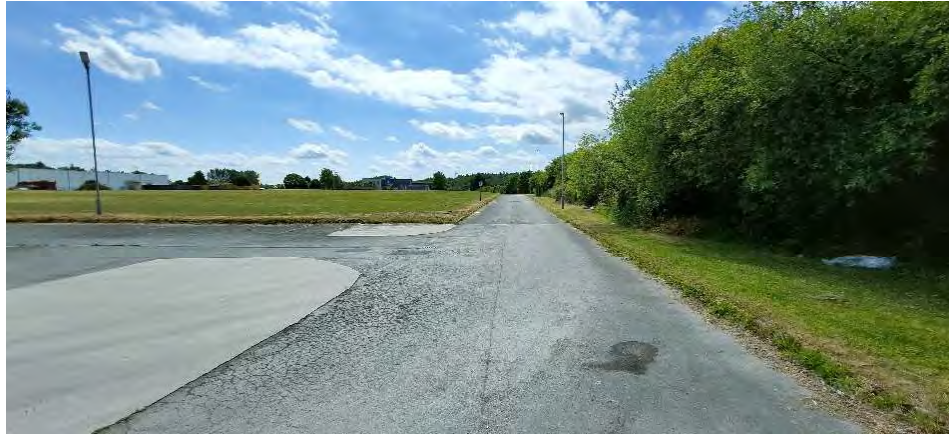
22. Access road west of the Site, view towards the south.

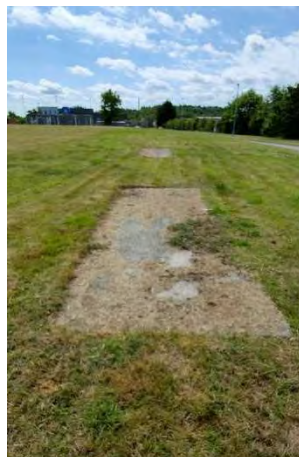
23. Occasional concrete slabs in the area of the proposed warehouse.

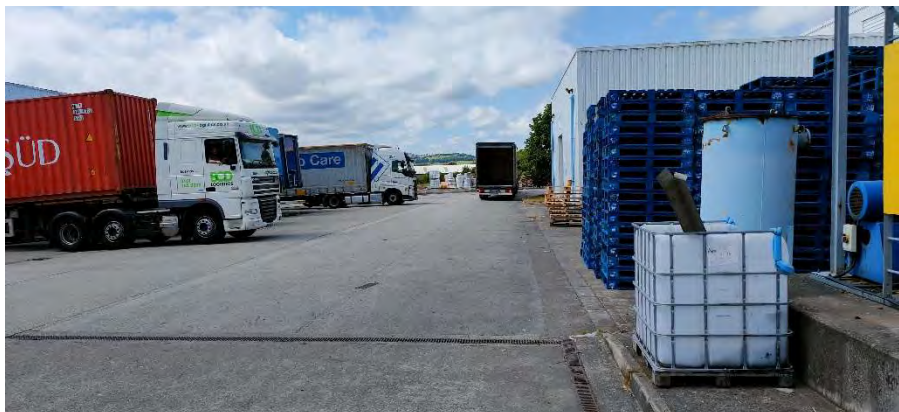
24. Access road between the SHARP and H-PACK warehouses.
