## **BAT GROUND LEVEL TREE ASSESSMENT**

### **Plot 3A**

Wrexham Industrial Estate  
Wrexham  
Wrexham County Borough  
L22 3XS

| UES reference: | UES03448/06 |

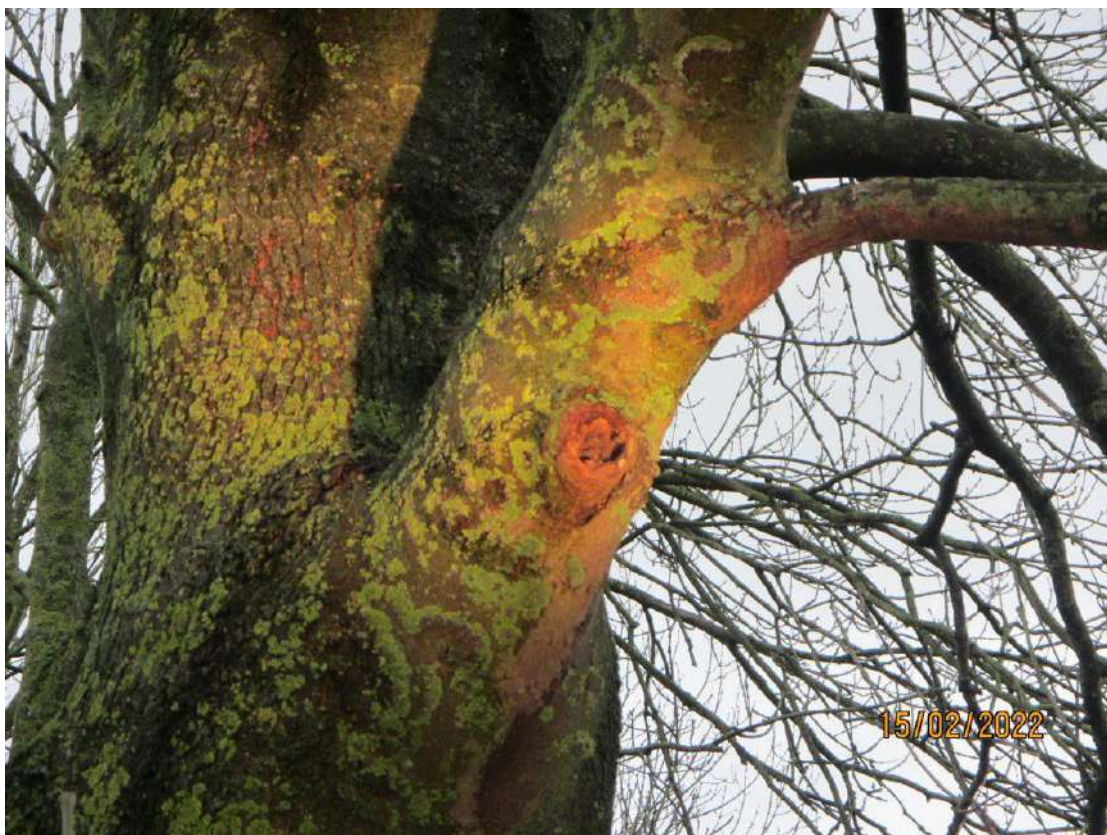
Photograph 1 – T1

**T1** is a dead tree of unknown species which lies at the south-west corner of the site, surrounded by dense scrub. It is approximately 3m in height with a diameter at breast height (DBH) of 0.7m. The tree features fissures in the stem and knot holes, and is considered to have moderate roosting potential.

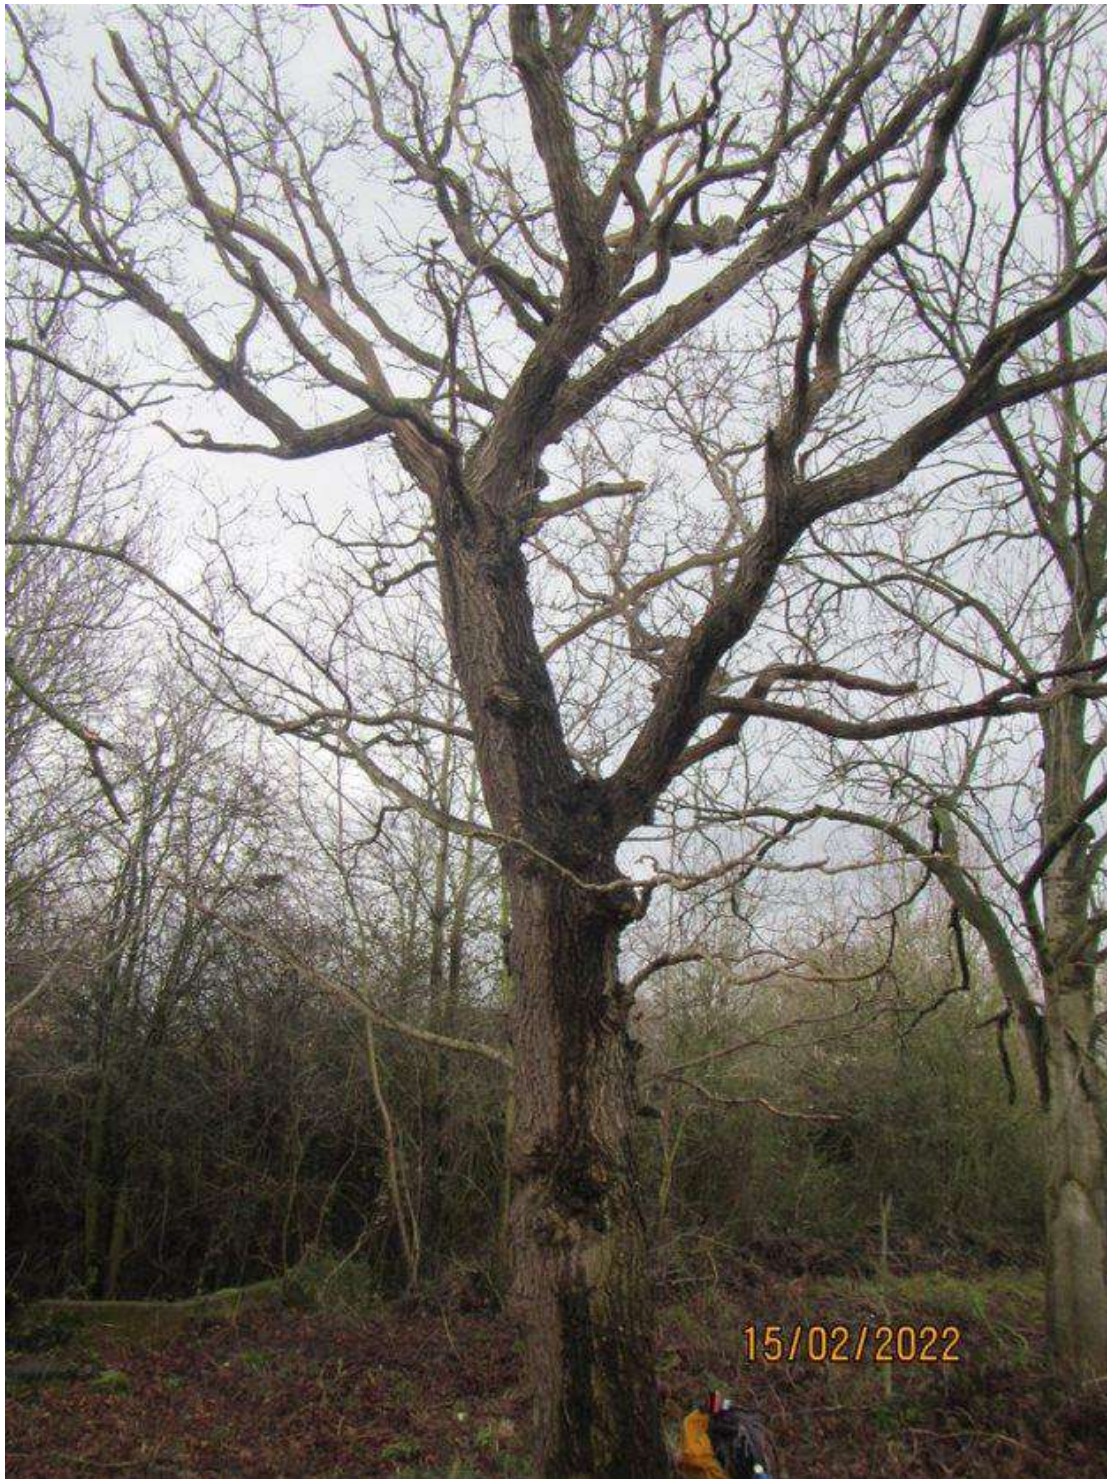
Photograph 4 – T3 showing tear-out at base of crown.

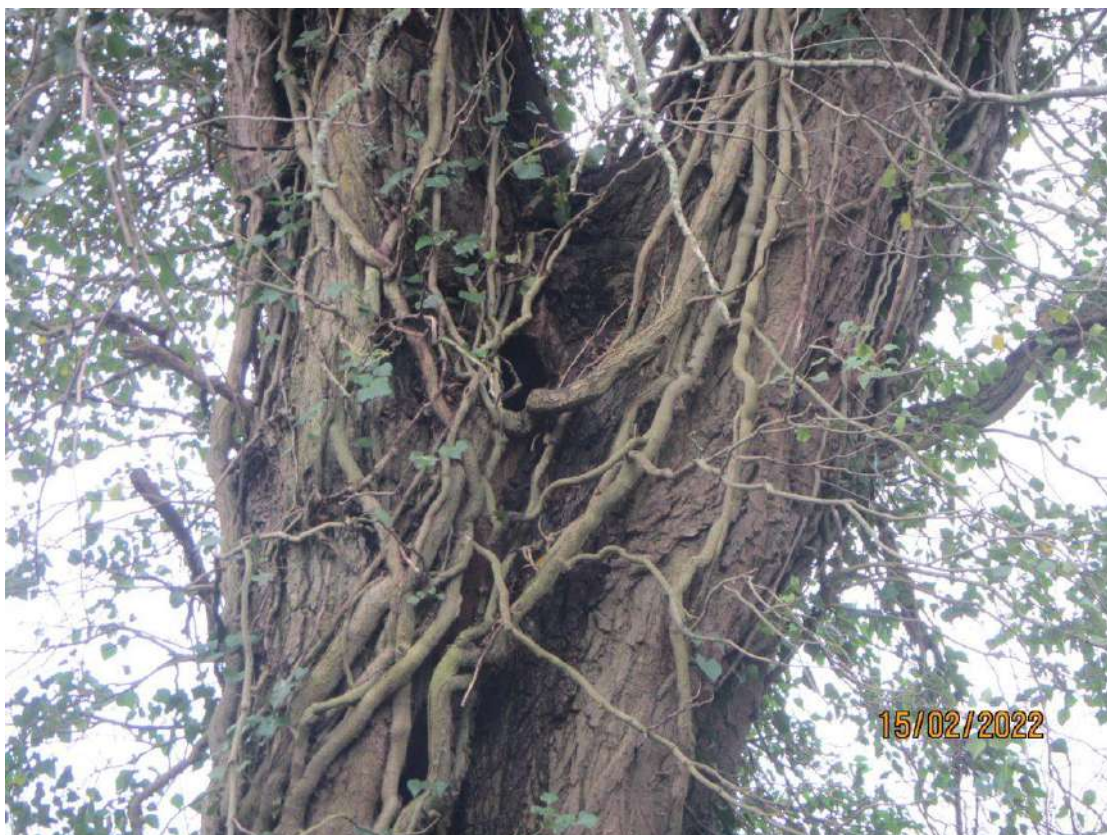
**T5** is a large Lombardy poplar *Populus nigra* "*Italica*" found just beyond the north-west corner of the site. It is approximately 25m in height with a DBH of 1.2m. The tree features a hollow stem from ground level upwards. This tree is considered to have moderate potential to support roosting bats.

Photograph 6 – T5 showing hollow stem.

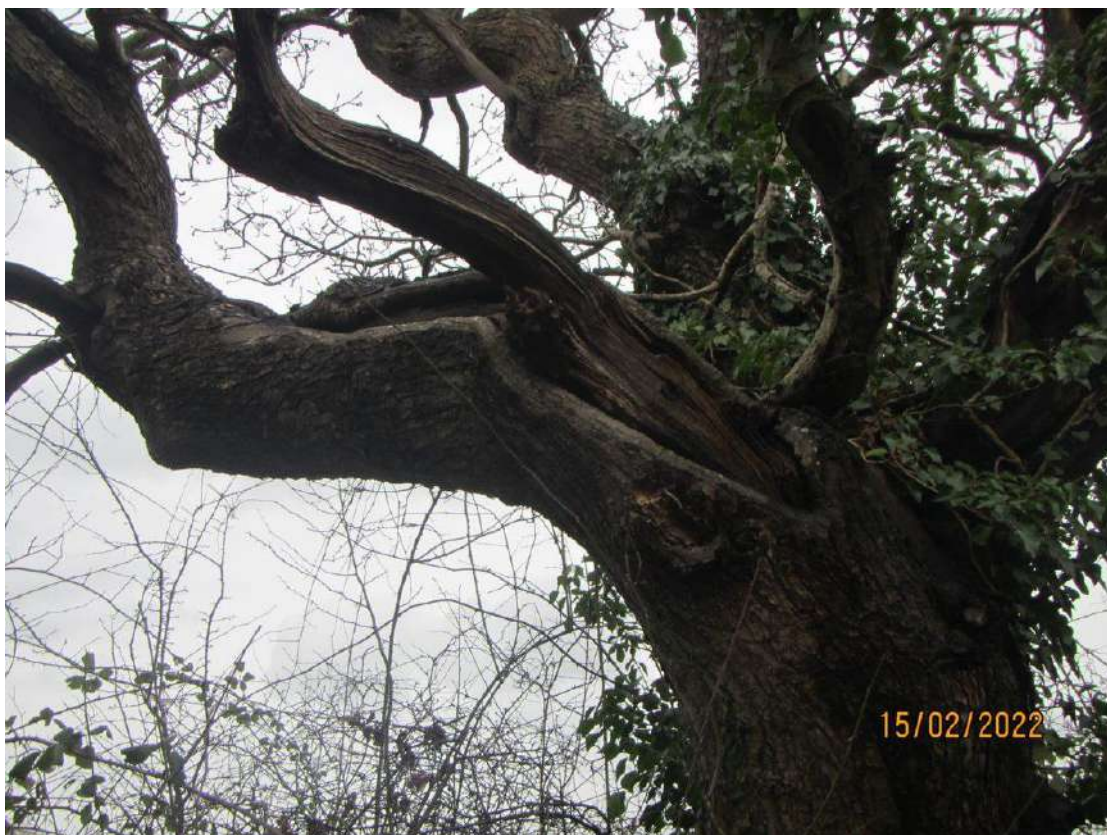
**T6** is the northernmost of a line of mature pedunculate oaks found in the continuous scrub which separates two areas of rough grassland in the north-west of the site. It is approximately 9m in height with a DBH of 0.8m. The tree features two tear outs on its western aspect at ~2.5m and 4m, large areas of flaking bark, and several hollow limbs. This tree is considered to have high potential to support roosting bats.

Photograph 8 – T6 showing tear-out.

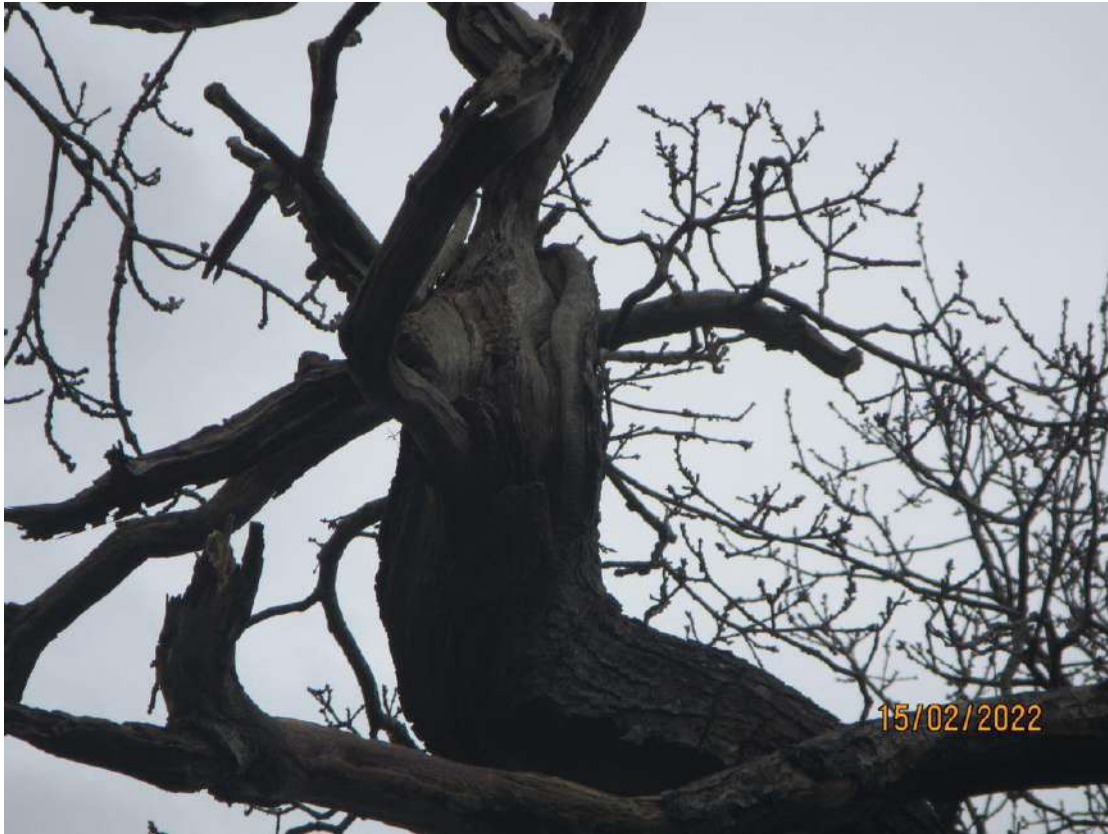
Photograph 9 – T6 showing tear-out.

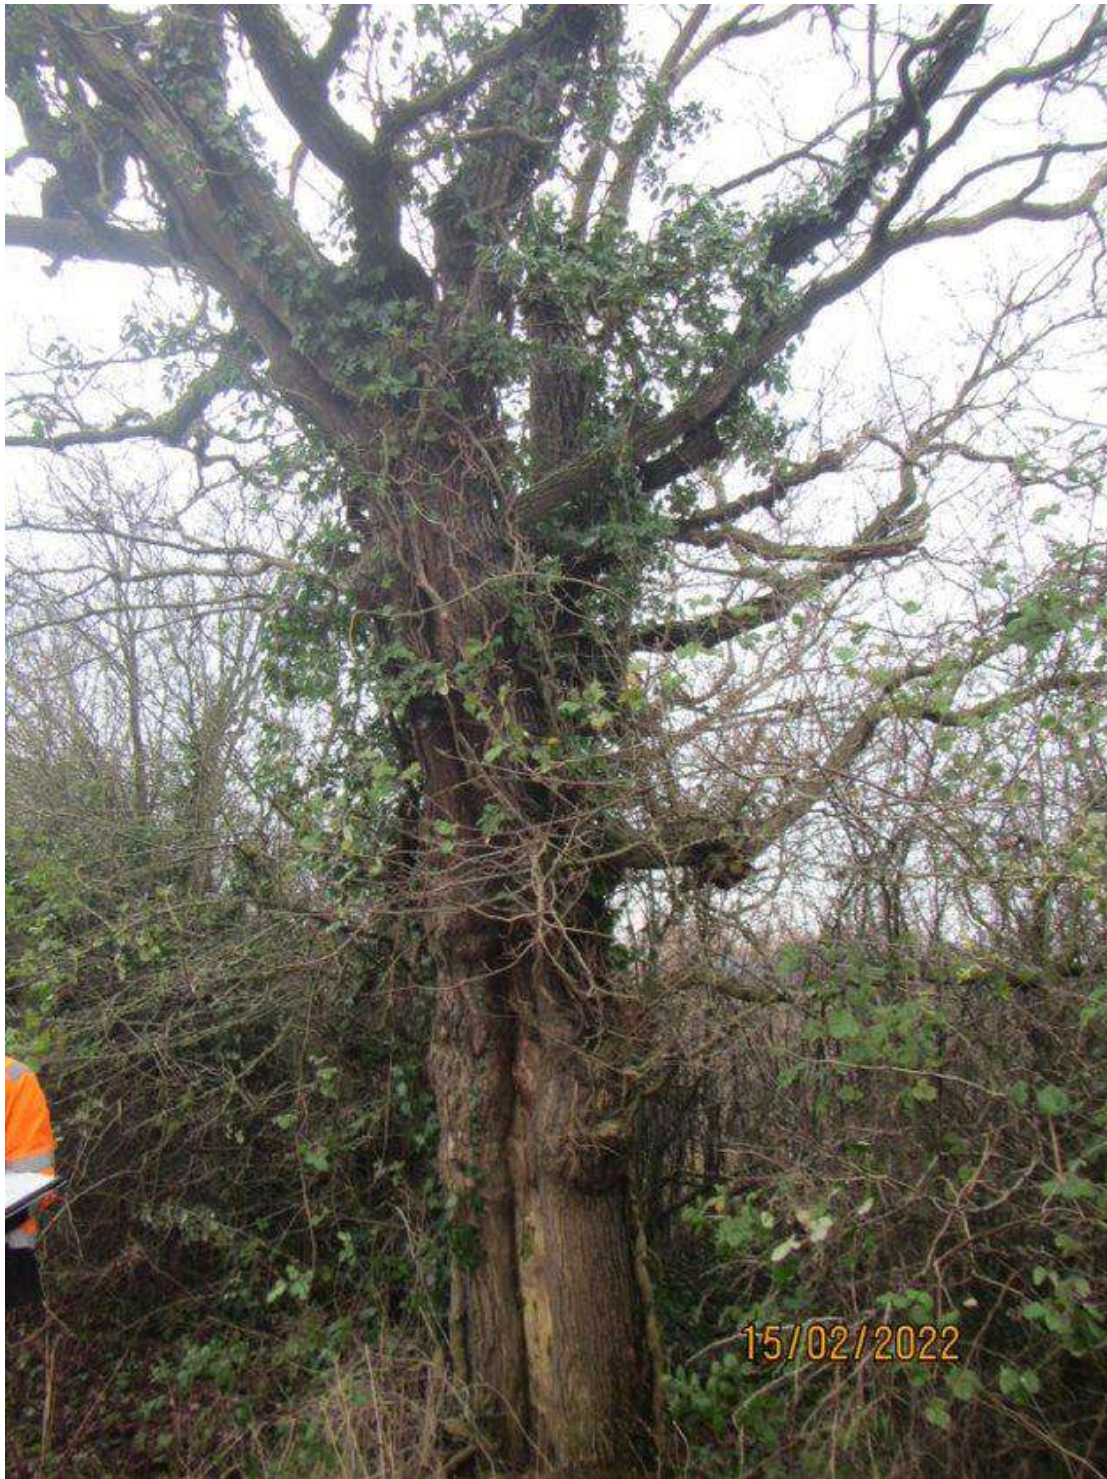
**T7** is a mature pedunculate oak found just to the south of T6, in the same line of scrub. It is approximately 9m in height with a DBH of 1.0m. This tree features a large callus roll from ground level on its south-eastern aspect, and an area of lifted bark at around 2m on its southern aspect. This tree is considered to have high potential to support roosting bats.

Photograph 10 – T7 showing callus roll and ivy cover.

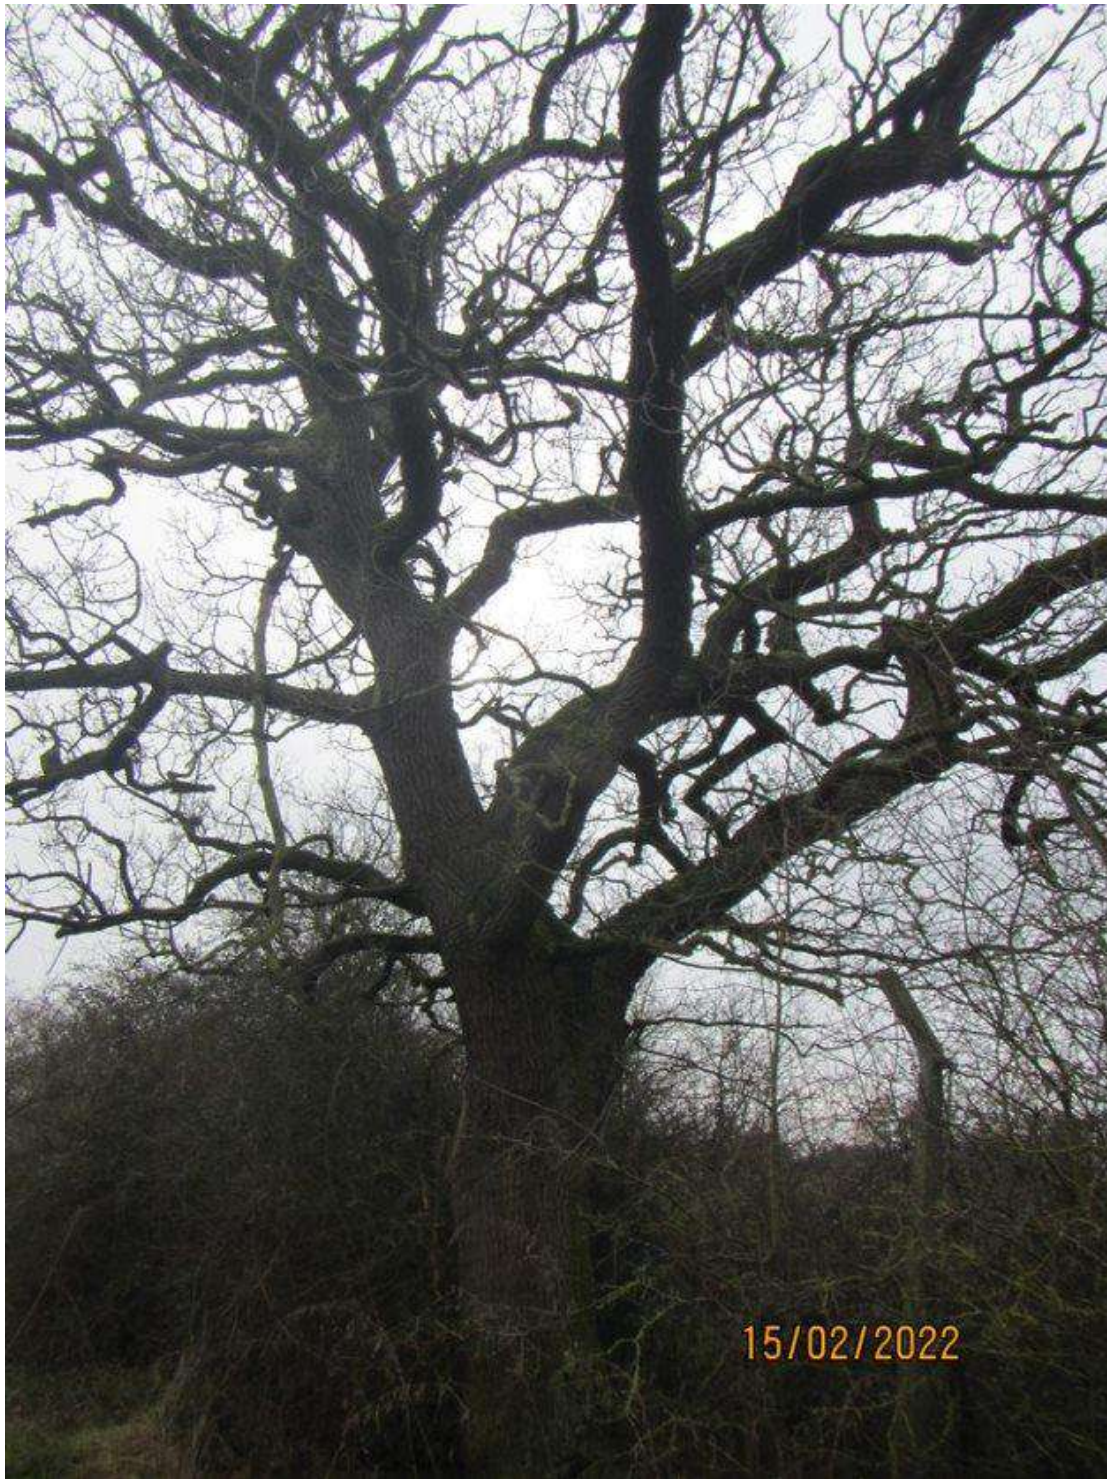
Photograph 11 – T8.

**T8** is the next mature pedunculate oak in the line of scrub, heading south. It is approximately 12m in height and has a DBH of 1.0m. The tree features a broken branch at around 5m on its eastern aspect, and deadwood at 3m on its north-western aspect. This tree is considered to have moderate potential to support roosting bats.

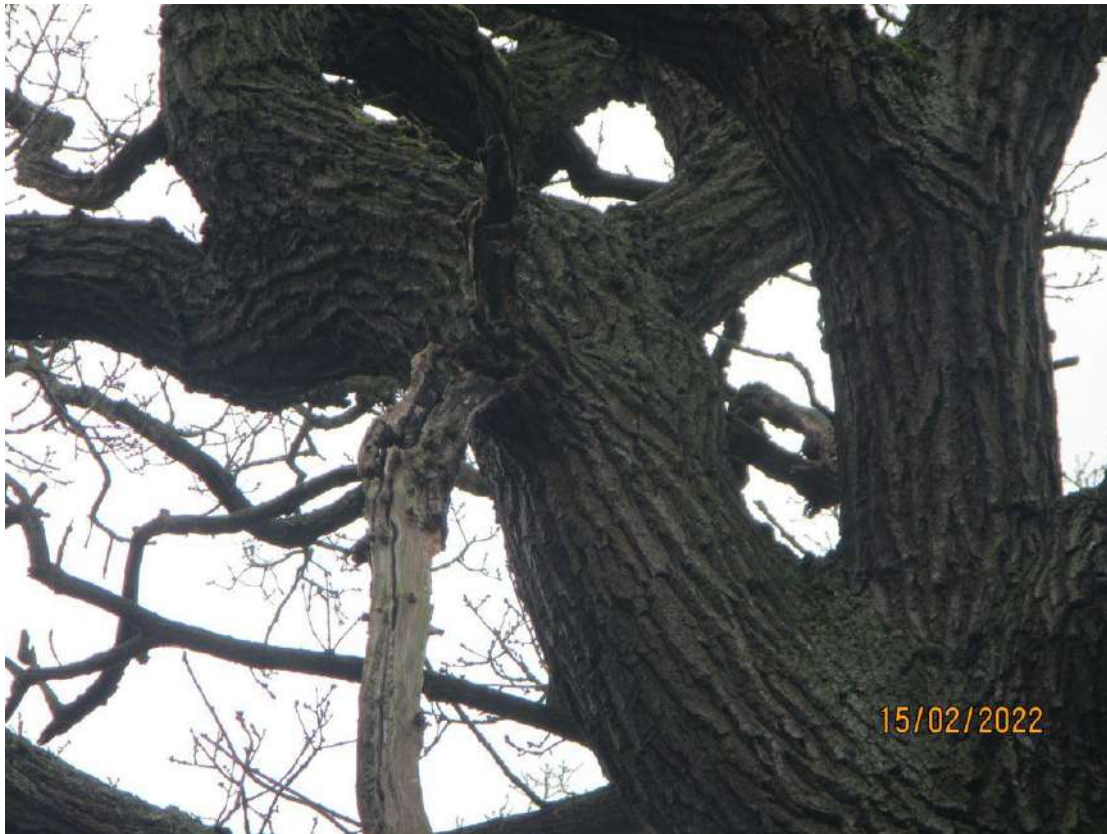
Photograph 12 – T8 showing cavity created by broken branch.

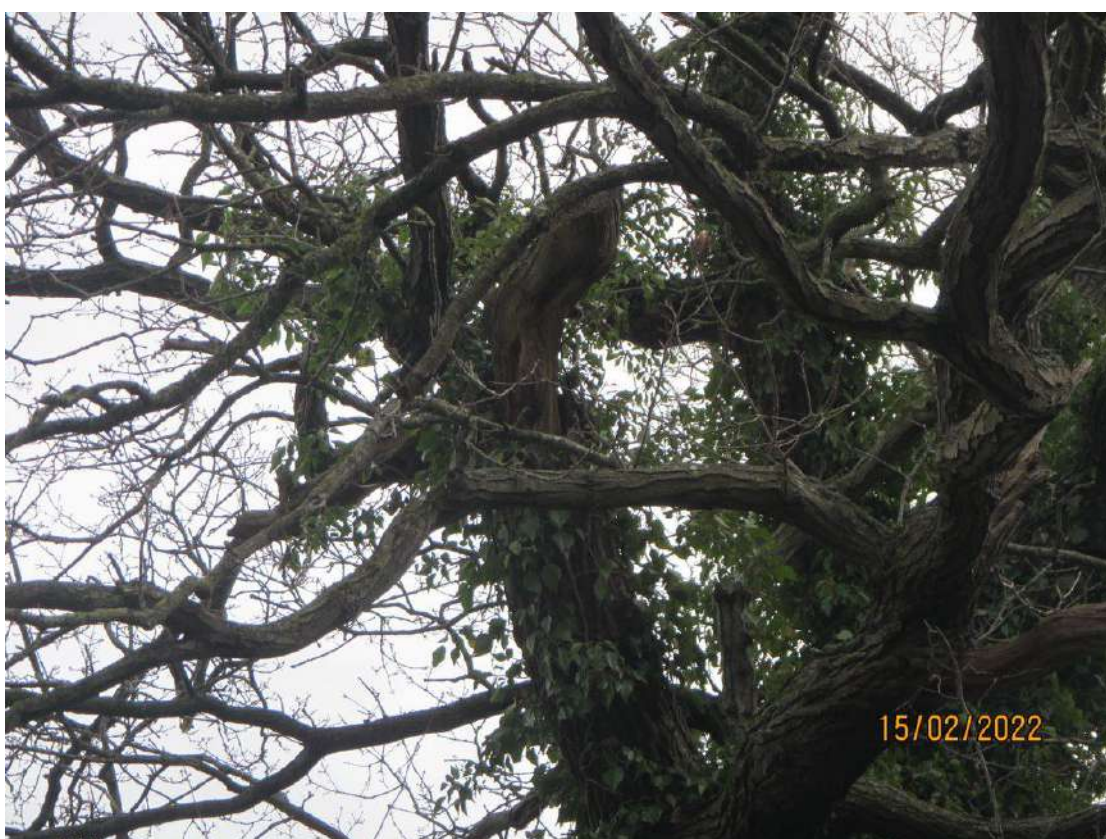
**T10** is the next mature pedunculate oak in the line of scrub, heading south. It is approximately 15m in height with a DBH of 1.0m. The tree features loose bark around some deadwood at 7m on its western aspect, a tear out at 6m on its northern aspect, a callus roll at ground level and another at 4m on its southern aspect, and a knot hole at 12m on its southern aspect. This tree is considered to have high potential to support roosting bats.

Photograph 15 – T10 showing vertical branch cavity.

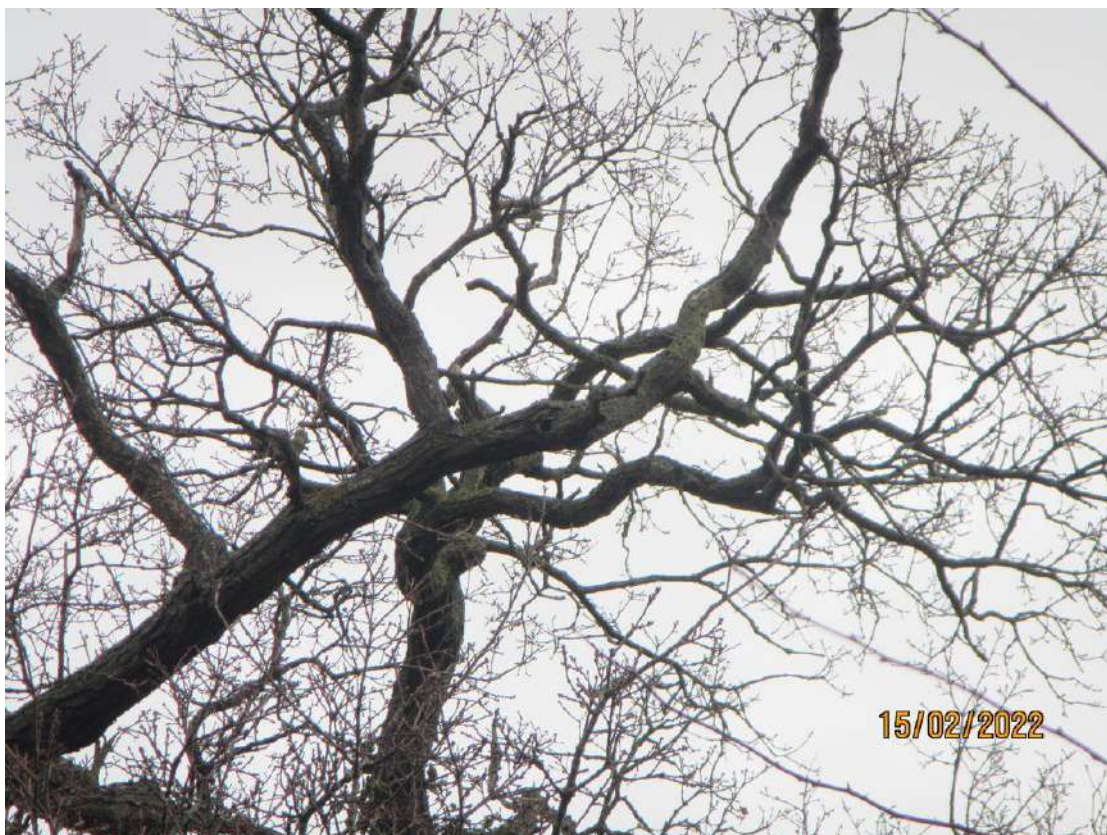
Photograph 17 – T10 showing knot-hole on horizontal branch.

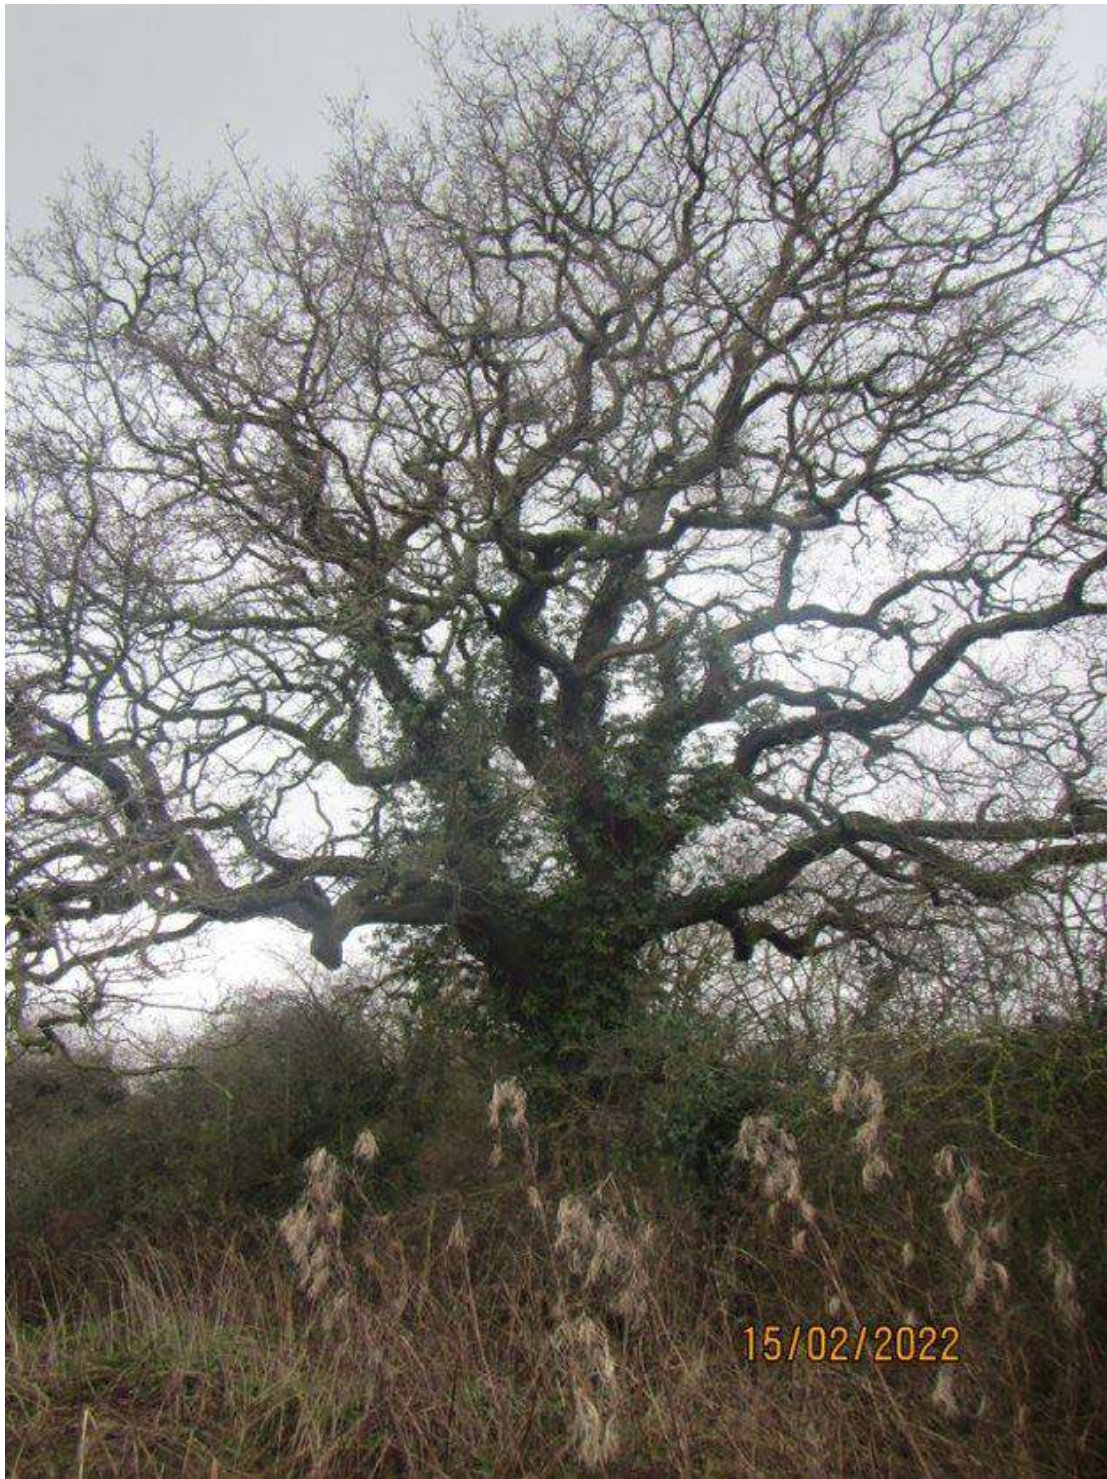
Photograph 20 – T12.

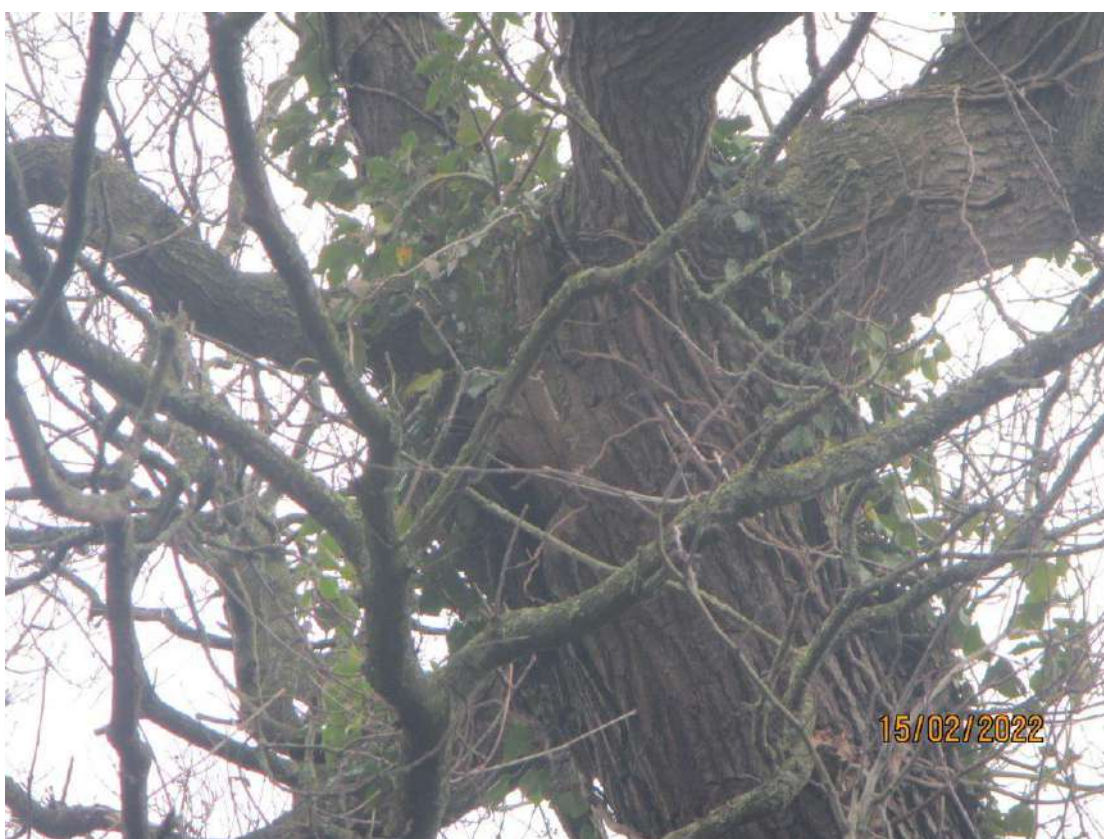
Photograph 25 – T14 showing cluttered vertical tear-out.

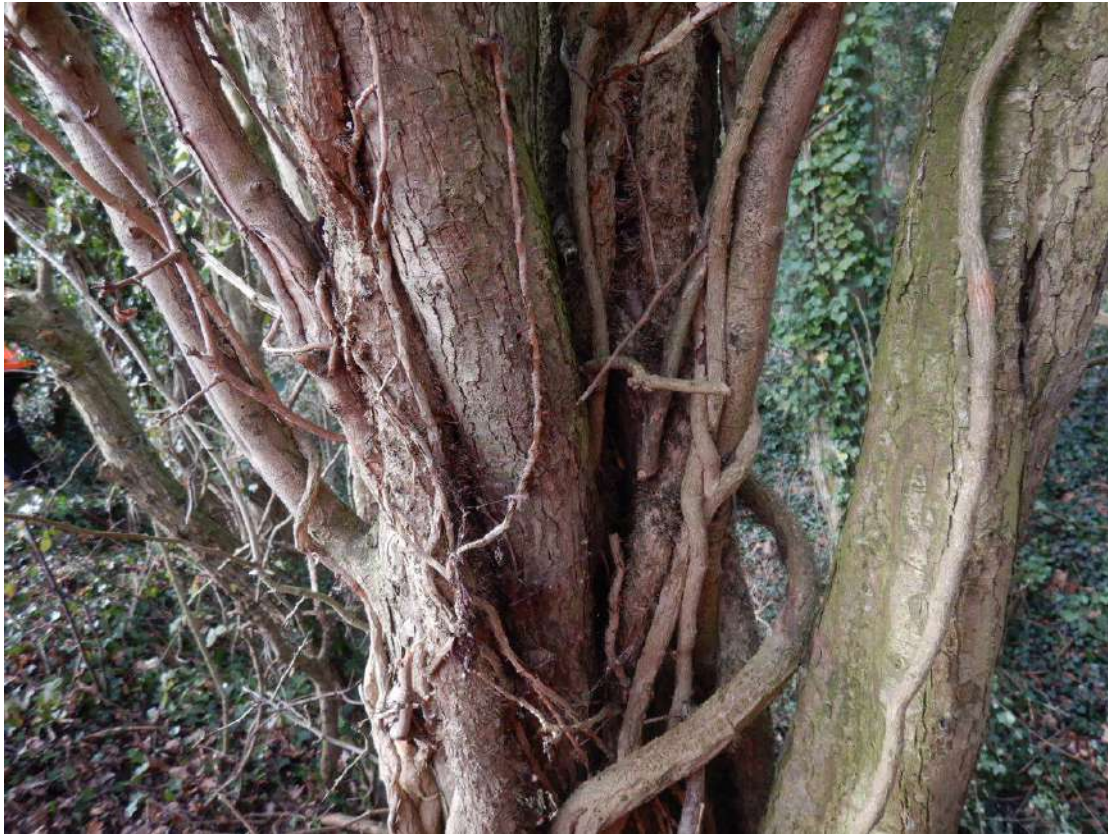
Photograph 29 – T17 showing ivy cover.

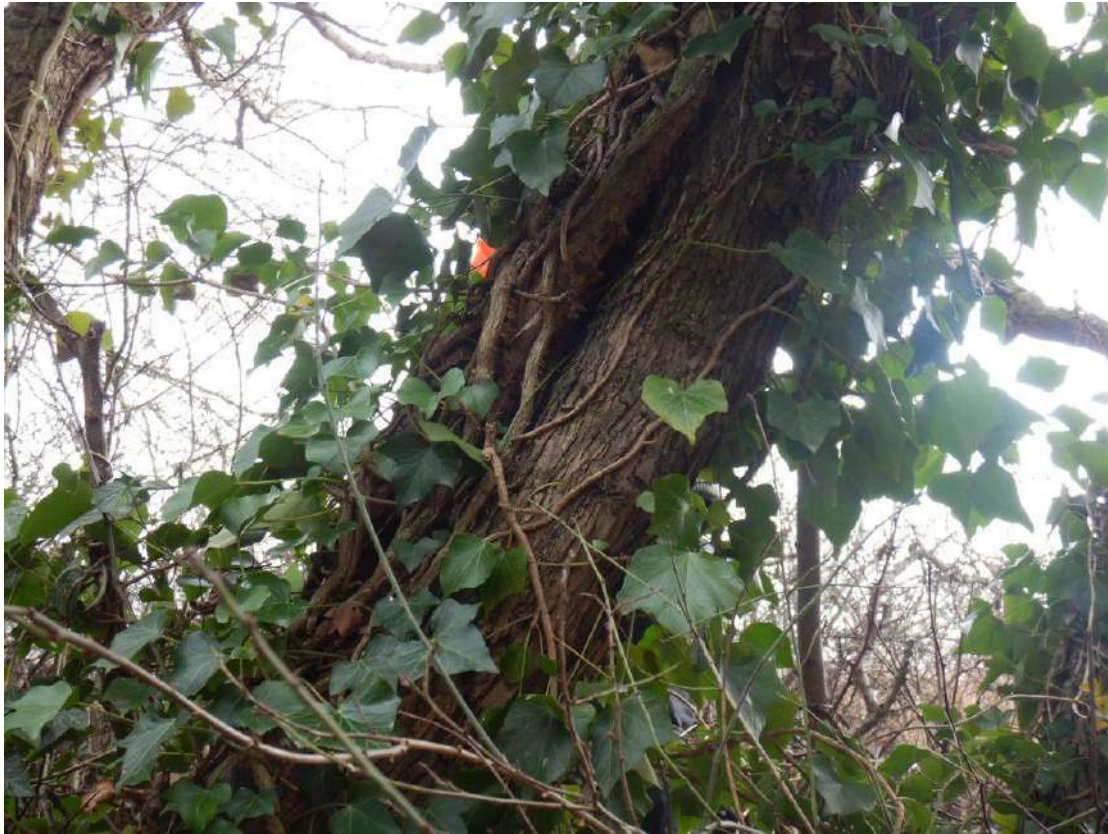
Photograph 31 – T19 showing crevice created where ivy meets bark.

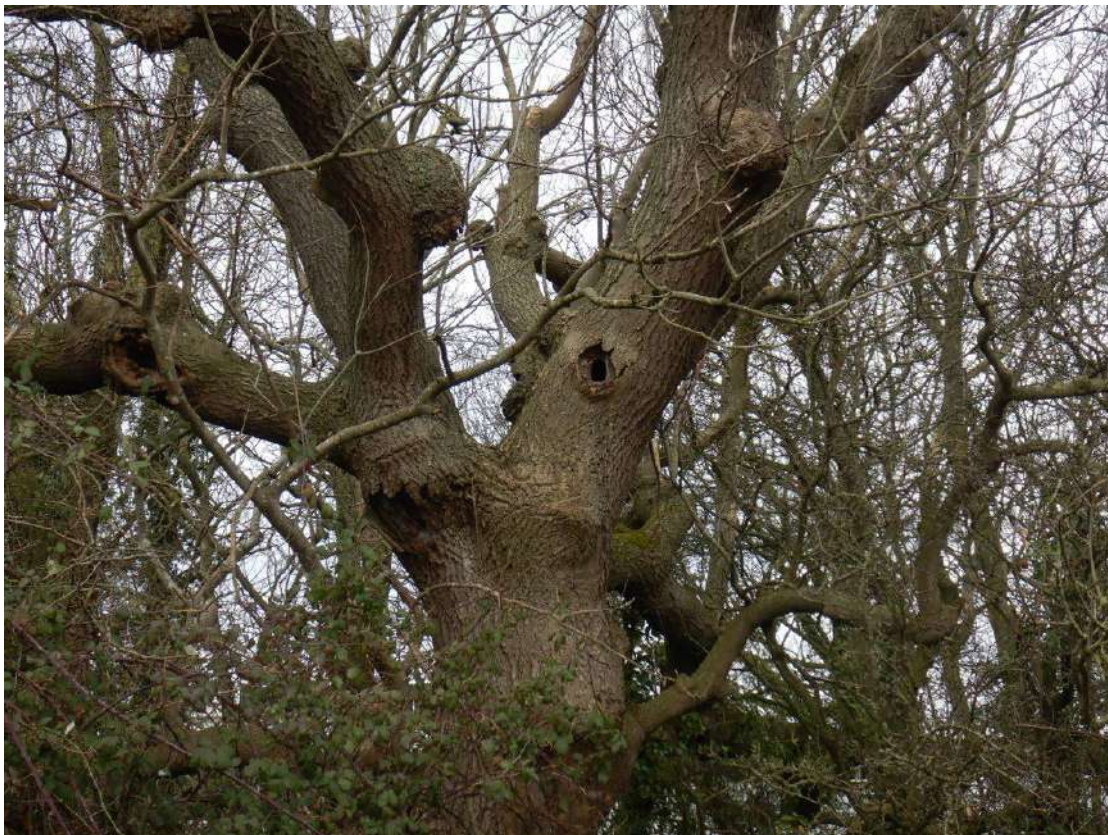
Photograph 32 – T20 showing knot-hole and flaking bark.

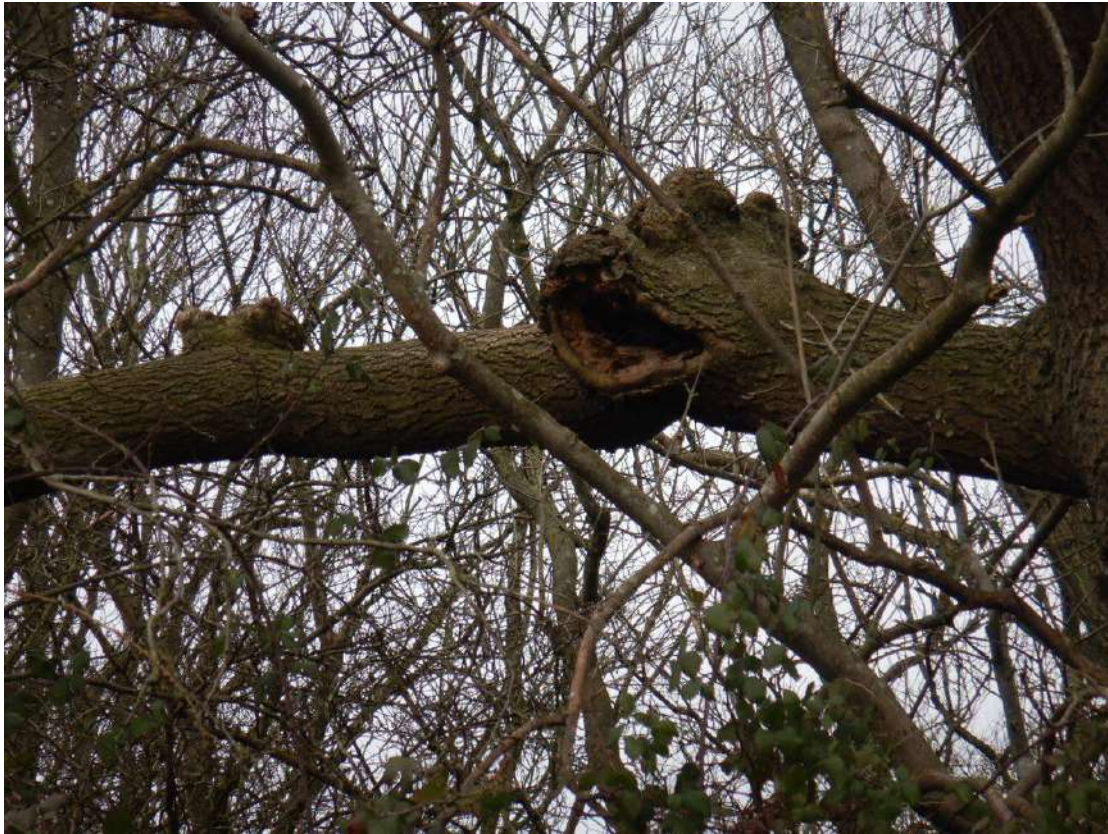
Photograph 33 – T20 showing large knot-hole on horizontal branch elbow.

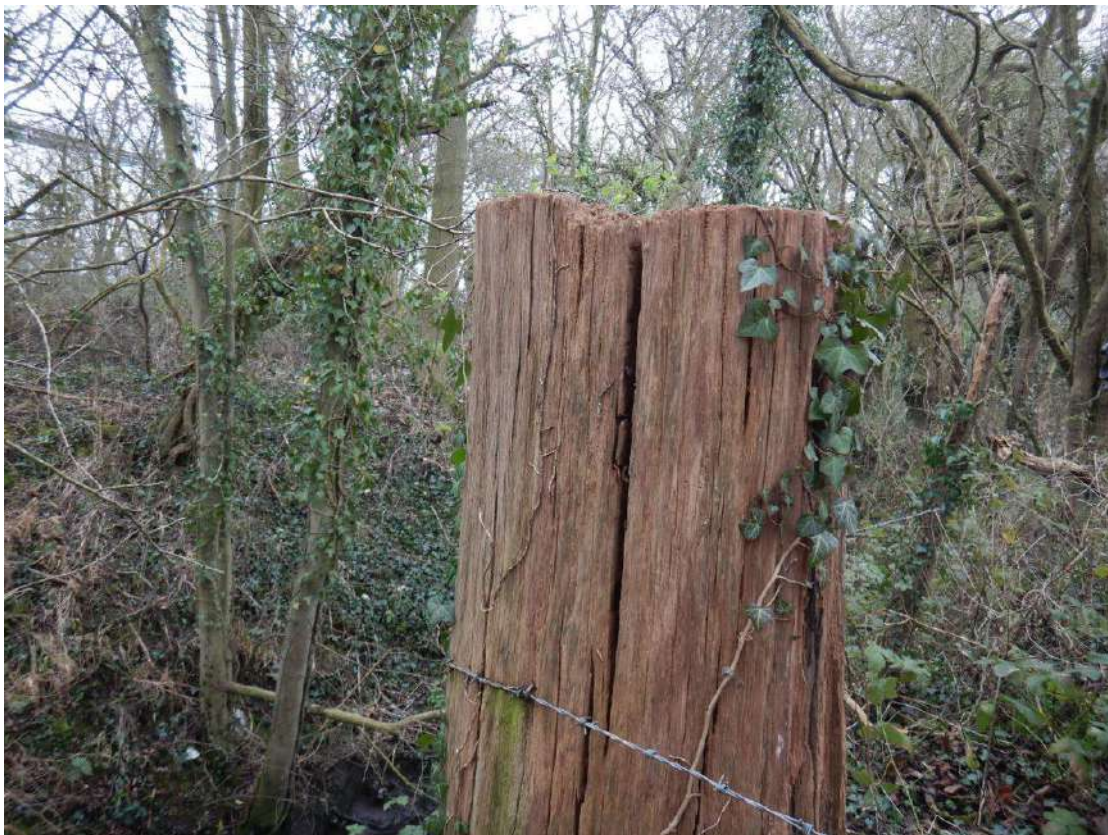
Photograph 34 – T21.

**T21** is a dead tree stump of unknown species around 1.5m in height with a DBH of 0.5m. It features fissures in the top of the stump and along its whole height on its south-western and south-eastern aspects. This tree is considered to have low potential to support roosting bats.

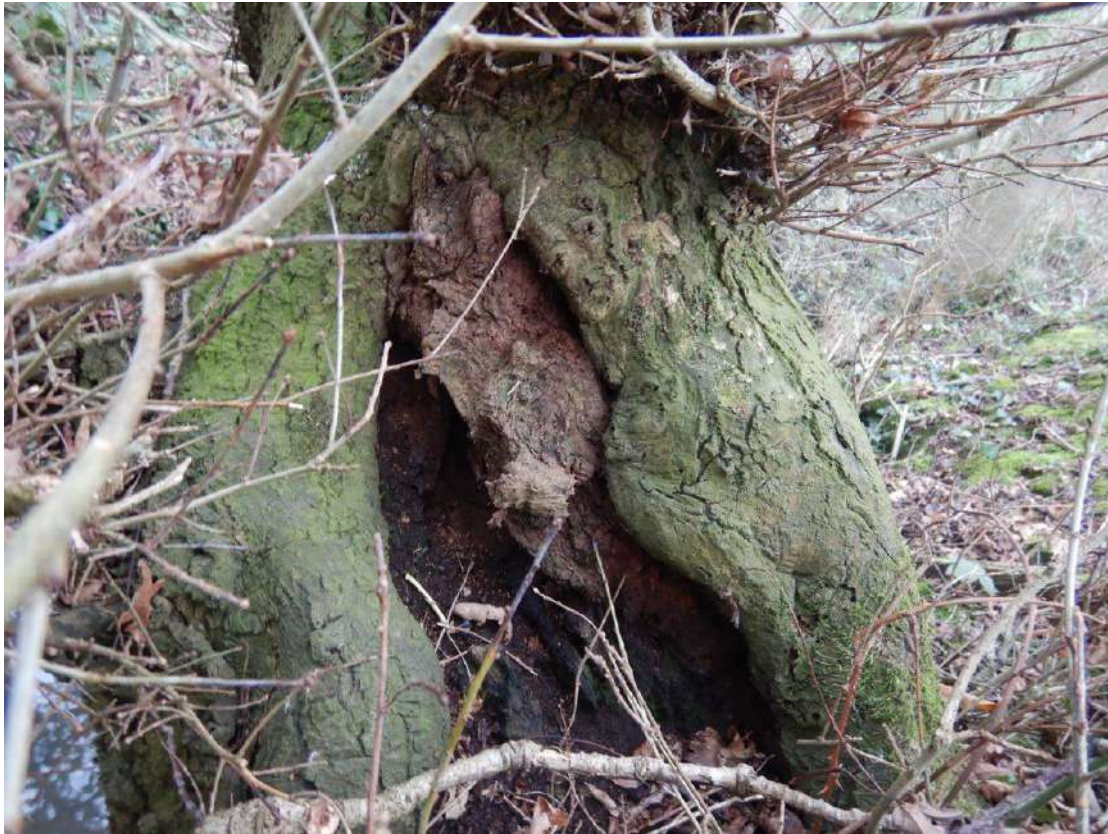
**T22** is a mature pedunculate oak in the broadleaved woodland which stretches along the northern boundary of the site. It is approximately 12m in height with a DBH of 0.5m. A small basal cavity is found on the south aspect of the tree. This tree is considered to have low potential to support roosting bats.

| T22<br>/<br>SJ39187<br>50574 | Pedunculate oak<br><i>Quercus robur</i> | Mature | 12<br>/<br>0.5 | Small basal cavity on southern aspect | L | In the strip of broadleaved woodland along the site's northern boundary. | N | Y | The feature was fully inspected with endoscope, no evidence of bat roosting was found. |

Photograph 35 – T22 showing basal stem cavity.

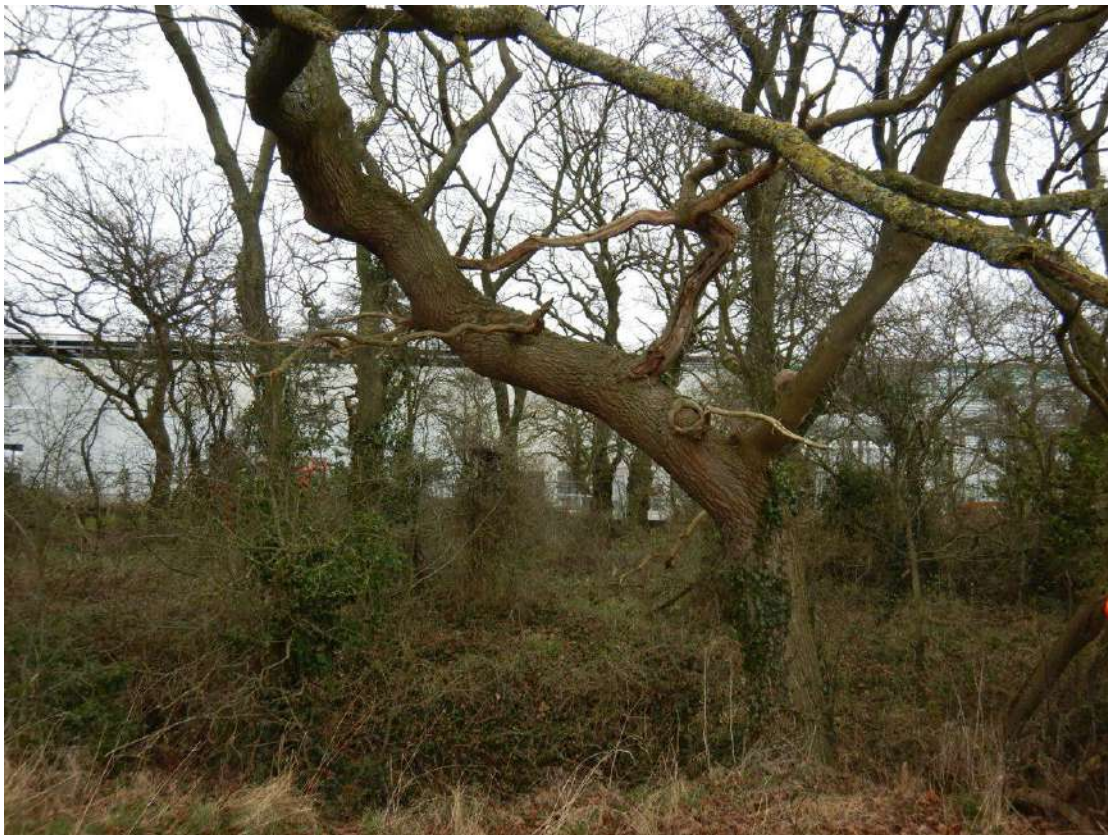
Photograph 36 – T23 showing tear-out from trunk (above pruning-cut).

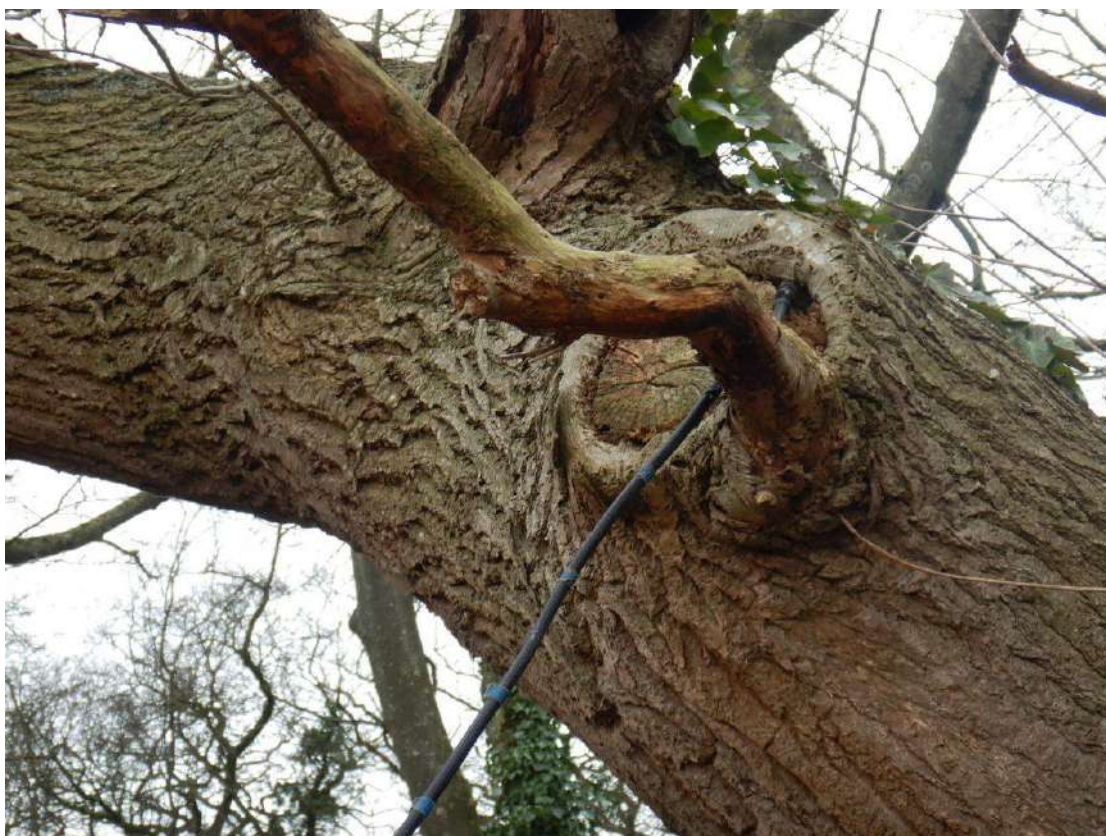
Photograph 37 – T23 showing cavity in pruning-cut.
