## **BAT GROUND LEVEL TREE ASSESSMENT**

### **Plot 3A**

Wrexham Industrial Estate  
Wrexham  
Wrexham County Borough  
L22 3XS

| UES reference: | UES03448/06 |

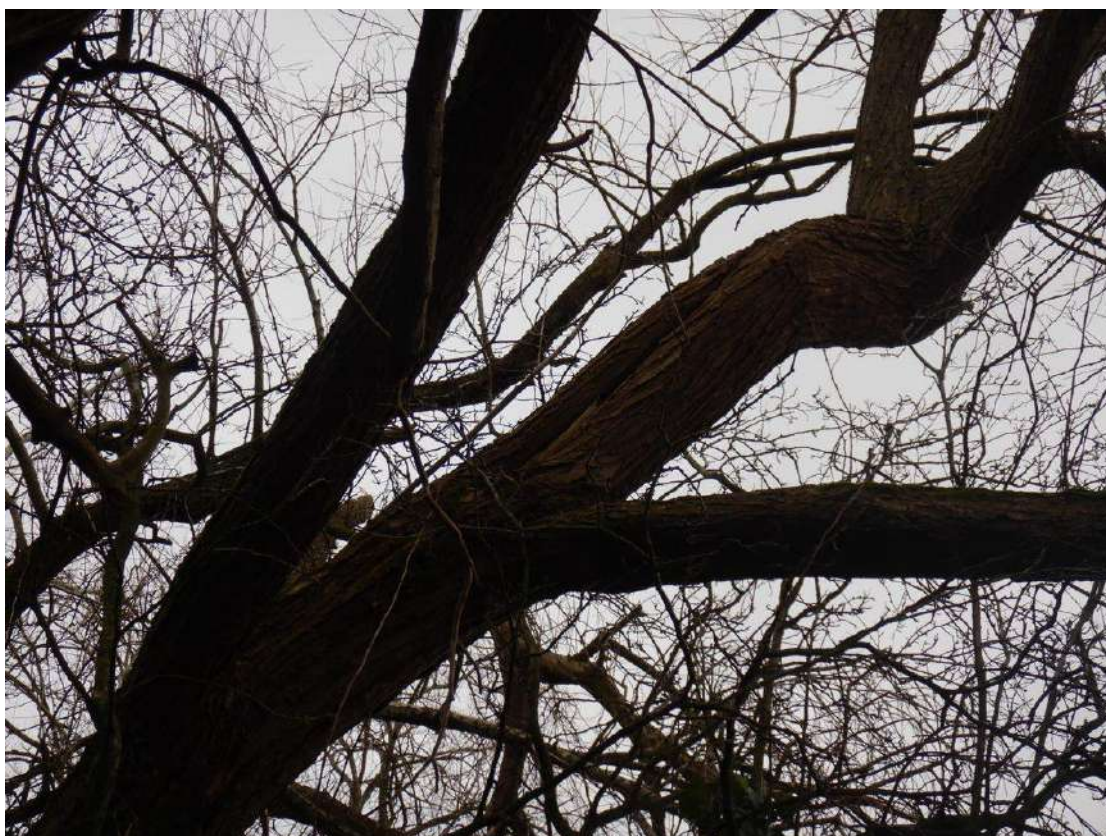
**T24** is a mature crack willow in the broadleaved woodland which stretches along the northern boundary of the site. It is approximately 16m in height with a DBH of 0.7m. The tree features a trunk cavity at 6m on its southern aspect and a branch cavity on a south-leaning limb at 7m. This tree is considered to have moderate potential to support roosting bats.

Photograph 39 – T24 showing diagonal trunk cavity.

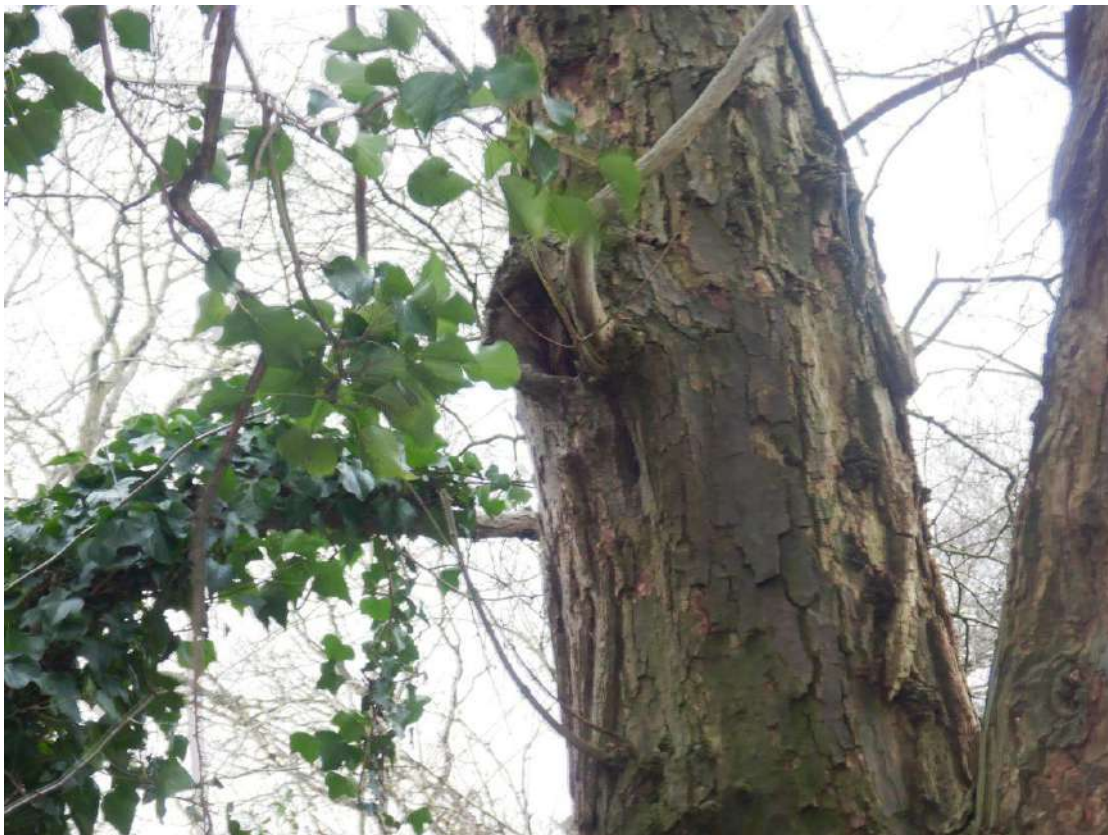
**T26** is a mature crack willow in the broadleaved woodland which stretches along the northern boundary of the site. It is approximately 16m in height with a DBH of 1.0m. The tree features a hollow northward-facing branch and several woodpecker holes on its southern aspect up to a height of 10m. The tree is considered to have high potential to support roosting bats.

Photograph 42 – T26 showing woodpecker hole.

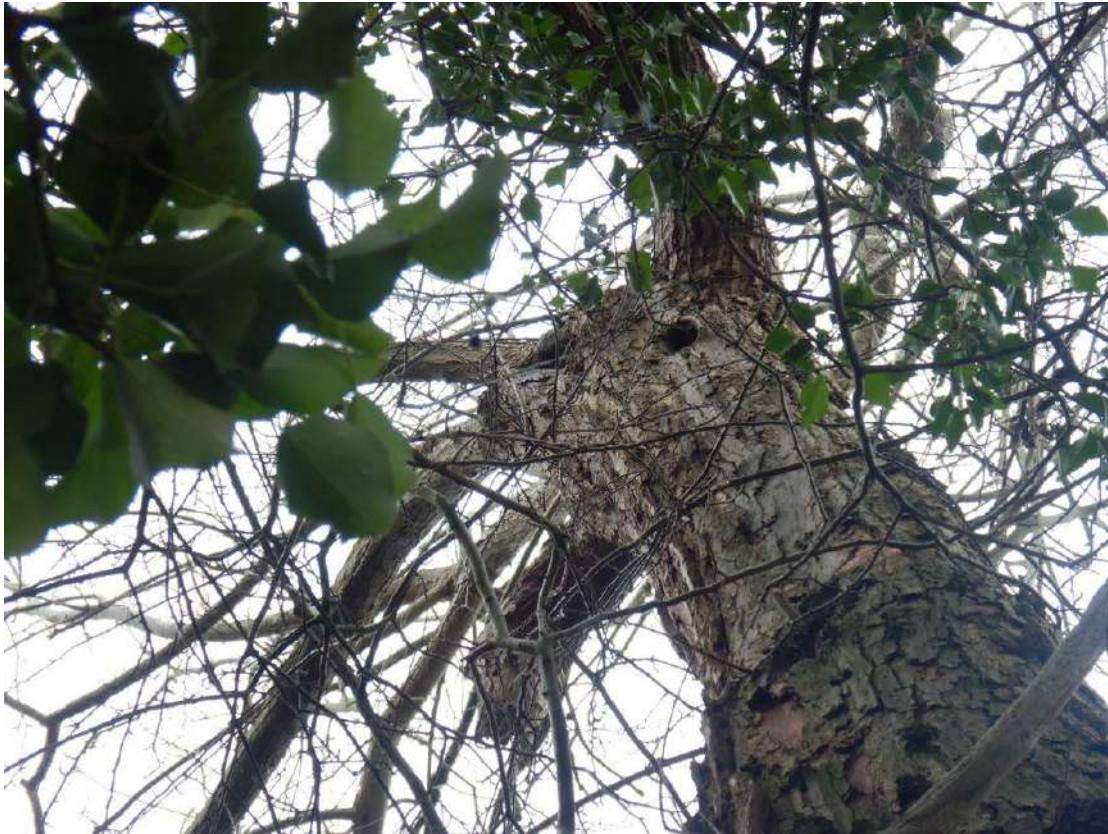
Photograph 43 – T26 showing woodpecker hole (upper right) and hollow branch (lower centre).

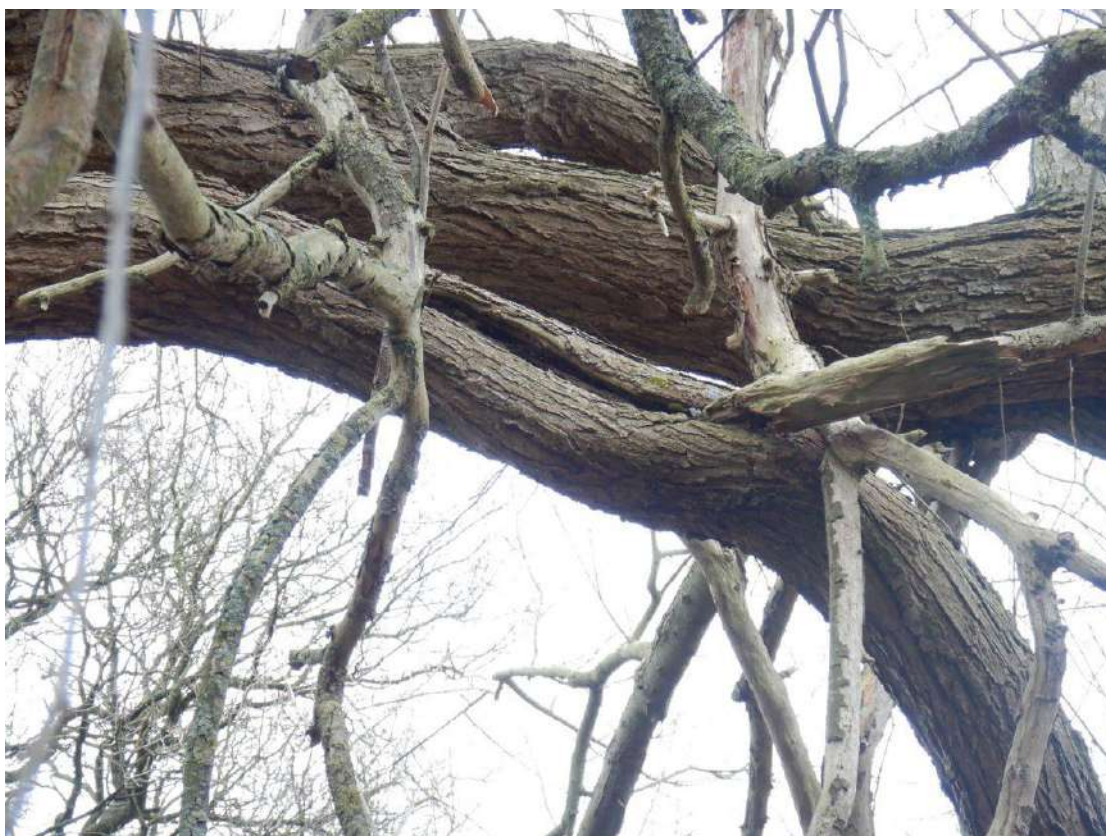
| T27<br>/<br>SJ39294<br>50603 | Crack<br>willow<br><i>Salix</i> ×<br><i>fragilis</i> | Mature | 16<br>/<br>1 | Branch cavity on a<br>southward-leaning<br>limb at ~4m and<br>nearby weld. Stem<br>cavity at ~3m on<br>western aspect. | H | In the strip of broadleaved<br>woodland along the site's<br>northern boundary. | N | Y | |

Photograph 45 – T27 showing horizontal branch cavity.

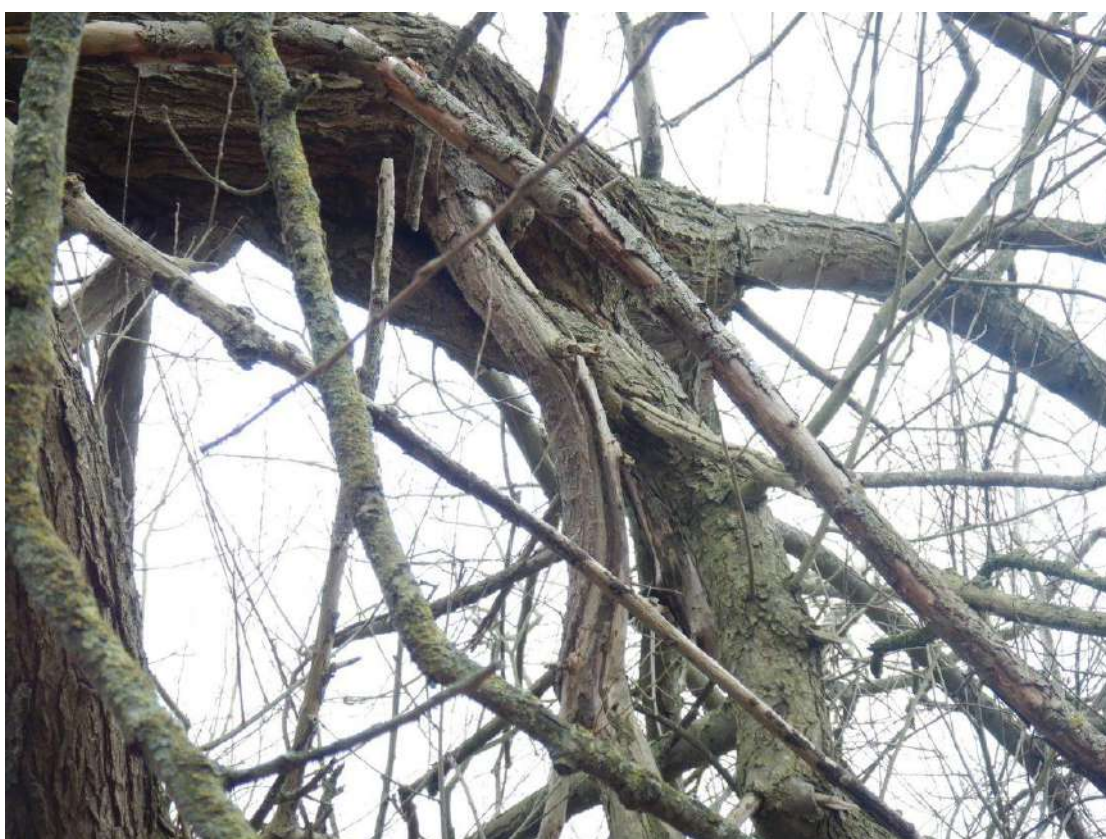
Photograph 46 – T27 showing branch weld.

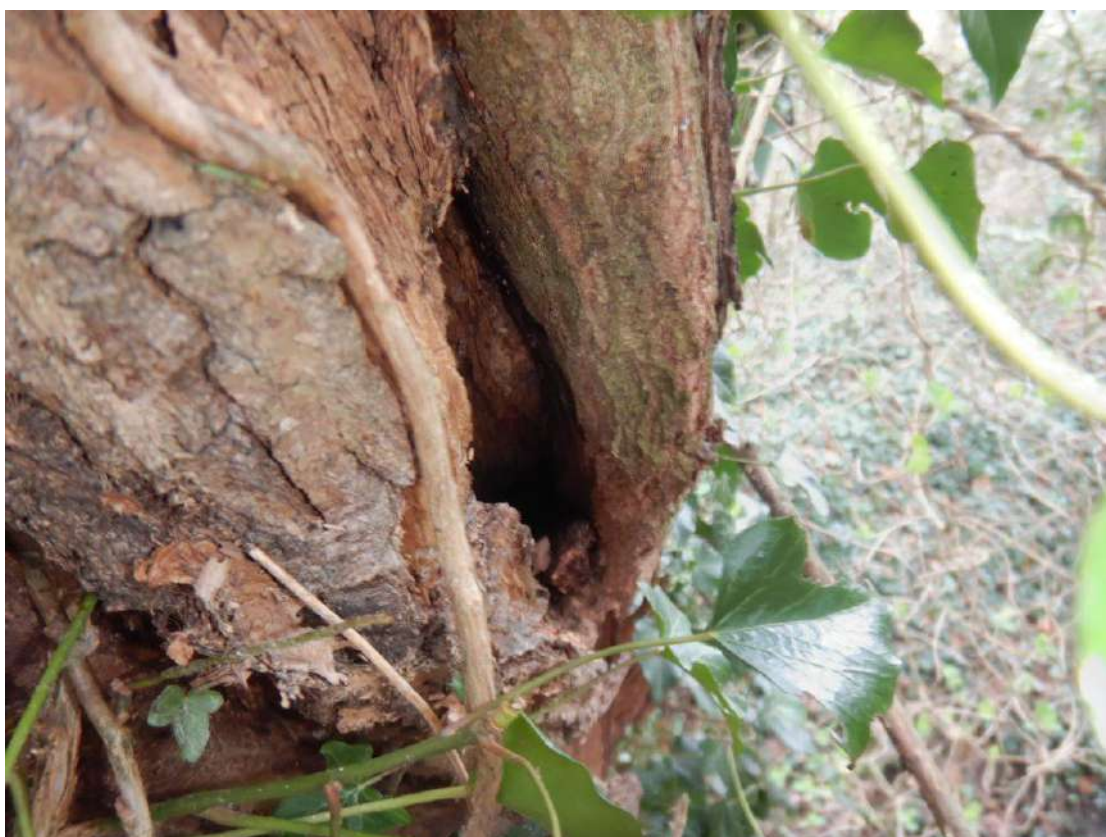
Photograph 50 – T29 showing stem cavity.

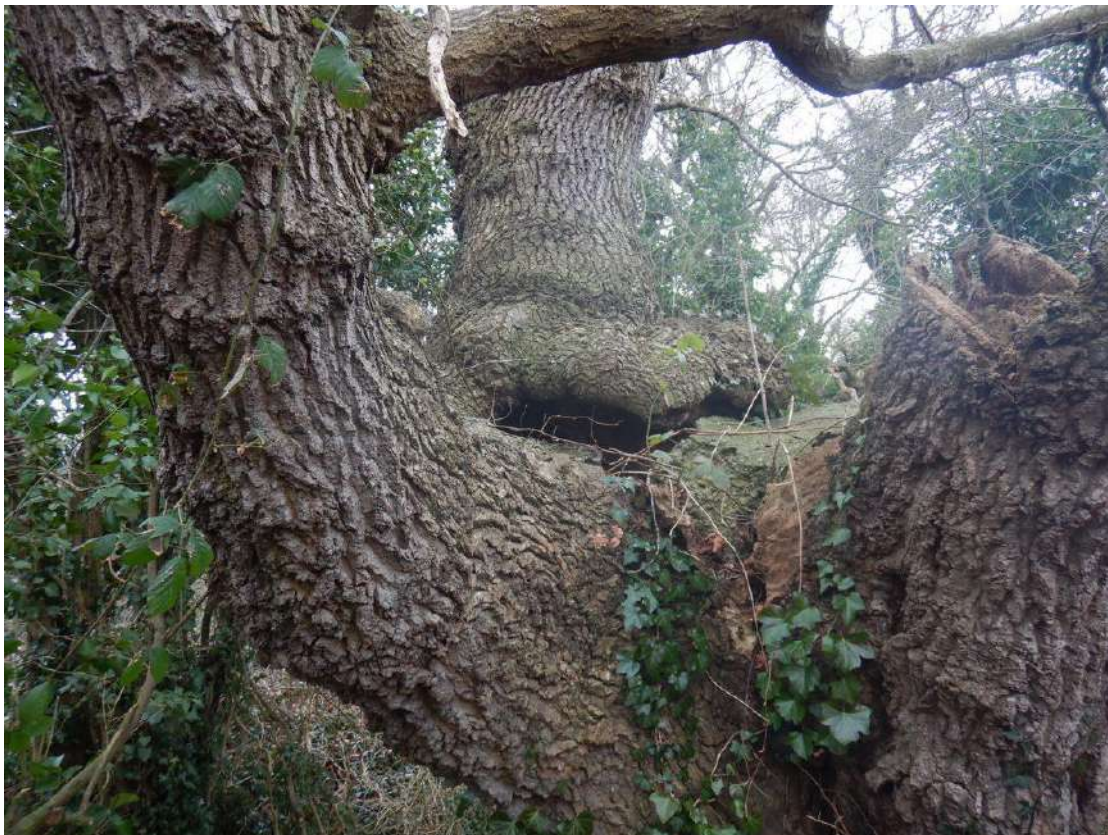
Photograph 56 – T32 showing v-split lateral stem cavity.

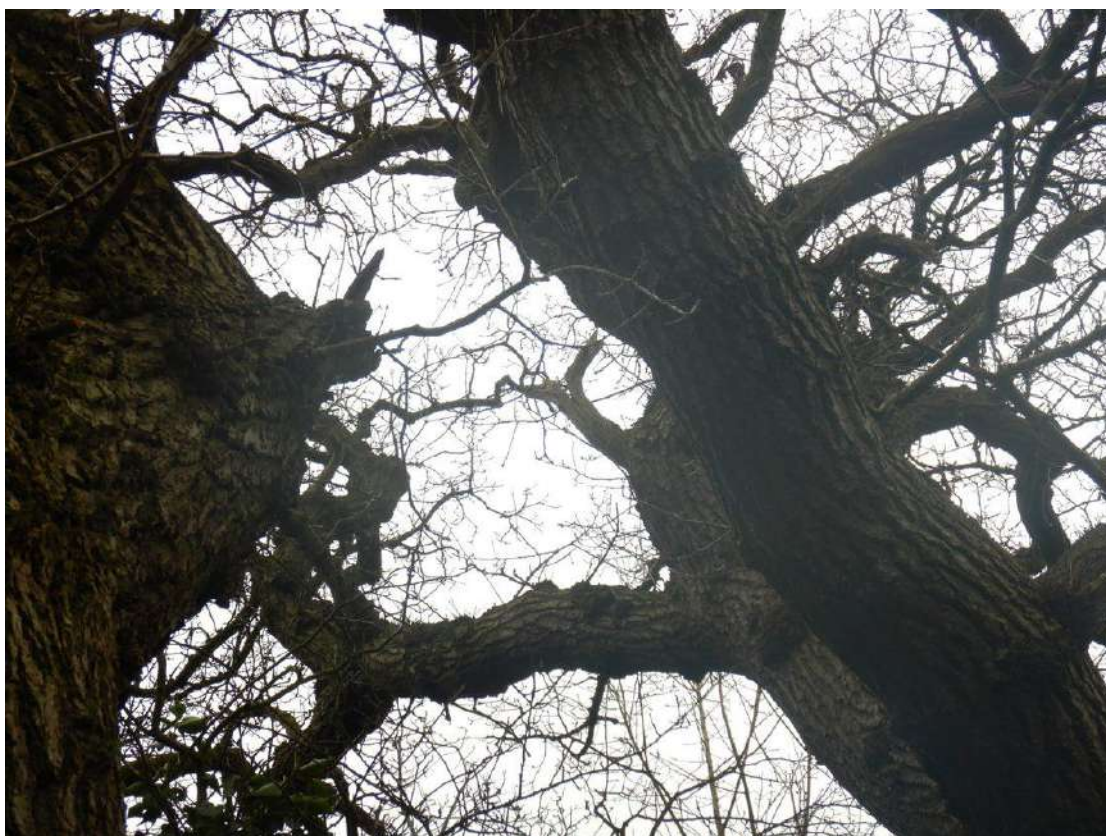
Photograph 57 – T32 showing split deadwood branch (centre, rear).

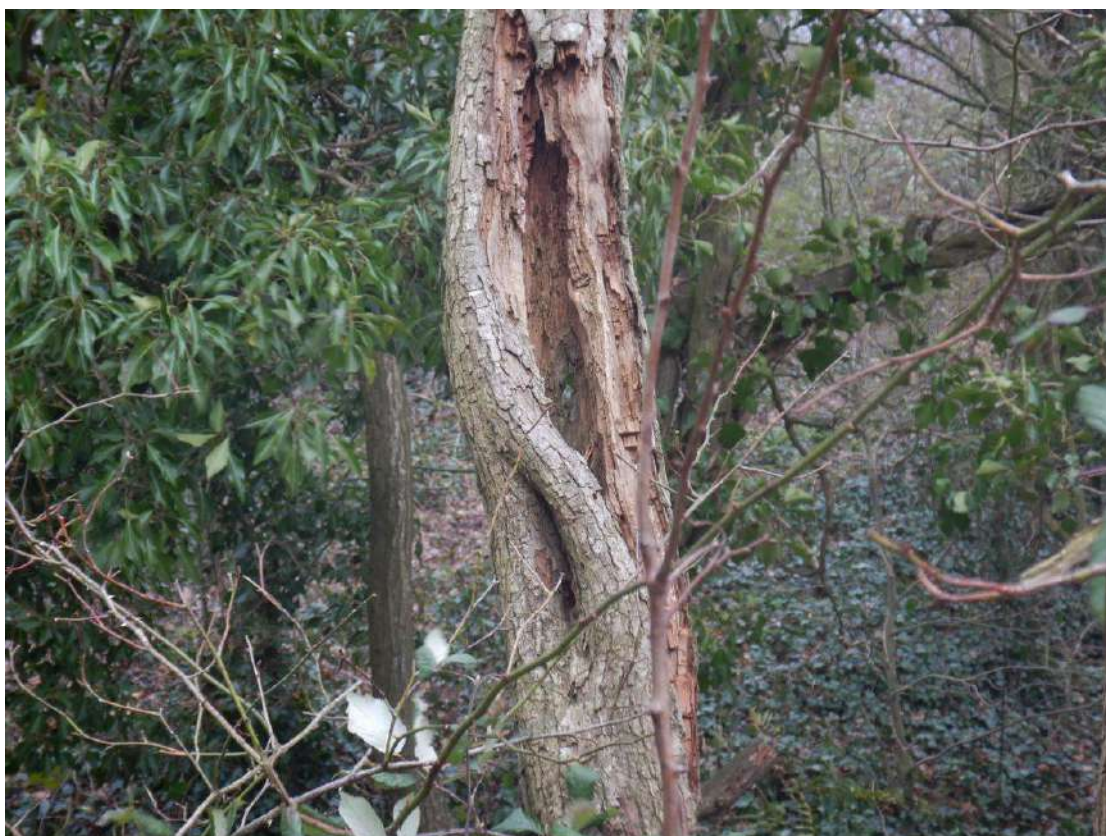
Photograph 59 – T33 showing vertical stem cavity.

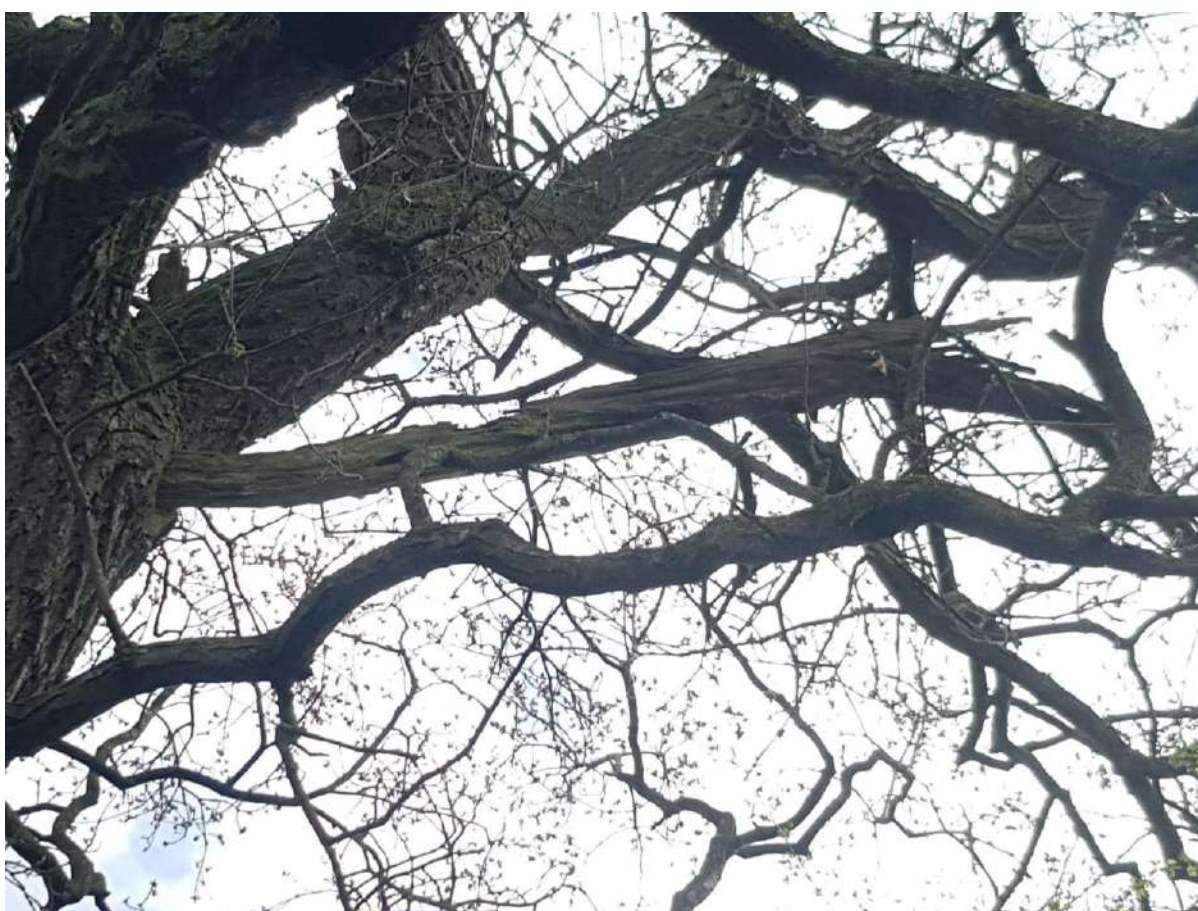
**T34** is a mature pedunculate oak found in the broadleaved woodland which stretches around a large pond in the south-east of the site. It is approximately 20m in height with a DBH of 1.0m. This tree features deadwood at 3m on its northern aspect and at 7m on both its northern and southern aspects. This tree is considered to have moderate roosting potential.

Photograph 62 – T34 showing deadwood on southern aspect.

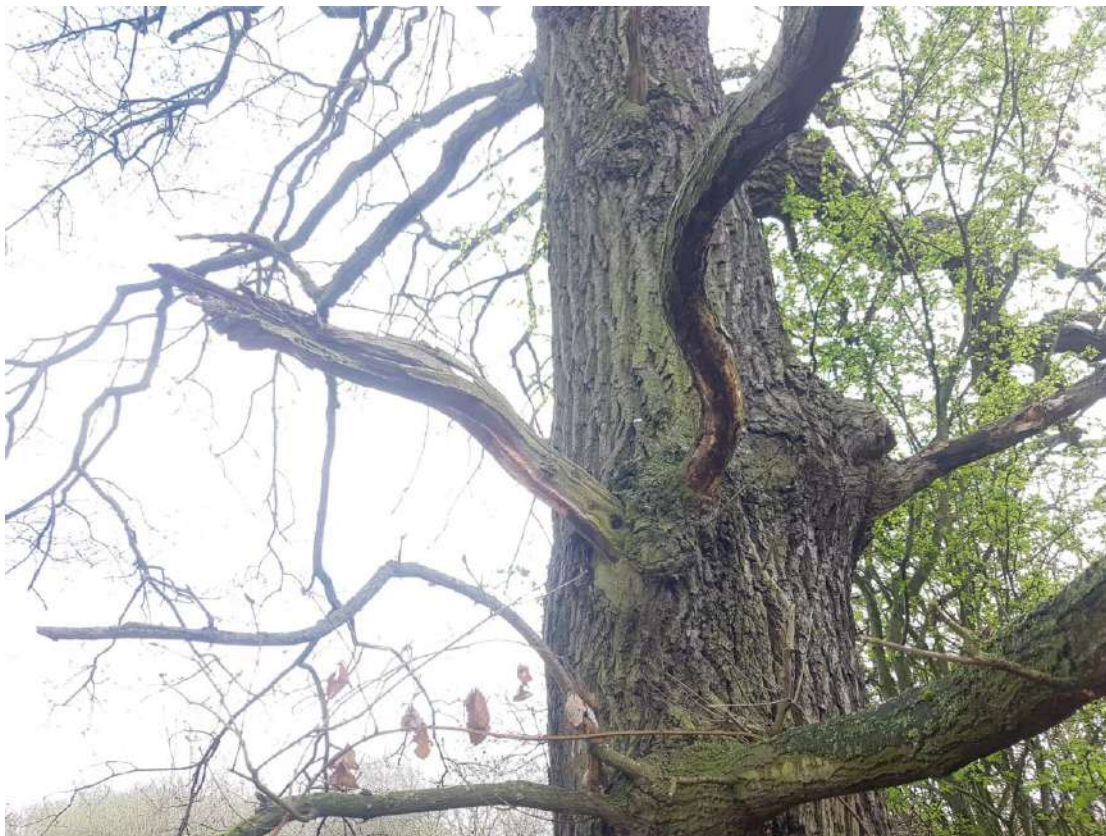
Photograph 63 – T34 showing deadwood on northern aspect.

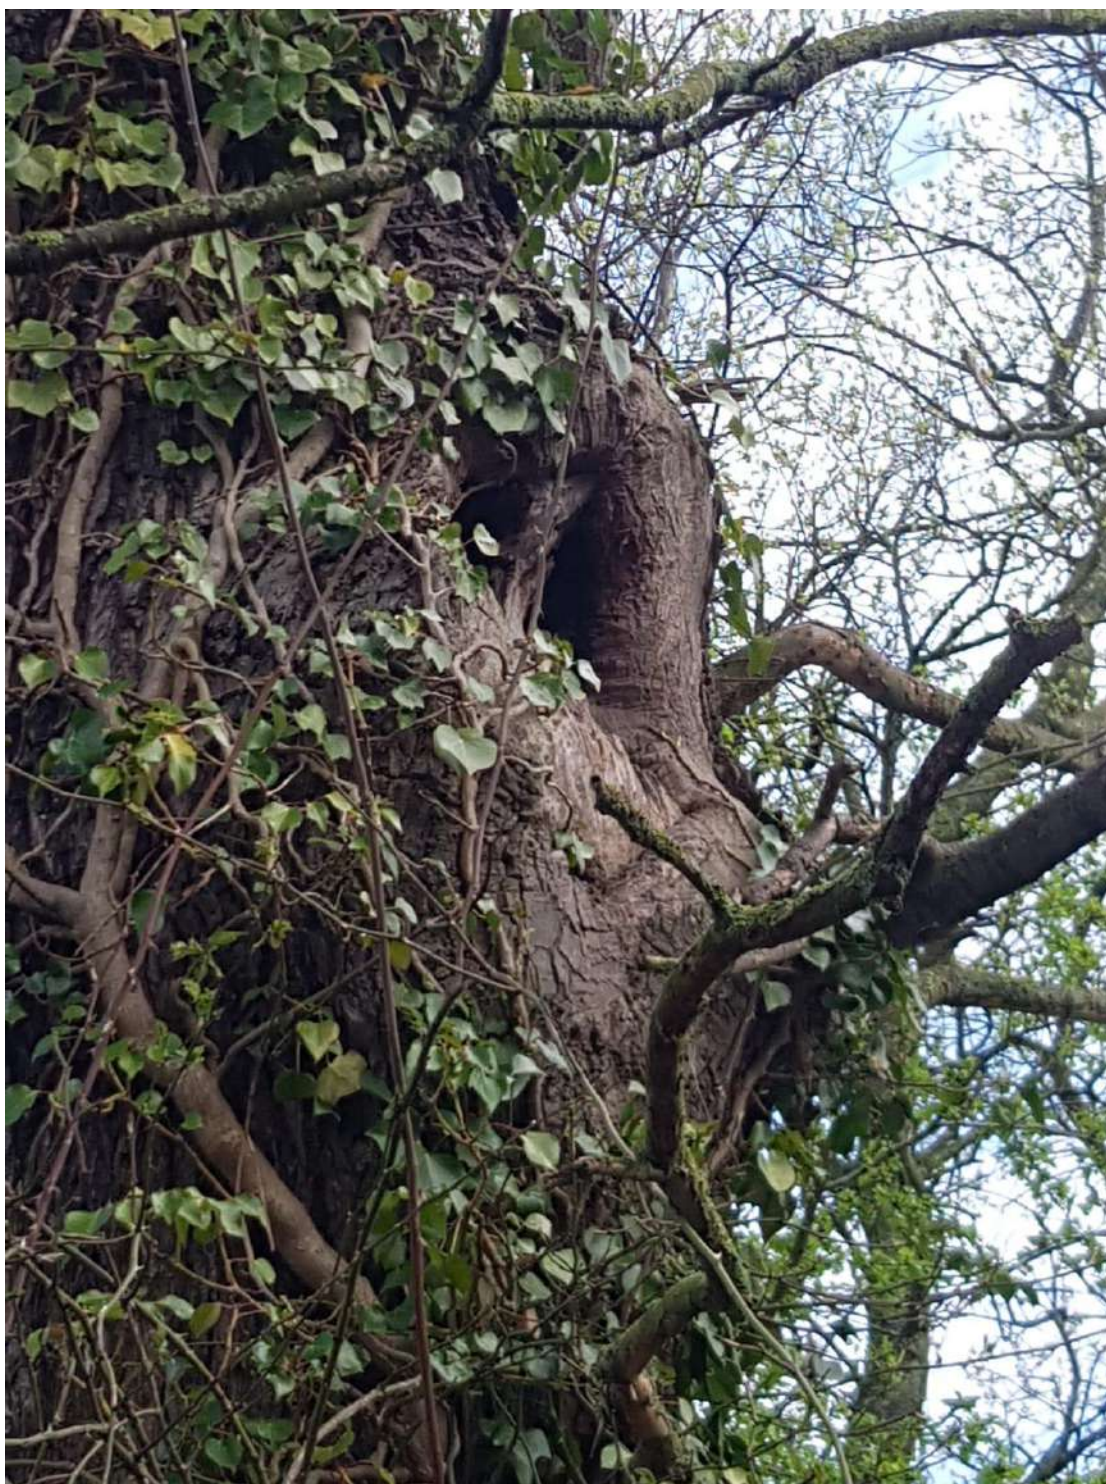
**T35** is a mature pedunculate oak found in the broadleaved woodland which stretches around a large pond in the south-east of the site. It is approximately 20m in height with a DBH of 1.0m. It has a stem cavity at 3.5m on its southern aspect, a knothole and deadwood on a western branch at 10m, and deadwood on the trunk at 4, 7 and 8m on its western, eastern, and southern aspects respectively. This tree is considered to have moderate potential to support roosting bats.

Photograph 65 – T35 showing stem cavity.

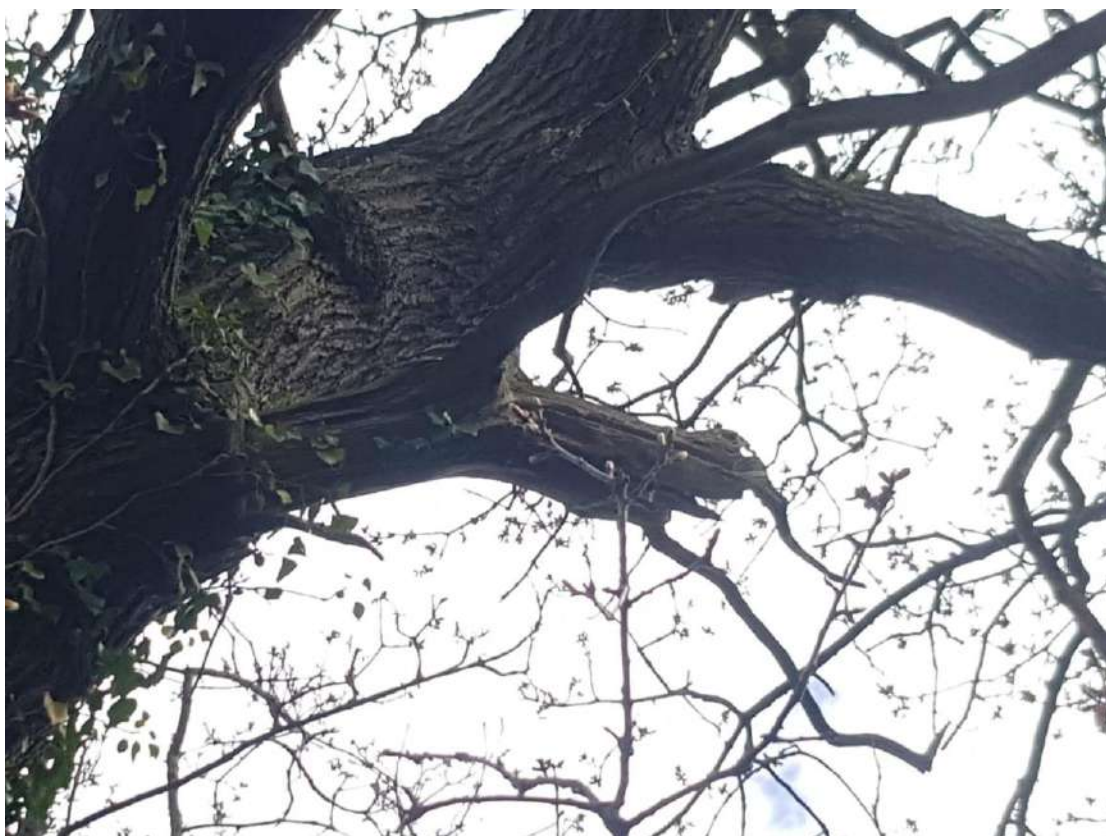
Photograph 66 – T35 showing deadwood on southern aspect.

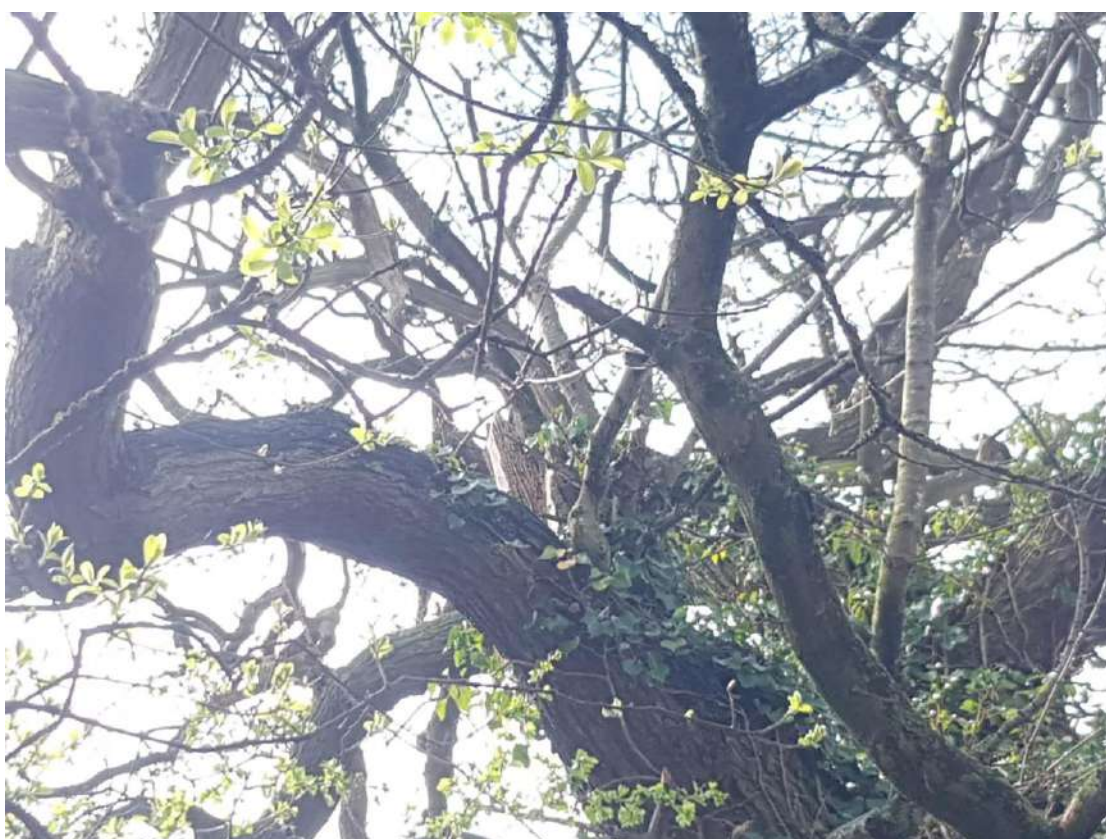
Photograph 67 – T35 showing deadwood on eastern aspect.

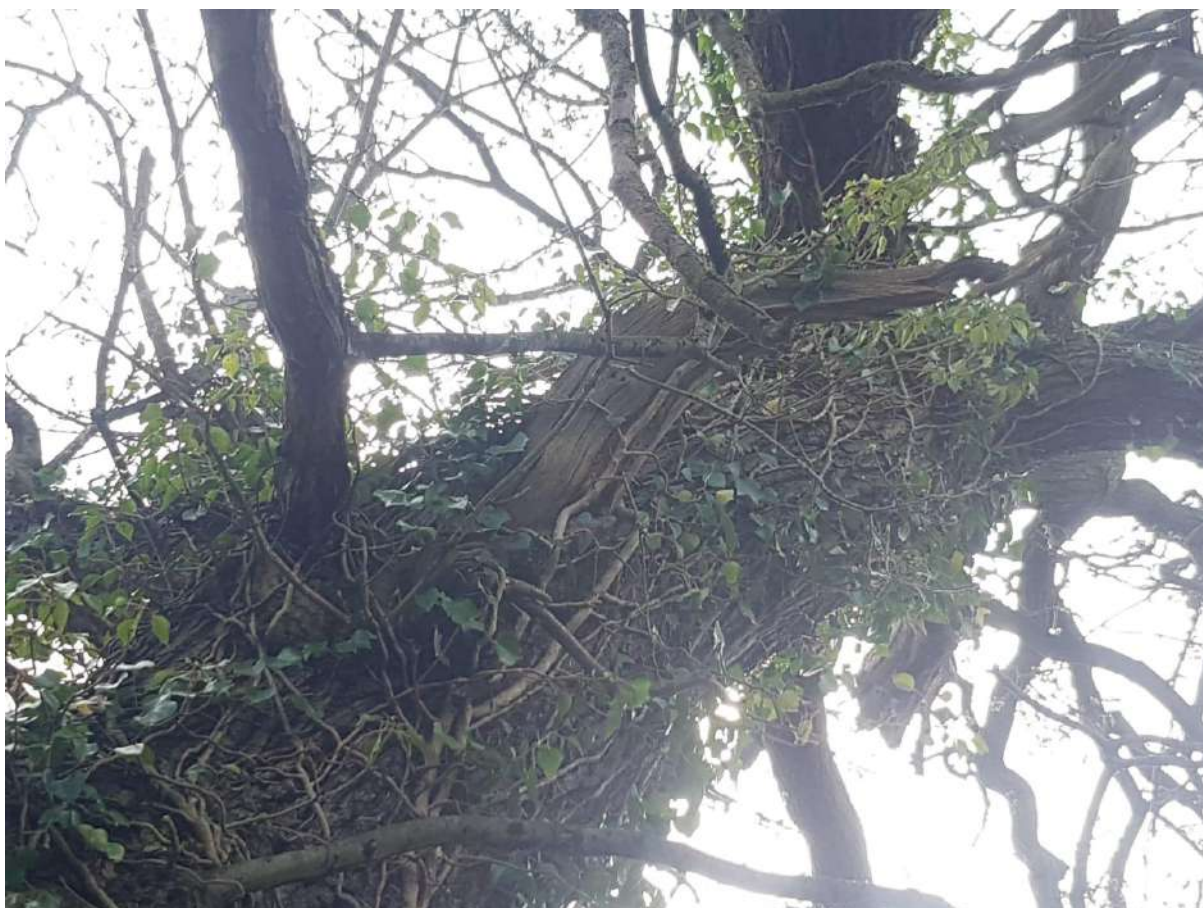
Photograph 68 – T35 showing deadwood on western aspect.

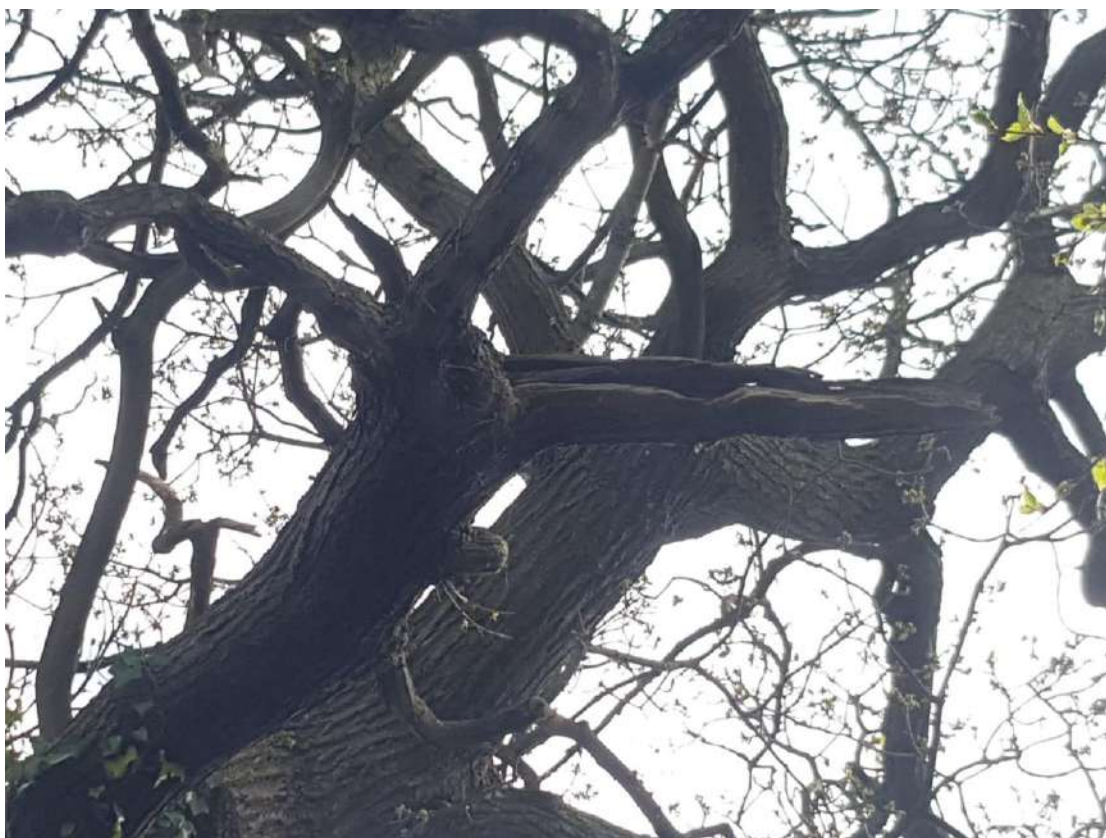
Photograph 69 – T35 showing deadwood and knot hole on western aspect.

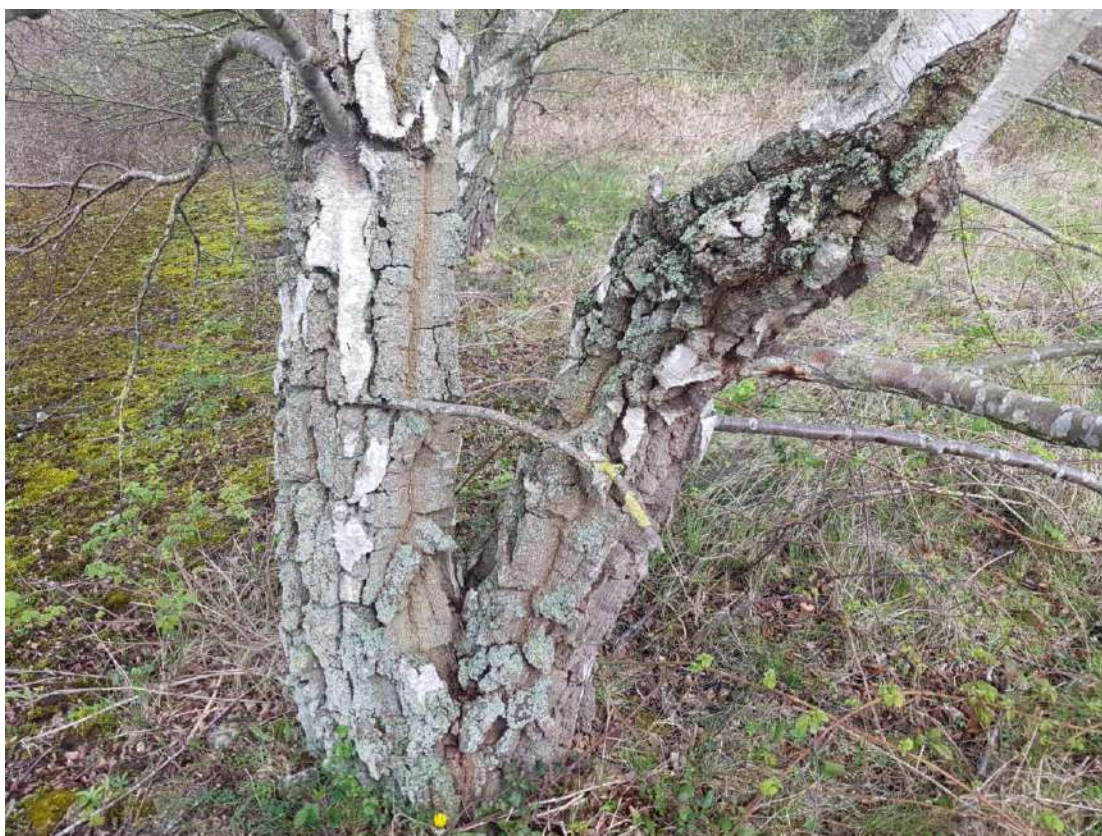
**T37** is a mature silver birch *Betula pendula* among scattered scrub near the eastern boundary of the site. It is approximately 12m in height with a DBH of 0.3m. This tree has a number of fissures in its bark from ground level up to 1.0m on all aspects, creating many small PRFs. This tree is considered to have low potential to support roosting bats.

Photograph 73 – T37 showing fissures in stem.

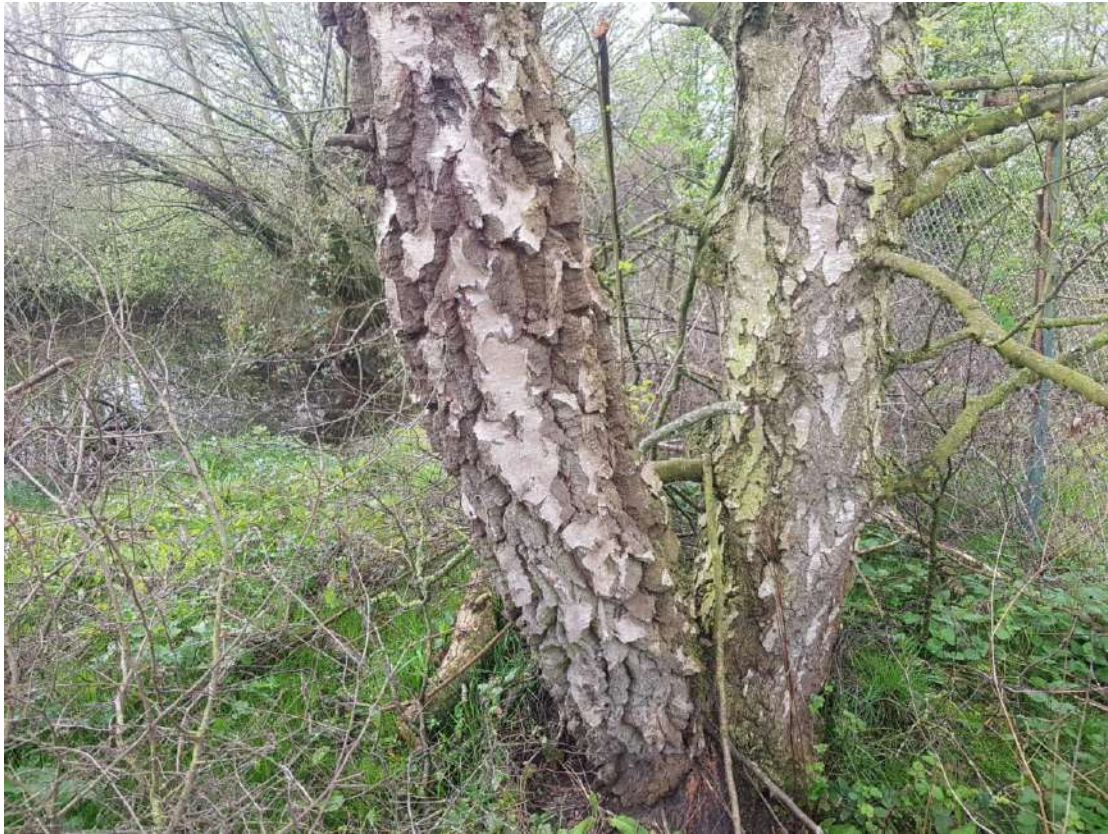
**T38** is a mature silver birch found in the broadleaved woodland which stretches around a large pond in the south-east of the site. It is approximately 12m in height with a DBH of 0.4m. This tree has a number of fissures in its bark from ground level up to 1.5m on all aspects, creating many small PRFs. This tree is considered to have low potential to support roosting bats.

Photograph 75 – T38 showing fissures in stem.

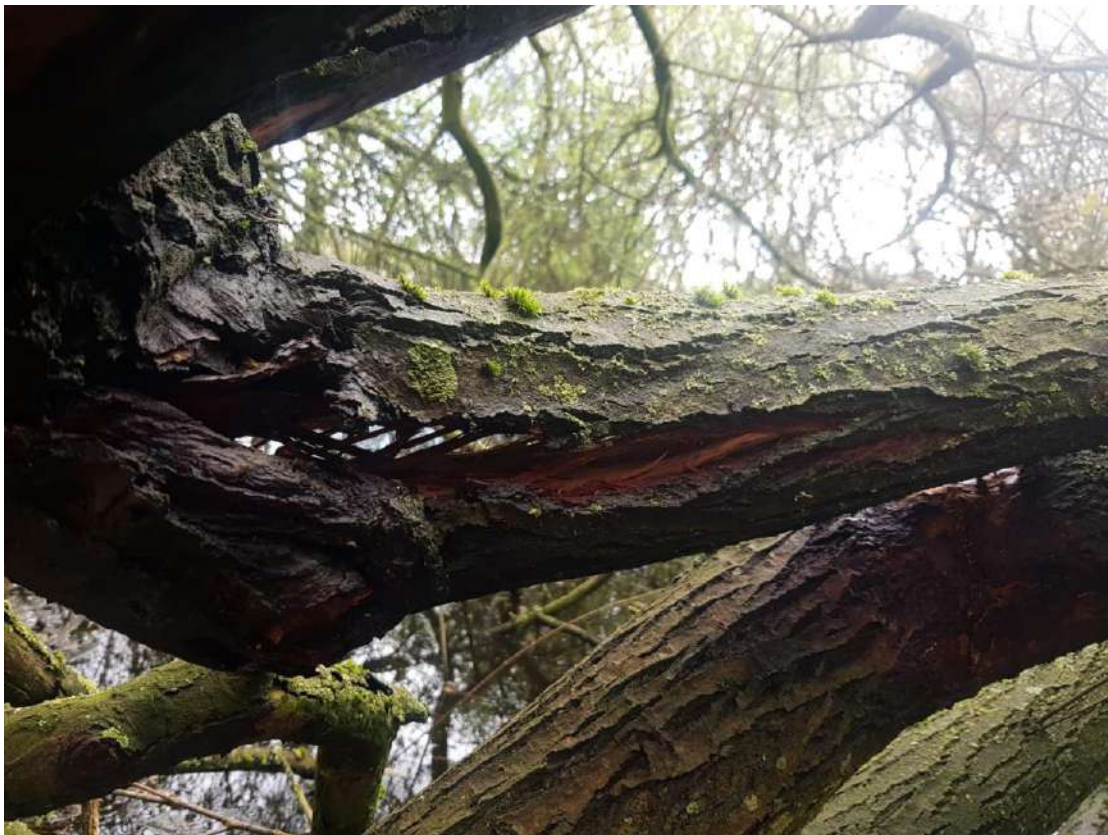
**T39** is a mature goat willow found in the broadleaved woodland which stretches around a large pond in the south-east of the site. It is approximately 5m in height with a DBH of 0.2m. It features stem cavities on all aspects from ground level up to a height of 1.0m, a branch cavity at 0.5m on its northern aspect, and welds at 1.0m on its southern aspect. It is considered to have low potential to support roosting bats.

Photograph 78 – T39 showing branch cavity.

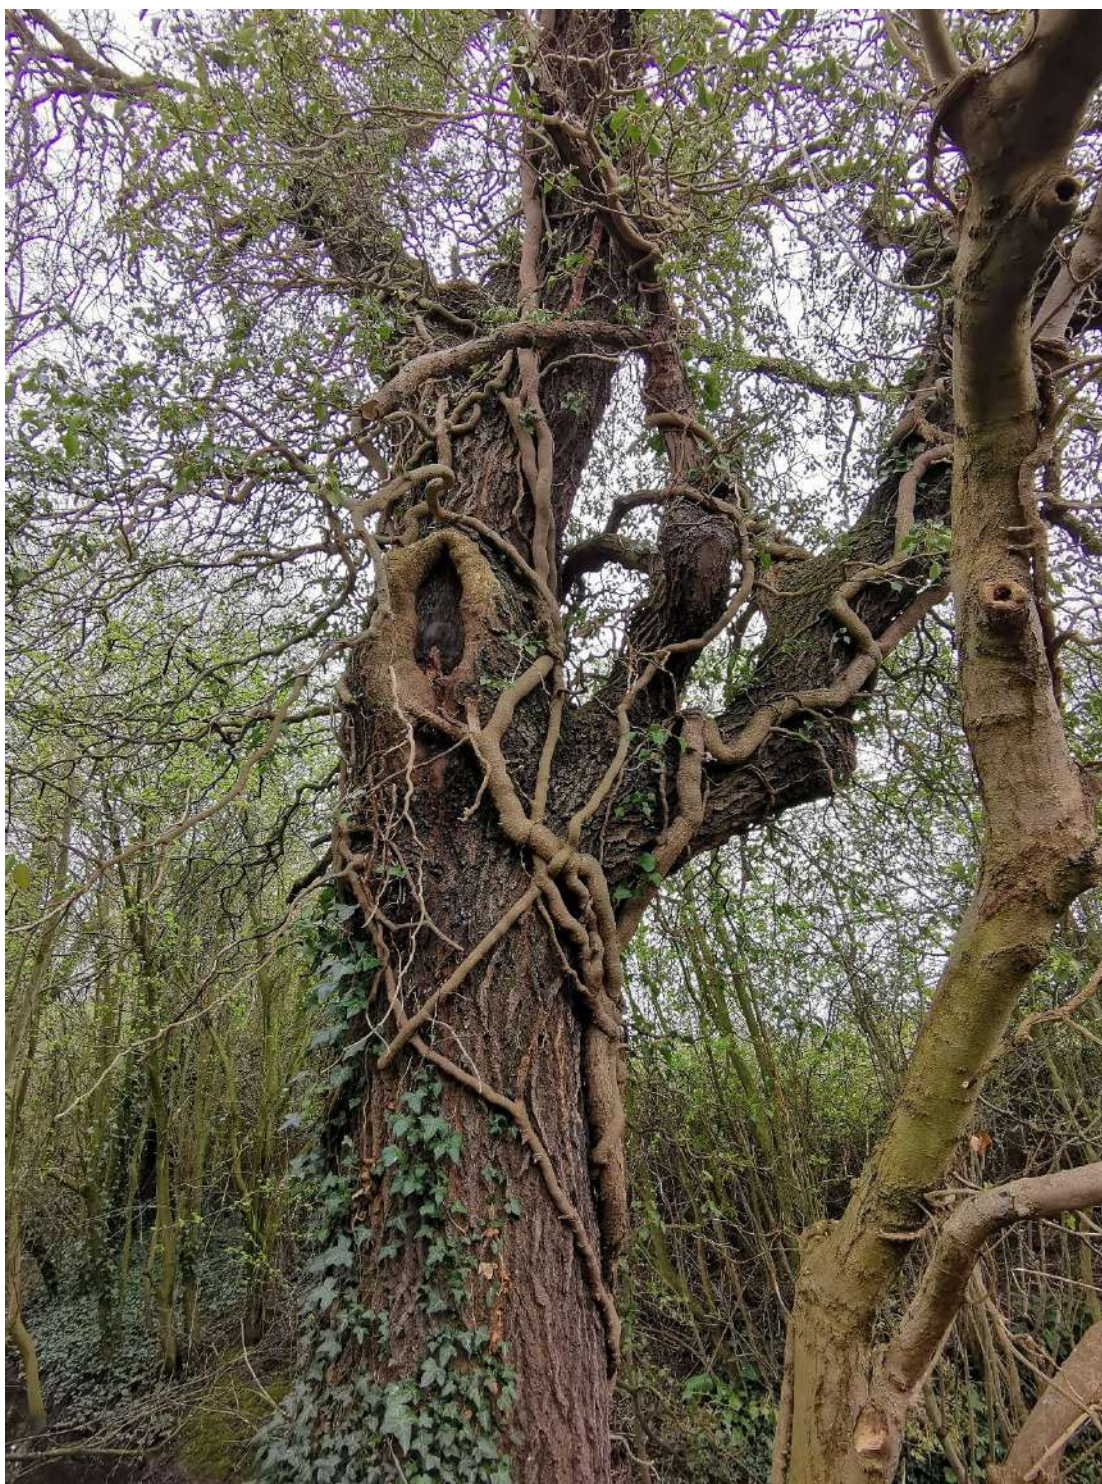
**T40** is a mature pedunculate oak found in the dense scrub which runs along the watercourse in the north-west corner of the site. It is approximately 13m in height with a DBH of 1.5m. It features a stem cavity at a height of 3m on its western aspect and extensive ivy cover on its trunk on aspects. This tree is considered to have moderate potential to support roosting bats.

Photograph 80 – T40 showing ivy cover.

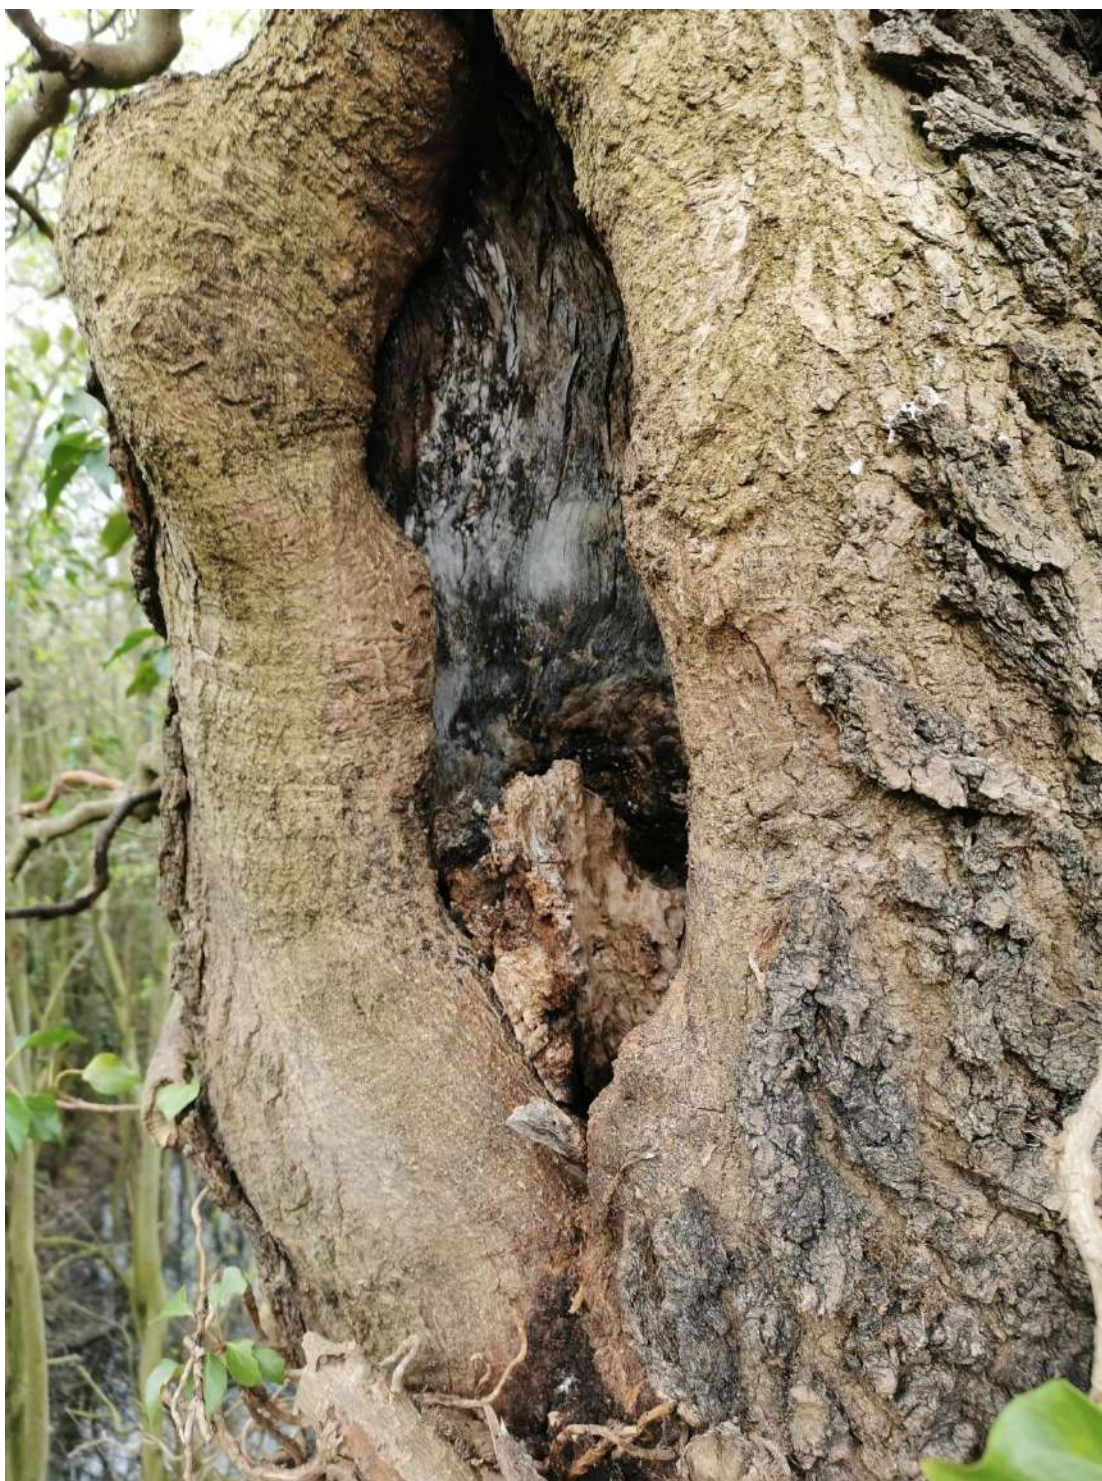
Photograph 81 – T40 showing stem cavity.
