## **BAT GROUND LEVEL TREE ASSESSMENT**

### **Plot 3A**

Wrexham Industrial Estate  
Wrexham  
Wrexham County Borough  
L22 3XS

| UES reference: | UES03448/06 |

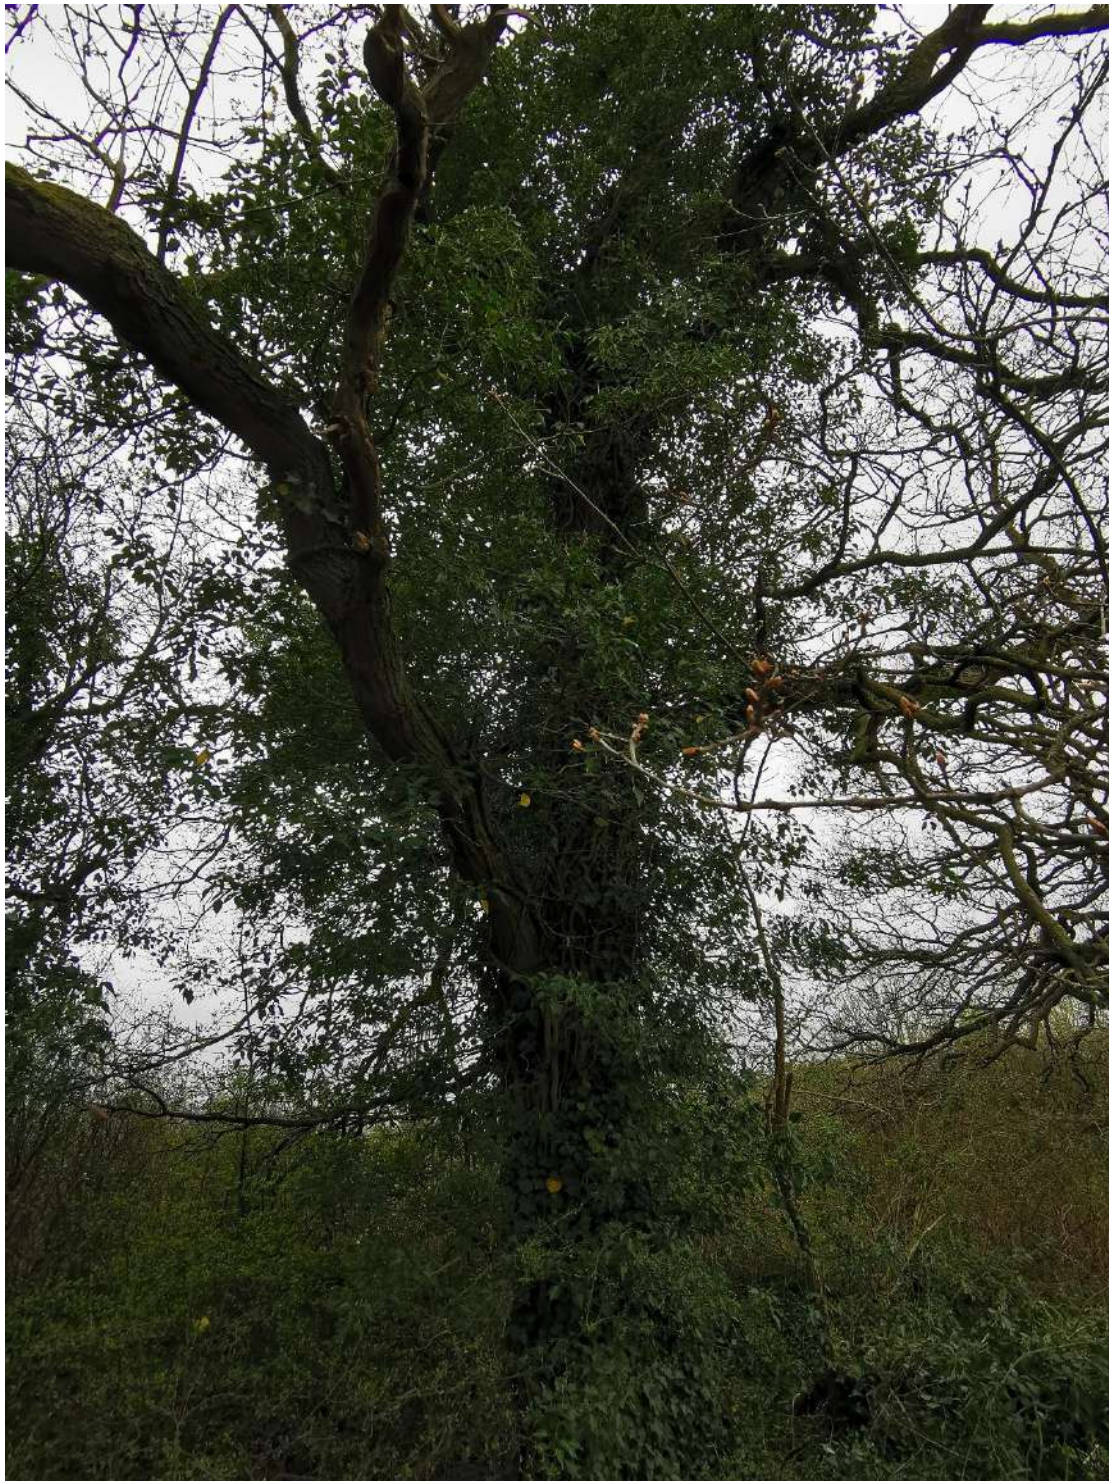
**T42** is a mature pedunculate oak found in the dense scrub which runs along the watercourse in the north-west corner of the site. It is approximately 12m in height with a DBH of 0.7m. The tree features dense ivy cover on all aspects and is considered to have moderate potential to support roosting bats.

Photograph 83 – T42 showing ivy cover.

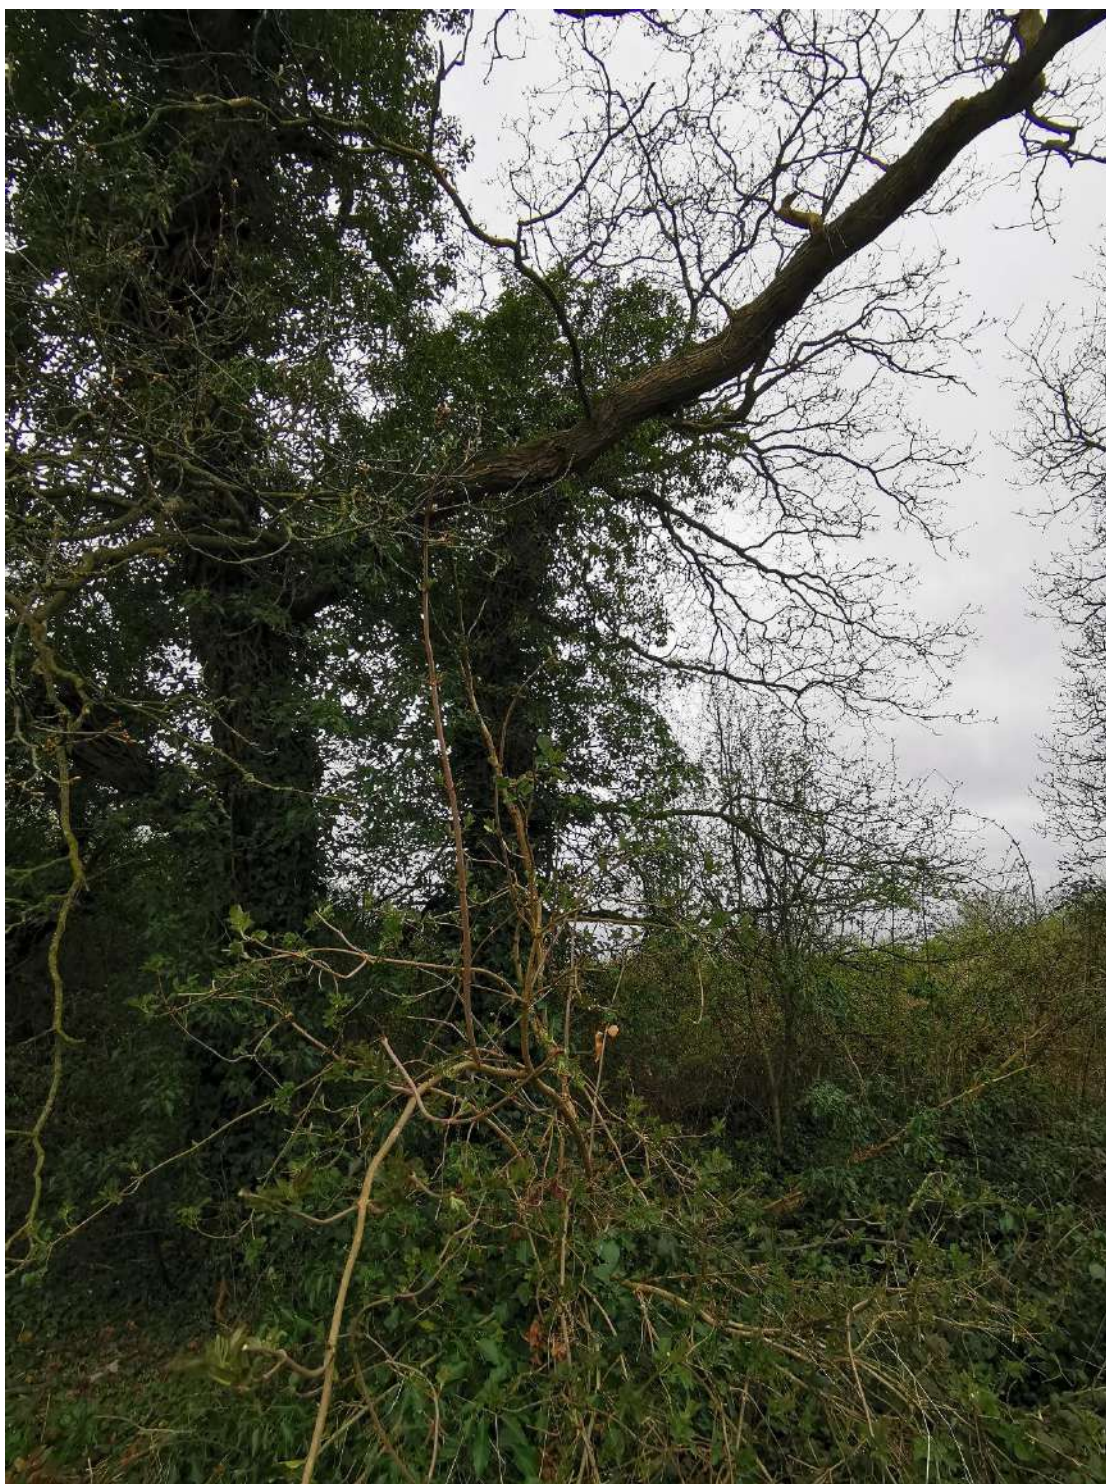
**T43** is a mature pedunculate oak found in the dense scrub which runs along the watercourse in the north-west corner of the site. It is approximately 12m in height with a DBH of 0.7m. The tree features dense ivy cover on all aspects and is considered to have moderate potential to support roosting bats.

Photograph 84 – T43 showing ivy cover.

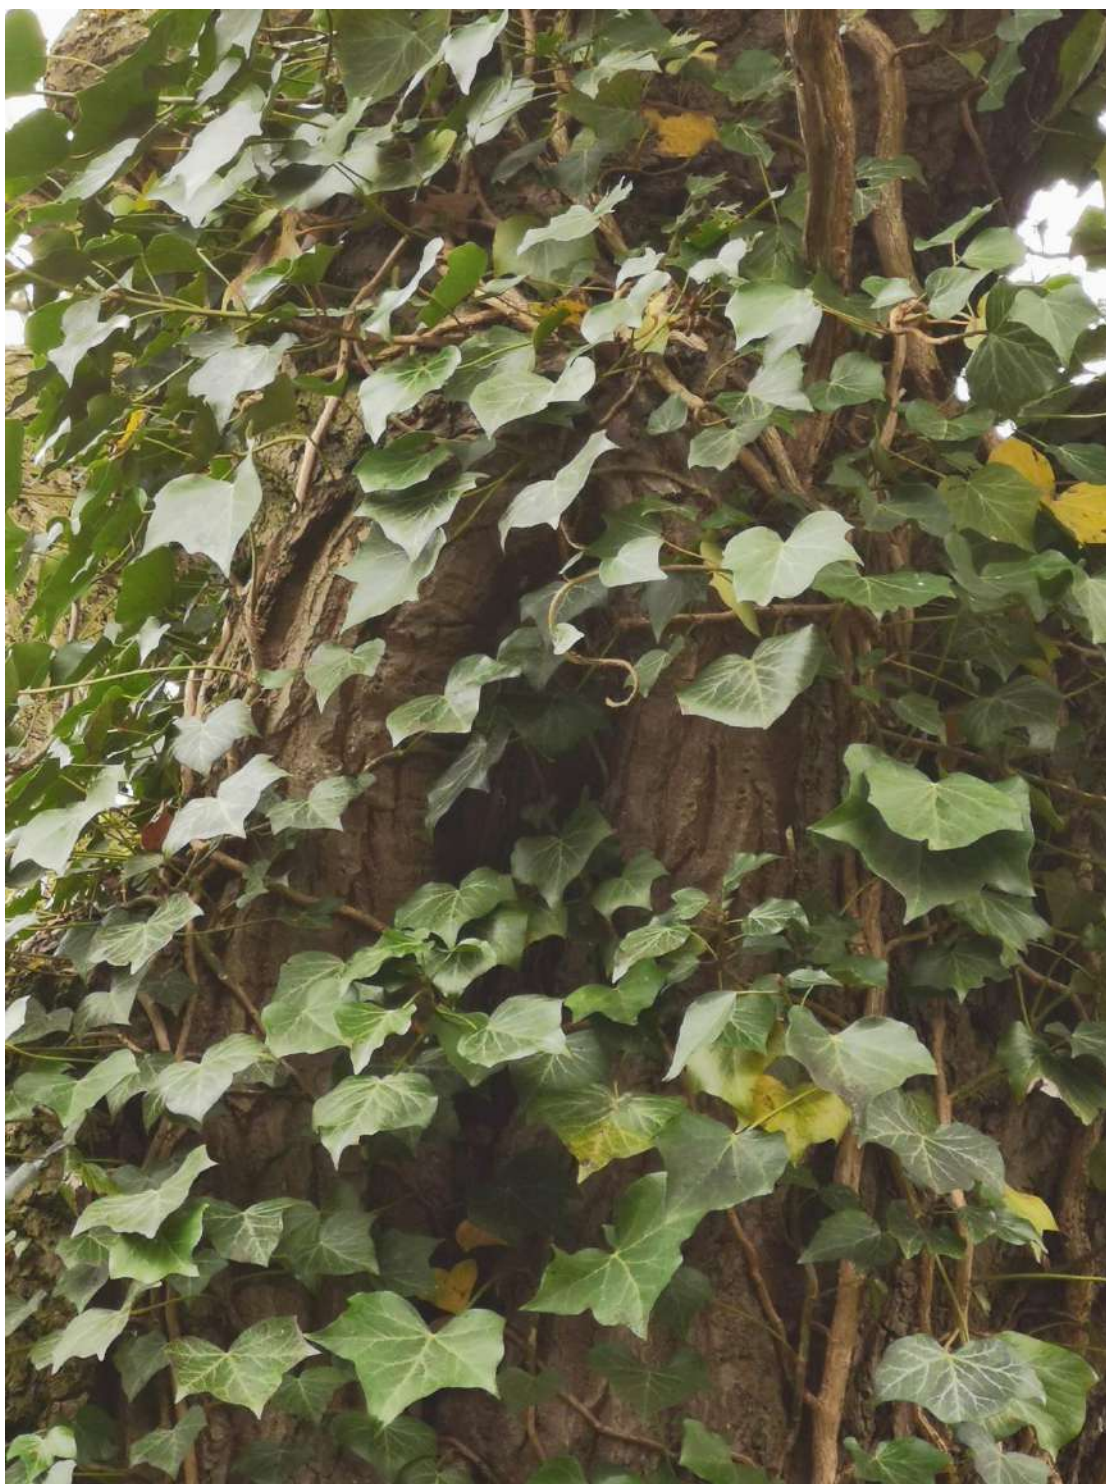
**T44** is a mature pedunculate oak found in the dense scrub which runs along the watercourse in the north-west corner of the site. It is approximately 10m in height with a DBH of 0.5m. It features a knot-hole on its western aspect at a height of 3m and a weld at a height of around 4m on its southern aspect. This tree is considered to have moderate potential to support roosting bats.

Photograph 86 – T44 showing knot-hole beneath ivy cover.

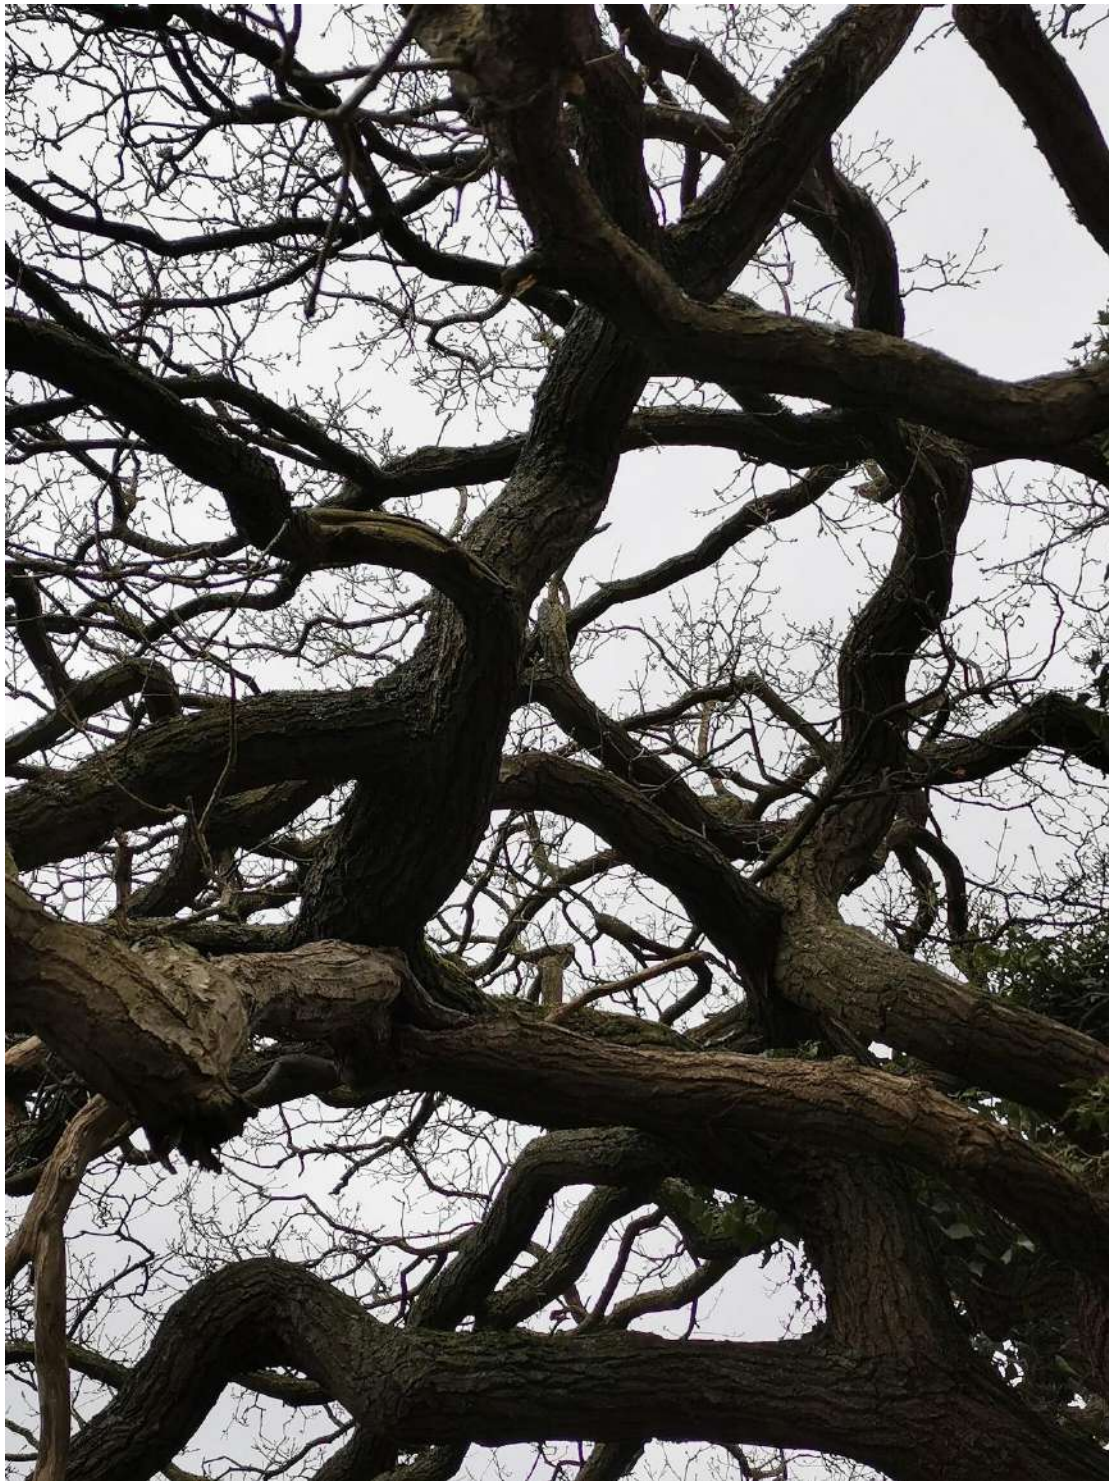
Photograph 87 – T44 showing welds.

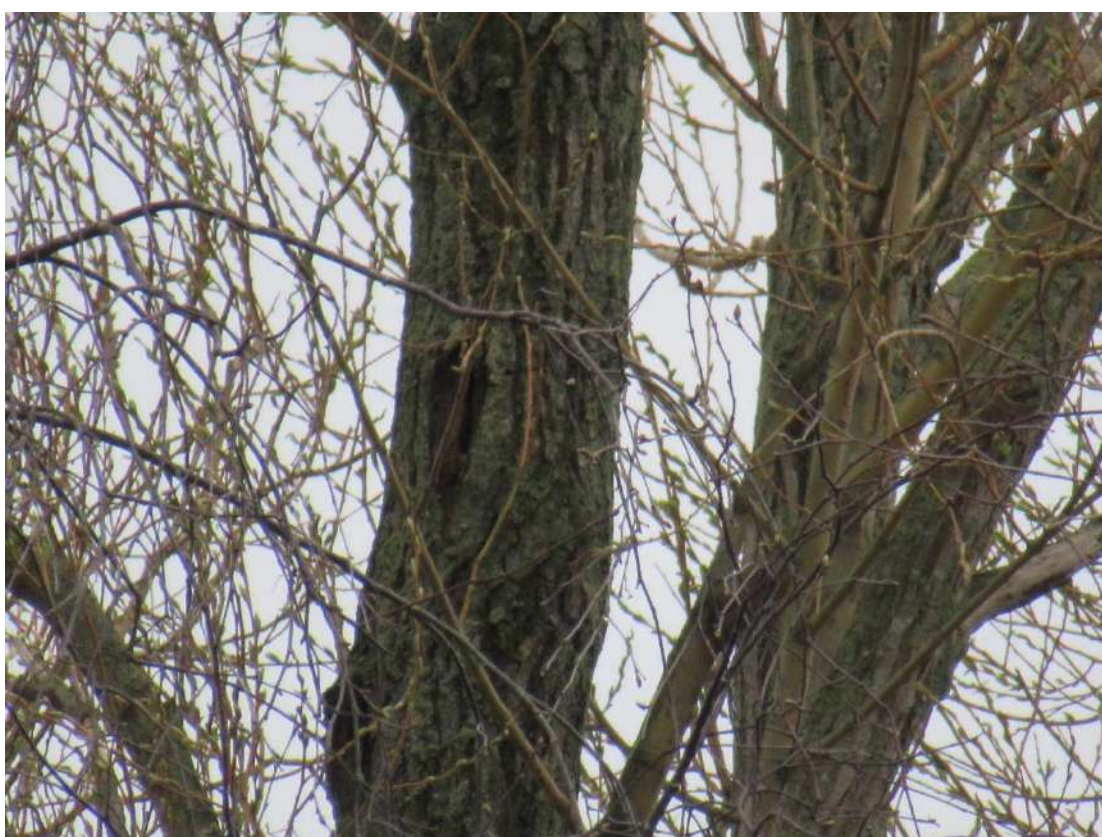
**T45** is a mature crack willow found on an island in a pond in the south of the site. It is approximately 16m in height with a DBH of ~1m. This tree cannot be fully inspected due to its position, although missing bark can be observed on its eastern aspect at a height of around 10m, possibly indicating a cavity underneath. As a precaution, this tree is considered to have moderate potential to support roosting bats.

Photograph 89 – T45 showing missing bark.

T45 is a large crack willow on an island in a large pond could not be accessed during the ground-level tree assessment and is unlikely to be accessible for aerial tree assessments. Therefore, two bat presence/absence surveys will be required, with a potential third roost characterisation survey if necessary. These surveys should be undertaken by an appropriately licenced ecologist during the bat survey season, May to September inclusive.
