# **AROSFA, FRON ISAF, CHIRK WREXHAM**

## **HERITAGE IMPACT STATEMENT**

**May 2023**

## **AROSFA, FRON ISAF, CHIRK LL14 5AH**

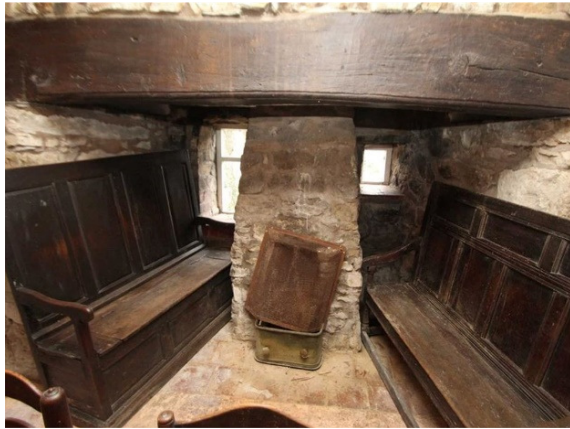
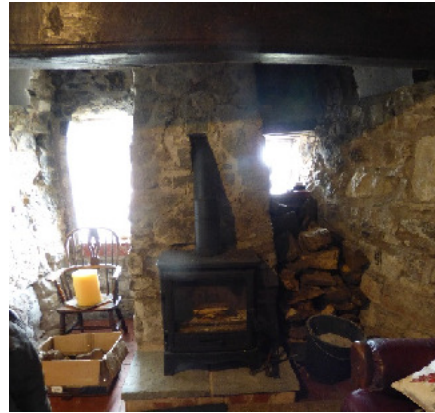
The stove and a new hearth plinth in the dining room replaces an open fire.

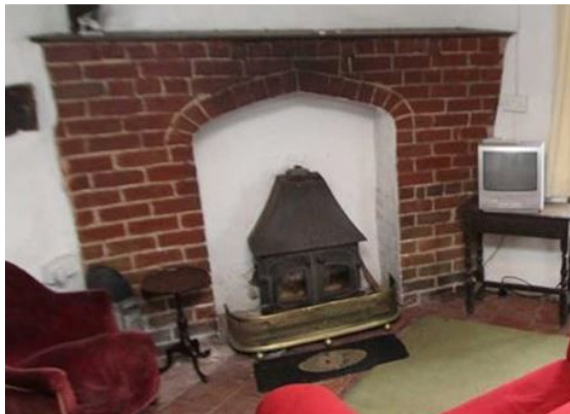
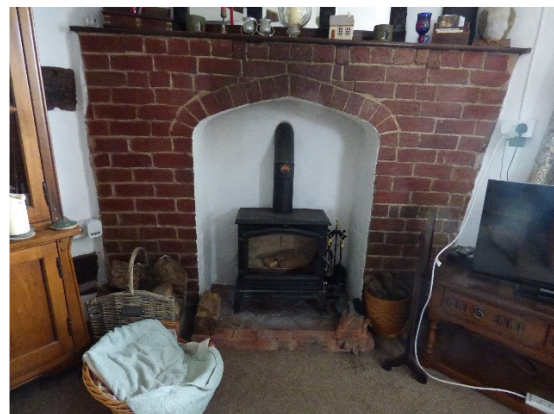
The stove and a new hearth plinth in the living room replaces a previous stove; the fireplace surround is unaltered.

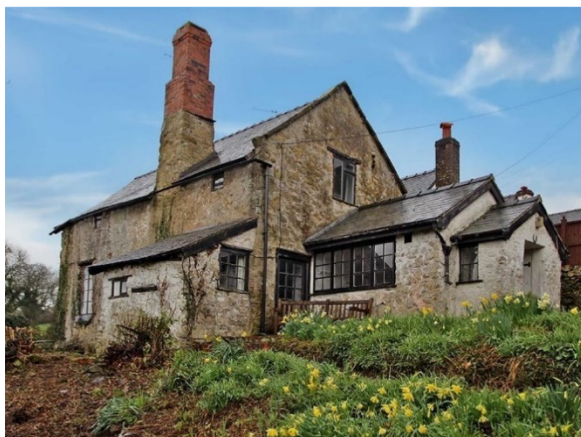
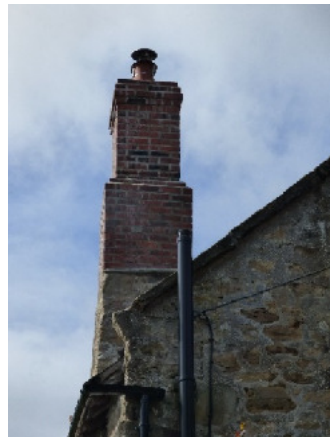
Both these stoves have flues inserted into the existing chimneys, and new chimneypots have been installed to comply with current regulations.

Although the new chimneypots do affect the external appearance of the building, they would have been necessary when more efficient modern wood burners were installed. Any reduction in significance is in my opinion

outweighed by the increased thermal comfort and saving in carbon, which in the long term will help to ensure that the heritage asset is sustained in use.

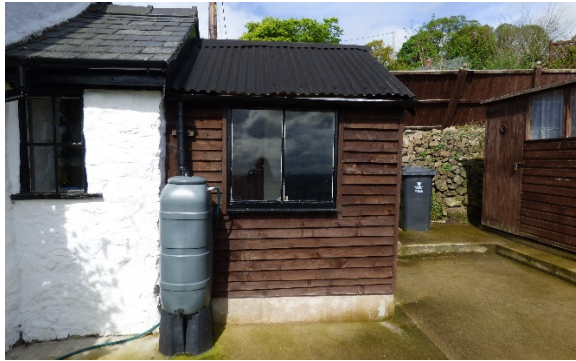
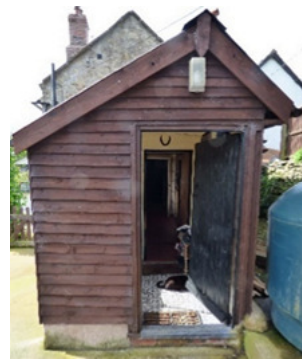
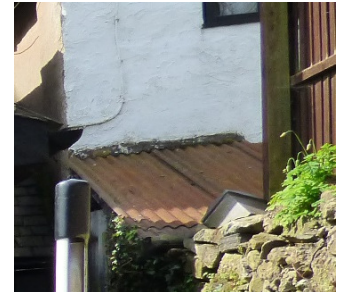
Photos taken 5/5/23

The screenshot of the Zoopla 2019 archive external view (above, 3.1) shows the kitchen and lobby without the porch. The timber construction is similar to the construction of other outbuildings in the grounds shown on the 2022 Zoopla website, while the corrugated iron roof is similar to one on an outbuilding next door.

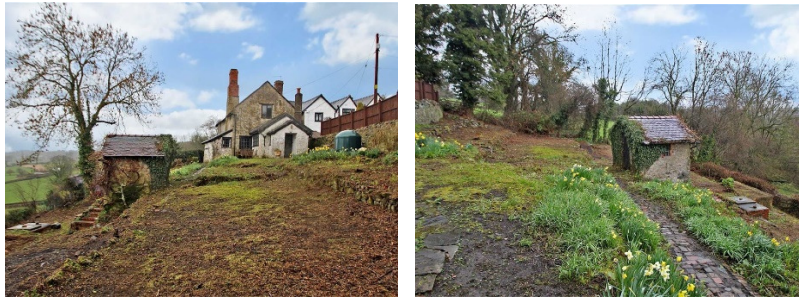
Screenshots from 2019 Zoopla website

It can be seen from the 2019 pictures that the stone shed was in poor repair; this has now been re-roofed.

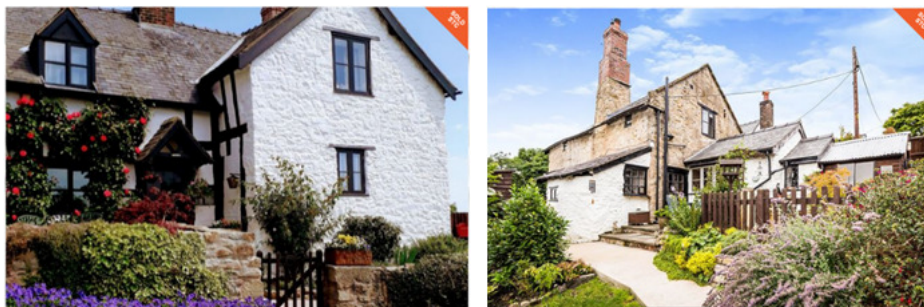
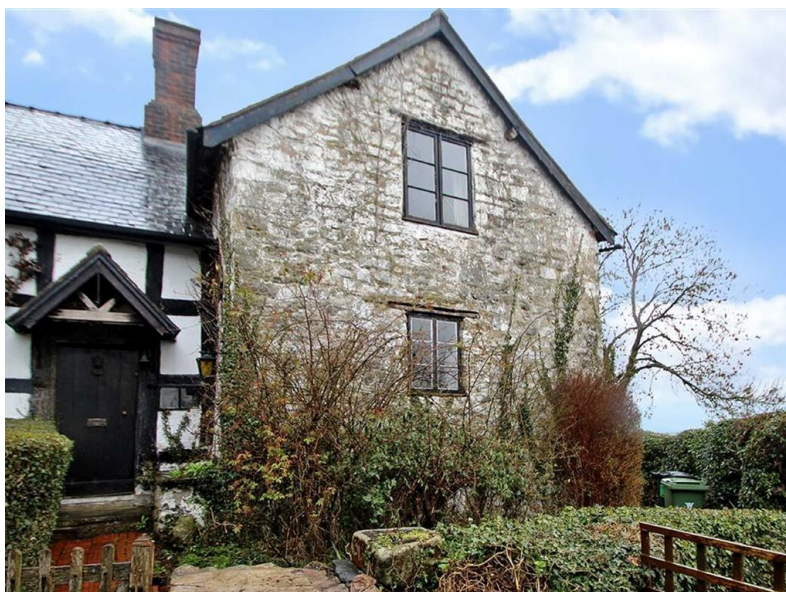
The CADW listing report says that the stone walls of Arosfa were colour washed, but by 2019 this had washed away although traces remain on the front elevation (see screenshot of Zoopla archive above, 3.1, and below).

The listing report also says that the half-timbering next door had rendered and whitewashed infill at the time of listing. The previous owner has painted the stone gable wall at the front of the property and the stone walls of extensions at the rear. The paint used would appear to be a breathable lime-based paint, but we have not analysed it. If it is, it will protect the stone, give some weather protection as well as enhancing the significance of the building.

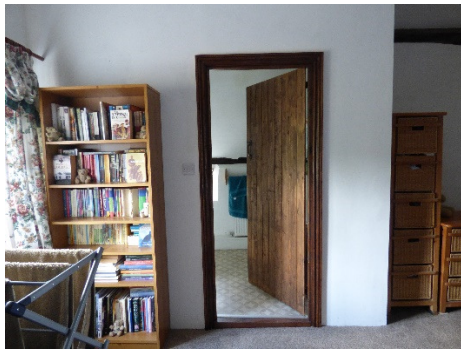
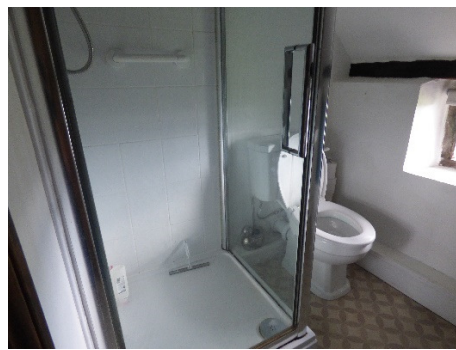
Photos of en suite taken 5/5/23

The ensuite in bedroom 1 is a new construction, with stud partition and a framed, ledged and braced cottage-style door. It has been tucked in behind the chimney and makes use of the existing small window W.1.3. The floor has been raised which will allow for a services void above the existing floorboards shown on the Zoopla 2019 archive. The waste feeds into a upvc soil vent pipe on the rear elevation, which is shown on the 2022 Zoopla screenshot.

The previous owner has clearly tried to reduce the impact particularly on the floor, but without an invasive investigation of the state of the boards below the new floor it is difficult to say whether they have been significantly damaged. The partition is stud and therefore a reversible intervention. On balance therefore the additional amenity would in my opinion compensate for any loss of significance. The plastic pipework is more problematic. Whilst cast iron is a suitable material for rainwater goods, it is not really suitable for foul drainage. I would therefore recommend leaving the SVP and associated plumbing as it is. It would be more damaging to route the pipework inside the building.

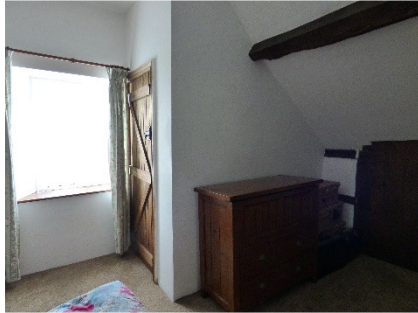
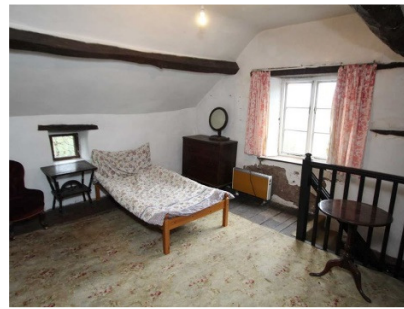
The stair has been enclosed with a stud partition. It is possible but unlikely that the handrail and balustrade was encapsulated within the partition; it is more likely

that it has been lost. The partition and door will reduce draughts between the ground and first floor, and so will improve amenity, but this may not outweigh the reduction to significance by the loss of the balustrade. However, as we do not have any details apart from the archive photograph I would ask for retrospective consent for this intervention rather than an attempted restoration. The door at the head of the stair is a framed, ledged and braced cottage-style door which seems appropriate.

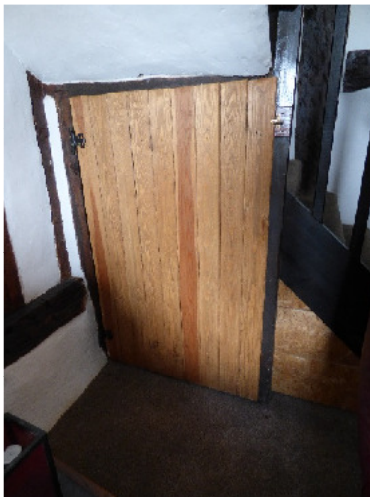
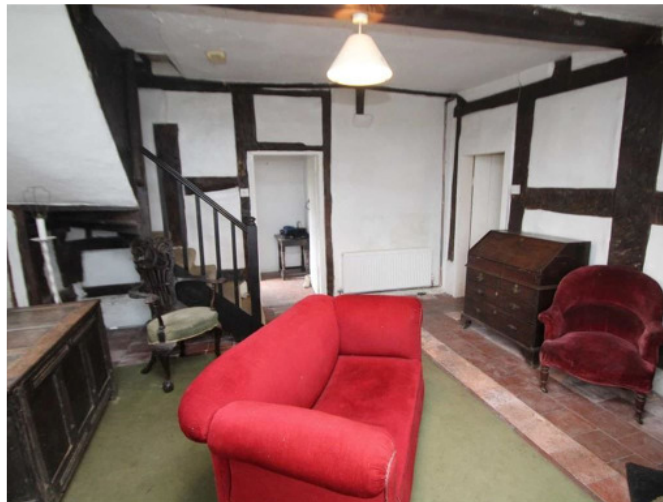
A vertically boarded door has been fitted to create a cupboard for storage below the stairs. This is in keeping with the style of doors in the rest of the house.

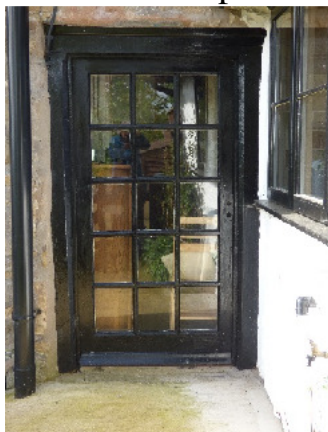
Door D.2

Door D.6 is similar to door D.2, and probably pre-dates the 1970s kitchen extension. The glass has been painted over on both sides, and it would be good to remove the paint if this is possible.

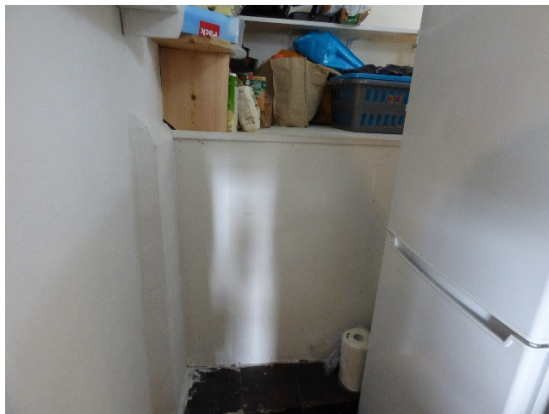
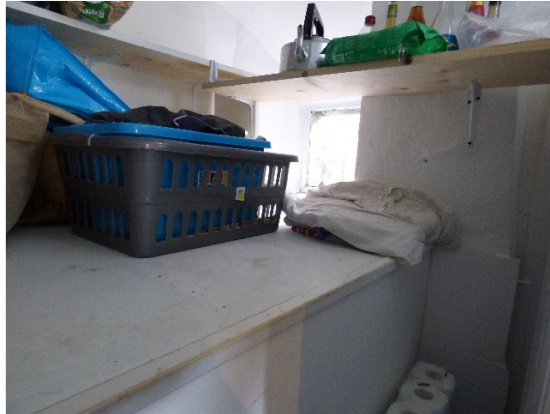
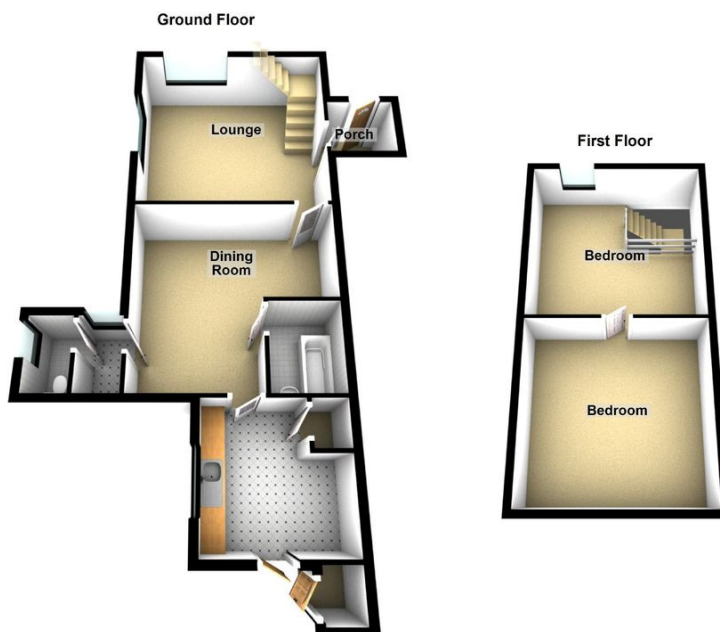
Photos taken 5/5/23

The ground-floor bathroom has been converted to a pantry, and it appears that the existing bath has simply been boarded over with the plumbing disconnected. The bath is shown on the 2019 Zoopla plan, but the modelling is generic and the bath may have some heritage value. It would be worth lifting the worktop to investigate.
