# Chapel House, Bronington Bat Report

Project Number                      TT3507

Title                                      Chapel House, Bronington

Document Number                  R01-Bat Report-Rev00

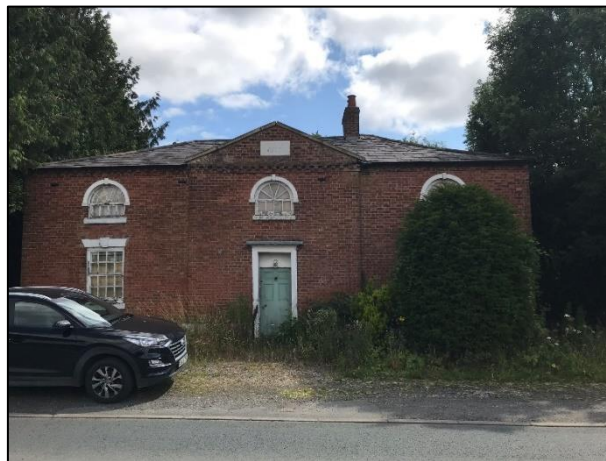
The Chapel has red brick walls with timber framed windows and doors, windows are single glazed with decorative, white-painted stone lintels. There are two full height windows in the centre of the building to the rear which allows light into the stairwell section of the property. A single-storey porch style extension has been demolished from the western end of the property which has left damaged brickwork visible on the rear wall. The roof is double hipped with slate roof and ridge tiles and a red brick chimney with lead flashing around the base is present on the western side of the building (*Plates 1 to 4*).

*Plate 1. Front (northern) elevation (looking south)*

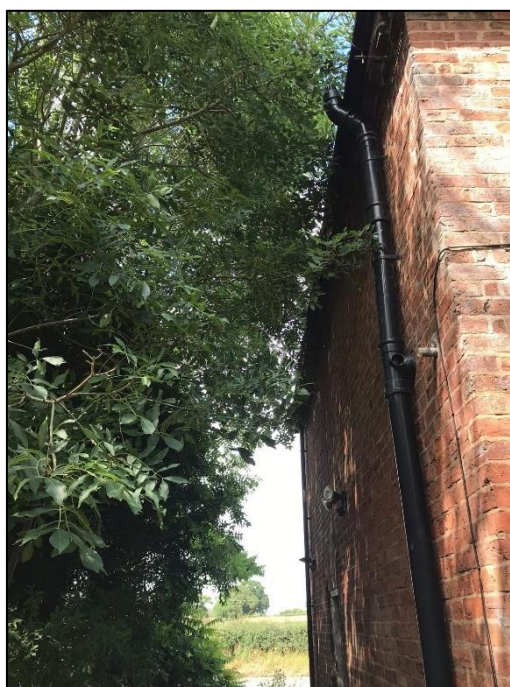
*Plate 2. Side (western) elevation (looking north-east)*

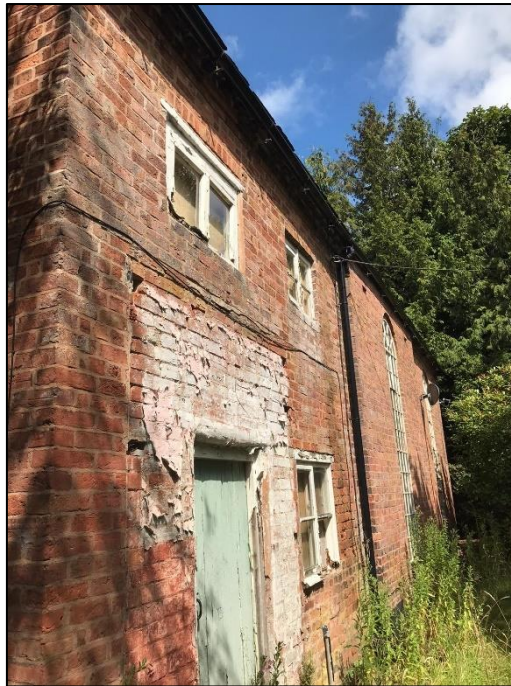
*Plate 3. Rear (southern) elevation (looking north-east)*

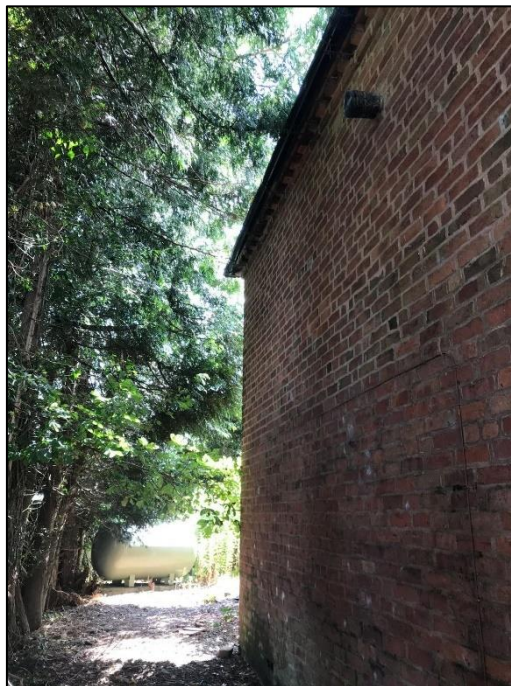
*Plate 4. Side (eastern) elevation (looking south-west)*

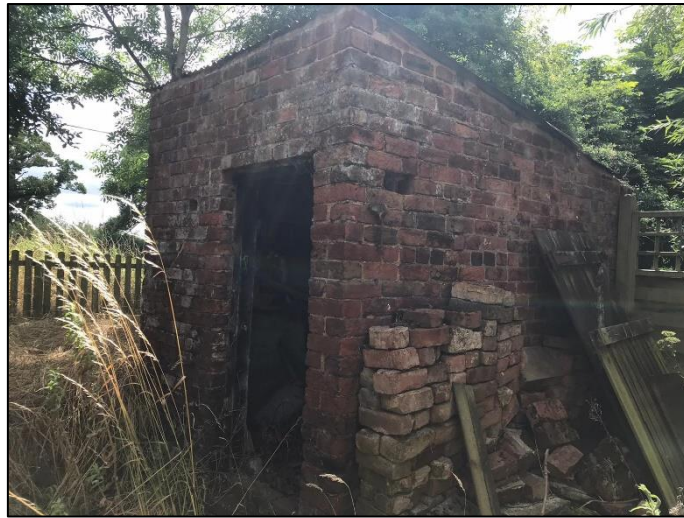
The outhouse is built from single thickness red brick with an open doorway and tin sheet roofing, this building is in poor condition with the door missing and roof damaged. The bricks are also crumbling due to the weather eroding the brickwork (*Plate 5*).

*Plate 5. Outhouse*

The small outhouse within the rear garden is in poor condition with crumbling brickwork, damaged roof sheets and a missing door. There is no enclosed loft space within this building and the walls are single thickness brick. No evidence of bat use was recording during the initial roost assessment and no suitable roosting features were found within this building. The building does offer some suitable areas for perch feeding, however no feeding remains were found inside the outbuilding (*Plate 5*).

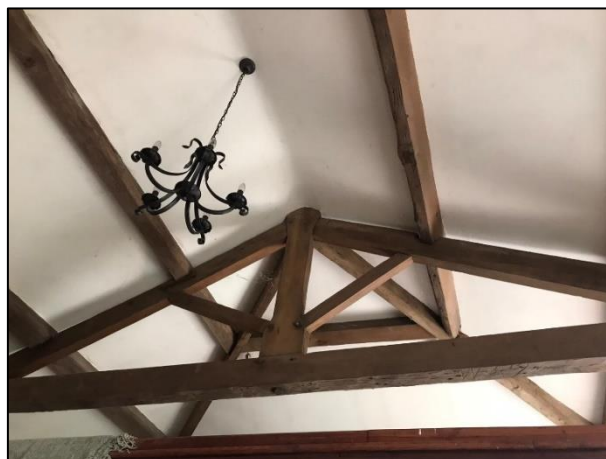
*Plate 6. Exposed timber roof beams in lounge*

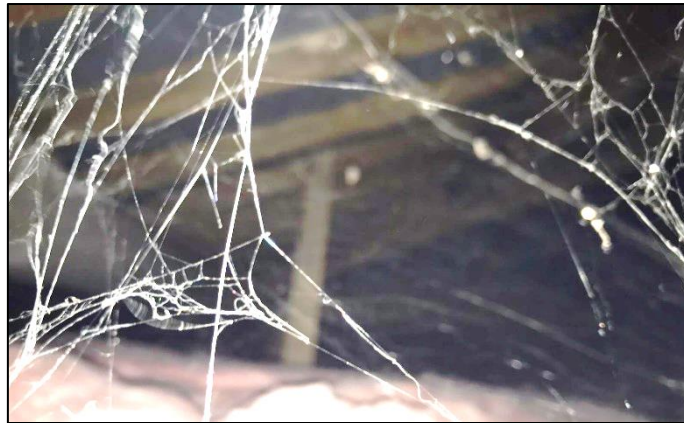
Internally the ground floor is in a poor state of disrepair with evidence vandals have been into the property and broken furniture, damaged walls and pulled up floorboards. The internal portioning walls have been damaged and signs of water damage within the ground-floor rooms was noted. A large staircase is present towards the centre of the property which leads to the first-floor living accommodation. The eastern side of the property is open to the ceiling with exposed original timber A frame beams and brick fireplace (*Plate 6*). The western side of the building is comprised of several smaller bedrooms and bathroom areas with an enclosed loft space above these sections. Access into the loft space was limited due to the poor condition of the ceiling making the loft space unsafe to enter. The loft space is low in height (max 1.2m at the apex) due to the double-hipped roof structure. The roof has been lined with a plastic membrane, some original timber framework was noted and old, decaying mortise and tenon joints support the main roof framework. Newer treated timber rafters and ridgeboards were also present in the loft space, likely replaced when the Chapel was converted into a residential dwelling (*Plates 7 to 8*).

*Plate 7. Interior of loft*

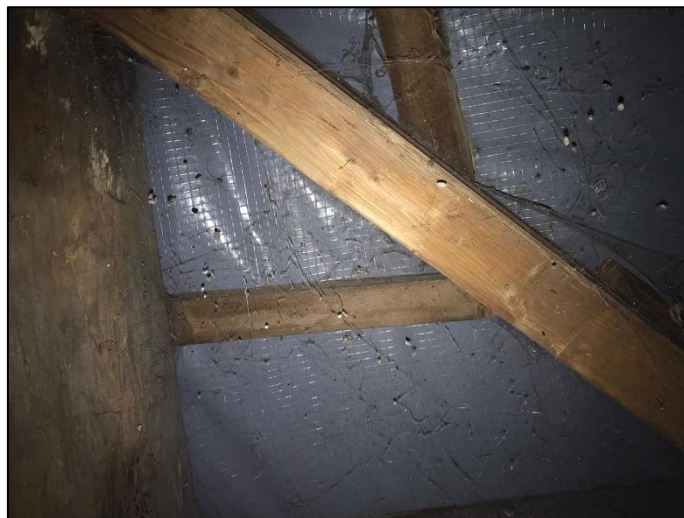
*Plate 8. Loft roof beams and roof membrane*

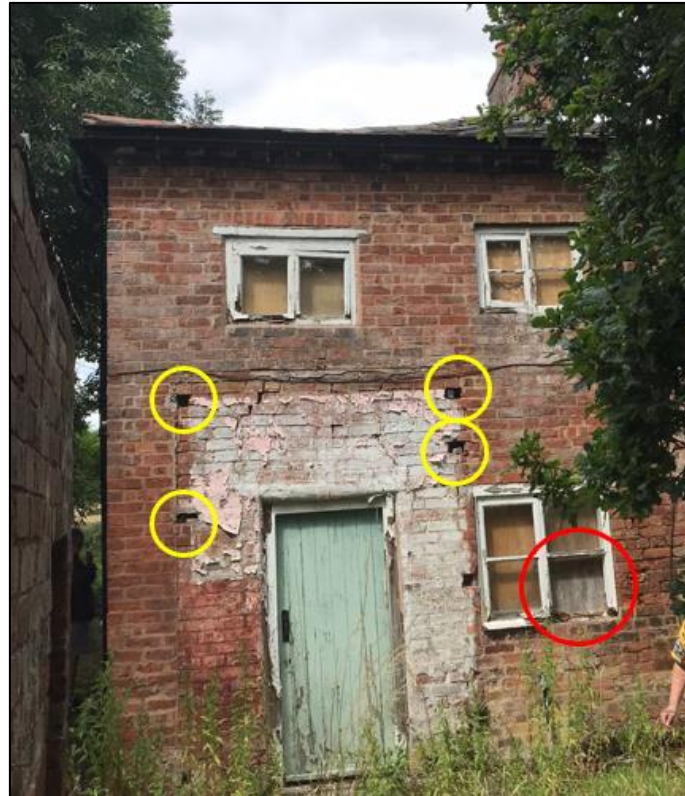
Suitable roosting features around the Chapel building include gaps around the wall tops where the roof tiles have lifted from the brick, holes in the brickwork at the rear of the property where an old extension has been demolished, a gap above the front door frame on the northern aspect of the building and a broken window on the first-floor of the Chapel overlooking the staircase which was large enough to allow access into the property for bats. There are also several lifted and missing roof tiles, gaps where the lead flashing around the chimney has lifted and gaps within the brick work of the chimney where the chimney has moved over time. (*Plates 9 to 11*).

*Plate 9. Holes in the brickwork on the rear of the property and damaged window frames/broken panes of glass*

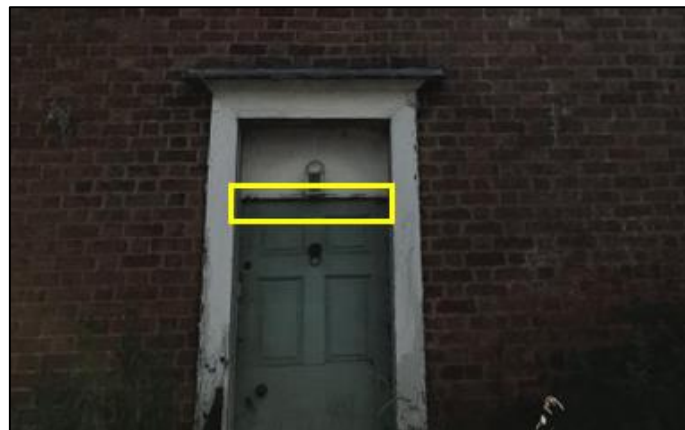
*Plate 10. Gap above the front door*

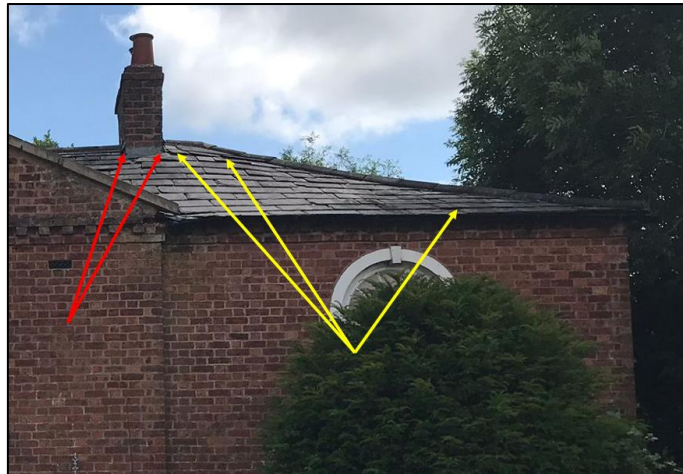
*Plate 11. Examples of lifted roof tiles (yellow arrows) and gaps under the chimney flashing (red arrows)*

- Roof stripping and the removal of the slate tiles and ridgeline tiles will be completed under the watching brief of a licenced ecologist, with the roof tiles being removed carefully by hand. Supervision by the ecologist of repair works to the roof, chimney and ridgeline will also be required due to these features offering suitable roosting areas for bat species.

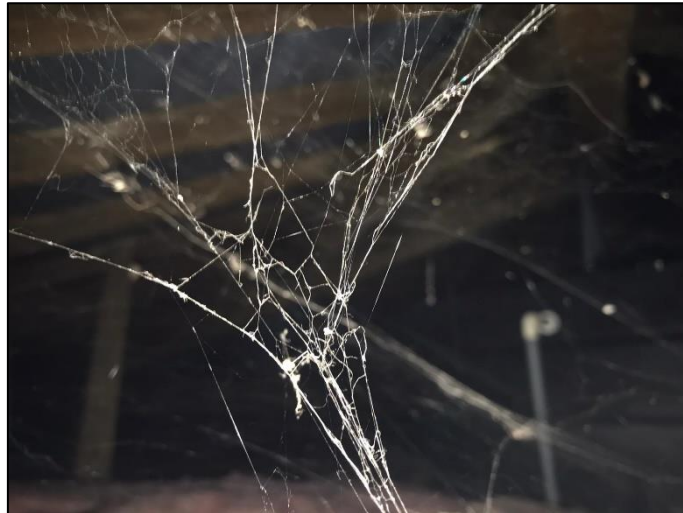
There were no bat droppings recorded within the loft space of the Chapel with cobwebs observed along the wall top inside the loft (*Plate 12*), however due to the limited access available into the loft space and the gaps noted around the chimney, gaps where tiles have slipped and gaps along the wall tops Chapel House offers roosting areas for bat species with access easily possible for bats into the loft space and wall tops.

*Plate 12. Cobwebs over beams within the loft space*

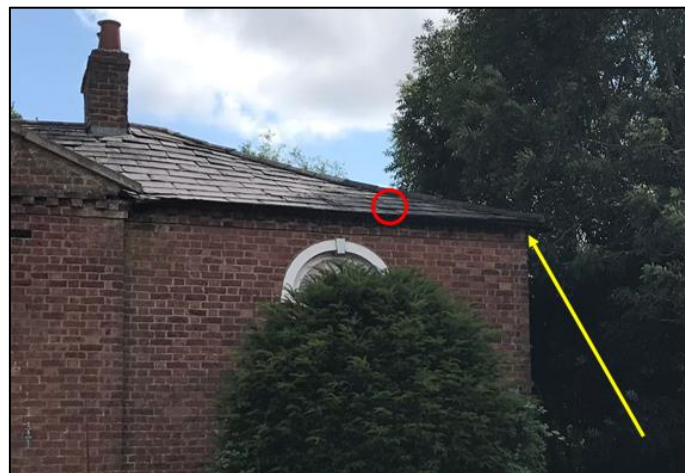
- **One *Myotis* spp.** appeared to re-enter at the wall top between the brick and tiles on the north-western corner of the Chapel at 04:57 (*Plate 13*)

- **One *Myotis* spp.** emerged from under a loose tile on the northern elevation of the Chapel at 20:25 (*Plate 13*)

*Plate 13. Location of emerging *Myotis* sp. during September dusk survey (red circle) and re-entry location of *Myotis* sp. during August dawn survey (yellow arrow)*

Based on the results of the Preliminary Roost Assessment and Bat Activity Surveys, the dwelling was found to support two day roosts of individual *Myotis* spp. The proposed extension works and roof repairs would therefore cause the loss or disturbance of two day roosts and/or injuring/killing of up to two *Myotis* spp. bats.

- No scaffolding to be erected over suitable access points for roosting bats until features have been checked, filled or excluded.
- Where possible, features used by bats will be retained or recreated with the roost at the wall top on the northern corner of the Chapel being retained post-development, some disturbance will occur during the construction phase when the roofs are being tied-in and repair work undertaken but the existing roost entrance at the wall top will not be affected by the proposed works.

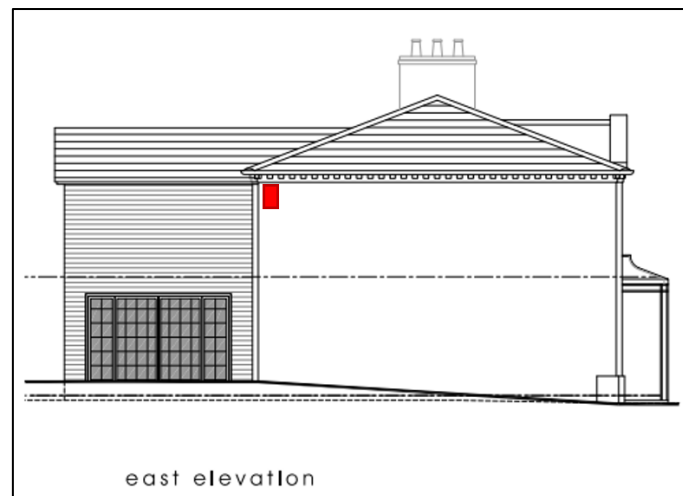
Figure 9. Proposed Beaumaris Woodstone bat box location on Chapel (red rectangle)

- If roosting features are to be lost then these must be replaced with similar features during the construction phase of the extension.
- Additional simple roosting features will also be created by incorporating at least two bat tiles and one Beaumaris Woodstone Bat Box (or equivalent) into the new extension section of the property (*Figures 9 & 10*).

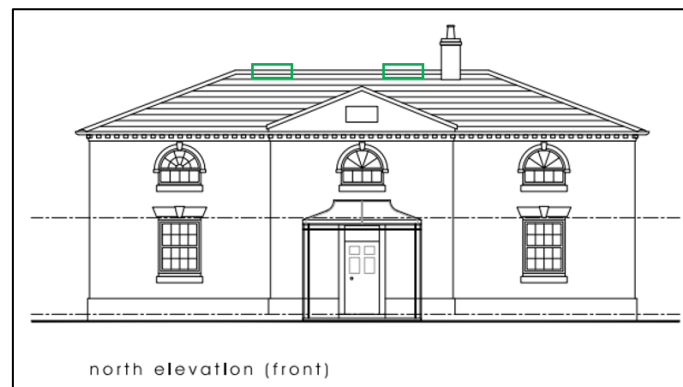
Figure 10. Proposed lifted ridge tile locations on Chapel (green rectangles)
