**Report Type:** Mitigation Strategy

**Site Address:** Brunett Barns  
Lower Wych Lane  
Ty Broughton  
Whitchurch  
SY13 3BA

**Report Reference:** 20-05 107.5Mit

**Date of Issue:** 6<sup>th</sup> April 2023

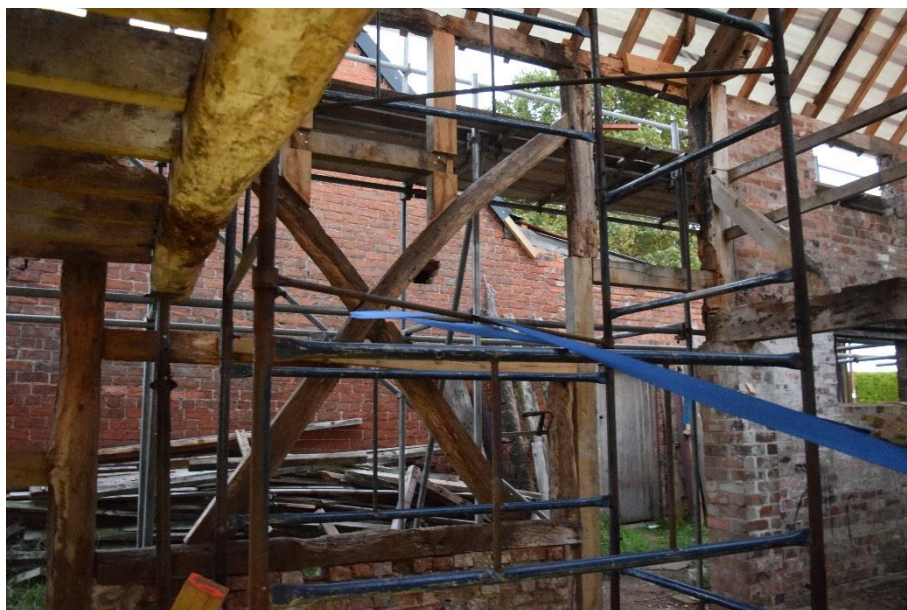
**Figure 3.3. View from interior through eastern elevation (Aug 2021)**

Scattered bat droppings were seen on the mezzanine floor to the north of the building. These seemed to be associated with areas where there remains open mortice joints in the timbers.

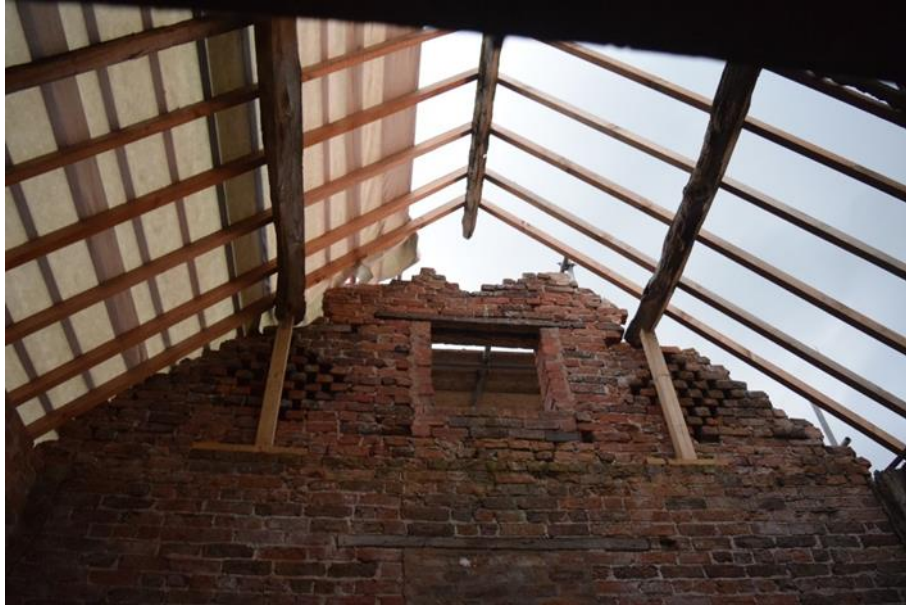
**Figure 3.4. Southern gable end (Aug 2021)**

Work had been stopped on this building by the council. The southern gable end was seen to be in as poor condition as in 2018.

**2023** - The missing brickwork has been replaced and internal stud work erected. This makes the building on the first floor darker and potentially of more interest to bats for roosting. A bat box has been erected on the northern elevation of the building.

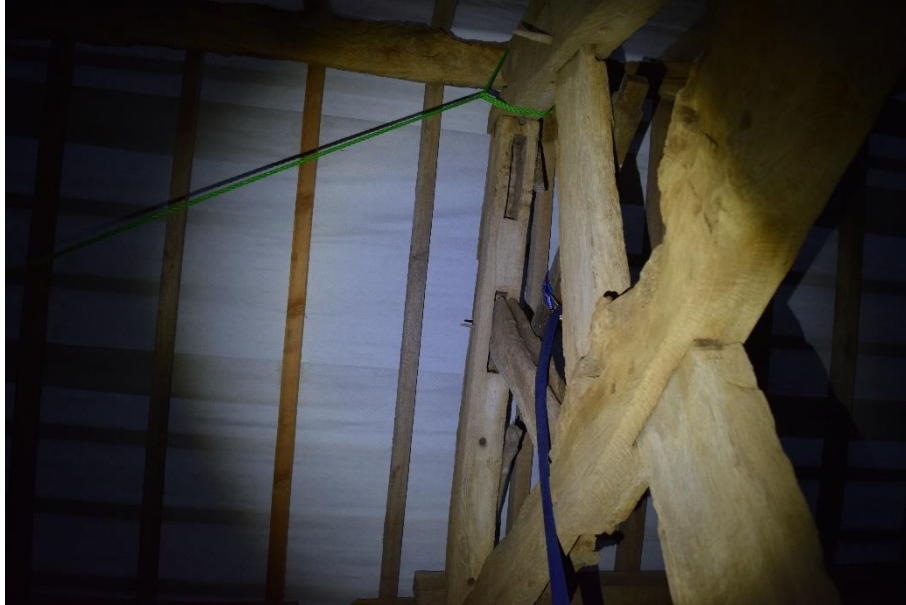
**Figure 3.6. Open mortice joint in roof timbers (Feb 2023)**

Open mortice joints were still apparent in February 2023 and this is where a bat roost was identified in 2021

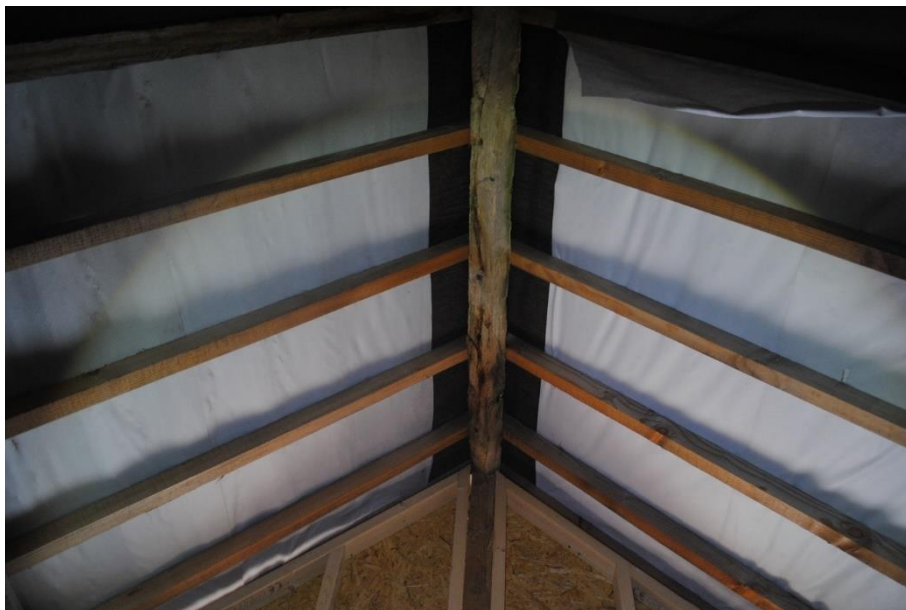
**Figure 3.7. View of bitumen hessian along ridge placed above the breathable membrane.**

| Building | Ongoing works | Observations |
|---|---|---|
| Barn 1.1 | Original metal sheet roof replaced with slates, with the addition of 1m strip of bitumen hessian lining along ridge. | Bats can still come into contact with non-bitumen coated roofing membrane (NBRM) |

A length of bitumen hessian lining material had been added to the ridge to allow bat access from slightly raised ridge tiles to this area.

1. Barn 1.1 has been re-roofed with breathable membrane and a strip of bitumen hessian lining along the ridge. If modern breathable membrane is installed atop the bitumen, this will be removed.
2. Access for bats below the bitumen hessian lining will be limited by sandwiching the bitumen hessian with a batten on each side of the material. This stops bats being able to pass down below the 100mm of material.
  - a. These timbers will also run down wallplates to prevent bats gaining access from exterior gable walls.

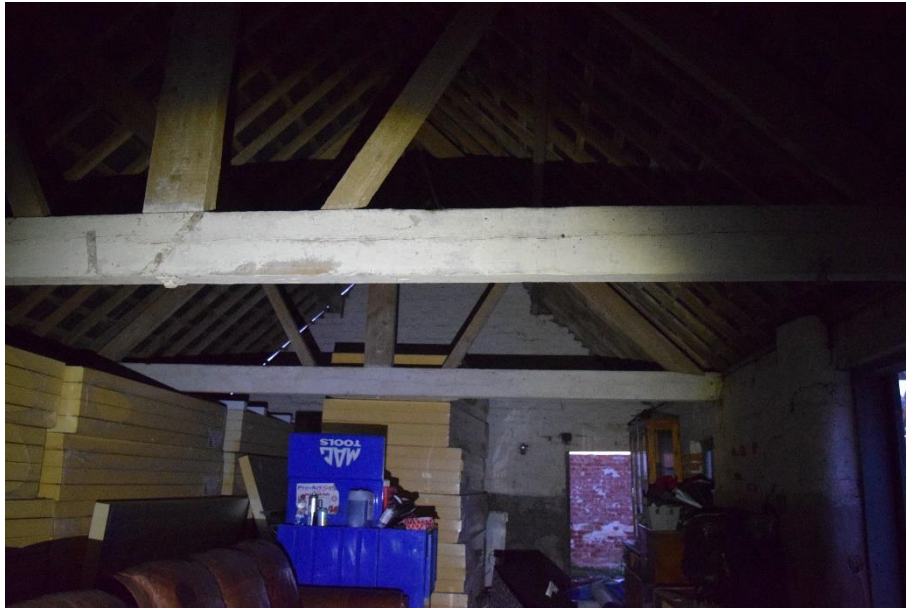
**Figure 3.10. Showing gap along western elevation**

This section of the building remained dark, but the slate roof was not lined and clear gaps can be seen between the roof and the western gable end. The building offered low opportunity for bats.

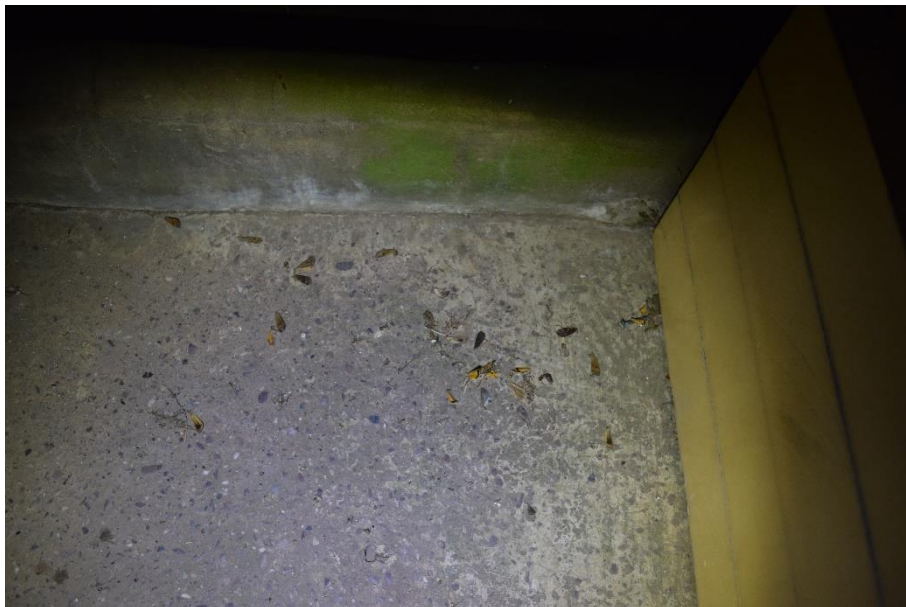
**Figure 3.11. Feeding remains**

Scattered bat droppings were observed within the building on stored items, but there was not enough accumulation of droppings to suggest the presence of a maternity roost.

Feeding remains of yellow underwing moth were observed suggesting presence of a brown long eared bat.

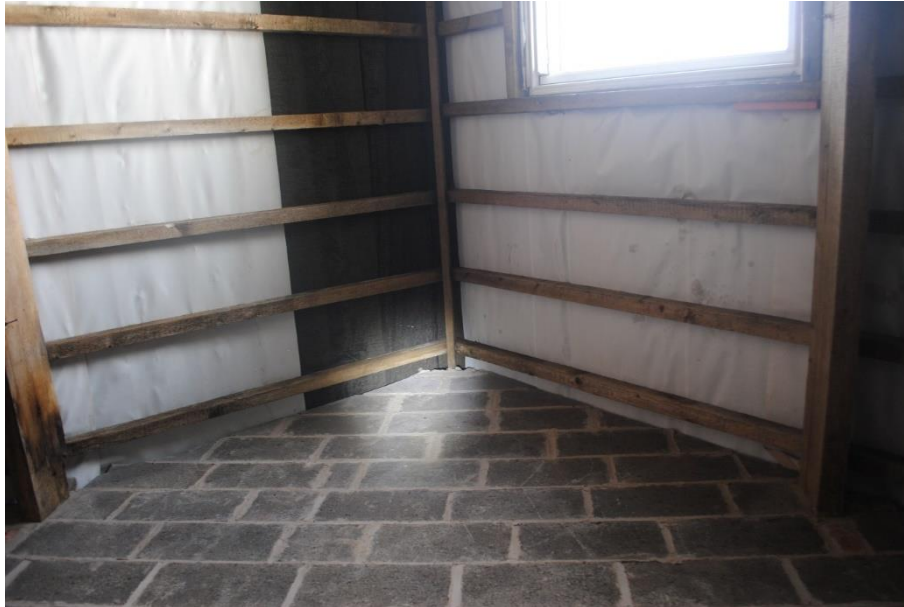
**Figure 3.12. Alterations to Barn 1.2 (Feb 2023)**

Significant work had been undertaken with the roof stripped and replaced with modern breathable membrane and a strip of traditional bitumen hessian lining at the ridge. The buildings had been separated with internal wall.

No bat droppings were observed on the floor in this area, however the concrete floor that had been present in 2021 had been removed with hardcore floor currently in place.

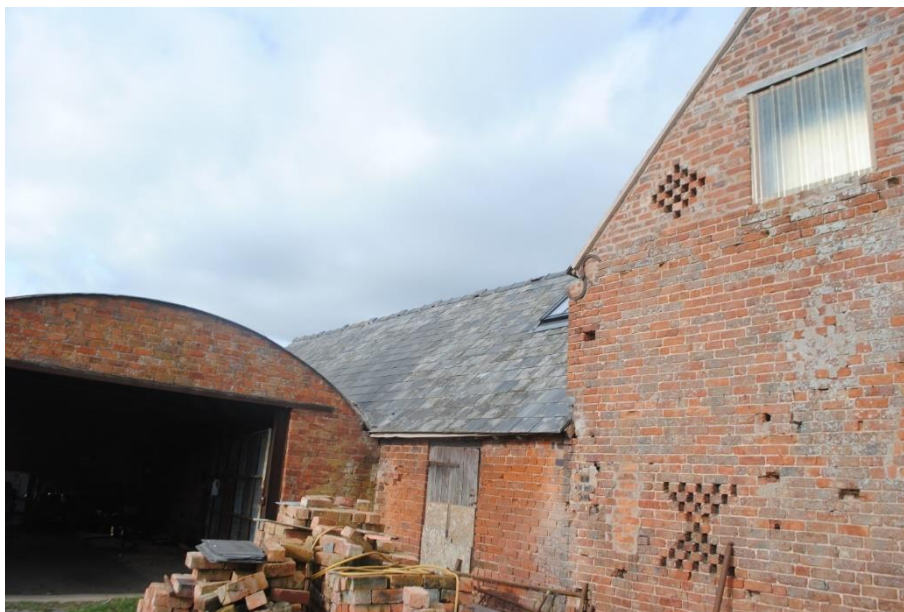
**Figure 3.13. View of ridge tiles with vents (Feb 2023)**

The bat access tiled are considered to be slightly too large for crevice dwelling bats.

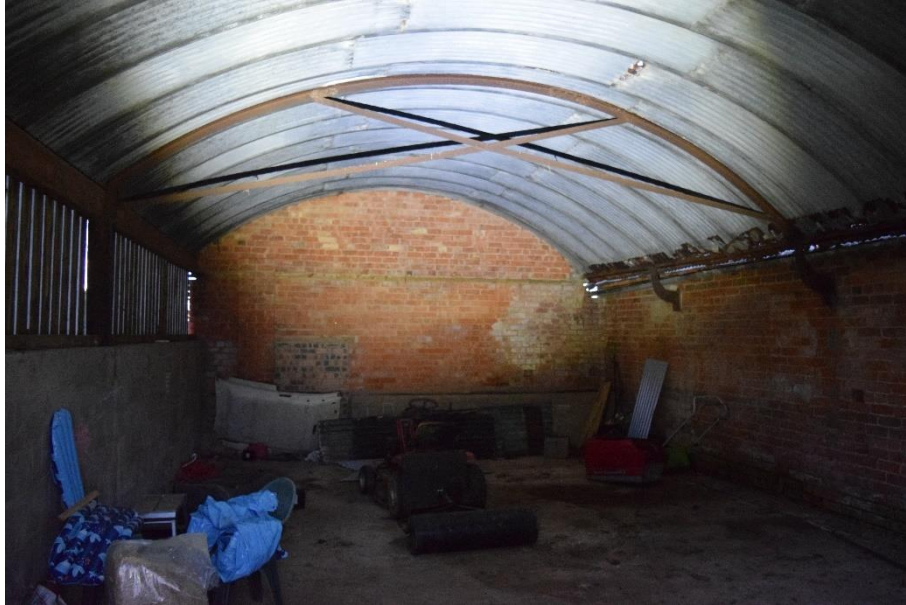
**Figure 3.16. Interior of barn 1.4 (Aug 2021)**

No bat droppings were seen within this building and with gaps along the wall plates is considered to have low potential for bat roosts.

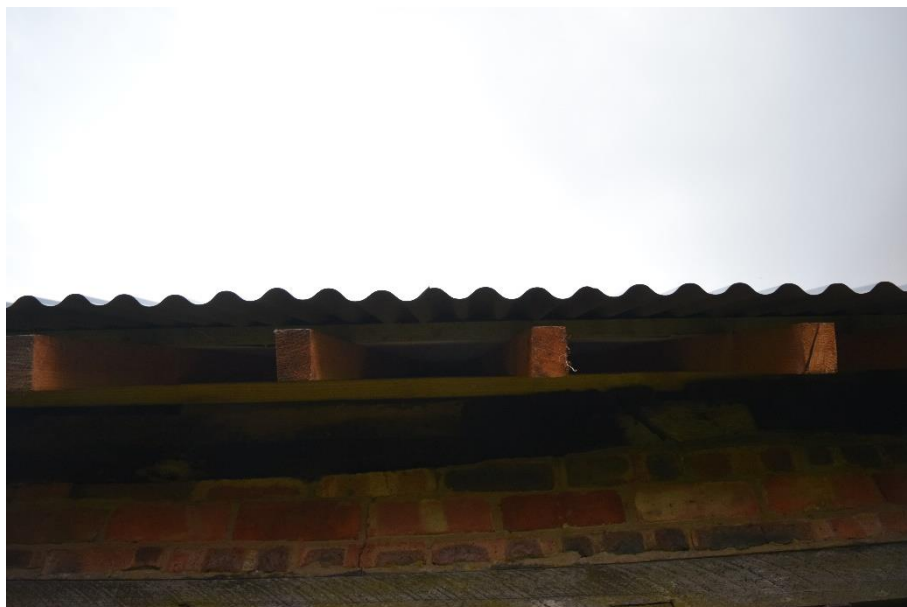
**Figure 3.19. Showing potential bat access areas. (Aug 2021)**

Large spaces are visible into the roof void of the building which allows continued access for bats.

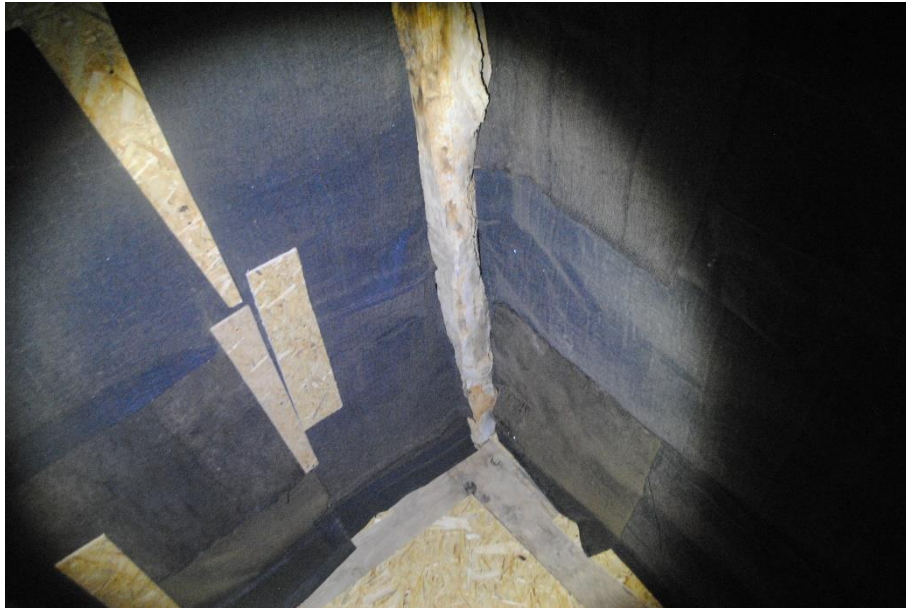
**Figure 3.20. Void left for bats in Barn 2.**

| Building | Ongoing works | Observations |
|---|---|---|
| Barn 2 | A bat loft has been provided with a section being lined with bitumen hessian lining so bats cannot come into contact with non-bitumen coated roofing membrane (NBRM) | A bat dropping was observed in the bat loft section, but it is still not considered fit for purpose by NRW representative. |

The void is over 2.5m high to the apex, 4x5m approximately in size. The bat access was left at the eaves of the building, and the void had been lined with bitumen hessian lining material and OSB board.

1. Barn 2 will be re-roofed with bitumen hessian lined slates. This will occur first so the bats in the area will have an alternative place to roost when work on Barn 1 recommences.
2. A bat loft will be prepared in barn 2. A loft floor will be installed (completed) and the loft space enhanced with appropriate roost features. The bat loft will be the extent of one section of the stables, 4mx5mx2m high.
3. Bat access through the slates will be provided with a lead tile shaped to allow bat access. The access will be 100mm wide, and 20mm high with a slot left in the slates below to allow bat access.
4. The felt will be slit behind this so bats can access the loft.

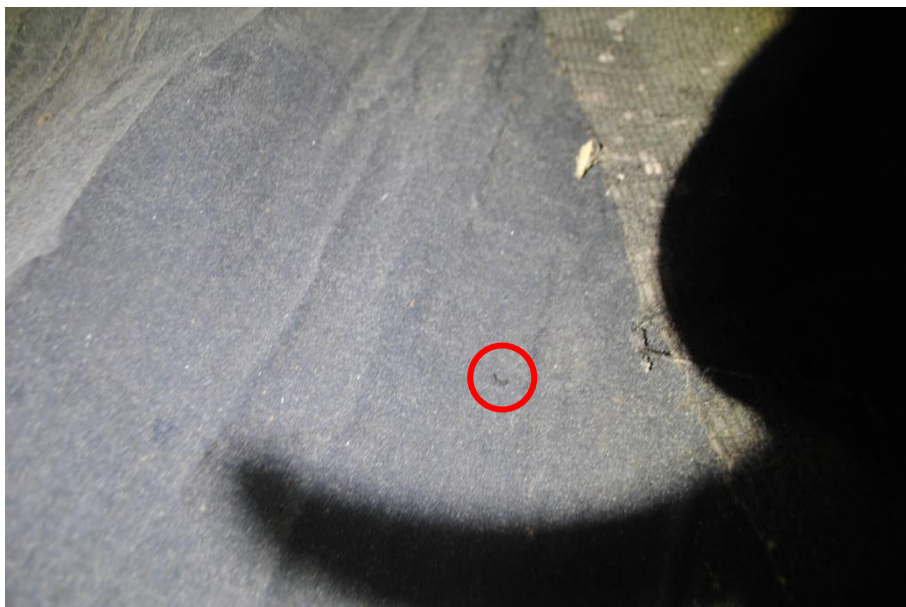
**Figure 3.21. Bat dropping seen on new material in new loft area Feb 2023**

One bat dropping was observed on a strip of left over felt, indicating the possible use of the void from last summer.

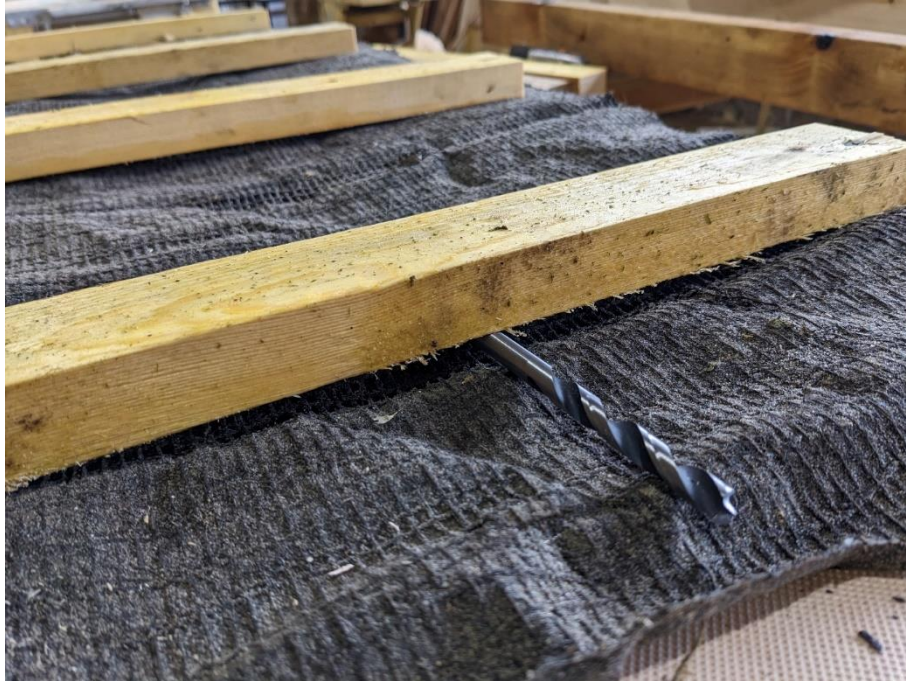
demonstrating how the bitumen currently sags and would allow bats to get through.

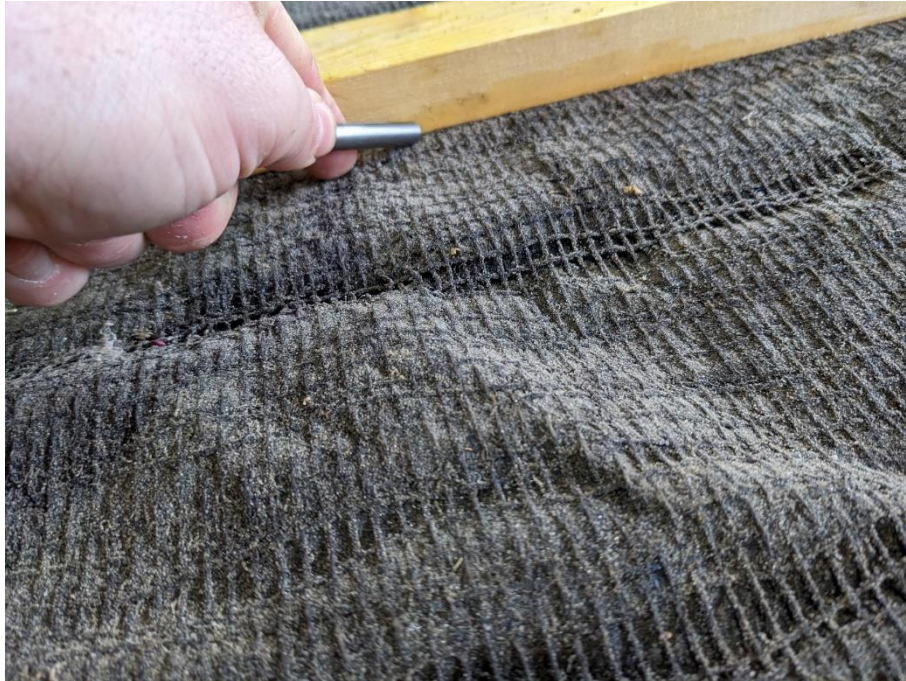
showing the gap has disappeared with use of the timber insert.

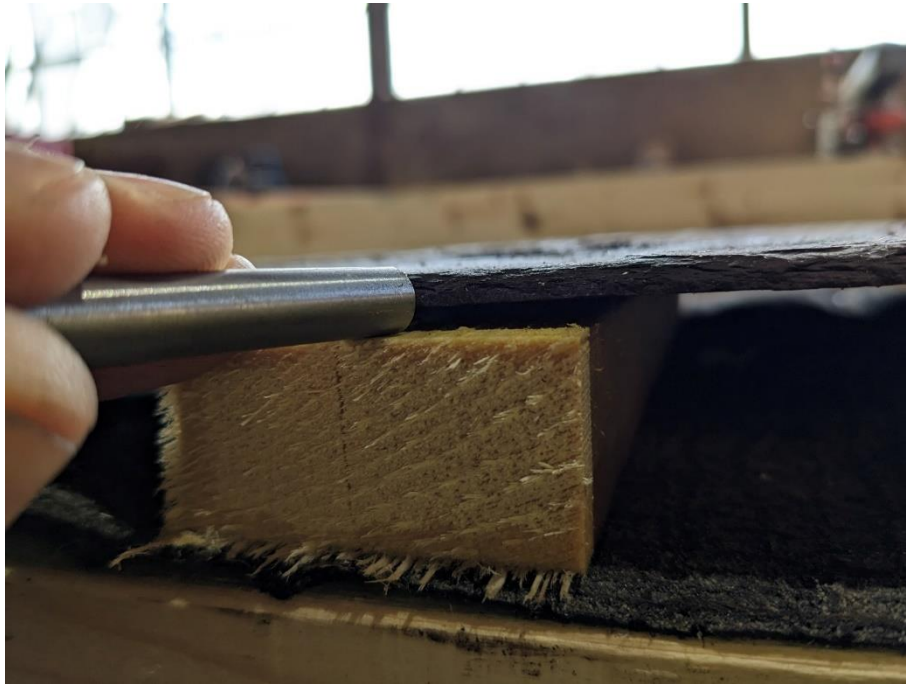
Showing that there is not enough space for bats to access the BRM through the slates.

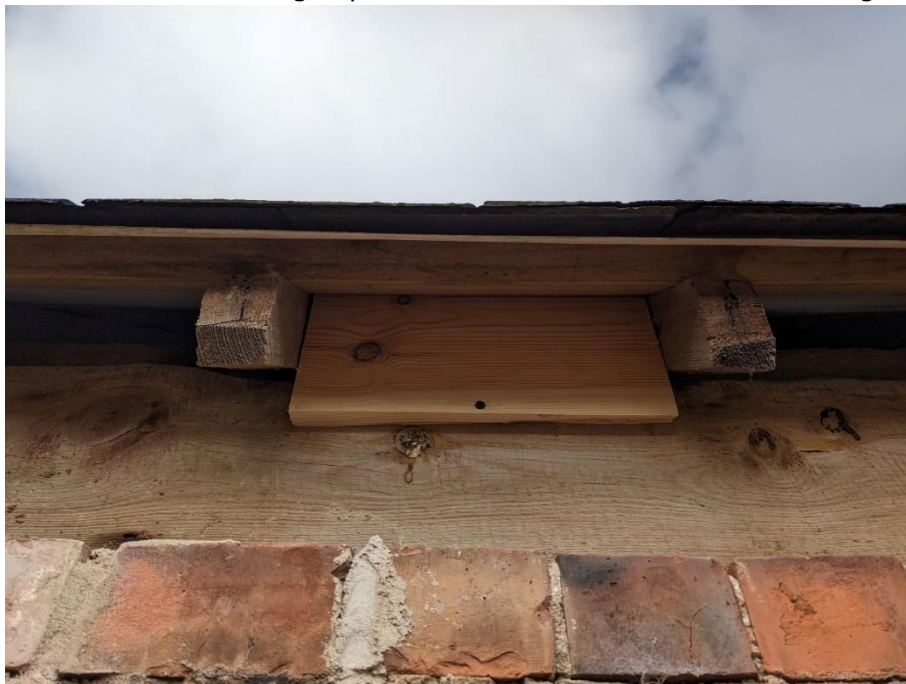
showing the timber fascia board blocking off access to the lower roof.

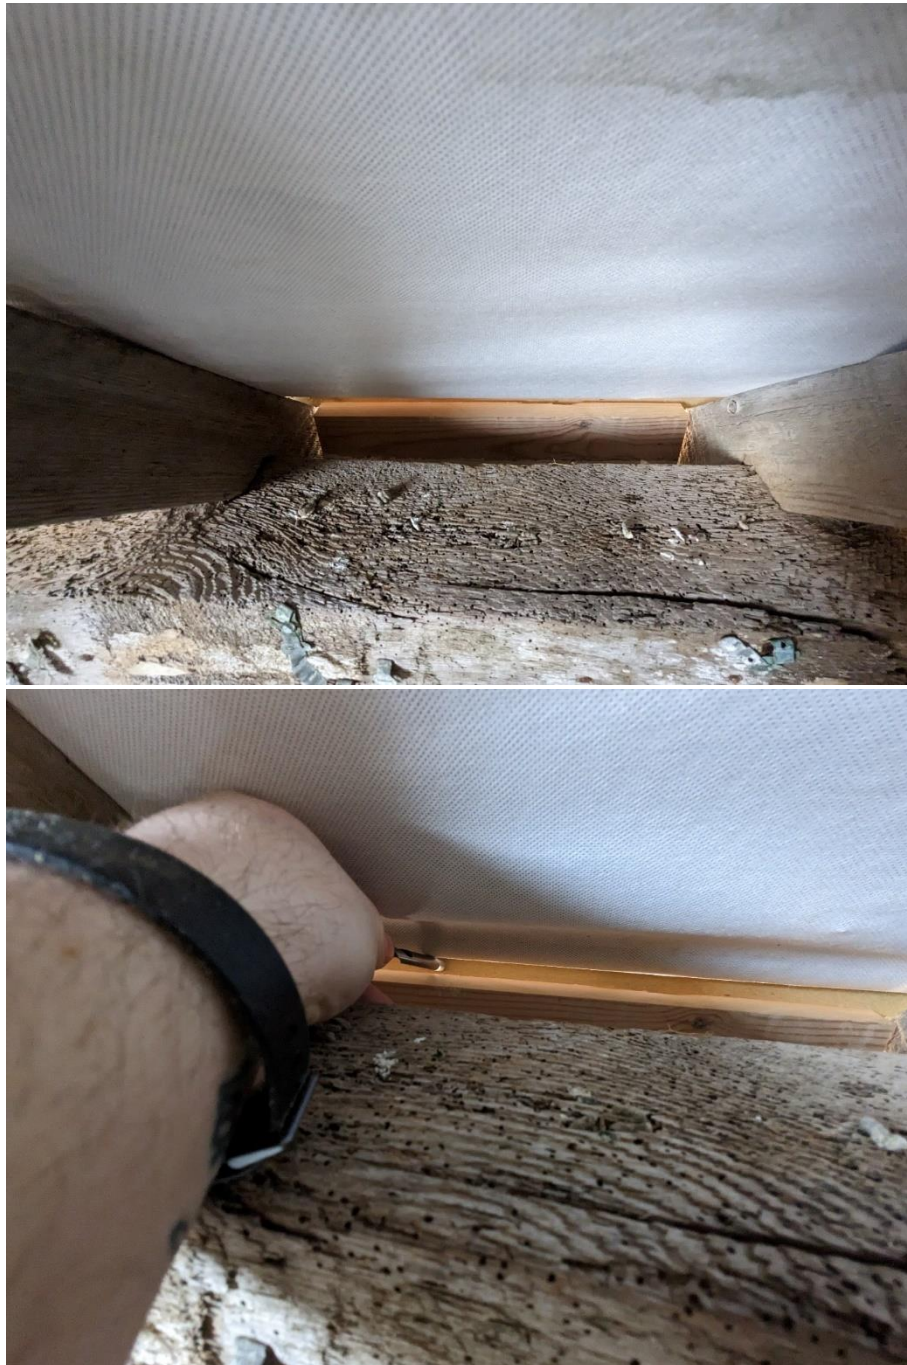
Showing that an 8mm drill bit cannot get through the gap.
