**BAT AERIAL TREE ASSESSMENT & PRESENCE /  
ABSENCE SURVEYS**

**Plot 3A**

Wrexham Industrial Estate  
Bryn Lane  
Wrexham  
LL13 9UT

| UES reference: | UES03448/16 |

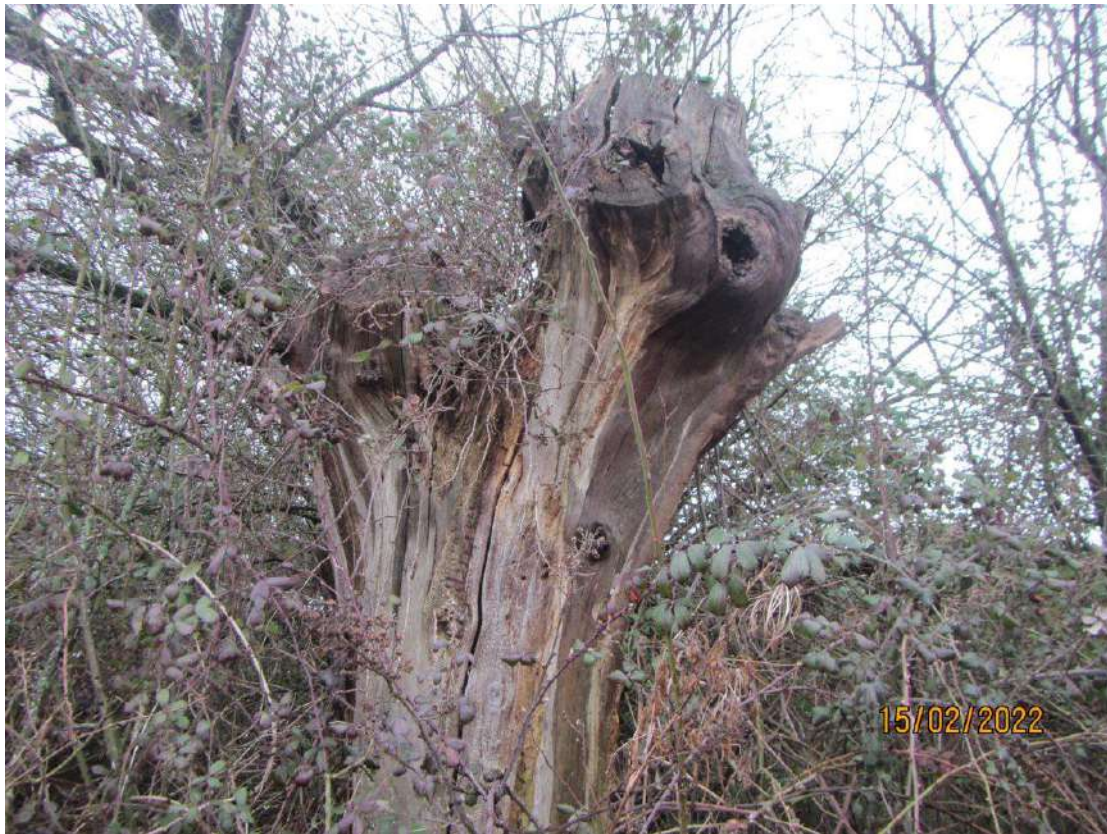
Photograph 1 – T1

**T1** is a dead tree of unknown species which lies at the south-west corner of the site, surrounded by dense scrub. It is approximately 3m in height with a diameter at breast height (DBH) of approximately 0.7m. The tree contains fissures in the stem (T1.1), a knot hole on its western aspect (T1.2), flaking bark on the northern aspect (T1.5), and three rot holes, one on the western aspect (T1.3) and two on the eastern aspect (T1.3 & T1.4). Upon close inspection, the rot holes were all found to be shallow and relatively exposed, while the fissures present are too narrow to be used by bats. All features were fully inspected and no evidence of roosting bats was observed. All features are considered to have low potential to support roosting bats.

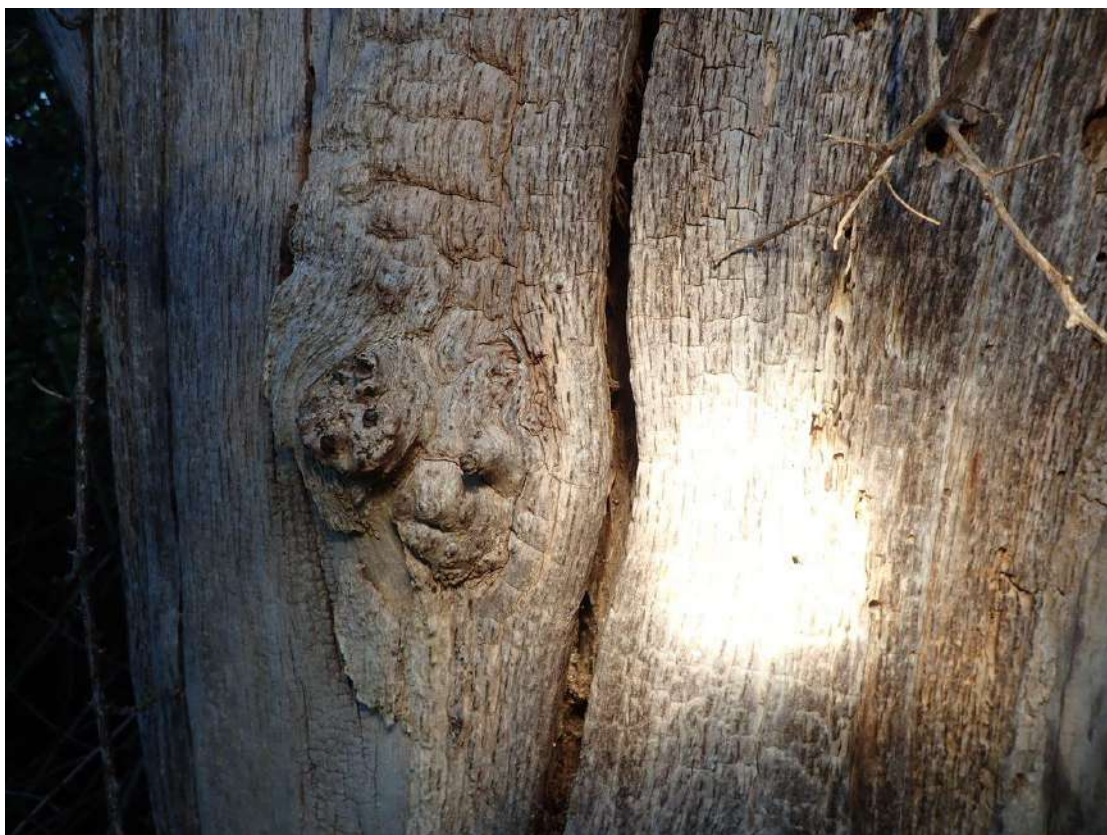
| Tree ID | PRF number | PRF type | Aspect | Height (m) | Distance from main stem (m) | Clutter | Entrance orientation | Size of entrance (cm) | Evidence | Roost potential (N/L/M/H) | Photo no. |
|---|---|---|---|---|---|---|---|---|---|---|---|
| T1 | T1.1 | Fissure | W | 0-2.5 | 0 | Bramble scrub up to ~1.5m | Horizontal | 5 | None | L | 2 |

Photograph 2 – T1 showing trunk fissure (T1.1).

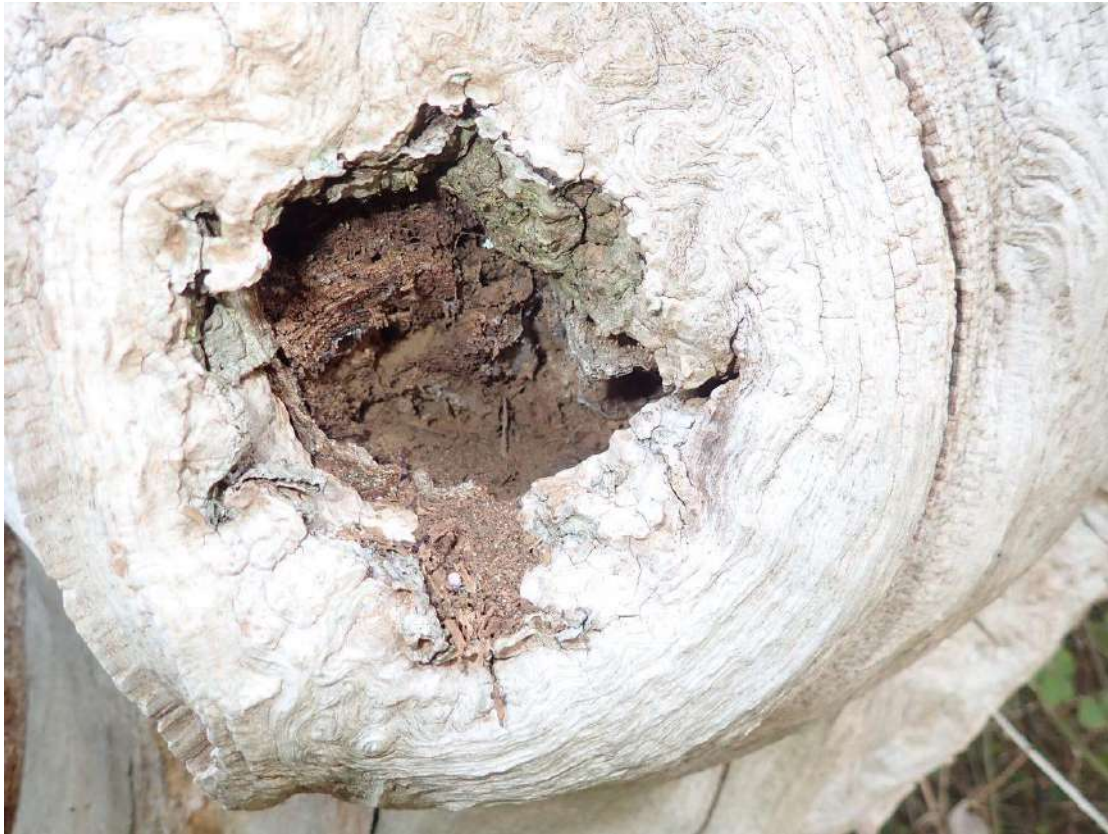
Photograph 3 – T1 showing knot-hole (T1.2).

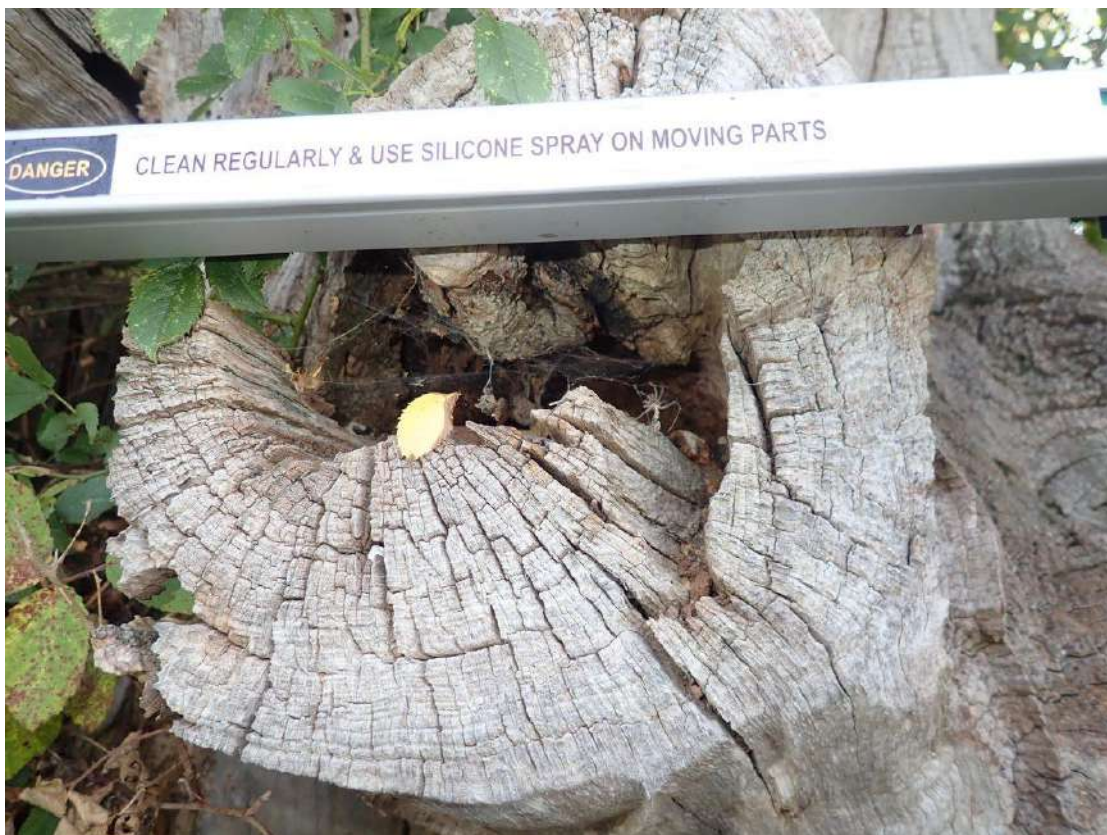
| Tree ID | PRF number | PRF type | Aspect | Height (m) | Distance from main stem (m) | Clutter | Entrance orientation | Size of entrance (cm) | Evidence | Roost potential (N/L/M/H) | Photo no. |
|---|---|---|---|---|---|---|---|---|---|---|---|
| | T1.3 | Rot hole | W | ~2.9 | 0 | None | Upwards-diagonal | 5x5 | None | L | 4 |

Photograph 4 – T1 showing rot-hole (T1.3).

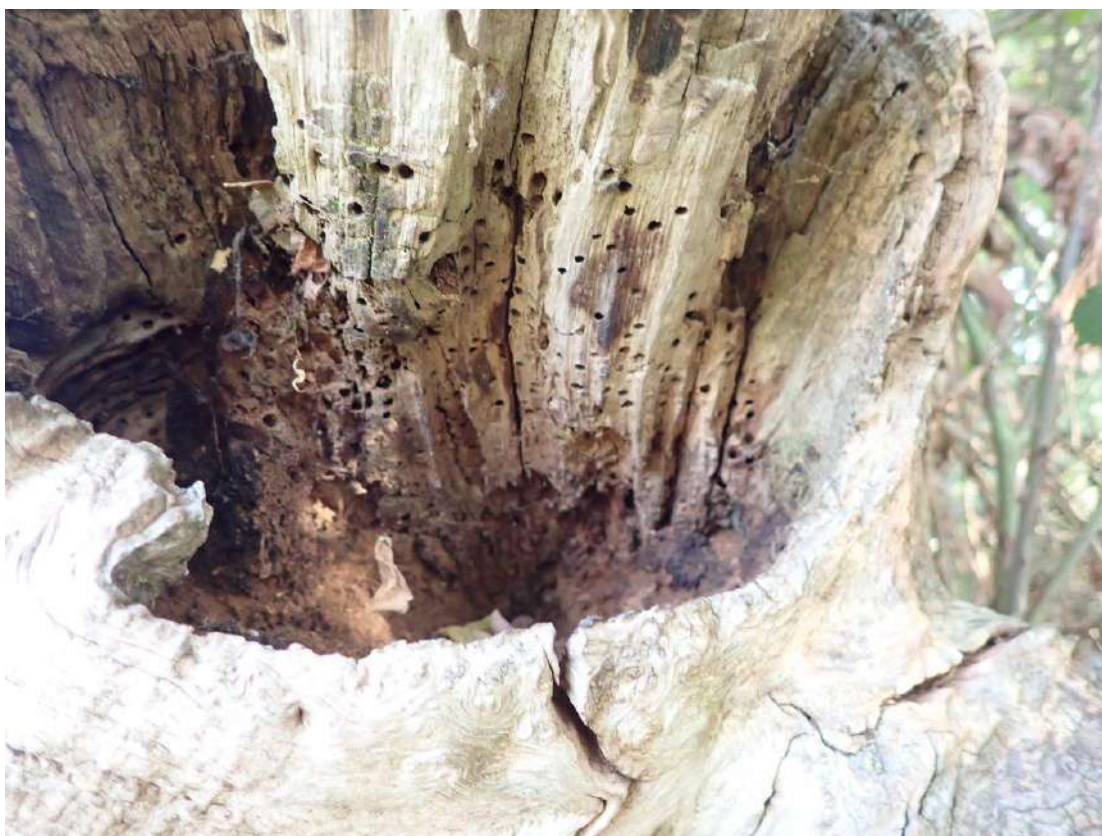
| Tree ID | PRF number | PRF type | Aspect | Height (m) | Distance from main stem (m) | Clutter | Entrance orientation | Size of entrance (cm) | Evidence | Roost potential (N/L/M/H) | Photo no. |
|---|---|---|---|---|---|---|---|---|---|---|---|
| | T1.4 | Rot hole | E | 2.5 | 0 | Willow and bramble scrub | Horizontal | 5x5 | None | L | 5 |

Photograph 5 – T1 showing rot-hole (T1.4).

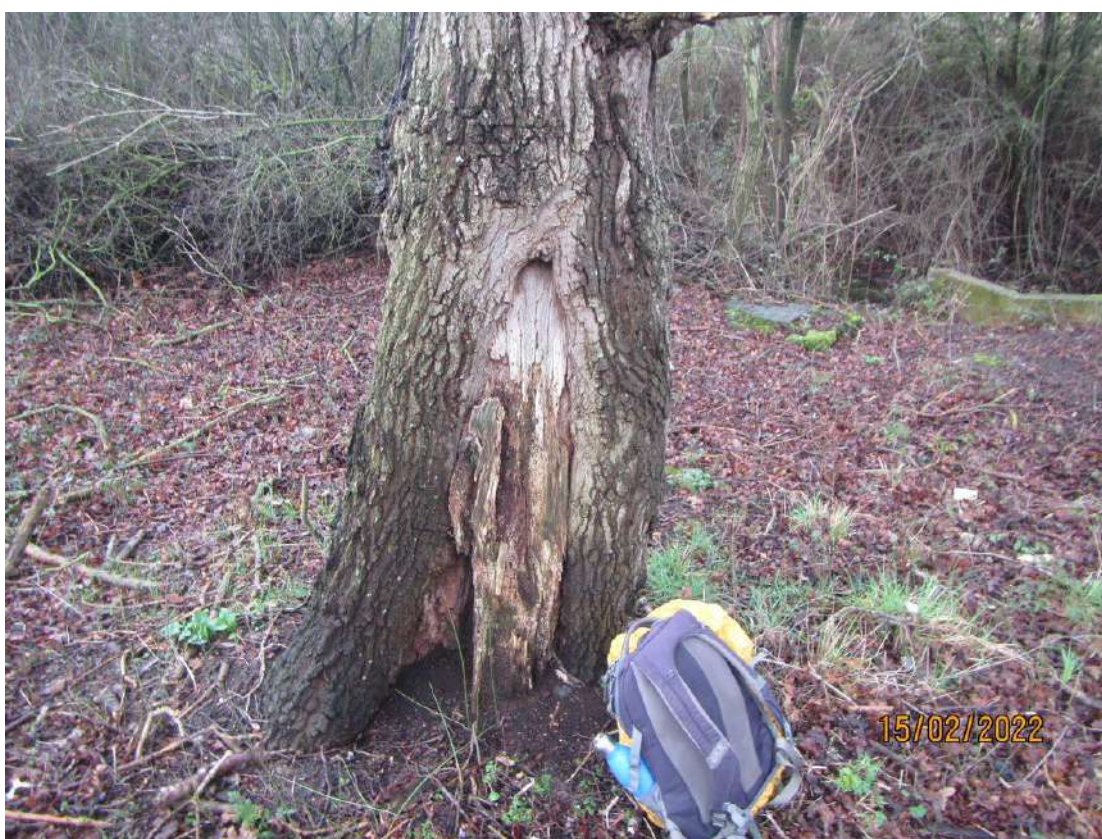
**T3** is a mature pedunculate oak *Quercus robur* found on the western boundary of the site, just beyond the scrub which runs along a wet ditch. It is approximately 14m in height with a DBH of approximately 0.5m. The tree features a basal stem cavity reaching 1.5m from the ground on its western aspect (PRF T3.1), a tear out at around 8m on its eastern aspect (T3.2), a branch cavity at 8m on its northern aspect (T3.3), and a callus roll at 4m on its southern aspect (T3.4). The basal cavity could not be fully inspected as it extends beyond endoscope reach up the stem, and as such was subject to two presence / absence surveys. T3.2 was found to be superficial upon inspection and is considered to have negligible roosting potential. T3.3 is shallow and faces upwards, and is considered to have low roosting potential. T3.4 is horizontal and extends 40-50cm, and is considered to have moderate roosting potential. T3.4 was therefore also subject to two presence / absence surveys alongside T3.1. No evidence of roosting bats was observed in any of the features.

Photograph 6 – T3 showing basal stem cavity.

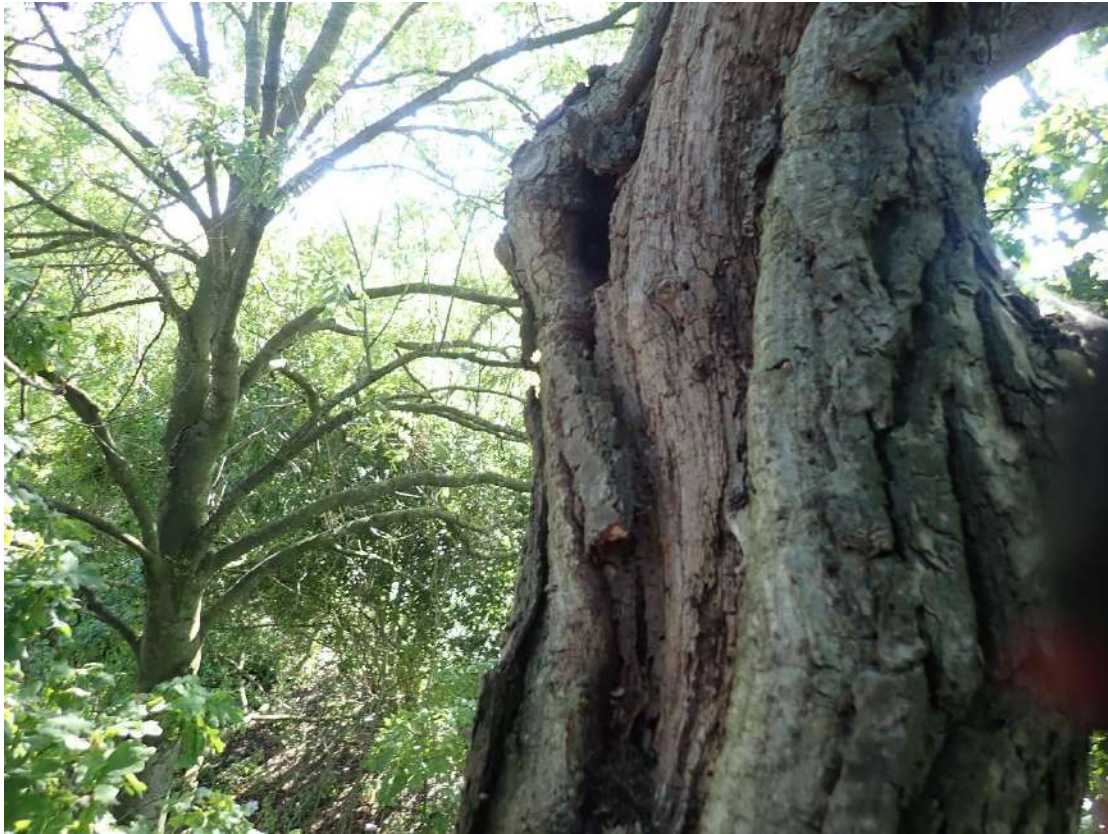
Photograph 7 – T3 showing tear-out (T3.2).

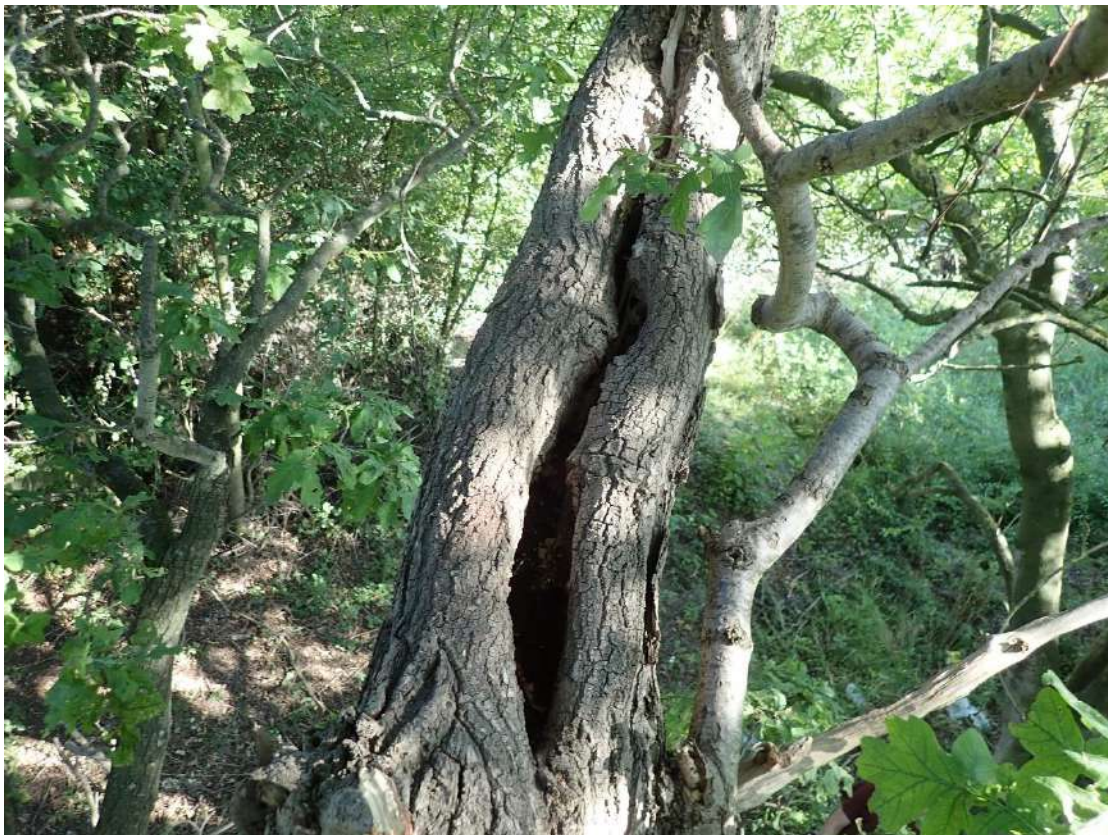
Photograph 8 – T3 showing upward-facing branch cavity (T3.3).

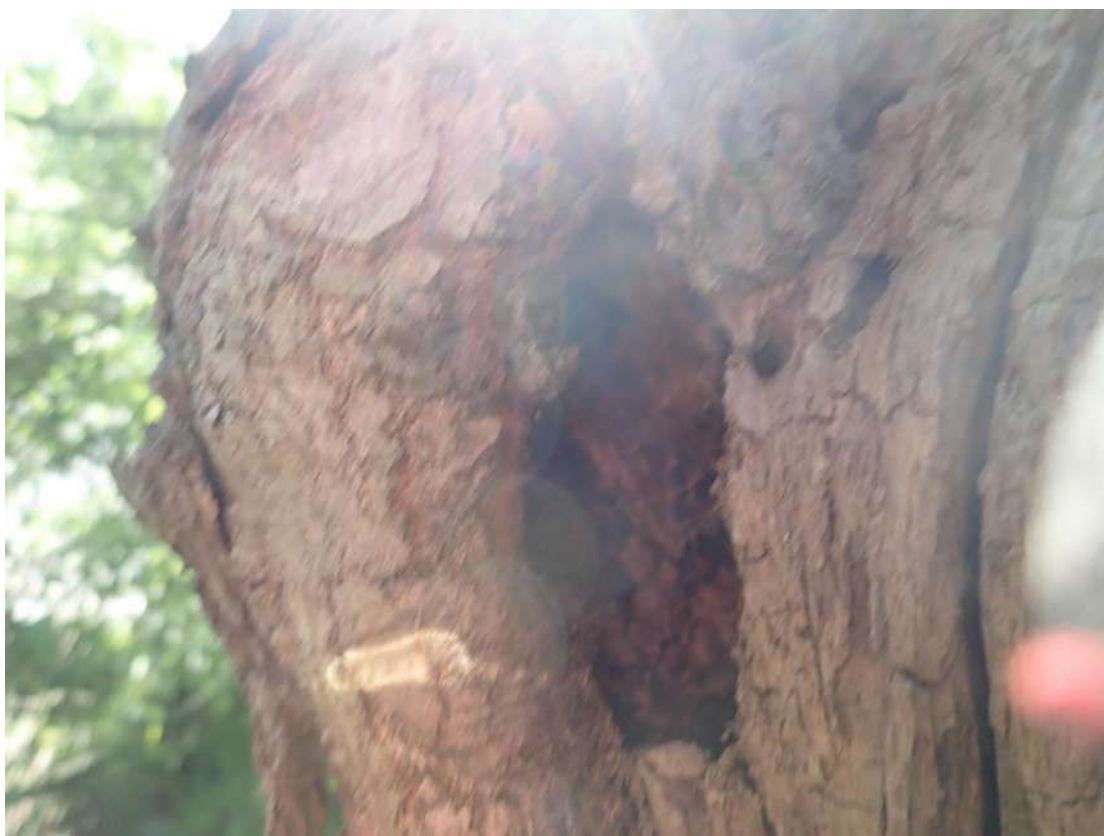
Photograph 9 – T3 showing callus-roll (T3.4).

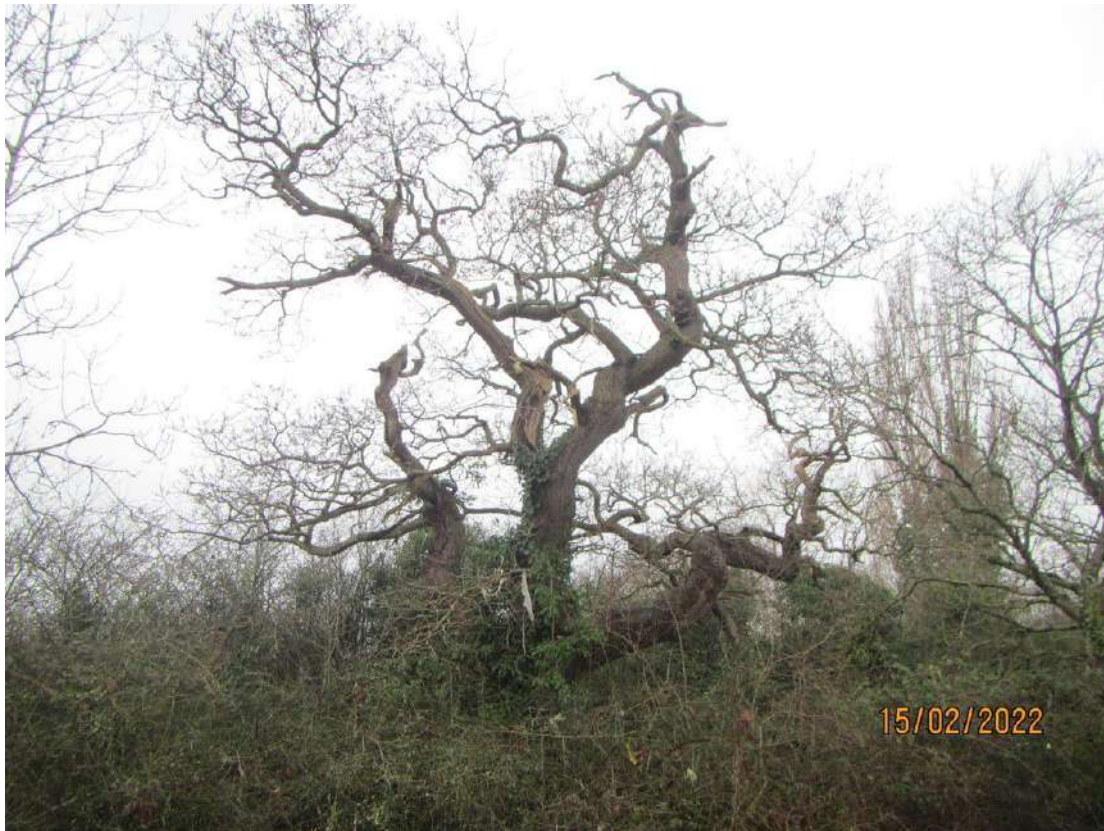
**T6** is the northernmost of a line of mature pedunculate oaks found in the continuous scrub which runs north-west/south-east and separates two areas of rough grassland in the north-western section of the site. It is approximately 9m in height with a DBH of approximately 0.8m. The tree contains two tear-outs on its western aspect at approximately 2.5m (PRF T6.1) and 4m (T6.2), at 5m on its northern aspect (T6.3), and at 4.5m on its north-western aspect (T6.4). T6.1 features two entrances into a large branch cavity, which extends approximately 2m up the limb and branches into several small chambers at its top. The limb is deteriorating and light ingress can be observed from other points within, and sections are too large and exposed, however the smaller chambers could support several bats. This feature is considered to contain moderate roosting potential. T6.2 forms a longitudinal crack into a hollow deadwood branch, which extends a short distance at both ends and is considered to have low roosting potential. T6.3 is fairly well sealed against the cambium, however the deadwood has small fissures which could provide shelter for individual bats. This feature is considered to have low roosting potential. T6.4 leads into a large branch cavity which extends downwards 60cm and upwards at least 1.5m to another opening, and is considered to have high bat roosting potential. This feature cannot be fully inspected by endoscope and thus T6 was subject to two presence / absence surveys. No evidence of roosting bats was observed during the tree inspections, however it should be noted that detritivores were present which could have consumed any present bat droppings.

Photograph 10 – The crown of T6.

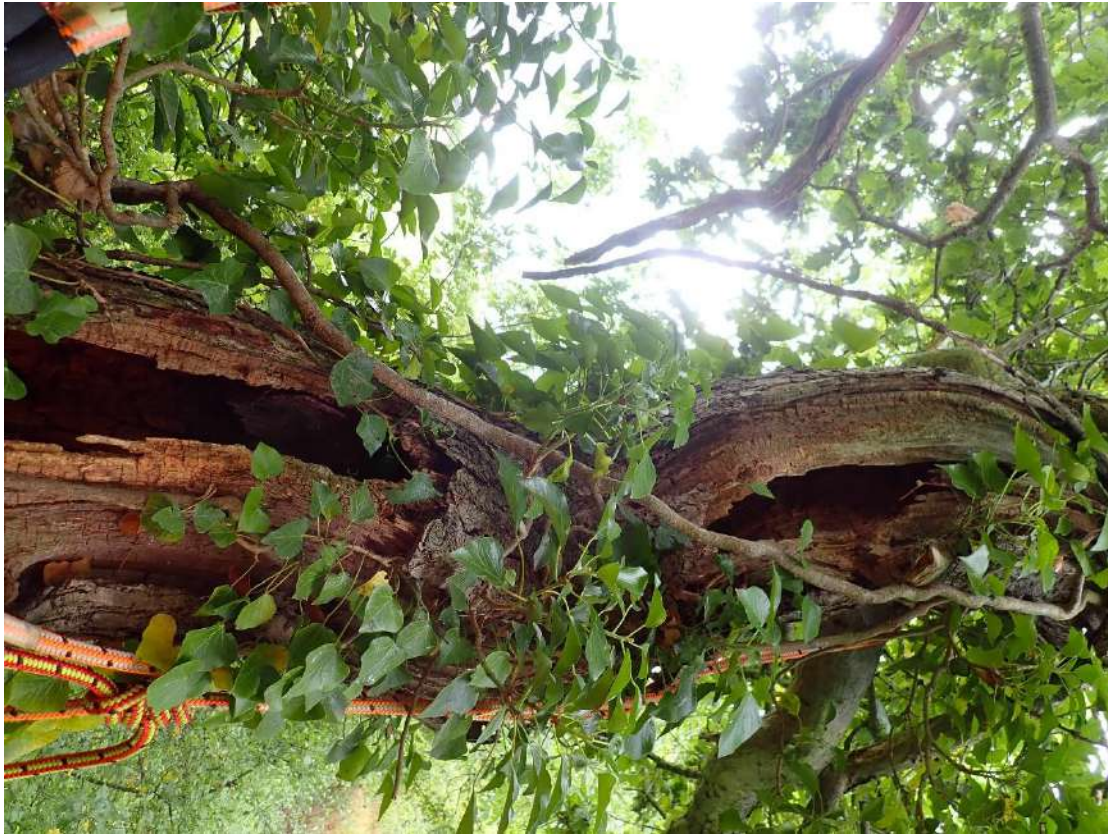
Photograph 11 – T6 showing entrances to T6.1.

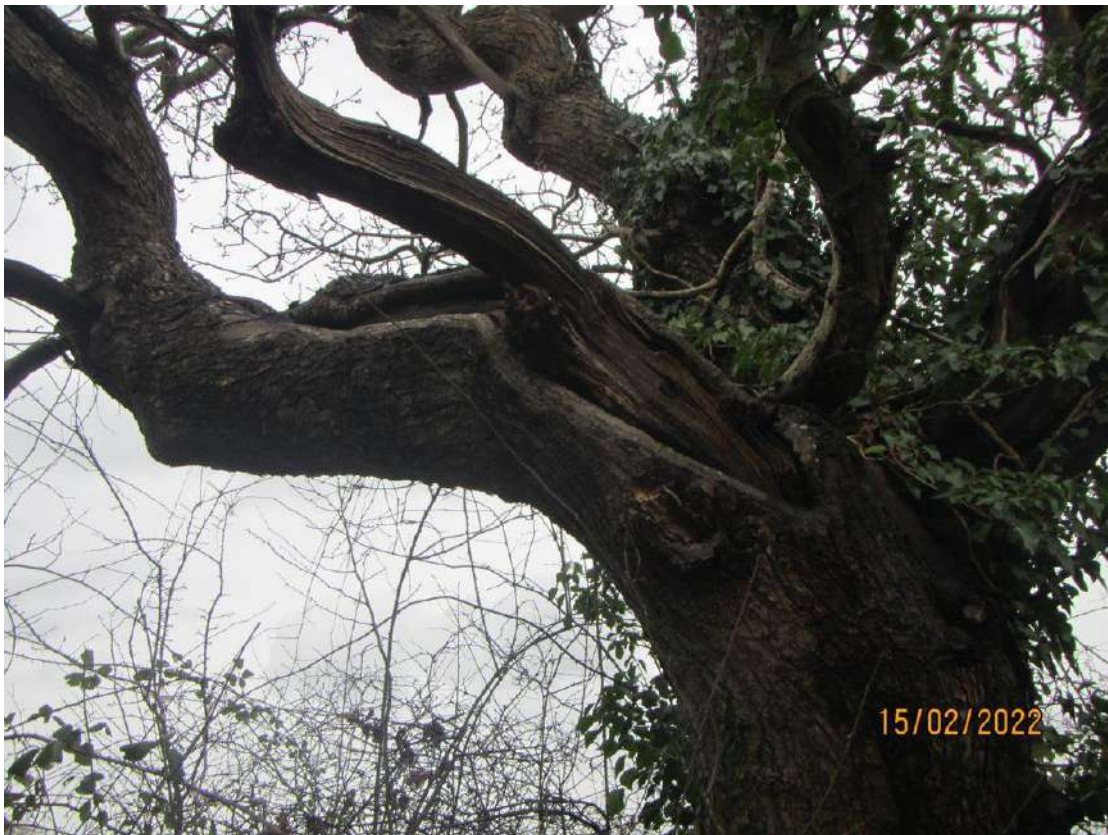
Photograph 12 – T6 showing tear-out (T6.2).

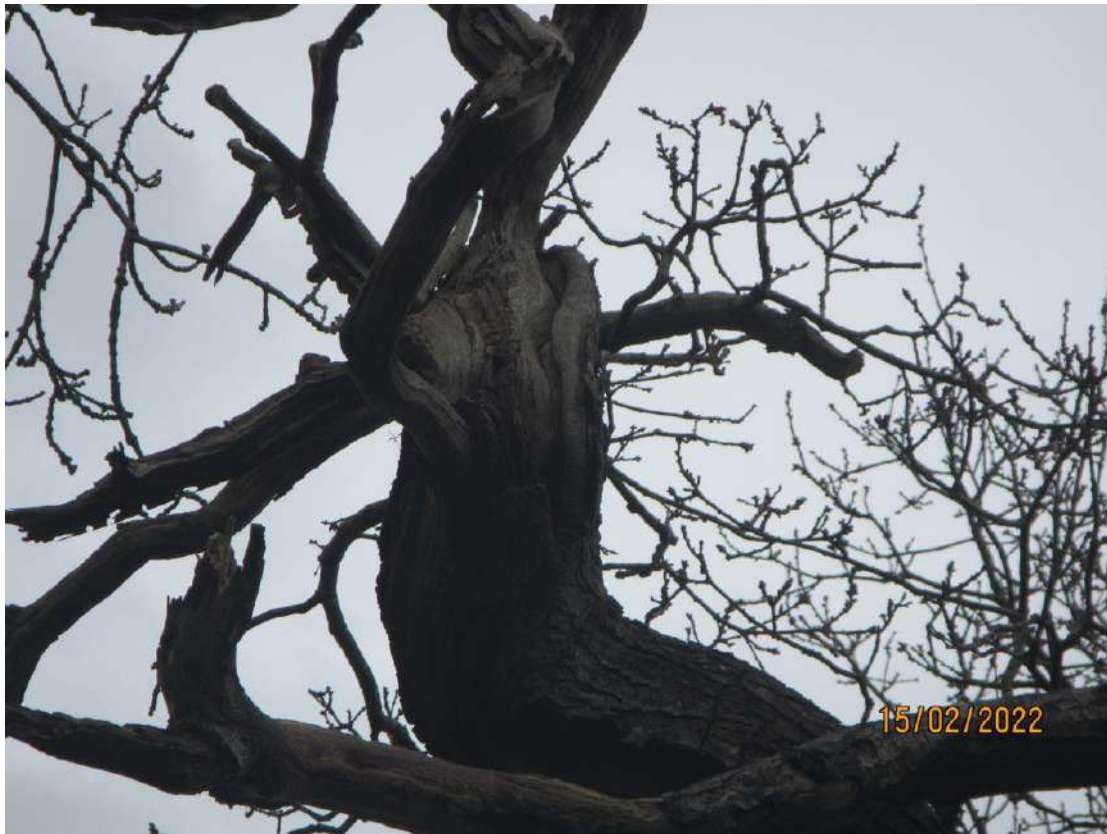
Photograph 13 – T6 showing tear-out (T6.3).

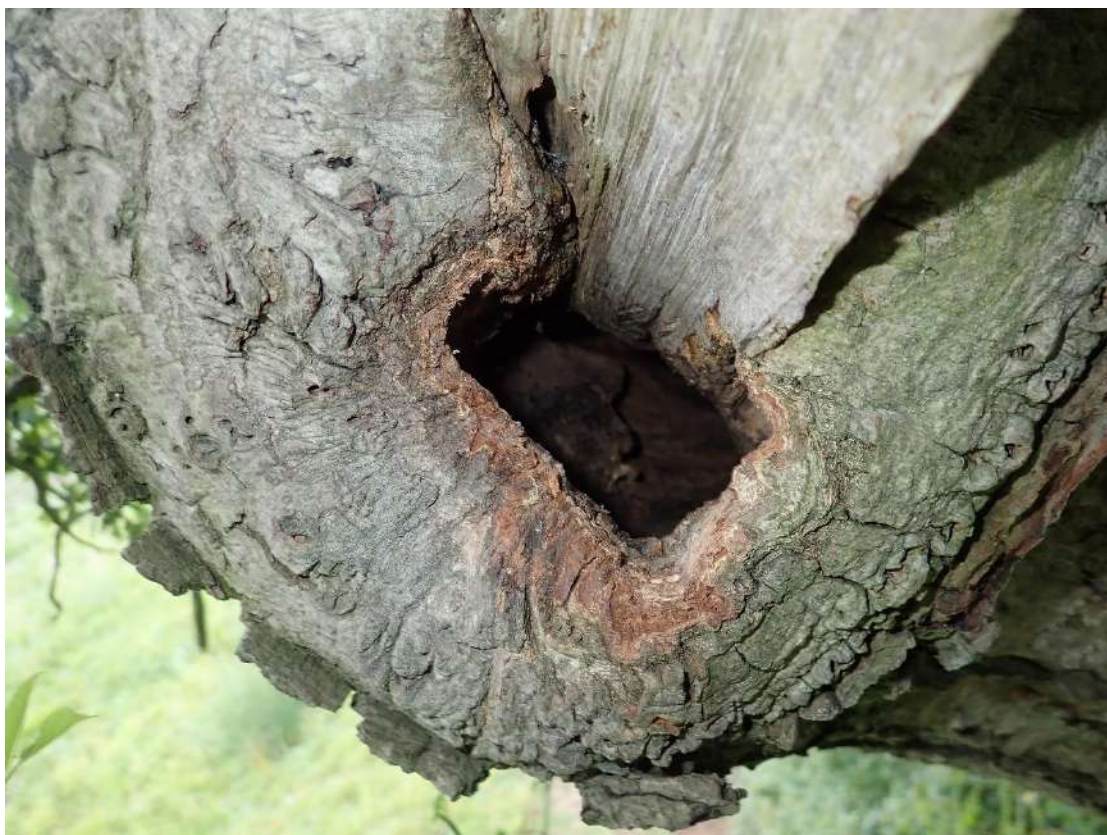
Photograph 14 – T6 showing tear-out (T6.4)

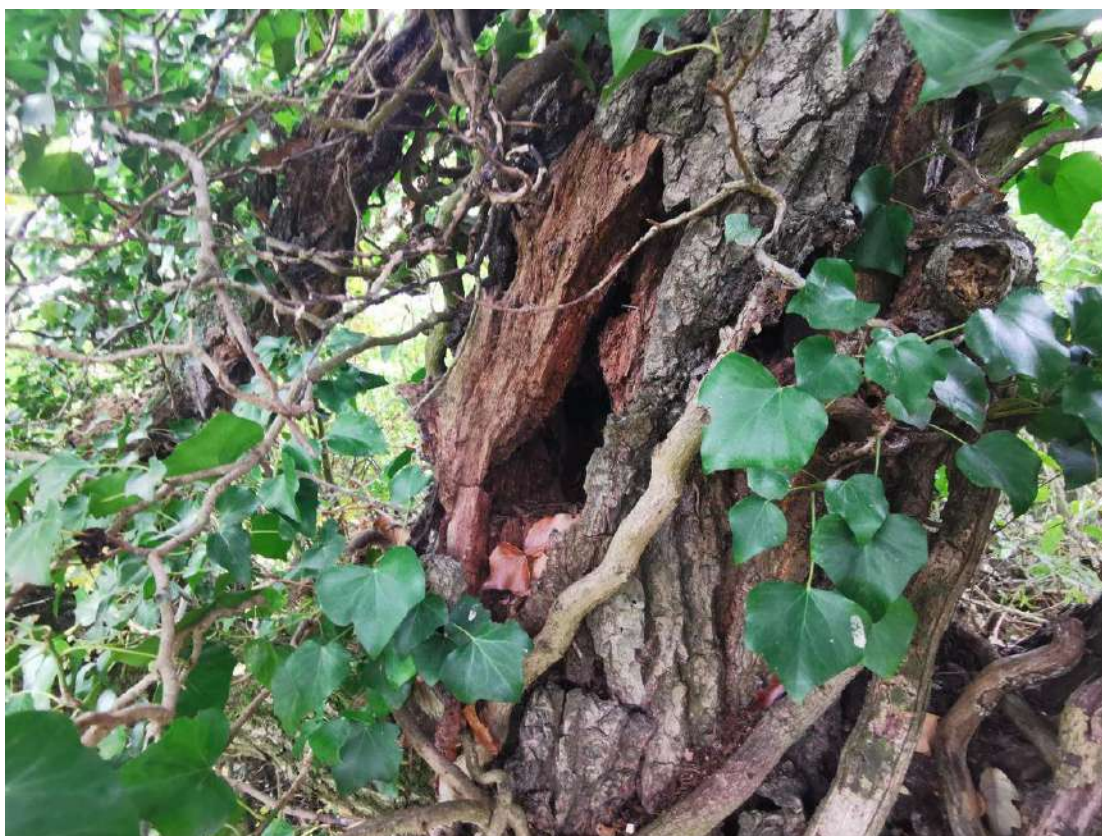
Photograph 16 – T7 showing branch cavity (T7.3).

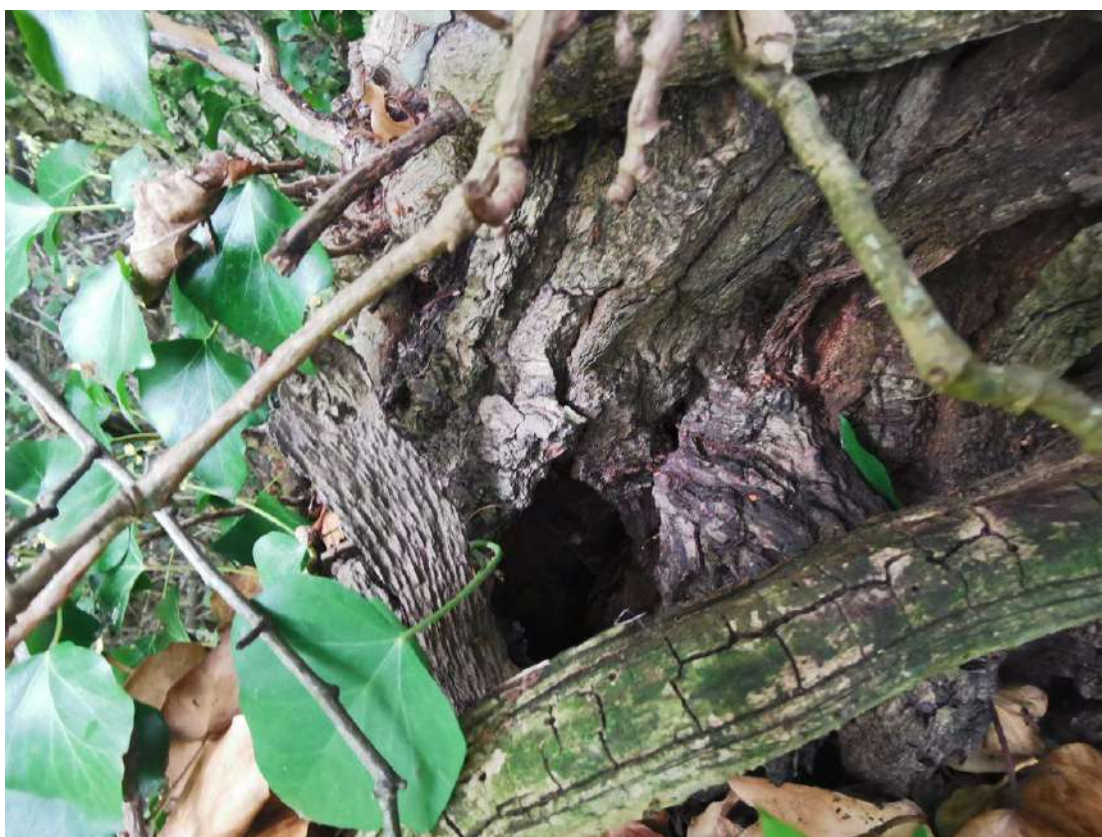
Photograph 17 – T7 showing branch cavity (T7.4).

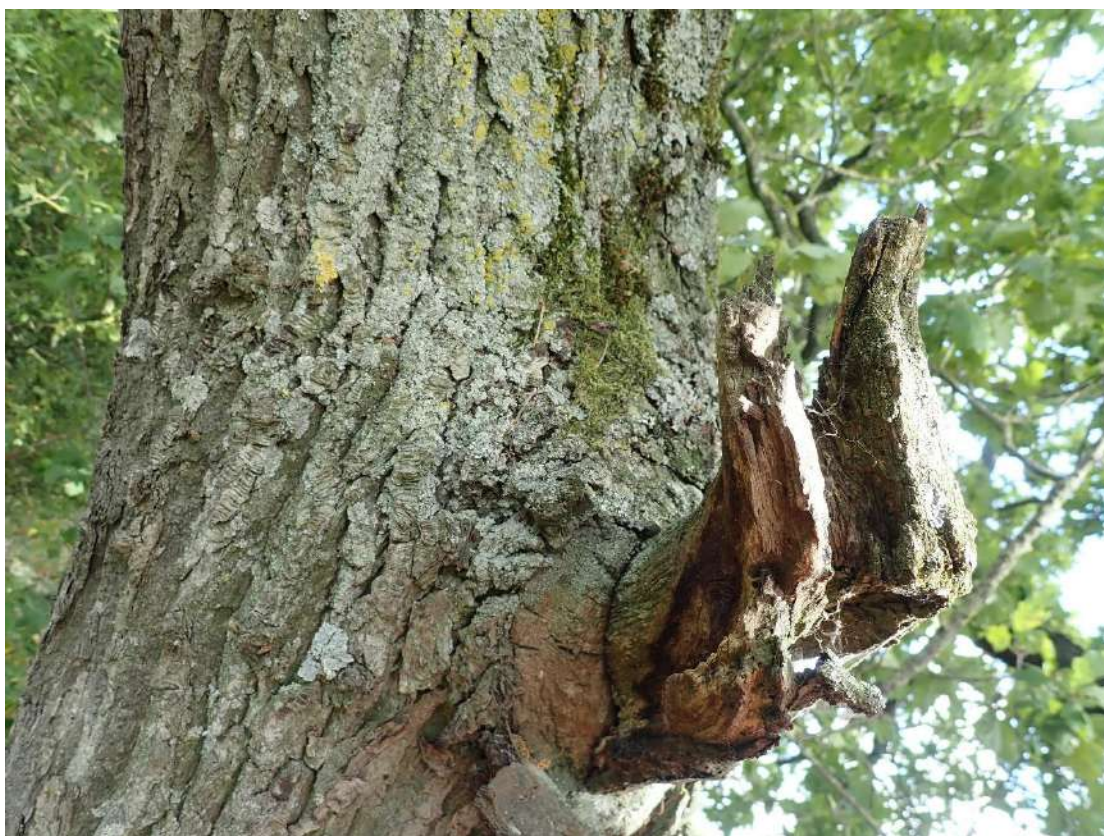
Photograph 19 – T8 showing superficial wound left by breaking deadwood.

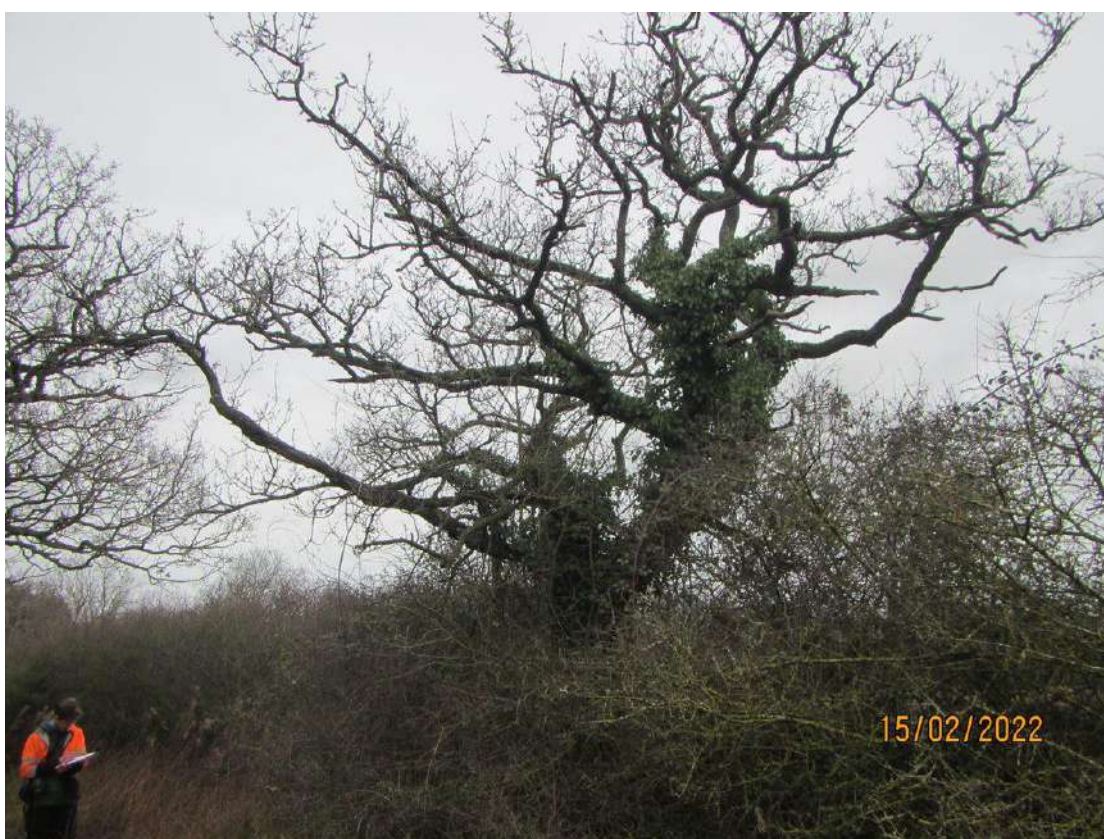
**T9** is the next mature pedunculate oak in the line of trees and scrub, heading south. It is approximately 7m in height and has a DBH of 0.5m. The tree features a hollow branch cavity on its western aspect at a height of 3m (T9.1). This cavity extends inwards 5 – 10cm, however the feature is very cluttered and unlikely to be used by a roosting bat. As such, this feature is considered to have low potential to support roosting bats. No evidence of roosting bats was observed in the feature.

Photograph 20 – The crown of T9.

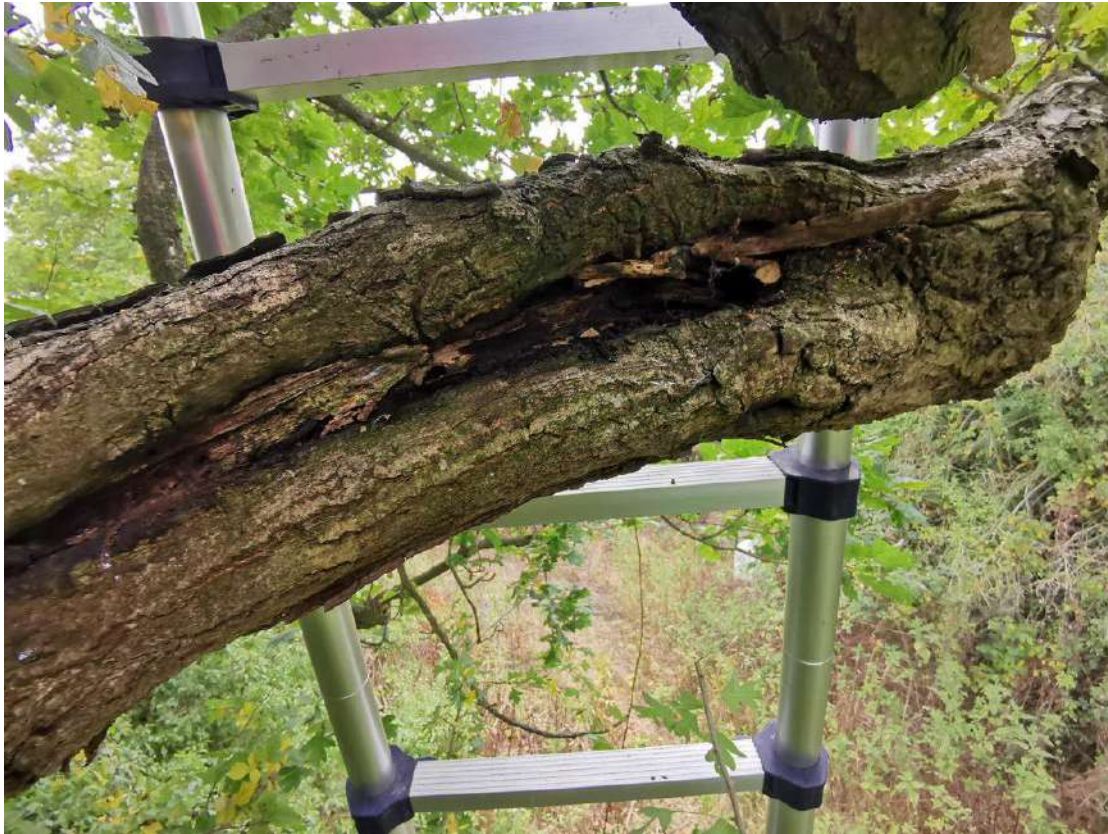
Photograph 21 – T9 showing lateral branch cavity.

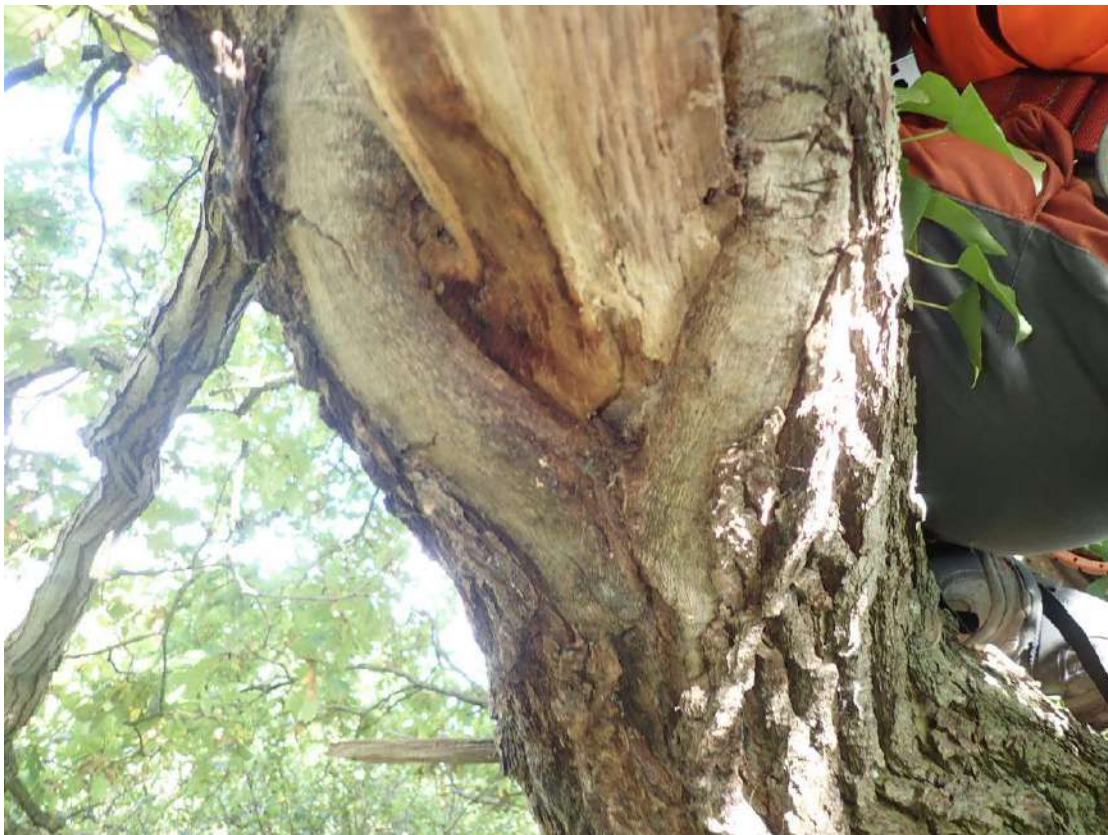
| T10 | T10.1 | Branch cavity/loose bark | W | 6 | 2 | None | N/A | N/A | None | L | 22 |

Photograph 22 – T10 showing T10.1.

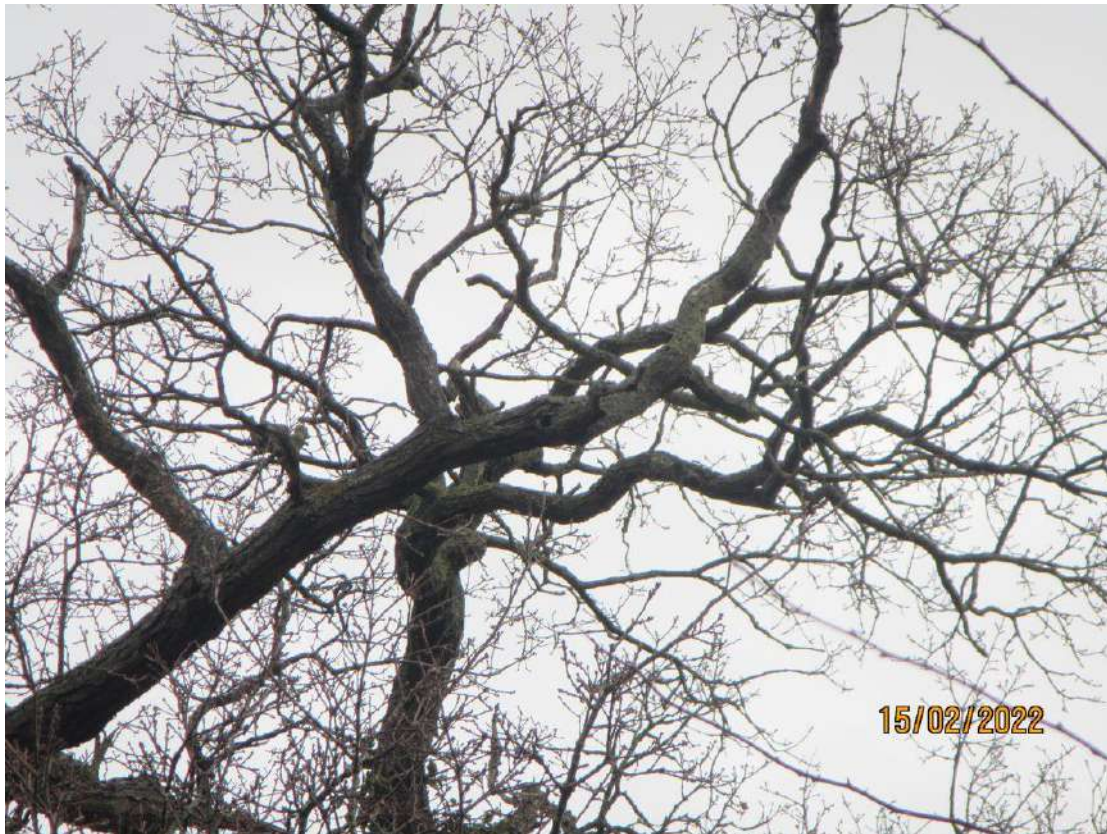
Photograph 23 – T10 showing knot-hole on horizontal branch (T10.2).

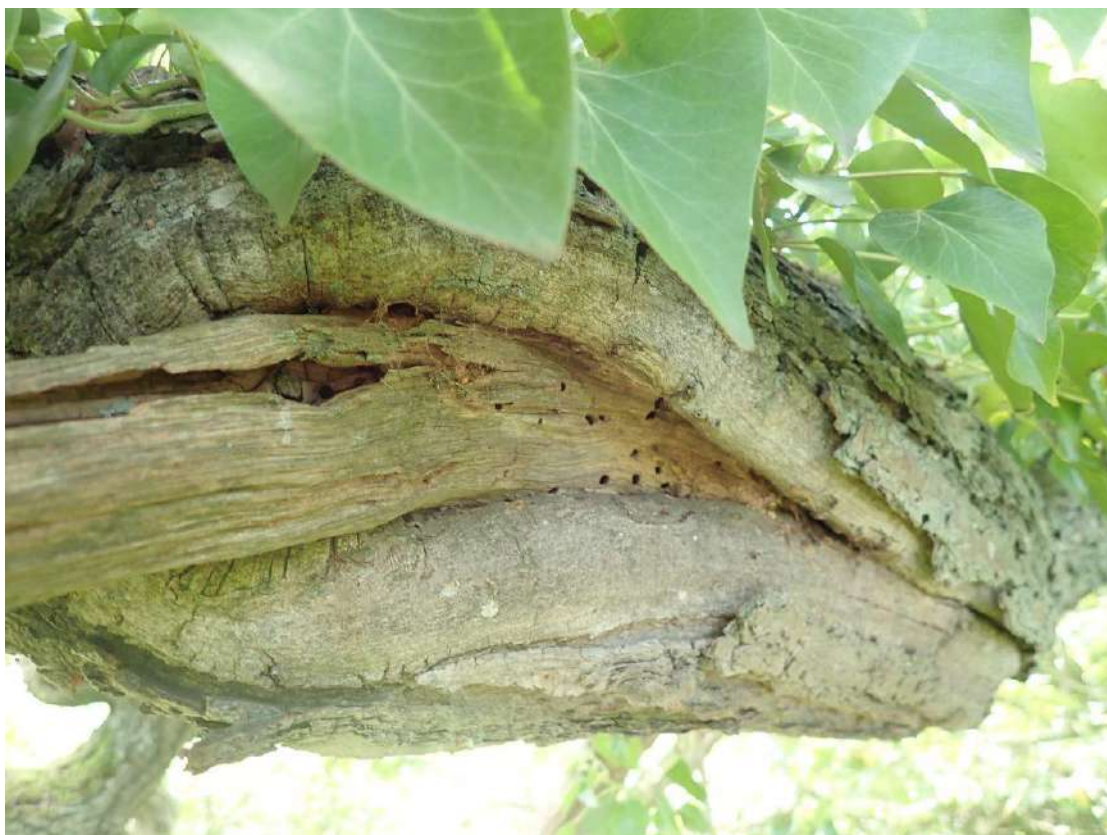
Photograph 24 – T10 showing tear-out on horizontal branch (T10.3).

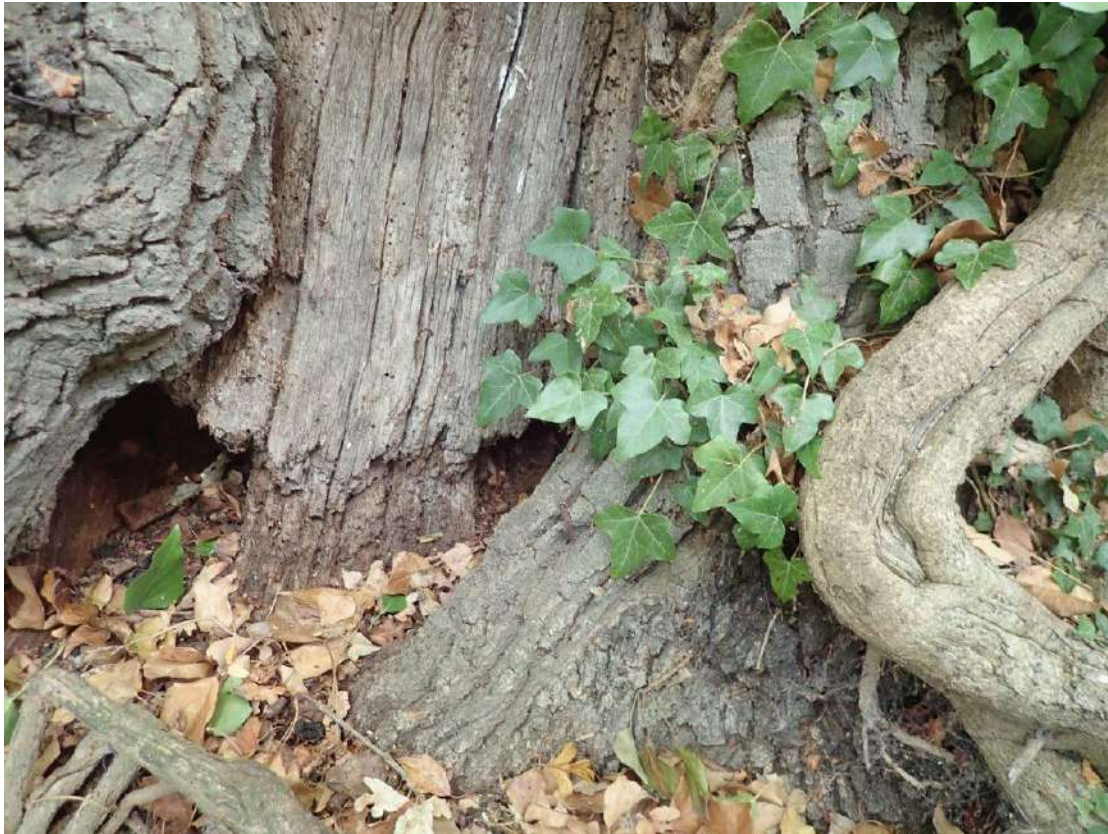
Photograph 25 – T10 showing entrances to basal stem cavity (T10.5).
