**BAT AERIAL TREE ASSESSMENT & PRESENCE /  
ABSENCE SURVEYS**

**Plot 3A**

Wrexham Industrial Estate  
Bryn Lane  
Wrexham  
LL13 9UT

| UES reference: | UES03448/16 |

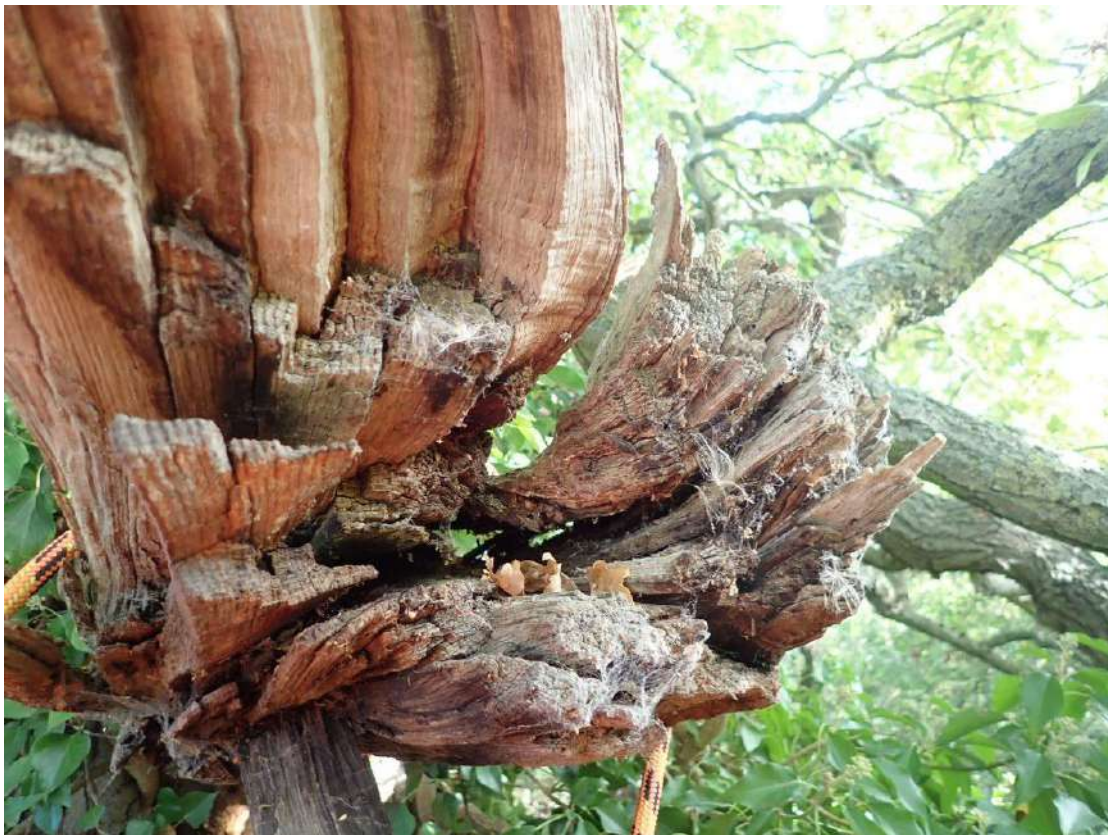
| | T10.5 | Fissure in snapped branch | S | 4 | 2 | None | N/A | 8x4 | None | L | 26 |

Photograph 26 – T10 showing fissures in split branch (T10.5).

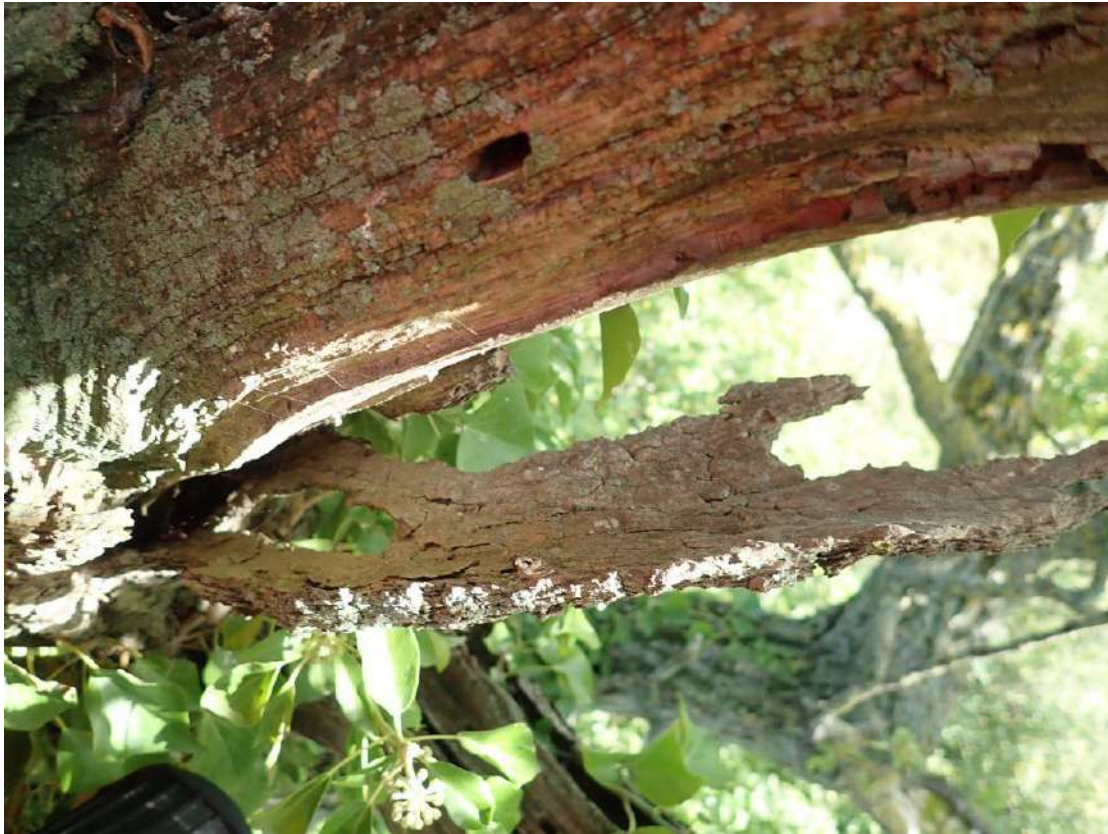
Photograph 27 – T10 showing flaking bark (T10.6).

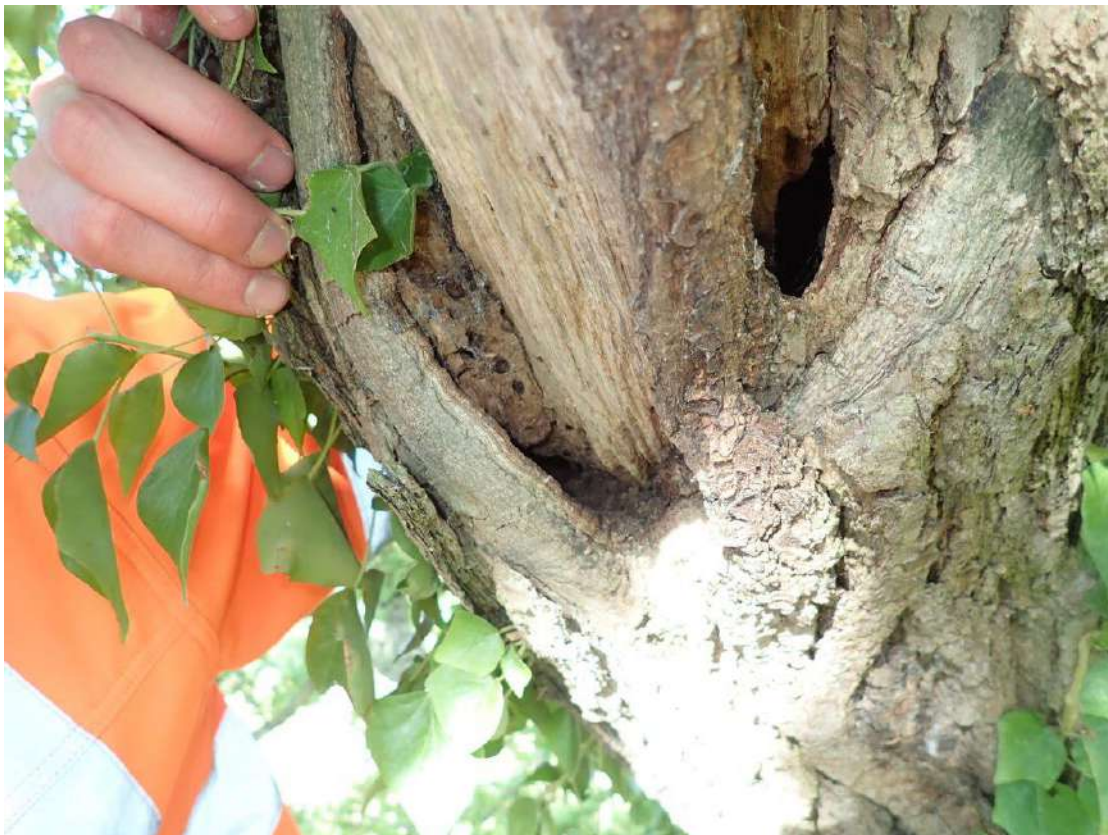
Photograph 28 – T10 showing cavities where dead branch meets stem (T10.7 & T10.8).

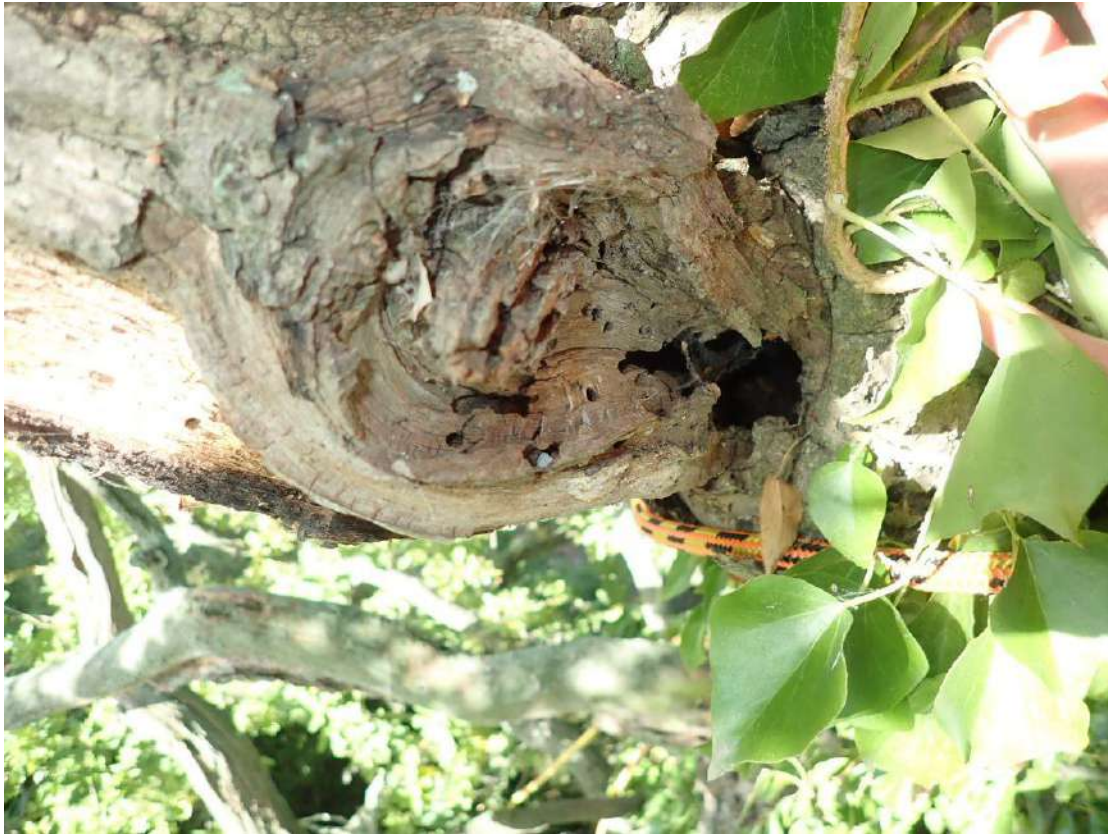
Photograph 29 – T10 showing cavity where dead branch meets stem (T10.9).

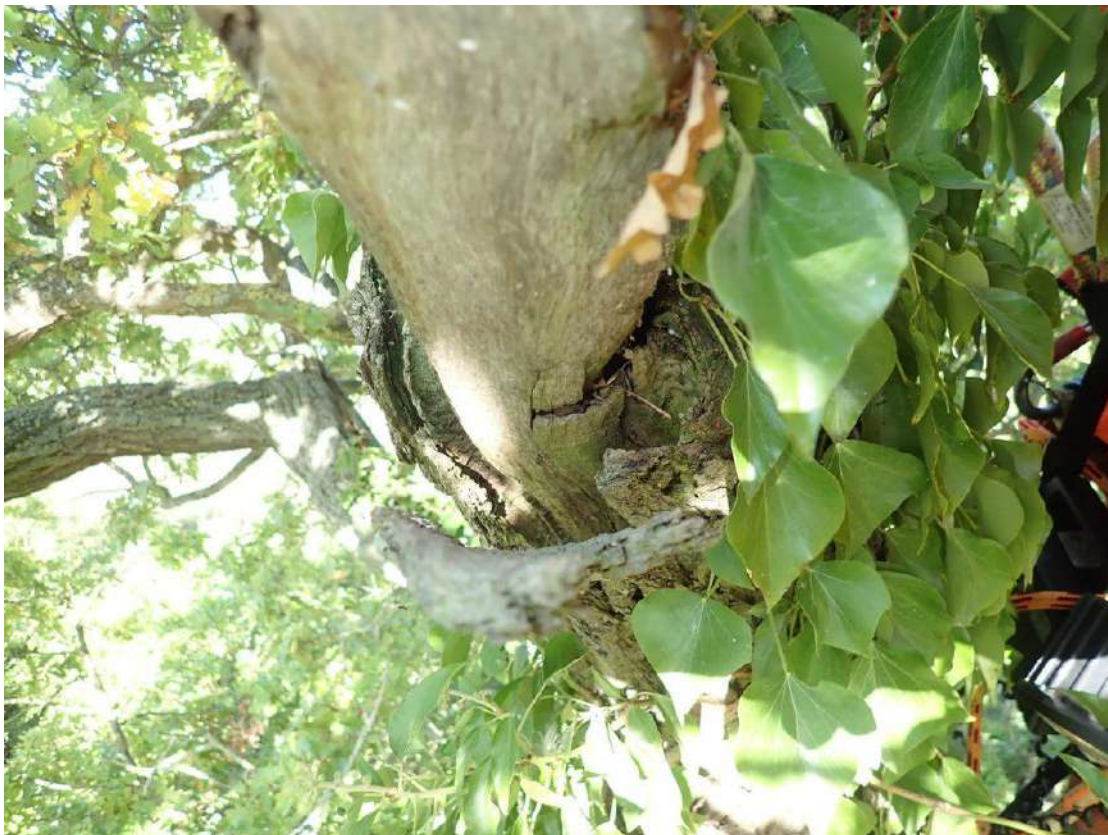
Photograph 30 – T10 showing raised bark (T10.10).

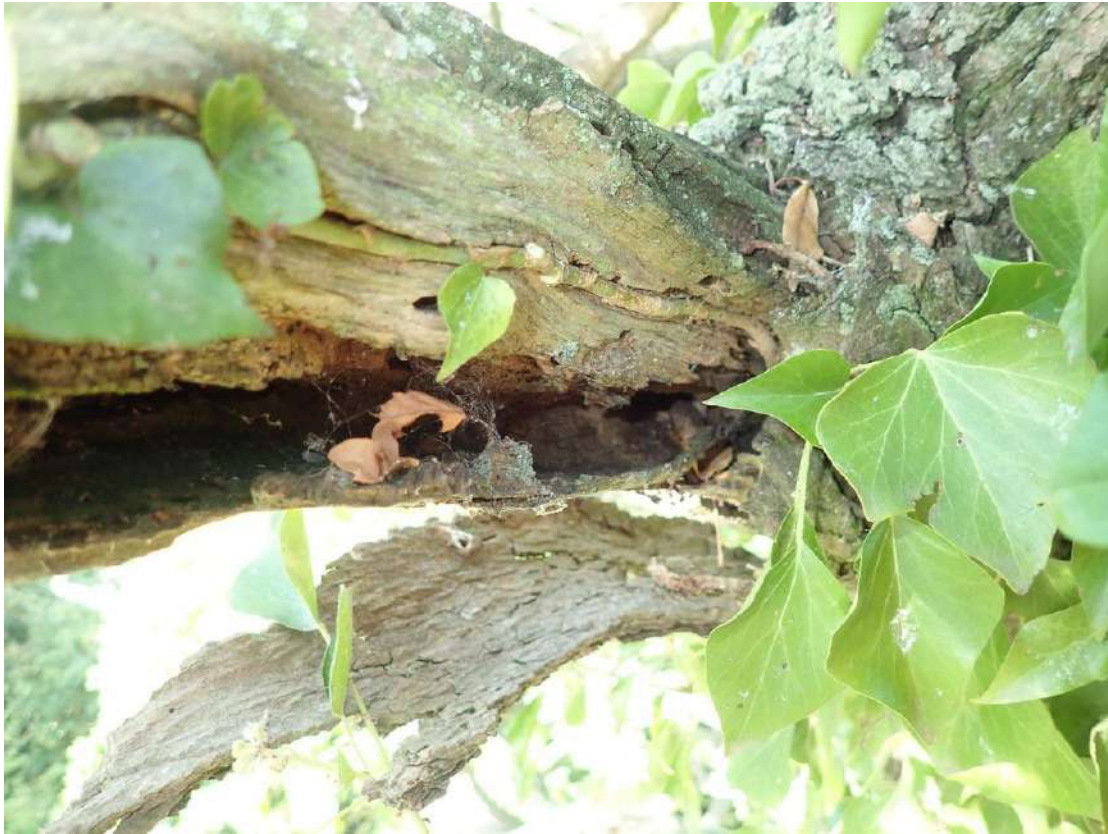
| | T10.11 | Branch fissure | S | 10.5 | 0.5 | Ivy | Upwards, diagonal | 5x5 | None | L | 31 |

Photograph 31 – T10 showing branch fissure (T10.11).

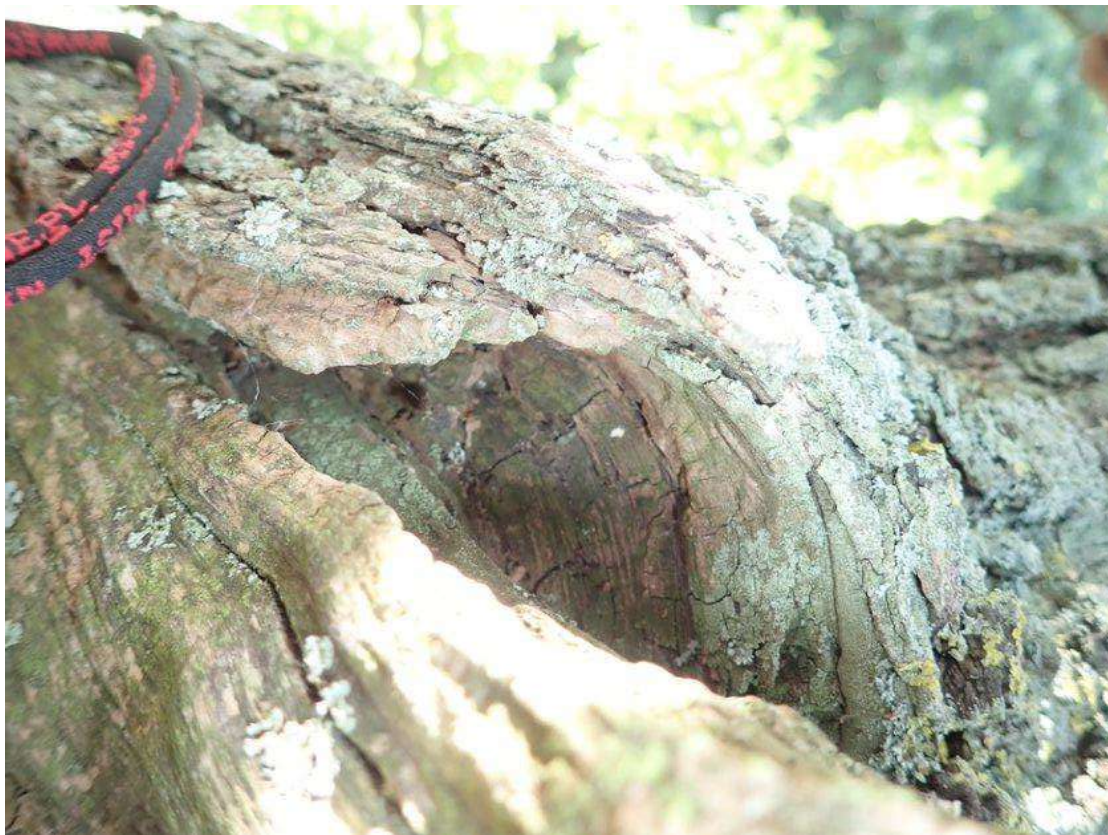
Photograph 32 – T10 showing tear-out (T10.12).

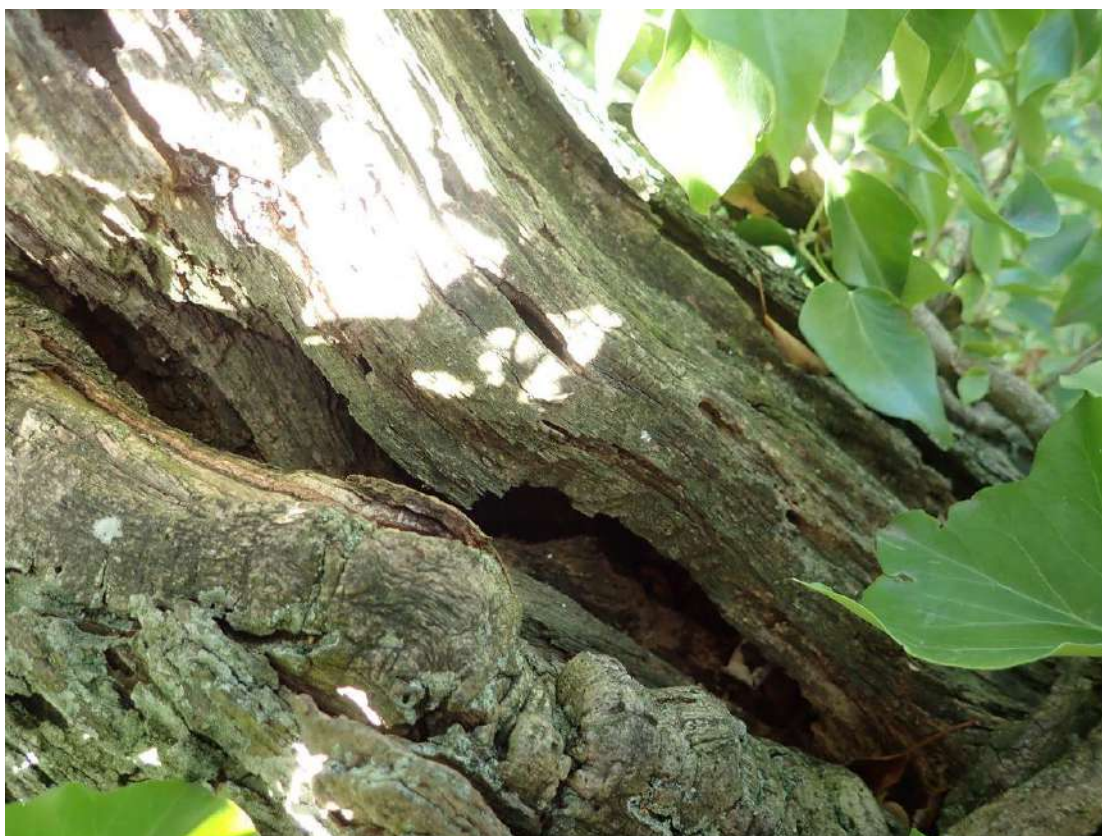
Photograph 33 – T10 showing branch cavity (T10.13).

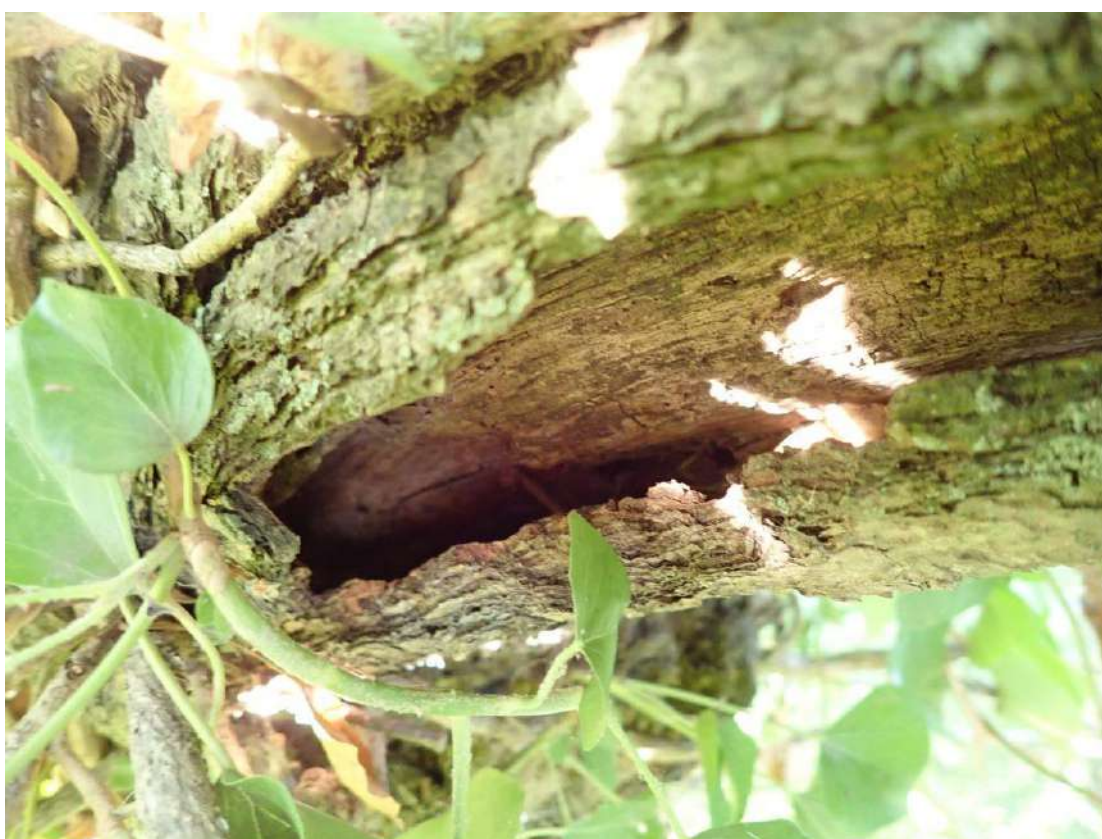
Photograph 34 – T10 showing flaking bark (T10.14).

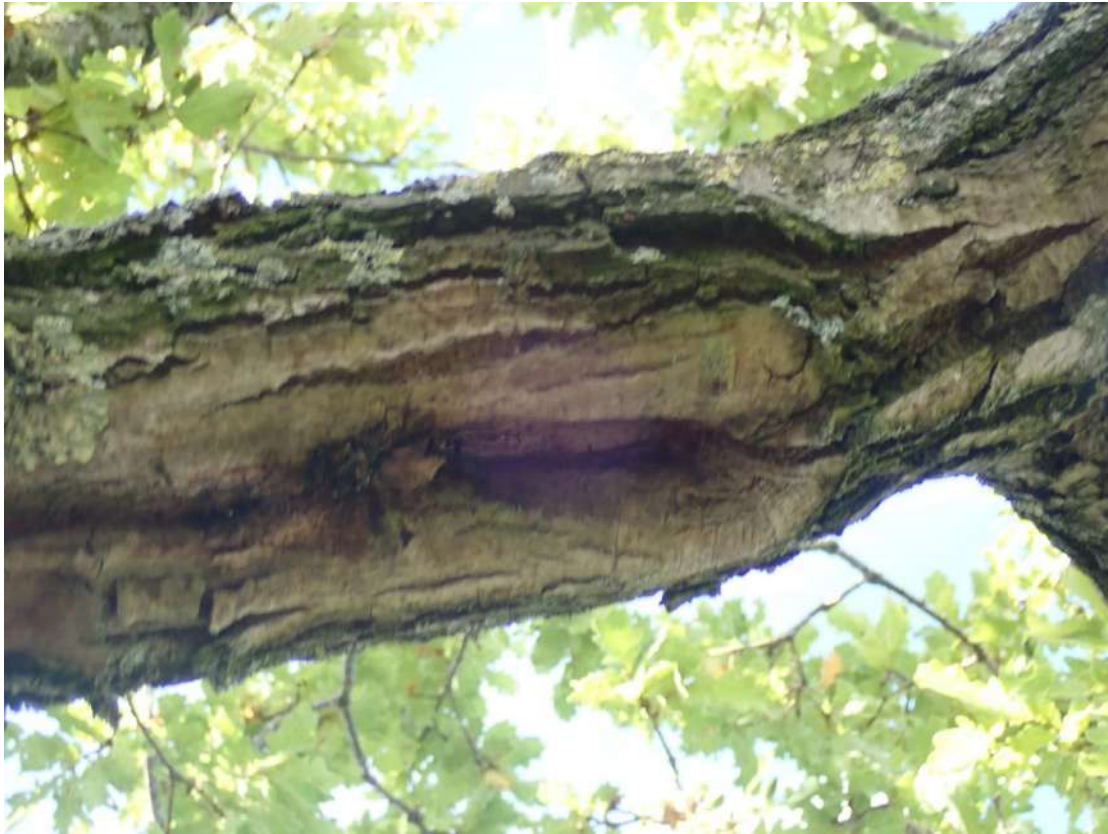
Photograph 35 – T10 showing callus roll (T10.15).

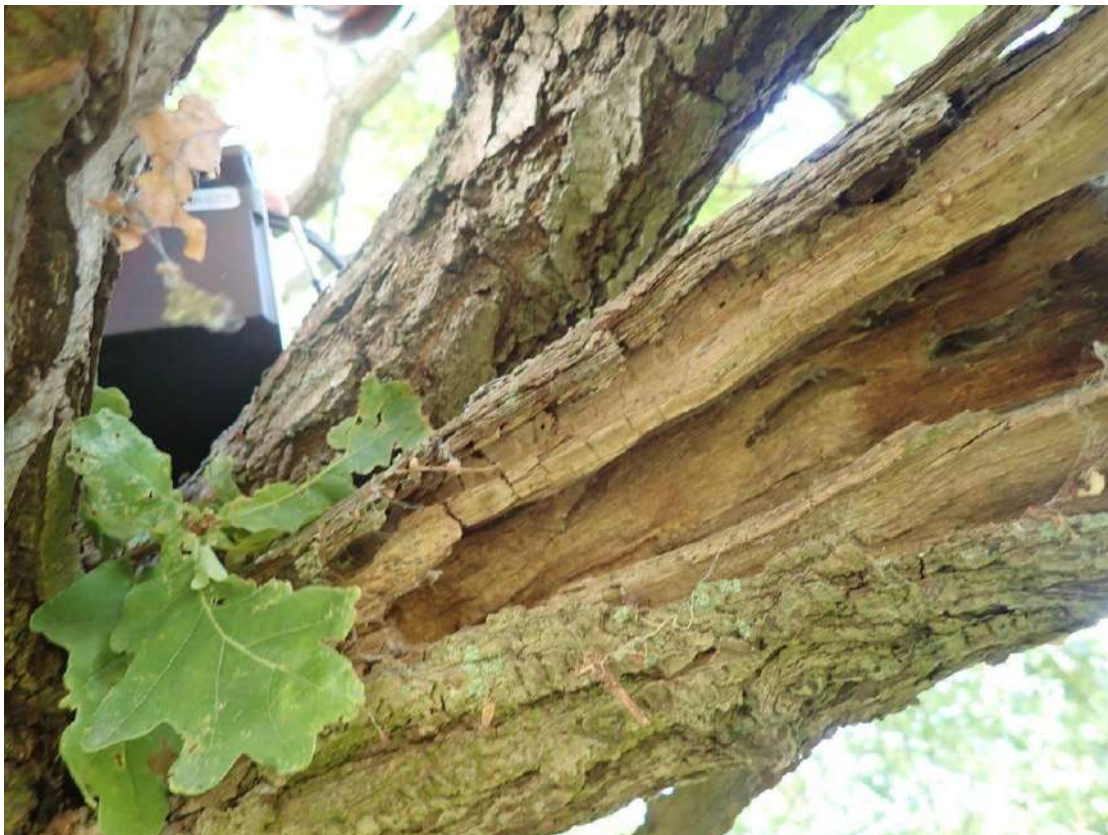
| | T10.16 | Hazard beam | N-E | 6 | 6 | None | Horizontal | 10x10 | None | N | 36 |

Photograph 36 – T10 showing hazard beam (T10.16).

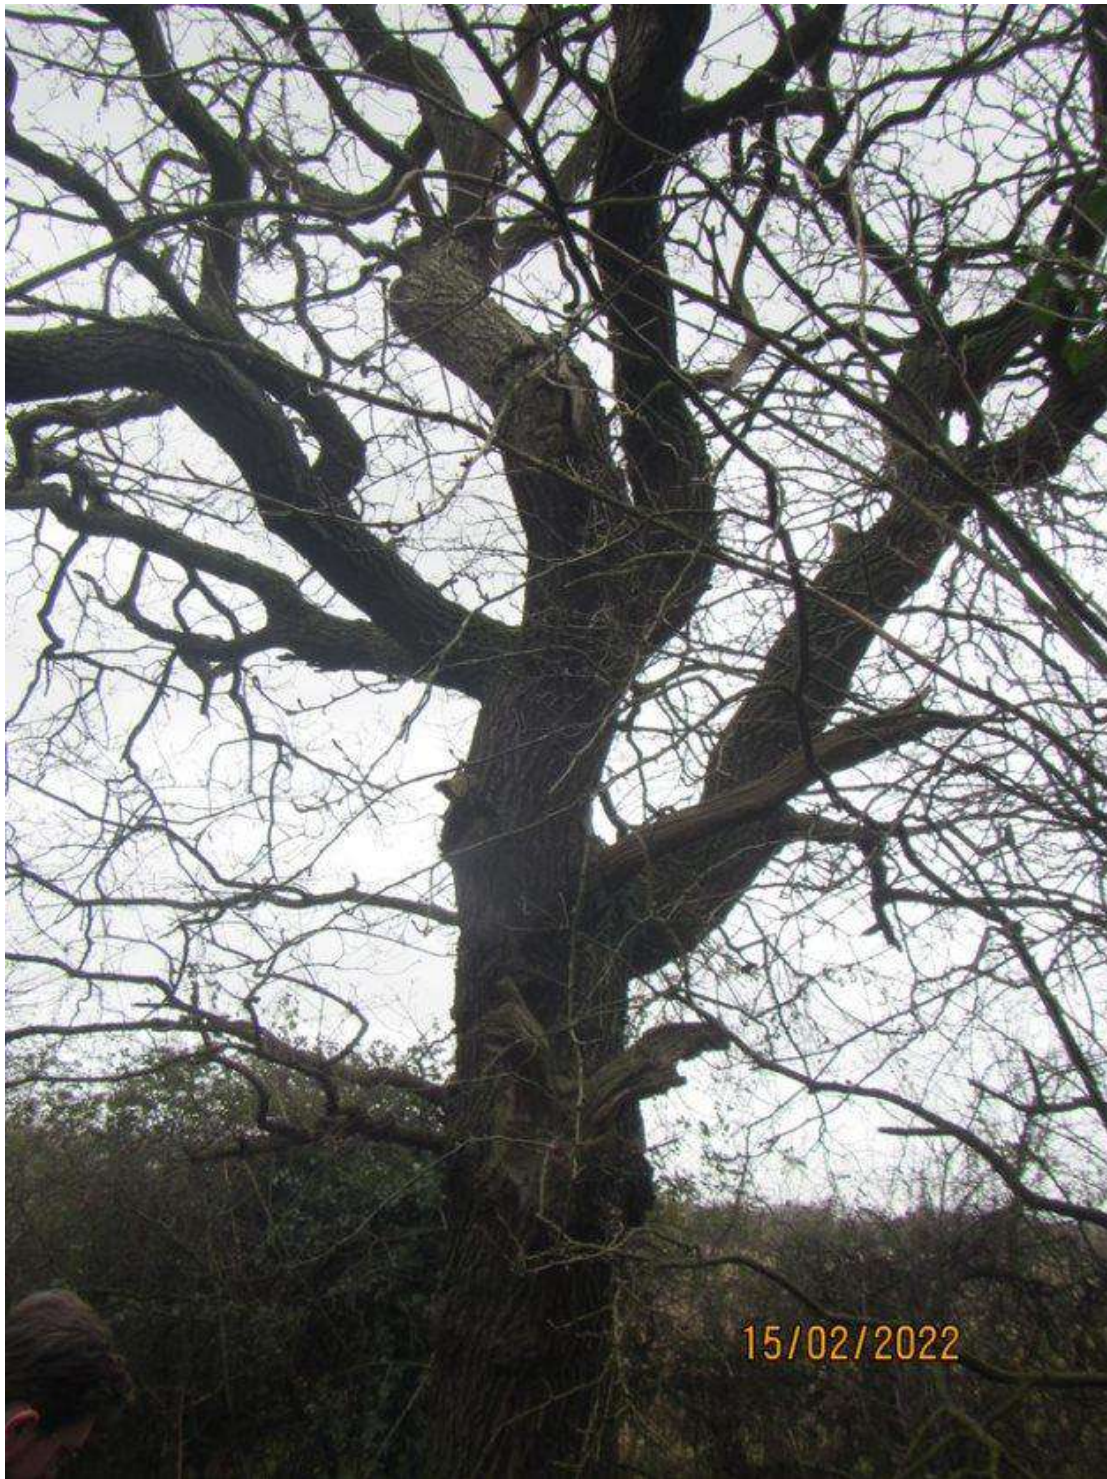
Photograph 37 – T11.

**T11** is the next mature pedunculate oak in the line of trees and scrub, heading south. It is approximately 13m in height with a DBH of 0.8m. PRFs include a callus roll 5m from ground level on an upward-facing branch on the tree's south-western aspect (T11.1), a crack in deadwood at 5m on the eastern aspect (T11.2), and a cavity created by a lost limb at a height of 6m on the north-western aspect (T11.3). T11.1 extends inwards 5cm and is considered to have low roosting potential, while T11.3 extends in 35cm and is considered to have moderate roosting potential; however evidence of nesting birds is present in T11.3 and no evidence of roosting bats was observed in either feature. T11.2 was found to be superficial upon inspection and has negligible roosting potential.

| T11<br>/<br>SJ 39139<br>50391 | Peduncul<br>ate oak<br><i>Quercus<br/>robur</i> | Mature | 13<br>/<br>0/8 | Callus roll at ~5m<br>on north-western<br>aspect. Crack by<br>deadwood at ~5m<br>on eastern aspect.<br>Knot hole cavity at<br>6m on south-<br>western aspect. | M | One of a line of oaks within<br>an area of dense scrub<br>running between two areas<br>of semi-improved<br>grassland. | Y | Y | 37-40 | Evidence of nesting birds in trunk<br>cavity. |

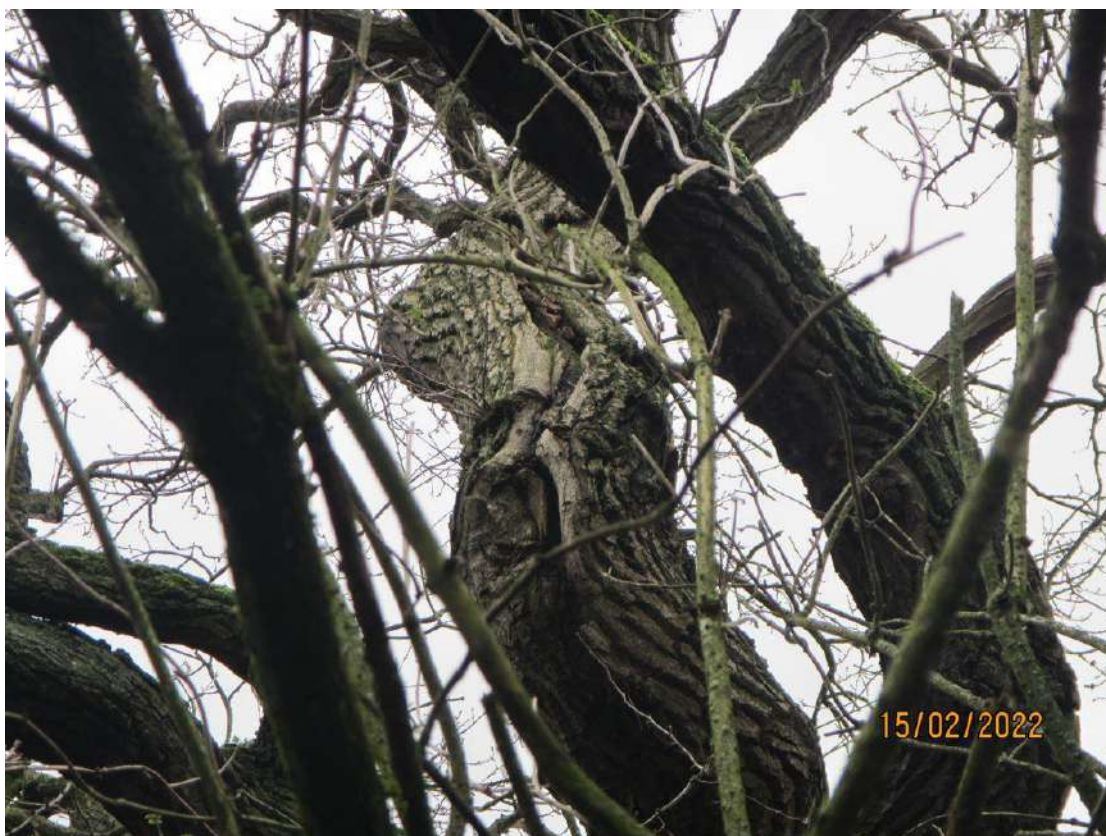
Photograph 38 – T11 showing vertical callus-roll (T11.1).

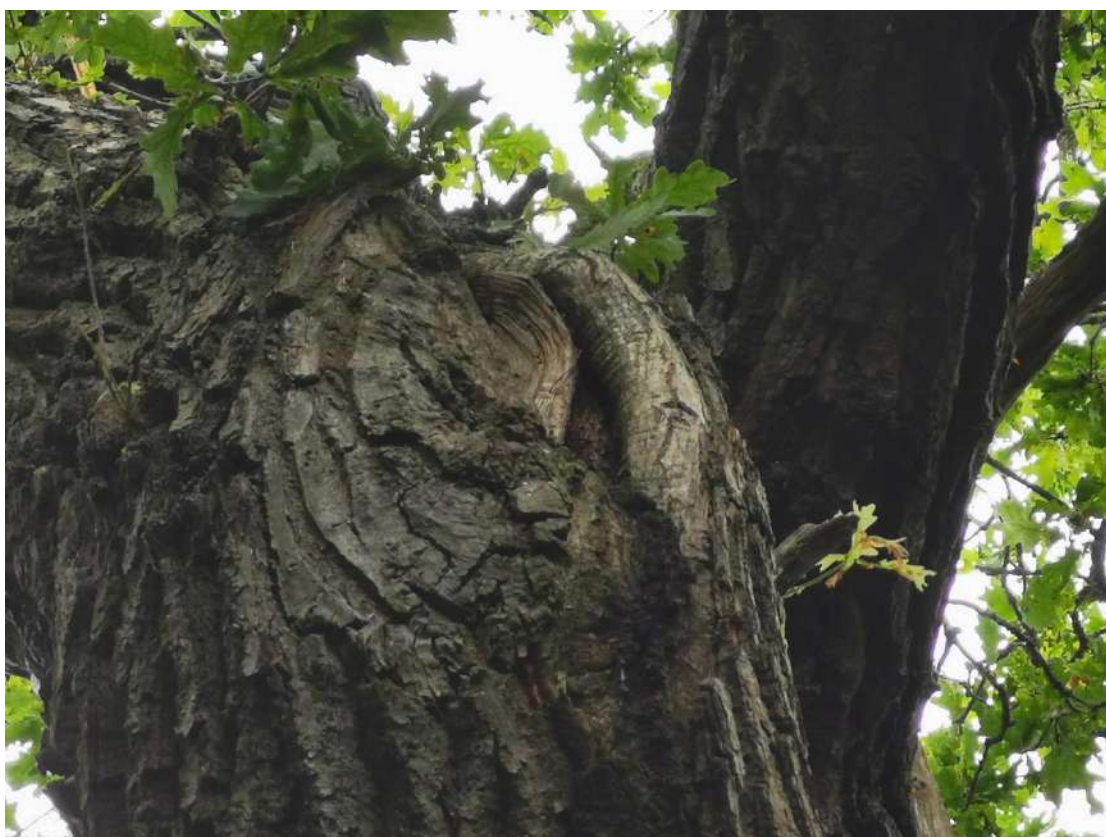
Photograph 39 – T11 showing knot-hole (T11.2).

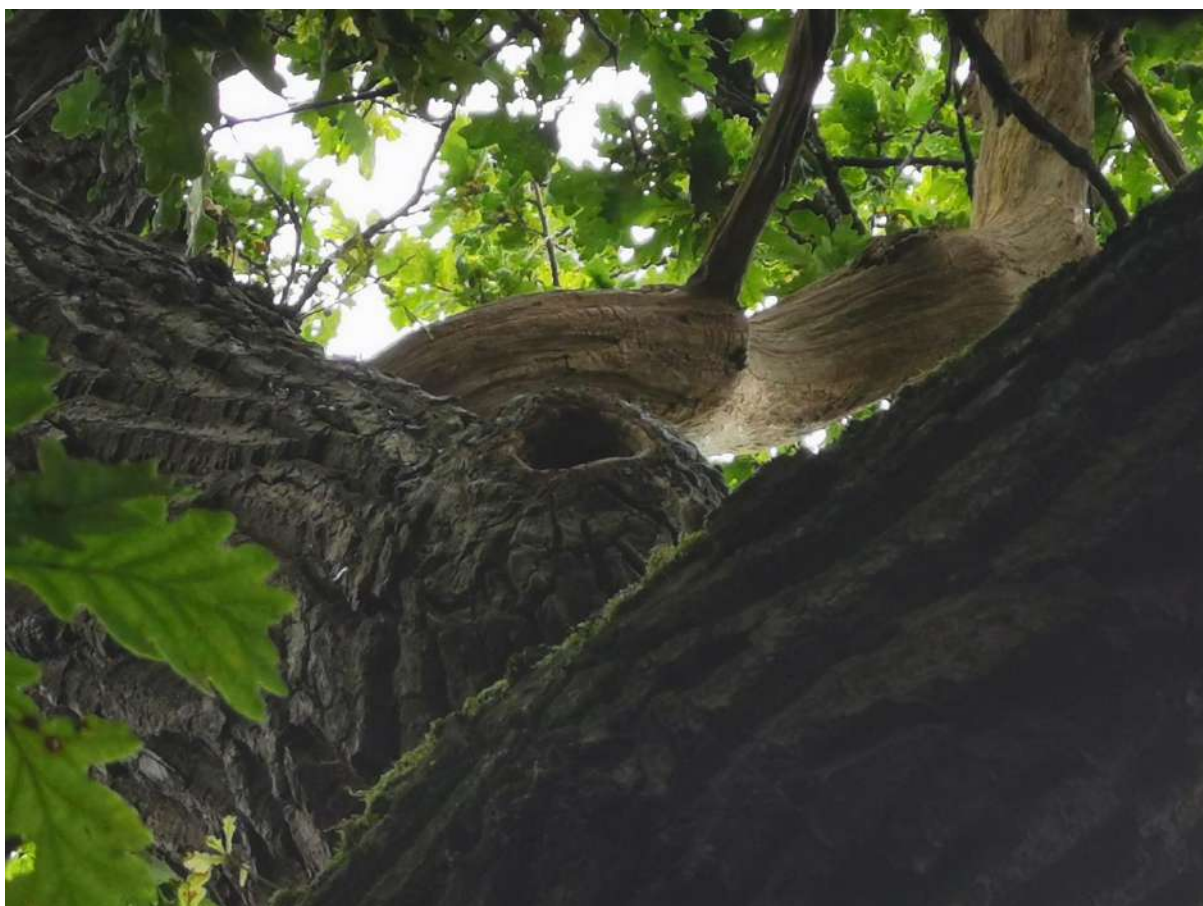
Photograph 40 – T11 showing knot-hole (T11.3).

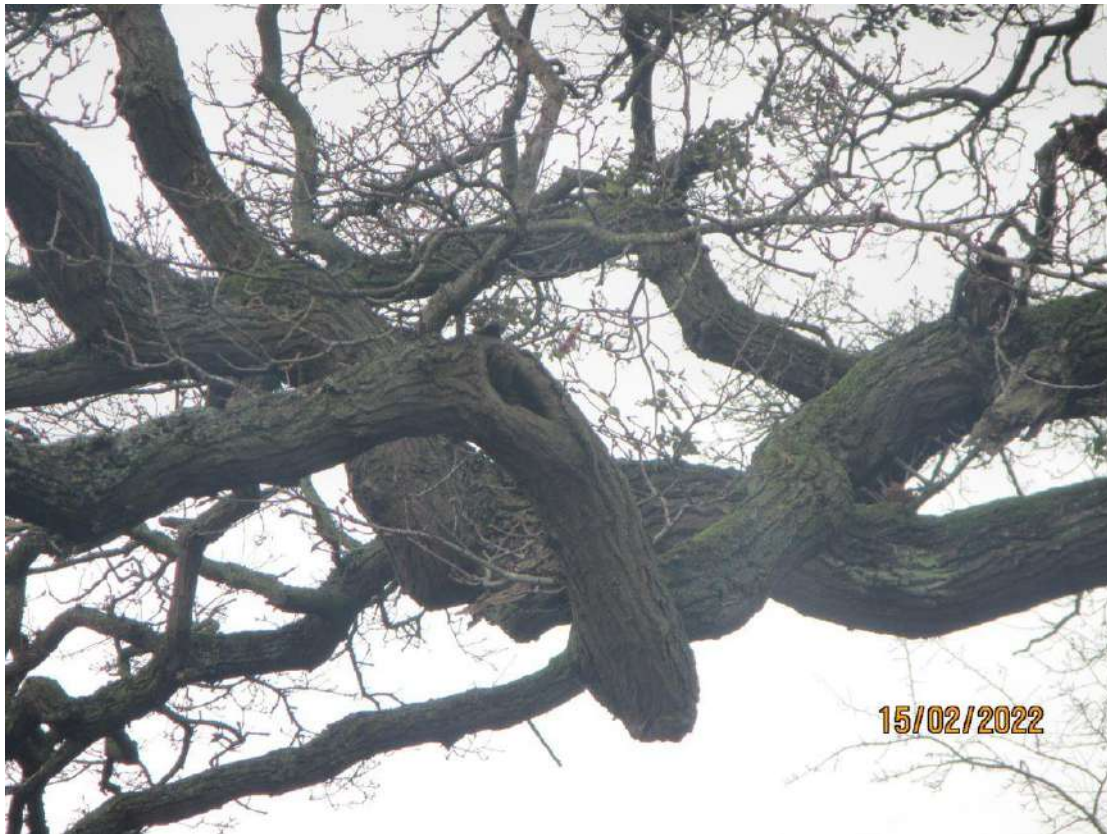
Photograph 42 – T12 showing knot-hole on branch elbow (T12.1).

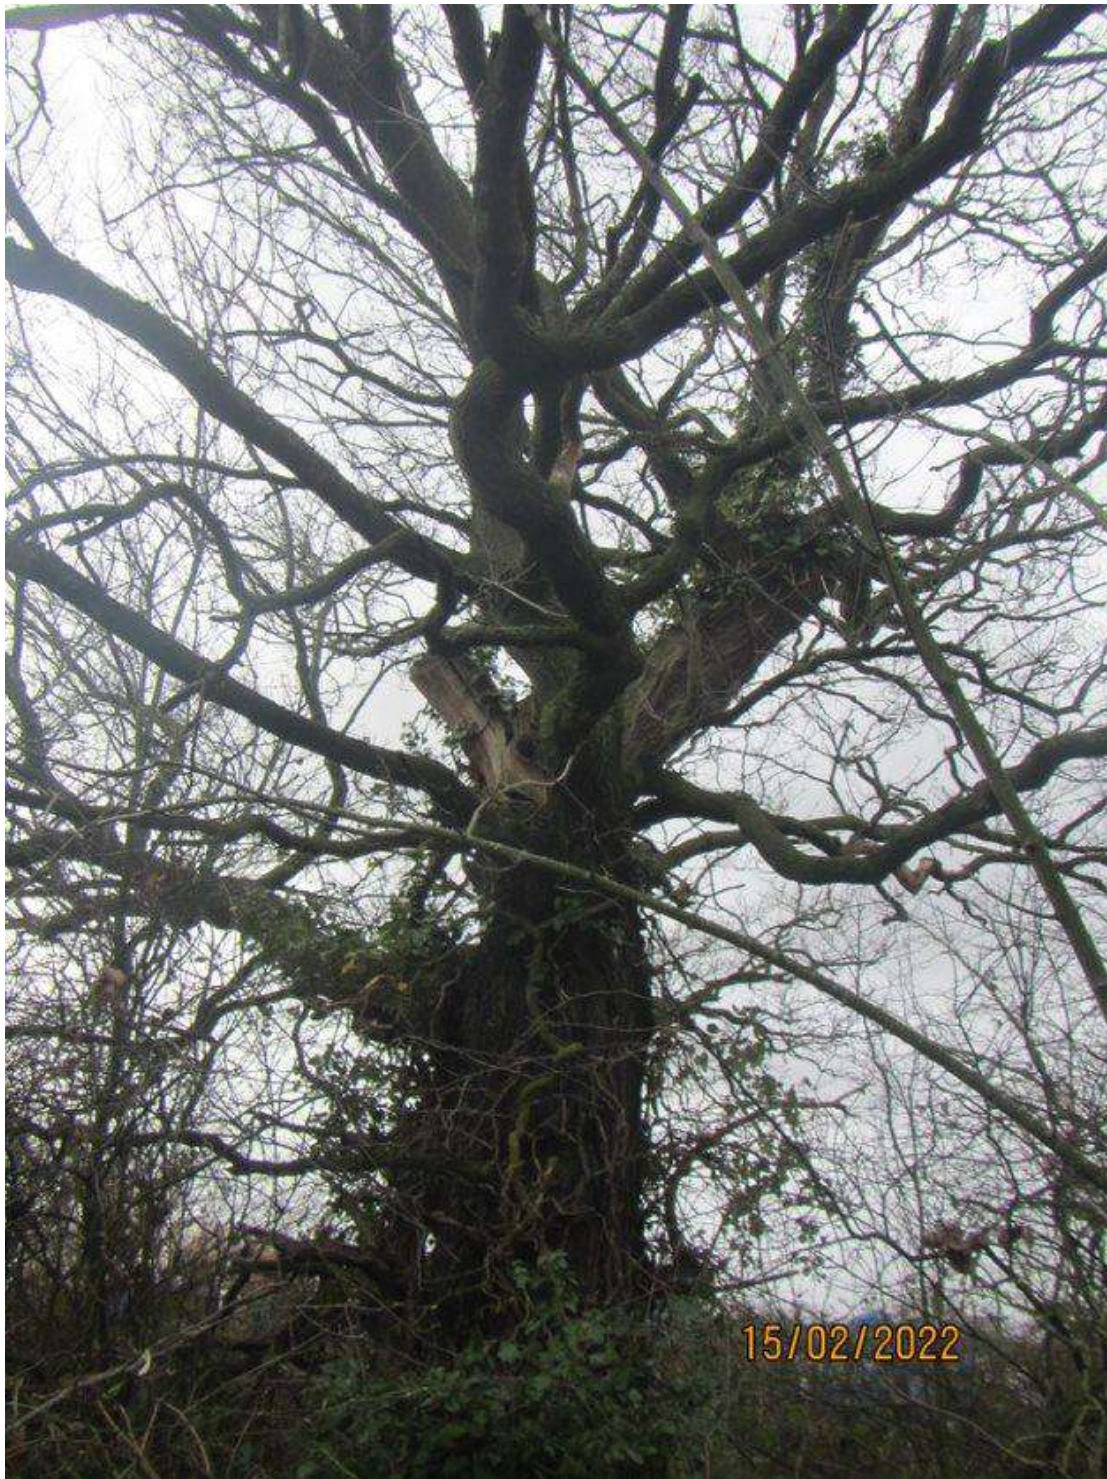
**T14** is a mature pedunculate oak in the dense scrub on the eastern side of the lorry park. It is approximately 15m in height with a DBH of 0.8m. The tree features a tear out at 3.5m on its western aspect (T14.1), an adjacent callus roll, a stem cavity at 8m on the tree's northern aspect (T14.2), deadwood at 5m on its southern aspect (T14.3), and peeling bark at 5m on the north-eastern aspect (T14.4). T14.1 was found to lead to only a small cavity, and is considered to have low potential to support roosting bats. T14.2 extends downwards approximately 50cm, but is open at the top and features multiple entrance points, and is thus subject to rain and light ingress and considered to contain low roosting potential. T14.4 leads to a small PRF, and is likewise considered to have low roosting potential. T14.3 was found to contain no suitable features upon inspection. No evidence of roosting bats was observed in any of the features.

Photograph 43 – T14 showing deadwood (T14.3).

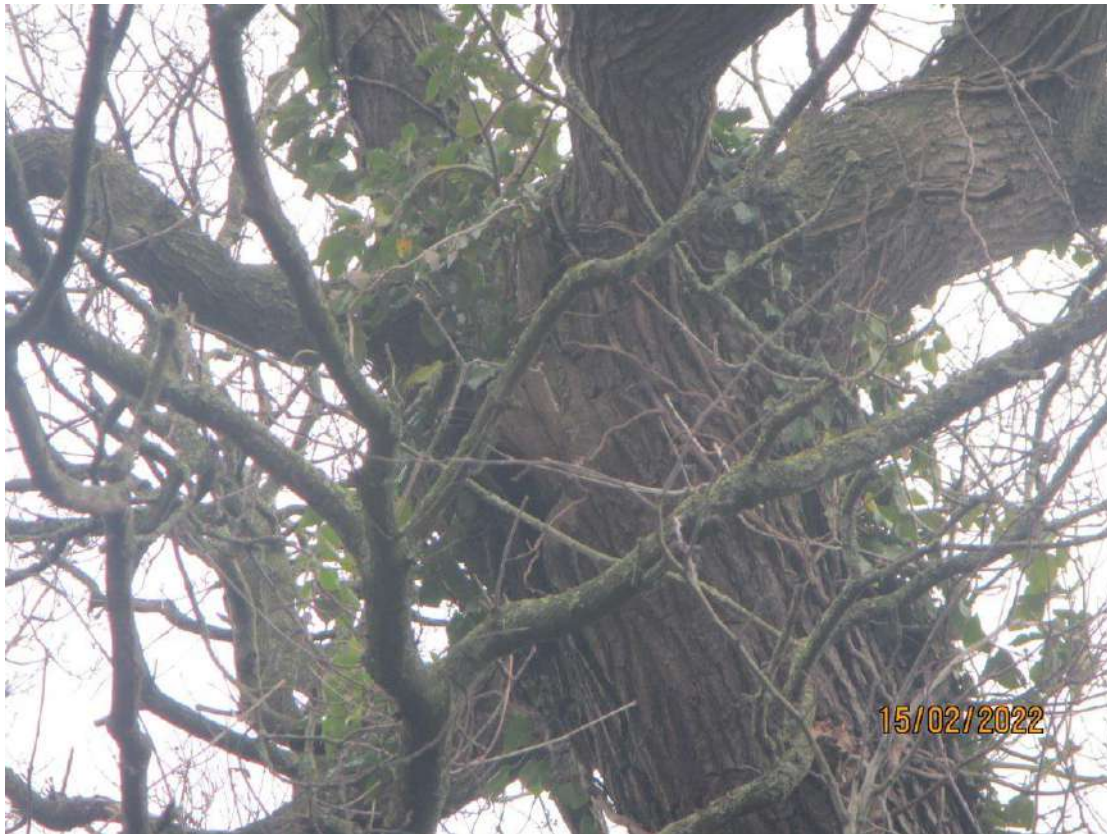
Photograph 44 – T14 showing cluttered vertical tear-out (T14.1).

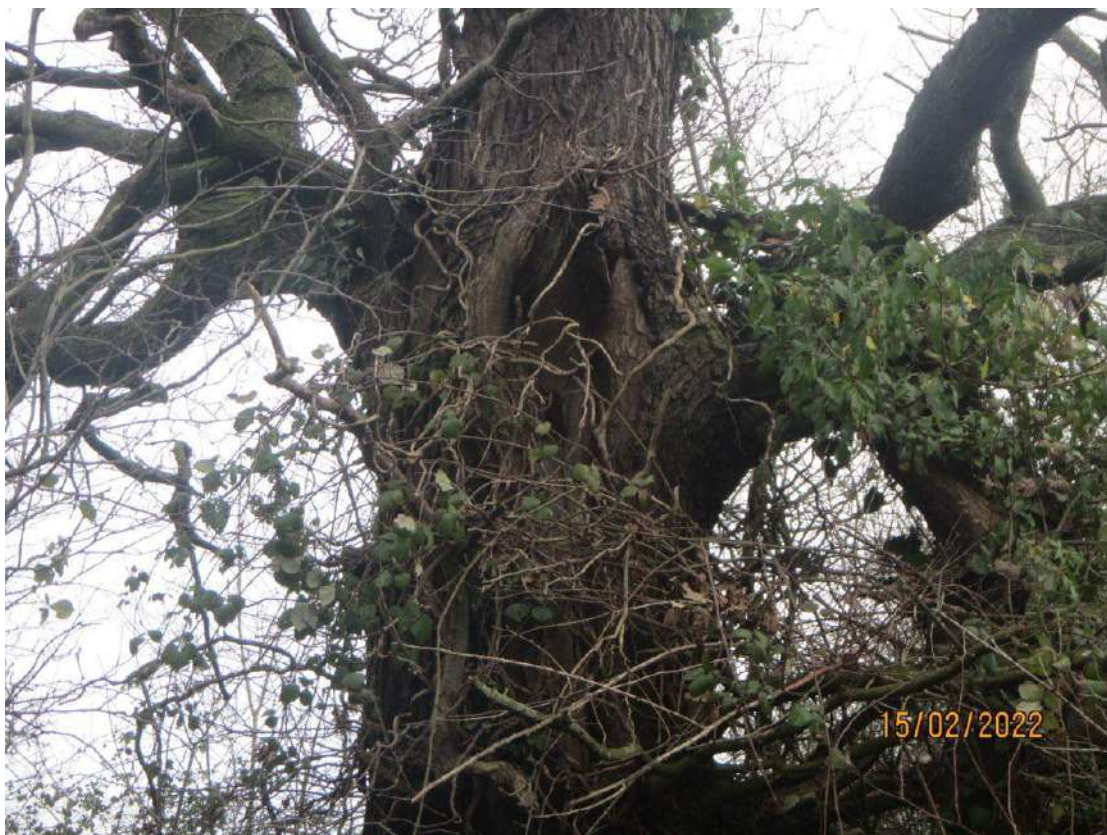
Photograph 45 – T14 showing stem cavity (T14.2).

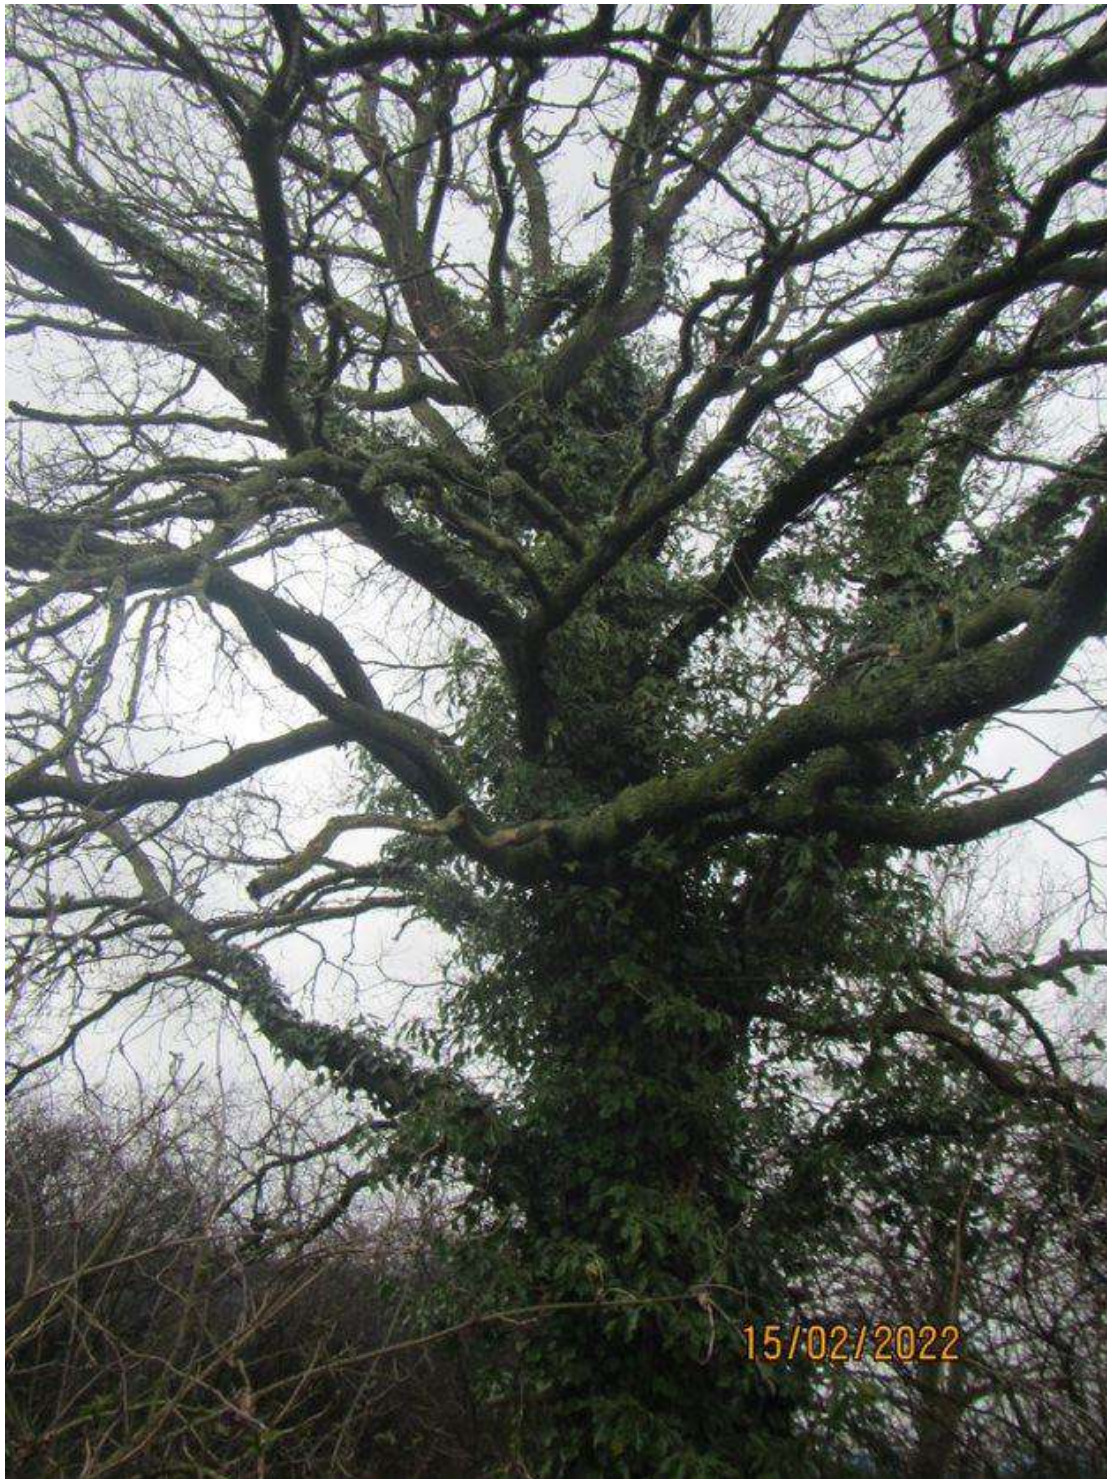
exposed heartwood on the southern aspect of its trunk at a height of 7m (T15.2), a tear-out at 6m on its western aspect (T15.3), fissures in a split branch at 4m on the south-western aspect (T15.4), and a stem cavity at 2m on its northern aspect (T15.5). T15.2 was found to be superficial upon inspection and was heavily cluttered by ivy, and as such is considered to have negligible potential to support roosting bats. The ivy cover on the tree becomes sparse above approximately 6m in height and is considered to provide low roosting potential. T15.4 extends inwards for approximately 20cm and tapers until it becomes too narrow to provide a suitable PRF, and is thus considered to have low roosting potential. Bird droppings were seen in this feature. T15.3 and T15.5 both extend inwards for around 40cm, but both feature upward-facing entrances and are thus relatively exposed, as well as subject to clutter from ivy and hawthorn scrub. These features are considered to contain moderate roosting potential. No evidence of roosting bats was observed in any of the features present.

Photograph 46 – T15 showing ivy cover on trunk and some limbs (T15.1).

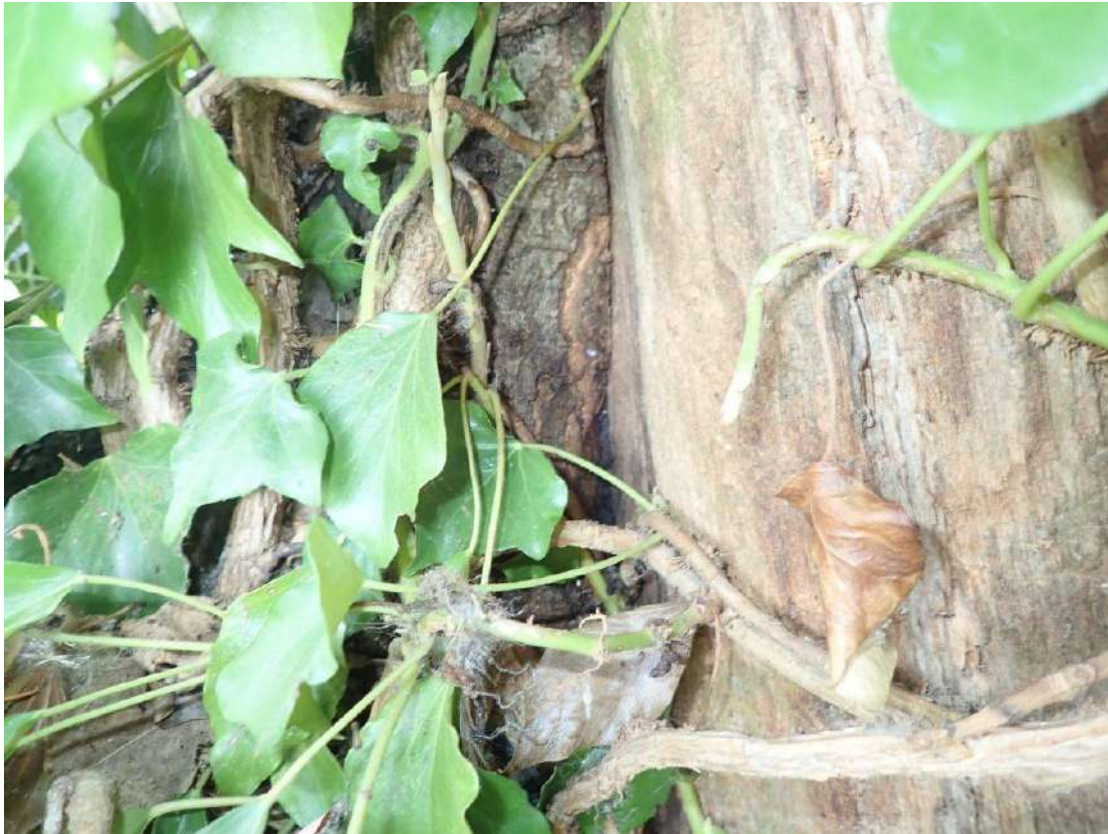
Photograph 47 – T15 showing exposed heartwood (T15.2).
