**BAT AERIAL TREE ASSESSMENT & PRESENCE /  
ABSENCE SURVEYS**

**Plot 3A**

Wrexham Industrial Estate  
Bryn Lane  
Wrexham  
LL13 9UT

| UES reference: | UES03448/16 |

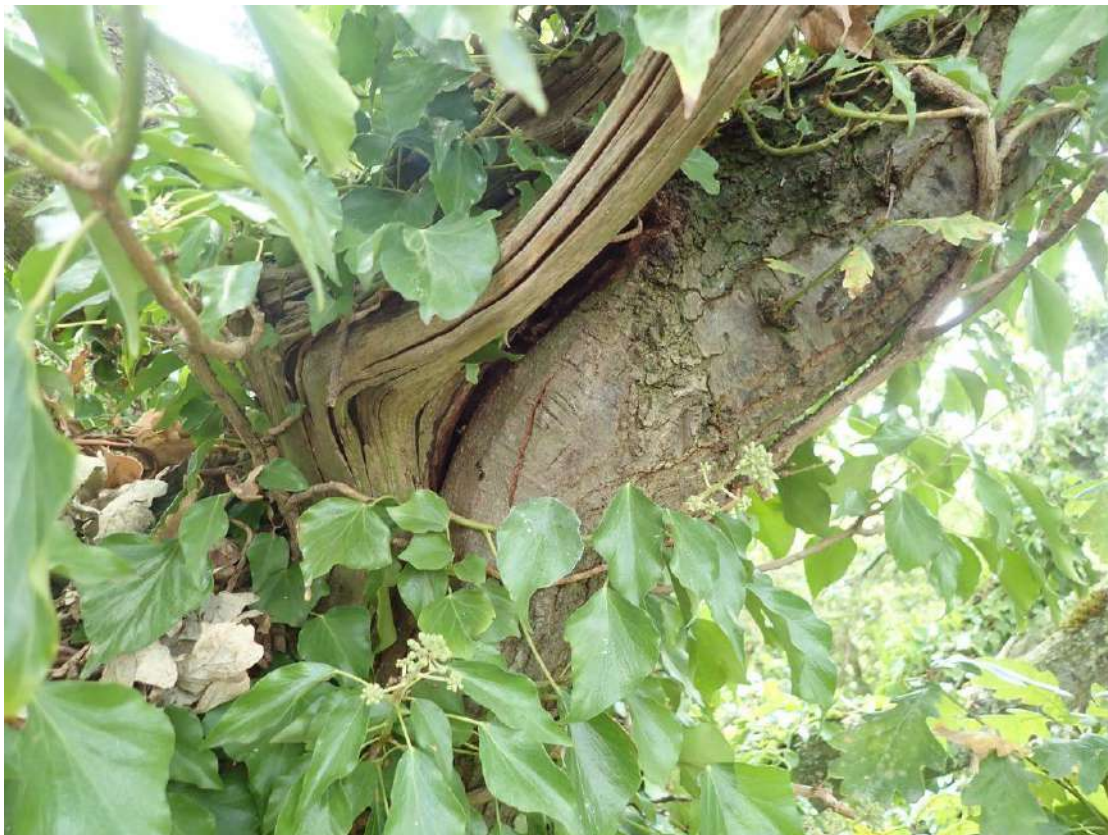
Photograph 48 – T15 showing tear-out (T15.3).

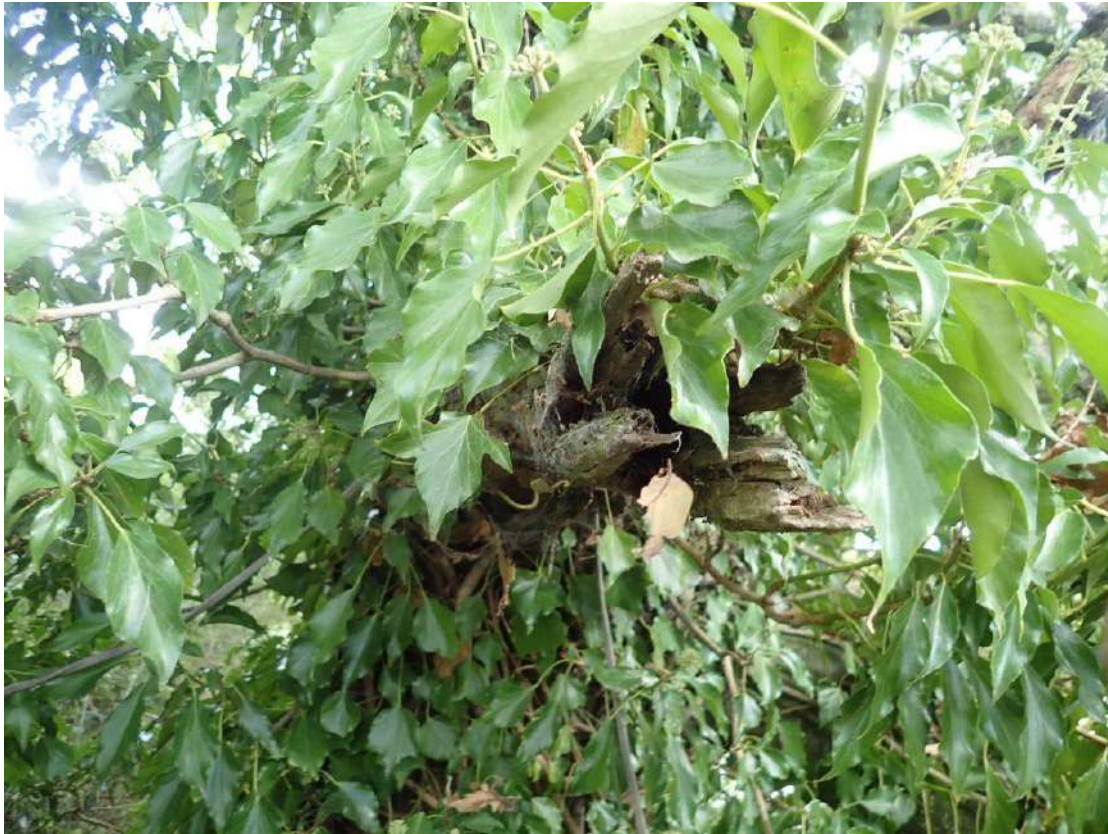
| | T15.4 | Branch fissure | S-W | 4 | 1 | Ivy | Horizontal | 5x5 | None | L | 49 |

Photograph 49 – T15 showing branch fissure (T15.4).

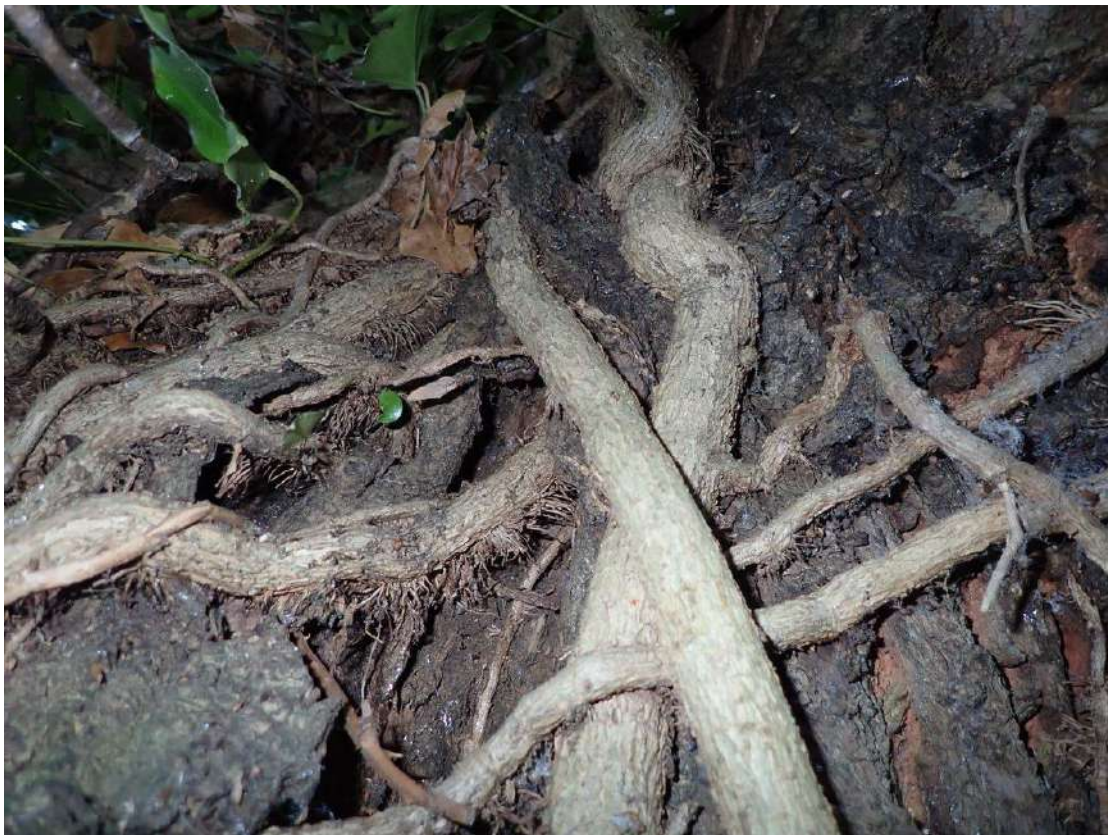
Photograph 50 – T15 showing trunk cavity (T15.5).

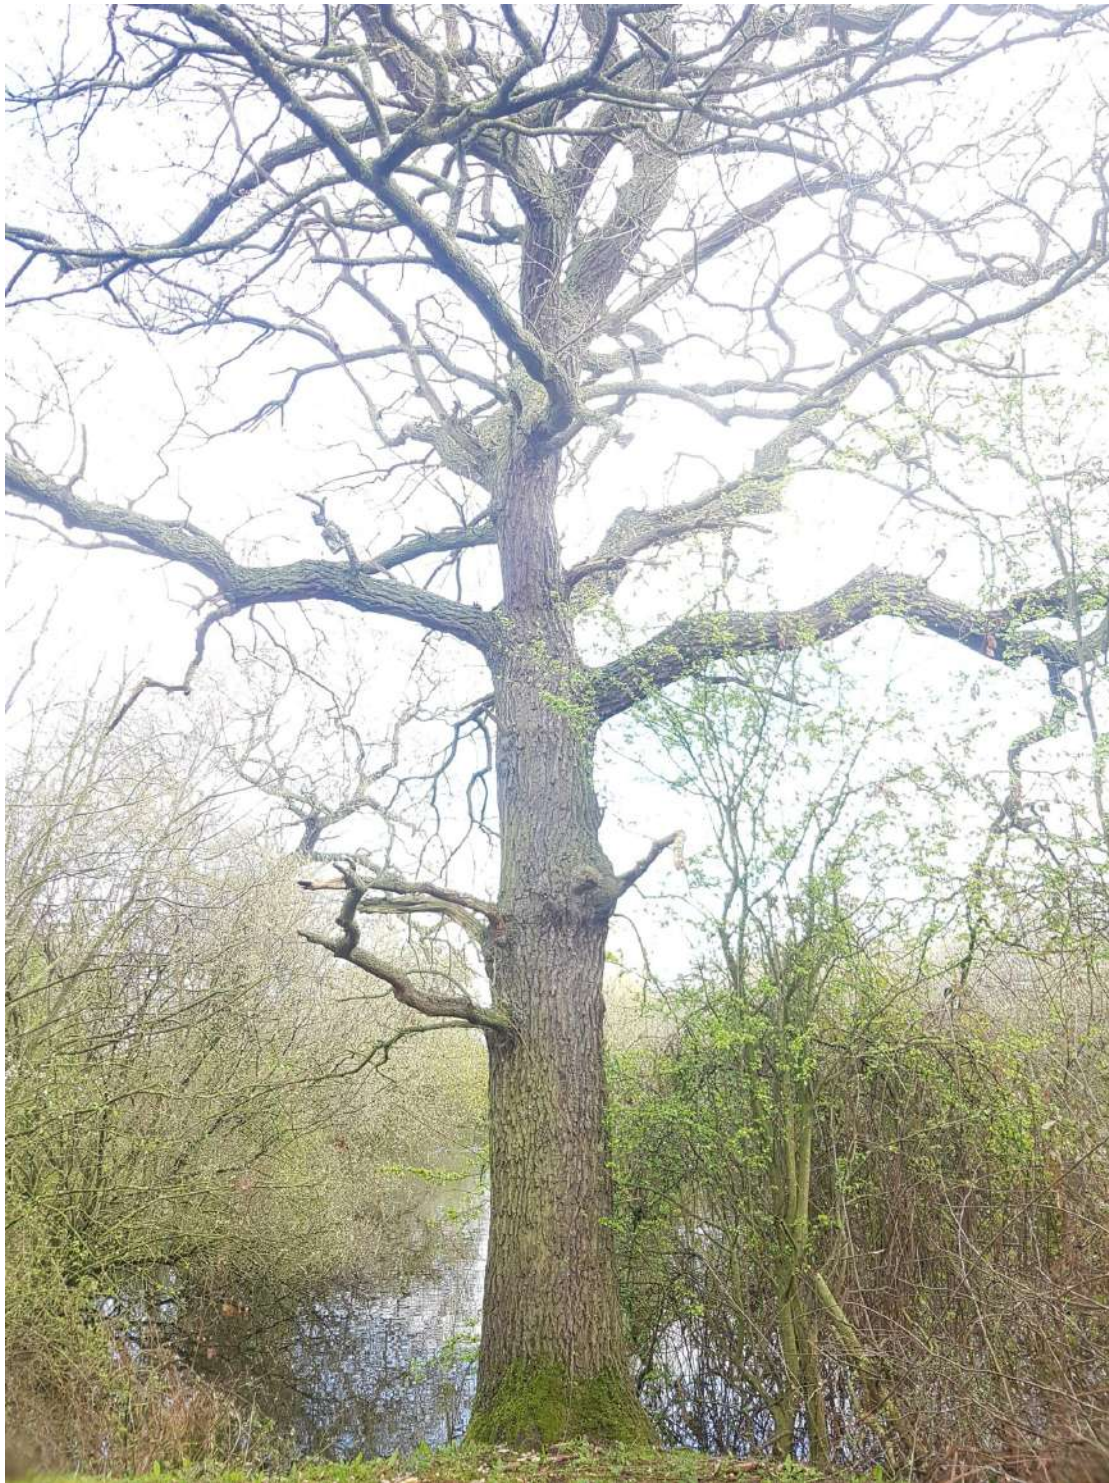
Photograph 51 – T34.

**T34** is a mature pedunculate oak found in the small stand of broadleaved woodland which stretches around Pond 2 in the south-eastern section of the site. It is approximately 20m in height with a DBH of 1.0m. This tree features deadwood at 3m on its northern aspect (T34.3) and at 7m on both its northern and southern aspects (T34.1 & T34.2 respectively). All features were found to be exposed and upward-facing upon close inspection, and are considered to have negligible potential to support roosting bats.

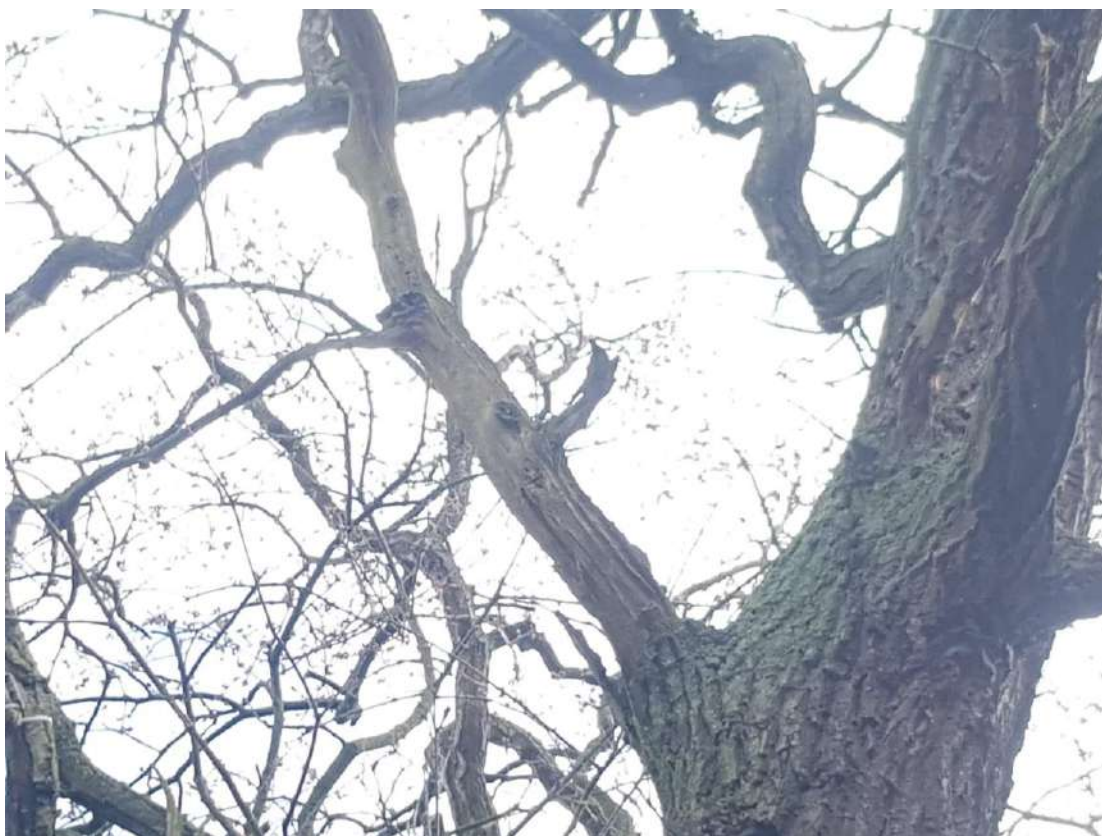
Photograph 52 – T34 showing deadwood on northern aspect (T34.1).

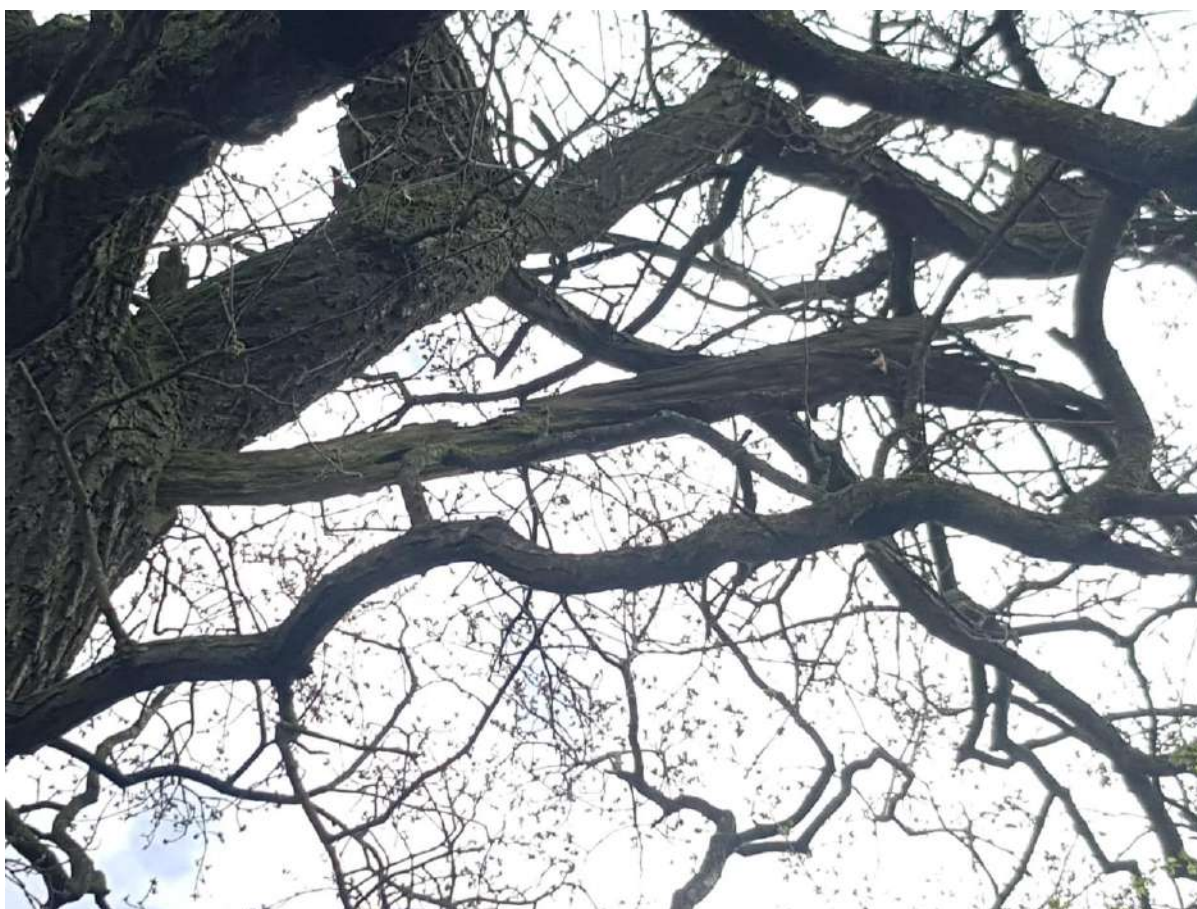
Photograph 53 – T34 showing deadwood on southern aspect (T34.2).

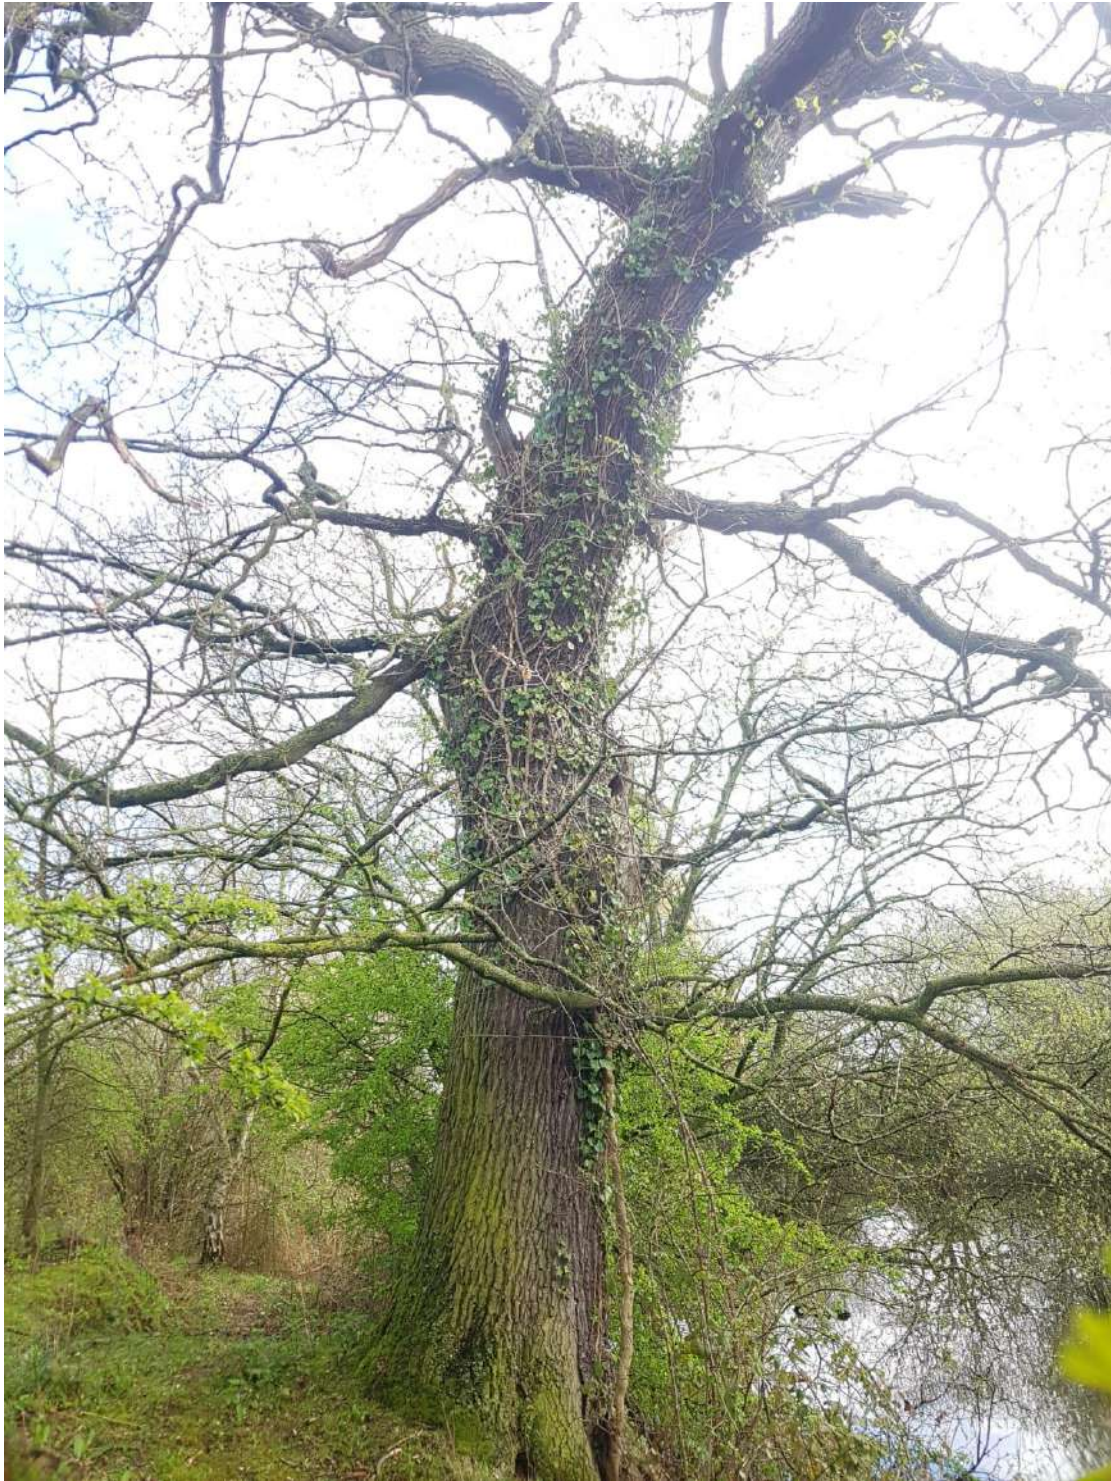
Photograph 55 – T35.

**T35** is a mature pedunculate oak found in the broadleaved woodland which stretches around a large pond in the south-east of the site. It is approximately 20m in height with a DBH of 1.0m. It has a stem cavity at 3.5m on its southern aspect (T35.1), and deadwood on the trunk at 4m, 7m and 8m on its western (T35.4), eastern (T35.3), and southern (T35.2) aspects respectively, and a knothole and deadwood on a western branch at 10m (T35.5). T35.2 and T35.4 were found to contain no suitable cavities upon inspection, and are considered to have negligible potential to support roosting bats. T35.1 has a 25cm diameter and extends upwards approximately 30cm, and bird droppings were observed inside. T35.3 likewise has a 25cm diameter and extends inwards at least 1.5m. T35.5 features a cavity which extends inwards 70cm and was found to contain an old bird nest. These features are considered to have high roosting potential. However, no evidence of roosting bats was observed in any of the features present.

| T35<br>/<br>SJ39303<br>50277 | Peduncul<br>ate oak<br><i>Quercus<br/>robur</i> | Mature | 20<br>/<br>1 | Stem cavity at ~3.5 on southern aspect. Deadwood at 7m on eastern aspect, 8m on the southern aspects and at 4m on the western aspect. Knot hole with associated deadwood on a western-leaning limb at ~10m. | H | Within broadleaved woodland surrounding Pond 2. | Y | Y | 55-60 | Bird droppings recorded in stem cavity on southern aspect. Deadwood on western and southern aspects contain no suitable cavities. Bird nest observed in knot hole on western aspect. Cavity associated with deadwood on eastern aspect cannot be fully inspected, presence / absence surveys required. |

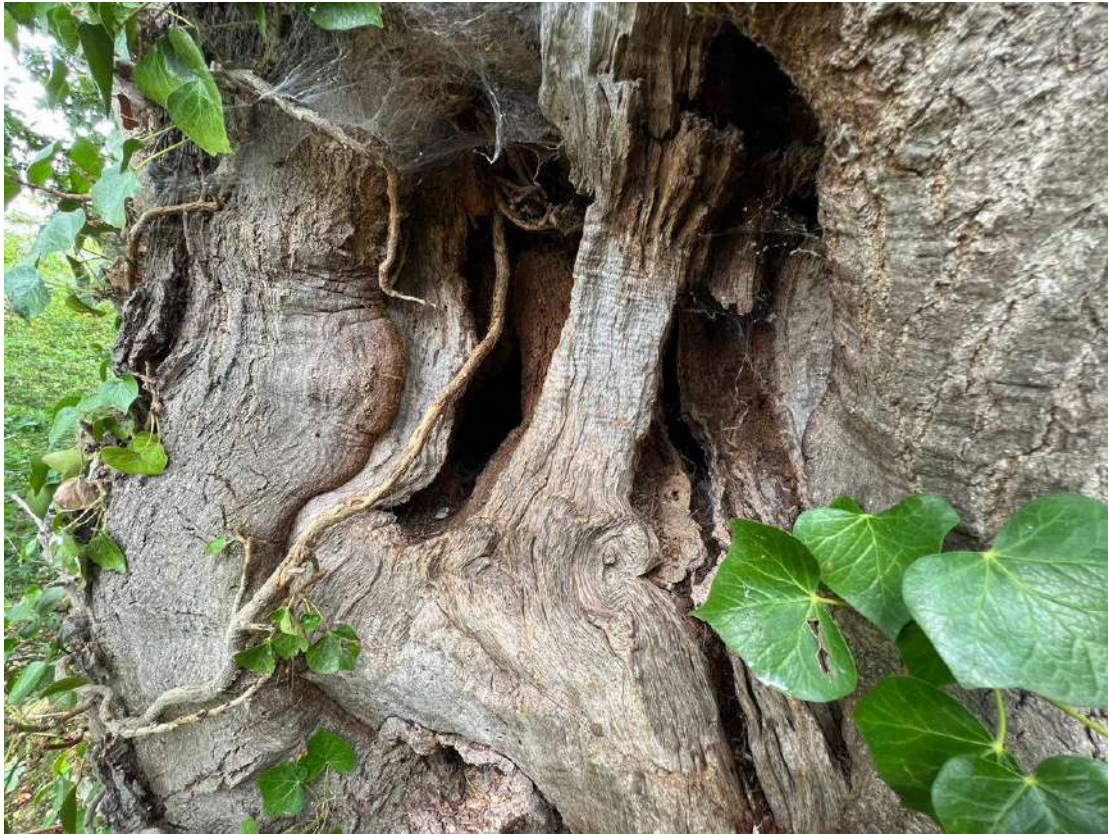
Photograph 56 – T35 showing stem cavity (T35.1).

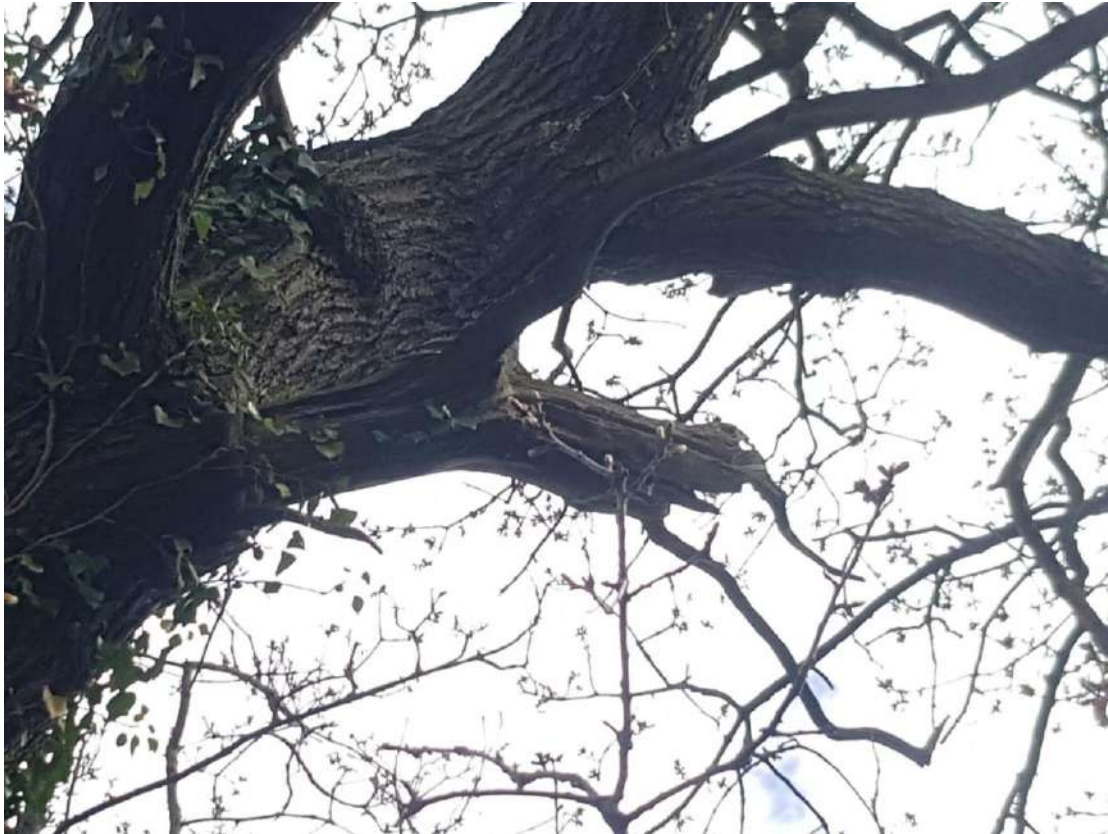
Photograph 57 – T35 showing deadwood on southern aspect (T35.2).

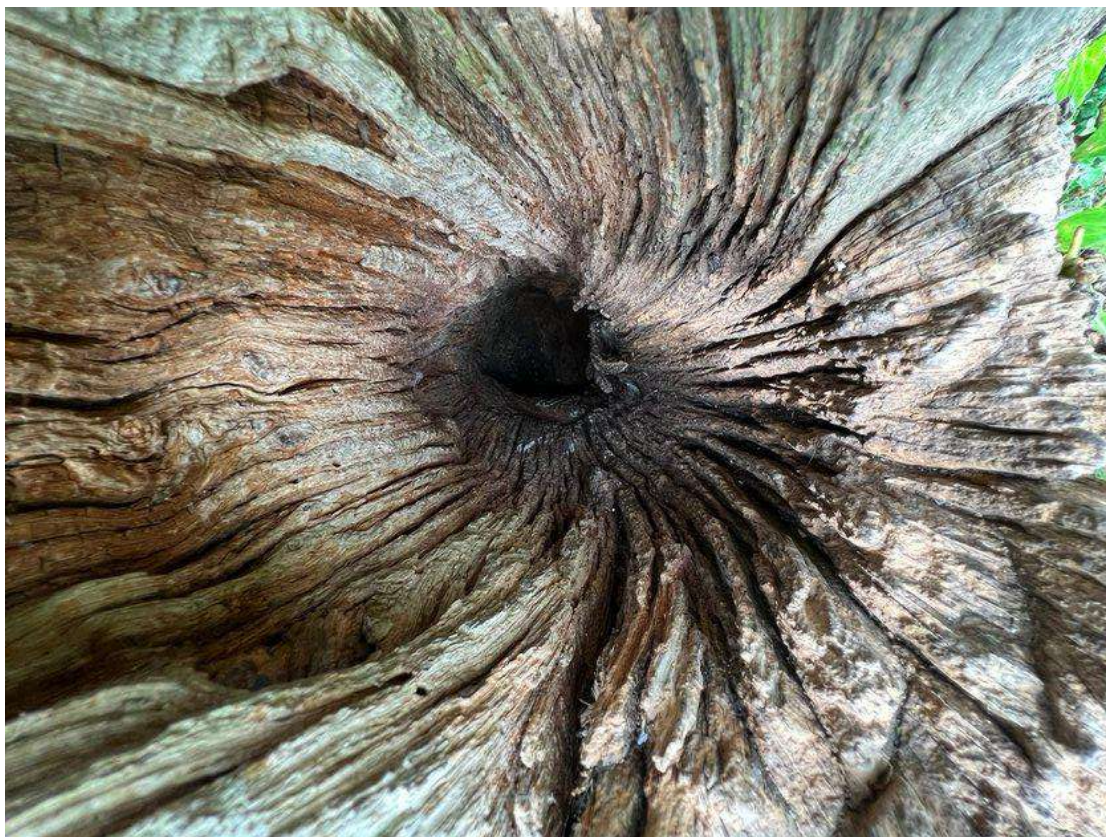
Photograph 58 – T35 showing deadwood on eastern aspect (T35.3).

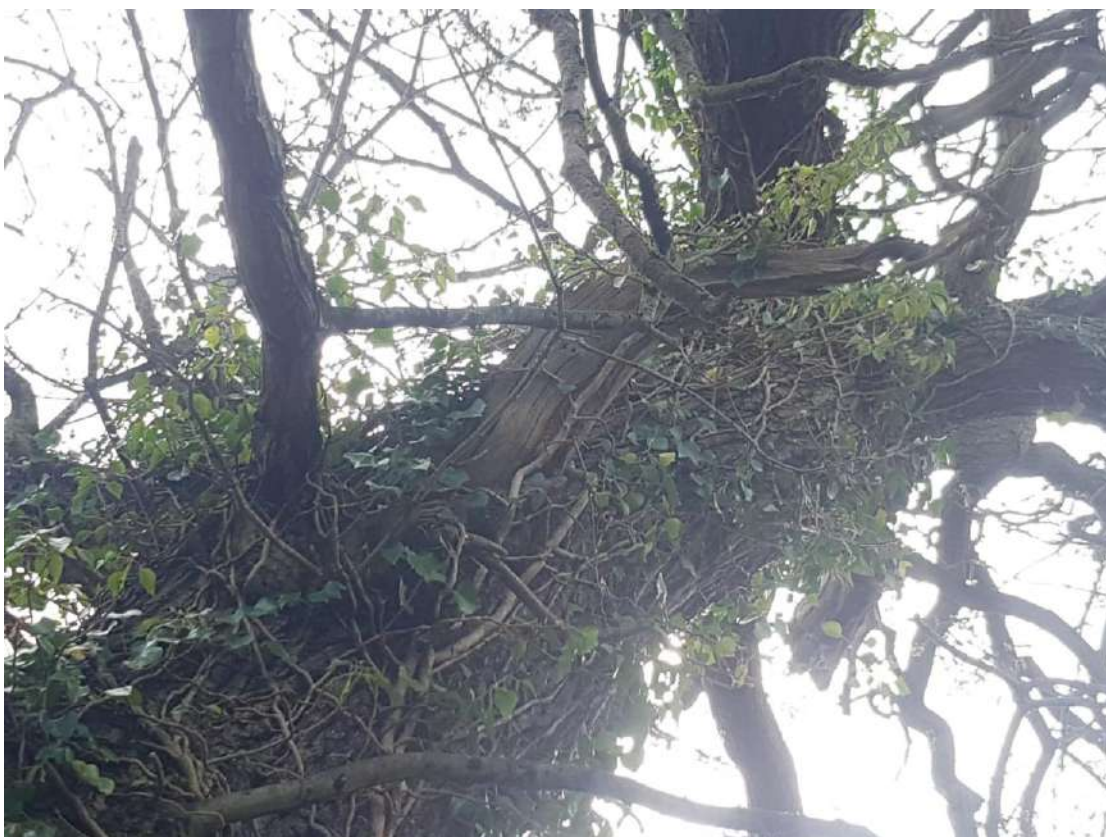
Photograph 59 – T35 showing deadwood on western aspect (T35.4).

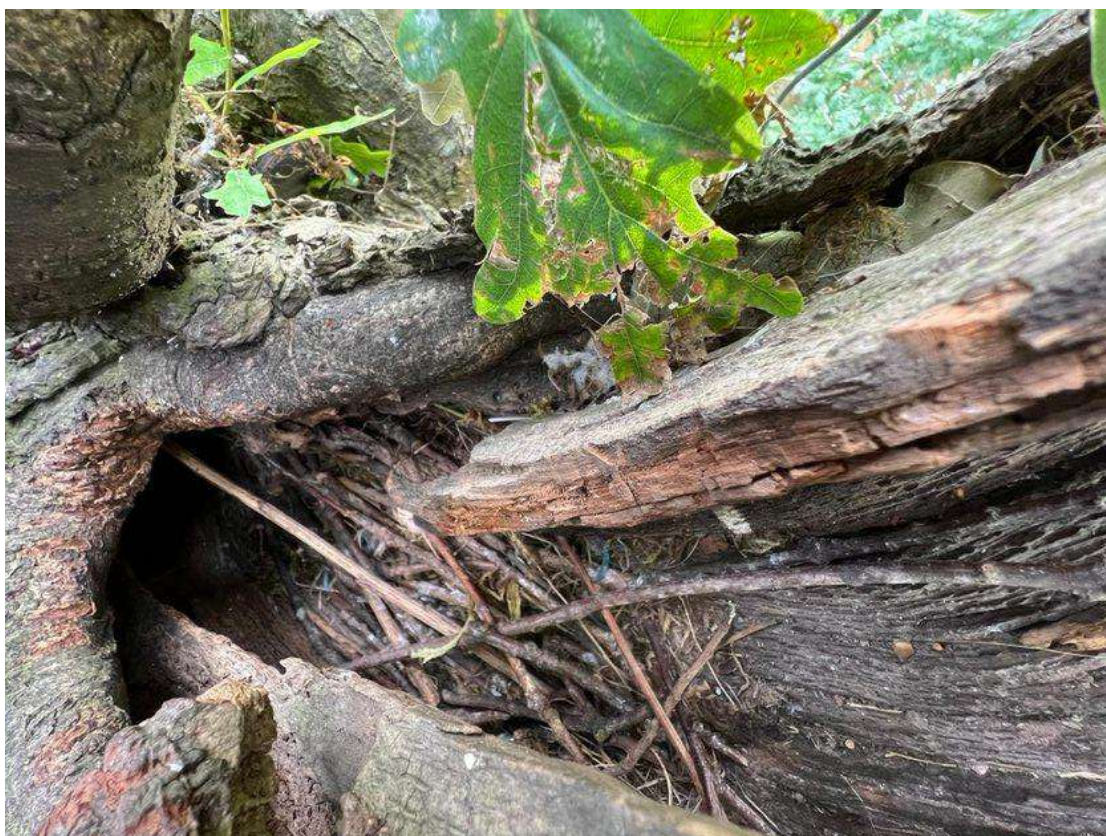
Photograph 60 – T35 showing deadwood and knot hole on western aspect (T35.5).

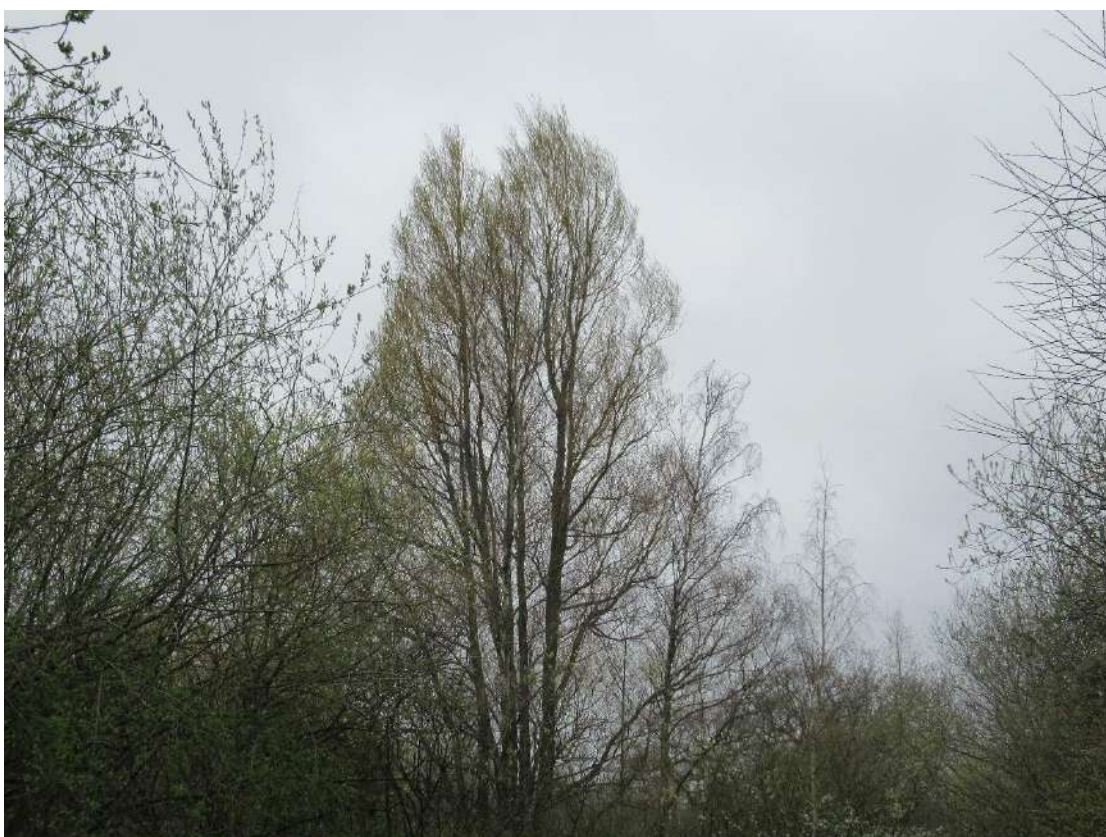
Photograph 61 – T45.

**T45** is a mature crack willow found on an island around Pond 2 in the southern section of the site. It is approximately 16m in height with a DBH of 1m. This tree cannot be fully inspected due to its position, although missing bark can be observed on its eastern aspect at a height of around 10m, possibly indicating a cavity underneath (T45.1). As a precaution, this tree was assessed as having moderate potential to support roosting bats and was subject to two presence / absence surveys.

| T45<br>/<br>SJ 39366<br>50299 | Crack<br>willow<br><i>Salix</i> ×<br><i>fragilis</i> | Mature | 16<br>/<br>1 | Missing bark at 10m on eastern aspect. | M | On an island in Pond 2, surrounded by broadleaved woodland. | Y | N | 61-62 | Tree unable to be fully inspected due to inaccessibility. Bat presence/absence survey undertaken. |

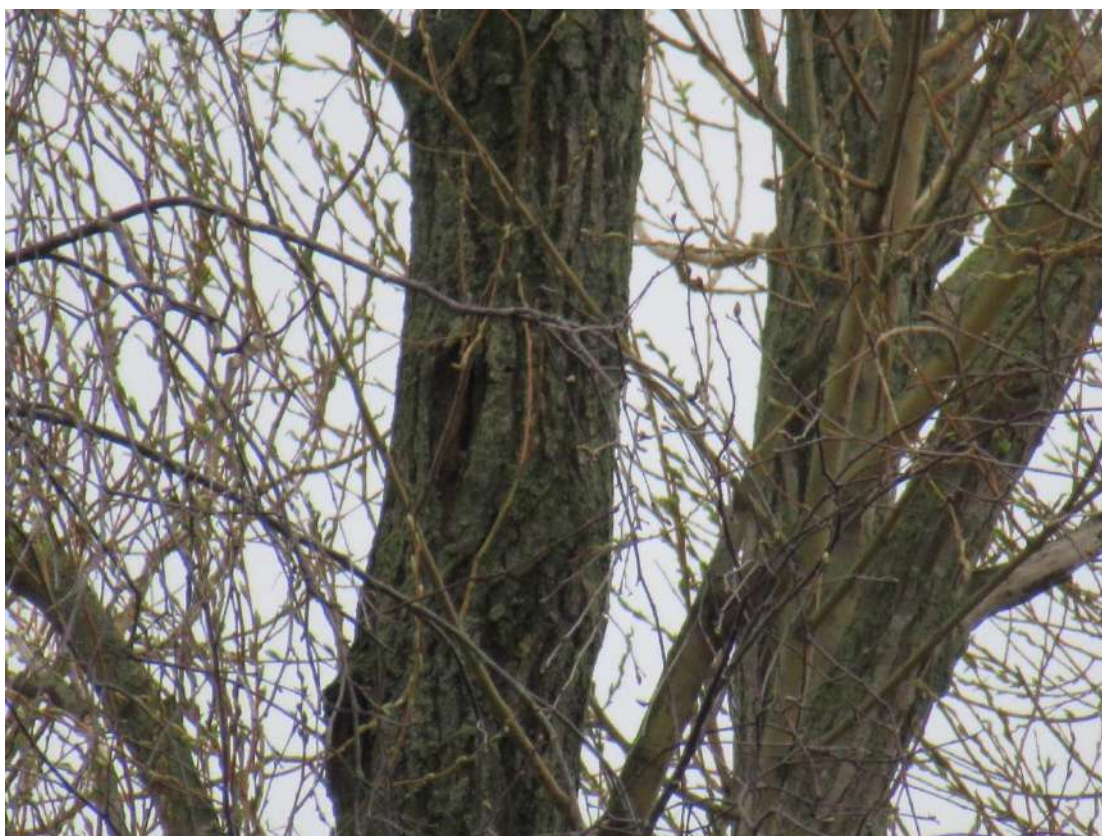
| T45 | T45.1 | Missing<br>bark<br>(possible<br>stem cavity) | 10 | E | 0 | None | N/A | N/A | None | M | 62 |

Photograph 62 – T45 showing missing bark (T45.1).
