Arboricultural report in support of a planning application to develop two sites off Derwent Crescent, Acton, Wrexham.

Client. Wrexham Council

Project: Derwent Crescent, Wrexham  
Client:  
Drawing Title: Arboricultural Report

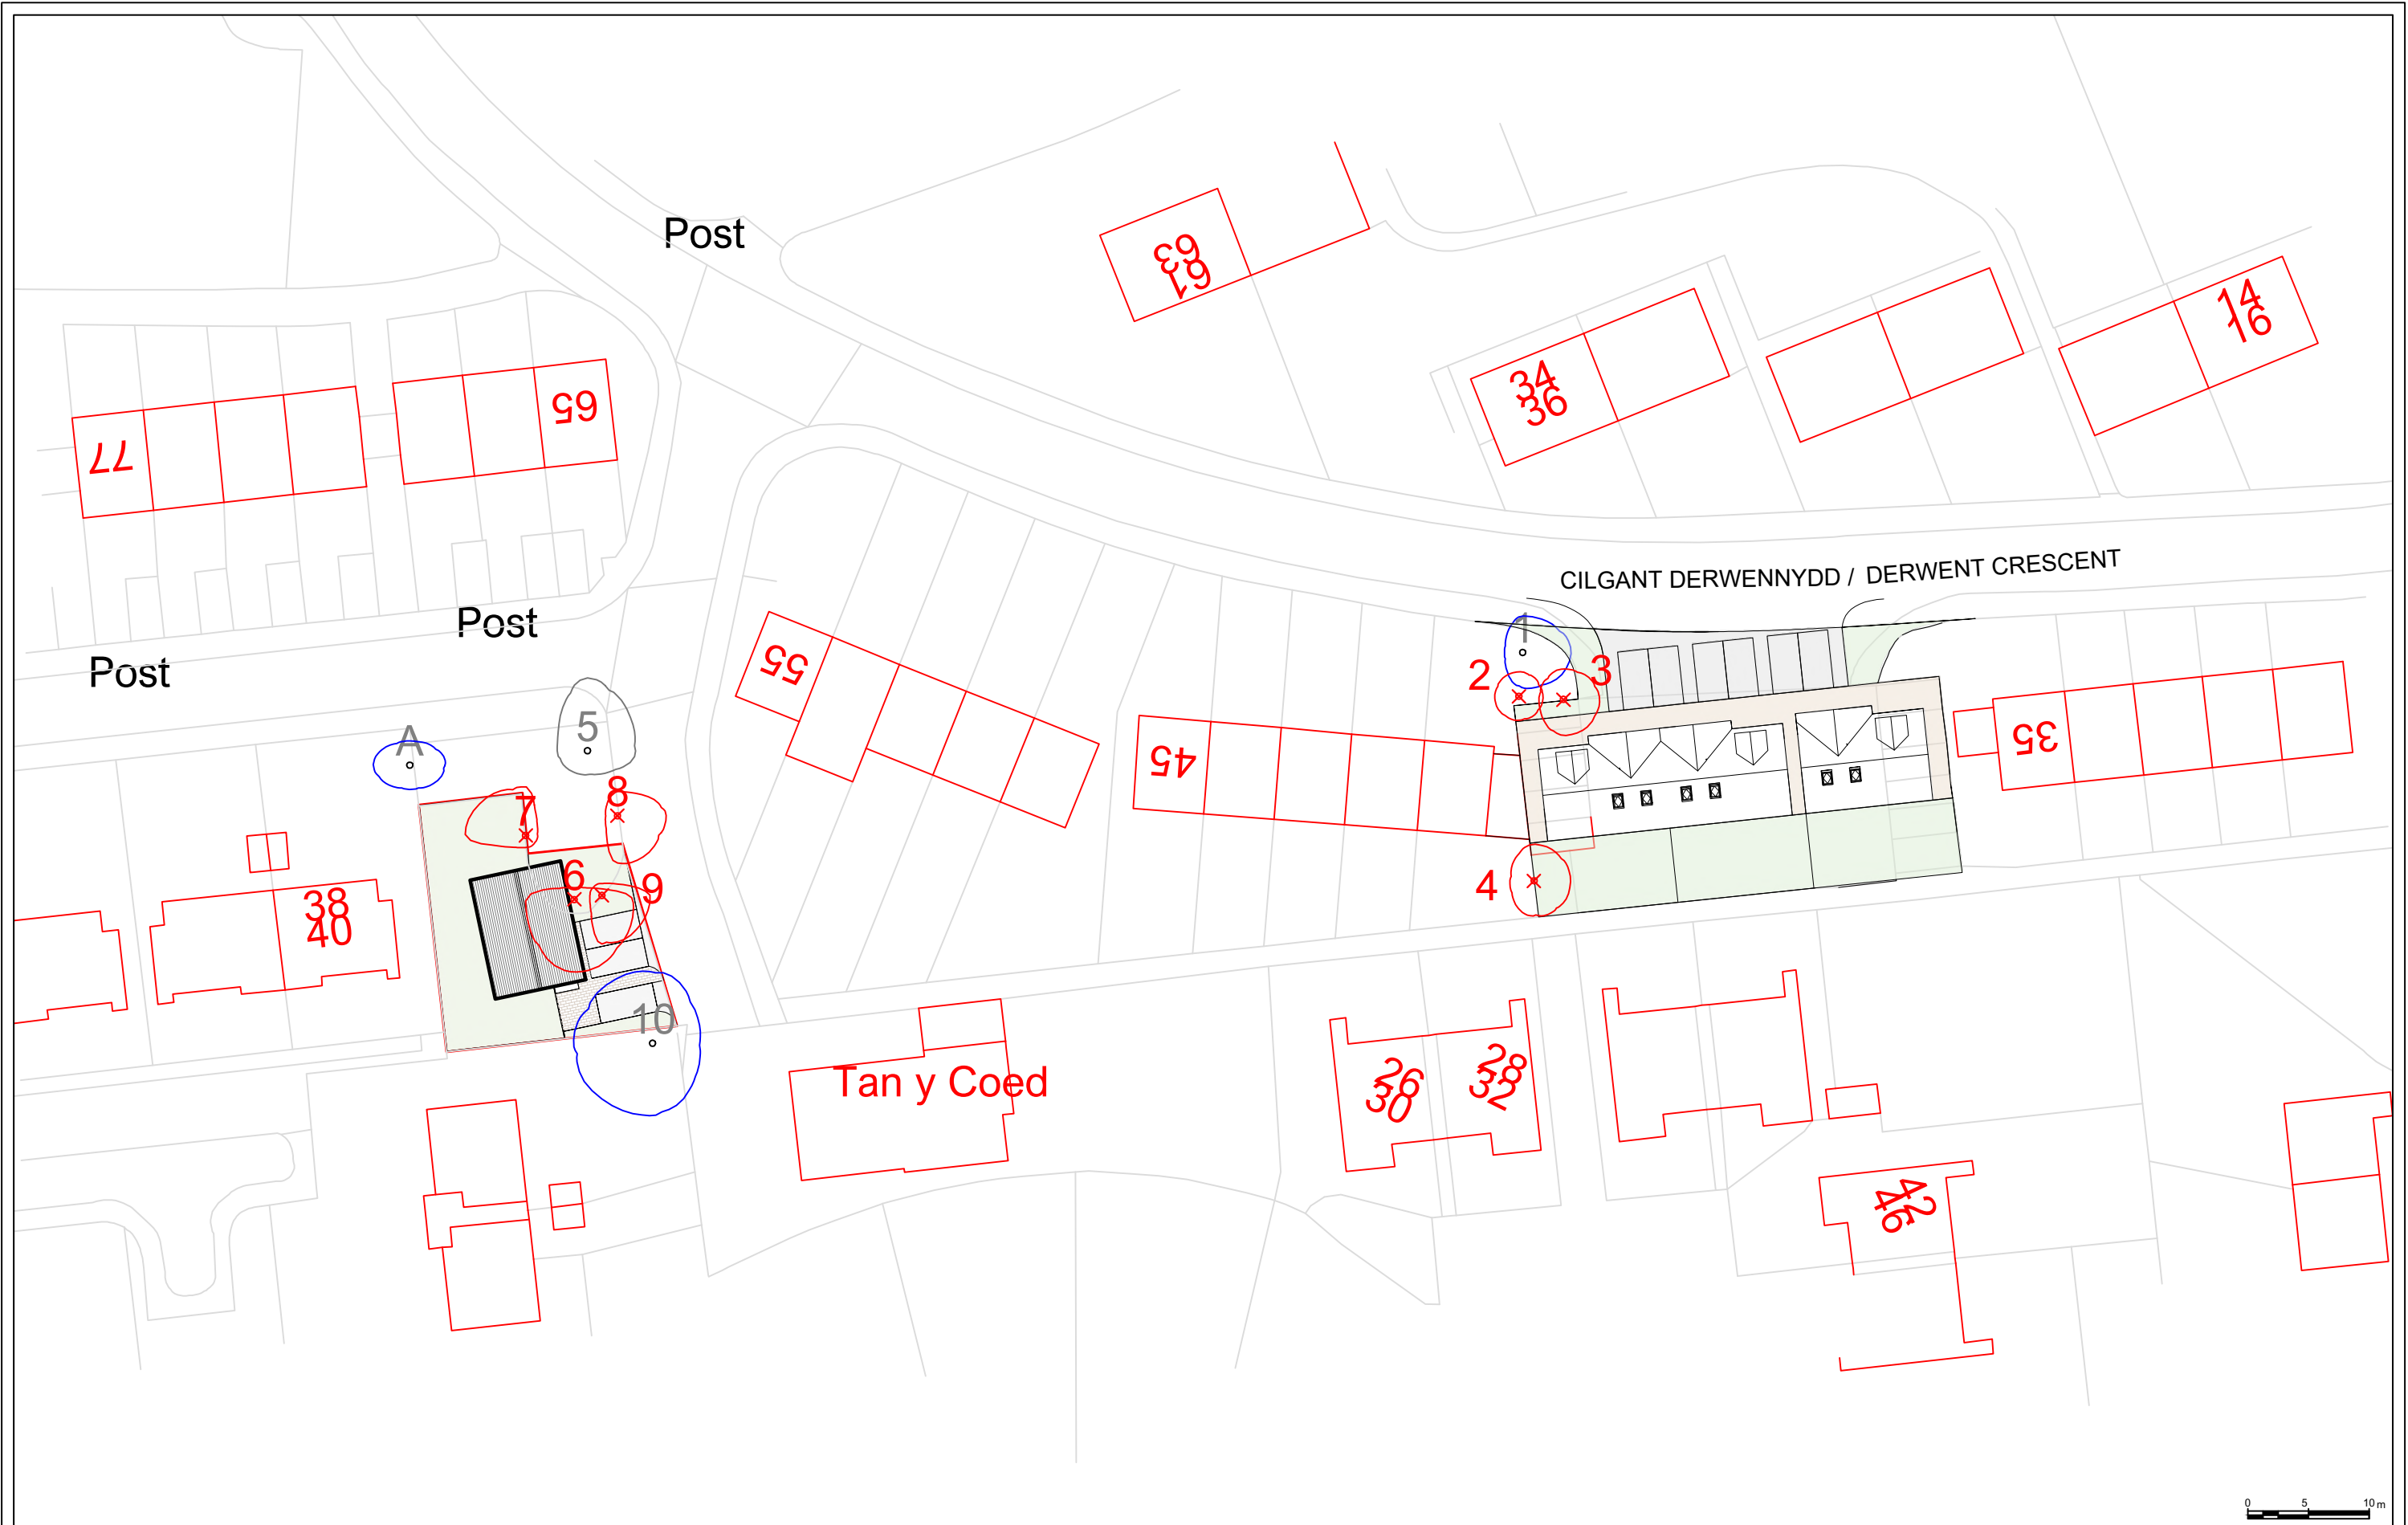
Drawing: SR2 Tree Removal  
Scale: 1:500 @ A3  
Date: 09.09.2021

- 6.2.1 The development proposals require the removal of Tree 6 shown on SR2. The removal of Trees 2,3,4 7,8 and 9 is also proposed. Although these trees could be protected through development, they are all poorly formed trees which make little contribution to local amenities. If retained, they are likely to become a nuisance to occupiers of and neighbours to the proposed development. Their removal provides an opportunity to replace them with better quality trees. Table 1 identifies the trees whose removal is proposed and the reasons for their removal.

Table 1 Trees identified for removal

| Tree number | Species | Reason for removal |
| 2 | Sycamore | Multi-stemmed growing from base of garage |
| 3 | Sycamore | Multi-stemmed growing from base of garage |
| 4 | Sycamore | Multi-stemmed, poorly formed, growing through hedge |
| 6 | Crack Willow | Poorly formed, basal decay, overlapped by development proposals |
| 7 | Crack Willow | Poorly formed, basal decay |
| 8 | Crack Willow | Poorly formed, cavities with decay. |
| 9 | Rowan | Poorly formed growing through crown of neighbouring tree. . |

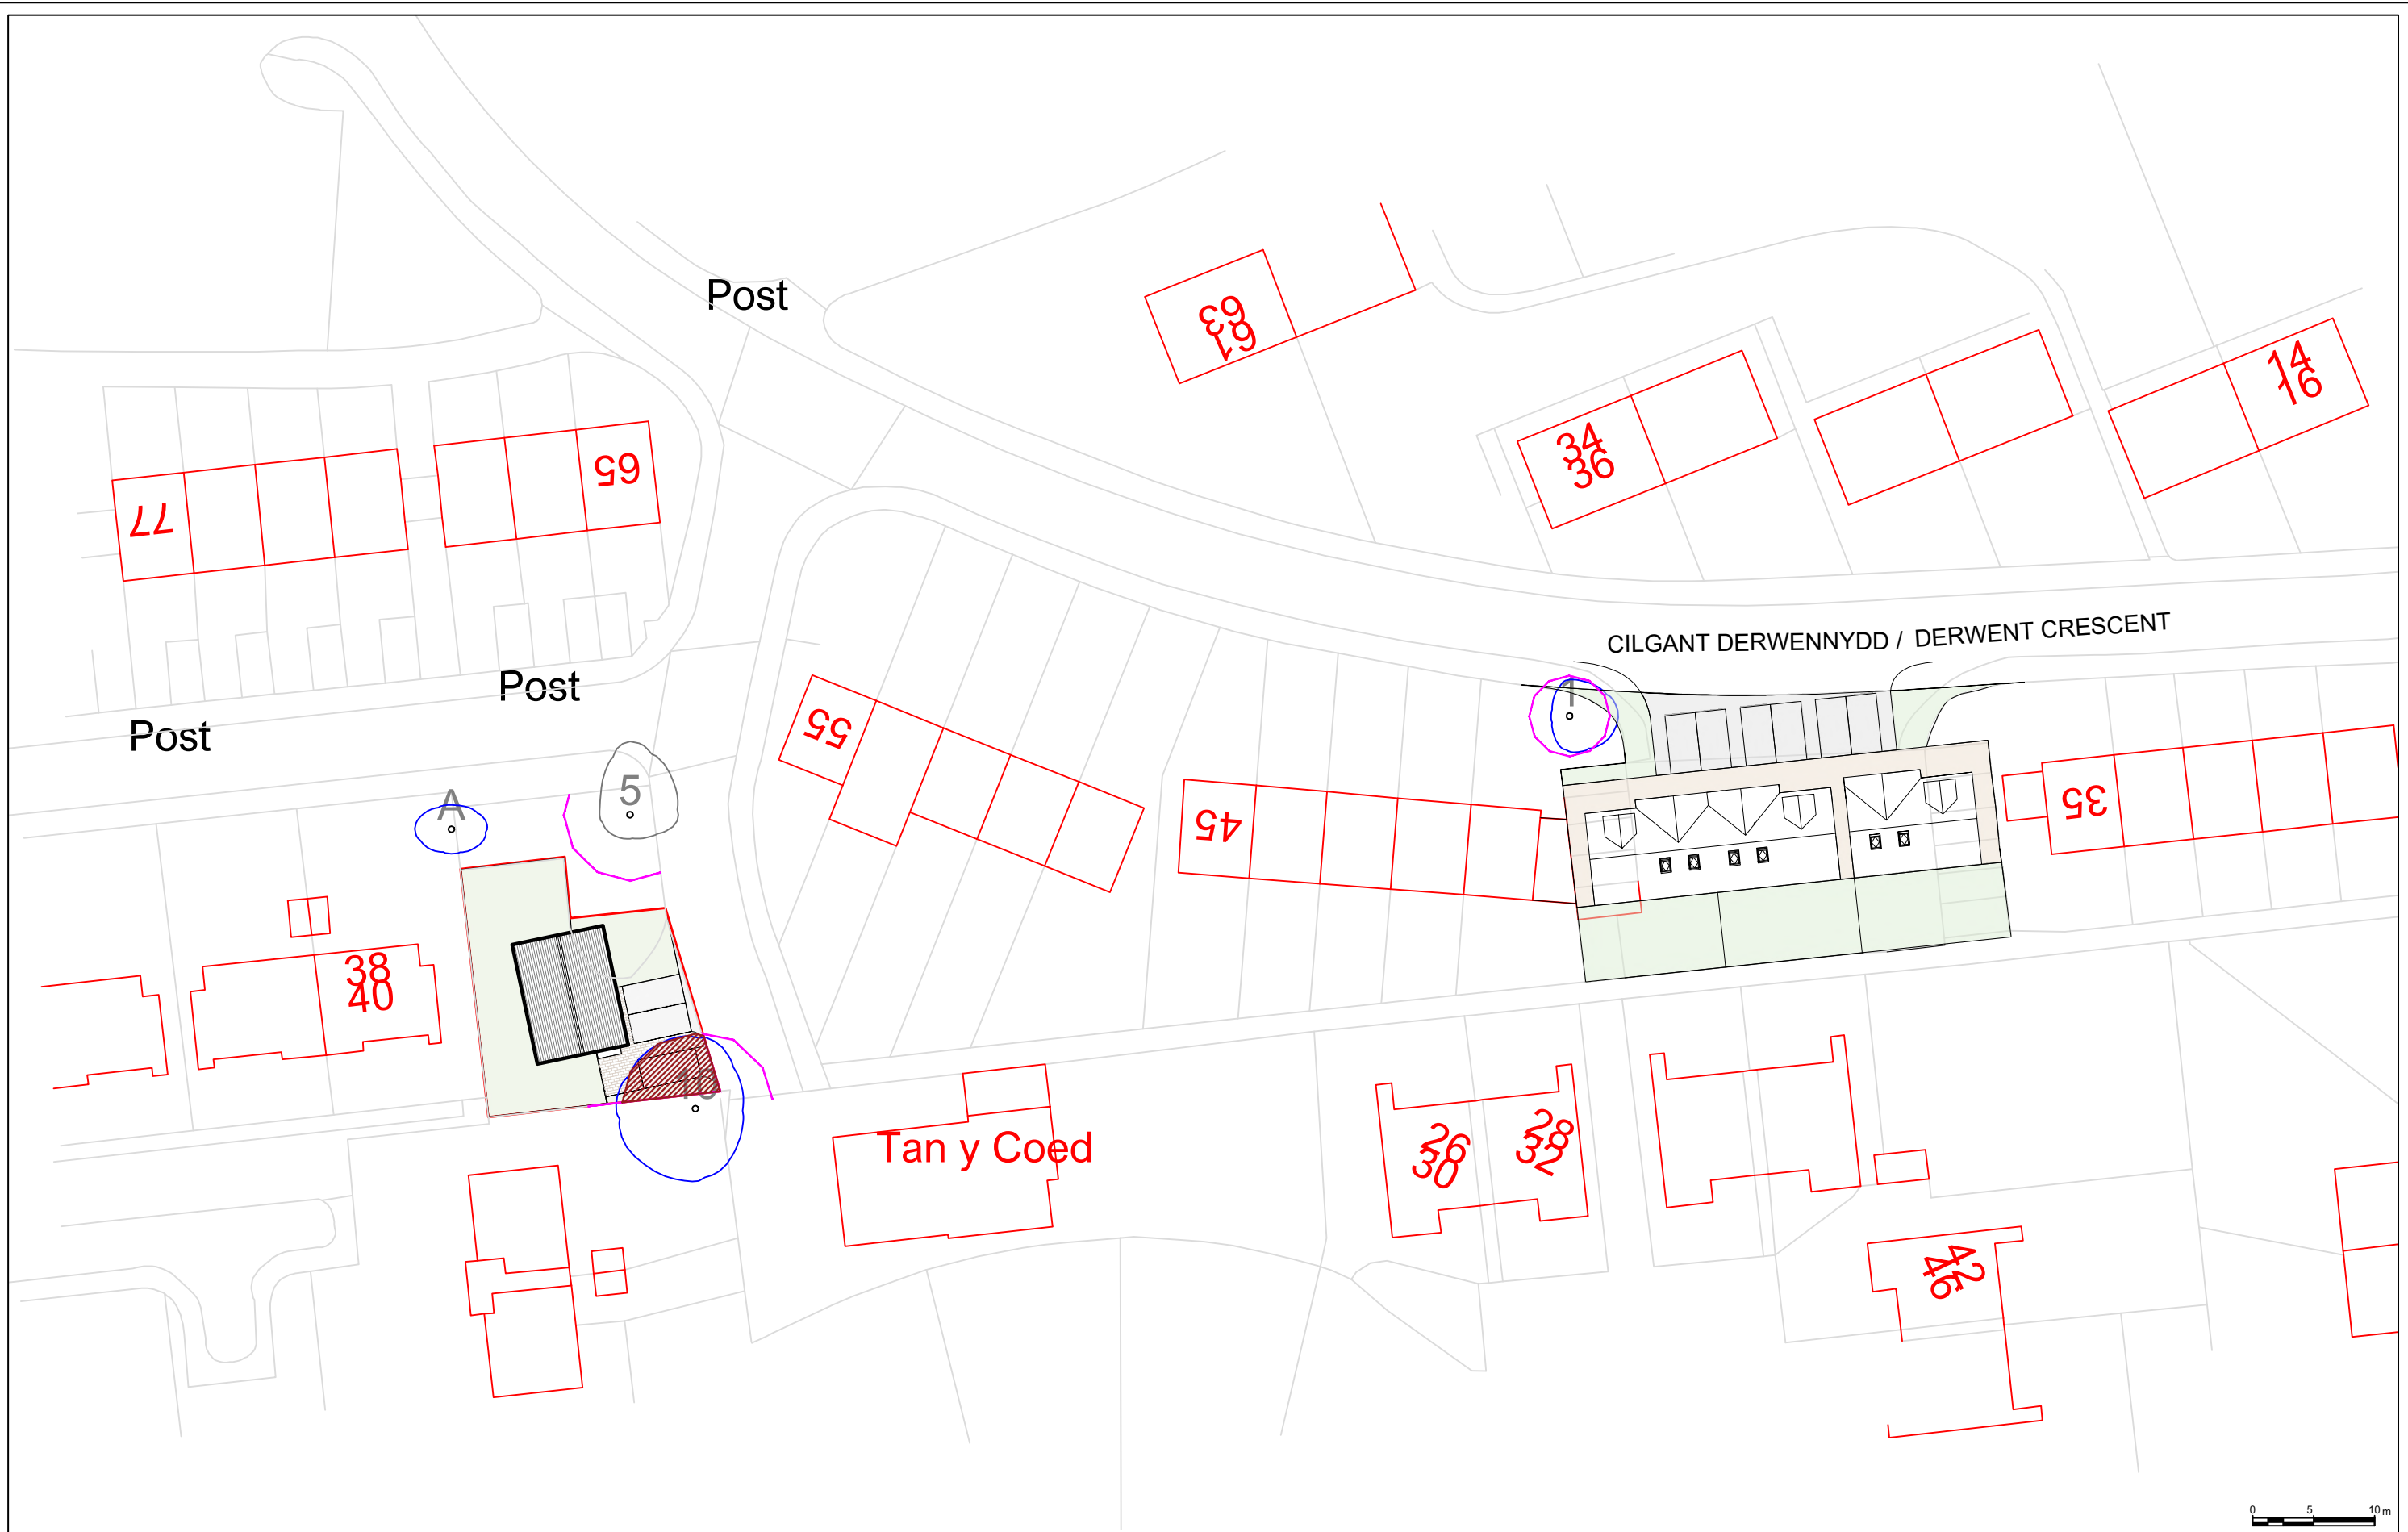
- 7.3 SR3 indicates that the RPA of an Ash tree identified on this plan as Tree 10, will be overlapped by development. The extent of overlapping is indicated on this plan by brown hatching. The affected area is already covered by a hard surface of concrete. Levels above the existing concrete may be raised, but they cannot be reduced below the base of the slab. The slab may be broken and lifted by machines working outside the affected area or off

retained sections within it. The exposed ground below the slab shall be left undisturbed. If it must be crossed by plant and machinery, it shall be protected by installing heavy duty Eve Trakpanels over 100mm of bark mulch laid over a geotextile membrane. This protection shall remain in situ until a new surface is laid. Since the segment of the tree's RPA which is overlapped by the concrete slab is already exposed to levels of loading which are unlikely to change post development, I do not consider that it is necessary to install ground protection if the existing slab is removed and replaced.
