REF: 2520/PB/CARepLet/mjs

## **HILLCROFT, PENTRE BYCHAN: FOUNDATION DESIGN**

## **HILLCROFT, PENTRE BYCHAN: MINING INVESTIGATION**

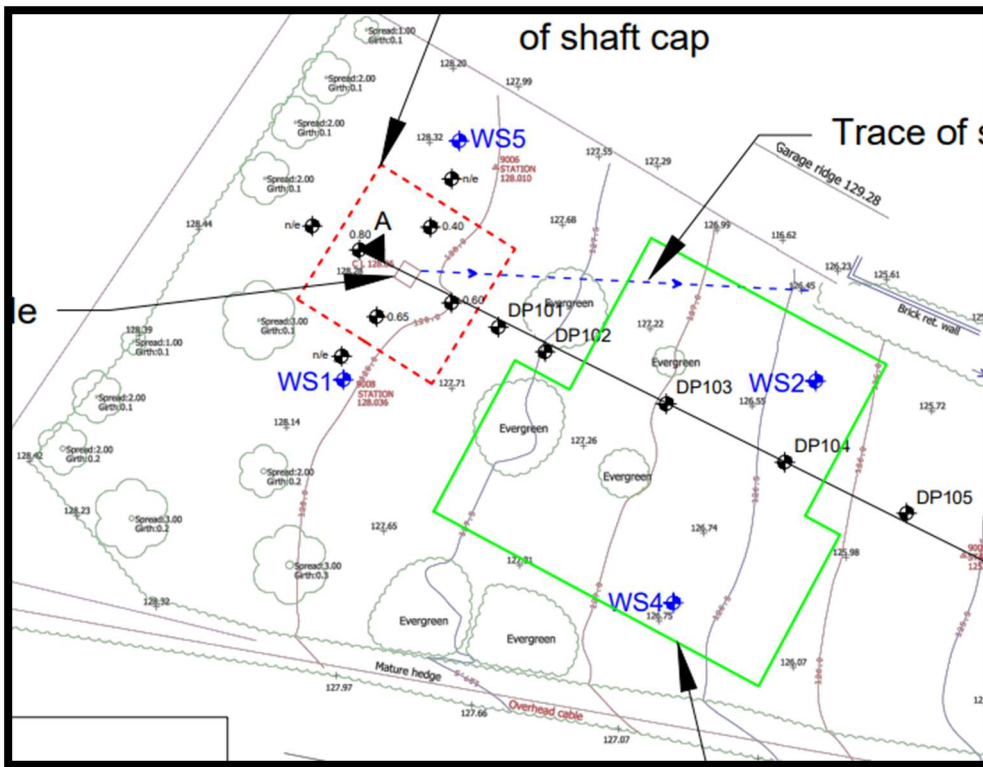
**Figure 1 Location of Proposed House and Shaft Cap**

It is proposed to construct a detached bungalow on site, with the proposed layout presented in Figure 1 below, which also shows the location of the shaft cap.

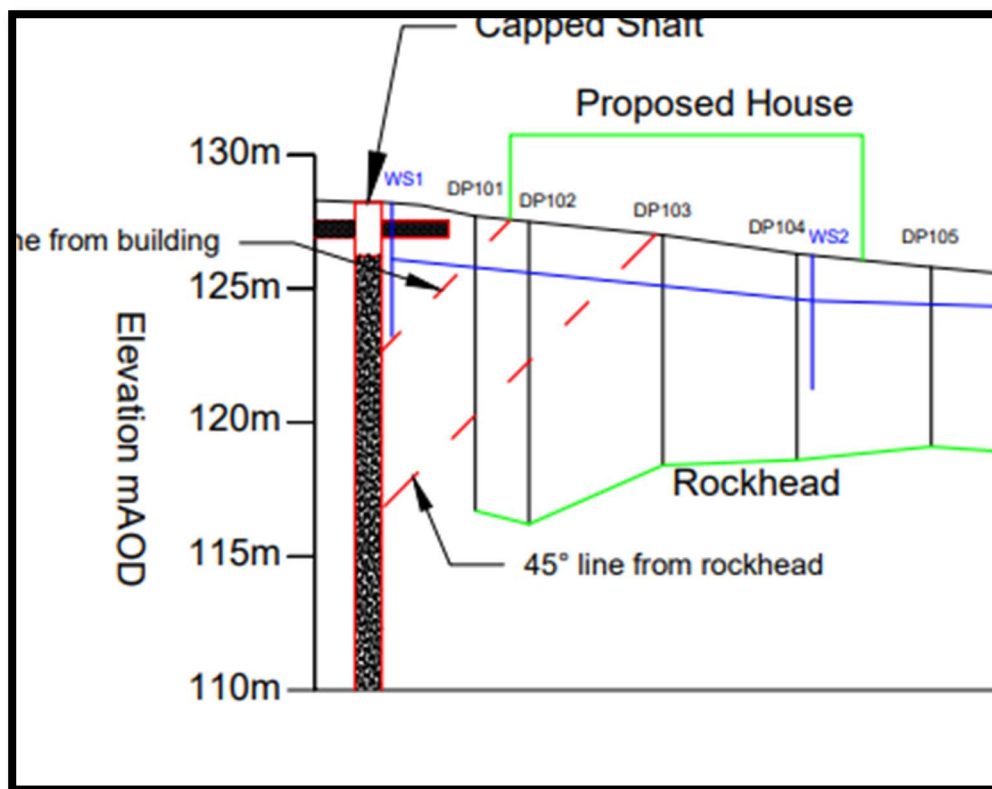
**Figure 2 Cross Section through the site**

When assessing a safe distance from a shaft the CIRIA guidance is typically followed, which assumes a 45° failure envelope through the overburden from bedrock, see Figure 2. This reveals that the 45° line from bedrock intersects the edge of the property at a depth of 6m.

A reasonably conservative  $\phi$  value for a firm to stiff clay would be 30°, which then gives an angle of repose of 60° which then reduces the influence on the property to 2m, from 6m.
