# Heritage, Design and Access Statement | Hollybush Cellar Restoration

## 1.0 Introduction

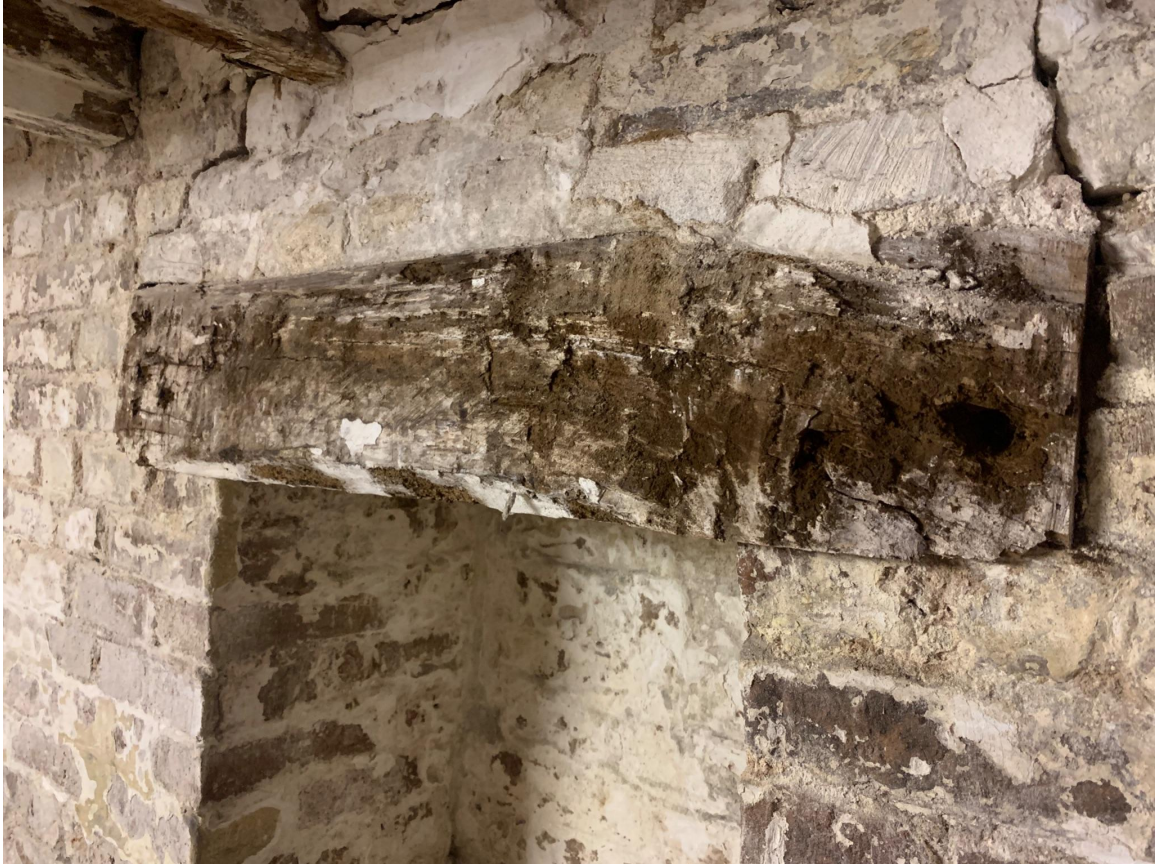
Prior to our acquiring of the property, the timber structure in the cellar had been wrapped with a synthetic, non-breathable “Rockwool” insulation for approximately 20 years. This was an apparent attempt to insulate the above room from the cold of the cellar during winter. However, the synthetic insulation coupled with poor ventilation resulted in trapped moisture close to and around the existing timbers. Furthermore, the timbers themselves have been seated directly onto brick without any means of isolation. Both of these conditions have accelerated the damage to the timber lintels and joints resulting in the need to undertake repairs.

*Figure 1 - Existing deteriorated condition of timber lintel*

The two rotten timber lintels in the North and West walls - as shown in blue on Figure 5 - will be replaced with new concrete Spanlite lintels of the same dimension as the existing timbers. The wall above the lintels will be secured using two acrow props with strongboys using timber boards to protect propping surfaces, the existing timber material will be removed and the concrete lintel will be inserted into the cavity. The lintel will be packed to ensure a tight fit prior to the props being removed.

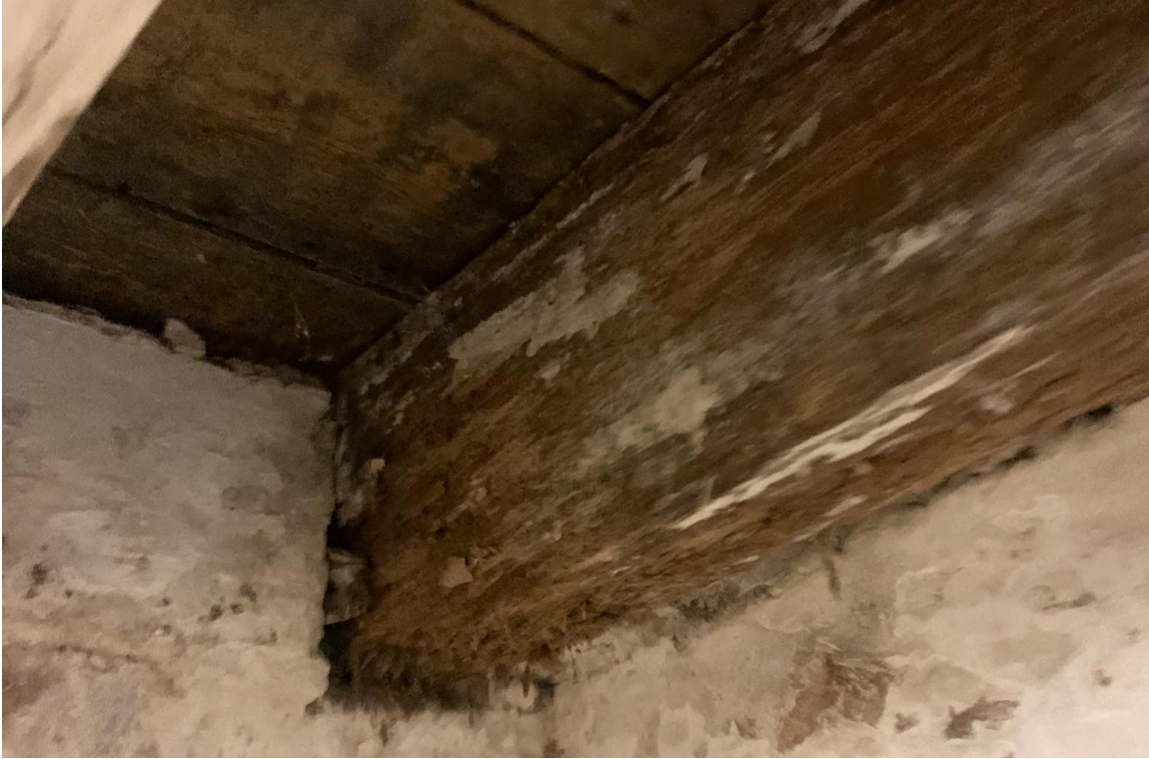
*Figure 2 - Existing condition of deteriorated timber joists sitting directly onto brick*

Small sections of the joist need to be replaced - as shown in red on Figure 5. Having reviewed with our builder and architect, replacing the full length of the joist is not a viable approach owing to the nature of the space and the requirement to position full span timbers into the wall. Additionally, the basement walls are sub-ground level and will always be exposed to varying degrees of damp. We would like to take this opportunity to isolate the timber from the brickwork and avoid further damp issues in the timber ends in the future.

The existing joists will be secured using an acrow prop at a point unaffected by damp utilizing timber boards to protect propping surfaces. The rotten sections of timber will be removed and new pieces of structural timber will be fitted alongside the existing joist, secured to the timber with through-bolts and to the wall using joist hangers - details shown in Figures 6 and 7 below. The proposed approach will remove all contact of wood on brick, thus ensuring the repair lasts much longer than the existing condition.

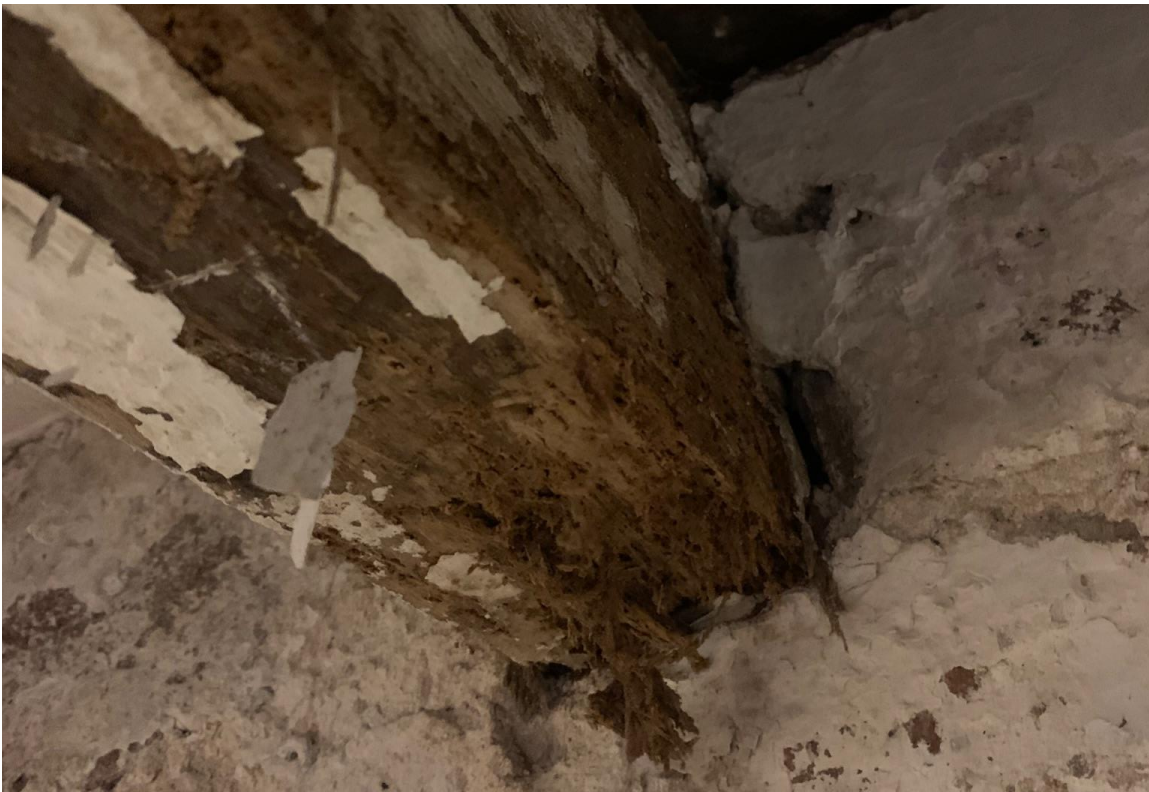
*Figure 3 - Additional image of existing joist condition*

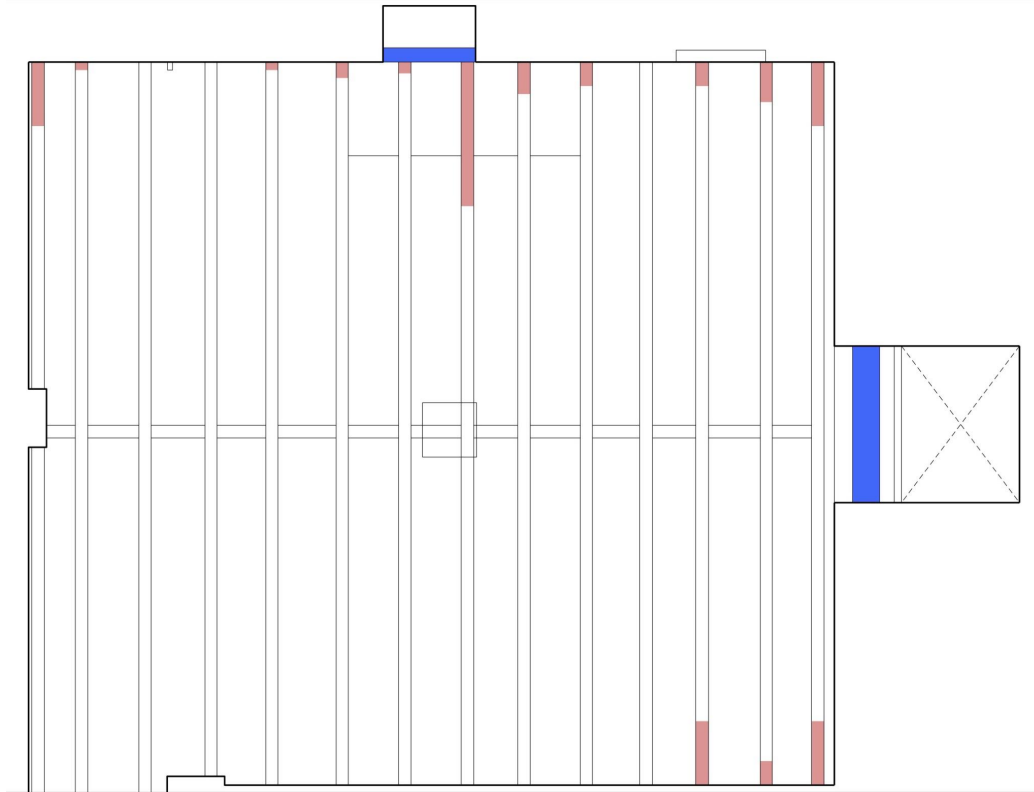
*Figure 5 - Position of deteriorated lintels (blue) and joists (red)*

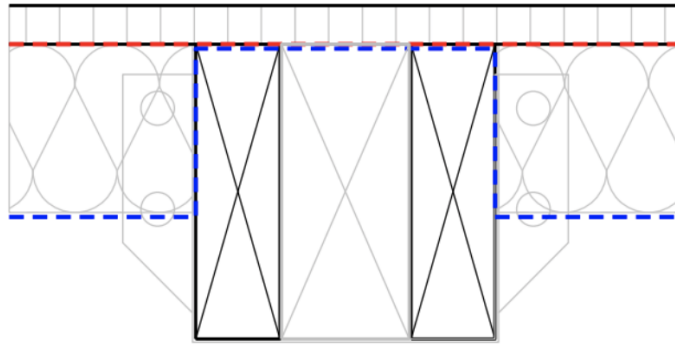
*Figure 6 - Proposed joist hanger detail*

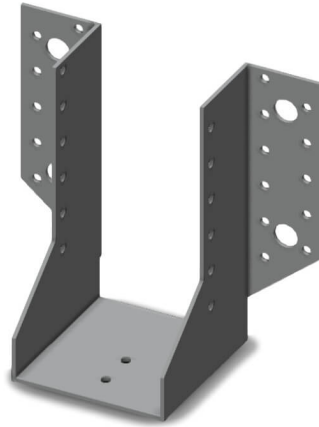
*Figure 7 - Proposed joist hanger*

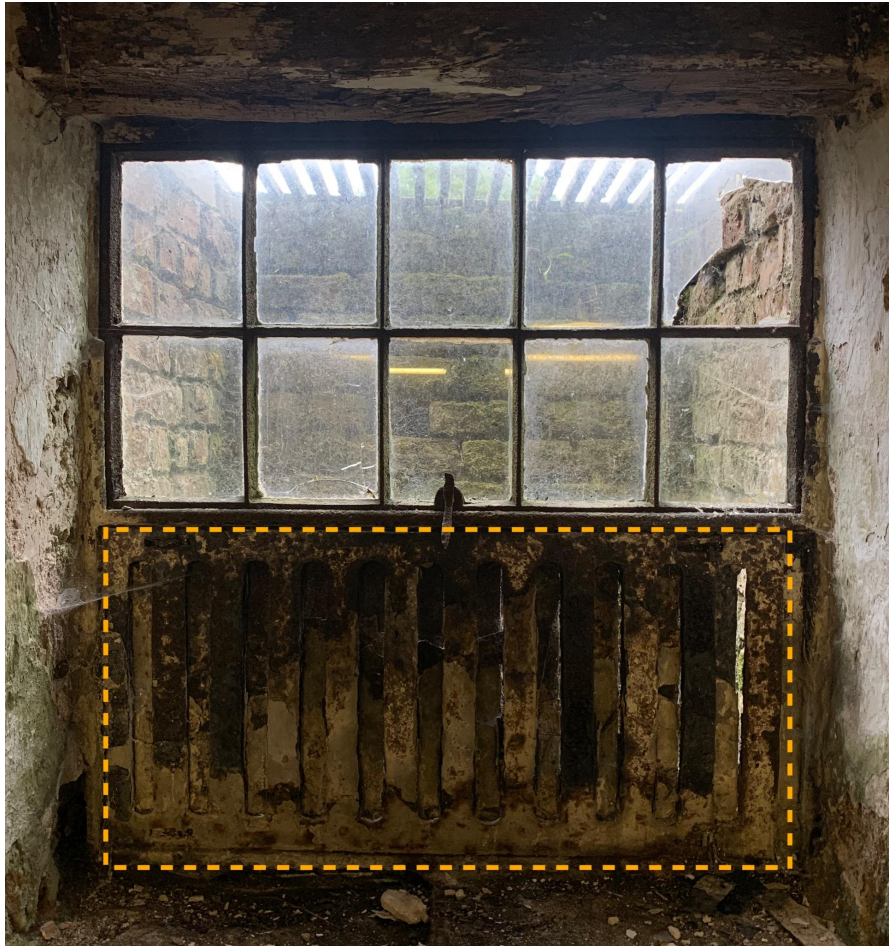
Inspection of the iron framed window in the cellar has shown the window surround to be in fair condition, however the hit-miss vent below the glass has delaminated and is resulting in significant moisture ingress during heavy rain. The existing condition can be seen in Figure 8.

*Figure 8 - Existing condition of small-paned iron framed window in cellar*

We intend to carefully remove by hand the delaminated and ineffective section of window - as shown marked in orange on Figure 8 - restore the frame by removing any loose oxidized areas, and, when dry and sound, repaint. The two broken panes of glass will be replaced with like-for-like single pane glass.

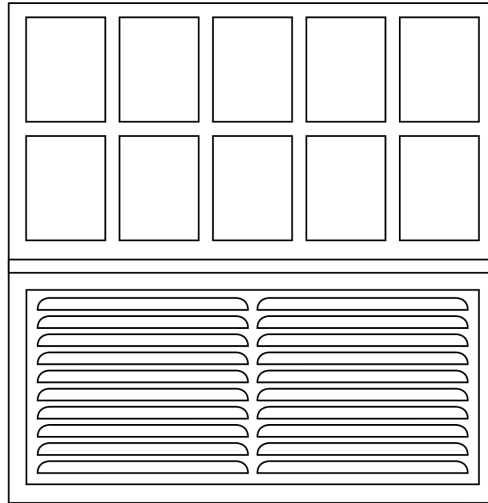
*Figure 9 - Detail of proposed lowered panel*

The delaminated hit-miss section will be replaced with a custom manufactured louvered panel as shown in Figure 9. The louvers will be angled outwards to ensure there is no water ingress while maintaining ventilation. The panel will be welded into place and treated in the same method as the frame.

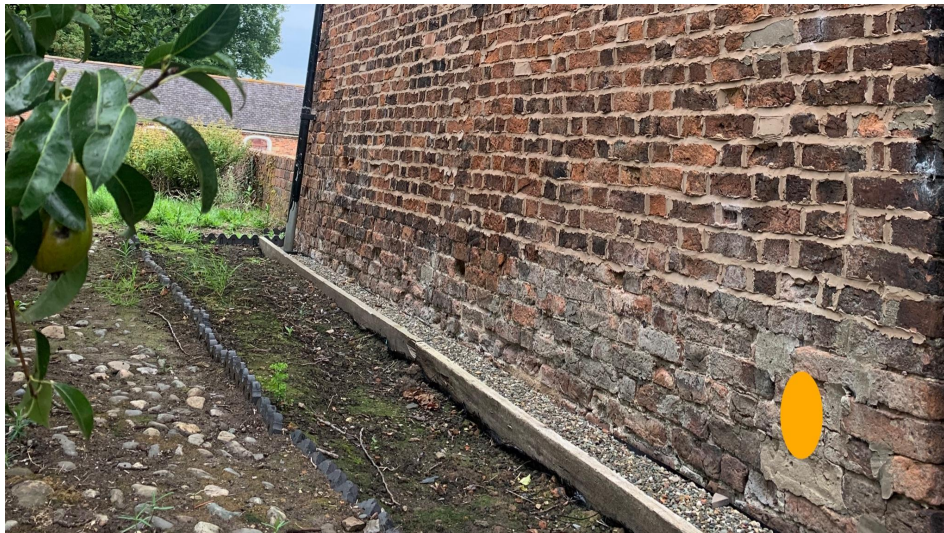
*Figure 10 - Proposed position of exterior vent detail on West Elevation*

We propose to create a small 120mm hole on West elevation - as shown in Figure 10 - and install ducting from the South west corner of the cellar, routing through the timber floor and terminating to the outside wall. The exterior will be finished with a venting cover detail as shown in Figure 11 to minimize visual impact. The ducting will be surface mounted through the room above the cellar and concealed using bespoke timber casework, replicating the existing casework detail in the room. Having received advice from heritage building consultants, a small, moisture-initiated forced air fan to assist with moisture control may be installed in the future - detail shown in Figure 11.
