**Project:** 21\_5837\_01\_25  
**Site:** Ty Nos, Holt Road, Wrexham,  
**Client:** Richards Moorehead & Laing Ltd

| Document Title: | Arboricultural Implications Assessment |
| Project Title: | Ty Nos, Holt Road, Wrexham |

Report no: 21\_5837\_01\_25

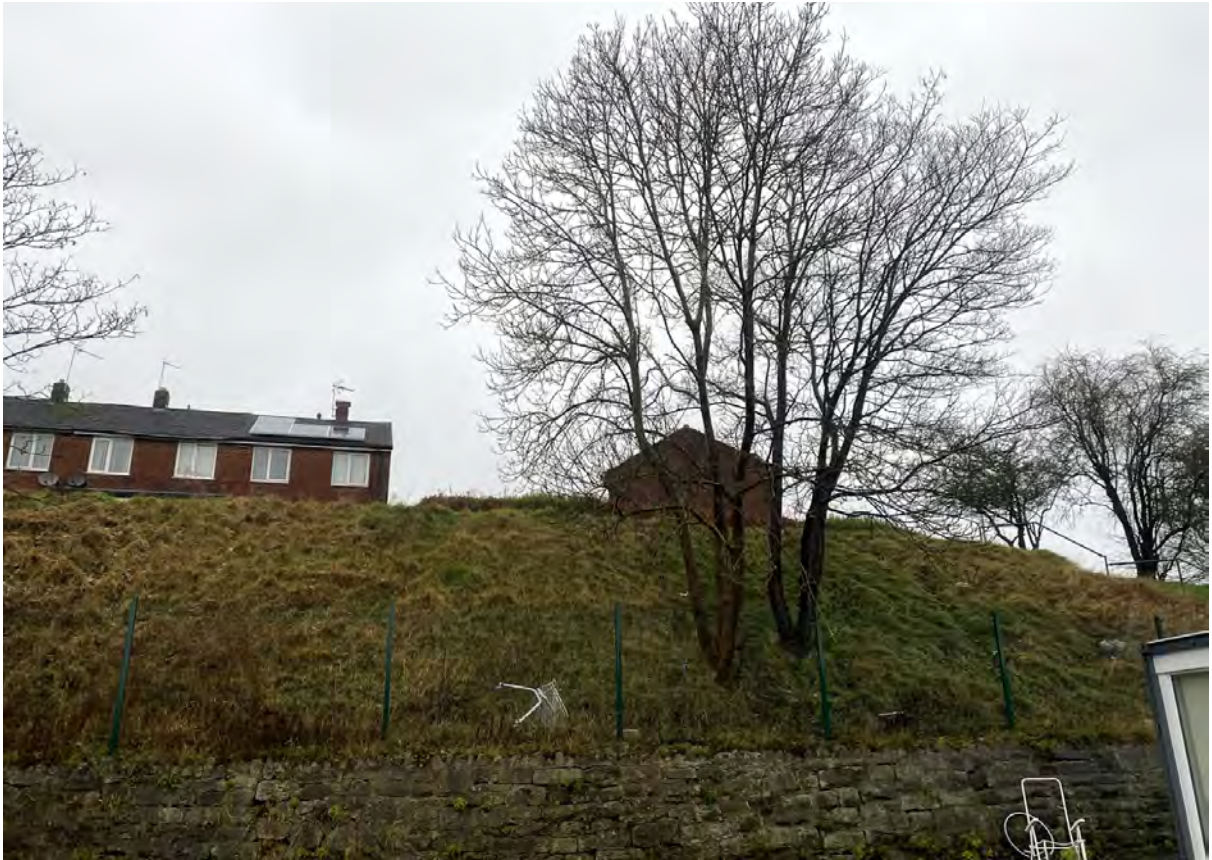
*Photographic plate showing one of the self-set clumps within G1 located offsite.*

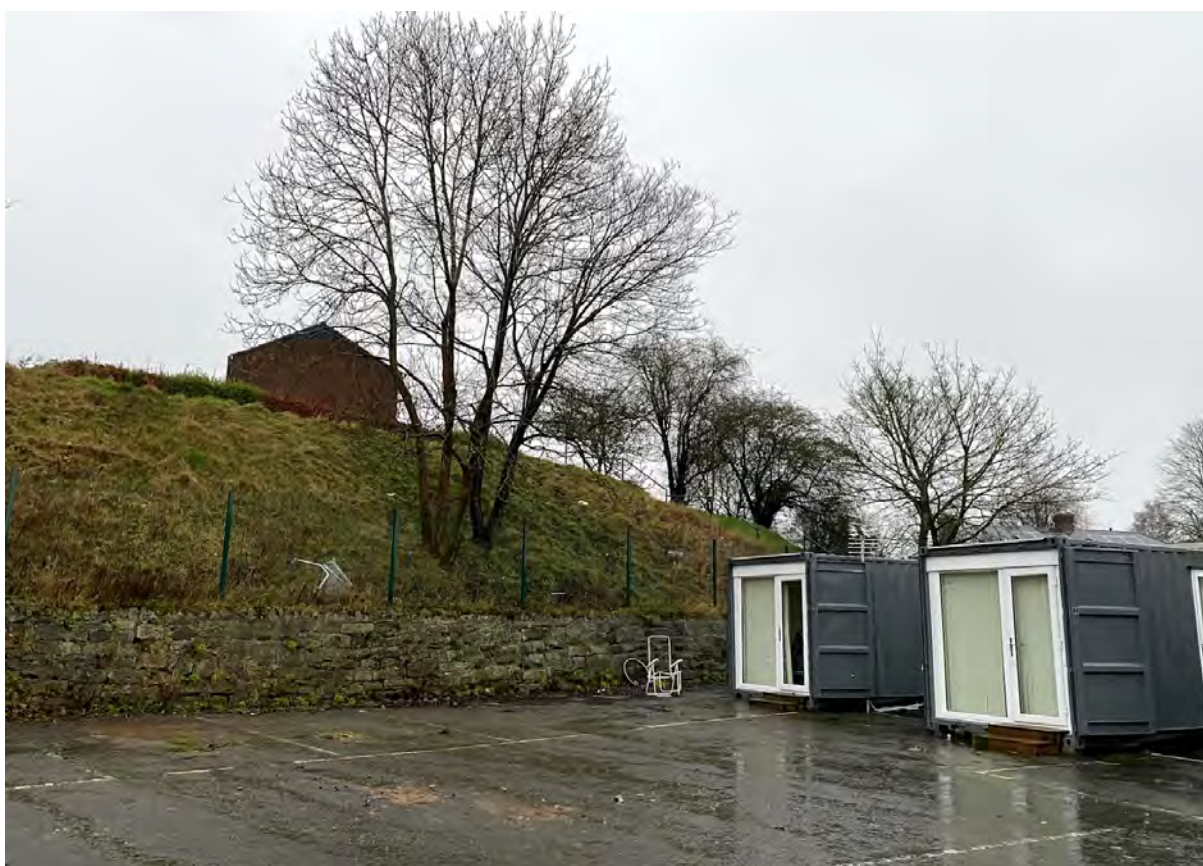
*Photographic plate showing one of the self-set clumps within G1 located offsite.*

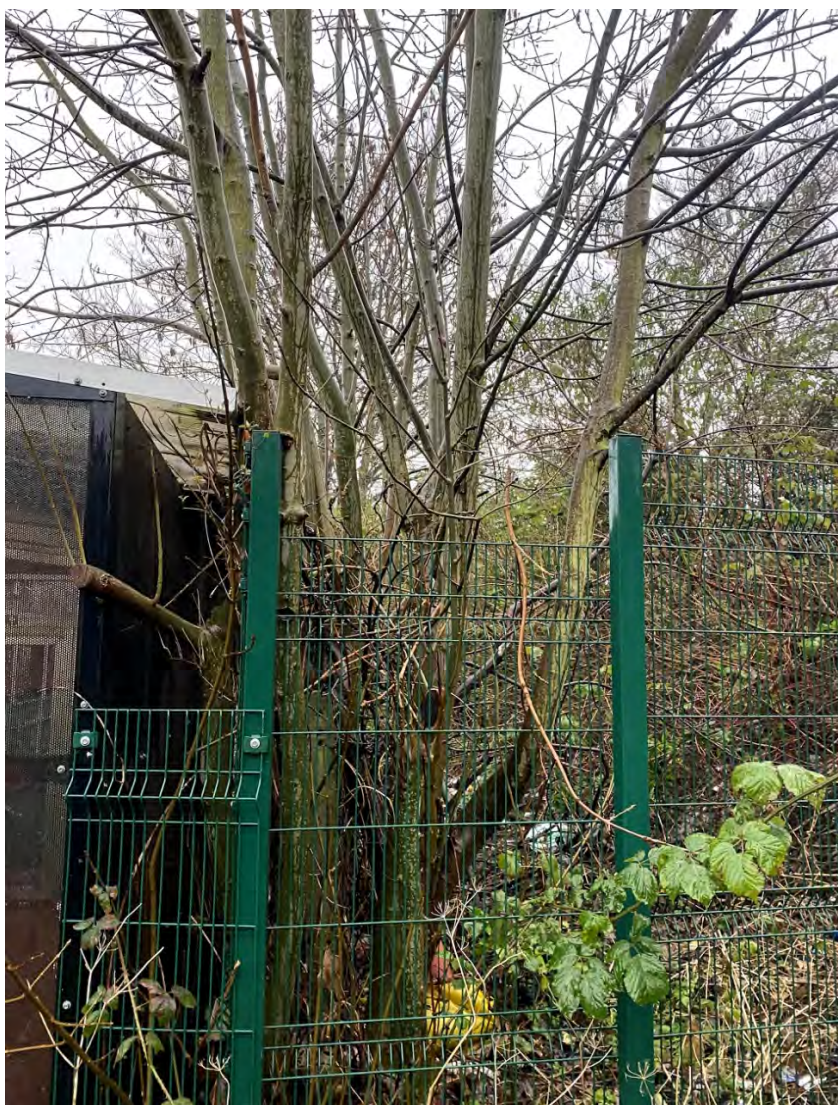
*Photographic plate showing one of the poor quality offsite clumps  
Growing through the boundary fence line.*

- 4.8 The majority of the surveyed trees are low quality self-set natural regeneration. They offer some useful screening but many are impacting the boundary fence lines with partially occluded stems. It is likely many will require removal due to condition within the next ten-years.

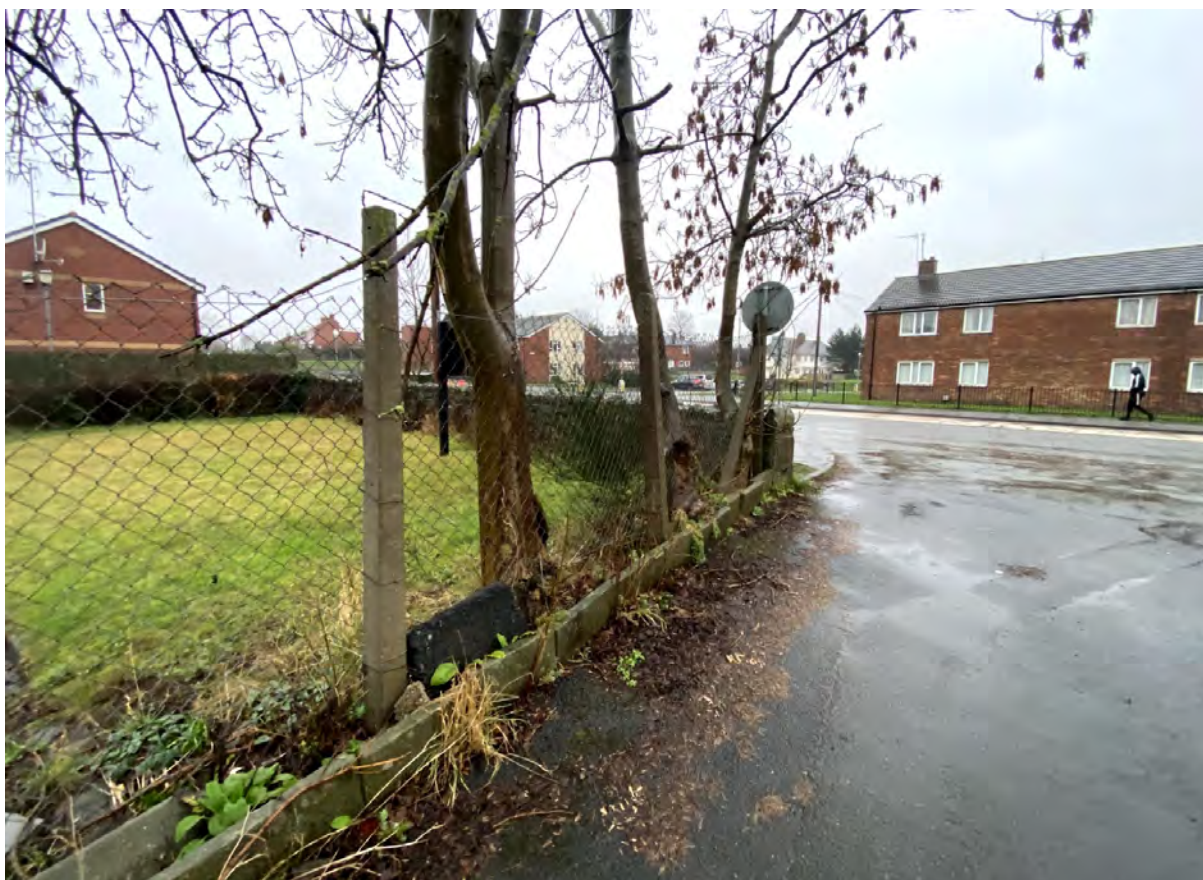
*Photographic plate showing the self-set ash and sycamore growing through the fence at the site entranceway.*

| Tree Number | Species | Age Class | DBH | Height (crown height) | N | E | S | W | Condition | Life Expectancy | Physical Description | Comments | Managment Recommendations | RPA offset from stem. | Category Rating |
|---|---|---|---|---|---|---|---|---|---|---|---|---|---|---|---|
| T10 | <i>Acer pseudoplatanus</i> (Sycamore) | M | 300 | 8(1) | 3 | 3 | 3 | 3 | Poor | <10 | Tree located within hard surface area. Epicormics on stem. Stem divides at ground level. Mechanical Damage. Low branches over road/footpath. | Partially occluded through fence at entrance to the site. | Requires removal | 3.6 | U |
| G11 | <i>Acer pseudoplatanus</i> (Sycamore) | SM-M | 310 max | 7 max | As drawn | | | | Poor | <10 | Poor shape & form. Declining. Tree located within hard surface area. Part of linear group. Major bark wounding on stem. Stem divides at ground level. Mechanical Damage. Low branches over road/footpath. | Partially occluded through fence at entrance to the site. | Requires removal | 3.72 | U |
