# Arboricultural Impact Assessment

| <b>Site Address</b> | Kronospan, Maesgwyn Farm, Wrexham LL14 5NT |
| <b>Proposal</b> | Demolition of the existing reception building and the erection of a building to create a covered loading yard and ancillary works |
| <b>Report Reference</b> | 220224-1.0-AIA-CLYK-T21-MW |

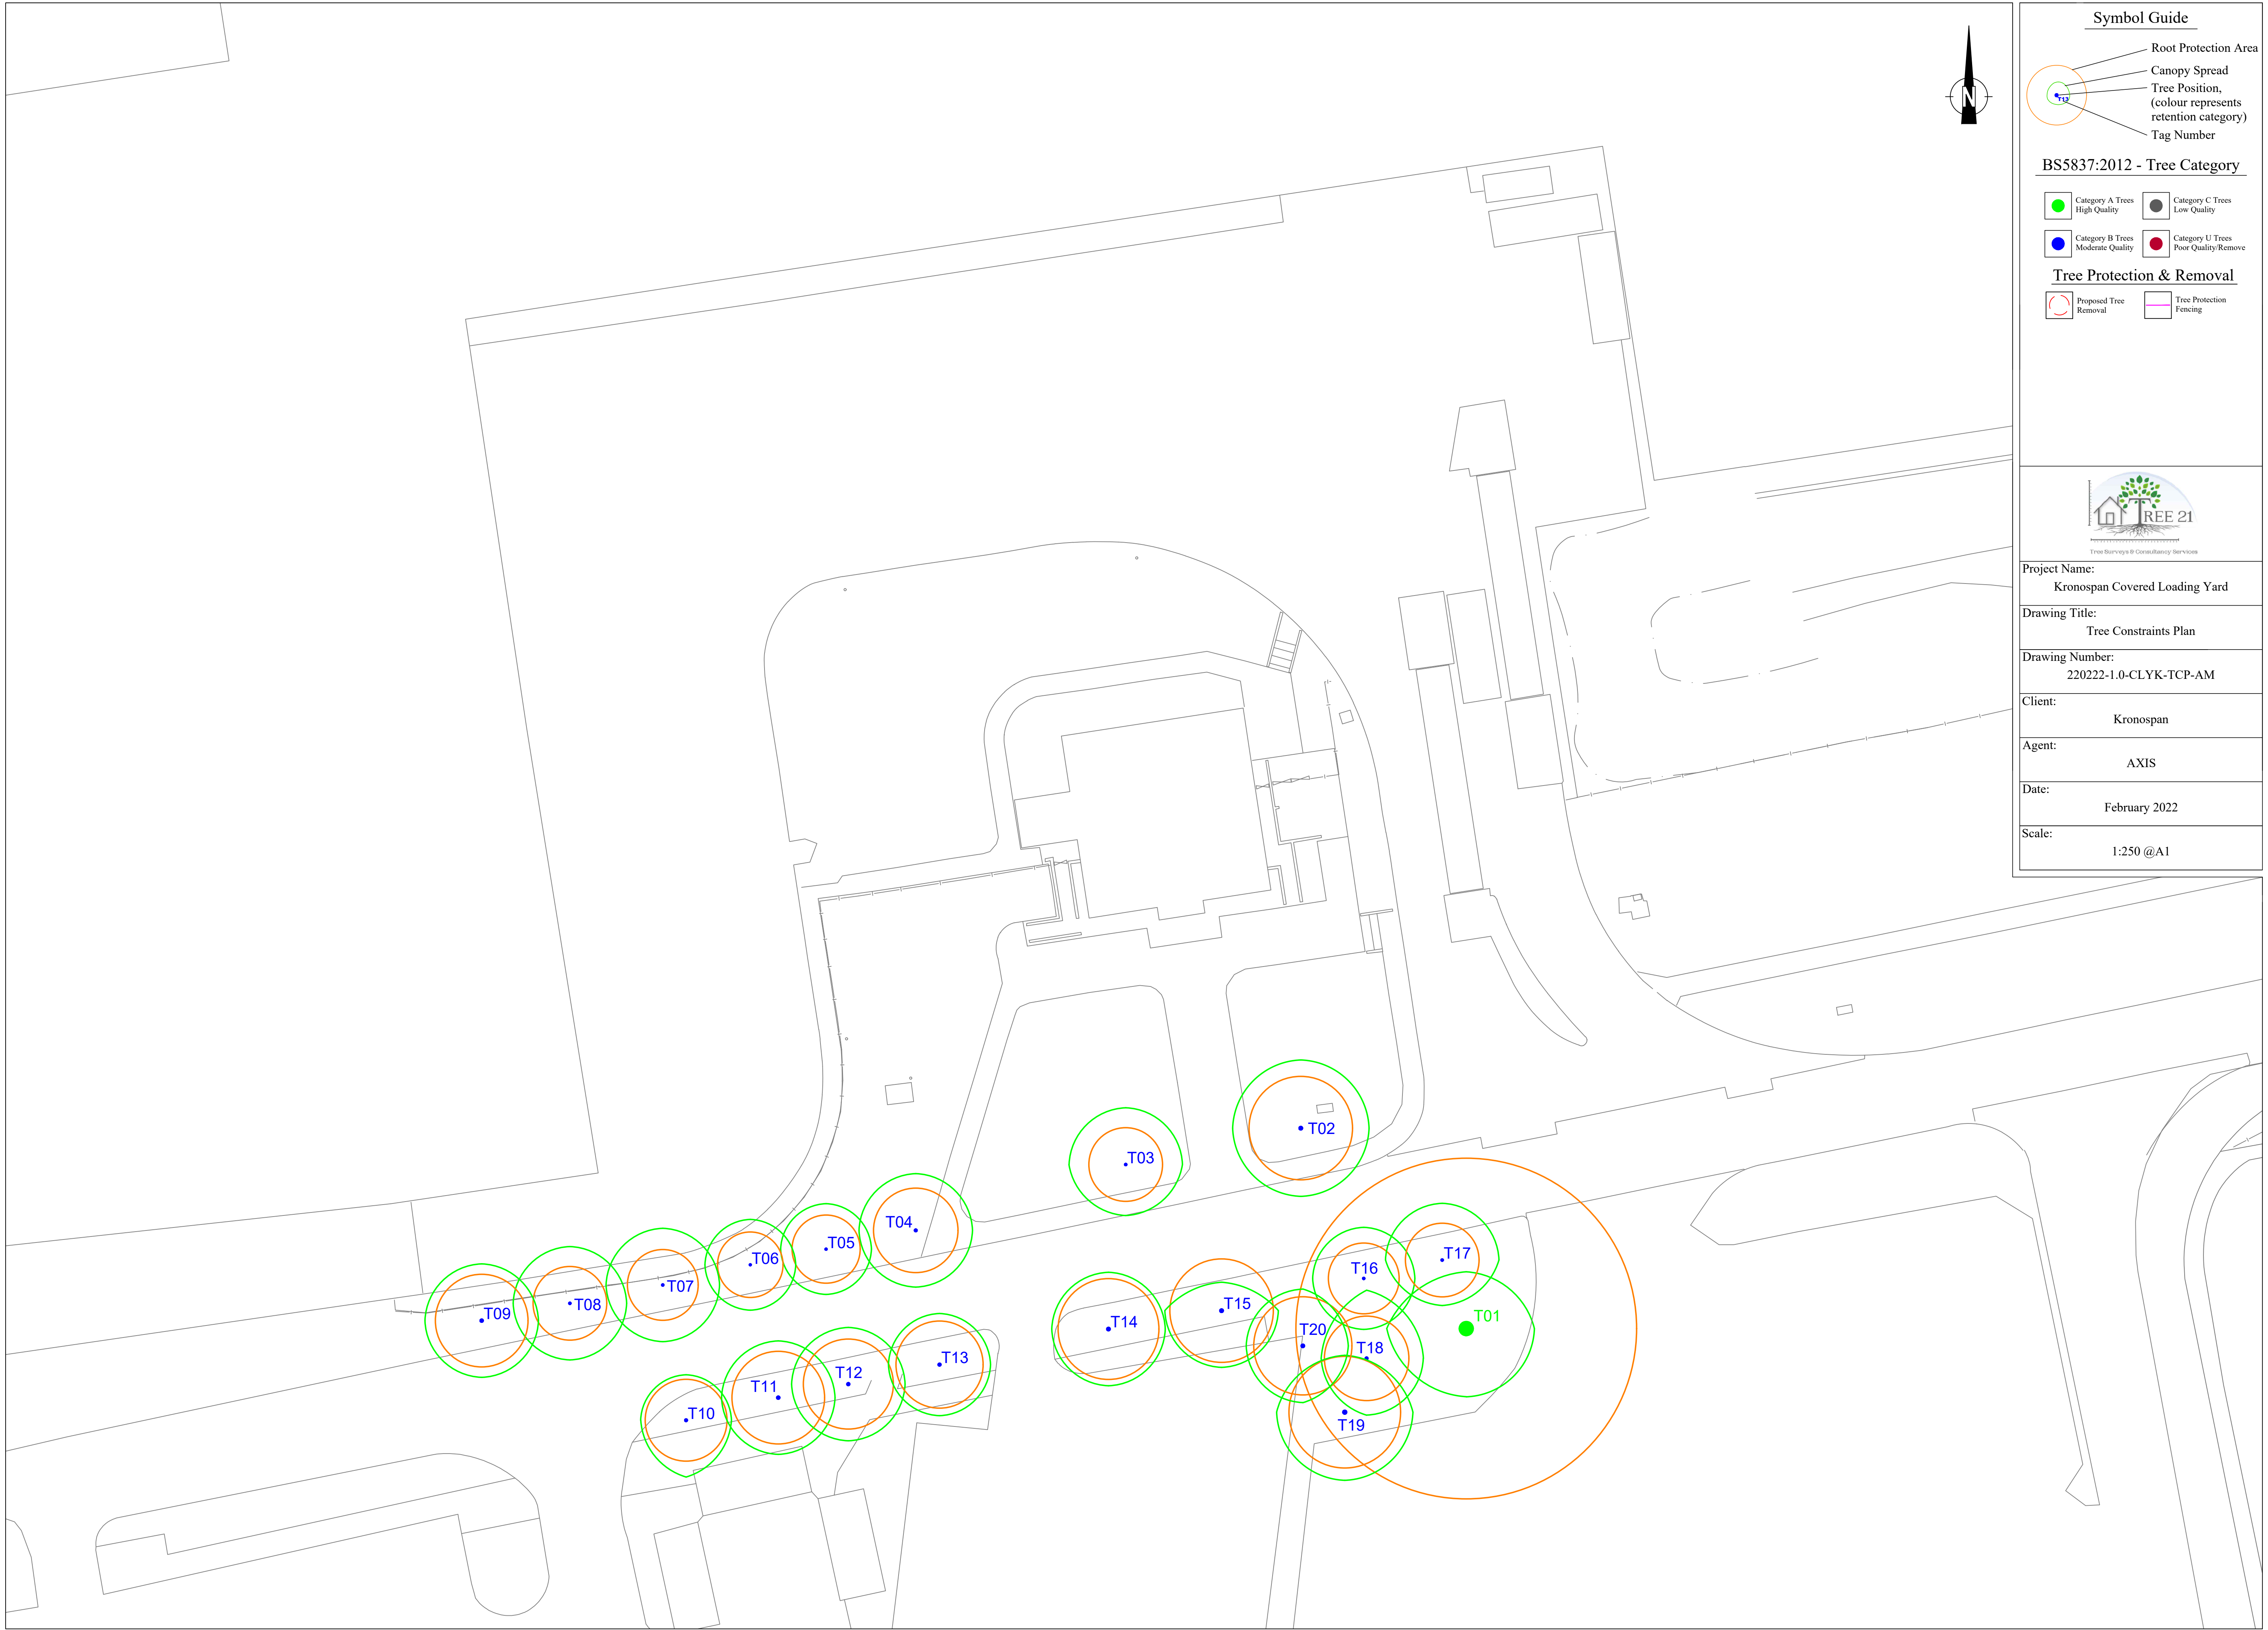
| Drawing Title: | Tree Constraints Plan |

**Plan showing constraints imposed on development layout by trees considered during the design process.**

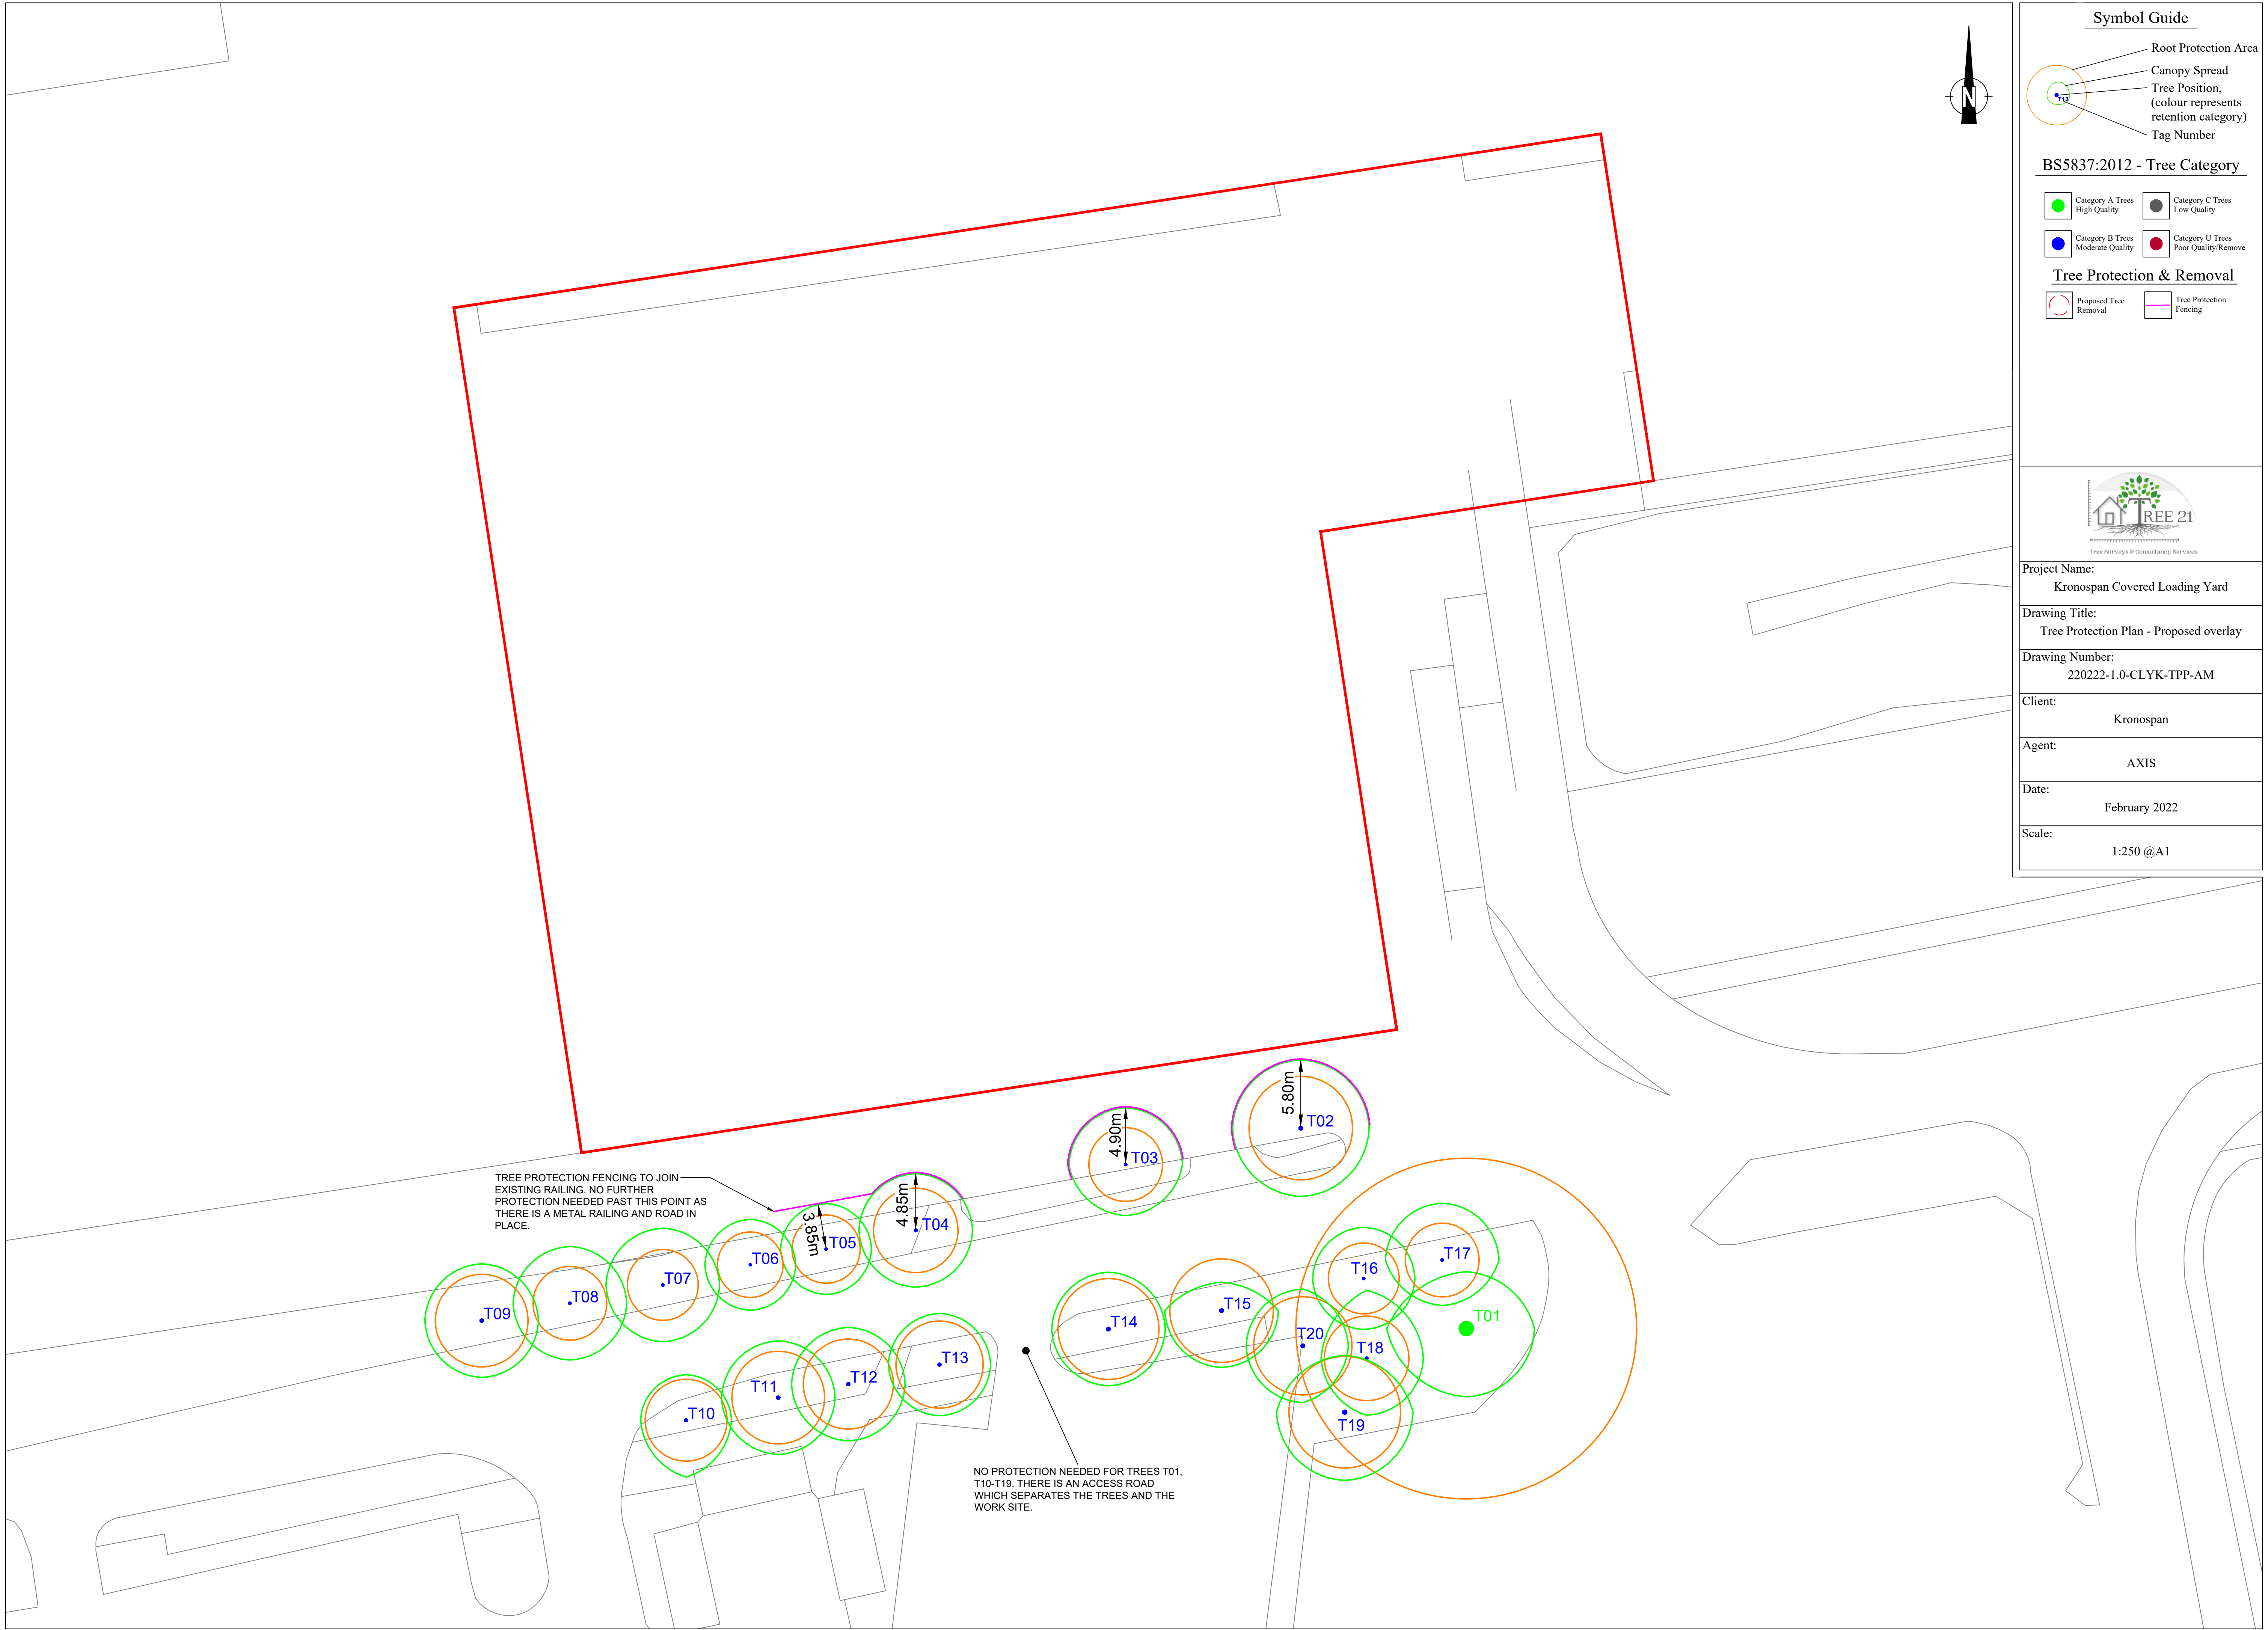
| Drawing Title: | Tree Protection Plan - Proposed overlay |

NO PROTECTION NEEDED FOR TREES T01,  
T10-T19. THERE IS AN ACCESS ROAD  
WHICH SEPARATES THE TREES AND THE  
WORK SITE.

**Plan showing Trees Proposed for Removal and General Arrangement with Notes on Tree Protection.**

TREE PROTECTION FENCING TO JOIN  
EXISTING RAILING. NO FURTHER  
PROTECTION NEEDED PAST THIS POINT AS  
THERE IS A METAL RAILING AND ROAD IN  
PLACE.
