**Project:** 21\_5837\_07\_40  
**Site:** Croesnewydd Road, Wrexham, LL13 7TD  
**Client:** Michael Alderson

| Document Title: | Tree Survey & Arboricultural Impact Assessment |
| Project Title: | Croesnewydd Road, Wrexham, LL13 7TD |

Report no: 21\_5837\_07\_40

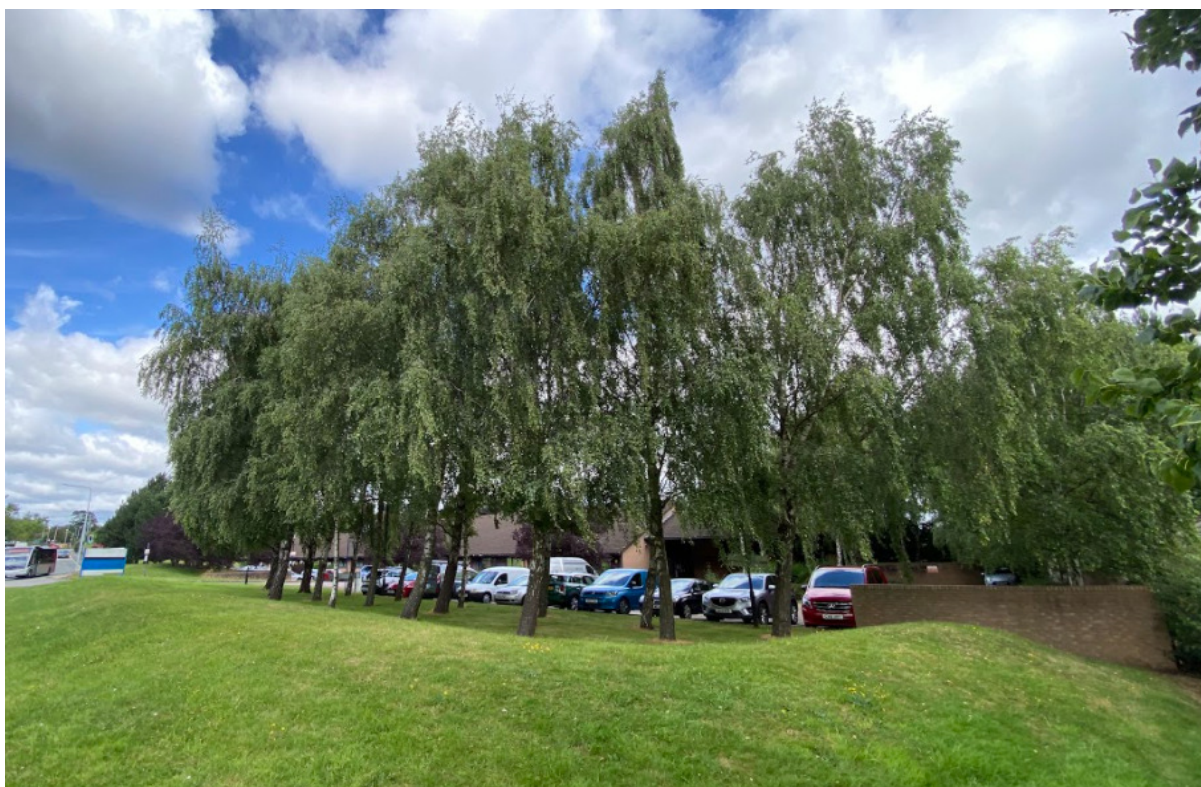
The construction of substations 1 & 2 will require the removal of six Category A trees, as the footprint of the proposed buildings are in direct conflict with the trees. The proposals have been amended to include some alterations to parking and turning areas, which will involve the removal of two further trees.

*Photographic plate showing Category A trees in the proposed location of Substations 1 & 2.*
