## Chapel Farm, Newbridge Road Cefn Mawr, Wrexham

### Bat Report

5<sup>th</sup> August 2022

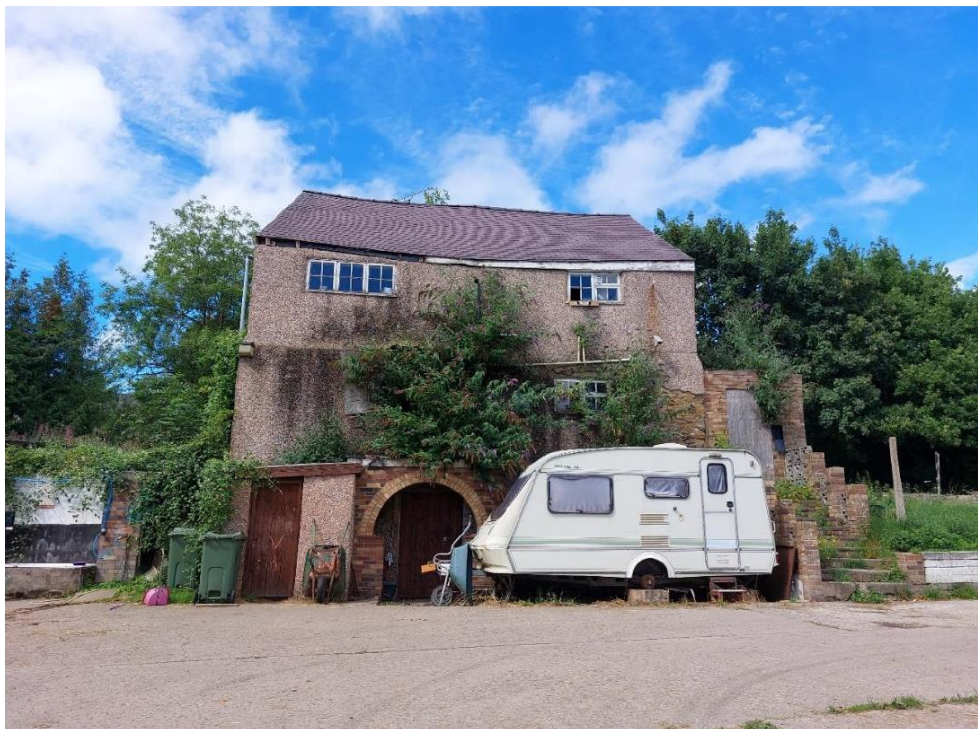
*Photograph 1- South face of farmhouse*

Externally, the building offers some suitable roosting features for individual/small numbers of non-breeding bats. These include areas of lifting and missing fascia boarding at the south facing eaves of the building (Target Notes 1 and 2); crevices around decayed render and stonework at the building's north face (Targets Note 6); and there are also some missing roof slates and areas of slightly raised ridge; however the roof was largely observed to be intact. The pebble dashing at each gable was observed extend over the verge and so the gables appeared to be well sealed.

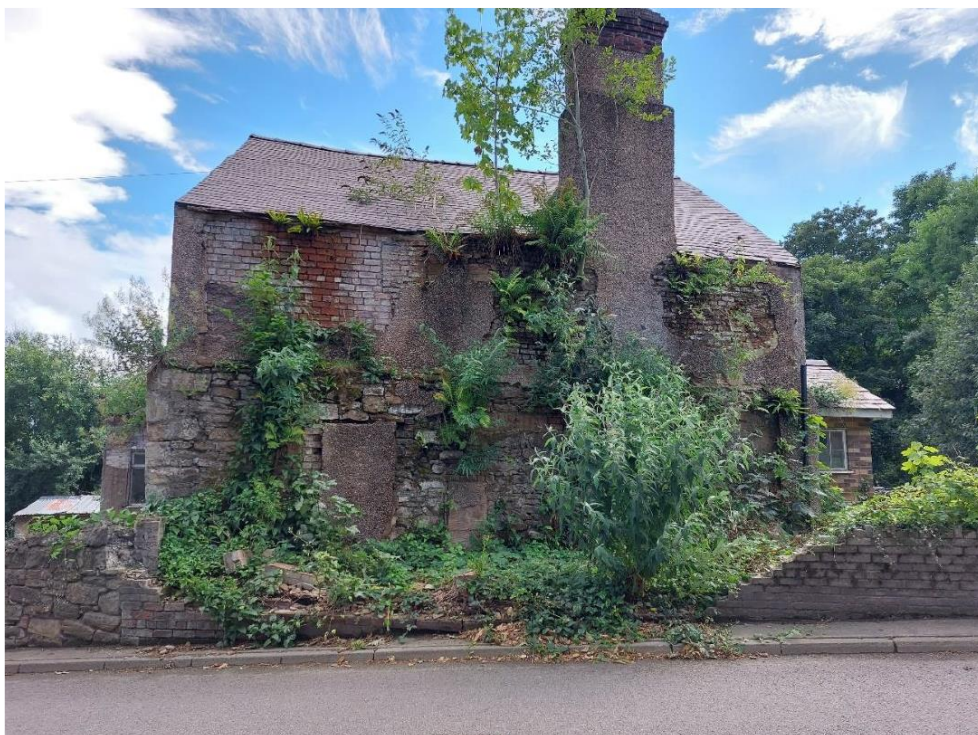
*Photograph 2- North face of farmhouse*

The exterior of the building has been rendered in pebble dashing. The rendering is mostly intact, apart from on the building's north face where large sections of render have decayed exposing the underlying stone and brick walls of the building. The damaged areas of render have been colonised by ferns and buddleia. There is also a large buddleia bush growing out of the south face of the building.

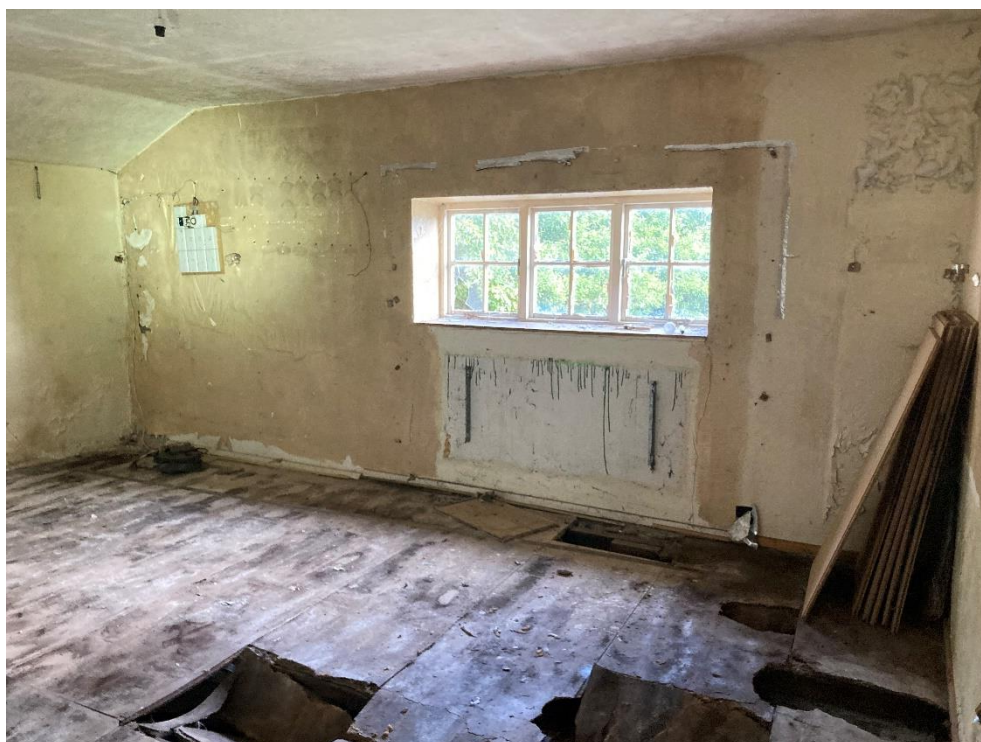
*Photograph 4- Upper floor room of Farmhouse*

Internally, the building is in a poor state of repair, with areas of collapsed ceiling and floor. The walls of the building are plastered, although this has decayed in several sections. The interior of the building is relatively bright as there are glazed windows on the building's south face and at the east and west gables. The interior of the building was found to be heavily cobwebbed.

The upper floor rooms partially extend into the roof void space. However, the building has an inaccessible void located above the upper floor rooms. Some sections of the upper floor lathe and plaster ceiling had collapsed, allowing the roof void space to be partially viewed. The loft space was observed to be approximately 2 m in height and the internal face of the roof is lined with bitumen hessian felt. The loft space is not insulated. The observable parts of the loft space were heavily cobwebbed throughout.

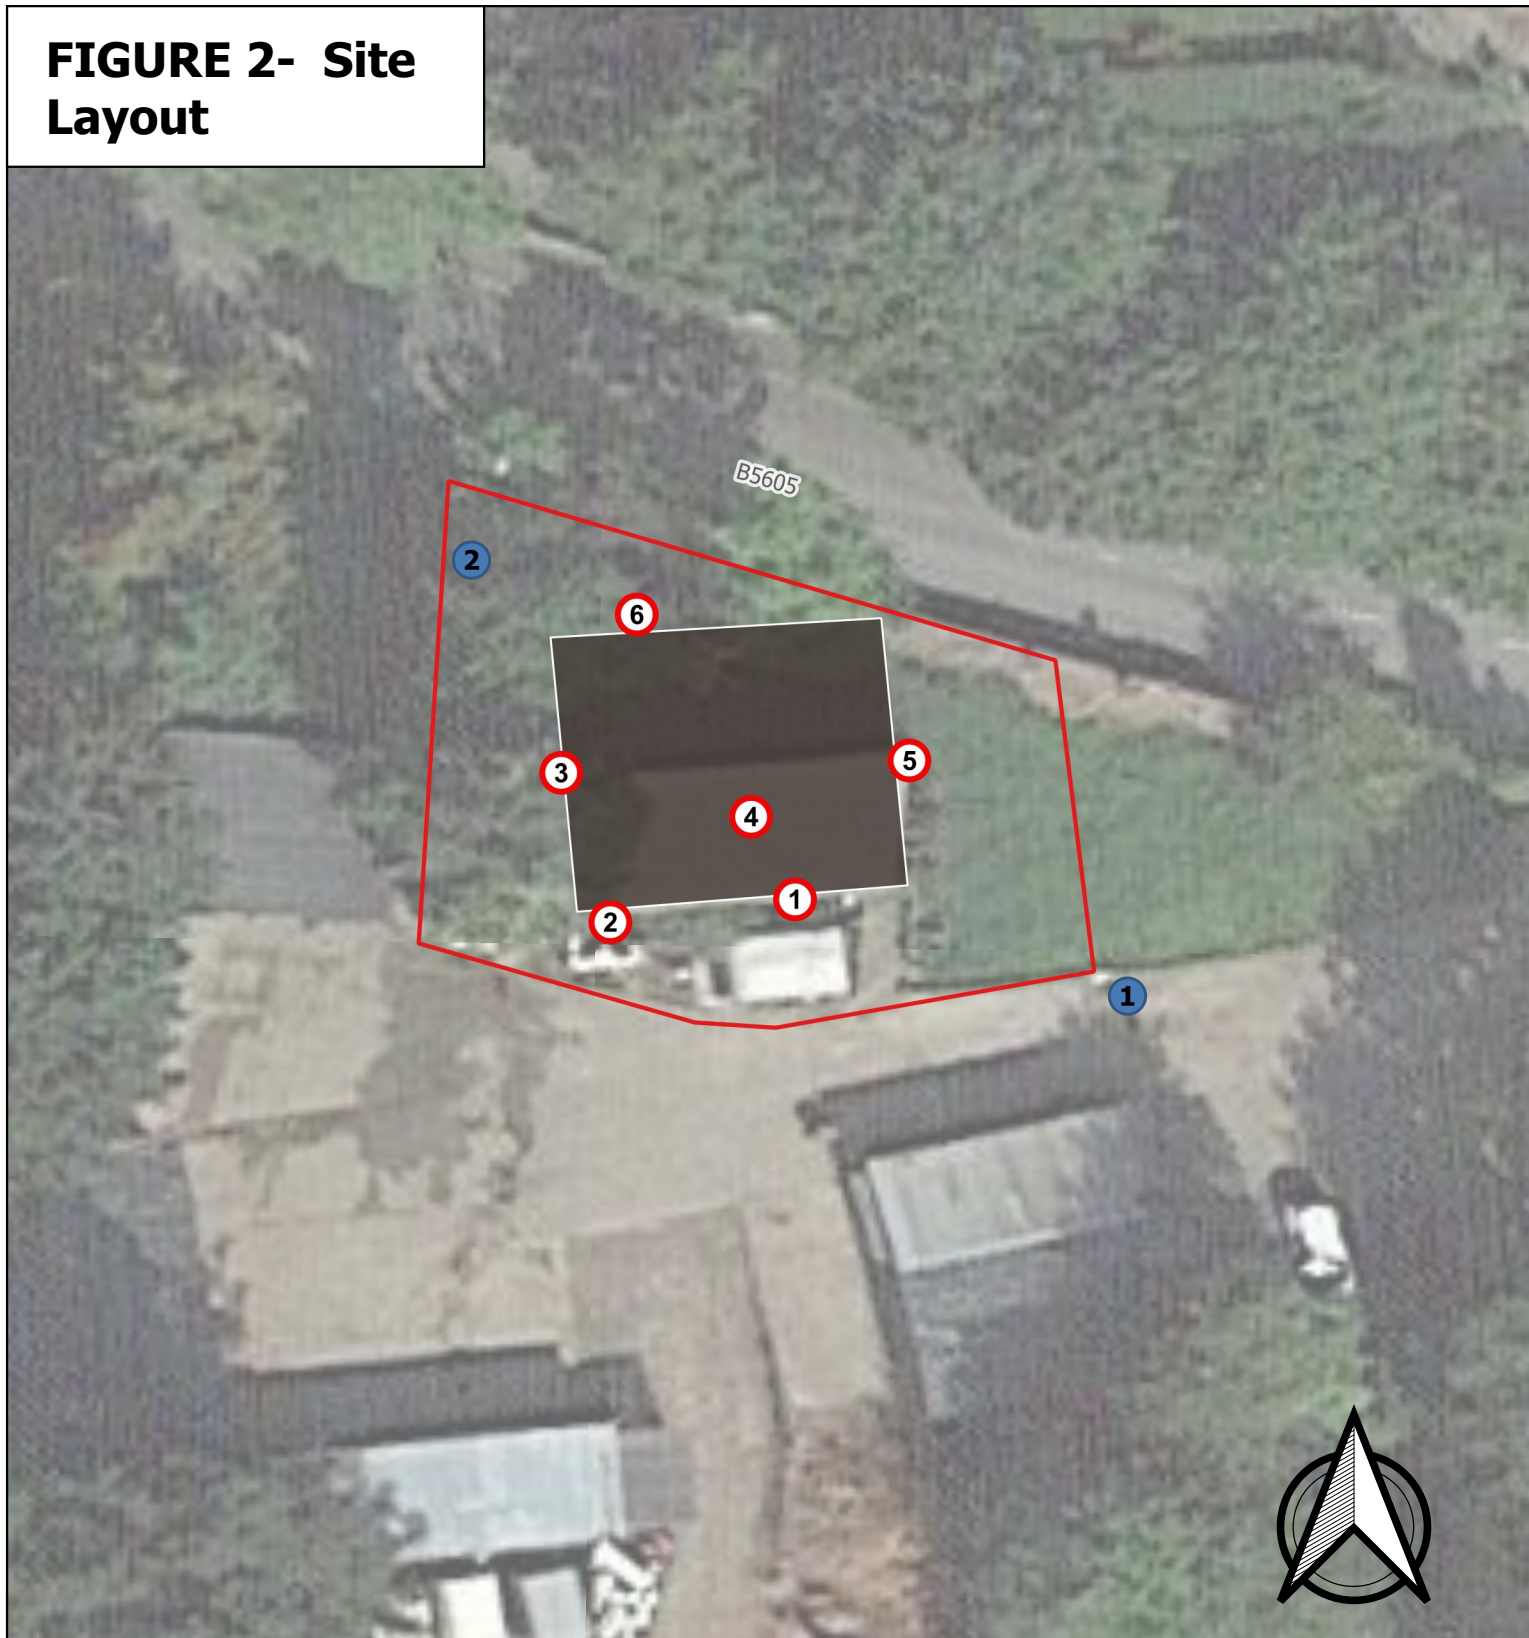
**FIGURE 2- Site Layout**

Bats can potentially enter the building interior via broken window panes at the buildings south, east and west faces (Target Notes 1, 3, and 5 on Figure 2). No other obvious potential bat access points to the building interior were identified.
