# **Bat and Nesting Bird Assessment Report**

**Dwelling and Detached Outbuilding,  
Dolwar,  
Park Road,  
Coedpoeth,  
Wrexham,  
LL11 3TD**

**Date: May 2022**

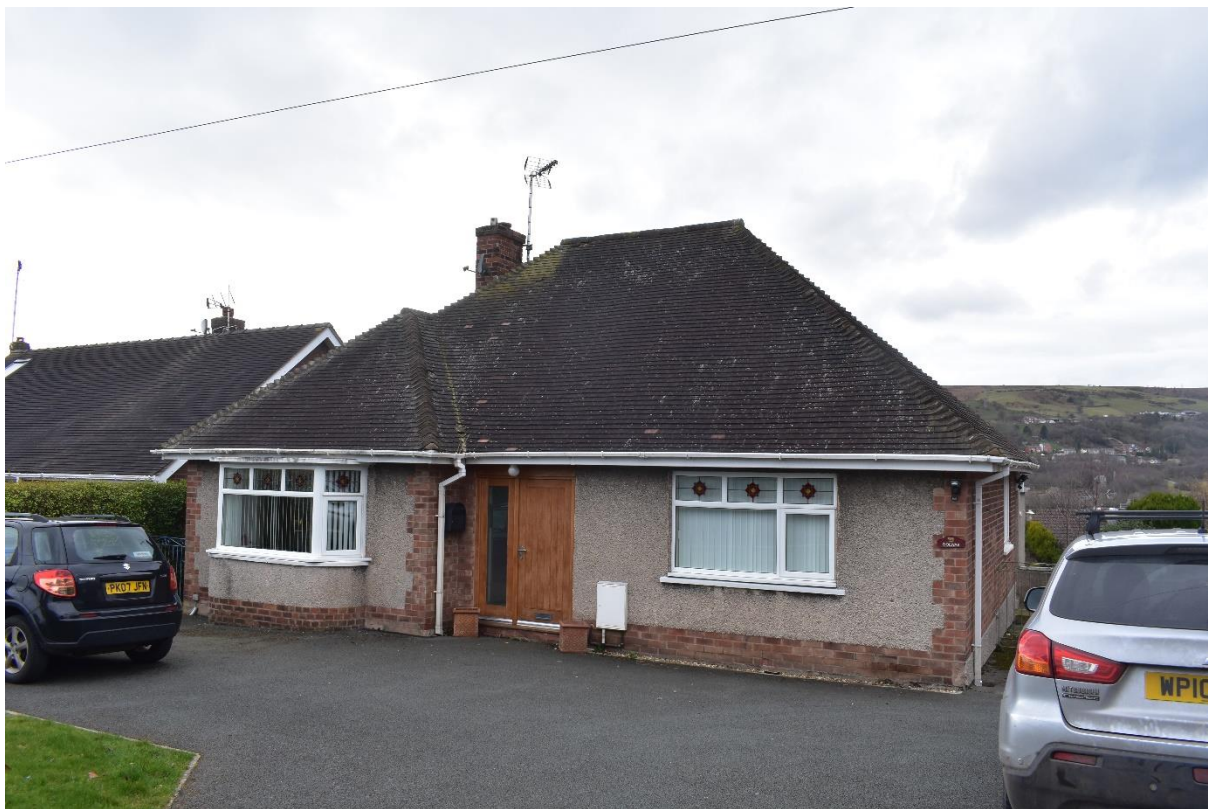
**Figure 3.2:** The front (east-facing) aspect of the dwelling.

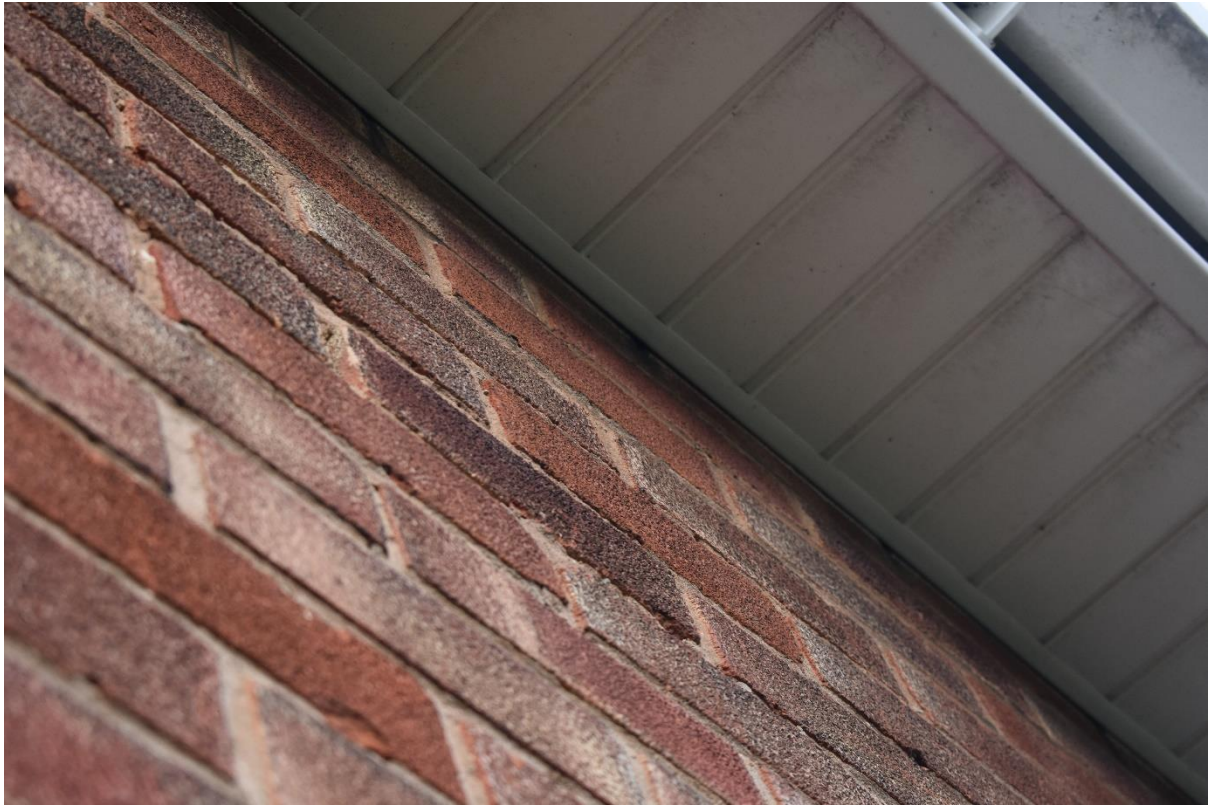
**Figure 3.5:** The tightly fitted soffits of the dwelling.

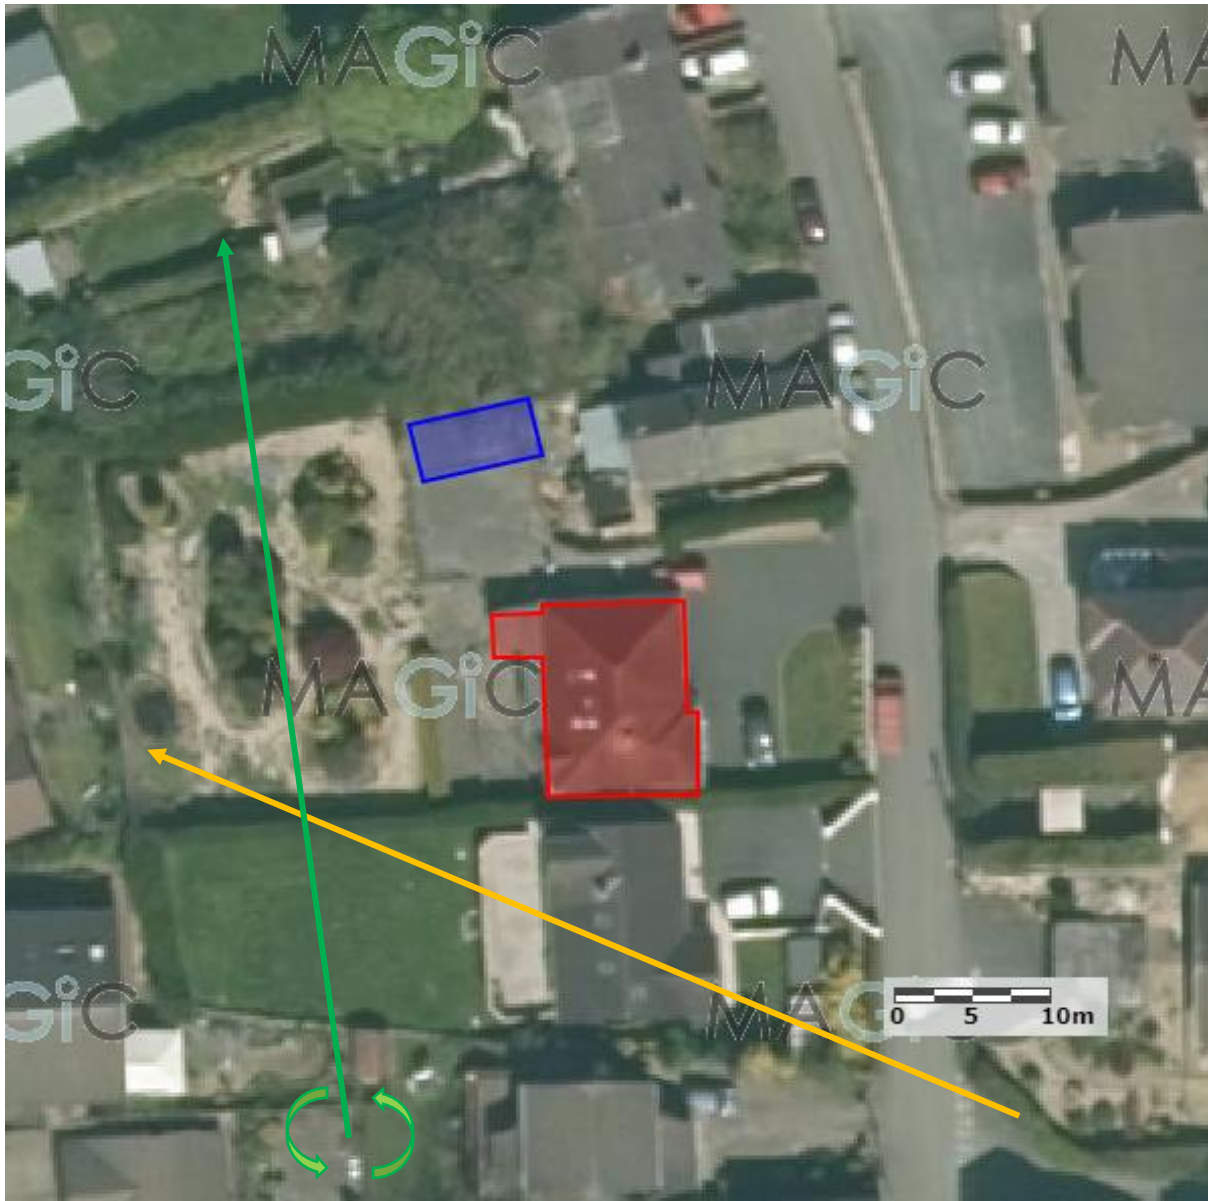
**09<sup>th</sup> of May 2022:** During the emergence survey, no bats were recorded or observed emerging from any part of the buildings. A common noctule bat (*Nyctalus noctula*) was recorded and observed to the south of the site at 21.15, flying southeast to northwest (see Figure 3.13). A second common noctule bat was recorded at 21.25. A common pipistrelle bat was observed foraging within the garden area of a neighbouring dwelling south of the site from 21.23 onwards, before flying north through the site at 21.26 (see Figure 3.13). No other bats were recorded or observed during the survey.

**Figure 3.13:** A plan of the site showing the flight routes identified. The flight path of the common noctule bat observed is shown in yellow. The foraging area and flight path of the common pipistrelle bat observed is shown in green.
