HOLT HILL, GREEN STREET, HOLT LL13 9JF

Heritage Statement

for Mr C Eaton

23/09/2021

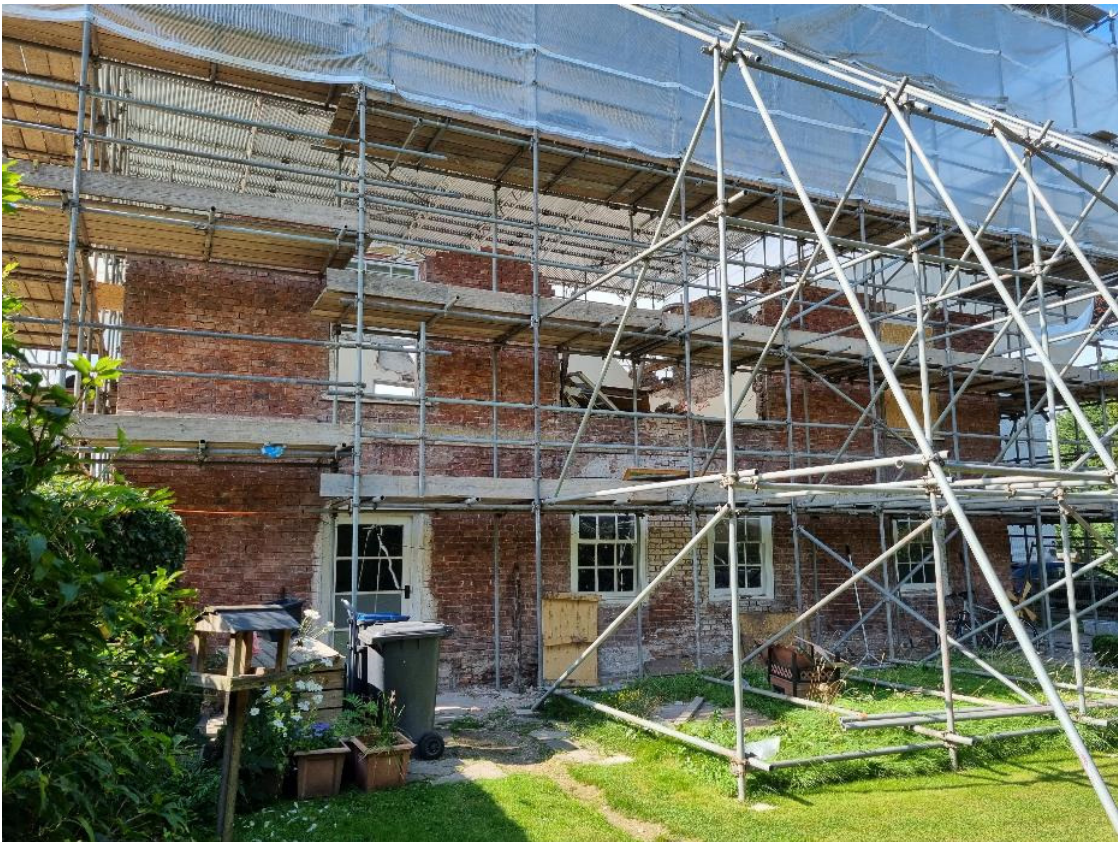
Photo 1: Eastern elevation, view to north west

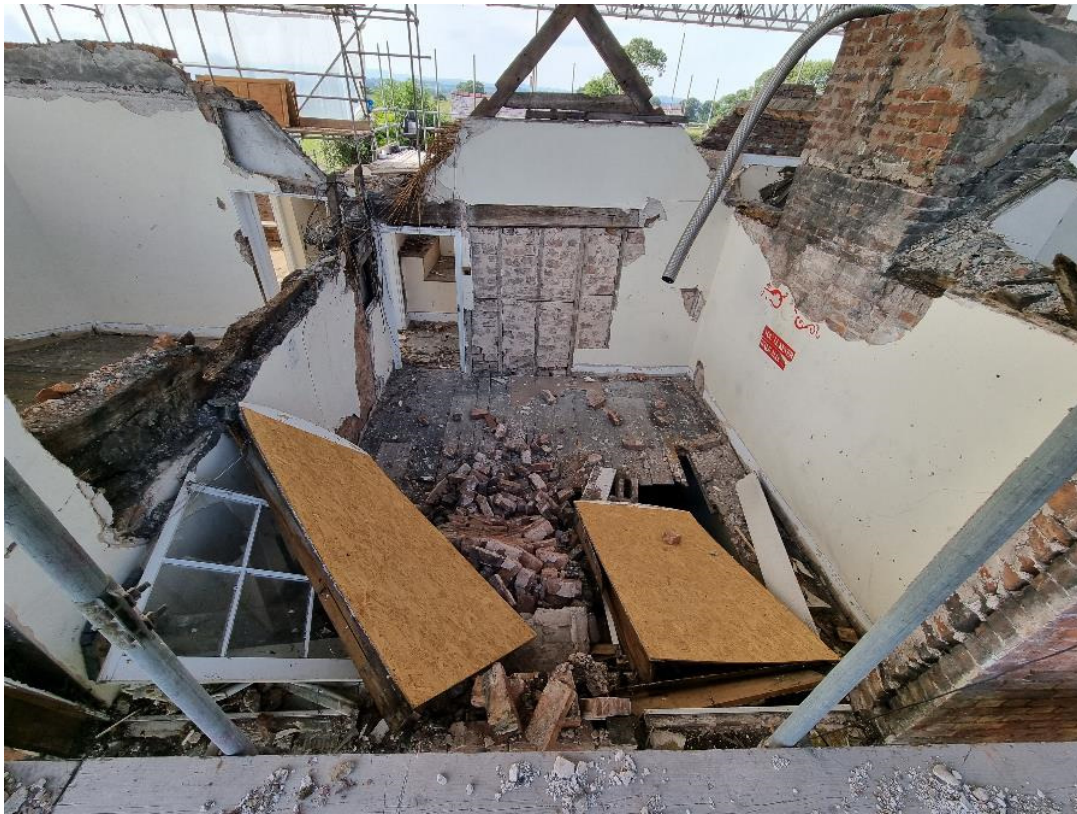
| Room | Notes |
|---|---|
| Bedroom 2 | <p>The windows and central section of brick masonry of the eastern wall have collapsed into this room. The brickwork on the northern side of the missing window illustrates that the early-mid 17<sup>th</sup> century facing brickwork is poorly bonded to the earlier masonry behind. Removal of plaster to the southern wall has exposed a void in the late 16<sup>th</sup>-early 17<sup>th</sup> century timber framing at the western end of the room, the plaster being applied over wide laths between the frame uprights. The early 18<sup>th</sup> century western wall is timber framed with brick infill below a wide tie beam which spans the central and northern bays of the building, now largely exposed following removal of plaster facing. Where exposed, the northern wall (early 18<sup>th</sup> century) is brick with timber wall plates in situ above a header course, to either side of a brick chimney stack.</p> <p>The floor comprises wide east-west aligned boards over north-south aligned joists. The collapse of the eastern wall has resulted in the floor joists tipping from their northern end into the lounge below, alongside the boards above.</p> |

Photo 11: Bedroom 2 facing west through wall collapse

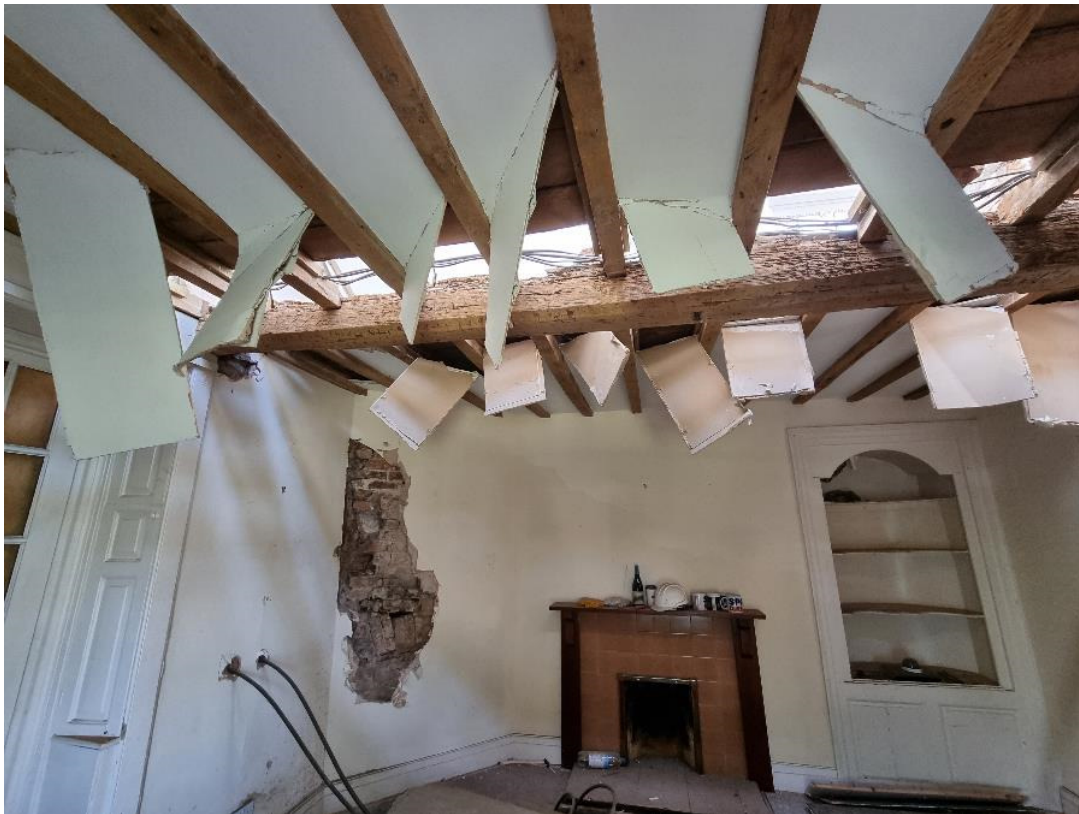
| Room | Notes |
|---|---|
| Former Parlour | The interior of the former parlour remains largely unchanged. Key areas noted were the ceiling, where the modern plasterboard between the ceiling joists has been partly removed to either side of the large axial beam, and an area of removed plaster on the corner chimney breast which has exposed part of the brick arch of the original fireplace. A change in the brick masonry above the fireplace suggests this has been rebuilt or repaired when the fireplace was moved into its current position on the western wall, which also required visible alteration of the flue in the garage behind. |

Photo 18: Former Parlour, view to west

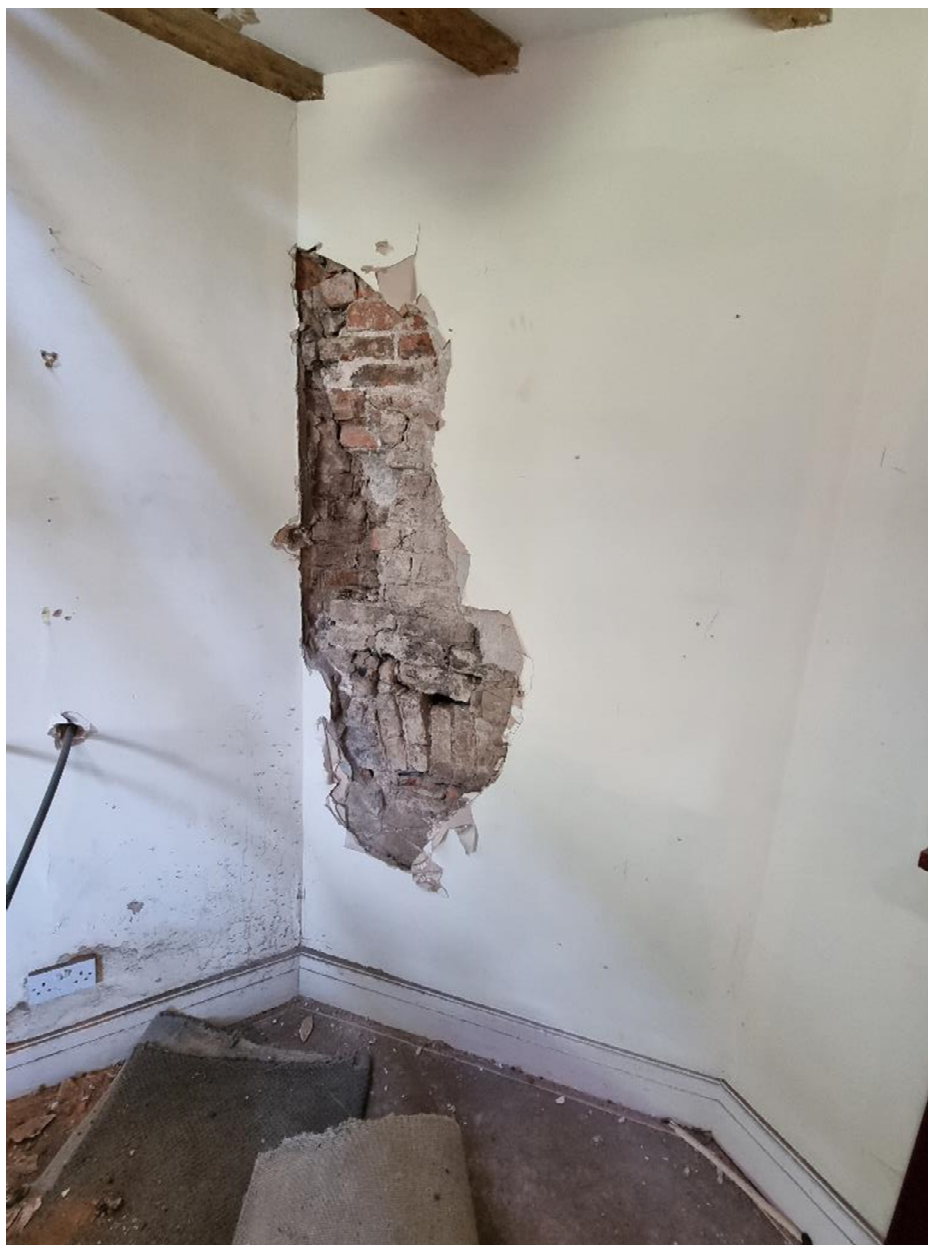
Photo 19: Detail of exposed chimney breast in former parlour, view to south west

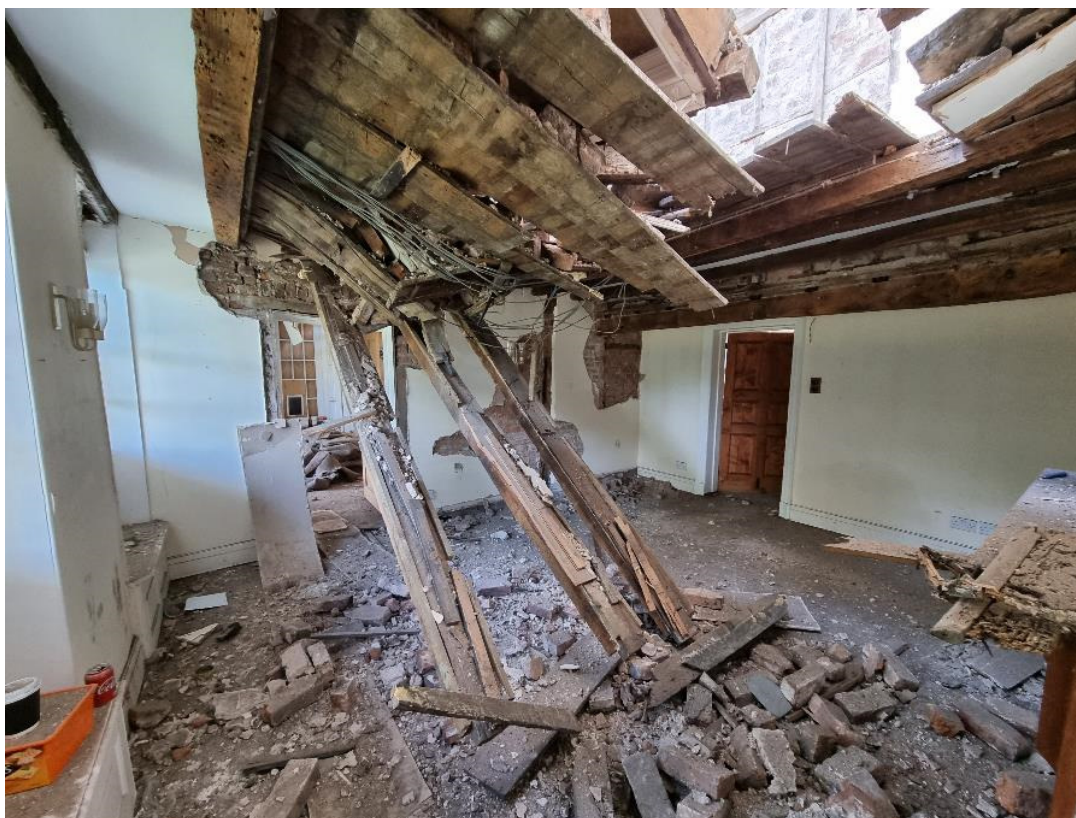
Photo 20: Lounge showing ceiling collapse, view to south west

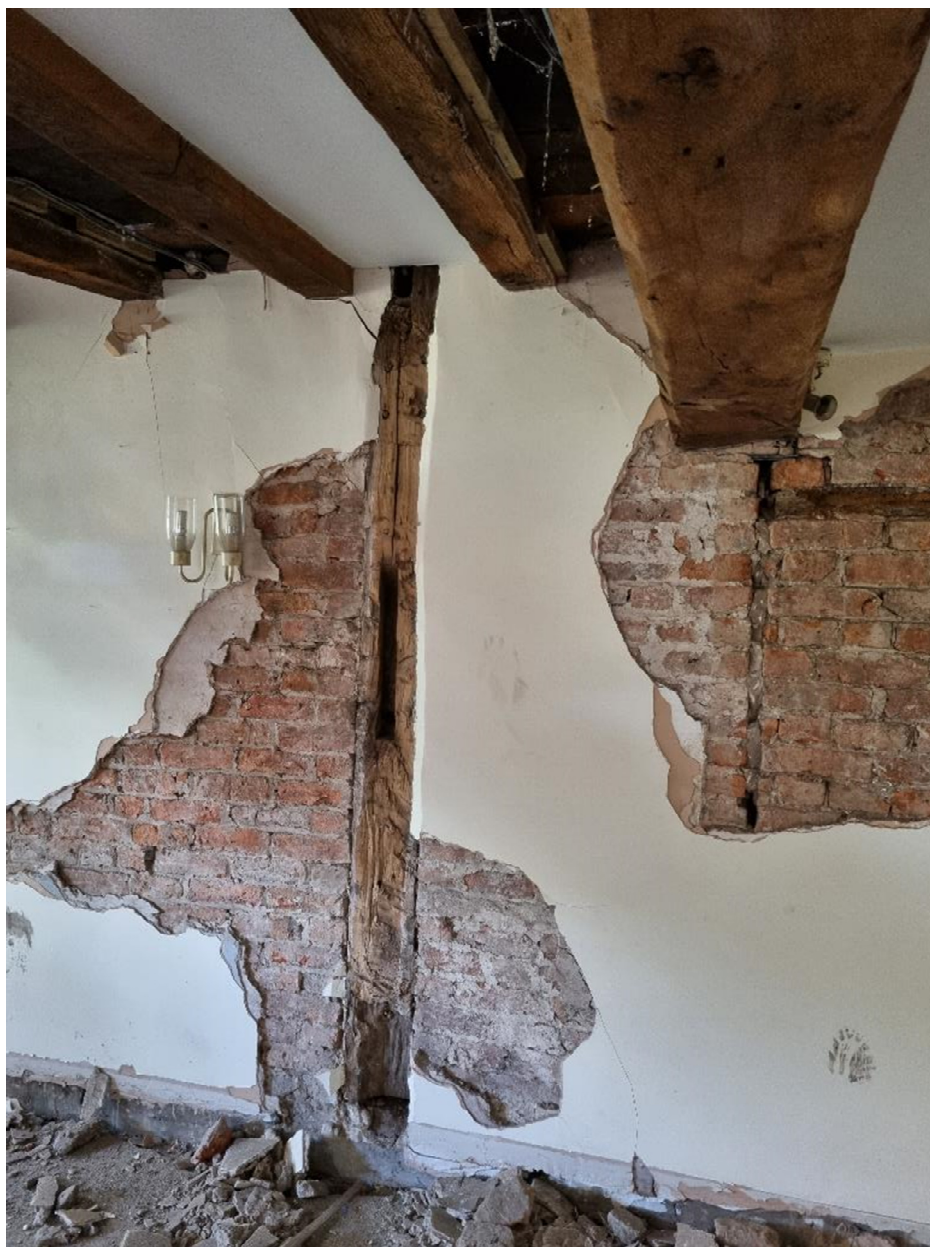
Photo 21: Detail of exposed wall upright and lintel embedded in wall to west, lounge, view to south

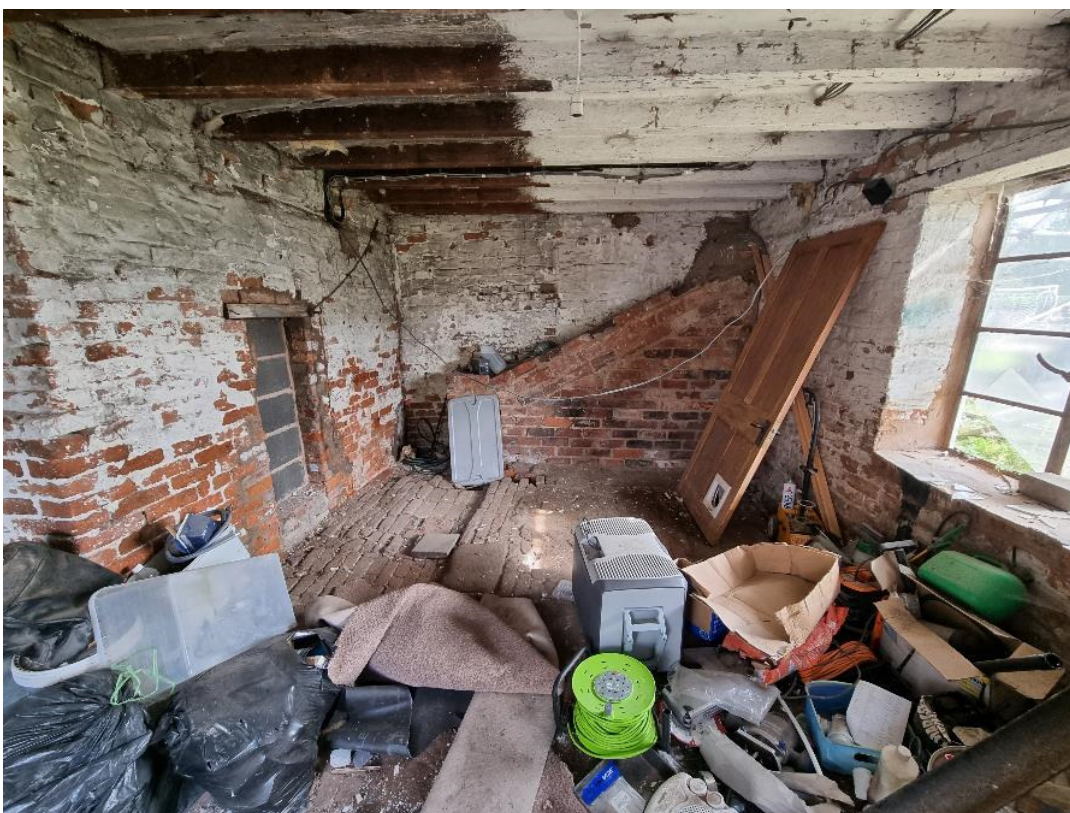
| Room | Notes |
|---|---|
| Garage | No work has been undertaken in the garage. The walls are whitewashed brick, and the floor also constructed from brick. Against the eastern wall (adjoining the former parlour) is an unusual brick built flue which rises at an angle from the fireplace on the opposite side of the wall and patches through to the southern chimney in the corner. Windows in the southern and western walls are steel-framed. Plaster and lath ceiling materials between the north-south aligned joists is partially failing, exposing the underside of the floorboards in Bedroom 4 above. |

Photo 23: Garage, view to east
