**Dwelling and Associated Outbuilding at Dolwar, Coedpoeth.  
LL11 3TD**

**Preliminary Bat and Nesting Bird Assessment**

**March 2022**

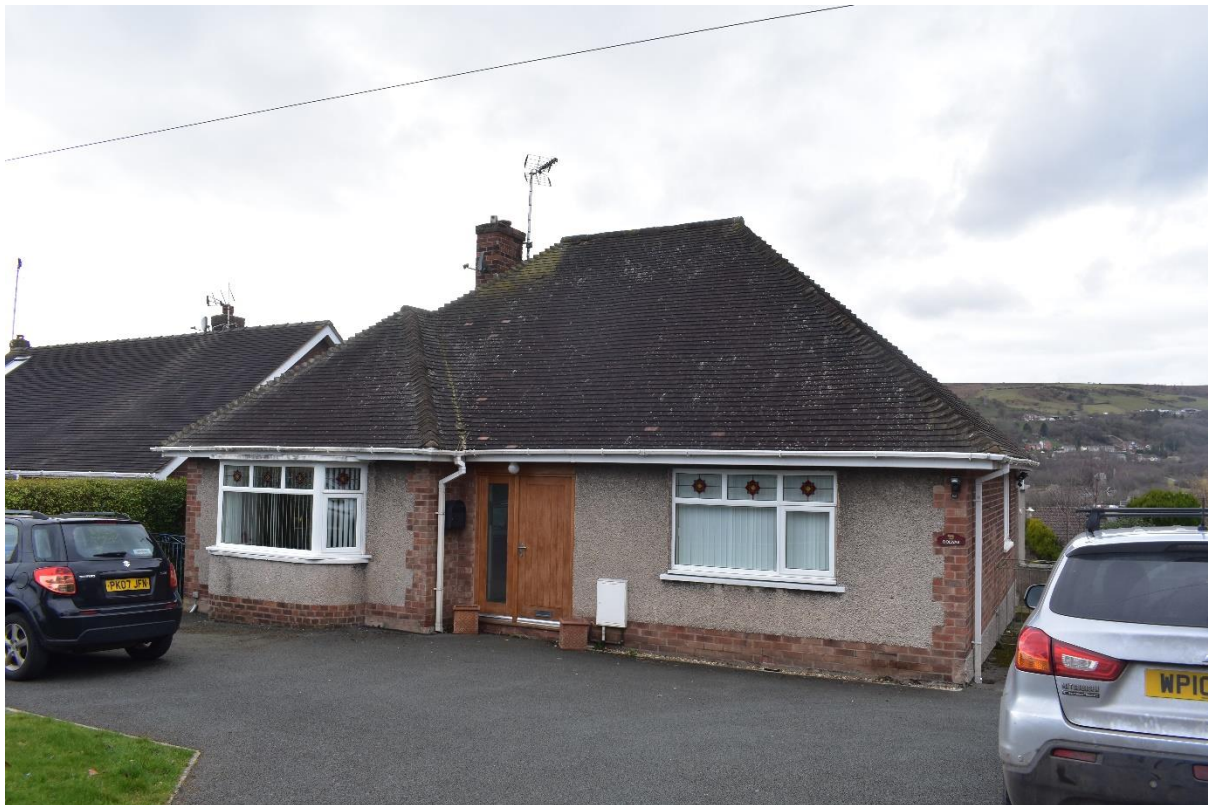
**Figure 3.2:** The front (east-facing) aspect of the dwelling.

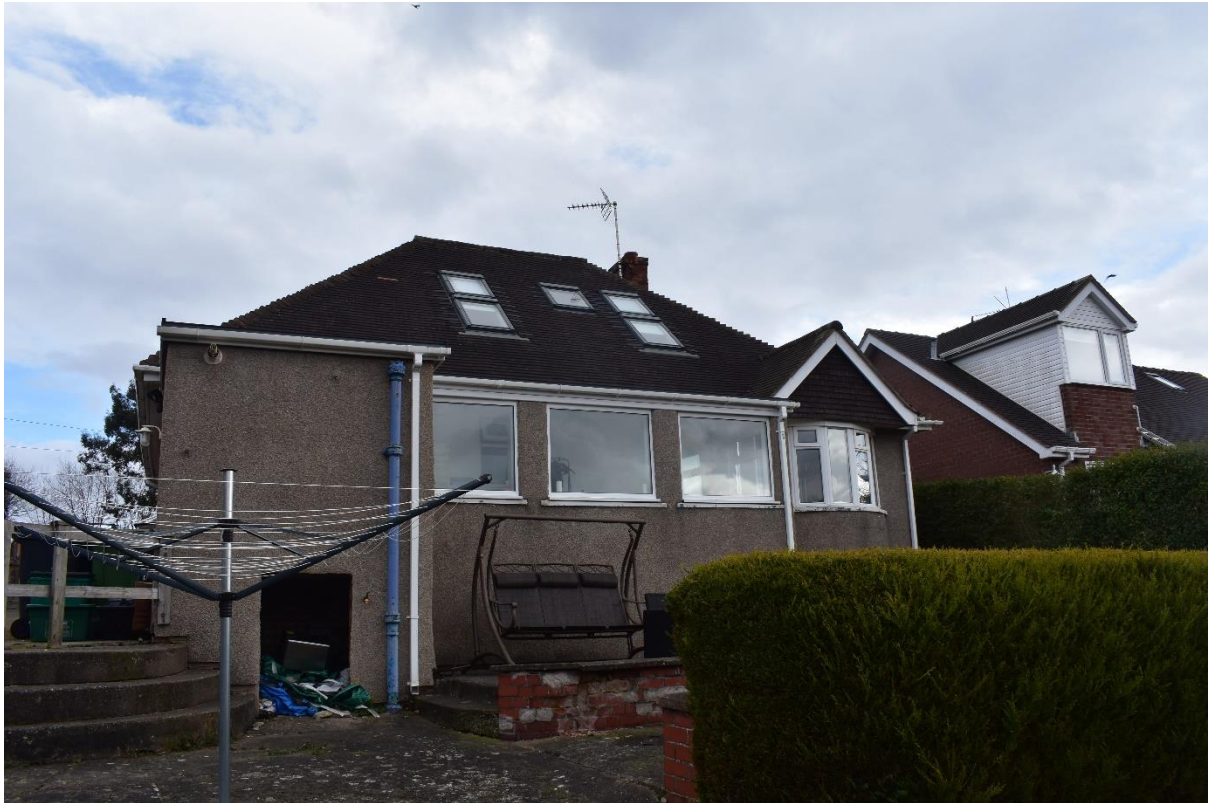
**Figure 3.3:** The rear (west-facing) aspect of the dwelling.

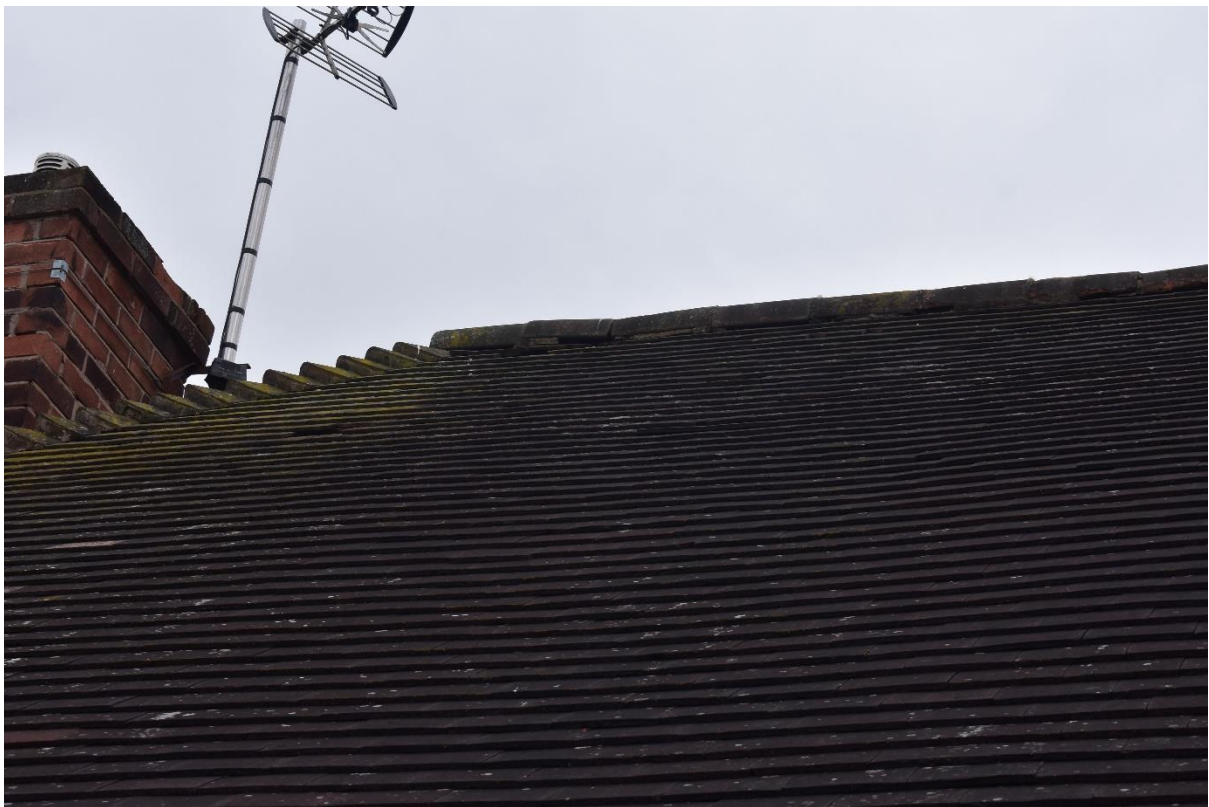
**Summary:** Of importance, it was noted that there are a small number of slipped roof tiles, a small number of lifted curved ridge tiles, and there are some gaps present beneath the hanging ceramic tiles which are fitted above the dormer window. There is also a single gap present between the otherwise-tightly fitted soffits and the walls on the west-facing aspect of the building.

**Figure 3.4:** The east-facing roof of the dwelling with a lifted ridge and slipped tile.

The dwelling to be affected was assessed as having low potential to support roosting bats. As such, a single bat activity (emergence) survey of the dwelling will be required before the works can proceed, to demonstrate to reasonable satisfaction that bat roosts are not present therein. If bats are recorded emerging from the building during the survey, an additional two bat activity surveys (including a bat re-entry/dawn survey) will be required, to ensure that sufficient data has been gathered to properly categorise the roosts, and to design appropriate reasonable avoidance measures and mitigation as necessary. In this event, a bat development licence from Natural Resources Wales will be required before site works can commence.

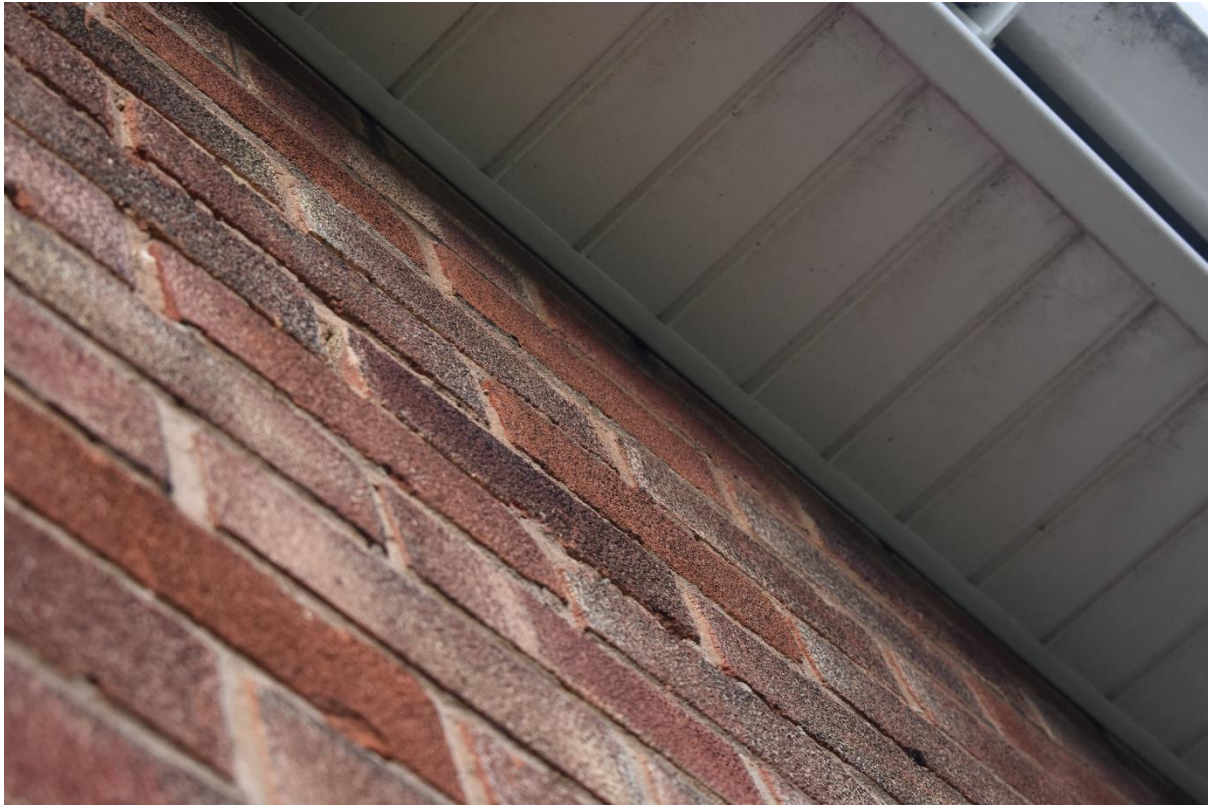
**Figure 3.5:** The tightly fitted soffits of the dwelling.

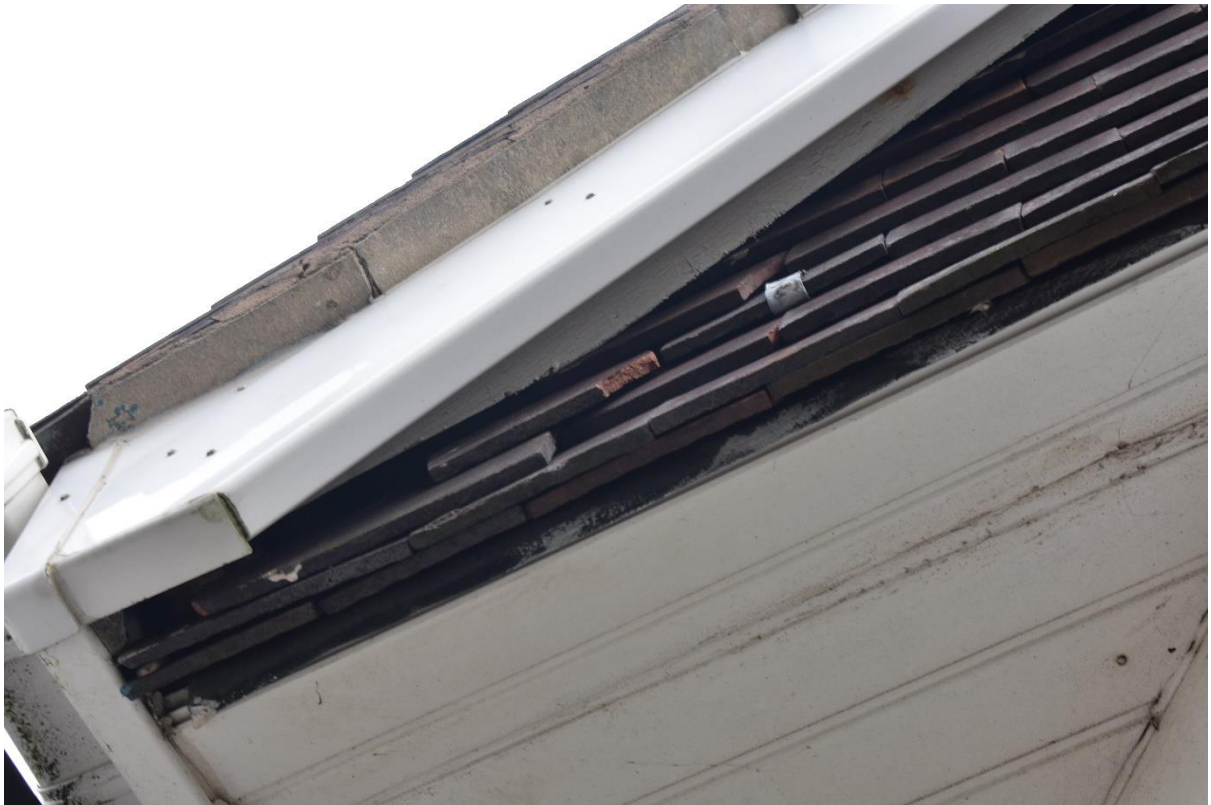
**Figure 3.6:** The gaps present on the hanging tiles fitted onto the dormer window.

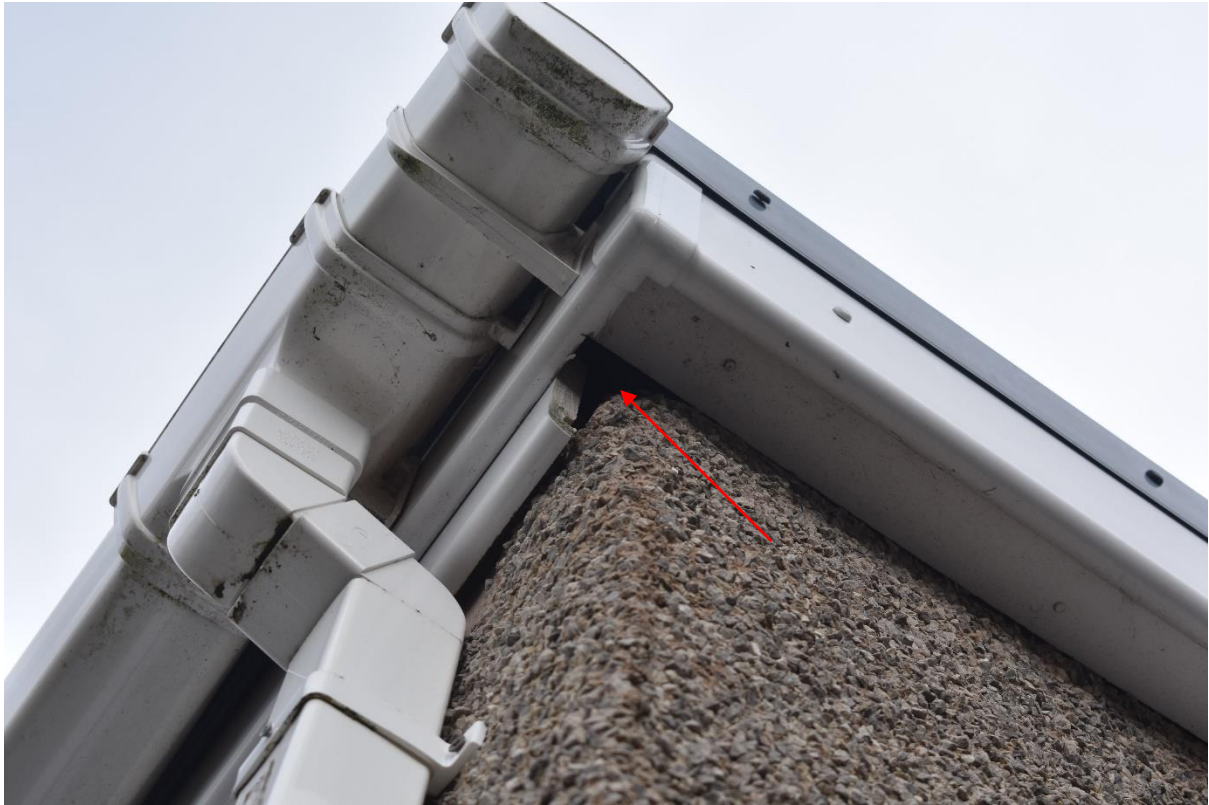
**Figure 3.7:** The single gap present between the soffits and the wall of the dwelling.

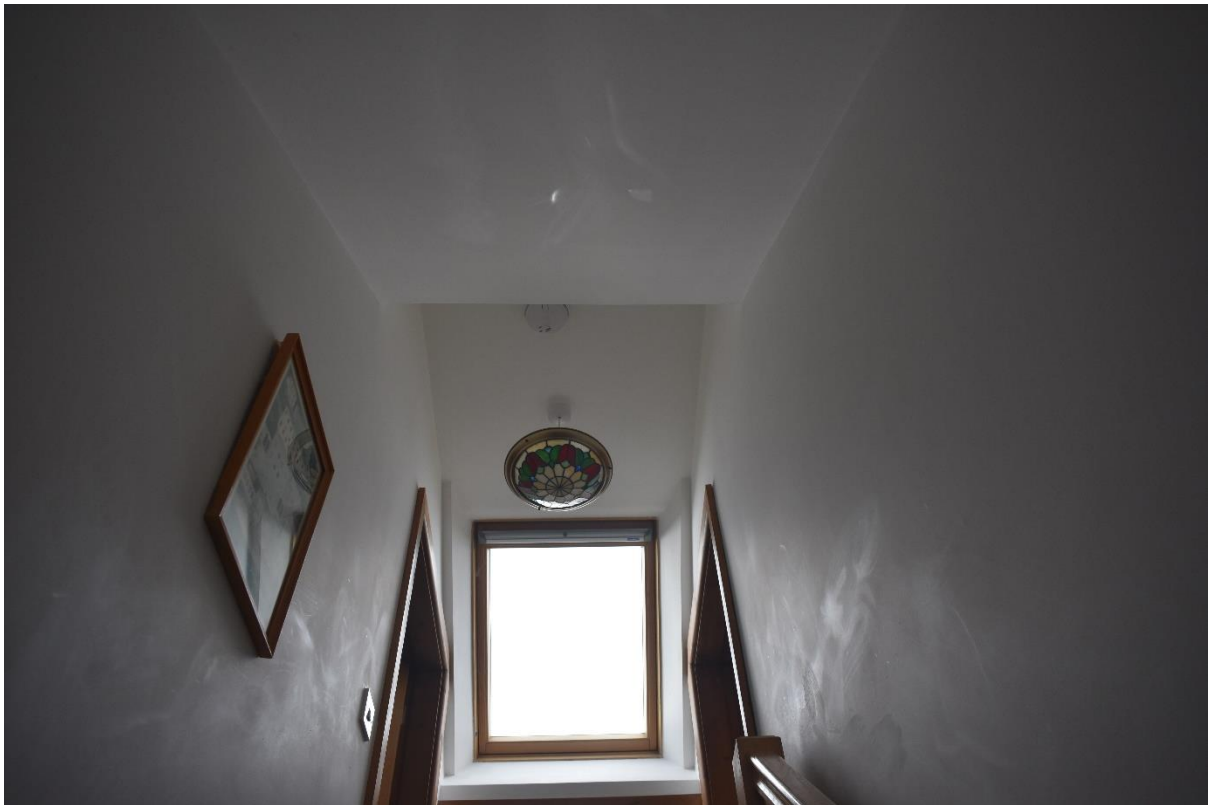
**Figure 3.8:** The interior of the dwelling. The building's loft space has been converted. The building does not feature a roof void.

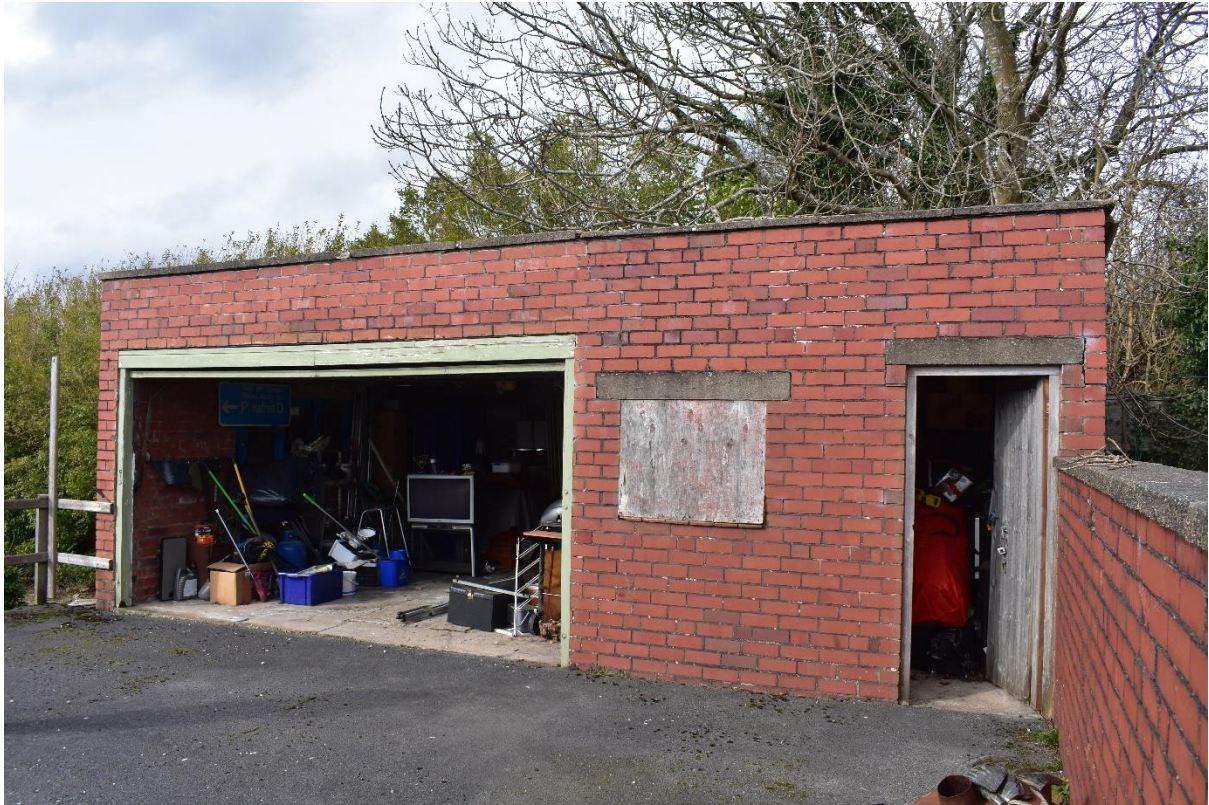
**Summary:** Given the absolute lack of potential roosting features present upon the exterior of the outbuilding, and the absolute lack of access to its interior, the outbuilding was categorised as having negligible potential to support roosting bats.

**Figure 3.9:** The front (south-facing) aspect of the outbuilding to be removed.

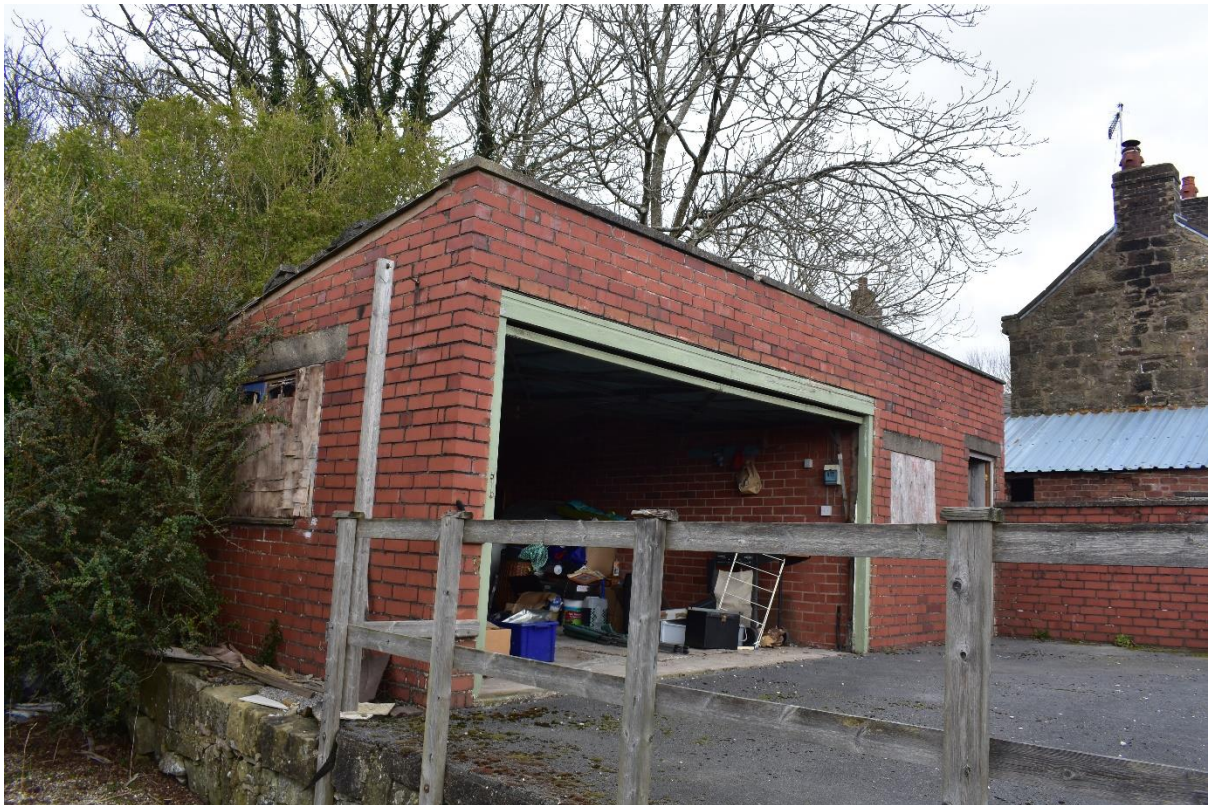
**Figure 3.10:** The single-pitched roof and the western section of the outbuilding to be removed.

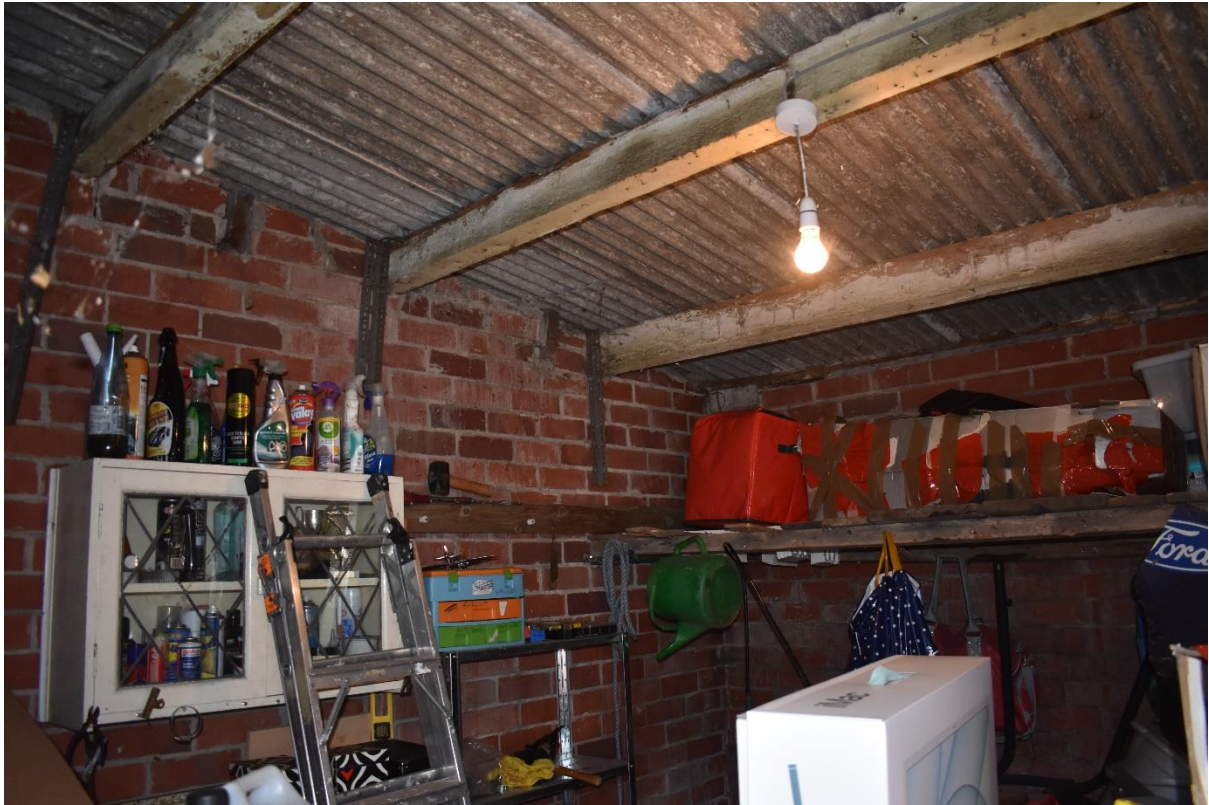
**Figure 3.11:** The interior of the outbuilding to be removed.

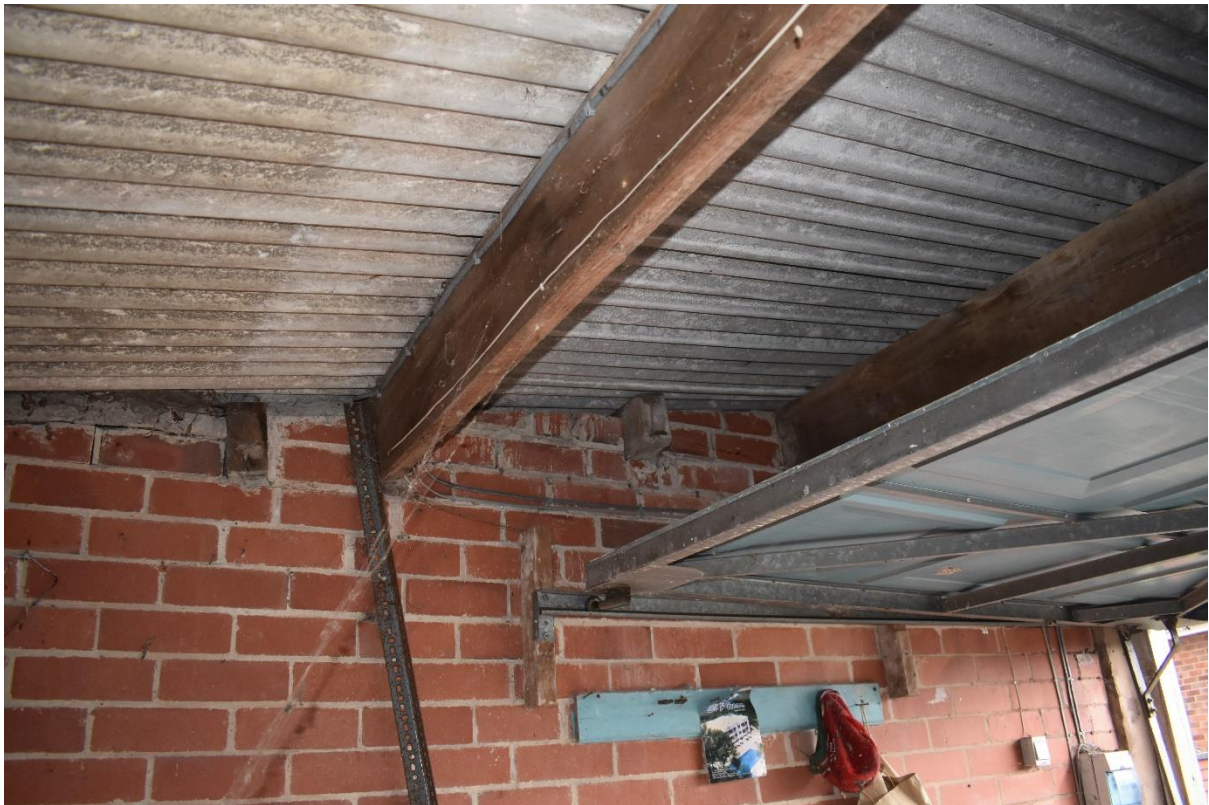
**Figure 3.12:** The wooden supports and roof-wall join of the interior of the outbuilding to be removed.
