# Preliminary Bat Roost Assessment

Plot 5 Plas Power, Wrexham Road

Mr J Beckett-Ward Supplies

17 October 2018

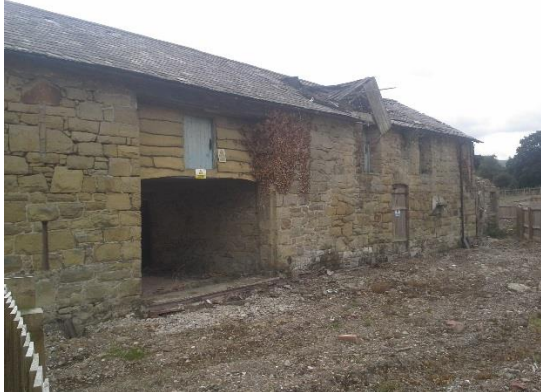
| Image | Description |
|---|---|
| | <p>The northern facing side of the building. The building is comprised of sandstone brick sides and has a damaged slate roof. There is an opening that runs through the middle of the building on the ground floor, which can be seen in this image and is thought to be a disused car port. The ground floor of the building is open to the east of this opening (left on image) and is closed to the west, with a door providing access. On the first floor is a dormer style opening providing open access to the first floor.</p> |

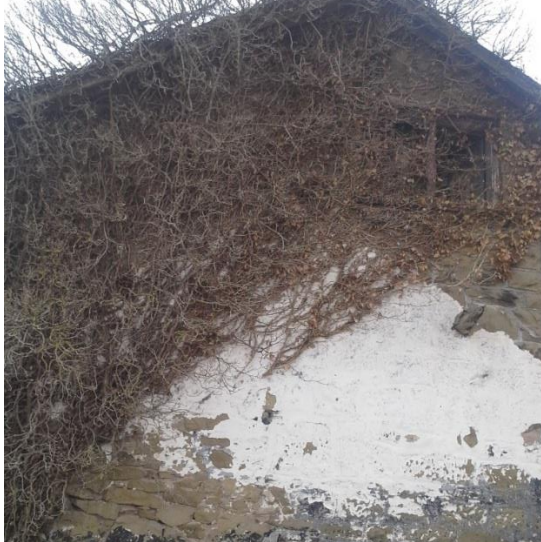
| Image | Description |
|---|---|
| | <p>Dead ivy on the eastern gable end of the building. This vegetation is considered too sparse to provide any bat roosting potential and is unlikely to provide sufficient shelter for nesting birds in its current condition.</p> |

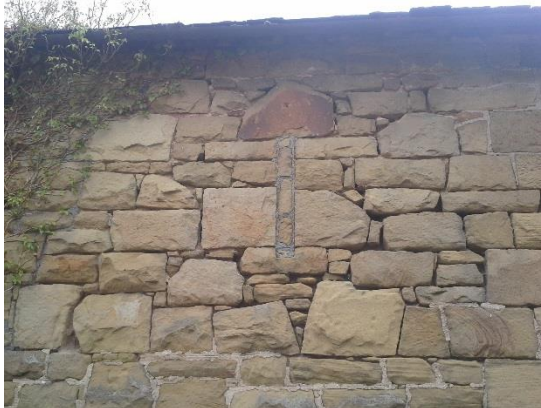
| Image | Description |
|---|---|
| | <p>Gaps within the sandstone brickwork on the southern facing side of the building. These gaps are considered to provide suitable roosting space for crevice-dwelling bats species and some of these gaps may also provide access into the internal space of the building.</p> |

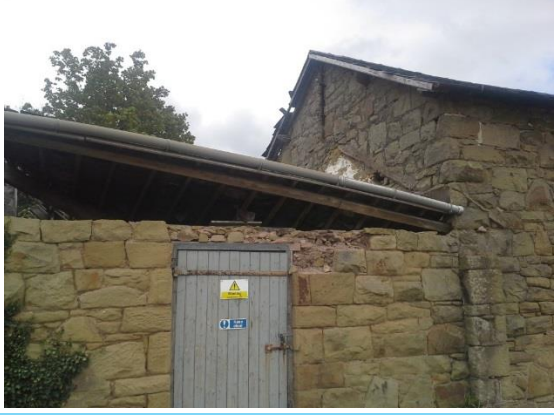
| Image | Description |
|---|---|
| | The western gable end of the building and single-storey lean-to with a damaged roof. |

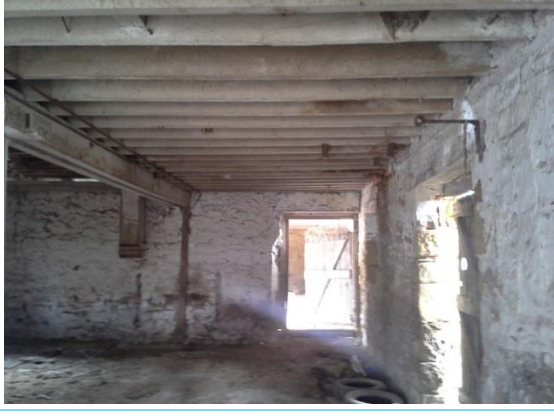
| Image | Description |
|---|---|
| | The ground floor of the building. This floor is considered to have less potential for roosting bats as there are less gaps suitable cavities in the brickwork. |

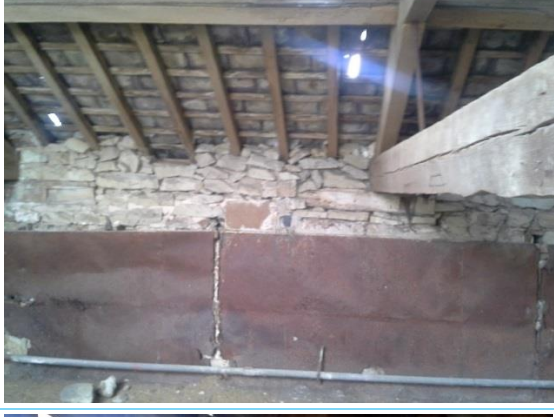
| Image | Description |
|---|---|
| | The first floor of the building. Gaps within the sandstone bricks are considered to provide potential roosting space for bat species. |

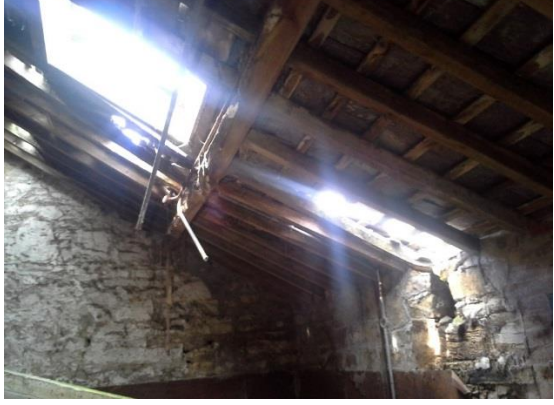
| Image | Description |
|---|---|
| | The damaged roof of the building. |

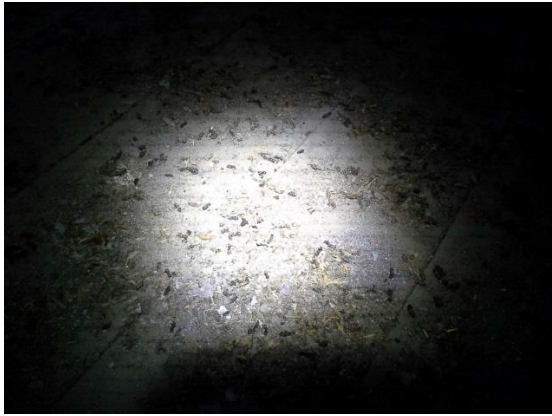
The building is considered to have high suitability for bats and is considered to be a confirmed roost site due to the presence of bat droppings and feeding remains.

| Image | Description |
|---|---|
| | Bat droppings found on the second-storey floor of the building. |

Based on the evidence of bat presence found within the building, it is recommended that further activity surveys are carried out in line with the BCT's 'roost characterisation' methodology. This requires three surveys to be undertaken to observe bats which may be roosting within the building, with at least one of these surveys undertaken at dawn. Each survey should be separated by a period of at least two weeks. Following the surveys, we will advise as to the bats found present and the mitigation required to enable the building to be developed into a residential dwelling. It is likely that a development licence will be required from NRW prior to works commencing.

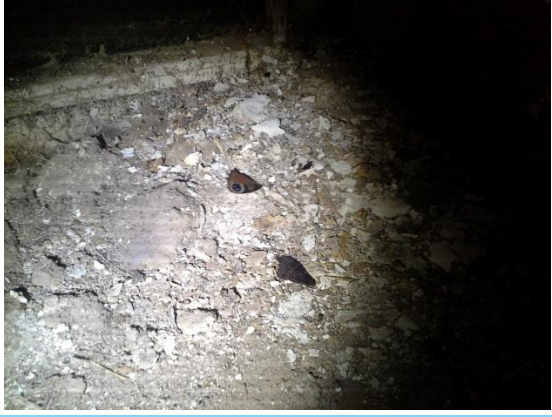
| Image | Description |
|---|---|
| | Butterfly wings found in the first floor of the building and considered likely to be evidence of bats feeding within the building. |

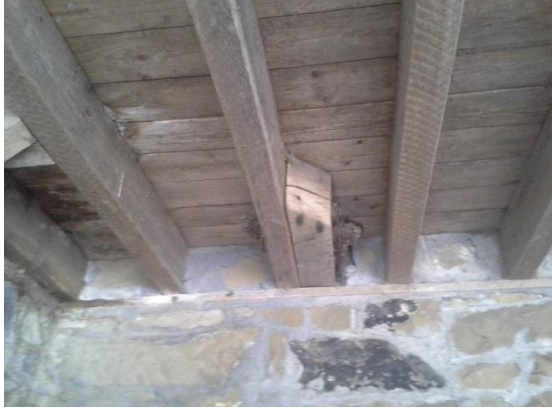
The building is considered to provide potential nesting spaces for breeding birds, including the exposed rafters within the building and the cracks within the sandstone brickwork, which are present both internally and externally. During the survey, swallow *Hirundo rustica* nests were recorded on exposed beams on the ground floor of the eastern side of the building. The building lies on a plot of land which was comprised of

| Image | Description |
|---|---|
| | Swallow nests found on the ground floor of the building. |

There were a number of swallow nests present on the ground floor of the building at the time of the survey and the building is considered to provide potential nesting habitat for further species. It is therefore recommended that any works are undertaken outside of the typical bird breeding season (March to August, inclusive) to ensure that no active nests are disturbed or destroyed. If this is not practical then a nesting bird check should be carried out prior to any work commencing. If any active nests are found then building work would have to be delayed until the young have fledged and are no longer dependent and using the nest. It is recommended that replacement nesting habitat, such as nesting platforms or artificial swallow nests, is provide and could be incorporated into the converted building design or integrated with any bat mitigation features (e.g. a bat house).
