## BS5837 2012 Tree Information Lady Margaret's Park, Chirk

Caravan and Motorhome Club, East  
Grinstead House, East Grinstead, West  
Sussex, RH19 1UA

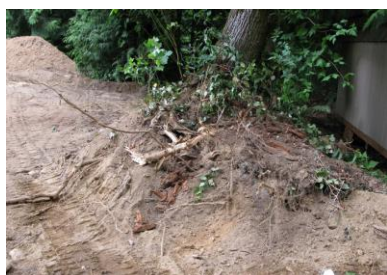
This photo shows a combination of damage. The roots have been severed or damaged in such a way that stability has been lost and this tree was felled. If the same damage had not led to an immediate tree failure the tree would have been sent into an irreversible spiral of decline.

The loss of roots will have caused a lack of structural support, loss of moisture take up, loss of oxygen take up and a means of the tree storing energy as starch within root structures. This type of root damage causes a slow decline in tree foliage known as crown die back.

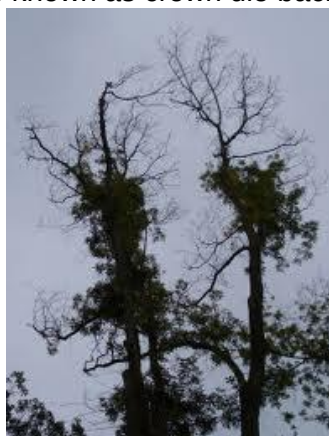
The picture to the right shows the years after the completion of a development site. Operators will often mention how they have driven over them. This is what happens once they leave.

die back of foliage several years after the completion of a development site. Machine operators have dug roots or driven over them.
