| Document Title: | Tree Survey and Arboricultural Impact Assessment |
| Project Title: | Holly Grove, Hugmore Lane, Llan-y-pwll, Holt, Wrexham, LL13 9YE. |

Report no: 21\_5837\_12\_04

## Tree Survey & Arboricultural Impact Assessment to BS 5837 2012 of trees at: Holly Grove, Hugmore Lane, Llan-y-pwll, Holt, Wrexham, LL13 9YE.

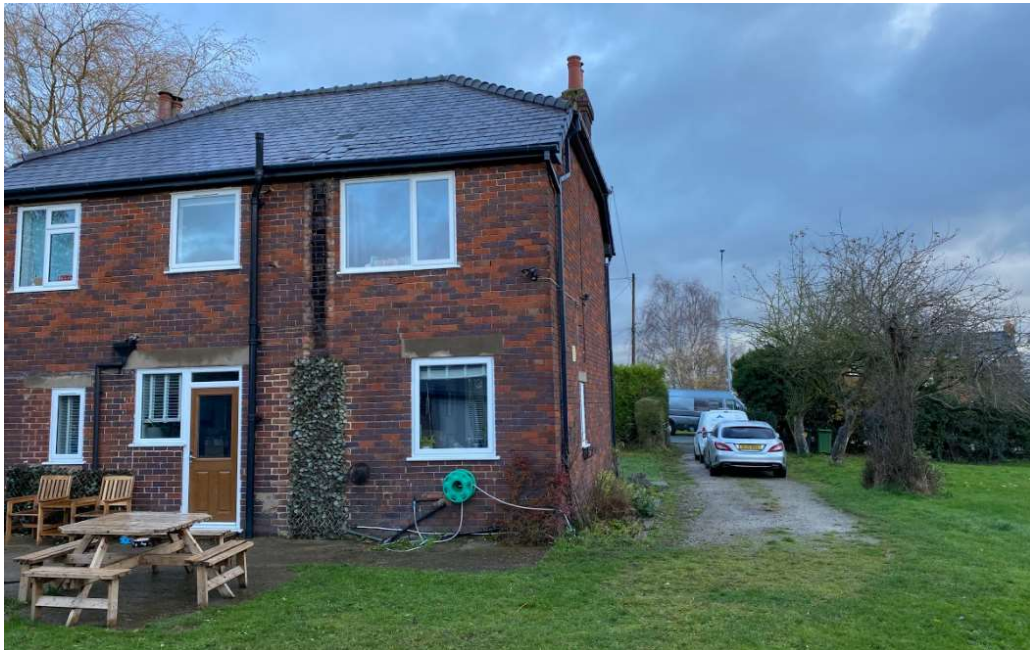
*Photographic plate showing rear of existing dwelling, and T3 to the right.*

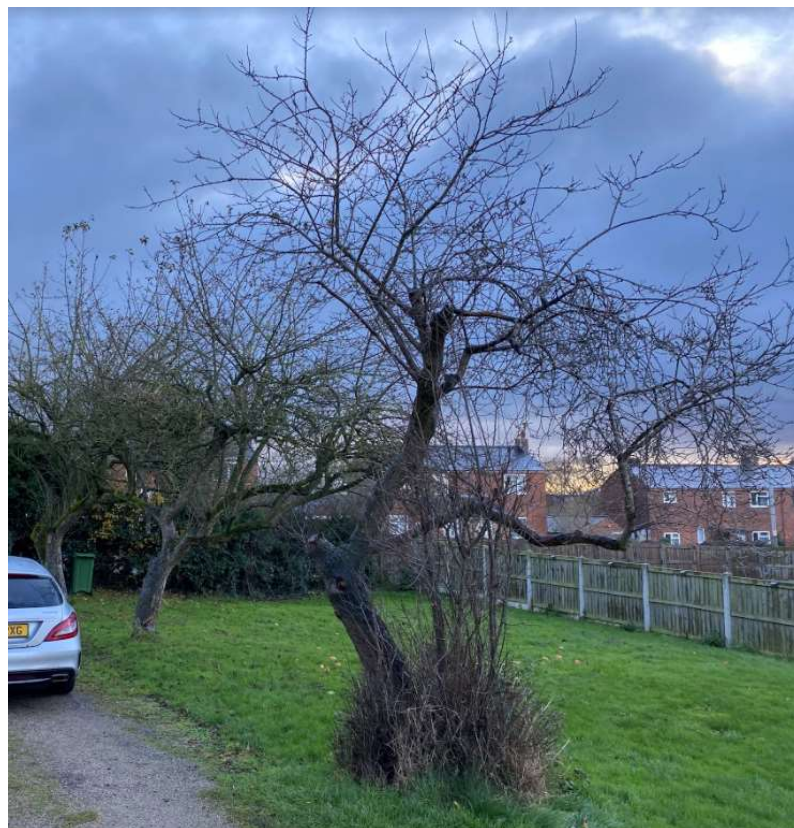
*Photographic plate showing T3, a low quality apple tree.*

| Tree | Cause For Removal |
|---|---|
| T3 | Is in direct conflict with the proposed extension and is in poor condition. |

| Tree ID | Tree Type | Common Name | Latin Name | Maturity | Measurements Estimated | Height (m) | Height and direction of significant branch (m) | Number of Stems | Diameter at Breast Height | Stem 2 (mm) | Spread - N (m) | Spread - E (m) | Spread - S (m) | Spread - W (m) | Canopy Height (m) | Crown Condition | Stem Condition | Basal Condition | Category | Life Expectancy | Subcategories | Phys Condition | Comment |
|---|---|---|---|---|---|---|---|---|---|---|---|---|---|---|---|---|---|---|---|---|---|---|---|
| T3 | Apple | Culinary Apple | <i>Malus domestica</i> | Mature | No | 2.5 | S-1 | 1 | 240 | | 1 | 1 | 2 | 2 | 1.5 | Fair | Fair | Fair | C | 10 to 20 yrs | 2 Landscape Values | Fair | Mechanical damage, leaning east, poor shape form, 5.3 metres off house. |

4.3.1. The tree to be removed should be replaced with a similar species, ideally on a dwarfing rootstock to ensure it can be retained long term within a garden setting.

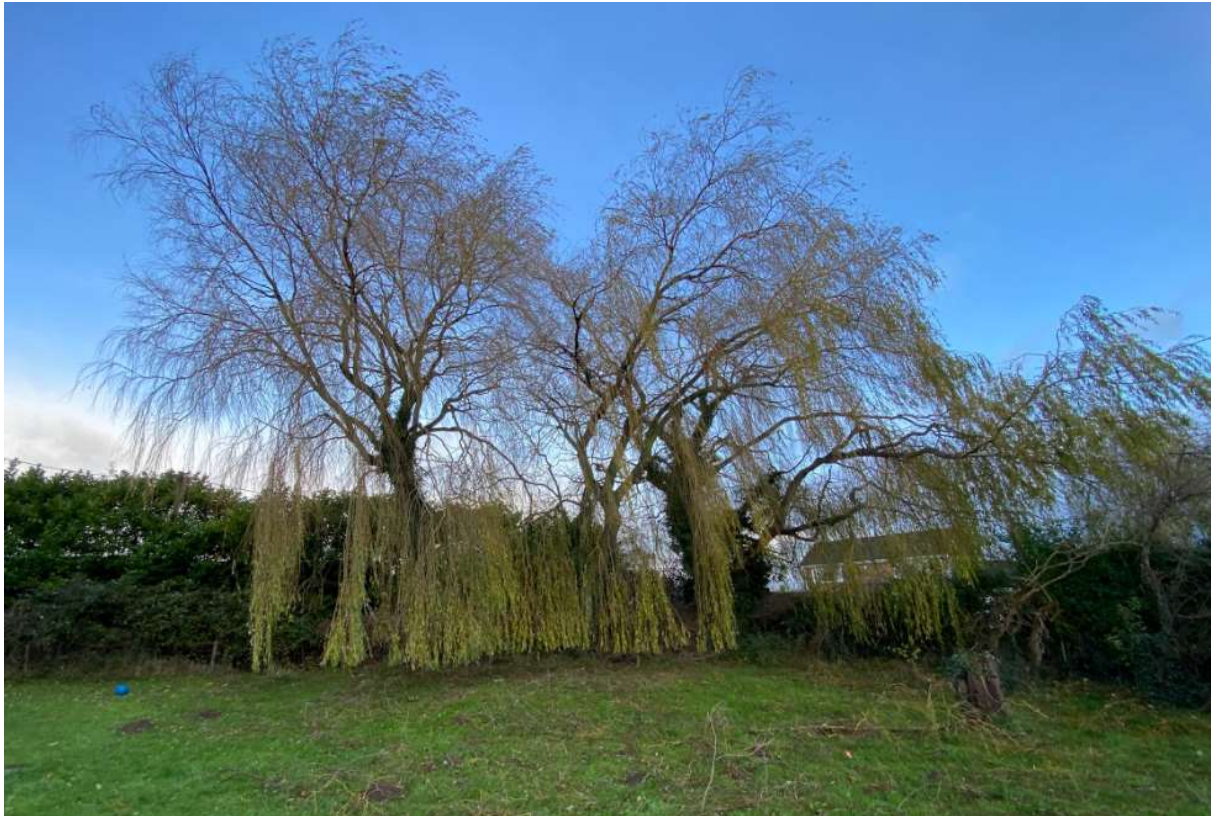
*Photographic plate showing trees T6-T8, unaffected by proposals.*

| Tree or Tree Group | Impacts |
|---|---|
| Trees T6, T7, & T8 | No direct impacts. Trees will require protective fencing during the construction phase. |
