**Higher Oak**  
on behalf of Mrs Alex Bould  
**Bat Mitigation Statement**

| Document Control | | | | |
|---|---|---|---|---|
| Project Name: | | Higher Oak | | |
| Report Title: | | Bat Mitigation Statement | | |

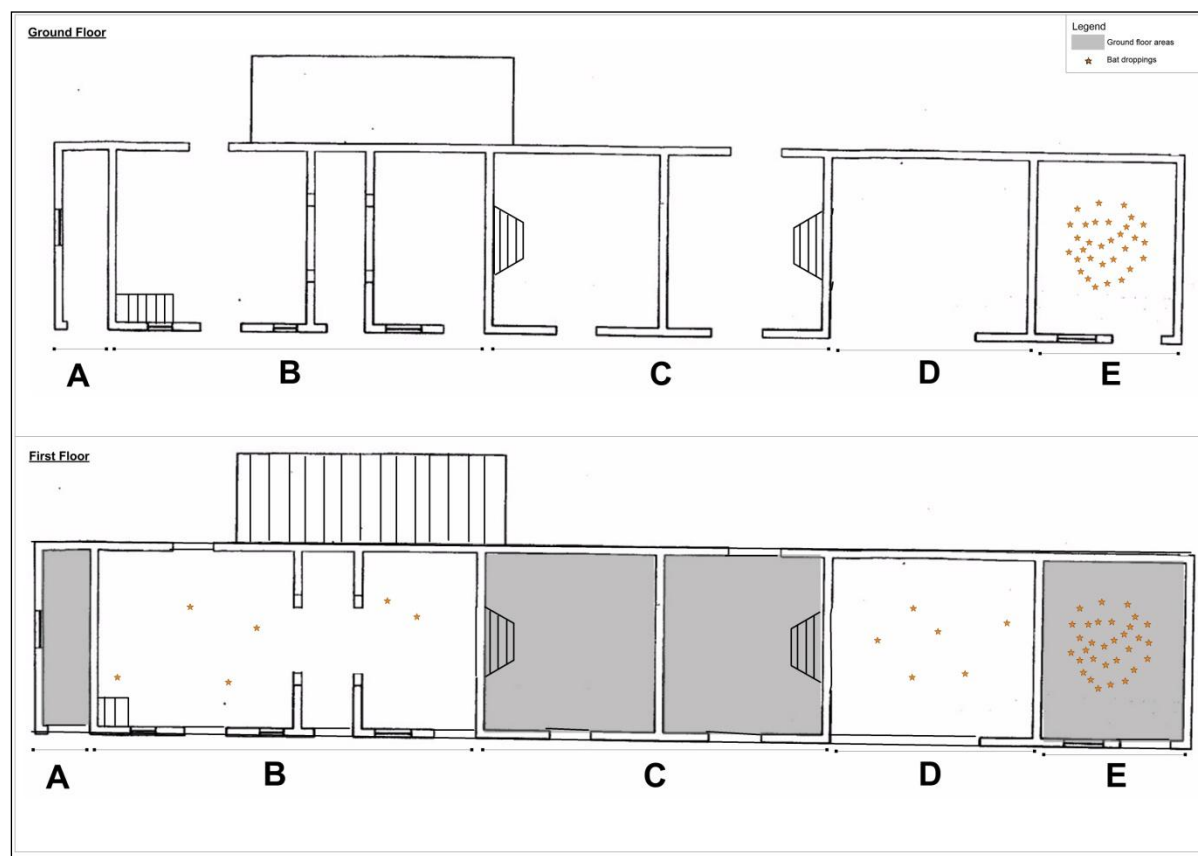
**Figure 4.1 Preliminary Roost Assessment**

4.1.1 A small number of bat droppings were found scattered throughout the majority of the first floor area of the barn (Areas A – D in **Figure 4.1**) and several moth wings were also present (indicative of feeding remains). The ground floor areas were being used for storage which made detailed visual inspection in these areas more difficult. More evidence of roosting bats was found within the section of the barn at the far eastern end (Area E) which is separated by an internal structural wall from the main section of the barn. A concentration of bat droppings of differing ages was found on top of stored materials in Area E indicating regular use by bats.

4.1.2 Evidence of roosting bats as identified during the PRA is shown on **Figure 4.1**.

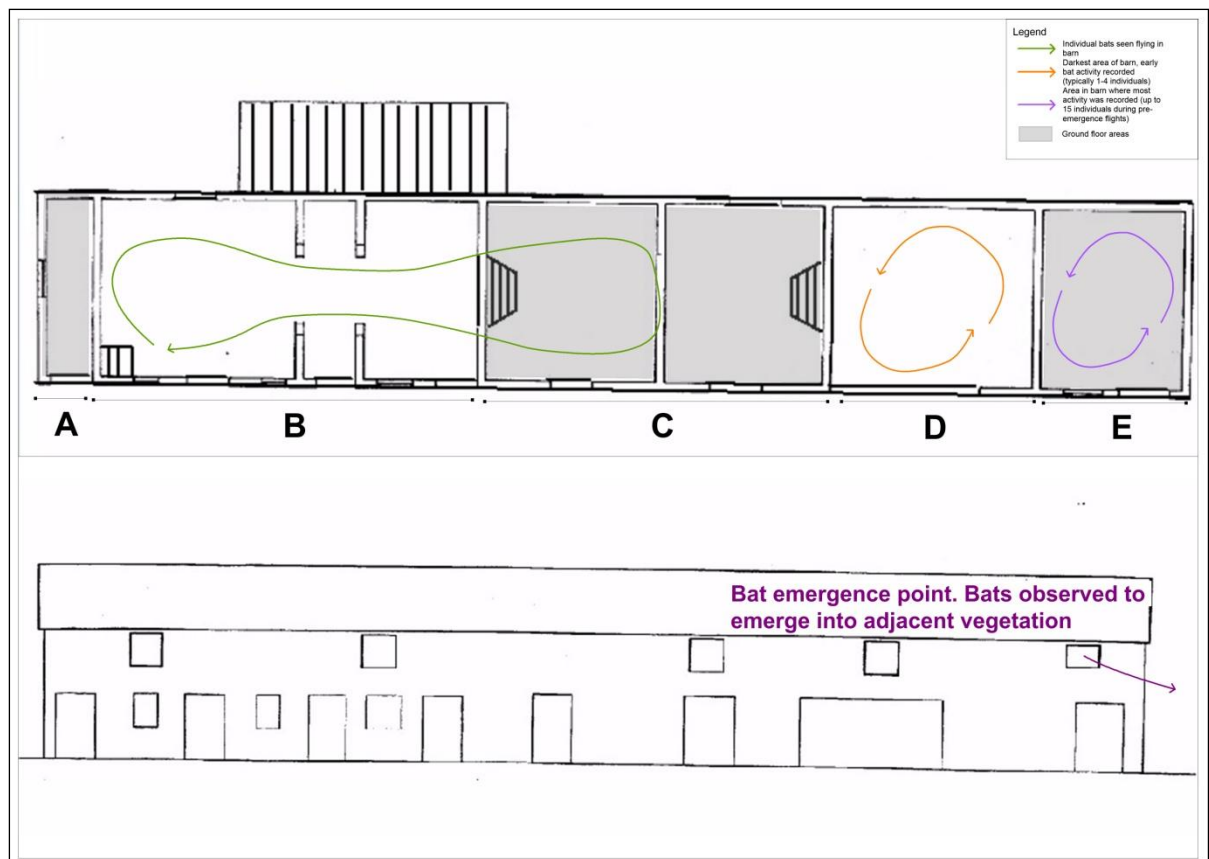
**Figure 4.2 Presence or Absence Surveys**

- 4.2.4 On arrival at site (approximately 30 minutes before sunset) on the 1<sup>st</sup> September 2016 for a dusk survey, the barn was entered and four bats were observed flying around the first floor area of Area D. This was notably darker than the rest of the barn due the lack of external windows or doorways. No other bat activity was observed within the barn prior to the commencement of the emergence surveys. The emergence observations would then indicate that pre-emergence flight concentrates in Area E (See **Figure 4.2**).

- 4.2.6 Emerging bats were seen to leave through an open window aperture (i.e. where just a wooden frame was present) located high up on the front wall at the eastern end of the barn (See **Figure 4.2** and **Photo 8, Appendix 2**). The emergence point is located within approximately 1-2m of adjacent vegetation and this end of the barn is partially sheltered by tree canopy (which results in this area getting darker earlier than the surrounds) allowing the brown long-eared bats to emerge directly into a sheltered trees / woodland.

- 4.2.7 Bat activity observed during the Presence or Absence surveys is illustrated on **Figure 4.2**

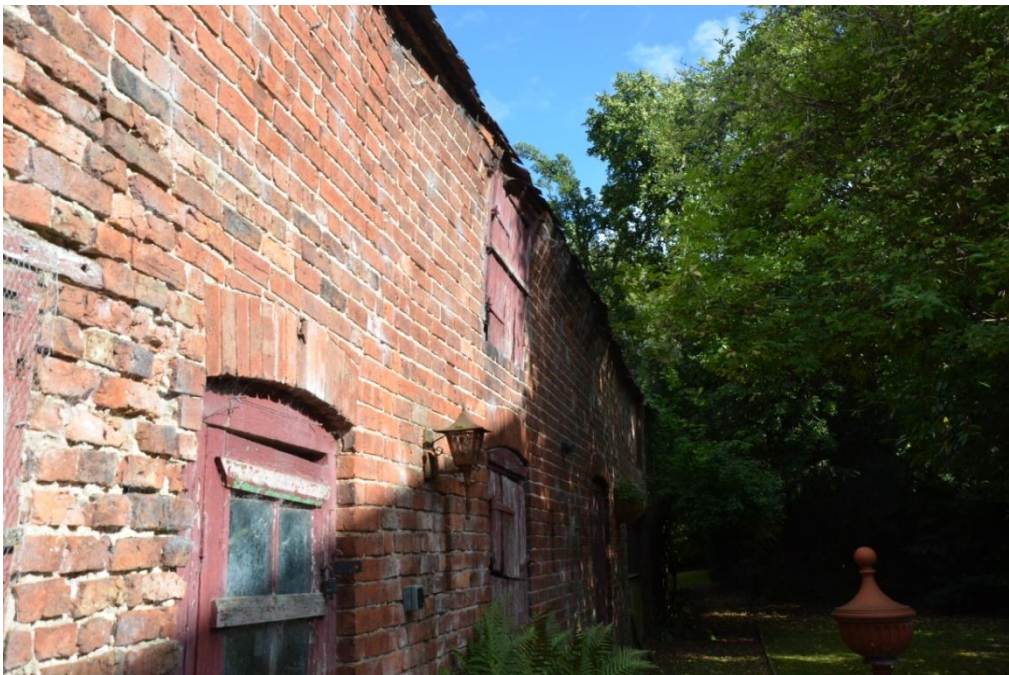
- 2.1.4 In September 2016 a partial collapse of an external wall occurred; bricks from the upper wall above a doorway falling into the adjacent courtyard / garden area. A further structural survey was undertaken and this concluded that this collapse had resulted from ongoing roof spread where the eaves wall plate had pushed out and in turn pushed the outer skin of brickwork below the eaves. From a structural viewpoint and with continuation of movement, repairs were recommended immediately from a Health and Safety perspective.

**Photo 2** - Front elevation of Higher Oak Barn showing bowing at the top of the external wall beneath the eaves prior to structural repair works.

- 2.1.5 Structural repairs were undertaken in December 2016 under a European Protected Species (EPS) licence issued by Natural Resources Wales (NRW). Sections of the outer wall were taken down and rebuilt and the wooden roof structure was braced. The barn is now considered to be structurally sound in the short to medium term, but is likely to further deteriorate over time if left in its current state.

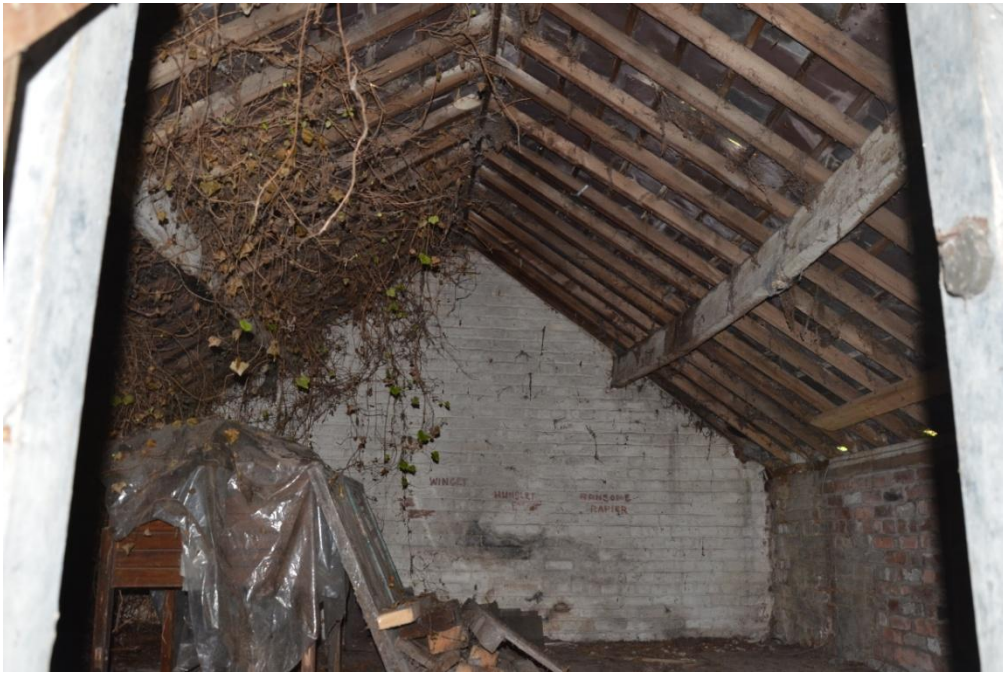
**Photo 4** - Internal view of Area D. This room was notably darker earlier than other areas of the barn lacking external windows and doors.

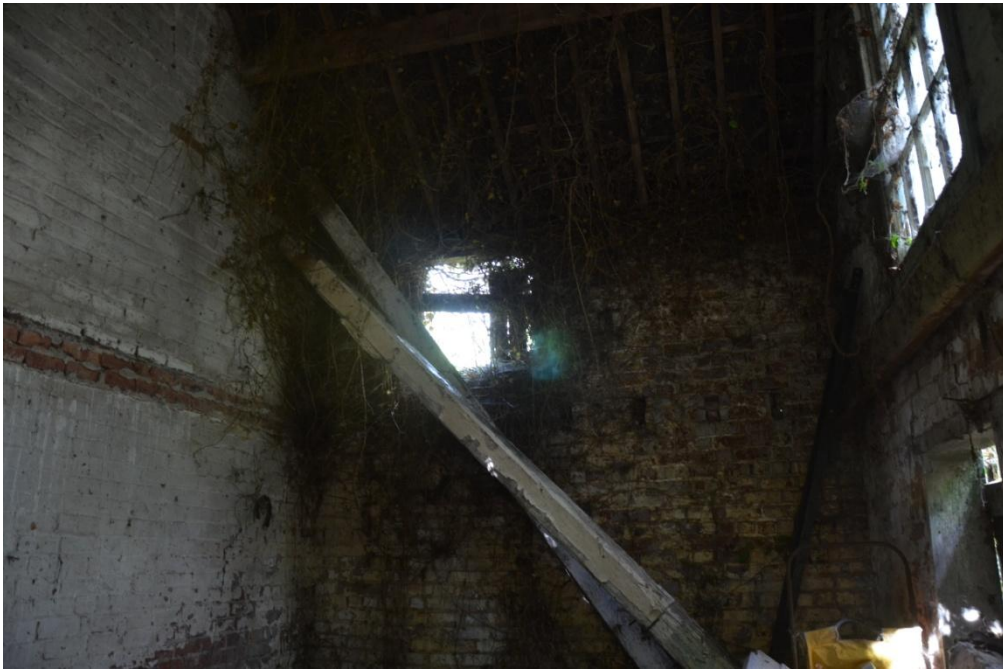
**Photo 5** - Internal view of Area E. The majority of the bat activity / pre-emergence flight was observed in this area of the barn.

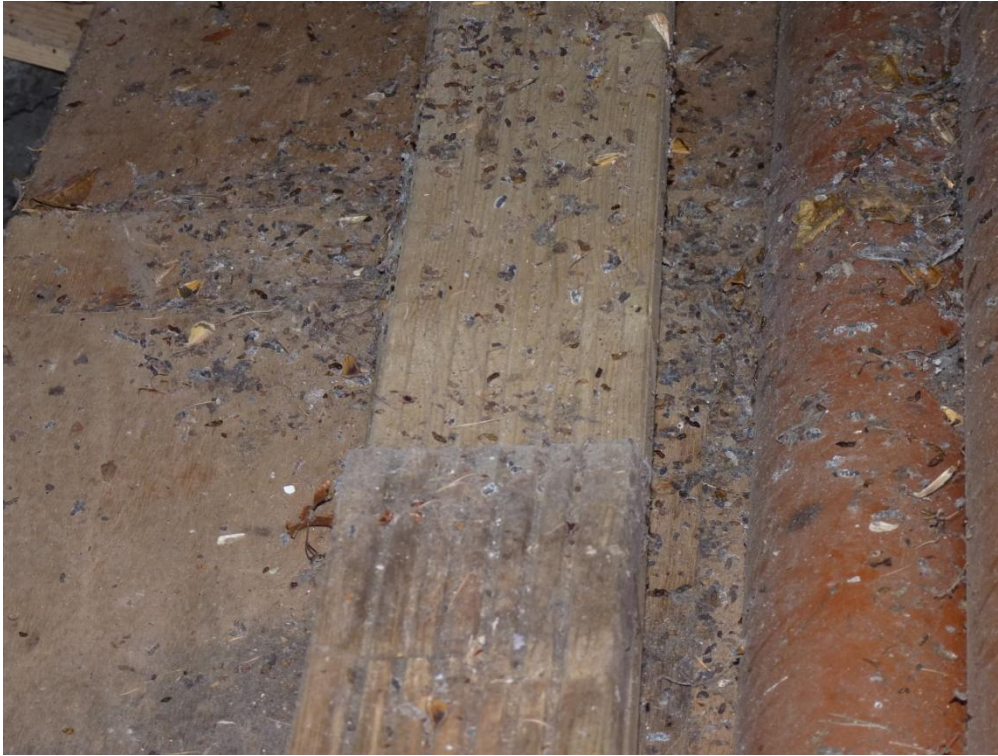
**Photo 7** – Bat droppings and moth wings on stored material in Area E.

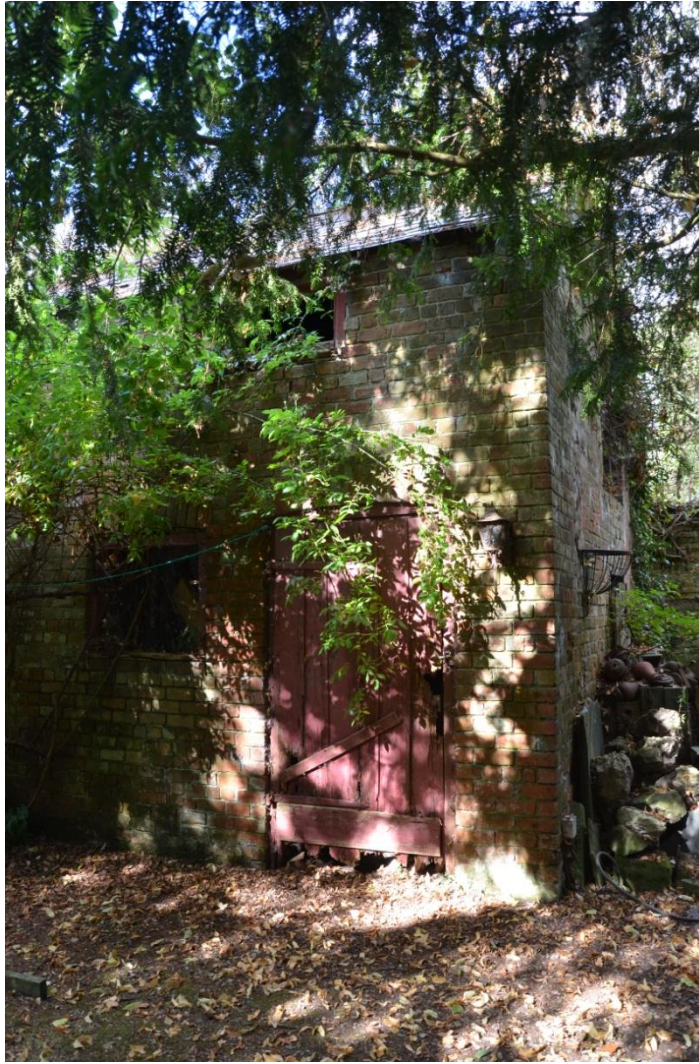
- 4.3.4 Emergence was observed from a window located high on the front elevation of the barn at the eastern end of the barn (Area E). The location of the emergence / access point is shown in **Figure 4.2 (Photo 8)** with emergence flight observed directly into adjacent vegetation.

**Photo 8 –**  
External view of  
the eastern end  
of the barn. The  
window high on  
wall was the  
observed  
emergence  
point.
