**BAT SURVEYS AT  
GWERN-Y-TO, SHOCKLACH LANE,  
WORTHENBURY, WREXHAM  
2018**

**RACHEL HACKING ECOLOGY**

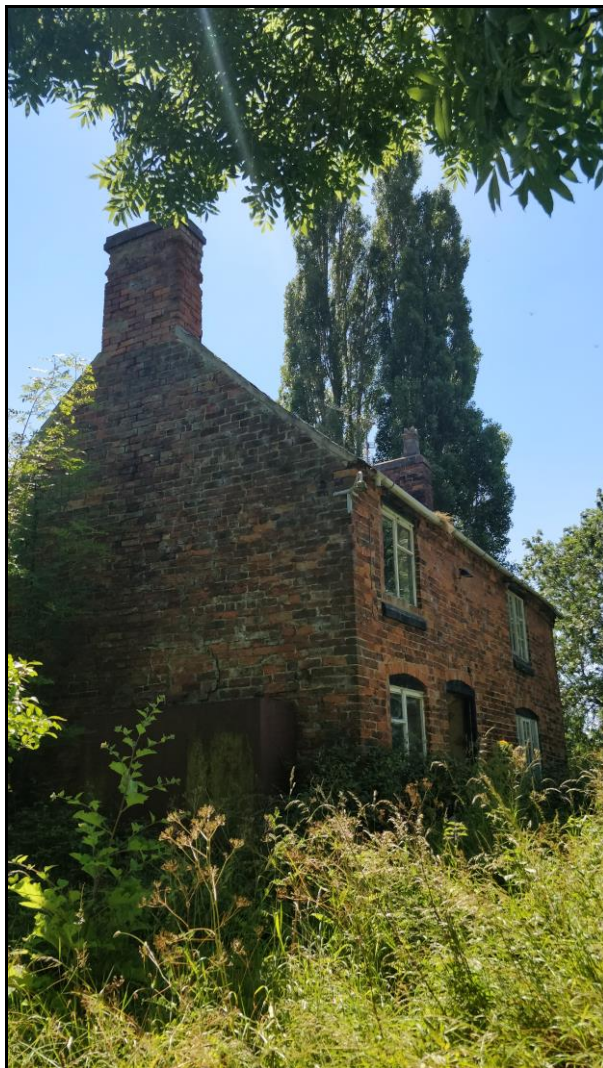
- 3.2 The detached dwelling is an old farmhouse (see Photograph 1), which has been unoccupied. It is two-storey in height with a small brick-built extension to the rear (see Photograph 2). The window frames and door frames are wooden and are starting to rot. No soffits or barge boards exist on this property. The guttering is coming away from the walls in many places

**Photograph 1 showing the detached dwelling**

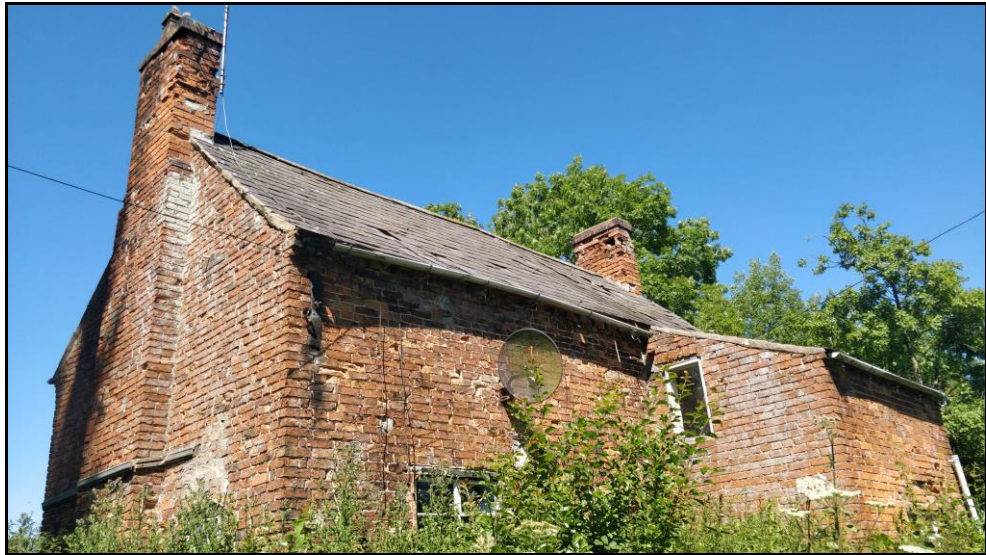
**Photograph 2 showing the rear of the detached dwelling**

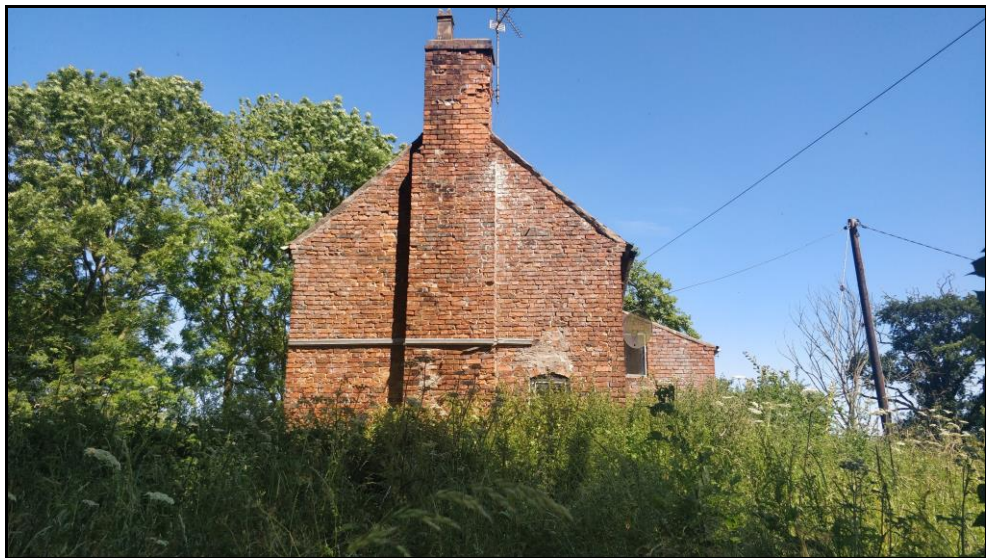
- 3.3 The brickwork is in worse repair in 2018 than in 2014. Brick faces have crumbled and mortar is missing, particularly on the chimneys (see Photograph 3). Mortar is also missing at the roof edges.

**Photograph 3 showing the gable end and chimney stack**

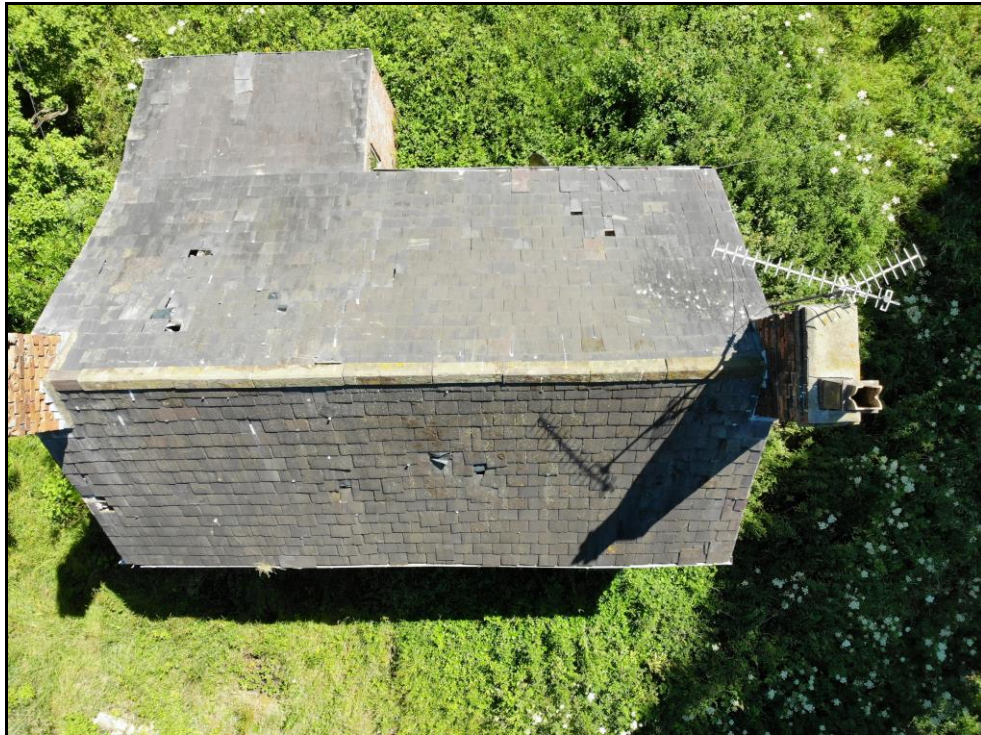
- 3.4 The roof is in a worse state of repair than in 2014, with many missing tiles (see Photograph 4)

**Photograph 4 showing the roof of the farmhouse**

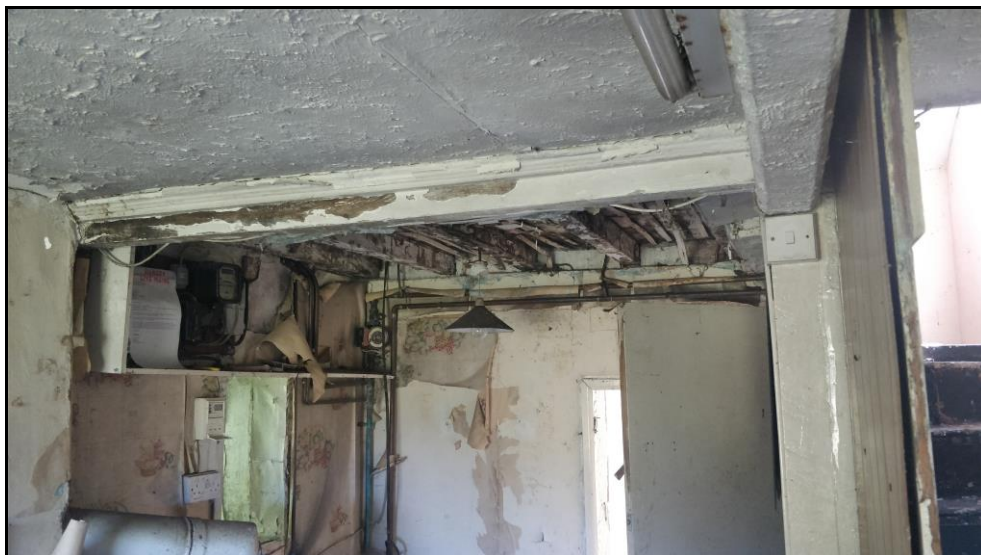
- 3.5 The property had been stripped (e.g. ceilings removed and plaster removed in places) prior to the 2014 survey and no work has taken place to the interior since then. Interior walls remain standing. Mould and damp occur throughout. The ground floor rooms are cold and damp (see Photograph 5), with peeling wallpaper. No evidence of bat activity was found on the ground floor.

**Photograph 5 showing part of the ground floor of the farmhouse**

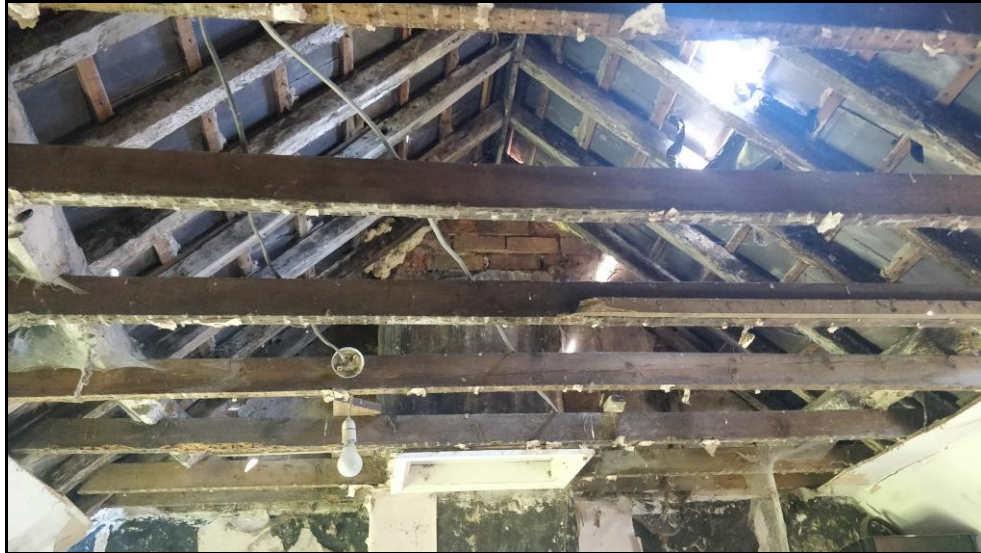
- 3.6 Extensive water damage has occurred, making the stairs and upstairs flooring unsound although access was still possible. The ceilings within the first floor have been removed, allowing the whole interior roof to be viewed (see Photograph 6). There are more missing tiles than in 2014, allowing more daylight and rainwater in.

**Photograph 6 showing the roof and ceiling joists**

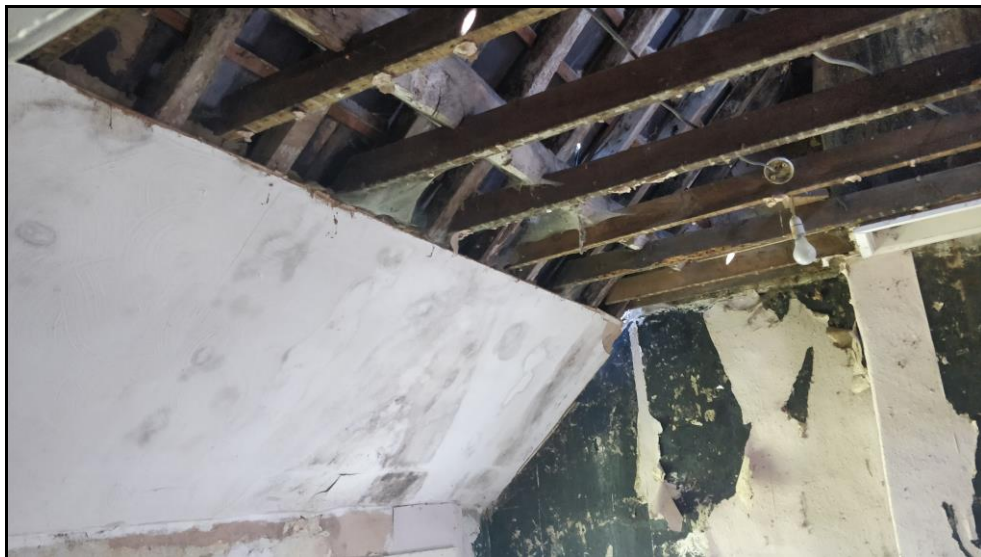
- 3.7 The wooden beams, roof and ceiling joists are intact, with no cracks or gaps evident. They are becoming mouldy due to water ingress. Where small parts of ceiling plasterboard remain, these could be easily inspected behind (see Photograph 7).

**Photograph 7 showing plasterboard and wooden beams**

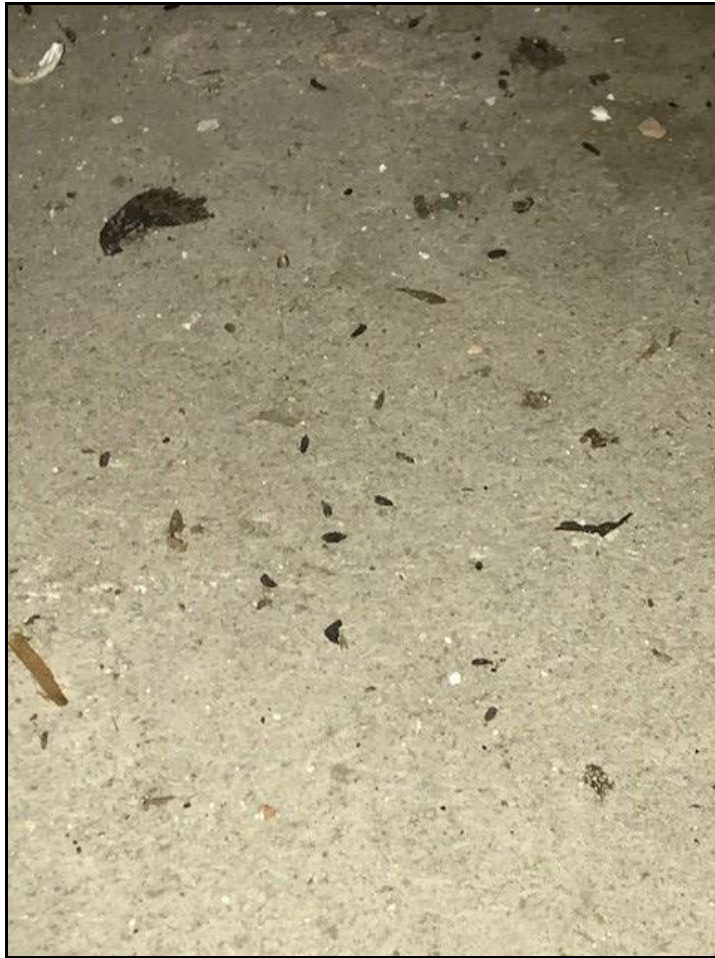
- 3.8 Scattered bat droppings and feeding remains (butterfly wings) were found again throughout the first floor, scattered on the floorboards (see Photograph 8). This is the same result as in 2014.

**Photograph 8 showing bat droppings and feeding remains**

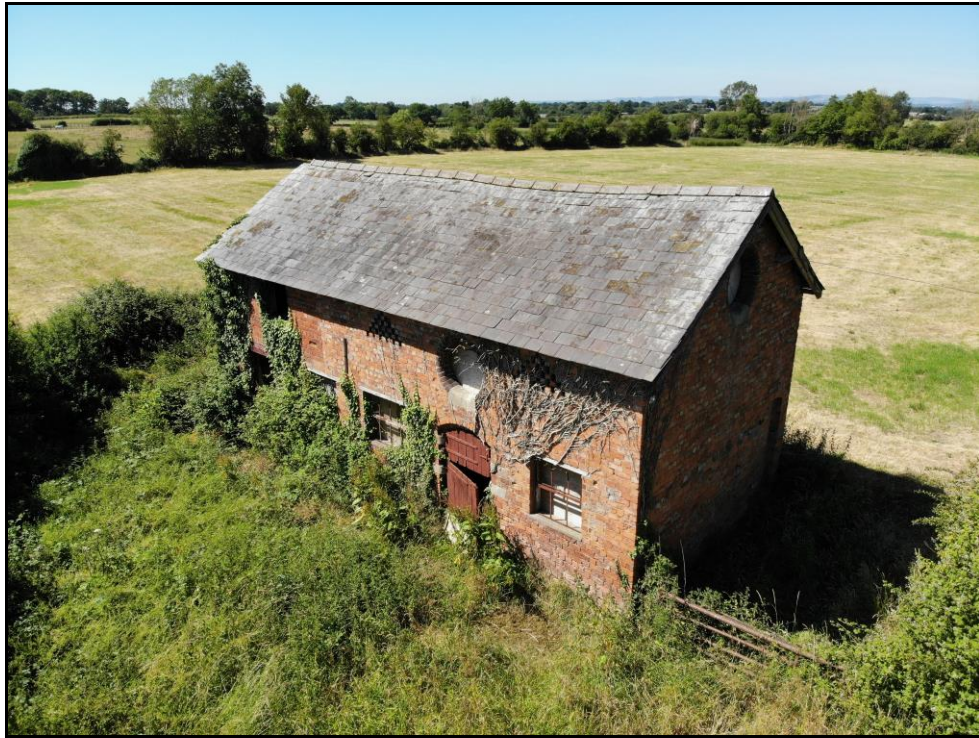
- 3.9 The barn is two-storey in height, of brick construction, with many repairs apparent (see Photograph 9). It has a pitched slate tile roof. The windows and doors were sealed with wooden boards (see Photograph 10) but these are no longer well-sealed. The door is permanently ajar and an upstairs window is completely open. Vegetation is now establishing across the exterior of the brickwork. Mortar is crumbling in places and the a small number of roof tiles have slipped.

**Photograph 9 showing the barn**

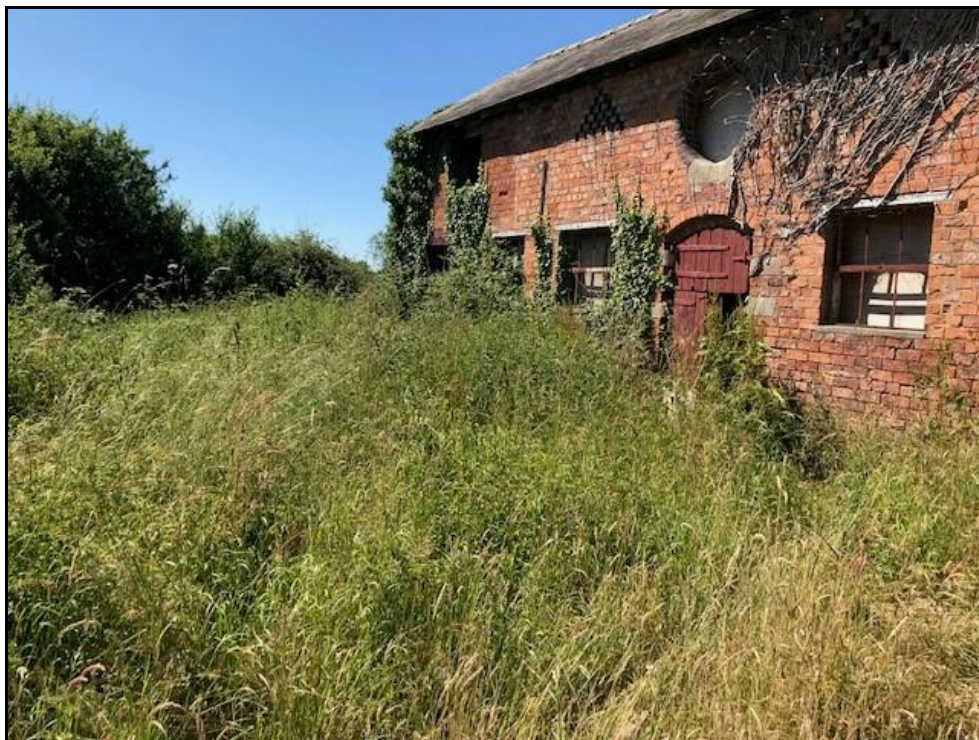
**Photograph 10 showing the front of the barn**

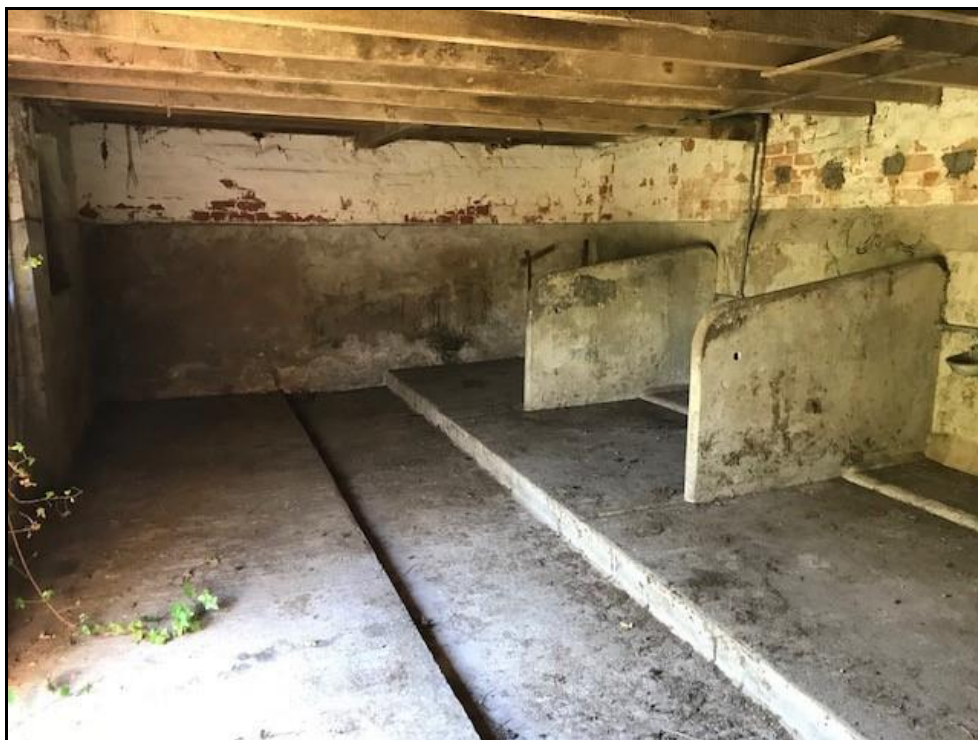
- 3.10 The barn was stripped prior to the 2014 daytime bat survey, with some ceilings removed. No work has taken place since then. The ground floor has concrete floors and walls (see Photograph 11). Cattle pens are still evident. The remaining wooden ceiling beams are intact, with no cavities suitable roosting bats. A small number of bat droppings were found scattered on the floor.

**Photograph 11 showing the ground floor of the barn**

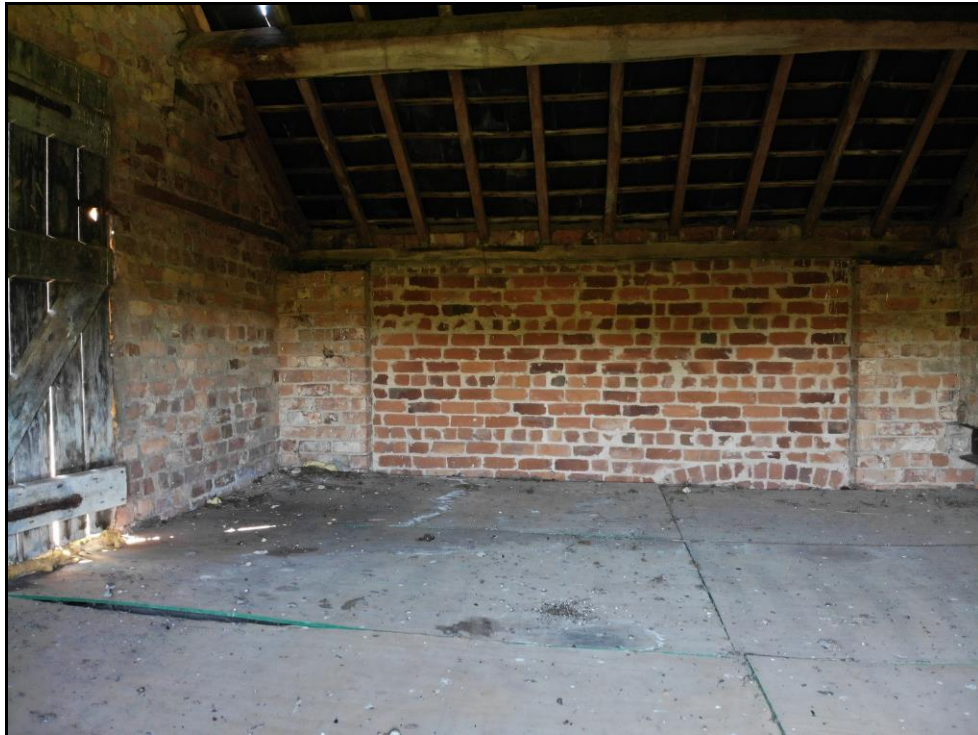
- 3.11 Part of the first floor of the barn was accessed by drone (see Photograph 12). Evidence of bird activity was noted (droppings) and daylight can be seen in many places, such as through slipped roof tiles and at the edges of the hay door and windows. Where access was possible, scattered bat droppings were found on the floor. This is the same result as in 2014.

**Photograph 12 showing the first floor of the barn**

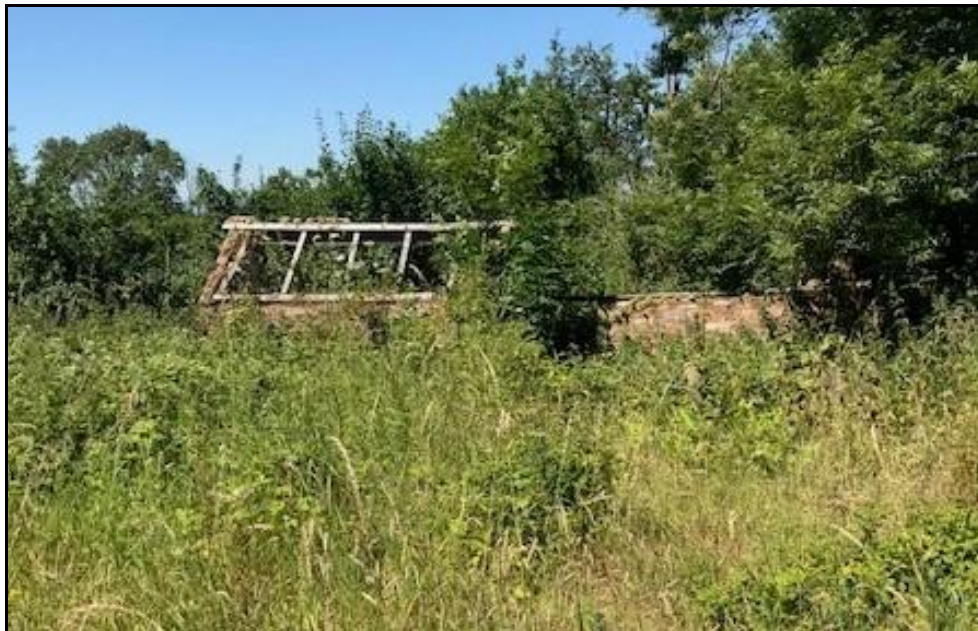
- 3.12 A dilapidated shippon still exists on the site. This has no roof (see Photograph 13) and is now nearly completely covered with vegetation. This was inspected and found to support no suitable roosting areas for bats.

**Photograph 13 showing the dilapidated shippon**

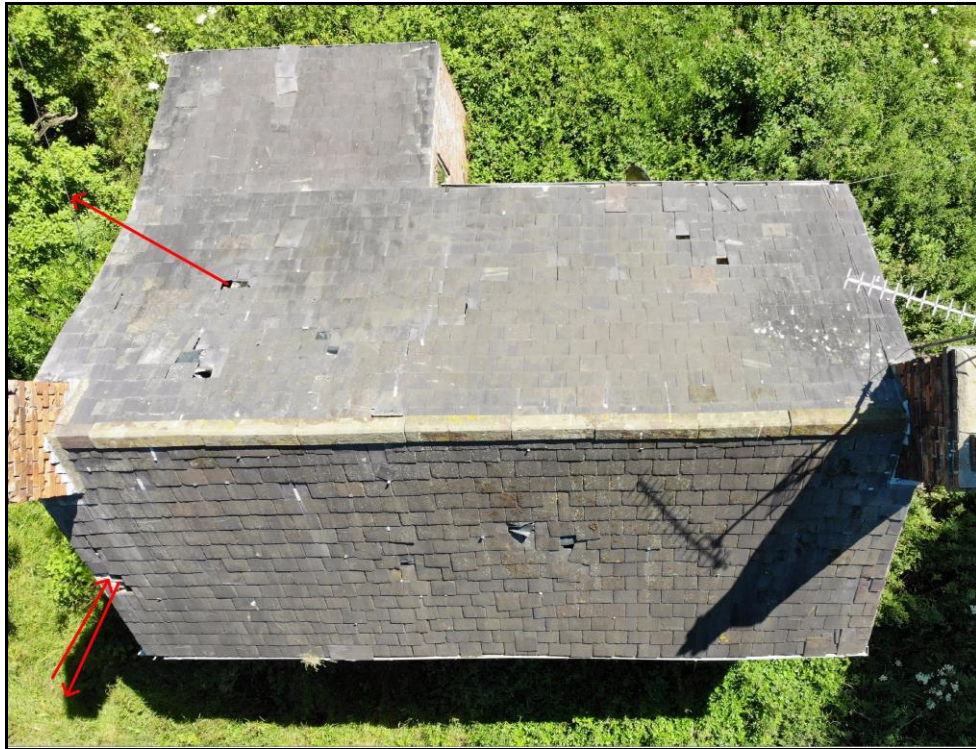
**Figure 2 showing the emergence and re-entry points at the farmhouse (red arrows). All bats emerged and re-entered the holes in the roof at the western end of the building**

- 4.3 A Mitigation Bat Licence from Natural Resources Wales will be required before any work can proceed on the farmhouse or the barn. This can only be applied for once full planning permission is granted.

- 2 x 2F Schwegler Crevice Bat Boxes to be erected onto the converted barn exterior or suitable retained trees following completion of the works. These will be erected more than 3 metres above ground, facing south, south-west or south-east.

- 4.5 The licence will include a method statement, excluding the bats prior to work commencing on the property and using methodologies such as soft-stripping under ecological supervision. There is no restriction on the timing of the works, given that the roost is a day roost.

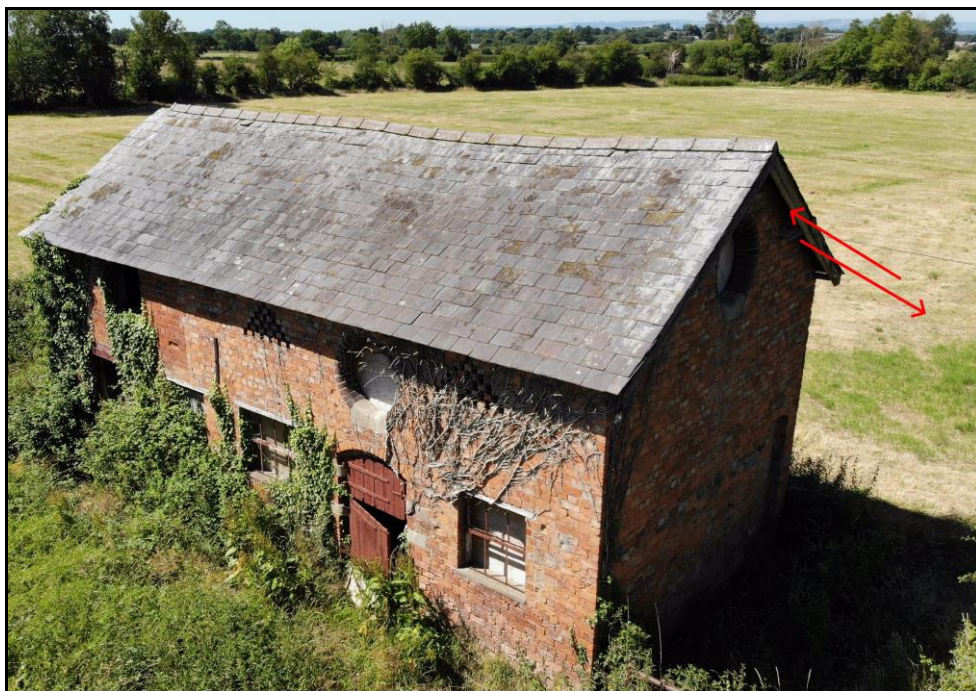
**Figure 3 showing the emergence and re-entry points at the barn (red arrows). All bats emerged and re-entered the roof eave at the western gable end**
